Sister Rod Destructive Examinations (FY22)

Appendix F: Cyclic Integrated Reversible- Bending Fatigue Tests

Oak Ridge National Laboratory

M2SF-23OR010201024 ORNL/TM-2022/2733

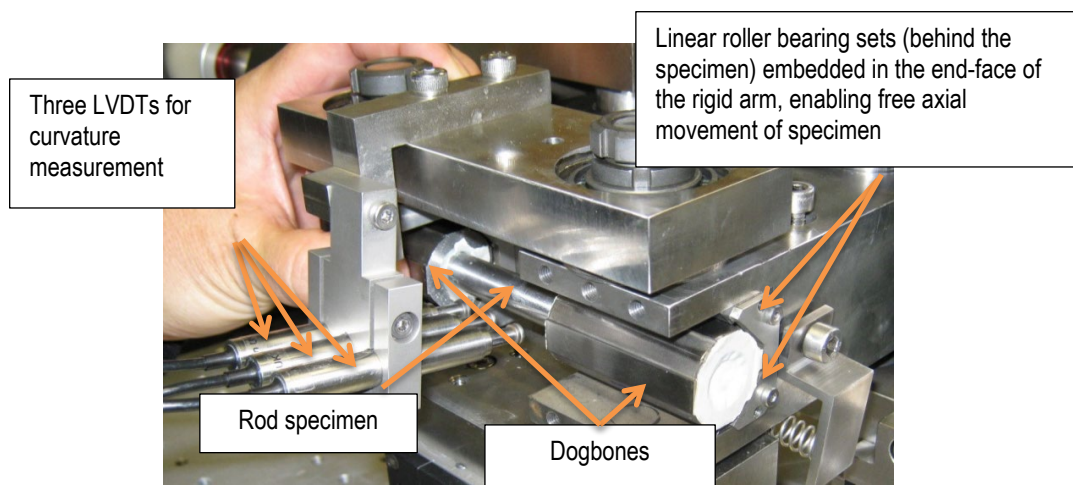
Figure F-3. Image showing the grip design of CIRFT with one end-block removed.

The distances built into the CIRFT machine and the length of the segment dogbone are important because they are used to calculate all load, moment, and curvature values. Important fixed physical distances include the length of the U-frame arms (101.60 mm) and the location and contact geometry of the LVDTs. Also, the motor's recorded stroke length during the test is directly applied in the data reduction, and the SNF rod outer diameter (OD) is used to calculate strain and stress.

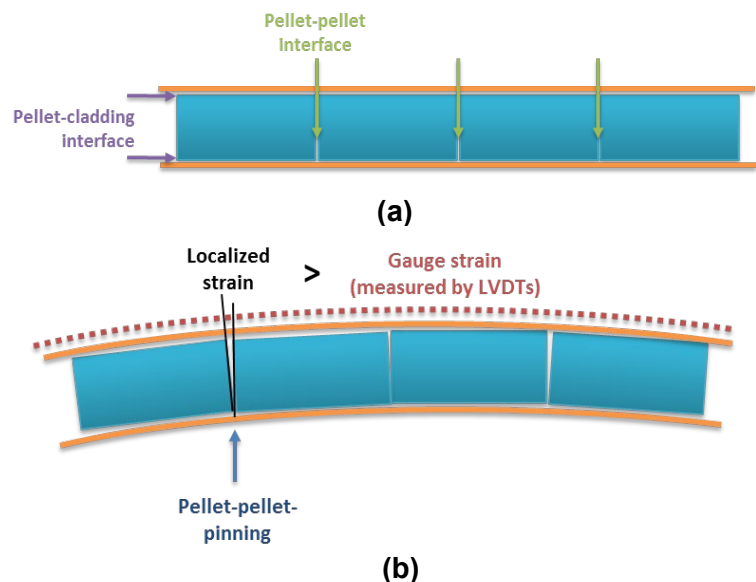
Figure F-6. Cladding and pellet stack (a) in the neutral position and (b) in bending. [F-5]

Wang and Wang further explored the shift in the neutral axis that occurs during pinning. The neutral axis shifts constantly with each cycle, but the maximum strain still occurs at the outer radius of the cladding.

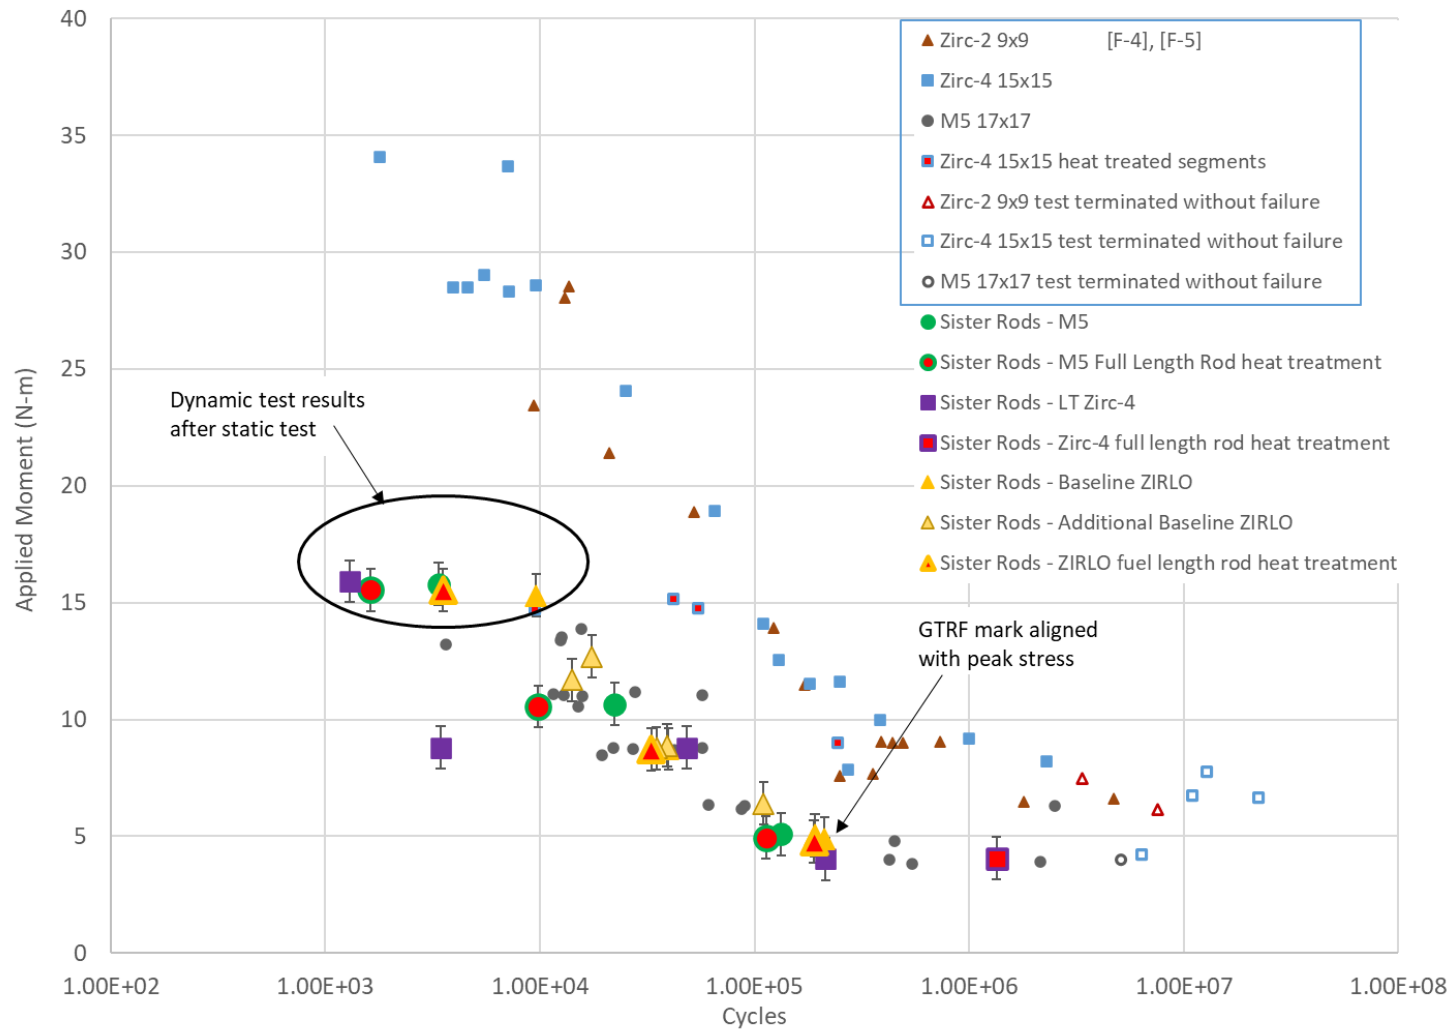
The error bars on the sister rod data represent the calculated uncertainty (0.8 N-m) in Section G-3.3, Appendix G (non-sister rod data from [F-4], [F-5])

Figure F-10. Results of CIRFT tests plotted with reference data, applied moment vs. cycles to failure.

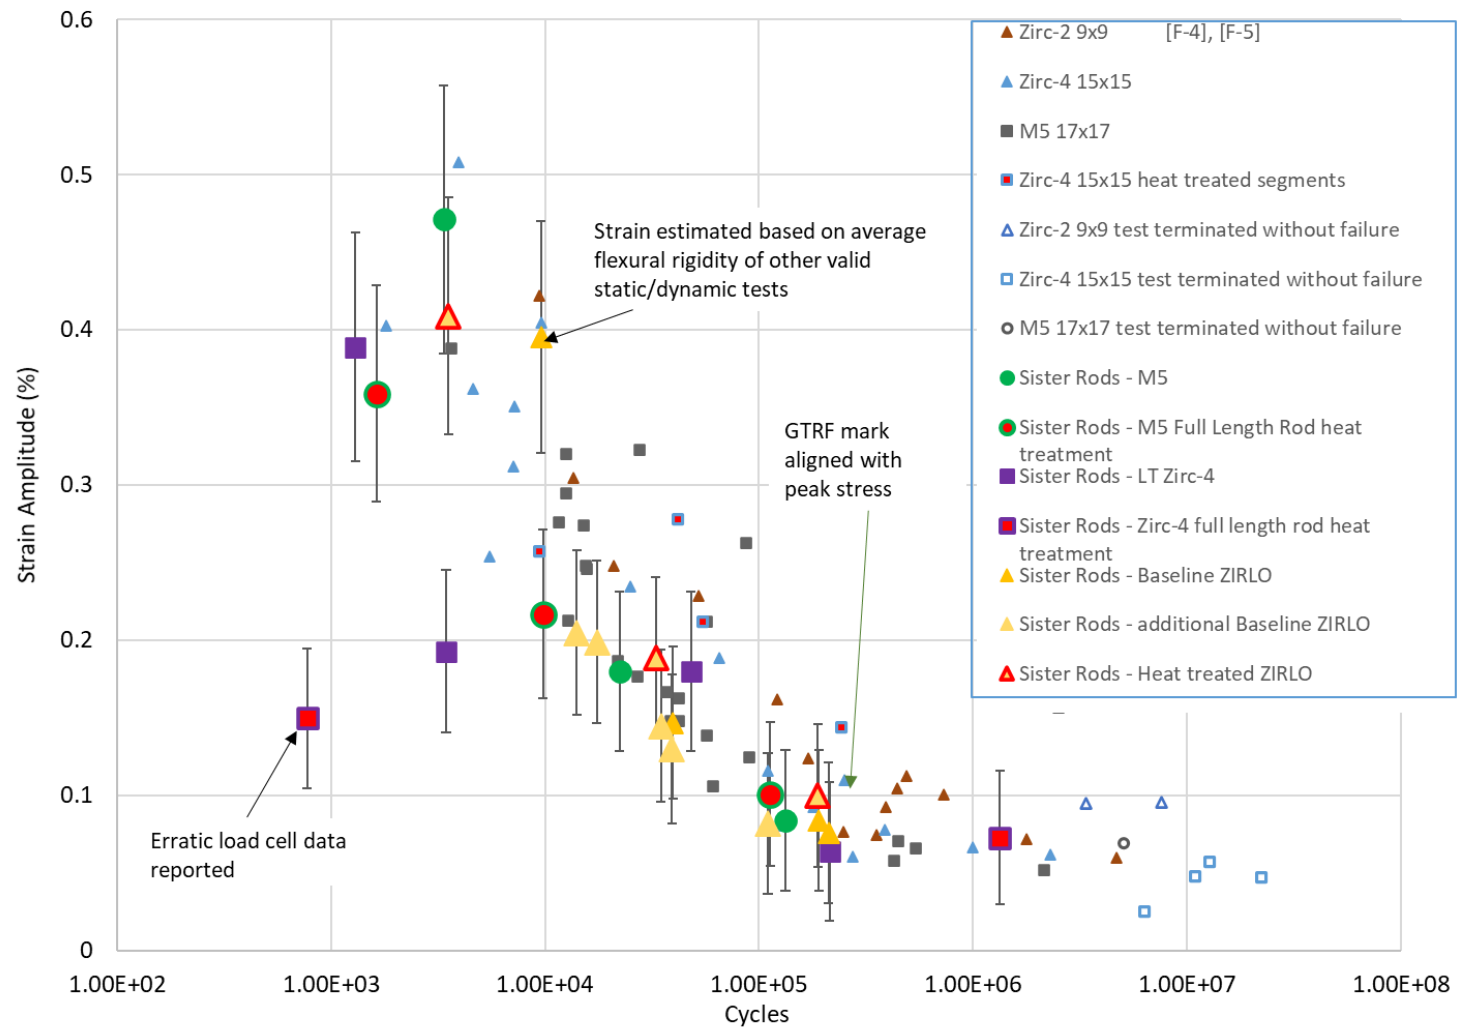
The error bars on the sister rod data represent the calculated uncertainty in Section G-3.4, Appendix G (non-sister rod data from [F-4], [F-5]).

Figure F-11. Results of CIRFT tests completed to date, strain amplitude vs. cycles to failure.

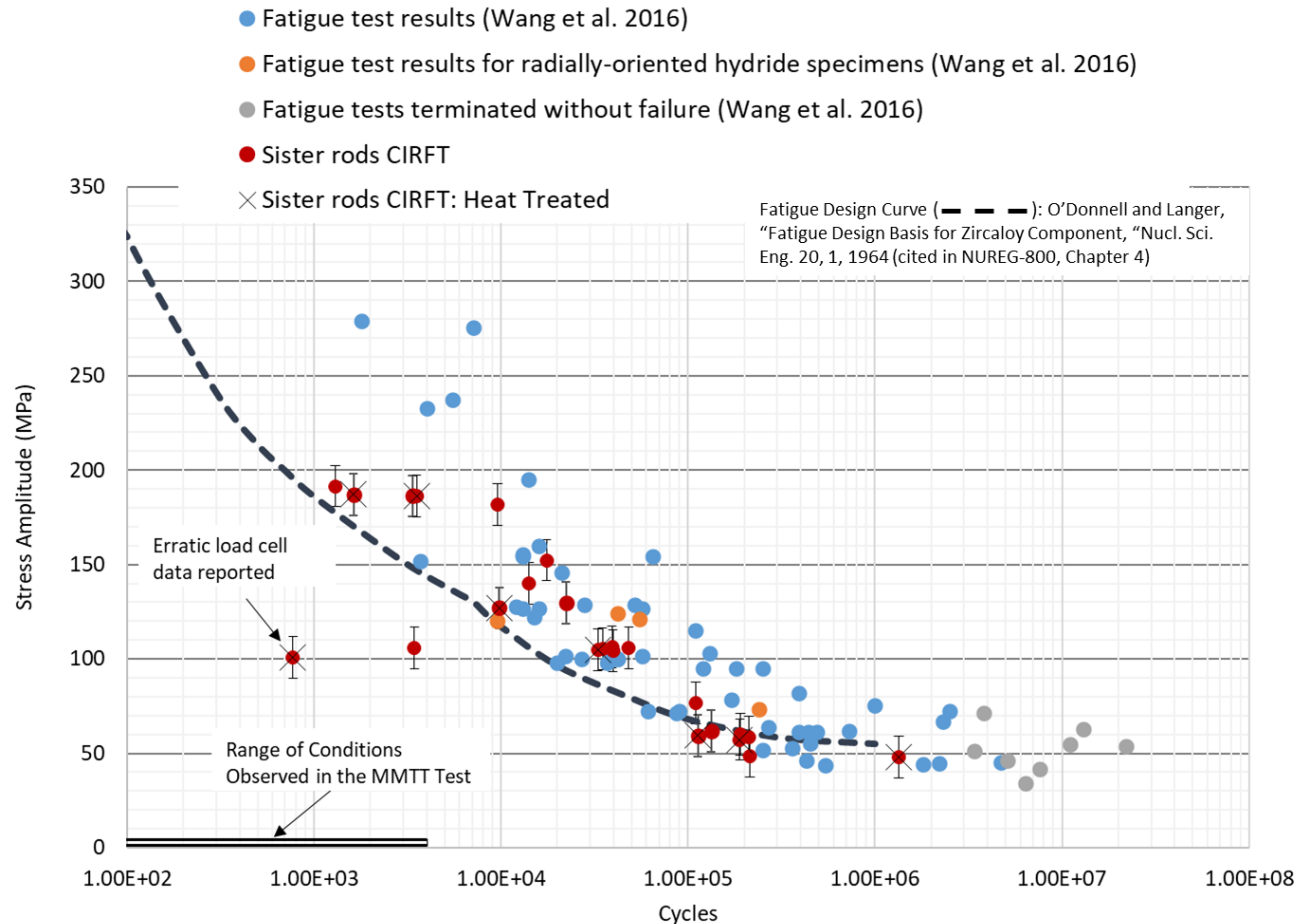
The error bars on the sister rod data represent the calculated uncertainty in Section G-3.5, Appendix G.

Figure F-12. Stress amplitude of the composite rod based on Eq. (F-7), as a function of cycles to failure for the sister rods. The stresses representing the conditions observed in the MMTT test are calculated based on measured strains: 1 MPa for the lower strain of 0.001% (or 10 μ strain) [F-25], which is the minimum strain of the highest 4000 cycles observed, and 4.2 MPa for the upper strain of 0.0042% (or 42 μ strain), which is the maximum strain observed during TTCI testing [F-16].

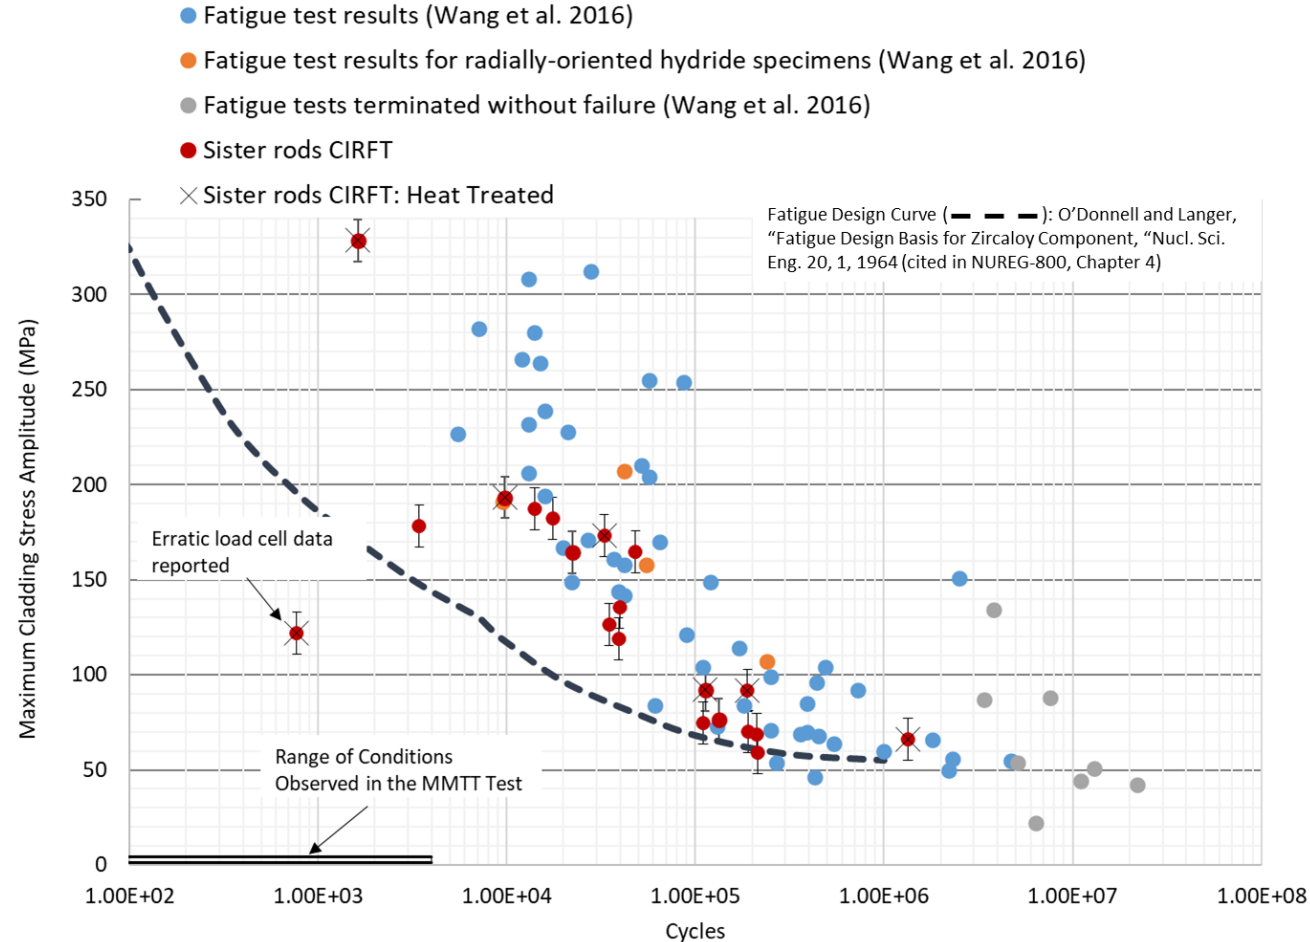
The error bars on the sister rod data represent the calculated uncertainty in Section G-3.5, Appendix G.

Figure F-13. Cladding stress amplitude as a function of cycles to failure for the sister rods. The stresses representing the conditions observed in the MMTT test are calculated based on measured strains: 1 MPa for the lower strain of 0.001% (or 10 μ strain) [F-25], which is the minimum strain of the highest 4000 cycles observed, and 4.2 MPa for the upper strain of 0.0042% (or 42 μ strain), which is the maximum strain observed during TTCI testing [F-16].

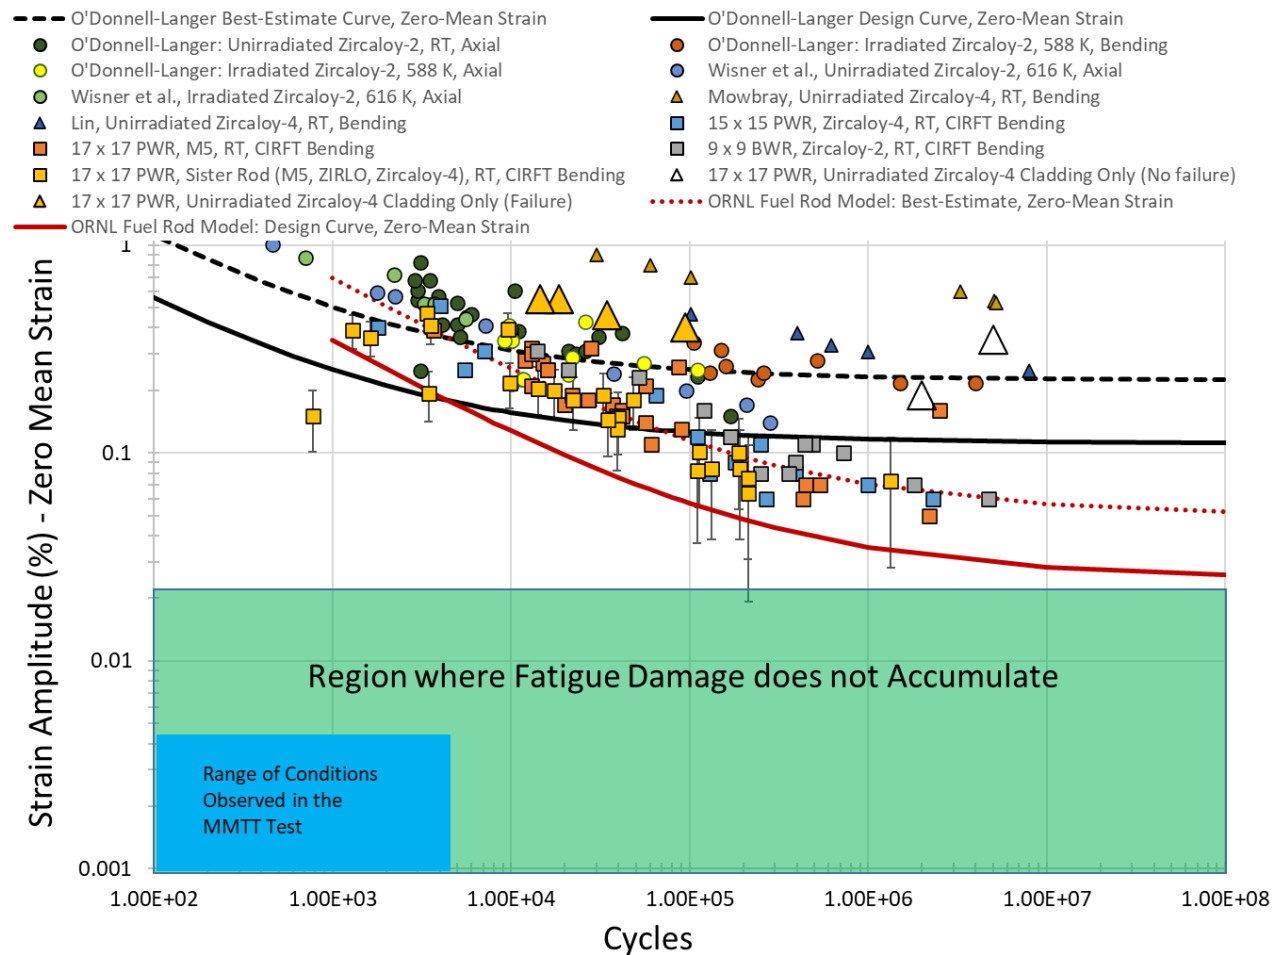
The error bars on the sister rod data represent the calculated uncertainty in Section G-3.5, Appendix G.

Figure F-14. Strain amplitude as a function of cycles to failure for the sister rods compared to the fatigue data on cladding alloys from Figure F-7 and the proposed ORNL fatigue limit for fuel rods. [F-24] The strains representing the conditions observed in the MMTT test are based on measured strains: the lower strain is 0.001% (or 10 μ strain) [F-25], which is the minimum strain of the highest 4000 cycles observed, and the upper strain is 0.0042% (or 42 μ strain), which is the maximum strain observed during TTCI testing [F-16].

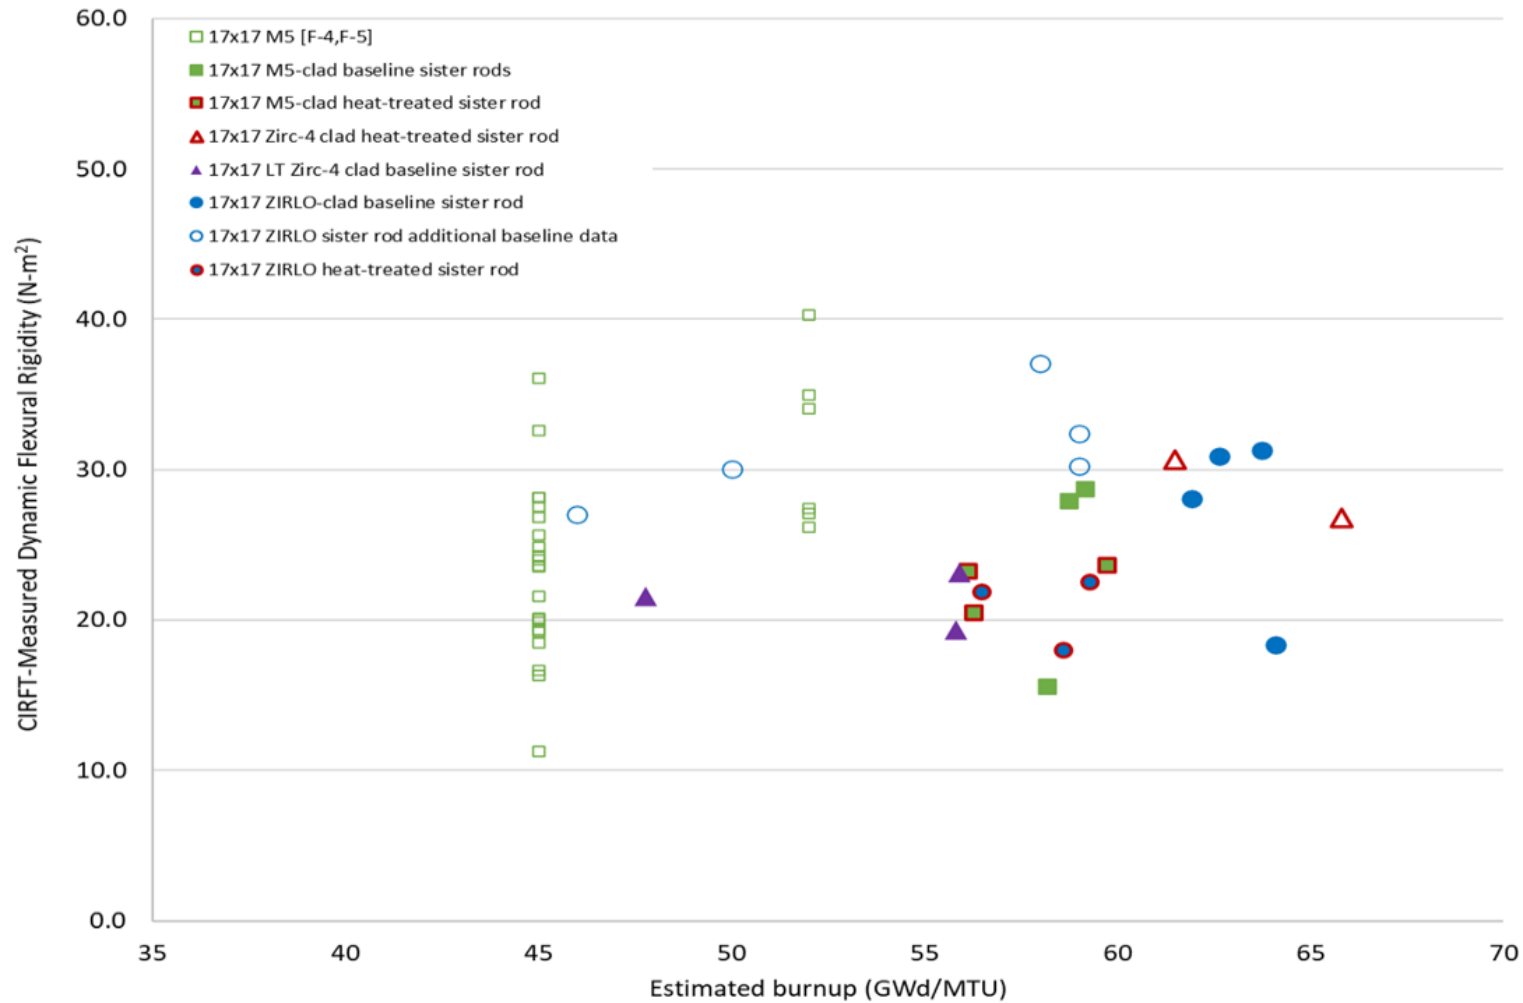
Figure F-15. CIRFT-measured flexural rigidity of the sister rod segments tested as a function of estimated segment burnup plotted with previous CIRFT data.

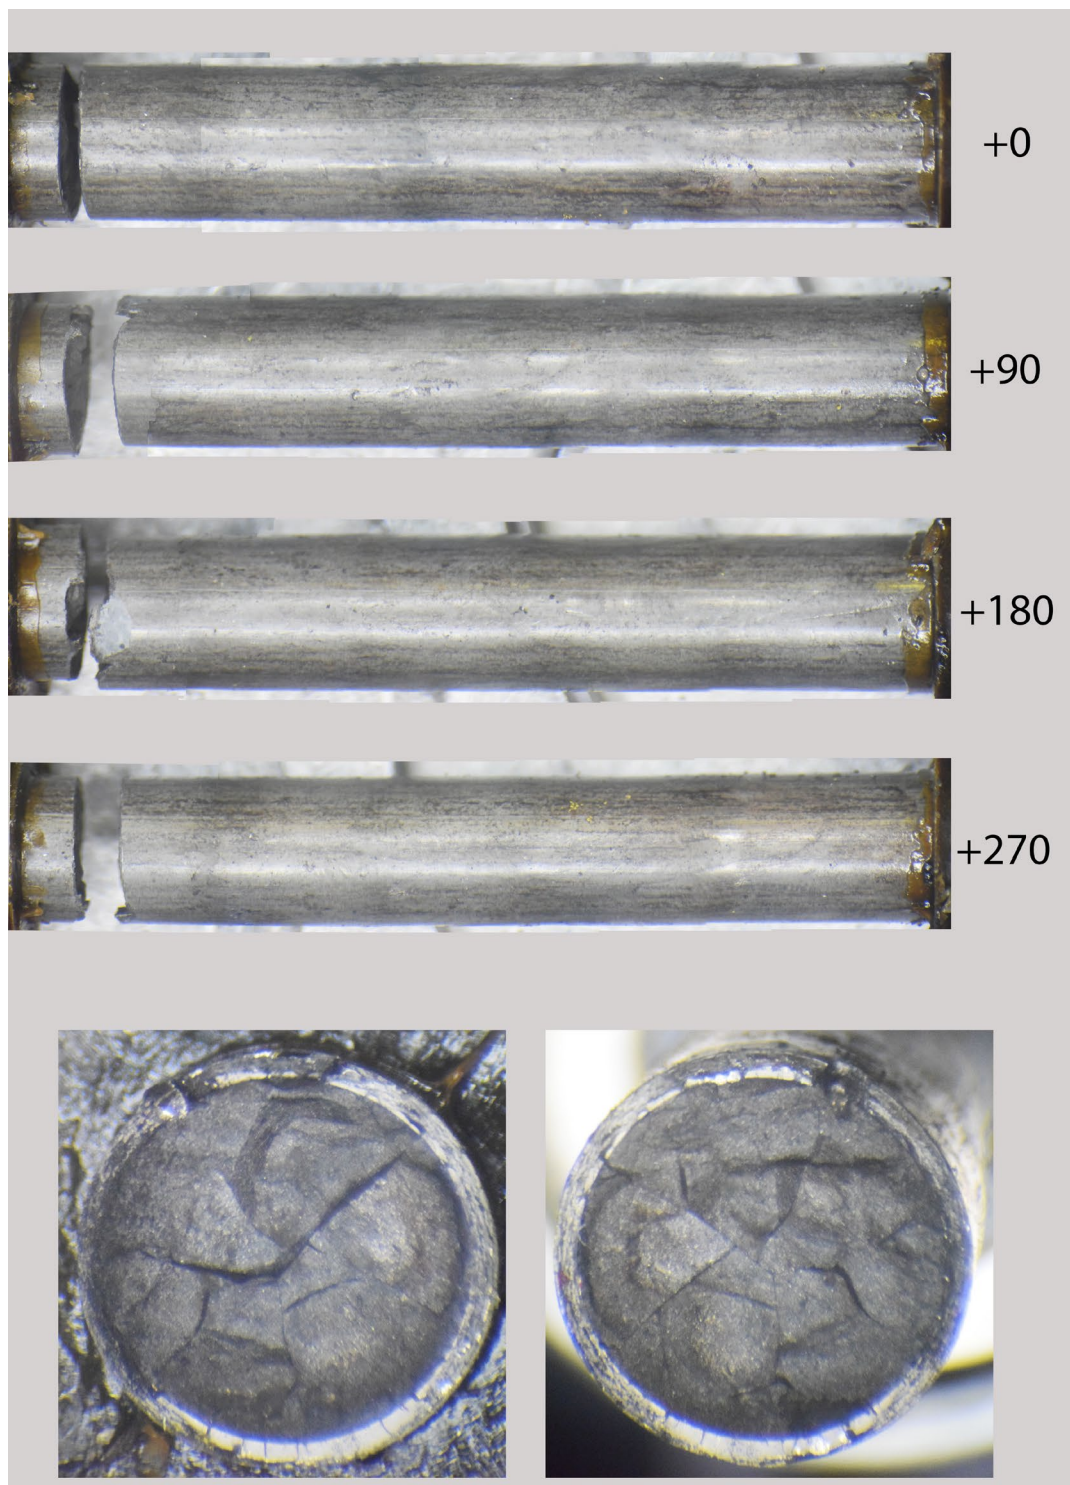
Figure F-17. 6U3K09-3353-3506 post-fatigue test condition.

| Rod type | Cladding material | Estimated specimen-average burnup (GWd/MTU) | Specimen ID | Fracture location | Cladding fracture orientation | Pellet fracture appearance |
|---|---|---|---|---|---|---|
| 17×17 | ZIRLO | 46 | 6U3K09-3353-3506 | Near grip | Circumferential | Pellet body |

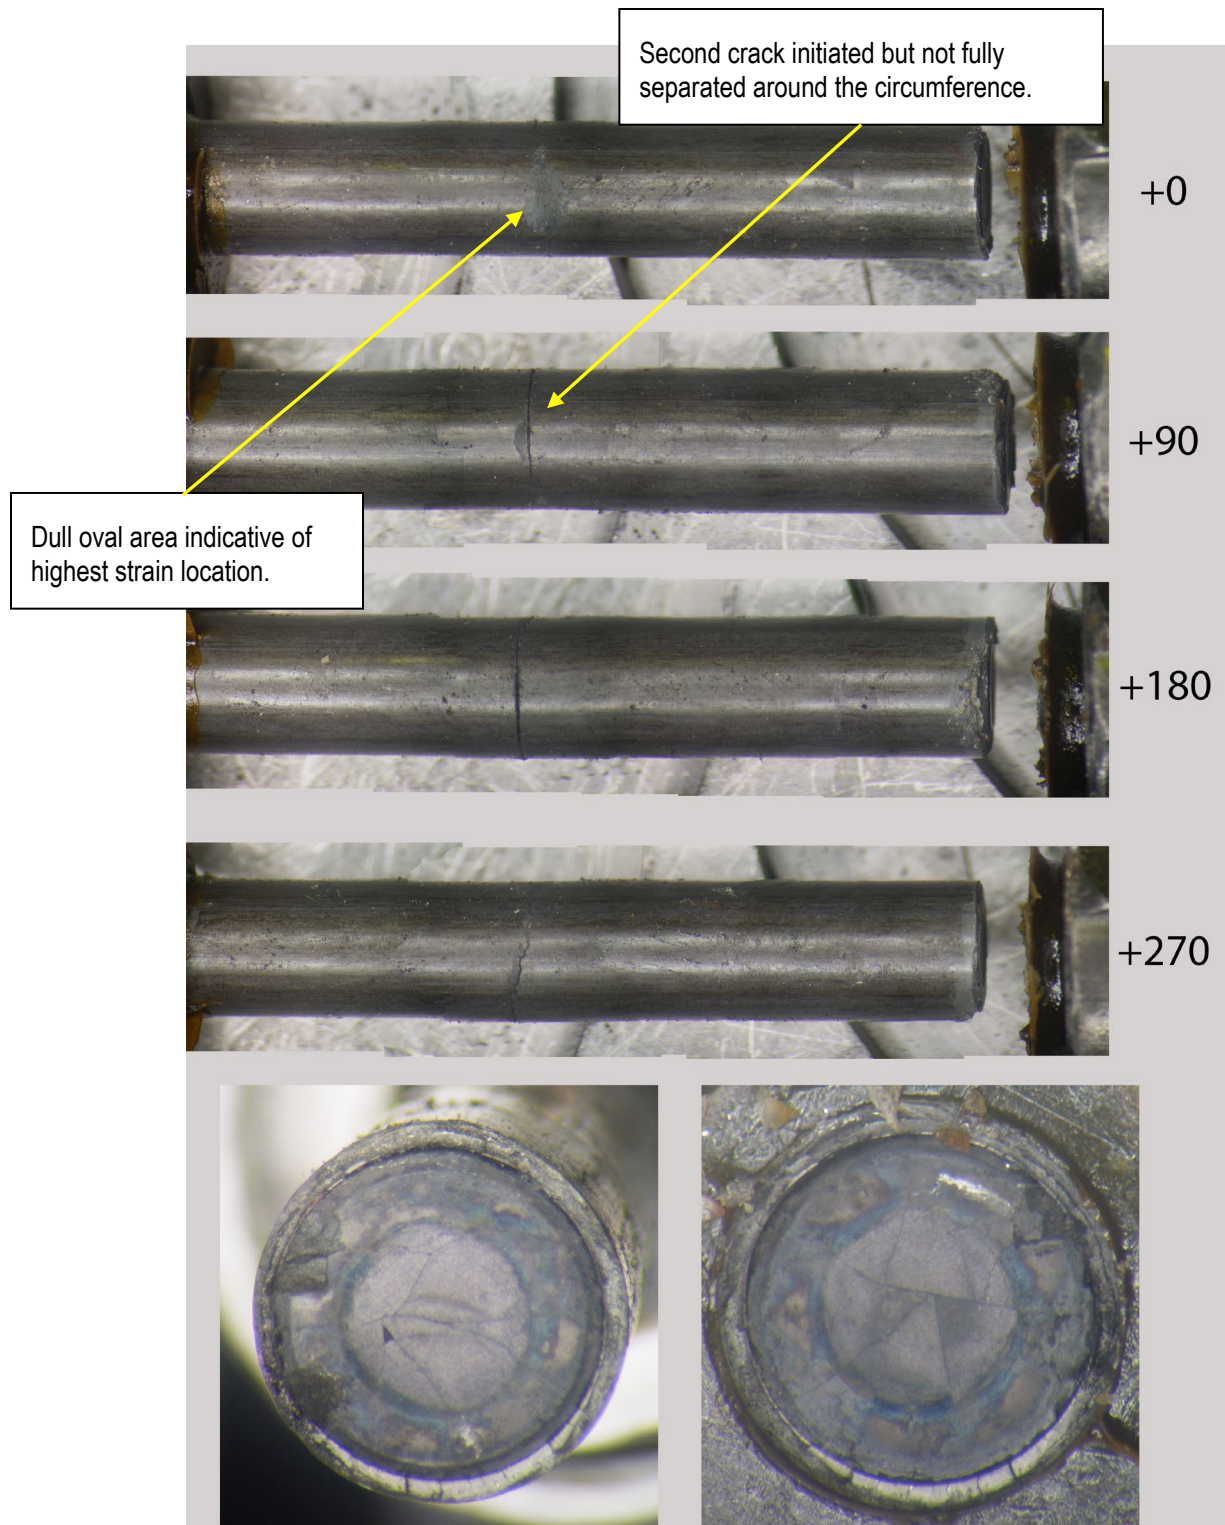
Figure F-18. 6U3K09-2310-2463 post-fatigue test condition.

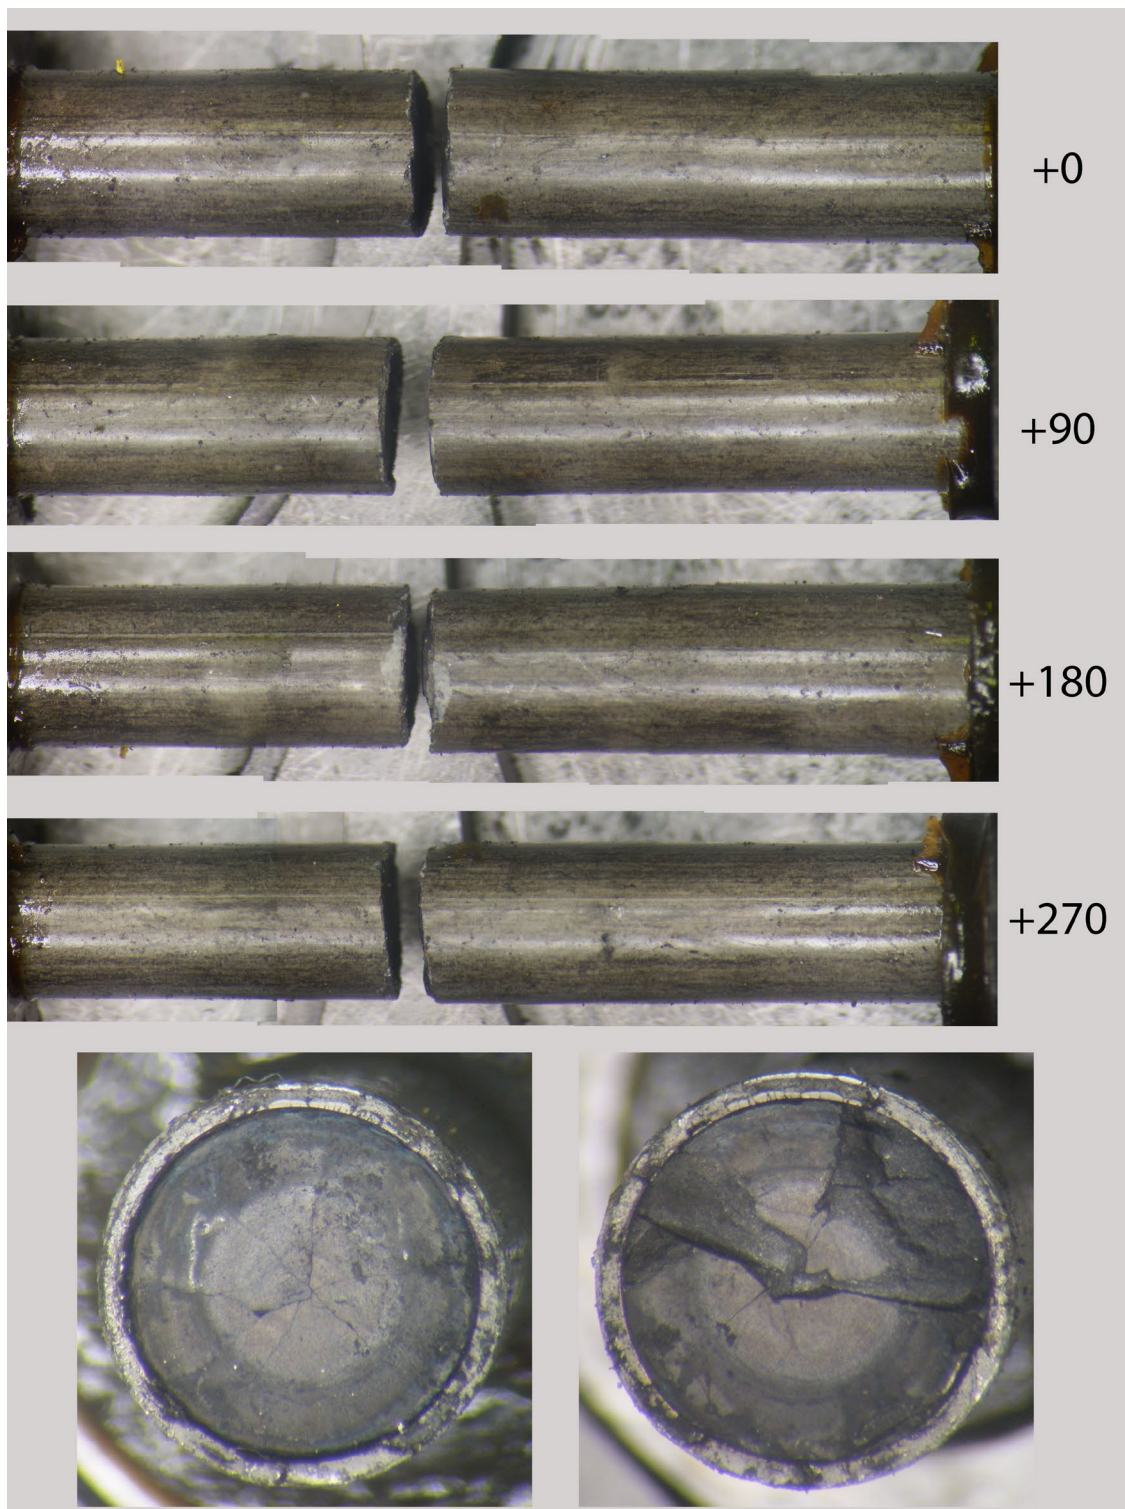
Figure F-25. 3D8E14-2963-3116 post-fatigue test condition.

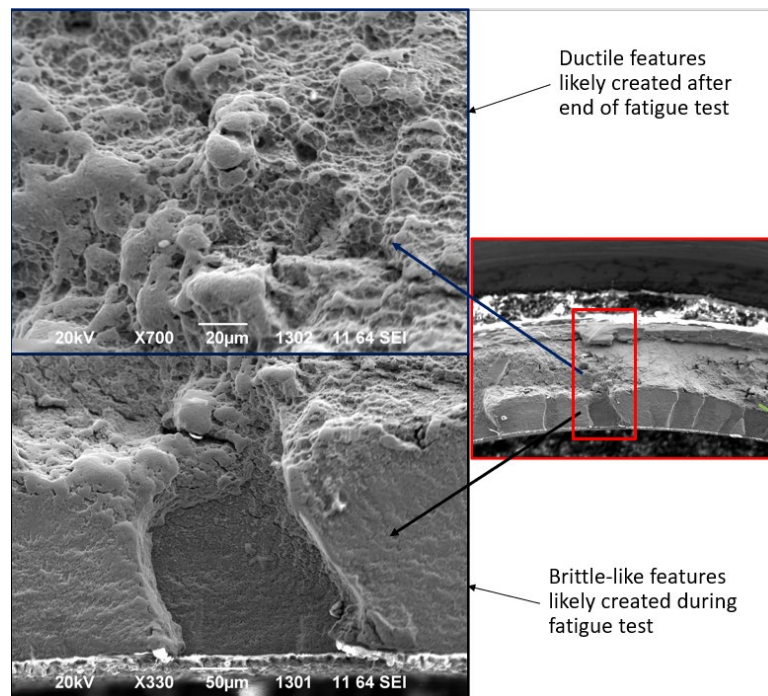
Figure F-42. 330× and 1,000× images of quadrant 1 in sample 3D8E14-2963-3116.

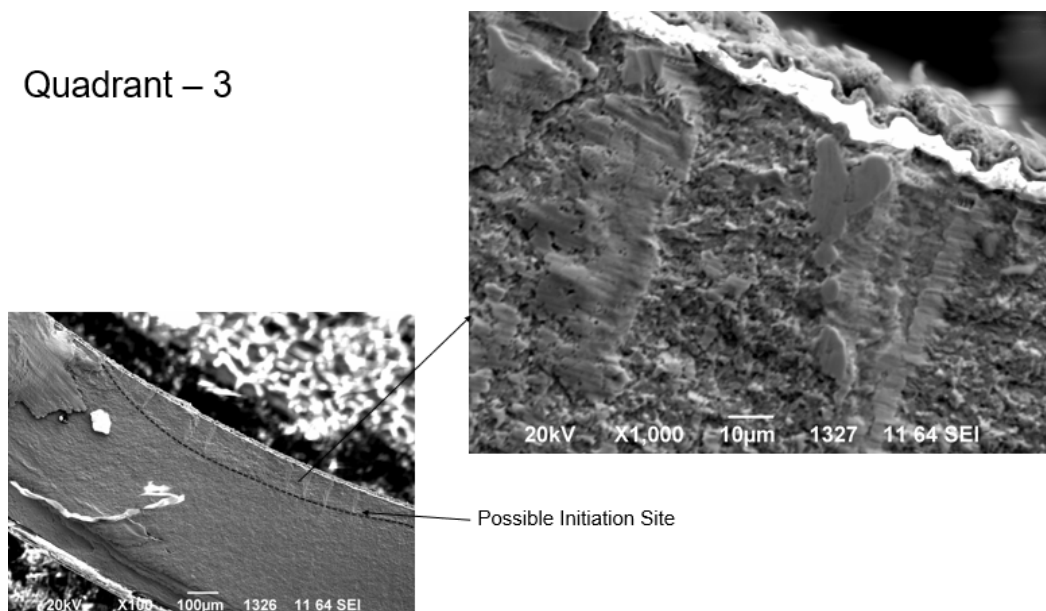
Figure F-43. 100× and 1,000× images of quadrant 3 in sample 3D8E14-2963-3116, approximately 180° from region in quadrant 1, that is suspected to have failed after fatigue test ended.

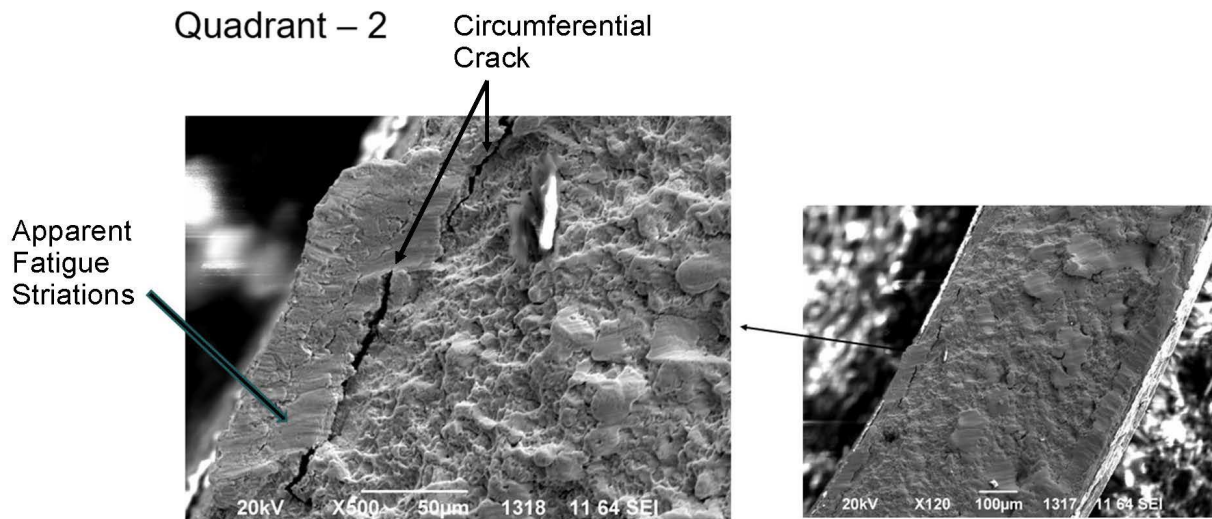
Figure F-44. 120× and 500× images of quadrant 2 in sample 3D8E14-2963-3116, showing signs of fatigue striations typical of fatigue crack propagation, indicating propagation in the circumferential direction.

The high magnification images from quadrants 2 and 4 both show remnants of fatigue crack propagation in the form of fatigue striations (see Figure F-44 and Figure F-45). These images also show indications of circumferential cracks in both quadrants, which may be associated with propagation of the crack along precipitated hydrides. The flat area on the cladding ID in quadrant 4 may be a fatigue crack initiation site.

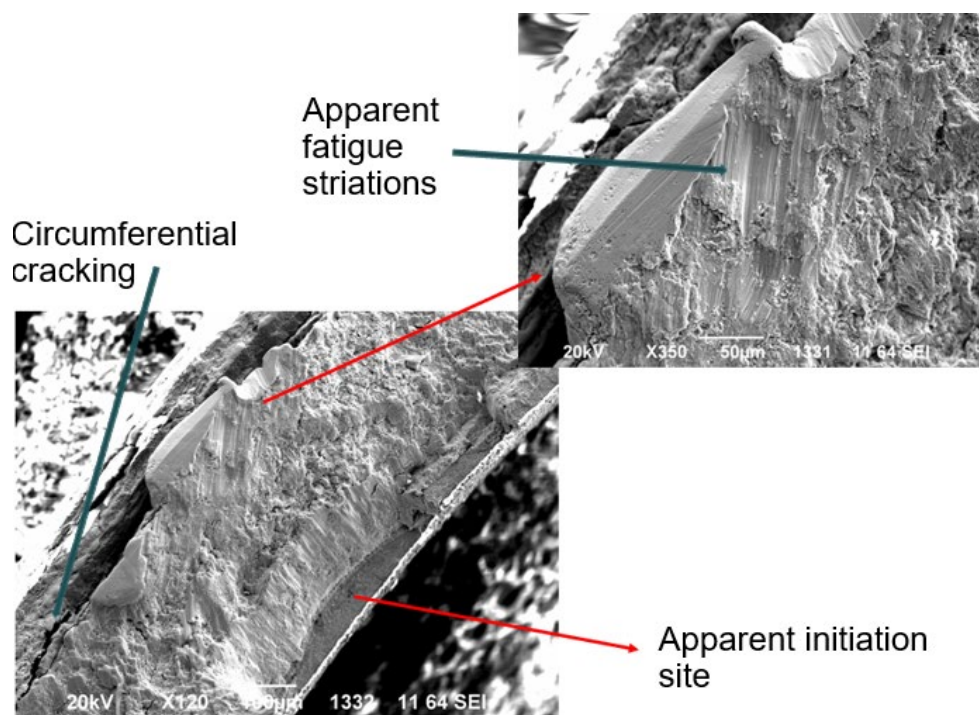
Figure F-45. 120× and 350× images of quadrant 4 in sample 3D8E14-2963-3116 showing signs of fatigue striations typical of fatigue crack propagation. The flatness of the feature on the cladding ID may be associated with fatigue initiation. There are also circumferential cracks near the cladding OD that may be associated with hydrides.

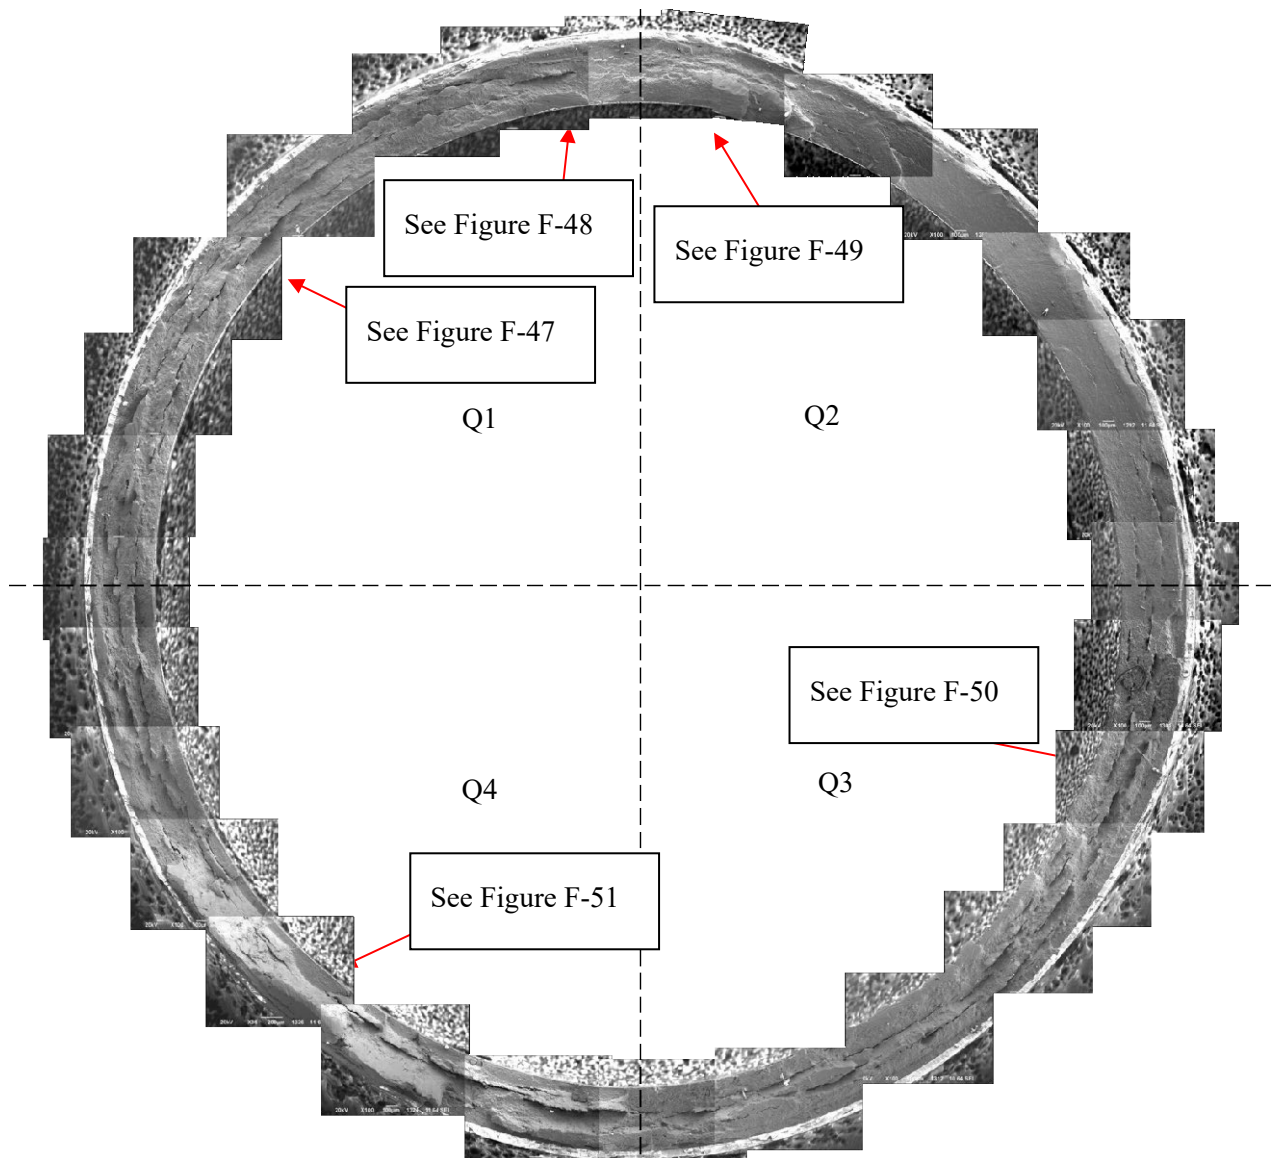
Figure F-46. 100X montage of the surface of the fatigue failure in dogbone sample DE50017. The areas identified in the various quadrants were investigated at higher magnification.

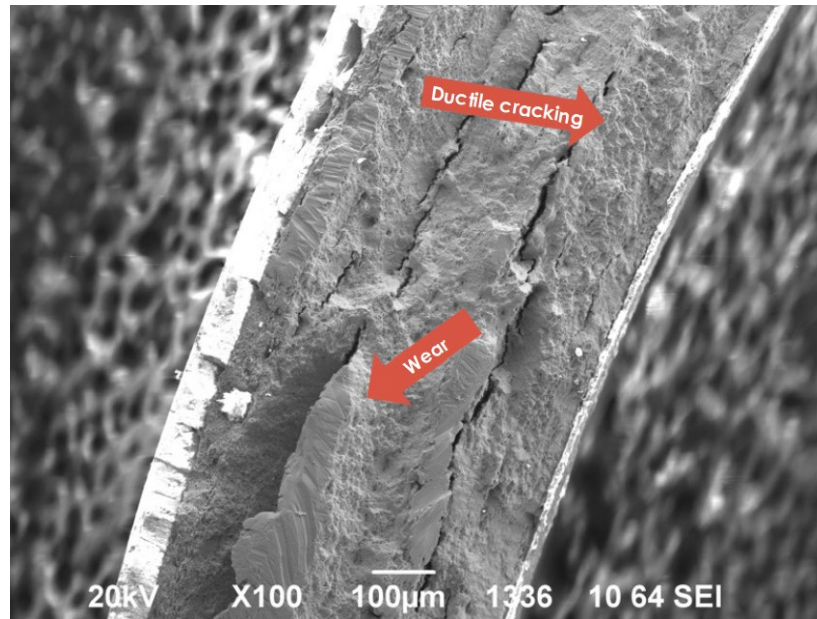
Figure F-47. Ductile regions and wear marks of Q1 in sample 3A1F05-2025-2178.

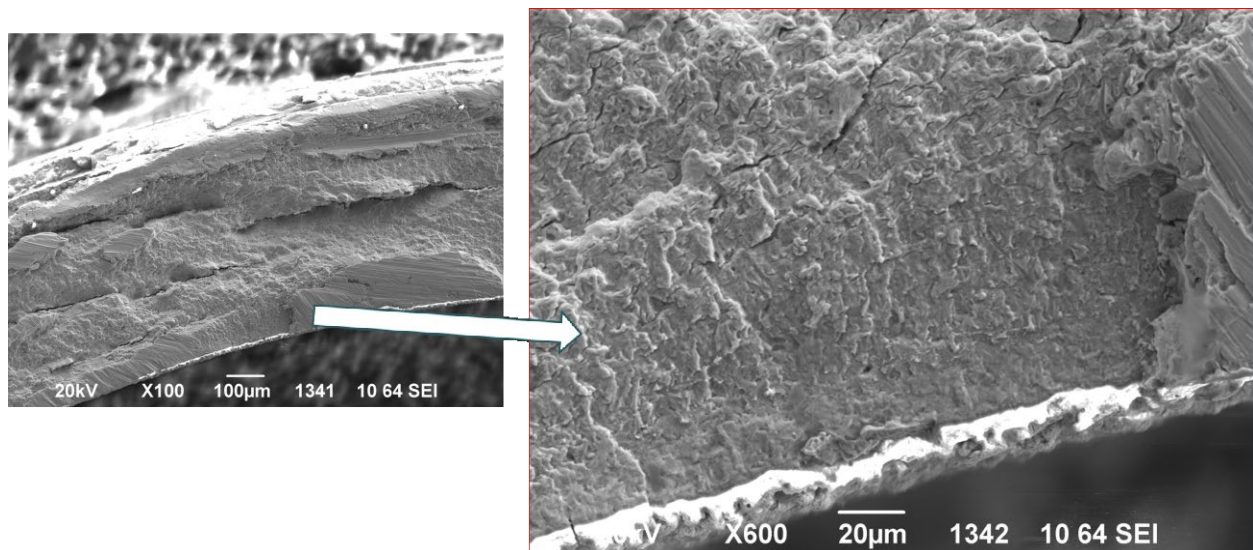
Figure F-48. Fuel-side brittle regions of Q1 (approaching Q2) in sample 3A1F05-2025-2178.

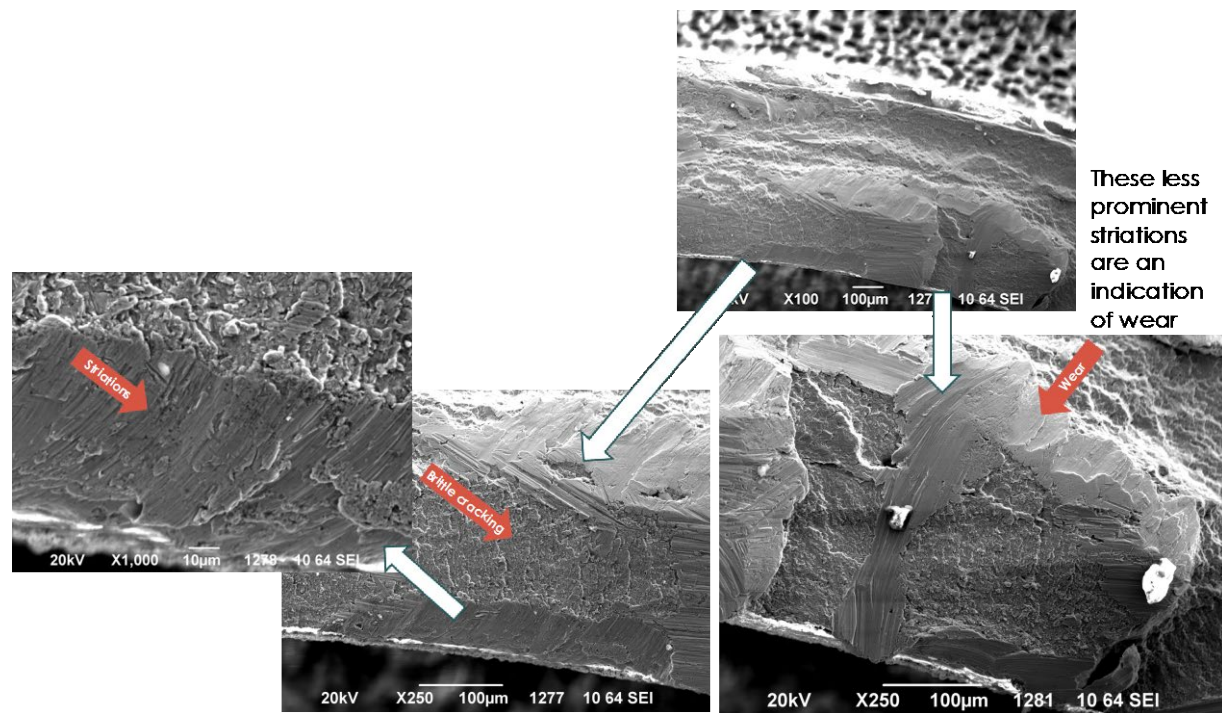
Figure F-49. Cleavage-like regions, apparent fatigue striations, and flat wear marks on the fuel side of Q2 in sample 3A1F05-2025-2178.

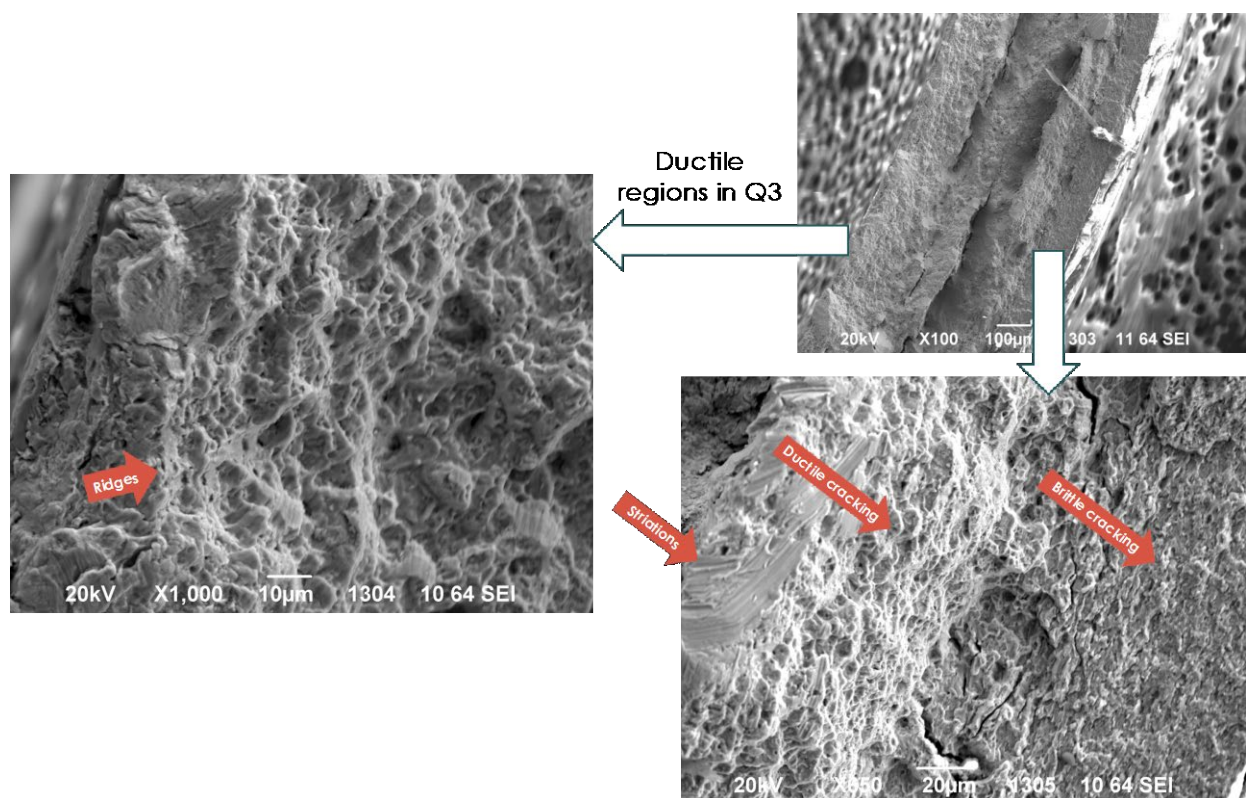
Figure F-50. Ductile fracture regions amidst striations and brittle cracks on Q3 in sample 3A1F05-2025-2178.
