Sister Rod Destructive Examinations (FY22)

Appendix F: Cyclic Integrated Reversible- Bending Fatigue Tests

Oak Ridge National Laboratory

M2SF-23OR010201024 ORNL/TM-2022/2733

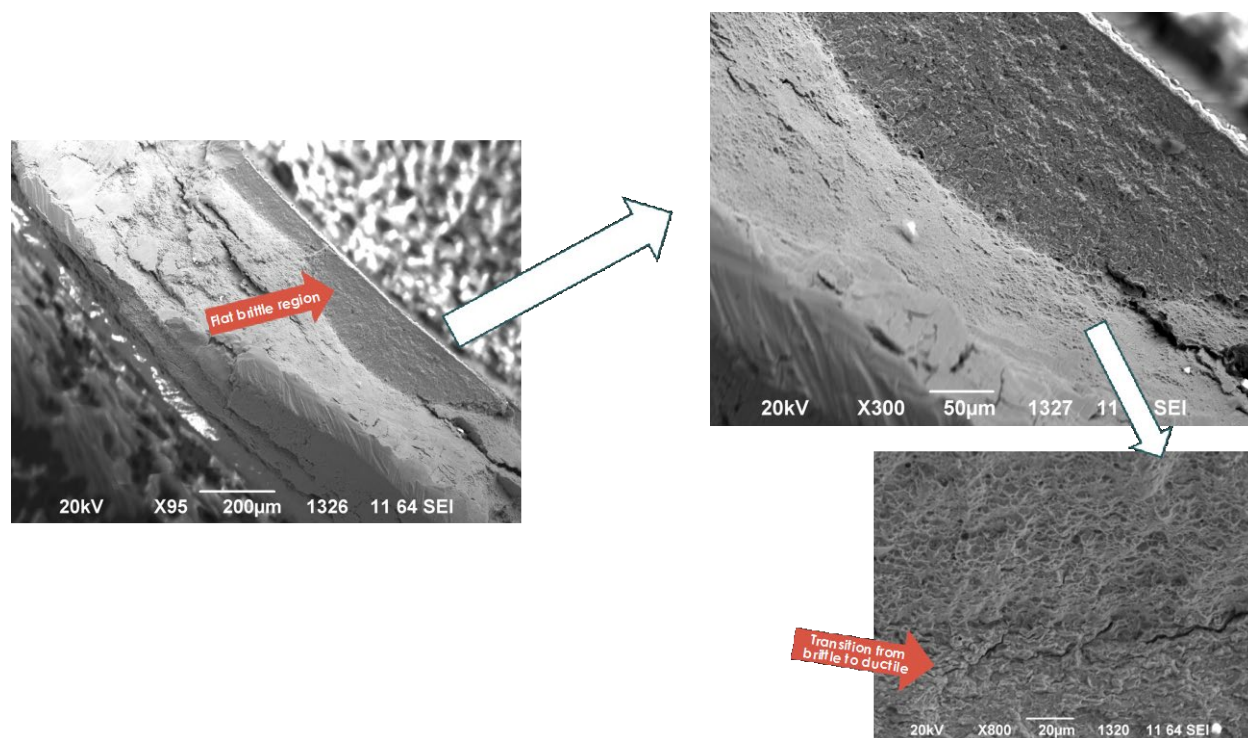
Figure F-51. Flat cleavage-like regions on the fuel side leading to cracks and ductile failure seen on Q4 in sample 3A1F05-2025-2178.

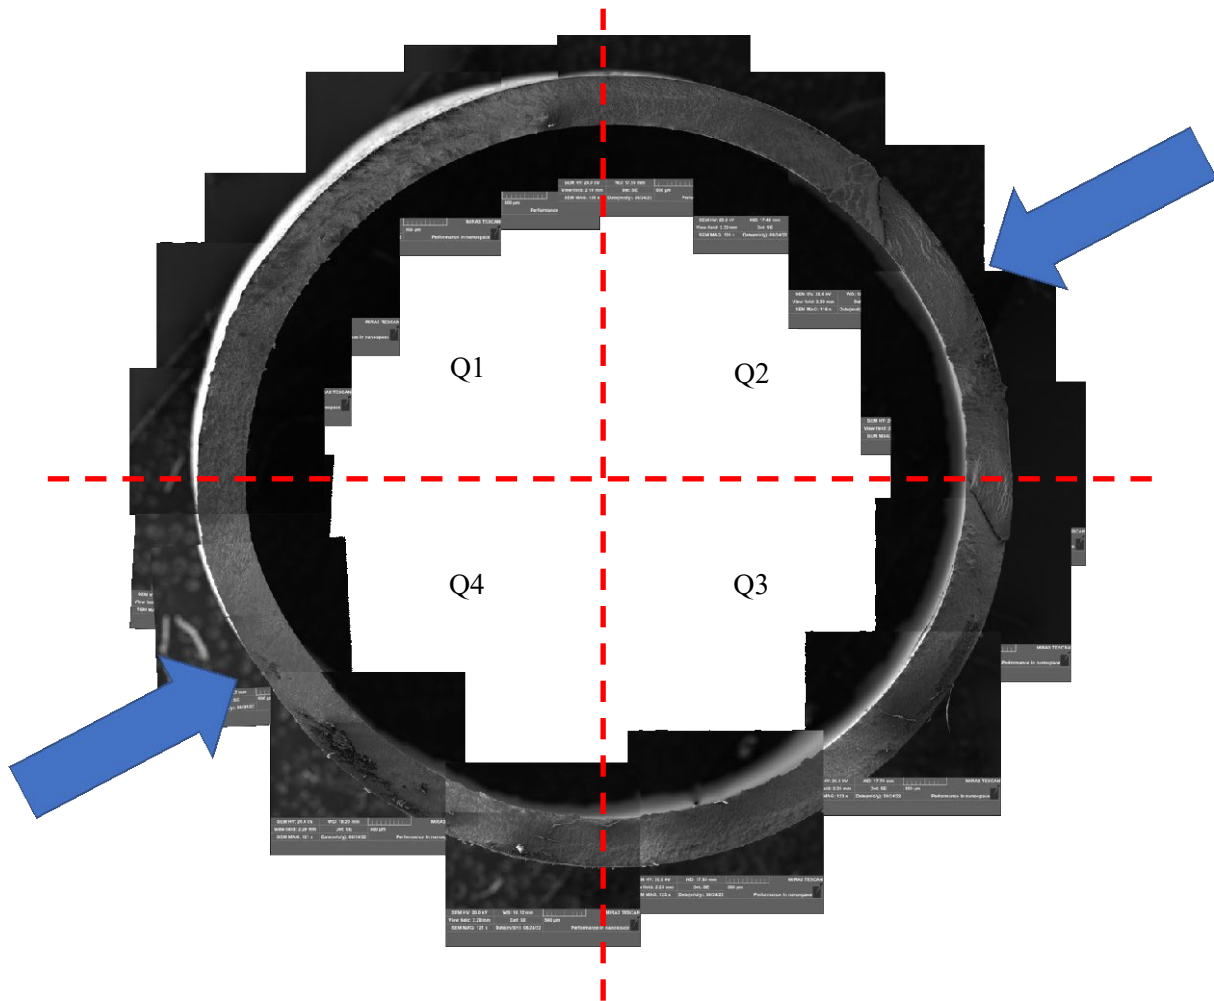
Figure F-52. 100× montage of the surface of the fatigue failure in dogbone sample Zirc-4-W-4. Arrow marks show regions of high bending strain in the sample.

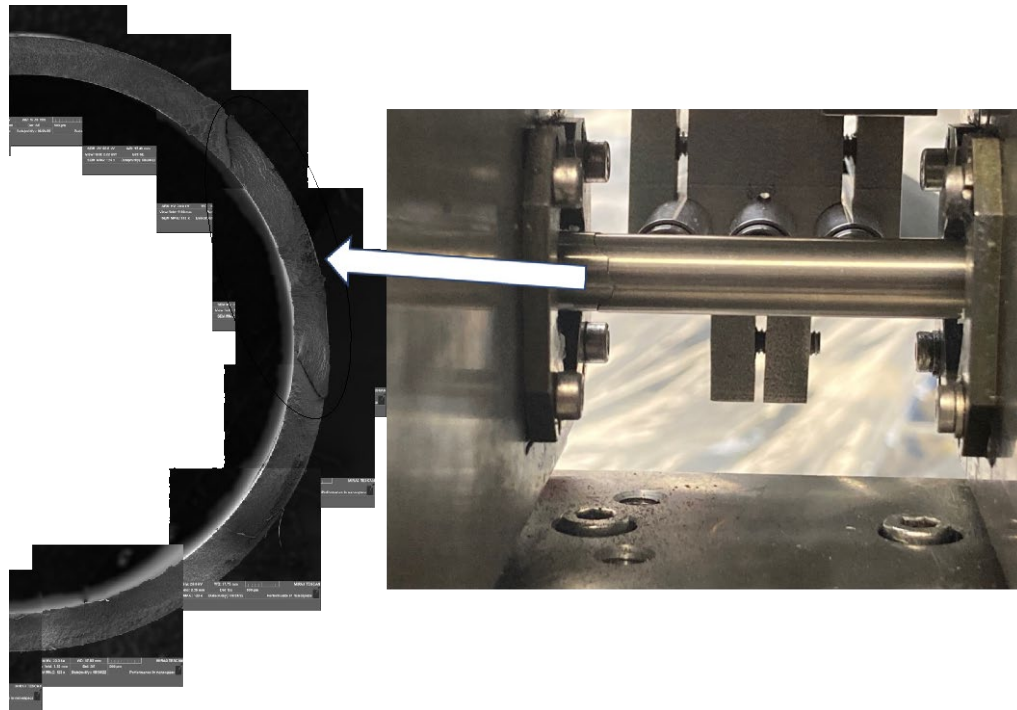
Figure F-53. Top (fracture) view and side view of the fatigue failure region in Q2 and Q3 of sample Zirc-4-W-4.

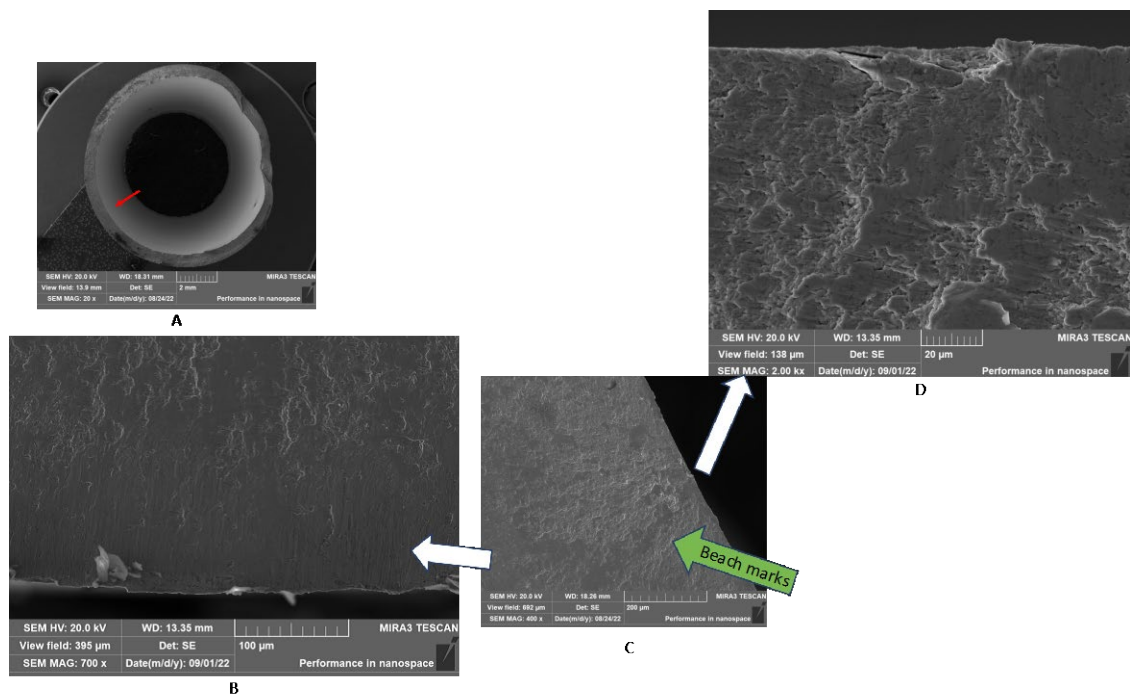
Figure F-54. Fatigue crack initiation region in Q4 of sample Zirc-4-W-4: (A) location of the region in a low-magnification image of the sample; (B) OD side of the fatigue failure initiation site; (C) ID side of the fatigue crack initiation site; and (D) detail view of C.

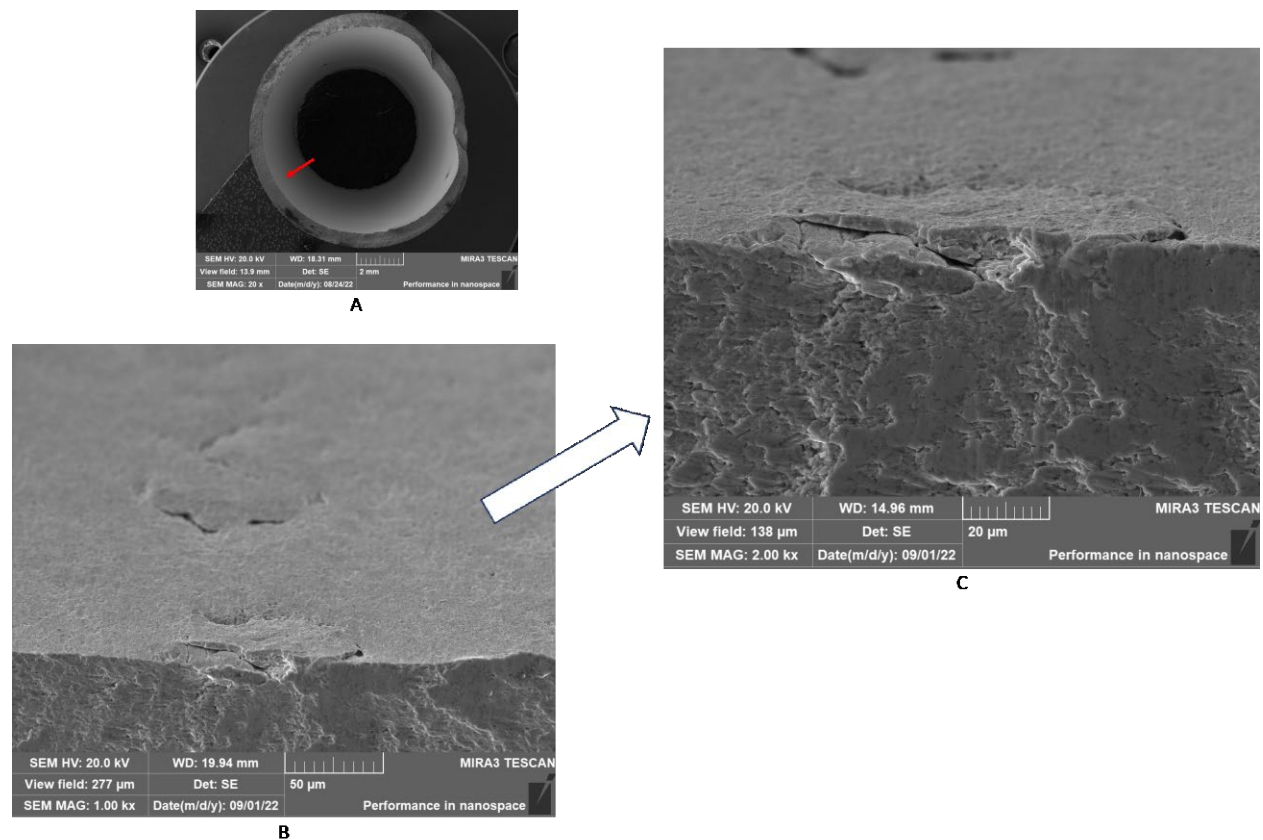
Figure F-55. Tilted image of Figure F-53 revealing the ID side of the fatigue failure initiation site on sample Zirc-4-W-4: (A) location of the region in a low magnification image of the sample; (B) ID side of the fatigue failure initiation site; and (C) detail view of the fatigue failure initiation fracture surface.

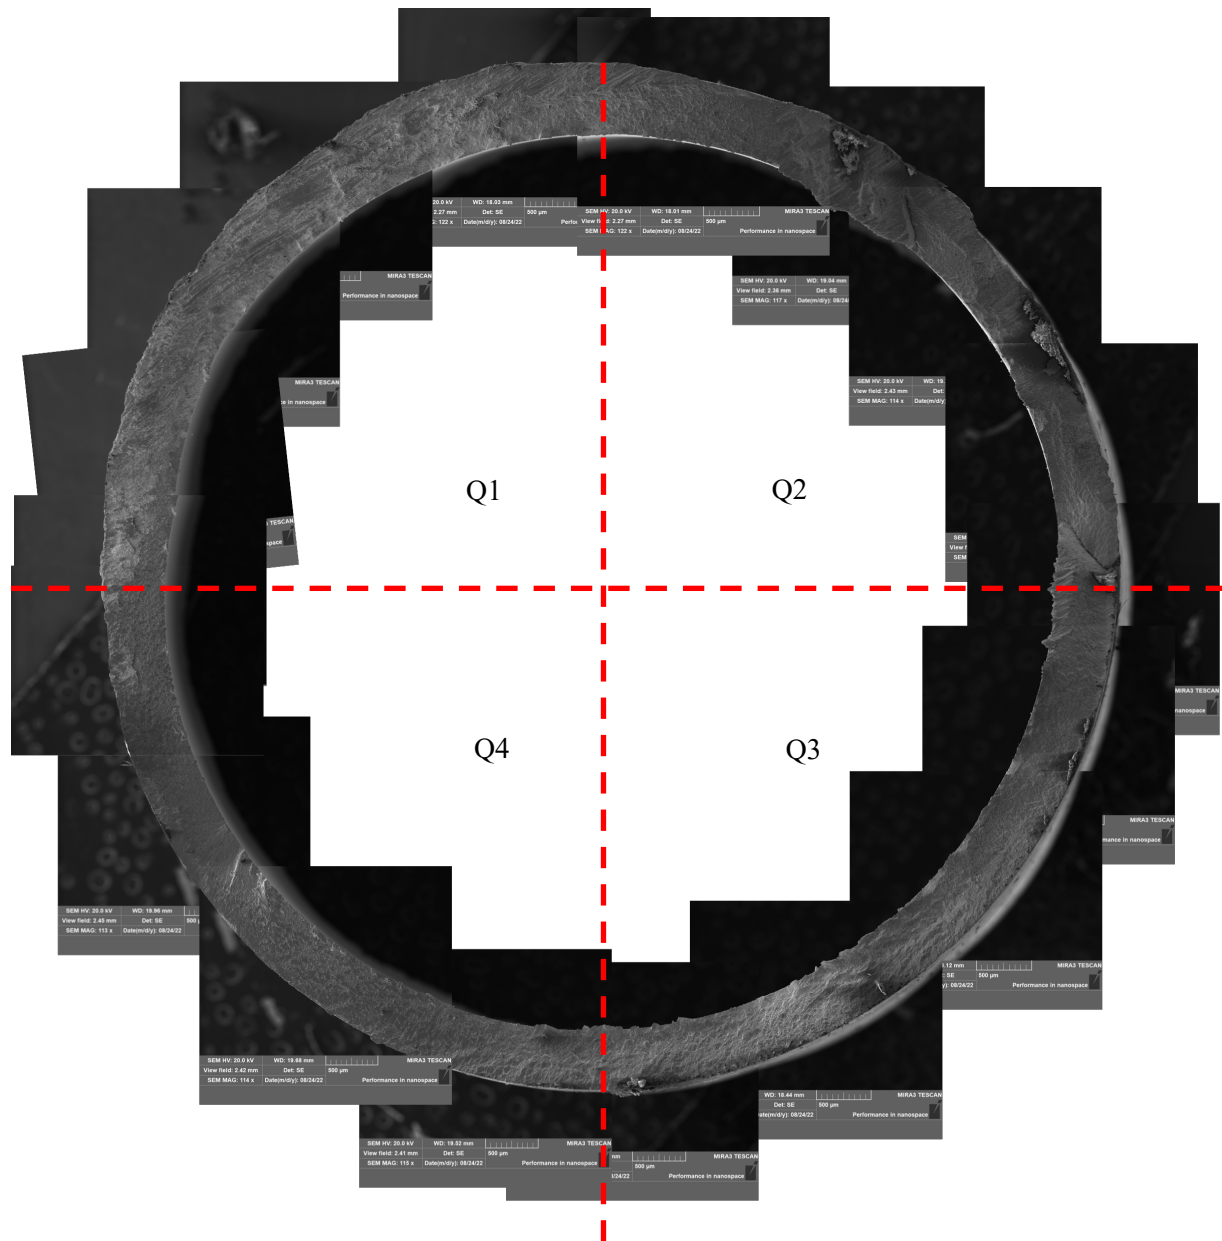
Figure F-57. 100X montage of the fatigue failure surface in dogbone sample Zirc-4-W-3.

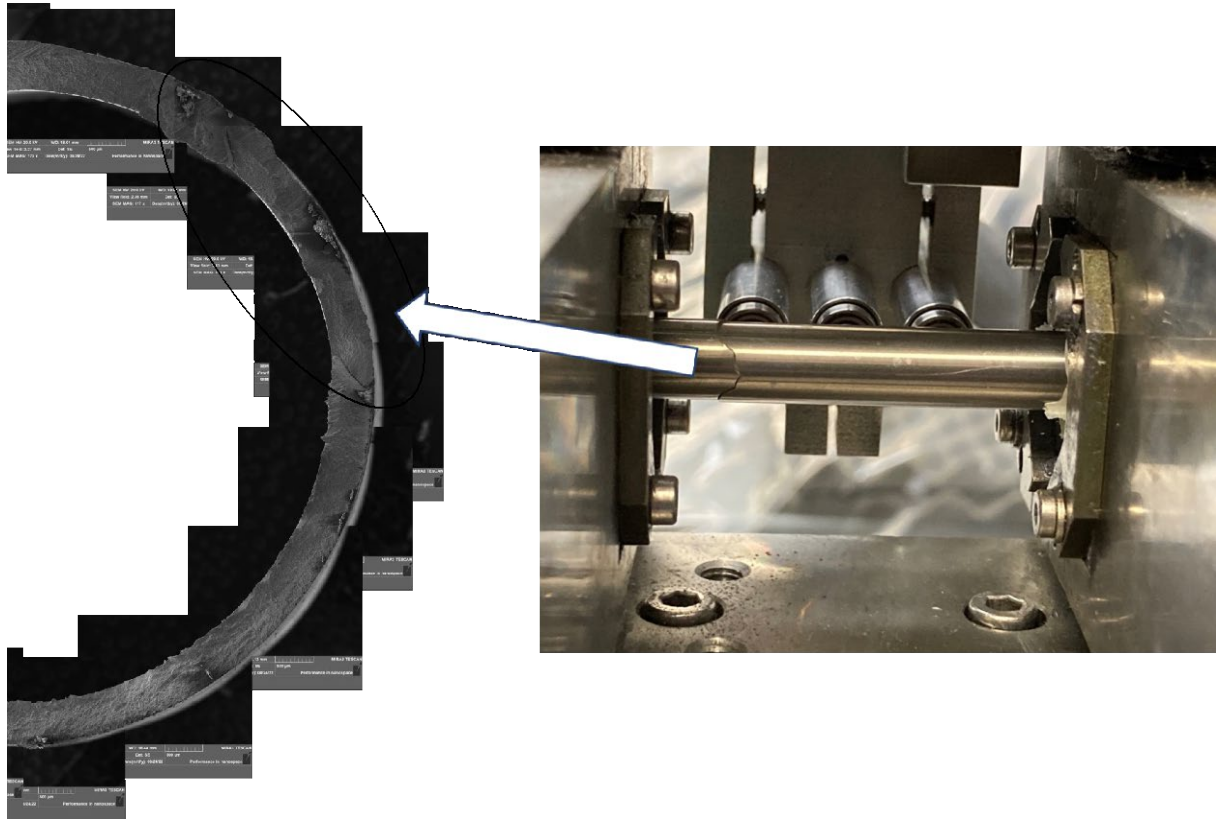
Figure F-58. The top (fracture) view and side view of the fatigue failure region in Q2 and Q3 of sample Zirc-4-W-3.

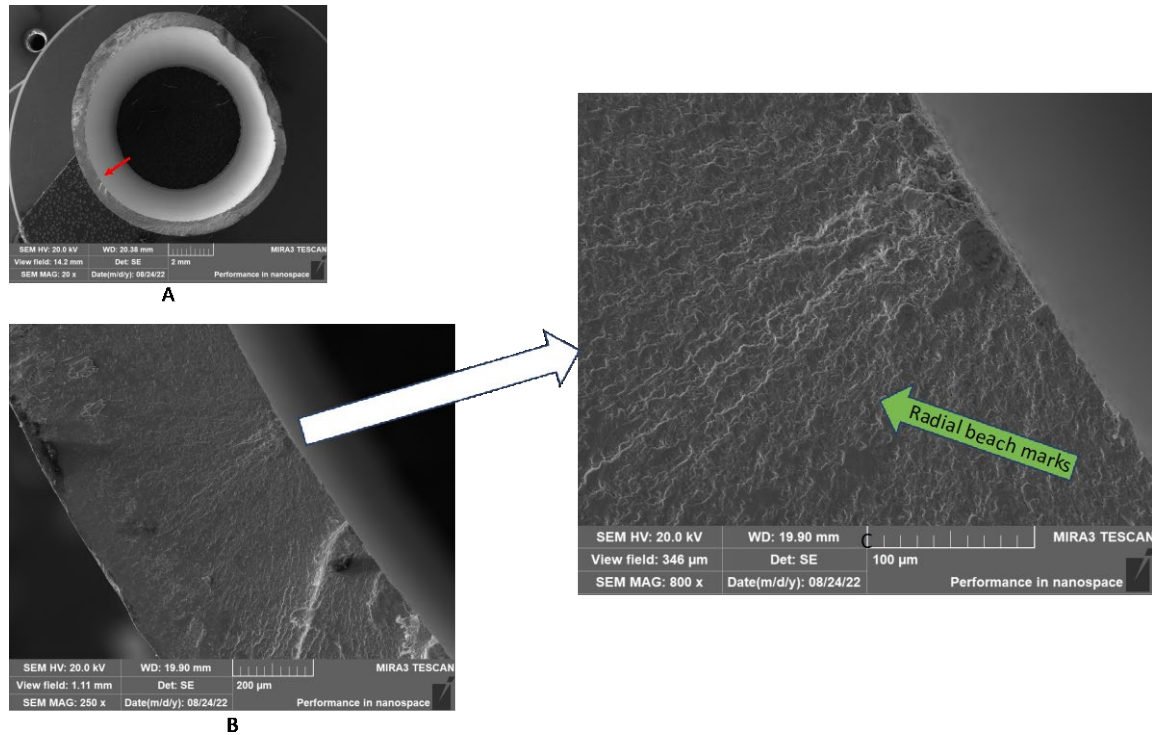
Figure F-59. Fatigue crack initiation region in Q4 of sample Zirc-4-W-3: (A) The location of the region in a low magnification image of the sample; (B) ID side of the fatigue crack initiation site; and (C) detail view of B

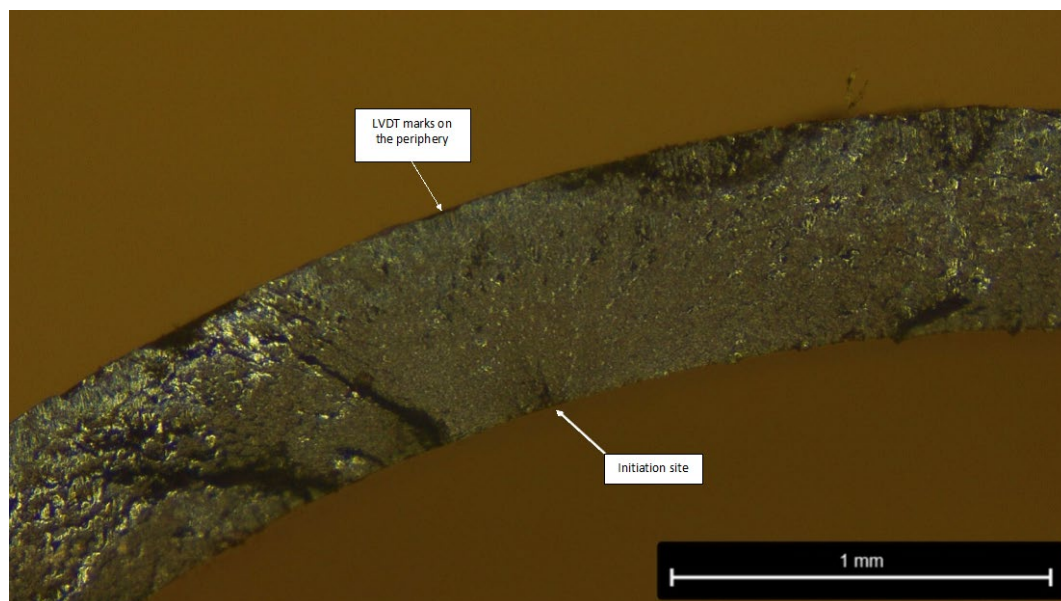
Figure F-60. Optical microscope image of sample Zirc-4-W-3 showing the fatigue failure initiation site; the peripheral region containing the LVDT marks is not visible.

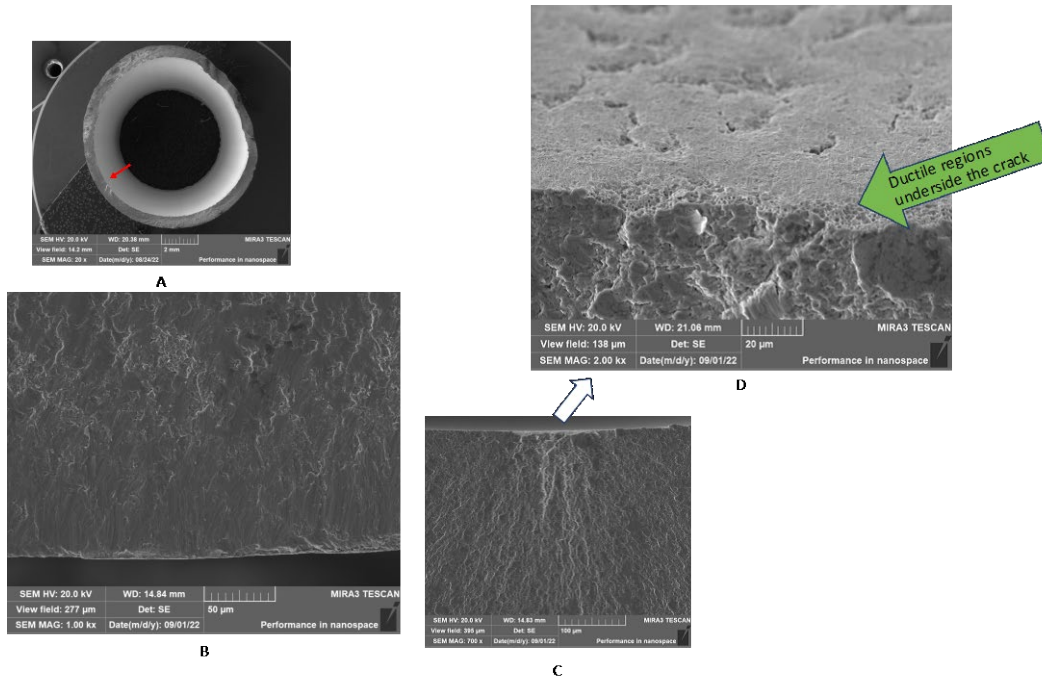
Figure F-61. Tilted SEM image of Figure F-59 revealing the ID side of the fatigue failure initiation site of sample Zirc-4-W-3: (A) location of the region in a low magnification image of the sample; (B) OD side of the fatigue failure initiation site; (C) ID side of the fatigue initiation site; and (D) inside of the ID side of sample Zirc-4-W-3 at the fatigue initiation site.

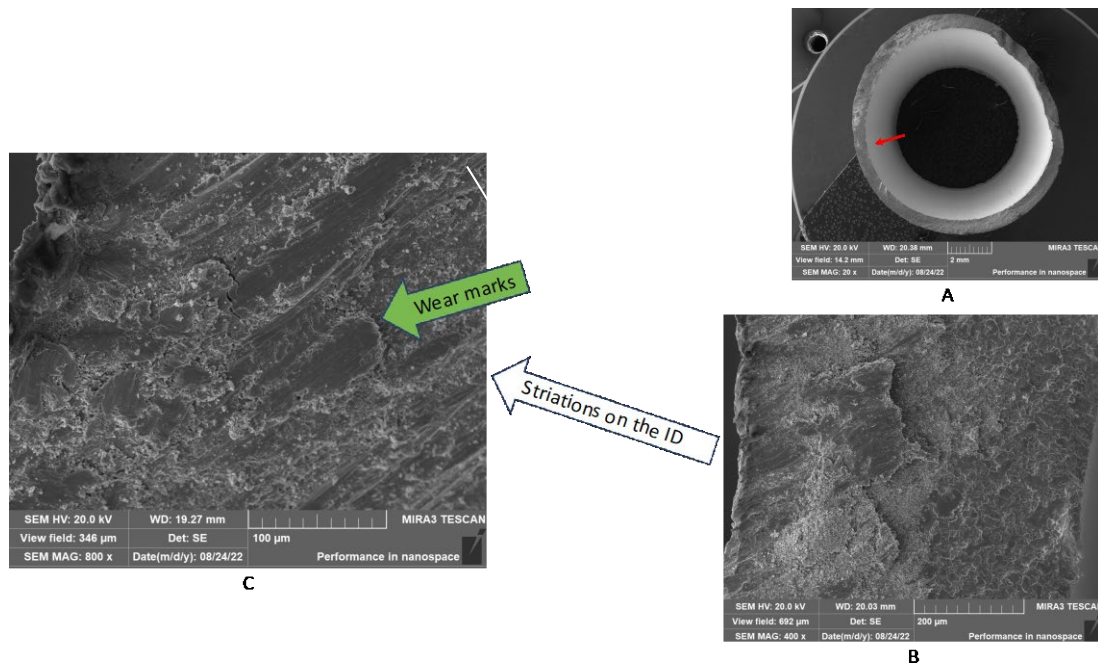
Figure F-62. Some striations visible amidst brittle or cleavage fracture like regions and wear marks of sample Zirc-4-W-3: (A) location of the region in a wide field view of the sample; (B) wear marks observed on the ID with striations on the OD and brittle fracture regions in the middle of Q1; and (C) detail view of the flat wear-like features between striations.

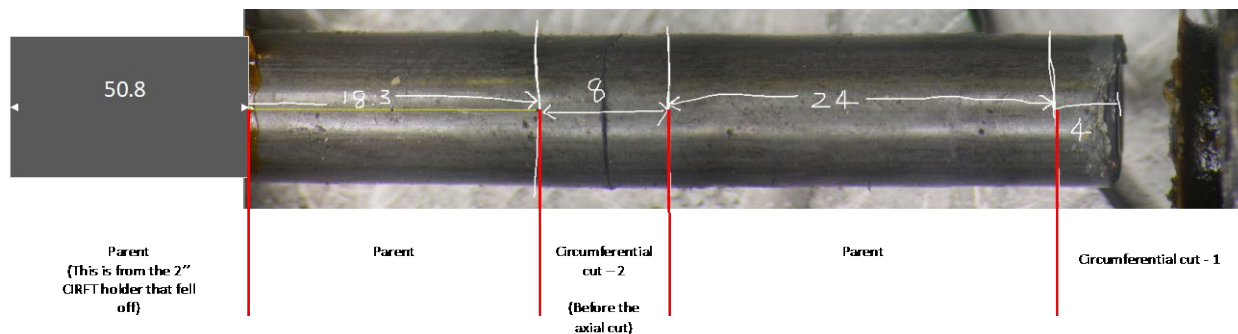
Figure F-63. Fatigue failure in sample 6U3K09-2310-2463 showing the second crack observed in the sample.

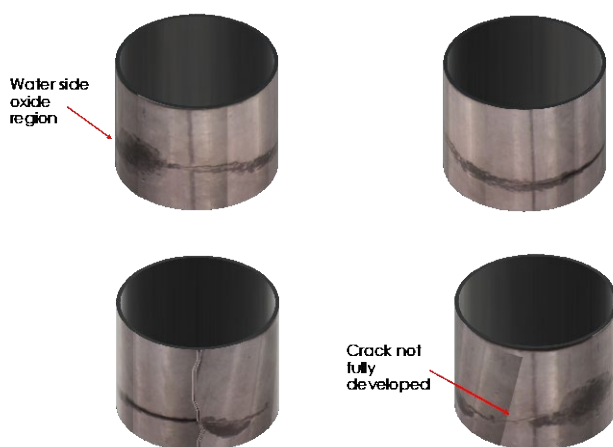
Figure F-64. Images of the circumferential cut-2 from sample 6U3K09-2310-2463 wrapped around a 3D cylinder to show a realistic image.

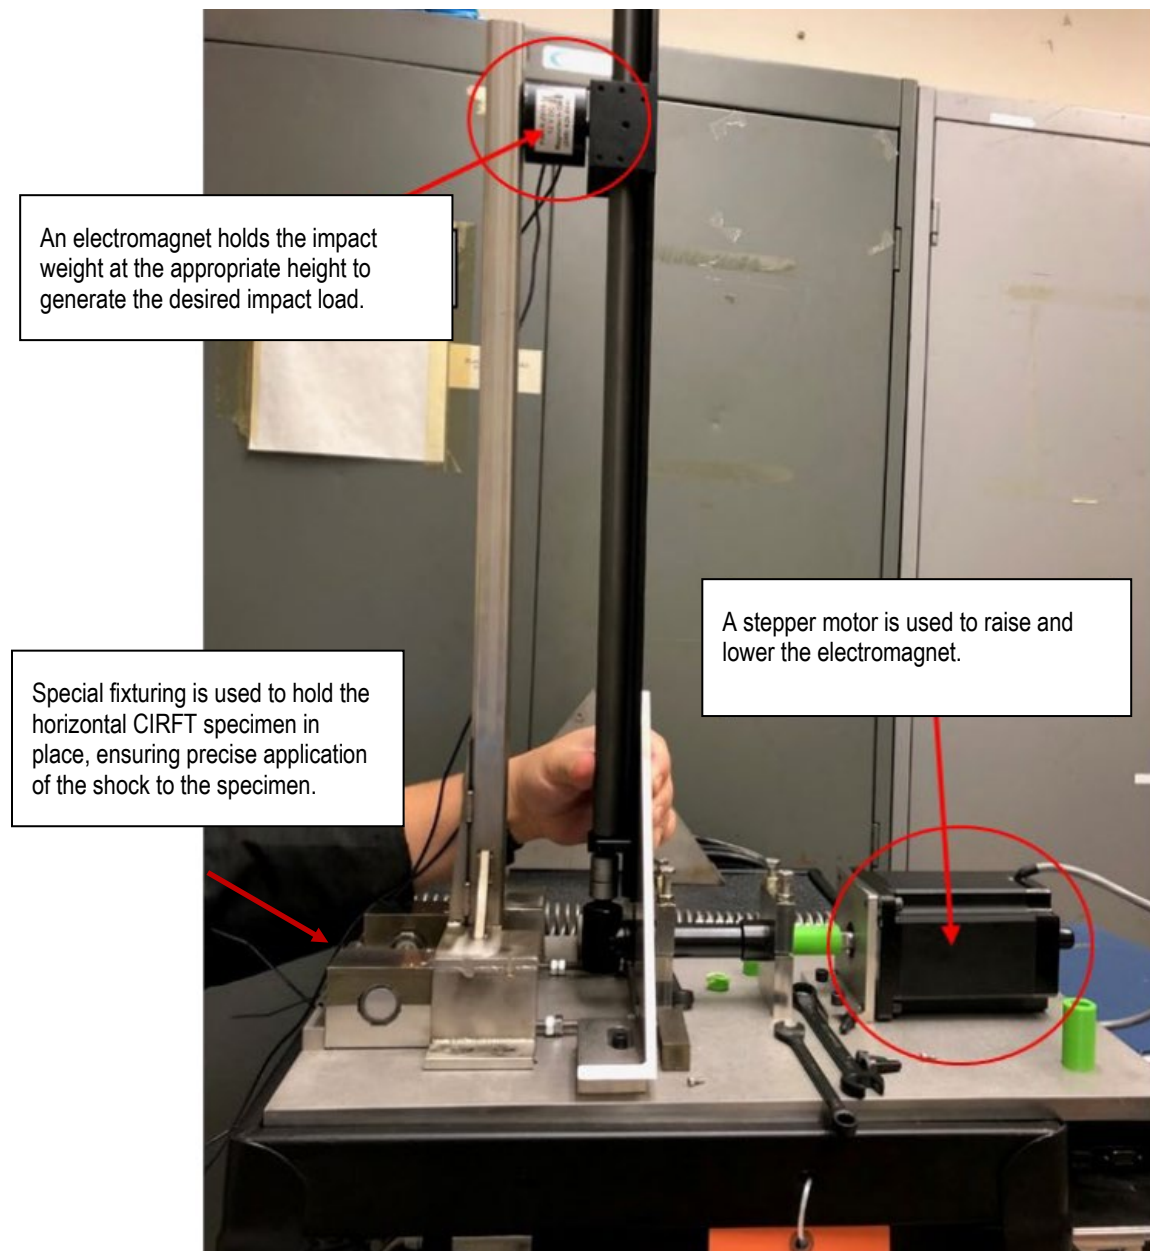
Figure F-65 Cumulative shock fixture developed to apply a normal transport condition shock before fatigue testing.

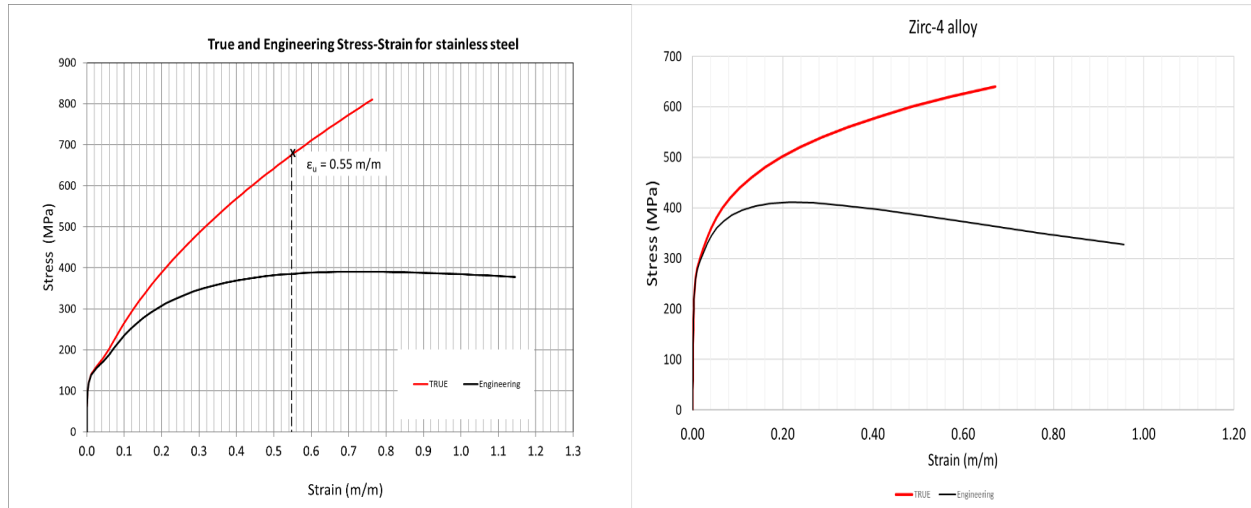
Figure F-67. 304 stainless steel (left) and Zirc-4 (right) true stress–strain curves used compared with corresponding engineering stress–strain curves.

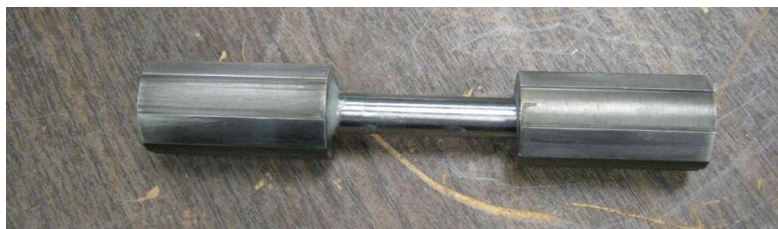
Figure F-71. CIRFT dogbone.

Based on the FEA, the main reason that the target g-load range cannot be achieved has nothing to do with the impactor itself. Rather, the problem is that the target rod segment is very stiff. It is necessary to prepare the segment for CIRFT testing by installing the heavy dogbone grips on each end. Only 50 mm of segment length is exposed for impact, as shown in Figure F-71. The dogbone provides a very stiff target that does not deflect in bending, so any impact will result in a high g-load, even with very low drop height, low impactor weight, and a soft impactor end configuration such as the dimples with a grid wall. With the dogbone as the target, low g-load impacts are not possible with the current fixture.

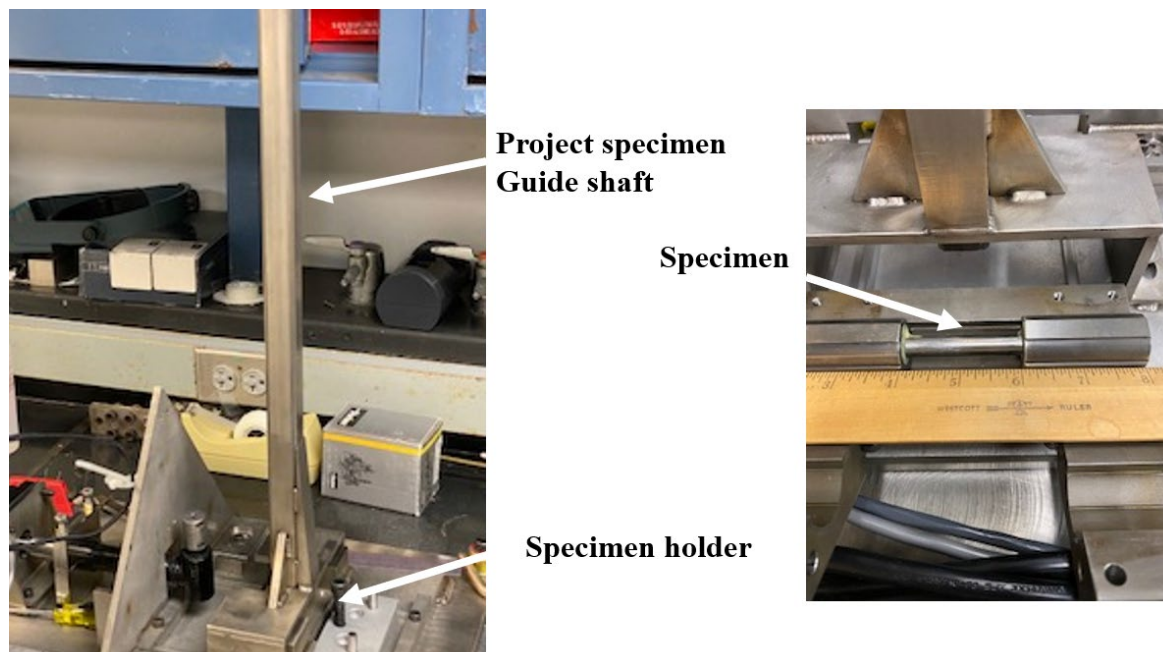
Figure F-72. Physical test configurations with the cumulative effects fixture.

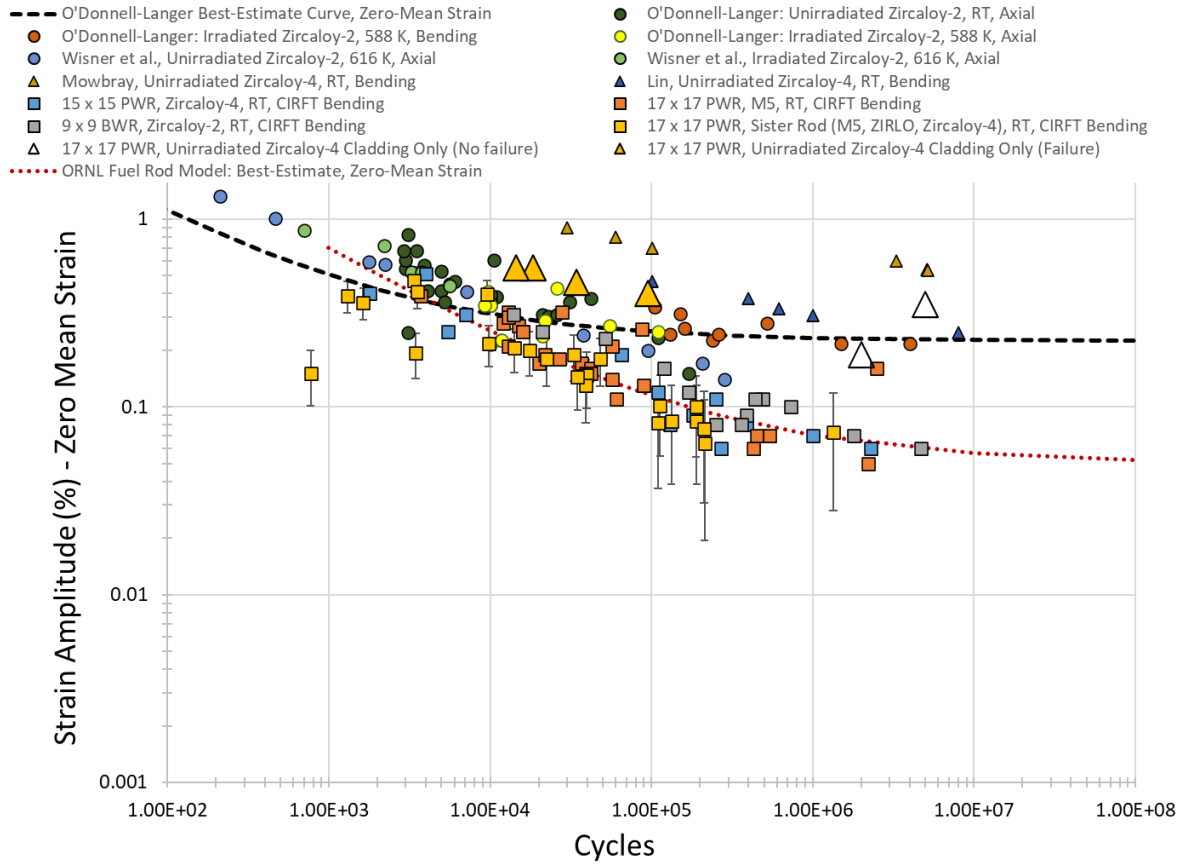
Figure F2-2. Fatigue of HBU fuel rods compared with Zr alloy and cladding-only test data. Note the strain amplitude of the HBU fuel rod data is calculated from the measured curvature in the CIRFT tests [F2-13]

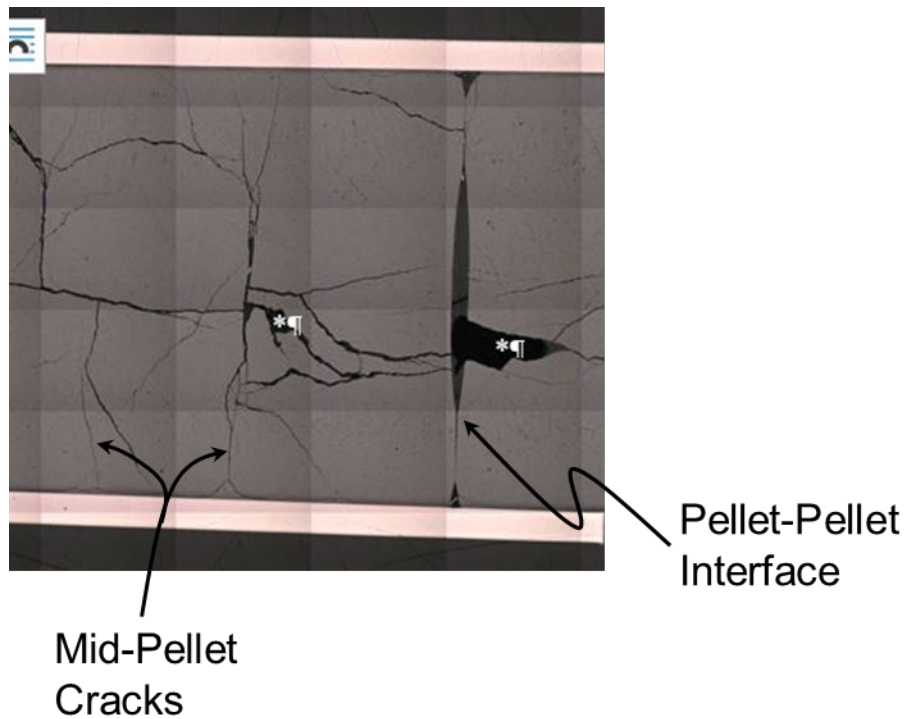
Figure F2-3. Axial cross section of a fuel rod highlighting the discontinuities in the pellet stack.

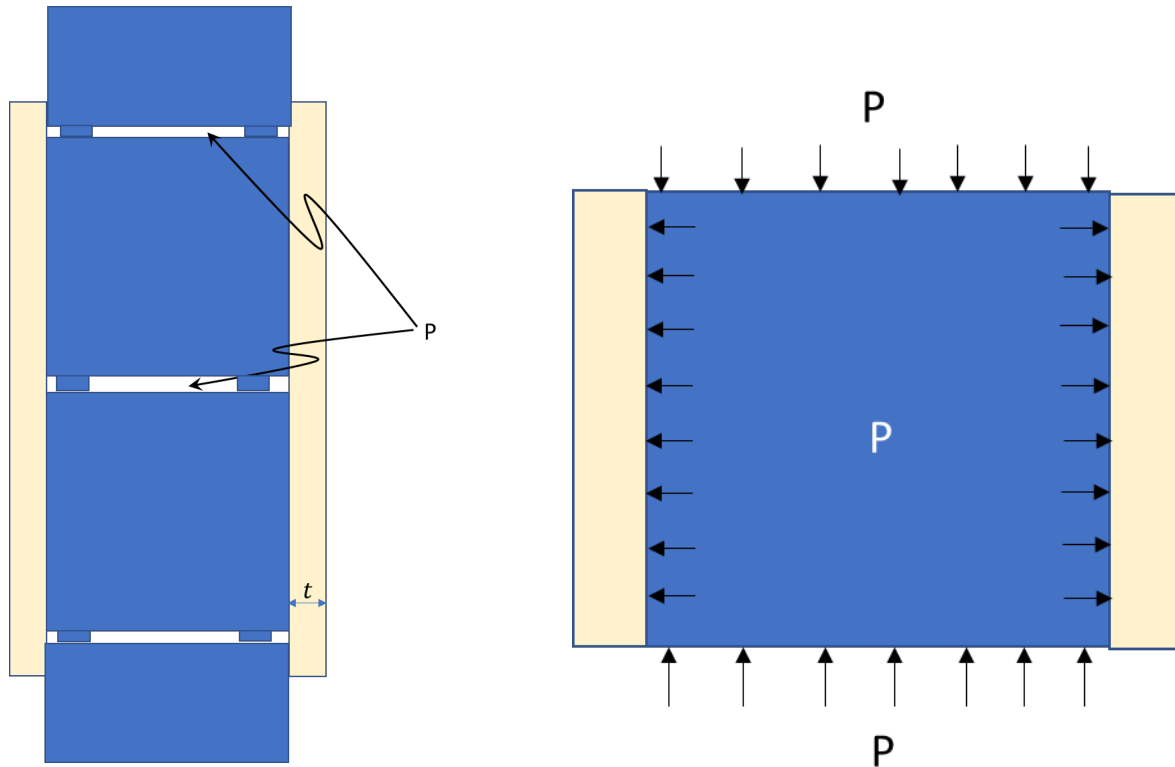
a) An idealized representation of a pellet stack in a high burnup fuel rod where the pellet and cladding are bonded and the pellet ends are in contact but not bonded

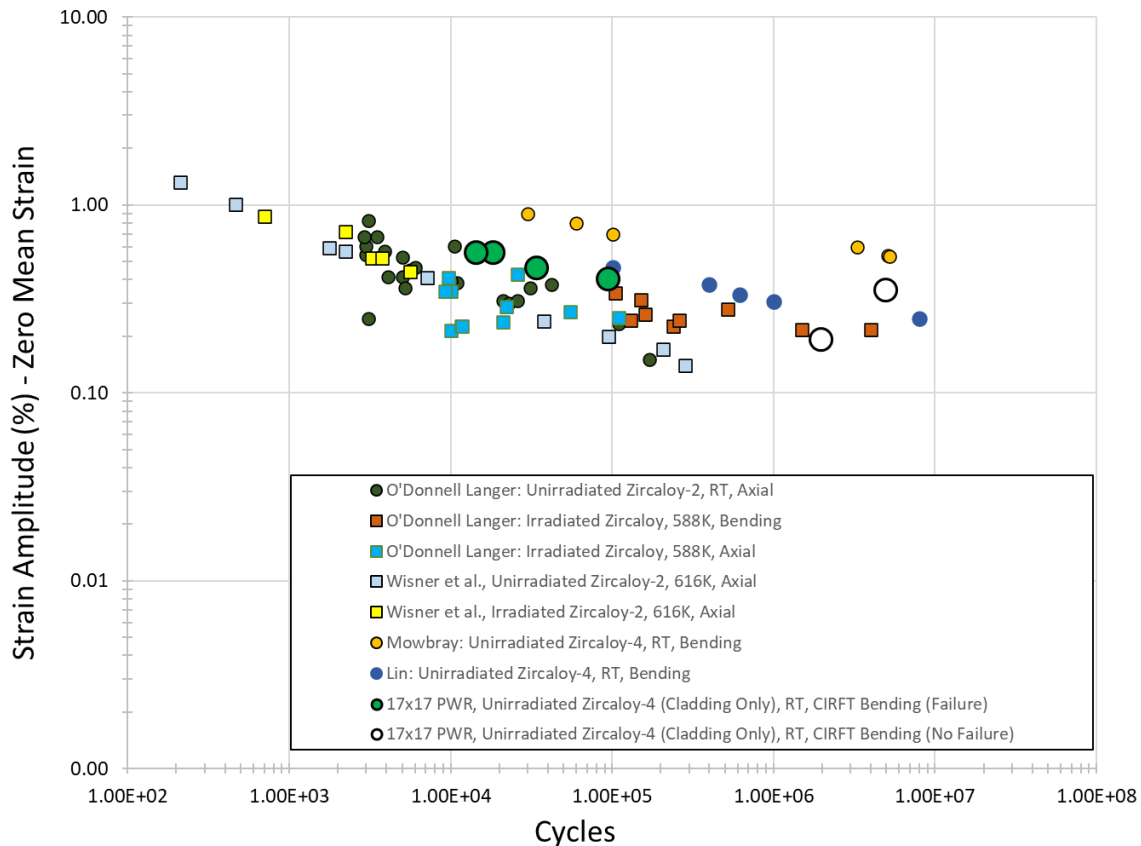
Figure F2-11. Fatigue response of unirradiated and irradiated Zircaloy for various sample geometries and temperatures, highlighting the better fatigue performance at RT (circles) compared with elevated temperatures (squares).

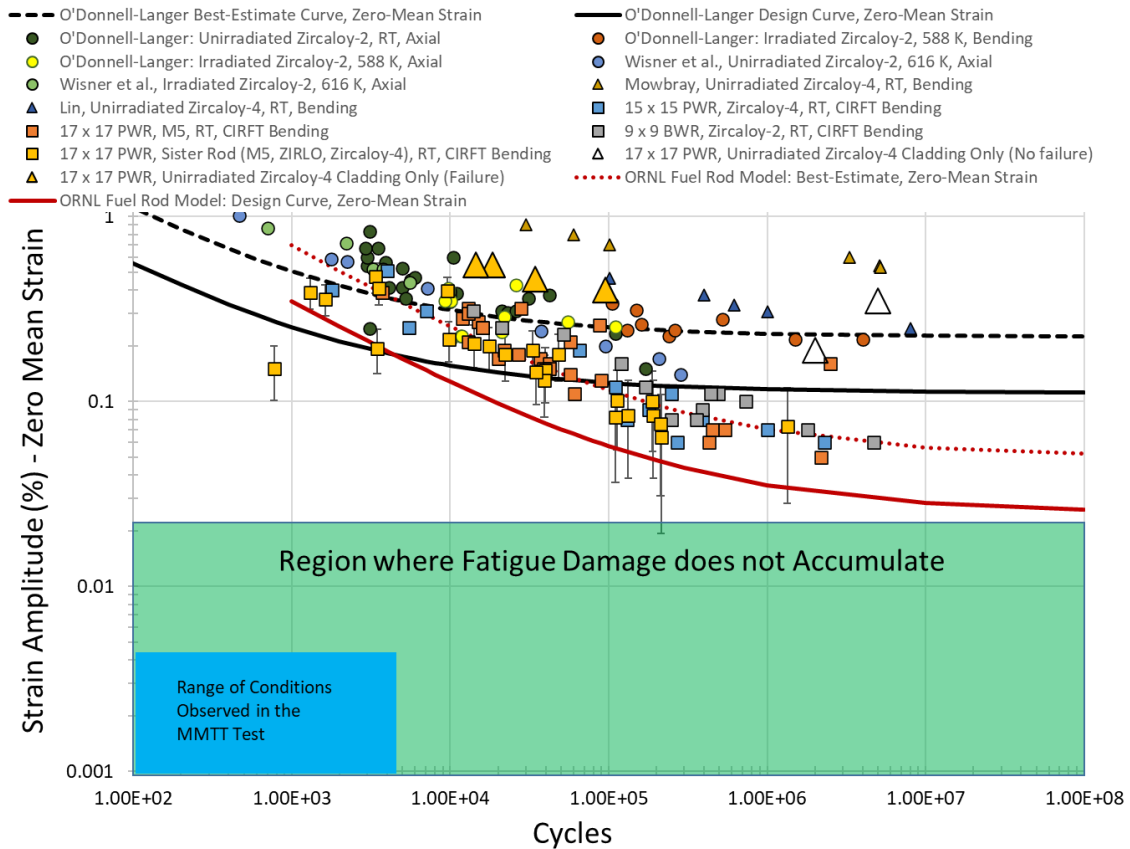
Figure F2-12. Comparison of the most severe range of conditions in the MMTT with the fatigue design curve for fuel rods tested under zero-mean strain conditions.
