Sister Rod Destructive Examinations (FY22)

Spent Fuel and Waste Disposition

January 13, 2023

ORNL/SPR-2022/2678

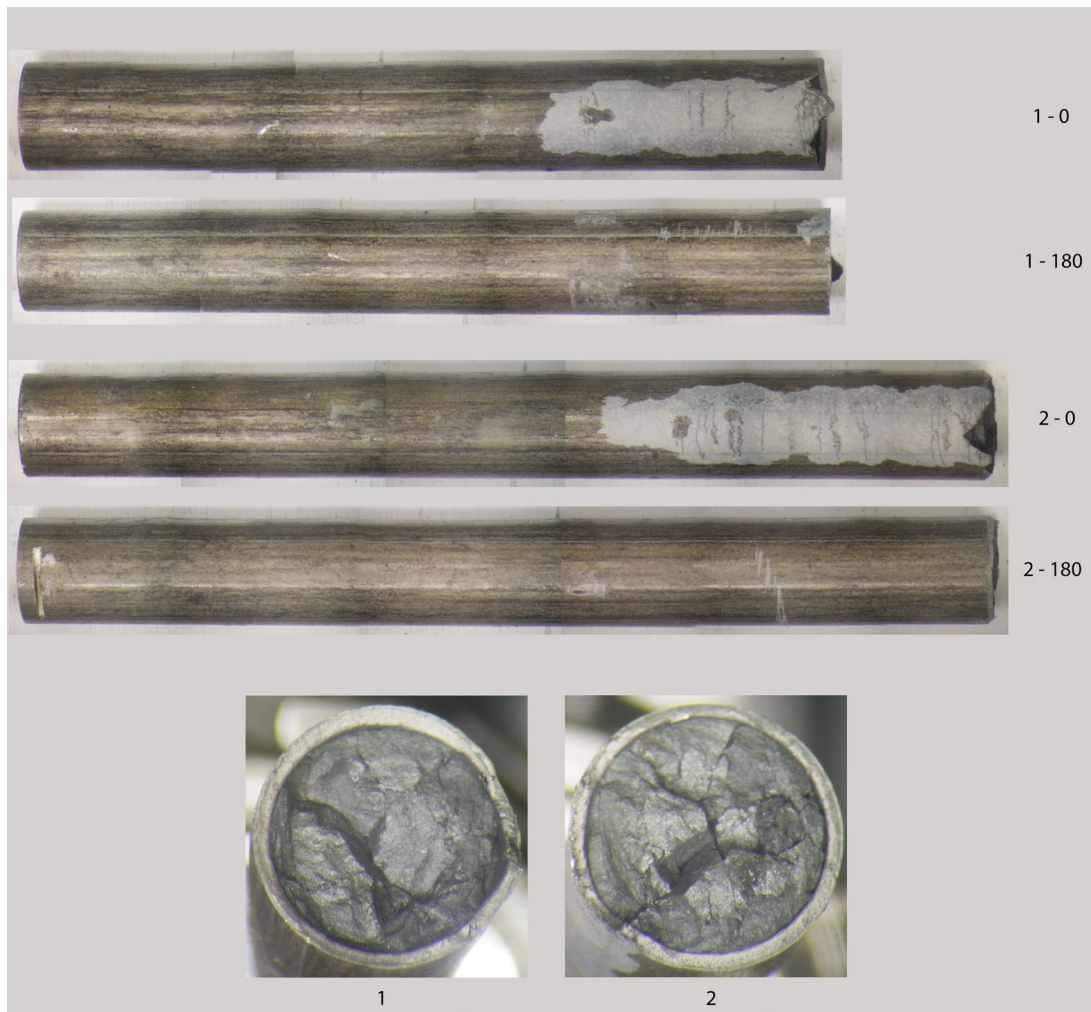
Figure 38. Image of the outer surfaces of the test rod following the aerosol collection 4PB test. The fracture occurred in the body of a pellet, producing coarse debris consistent with ORNL's past 4PB experience.
