**MILESTONE REPORT ON MICROSTRUCTURE OF IRRADIATED SENSORS AND
COUPLING ADHESIVE BONDS**

NSUF Milestone Report M3UA-22OR0803012

This report describes the ORNL aspects of an NSUF project in collaboration between EPRI, ORNL, and NCSU. Preliminary characterizations at ORNL LAMDA laboratory on piezoelectric sensors and bonds before and after NCSU PULSTAR reactor irradiation. Five pre-irradiation and seven post-irradiation samples have been examined by scanning electron microscopy and related methods so far. Samples consisted of (Pb,Bi)(Sc,Ti)O₃ or LiNbO₃ ceramics. Bonding layers consisted of epoxy, zirconia, alumina, aluminosilicate, or a complex soda-lime type slurry.

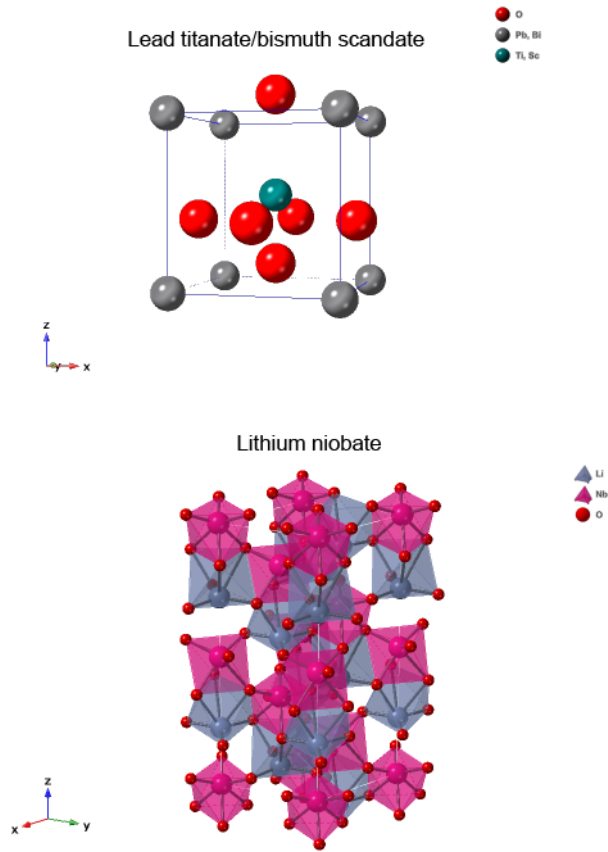
Figure 1. CrystalMaker™ renderings of the piezoelectrics' crystal structures.

Samples examined thus far at ORNL are listed in Table 1. Five unirradiated (control) samples and seven irradiated samples have been examined. Samples were determined by energy dispersive X-ray spectroscopy (EDS) to consist of either Pb-Bi-Sc-Ti-O or Nb-O. These are interpreted to be (PbTiO₃)_x-(BiScO₃)_(1-x), lead titanate-bismuth scanadate “PBSTO,” and LiNbO₃, lithium niobate. Crystal structures are rendered in Figure 1.

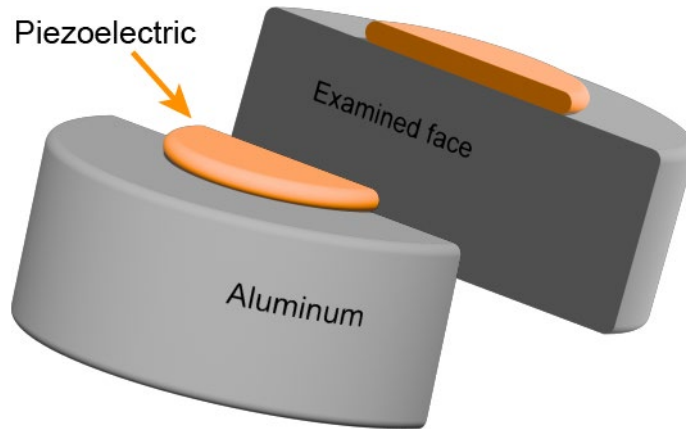
Figure 2. Sample geometry and cutting orientation for cross-sections.

Samples, irradiated or unirradiated, arrived at ORNL in the form of thin piezoelectric disks ~13 mm in diameter bonded to aluminum substrates ~25 mm in diameter by 10 mm tall. Unirradiated samples were prepared in the ORNL central metallography laboratory and irradiated samples in the LAMDA contamination zone metallography laboratory. The samples were embedded as-received in conductive room-temperature-setting epoxy to ensure the piezoelectric disks would not fall off the aluminum substrate during subsequent handling. Once the epoxy set, the samples were sectioned in half with a low-speed diamond saw, and then one half of each specimen was re-mounted to examine the cut face, again in conductive cold-setting epoxy, and then polished metallographically to colloidal silica for an EBSD-quality polish. After polishing, samples were coated with evaporated carbon using a Cressington carbon coater, and then examined in a Tescan MIRA3 GMH SEM equipped with Oxford SDD EDS and Oxford Symmetry EBSD. Figure 2 illustrates the cutting geometry for cross-sectional samples.

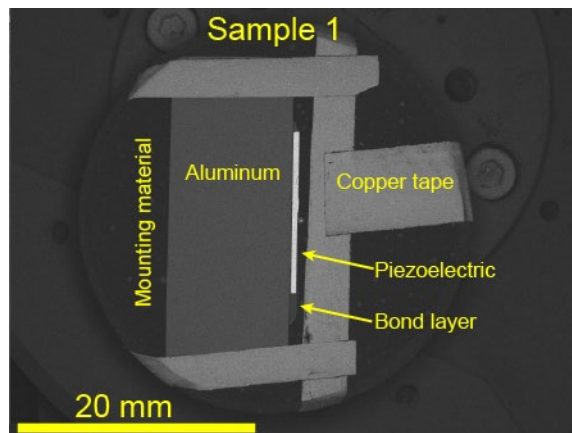
Figure 3. Backscatter electron image of Unirradiated Sample #1 cross-sectioned in its epoxy mount, on the aluminum substrate and mounted with copper tape. Solder ball is not visible in this cut.

Unirradiated Samples #1, 5, 11, 12, and 13 were examined via SEM and SEM-EDS. Figure 3 illustrates the geometry of the cross-sections. Specifically, the epoxy mount is ~32 mm in diameter, the aluminum substrate ~10 mm thick, the piezoelectric disk around 0.5 mm, and the bonding layer <0.5 mm. As seen in Figure 4, the bond is ~150 μm thick, the piezoceramic disk ~400 μm thick, and the bond bulges out around the edge of the disk. The disk is also seen to be porous (black spots, Figure 4-Figure 5). Within the center of the piezoelectric, distinct grains are visible, along with significant porosity. Within individual grains, there appear to be fine piezoelectric domains and high densities of domain walls, Figure 5. The bonding region is imaged in Figure 6, but relatively few details are visible. Note the bright particles in the aluminum (Figure 6, left) are strengthening precipitates expected from aluminum alloy.

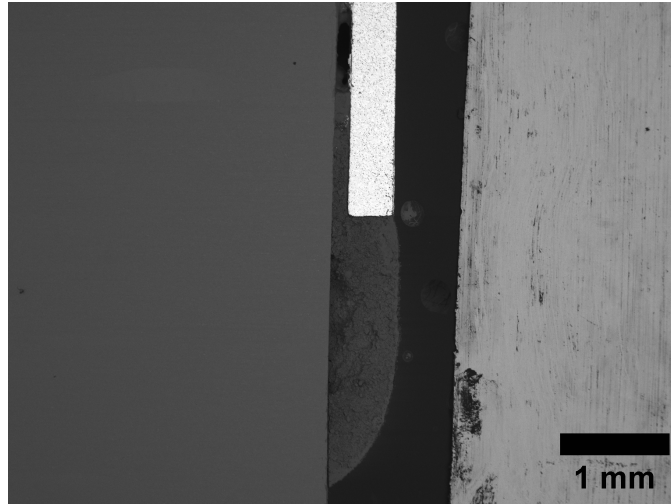
Figure 4. Backscatter electron image of Unirradiated Sample #1, showing details of the bond and piezoceramic.

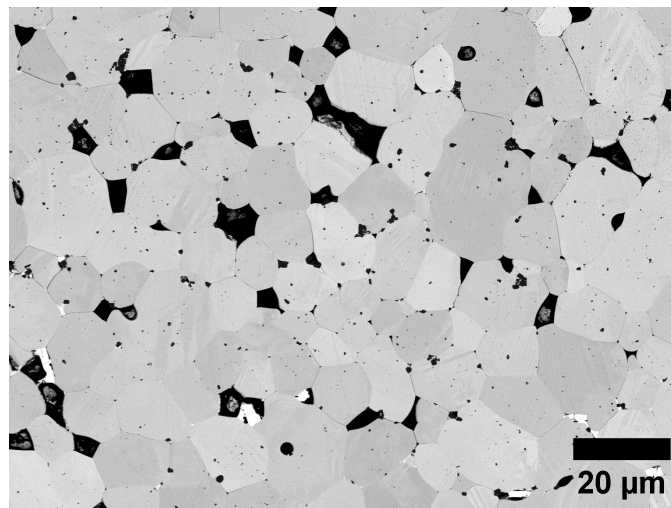
Figure 5. Backscatter electron image of Unirradiated Sample #1, showing details in the middle of the piezoelectric region.

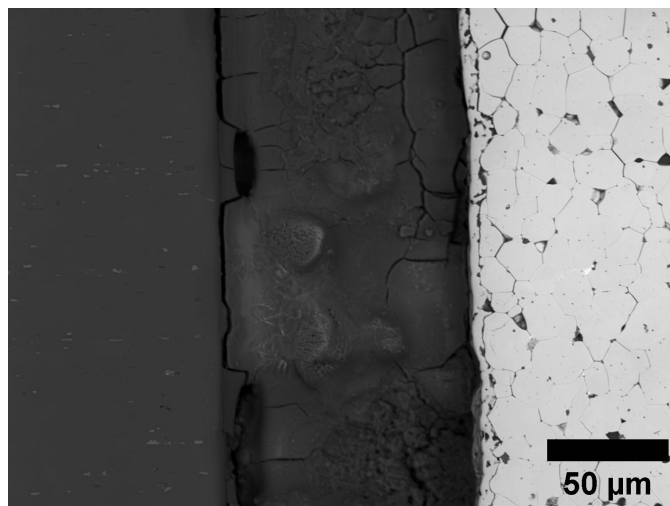
Figure 6. Backscatter electron image of Unirradiated Sample #1, showing details in the bond.

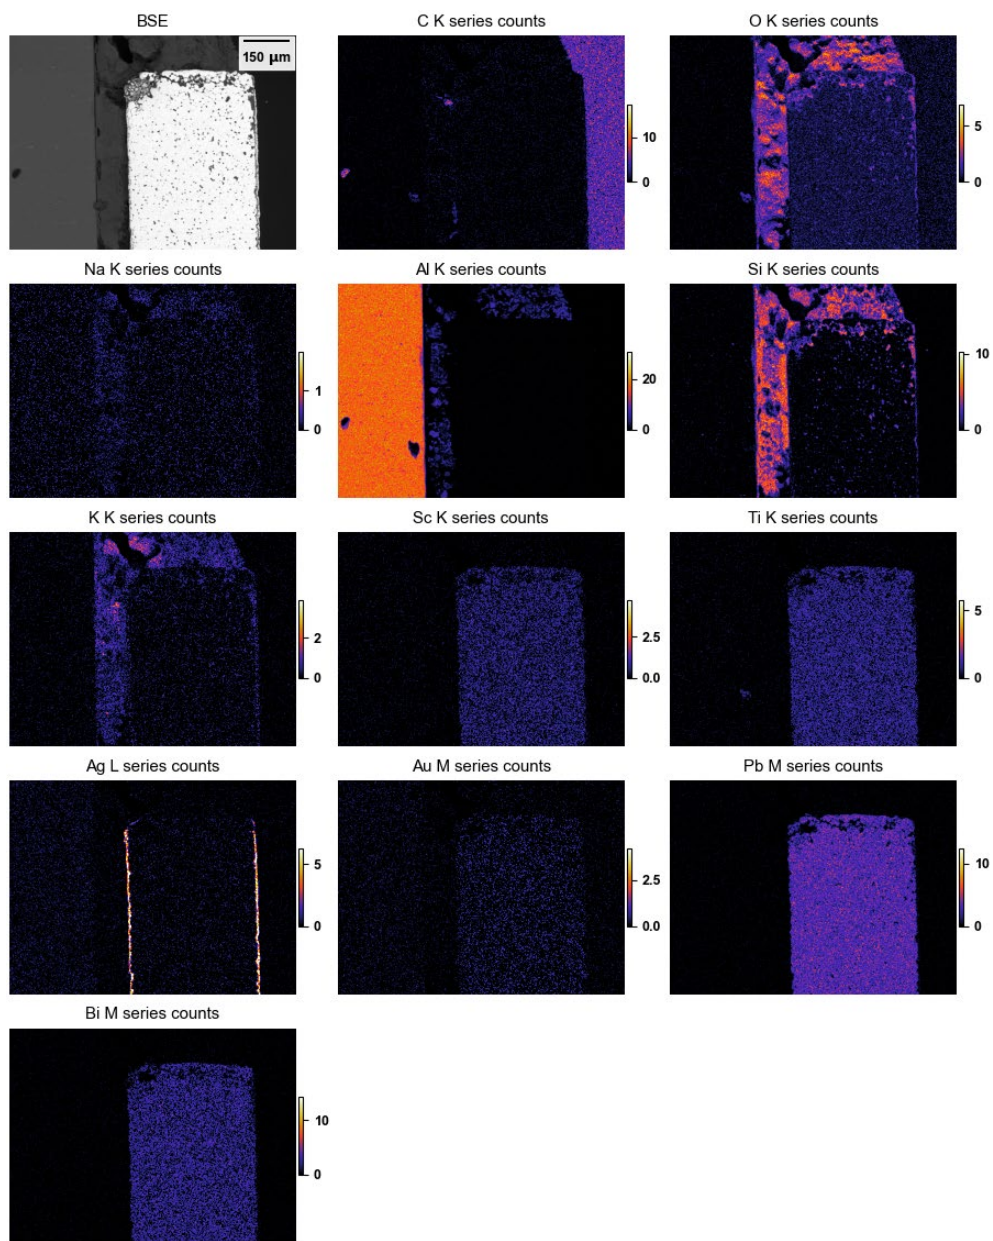
Figure 7. EDS integrated elemental lines extracted from a 15 kV spectrum image from Unirradiated Sample 1.

The bonding layer shows mostly Si, with Al as second-most and K and Na being trace. X-ray maps, computed by integrating the peaks and subtracting the backgrounds and overlaps (Oxford Instruments "TruMapTM" algorithm) are given in Figure 7. The substrate is Al, the metallographic mounting epoxy C, the piezoelectric disk Pb-Bi-Sc-Ti-O, the bonding layer Al-Si-K-Na-O, and the electrodes on top and bottom of the disk Ag. A high magnification map of the bonding layer, Figure 8, shows that the Al-O and Si-K-Na-O appear as separate regions. Figure 7 and Figure 8 show small packets of Sc-rich material within the piezoelectric.

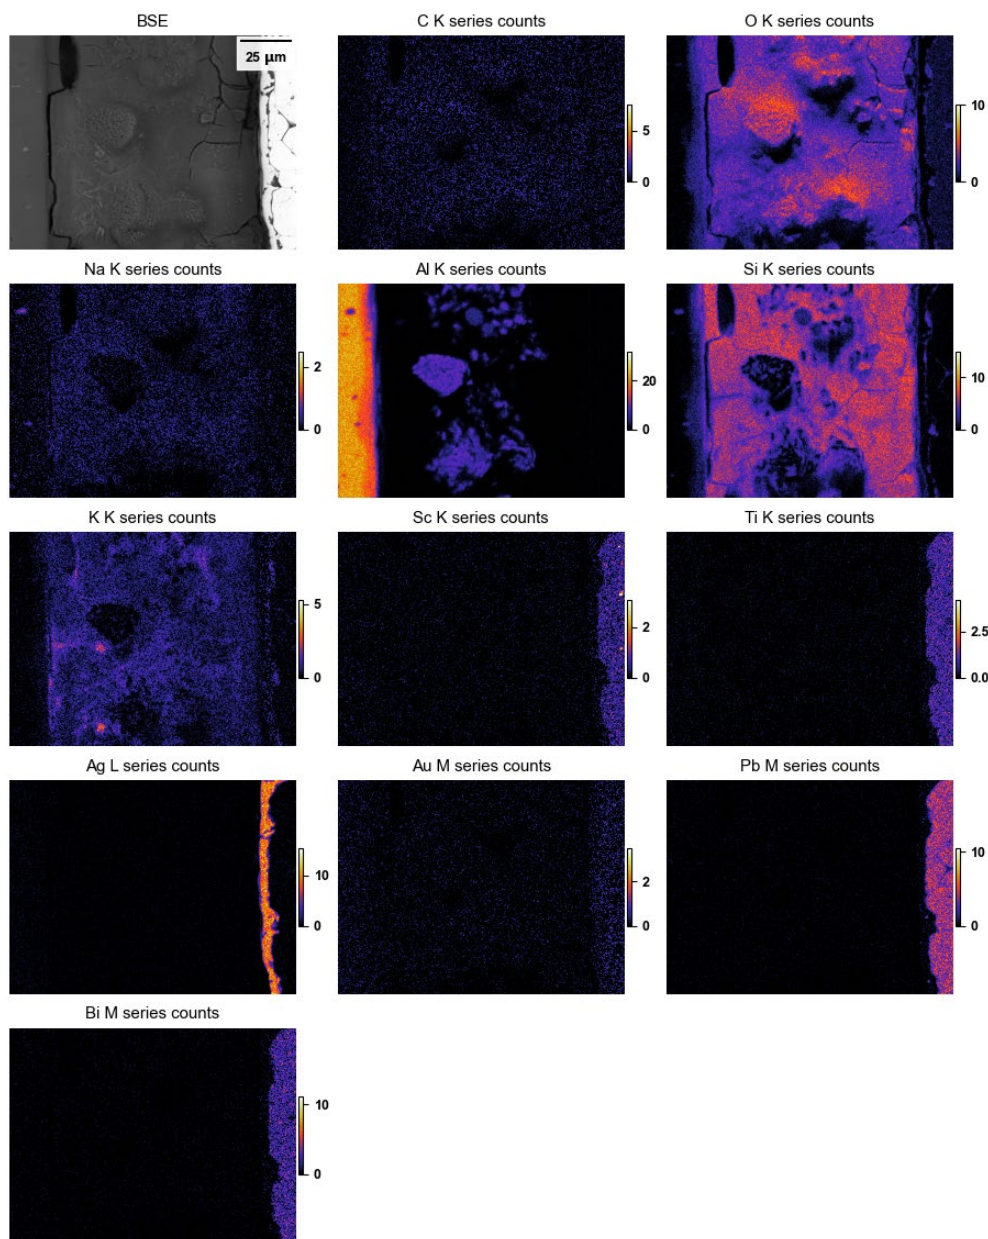
Figure 8. EDS integrated elemental lines extracted from a 15 kV spectrum image from Unirradiated Sample 1 (higher magnification).

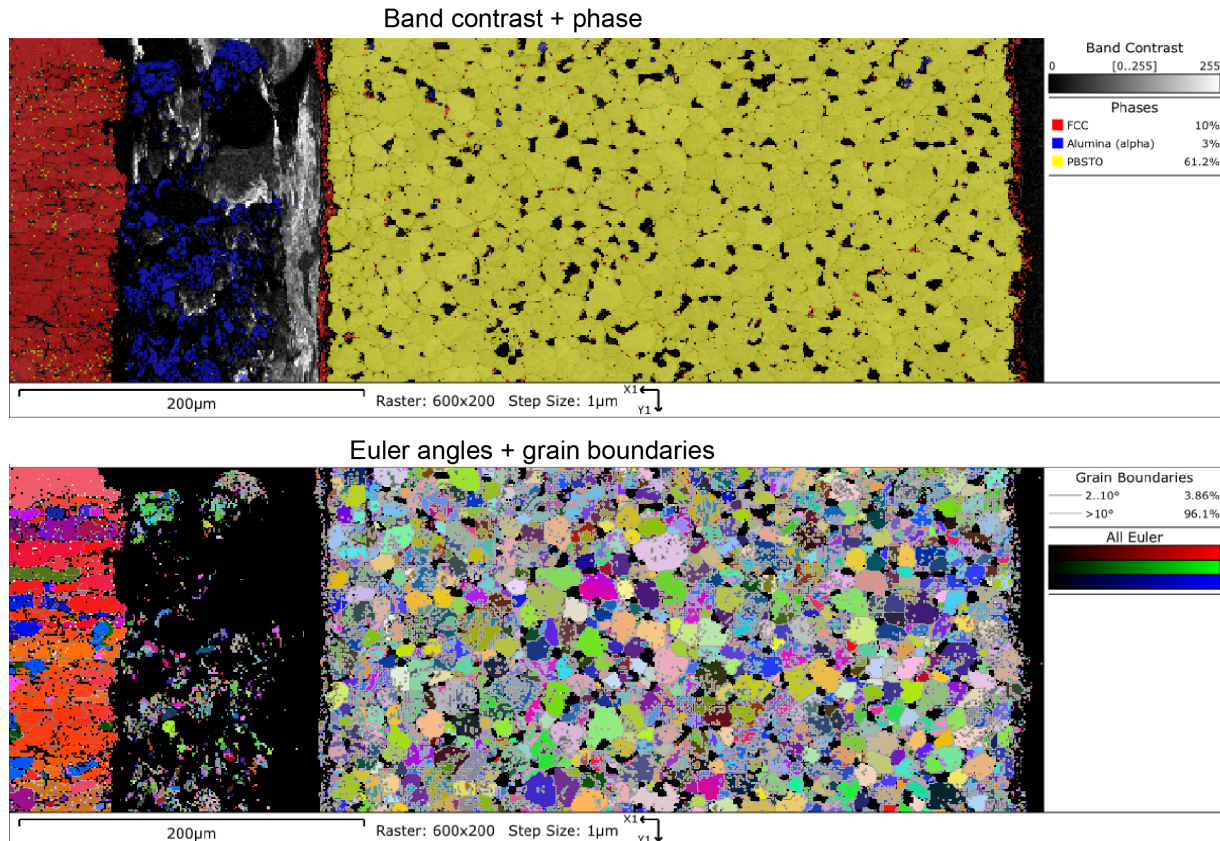
Figure 9. EBSD results from Unirradiated Sample 1. Red phase: FCC, Al or Ag. Blue phase, Al_2O_3 . Yellow phase: PBSTO (Pb-Bi-Sc-Ti-O).

Electron backscatter diffraction from the aluminum substrate, across the bonding layer, and into the piezoelectric disk, indexed the aluminum as aluminum metal (unsurprisingly); silver also indexed to Al, because the identical crystal structures cannot be differentiated via EBSD, so only Al was used as a crystal card, not Ag, and both are labelled “FCC (Al/Ag).” The piezoelectric indexed reasonably well as ICSD crystal card #186424, $(\text{PbTiO}_3)_{0.64}(\text{BiScO}_3)_{0.36}$, space group P 4/mmm #99. It’s vital to point out that the perovskite PTO-based system shows many similar crystal structures, so the exact crystal structure cannot be determined with confidence via electron scattering, and X-ray scattering would be more reliable. However, within the boundaries of expecting pseudosymmetry artifacts, this P 4/mmm card worked well. The EBSD results are summarized in Figure 9. Broadly, the aluminum substrate is well-indexed and the grains highly bamboosed, probably from extrusion processing. The bonding layer shows a few small particles indexed as Al_2O_3 but is mostly unindexed, indicating

some combination of amorphous material, material too soft to polish to EBSD quality, and/or material whose crystal structure is immediately damaged by the electron beam. Small grains of Ag are present in the electrode, and then the piezoelectric disk shows clear, mostly equiaxed grains with complex domain structures and pseudosymmetry mis-indexing.

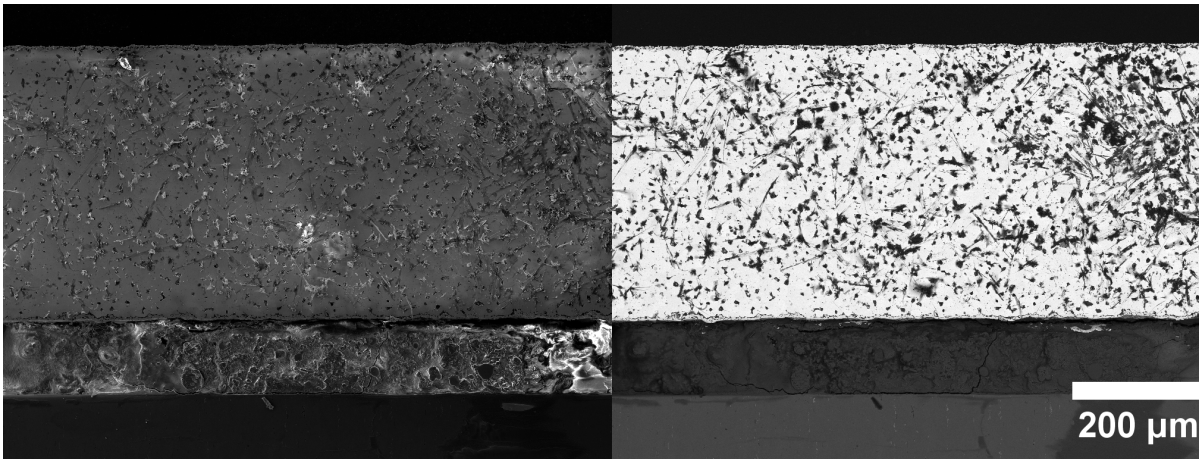
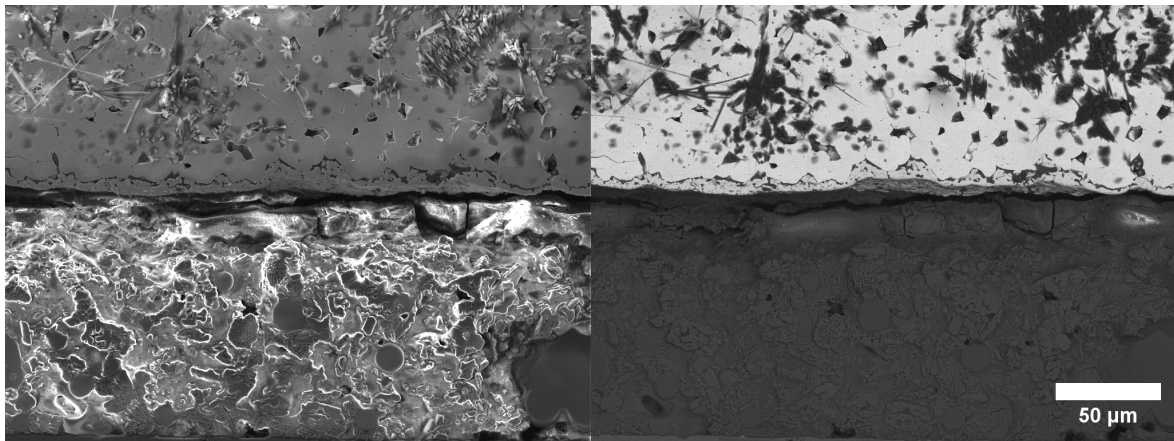
Figure 10. Secondary electron (left) and backscatter electron (right) image of Unirradiated Sample #1 after several months of storage in room air, showing the Na-K-O “needles” growing across the piezoceramic.

Figure 11. Secondary electron (left) and backscatter electron (right) image of Unirradiated Sample #1 after several months of storage in room air, showing the Na-K-O “needles” growing across the piezoceramic.

After examination of Irradiated Sample #4, below in Section 3.2 revealed unexpected Na-O features (see below), this Unirradiated Sample #1 was re-examined after several months of storage in room air. Needle-like features had grown across the surface of the piezoelectric, Figure 10-Figure 11. EDS mapping found these needles to be Na-K-O rich, Figure 12. This is probably due to reactions between humidity and the reactive metals Na-K; see Irradiated Sample #4, in Section 3.2 below, for comparison and contrast.

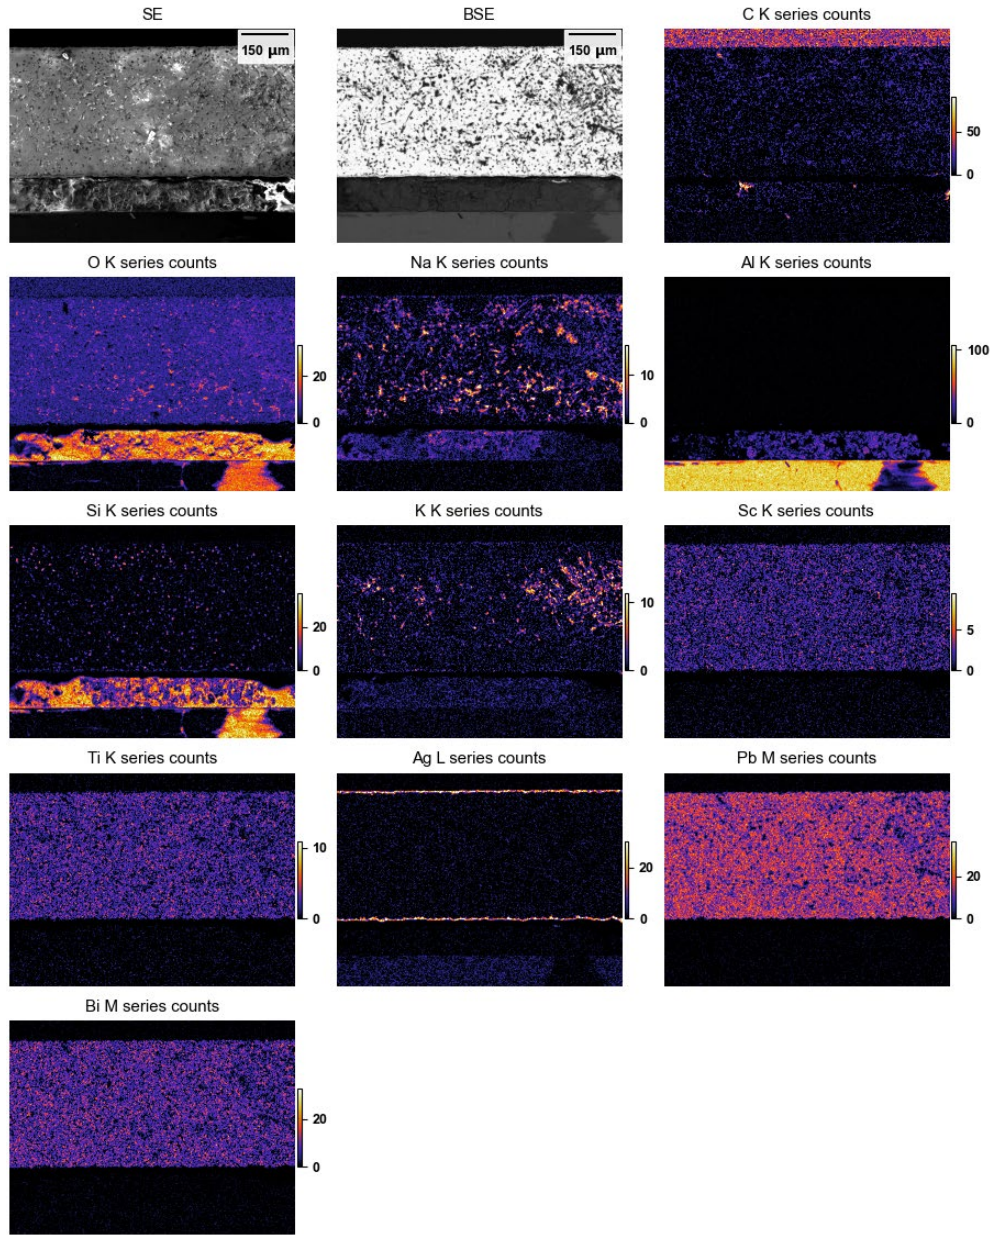
Figure 12. EDS integrated elemental lines extracted from a 10 kV spectrum image from Unirradiated Sample #1, showing the Na–K–O rich needles.

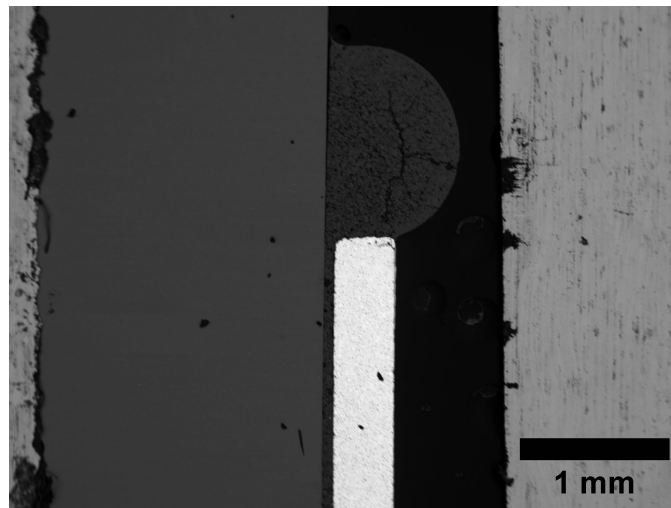
Figure 13. Backscatter electron image of Unirradiated Sample #5, showing details of the bond and piezoceramic.

Results from Unirradiated Sample 5 are essentially the same, although the bond layer is Al–Si without (or with negligible) Na–K. The gross structure — disk on bond layer on aluminum, embedded in epoxy — is the same, Figure 13. Looking at the bond layer in detail, it shows much blockier crystals with interspersed low-atomic-number regions, as well as small particles, Figure 14. EDS indicates the crystals are essentially Al–O, Figure 15. The piezoceramic shows no visible differences compared to Unirradiated Sample 1, but the bond layer is very different. Indeed, the Si level is very low, and mostly present at the inter-granular regions in the bond layer, so it's possible Si is a minor addition or an artifact of the final polishing step (colloidal silica). The EBSD results, Figure 16, are taken at high magnification around the bonding layer, because of the higher crystallinity of the bonding layer compared to Unirradiated Sample 1. The layer is seen to consist of high-crystal-quality Al_2O_3 ; the

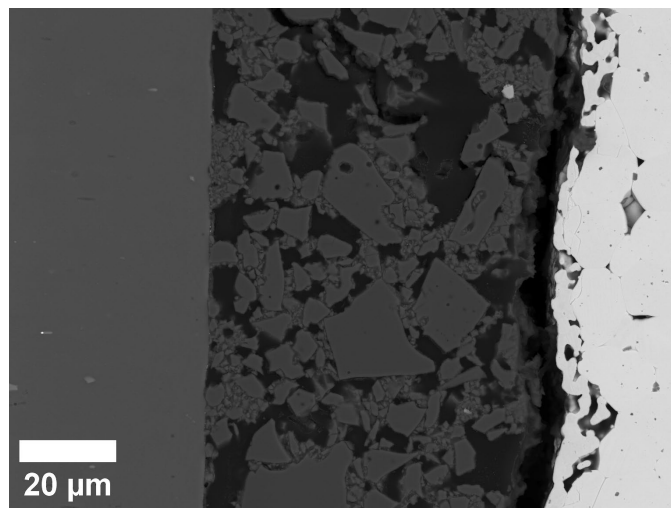
Figure 14. Backscatter electron image of Unirradiated Sample #5. The bond is clearly very crystalline.

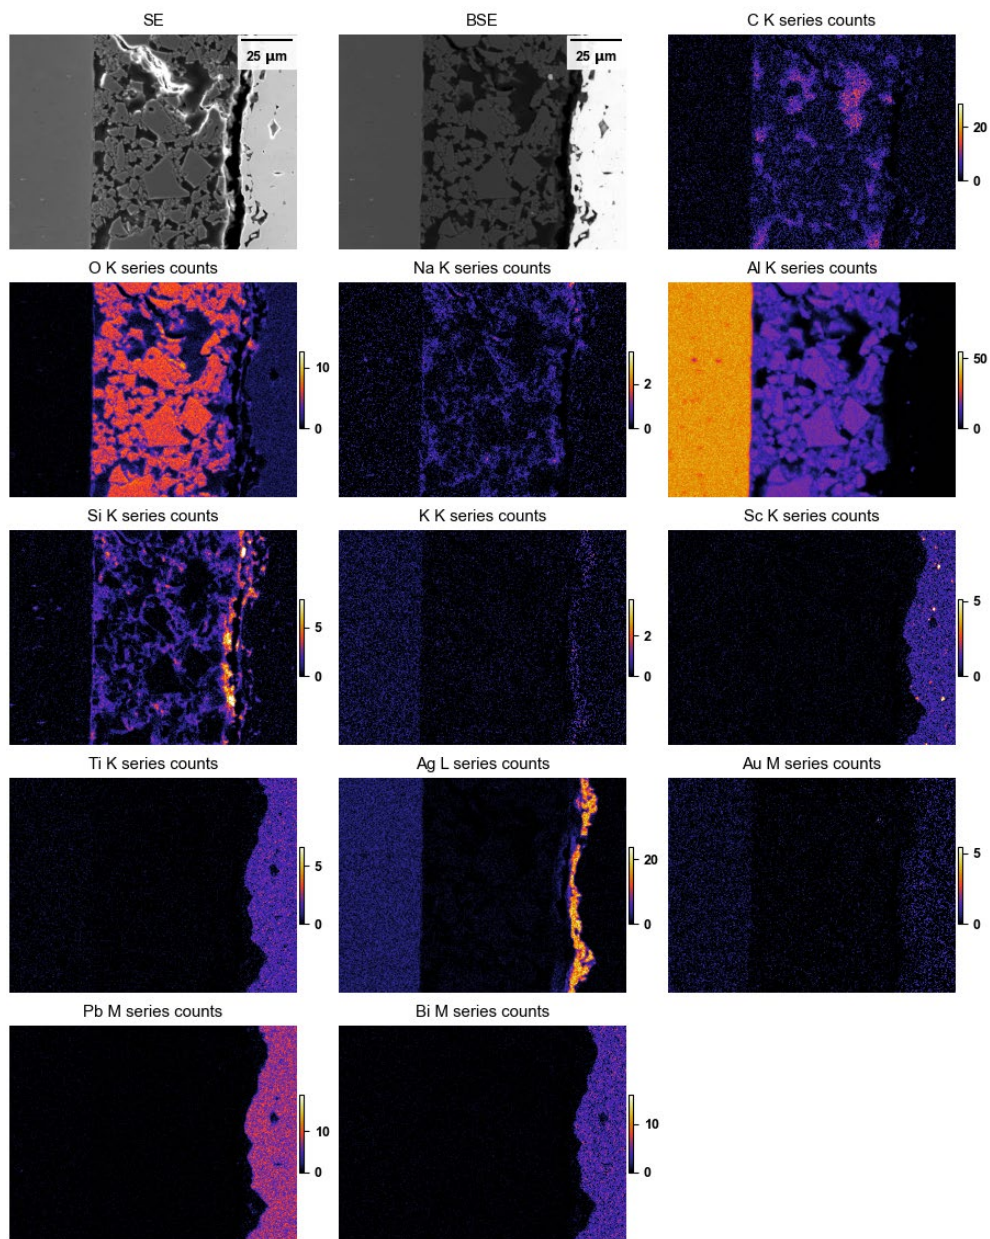
Figure 15. EDS integrated elemental lines extracted from a 15 kV spectrum image from Unirradiated Sample 5.

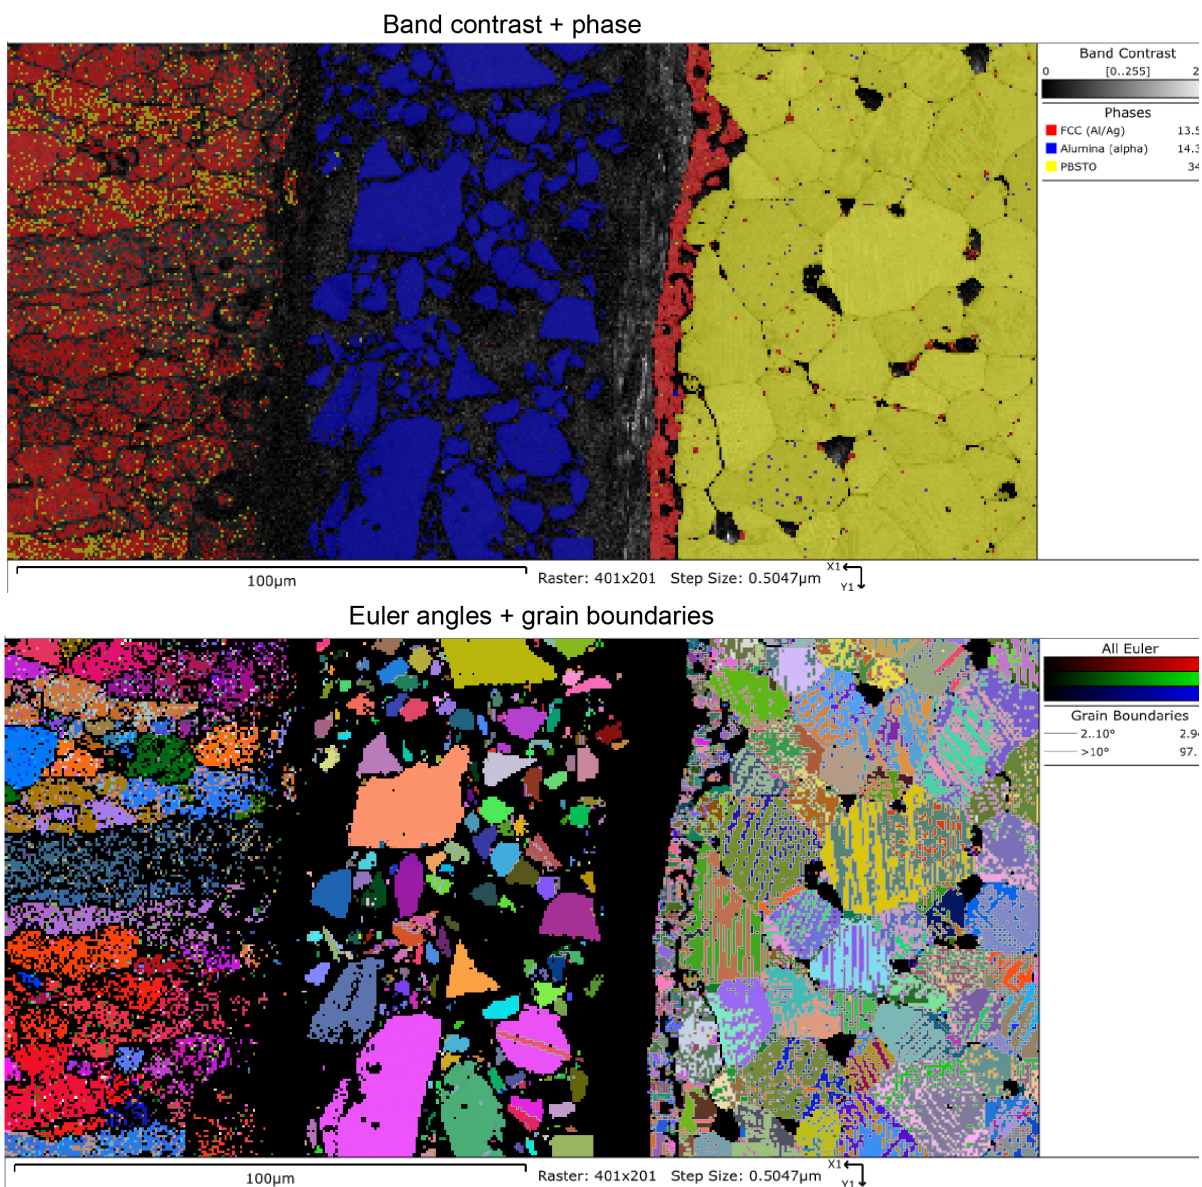
Figure 16. EBSD results from Unirradiated Sample 5. Red phase: FCC, Al or Ag. Blue phase, Al_2O_3 . Yellow phase: PBSTO (Pb-Bi-Sc-Ti-O).

piezoelectric layer shows more details of the domain structure, thanks to the higher magnification (smaller pixel pitch) in this dataset.

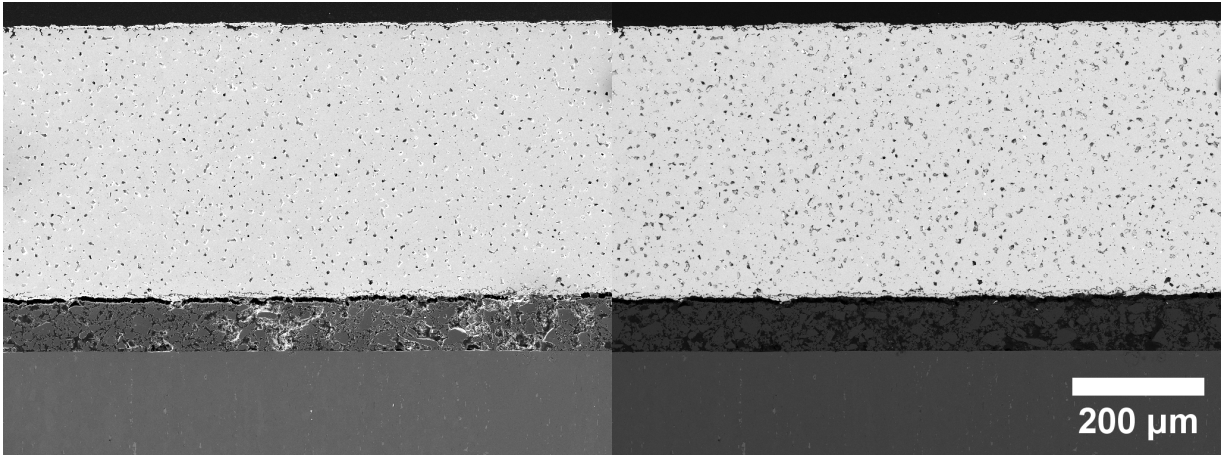
Figure 17. Secondary electron (left) and backscatter electron (right) image of Unirradiated Sample #5 after several months of storage in room air, no changes from imaging when freshly polished.

After the observation of Na-K-O needles growing on Unirradiated Sample #1 after several months storage in laboratory air, Unirradiated Sample #5 was re-examined, Figure 17, and is unchanged compared to when freshly polished. Whatever effect led to the growth of features on the as-polished surface in Unirradiated Sample #1 and Irradiated Sample #4, was not present in Unirradiated Sample #5.

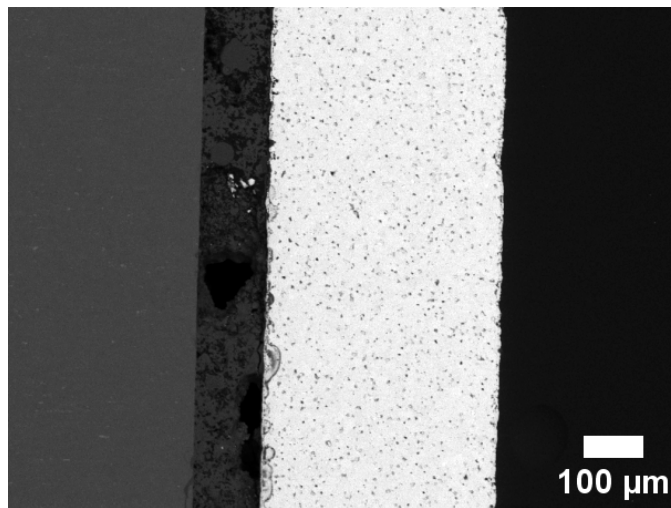
Figure 18. Backscatter electron image of Unirradiated Sample #11, showing details of the bond and piezoceramic.

Unirradiated Sample 11 was also a PBSTO piezoelectric ceramic, and the bonding layer was also Al_2O_3 -based. The layers are quite similar, Figure 18. The EDS maps show dense Al-O rich bonding layer and the same PBSTO ceramic, Figure 19 and Figure 20. The EBSD, similarly, shows high quality Al_2O_3 crystals, Figure 21

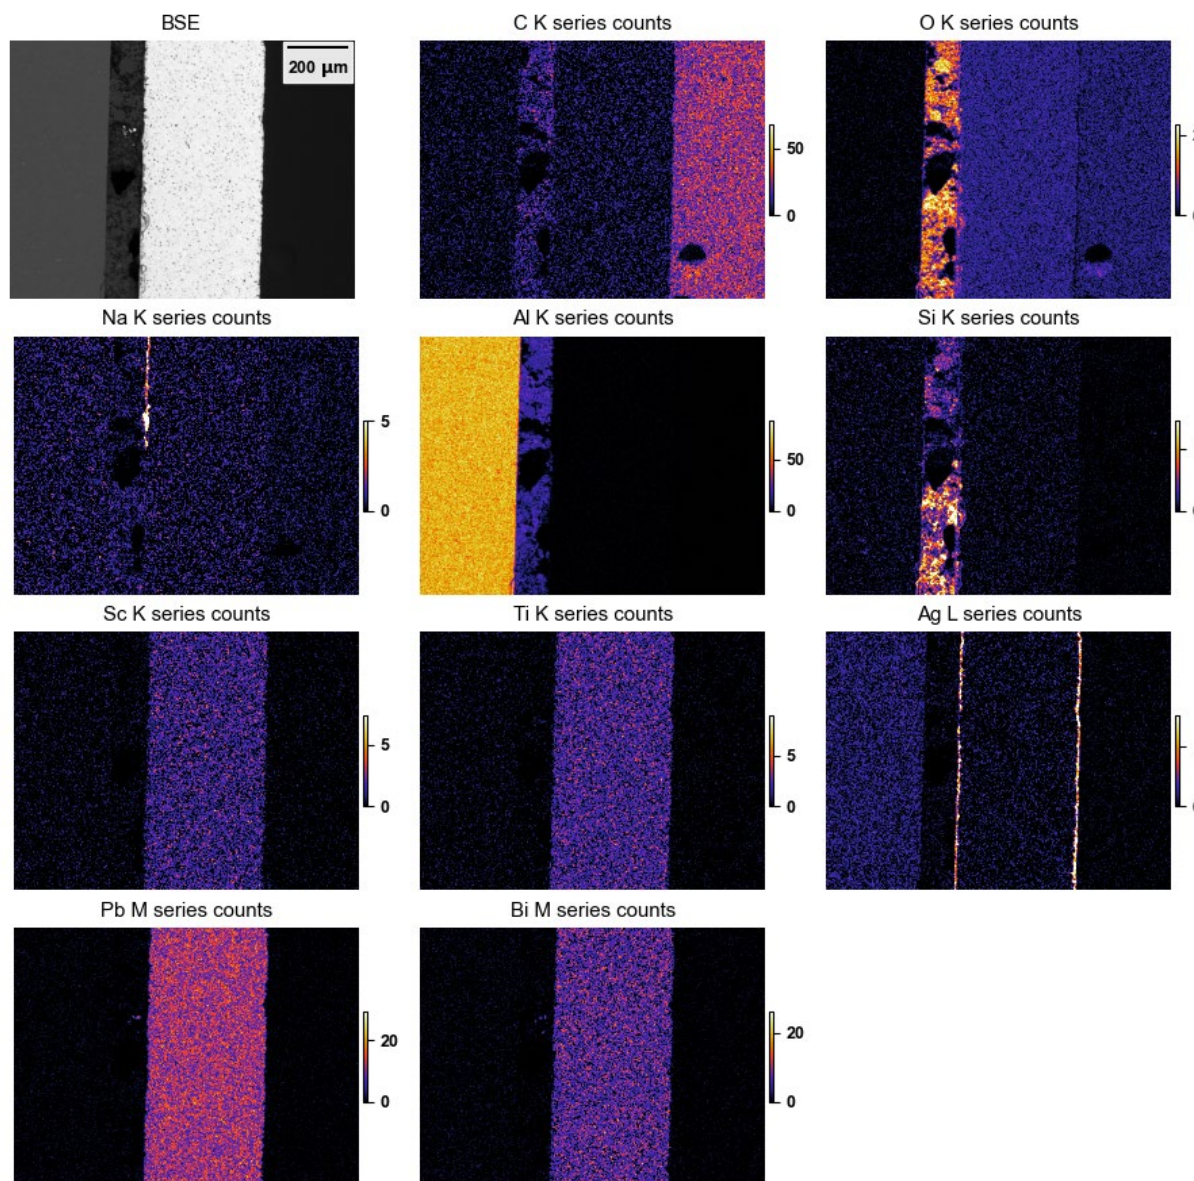
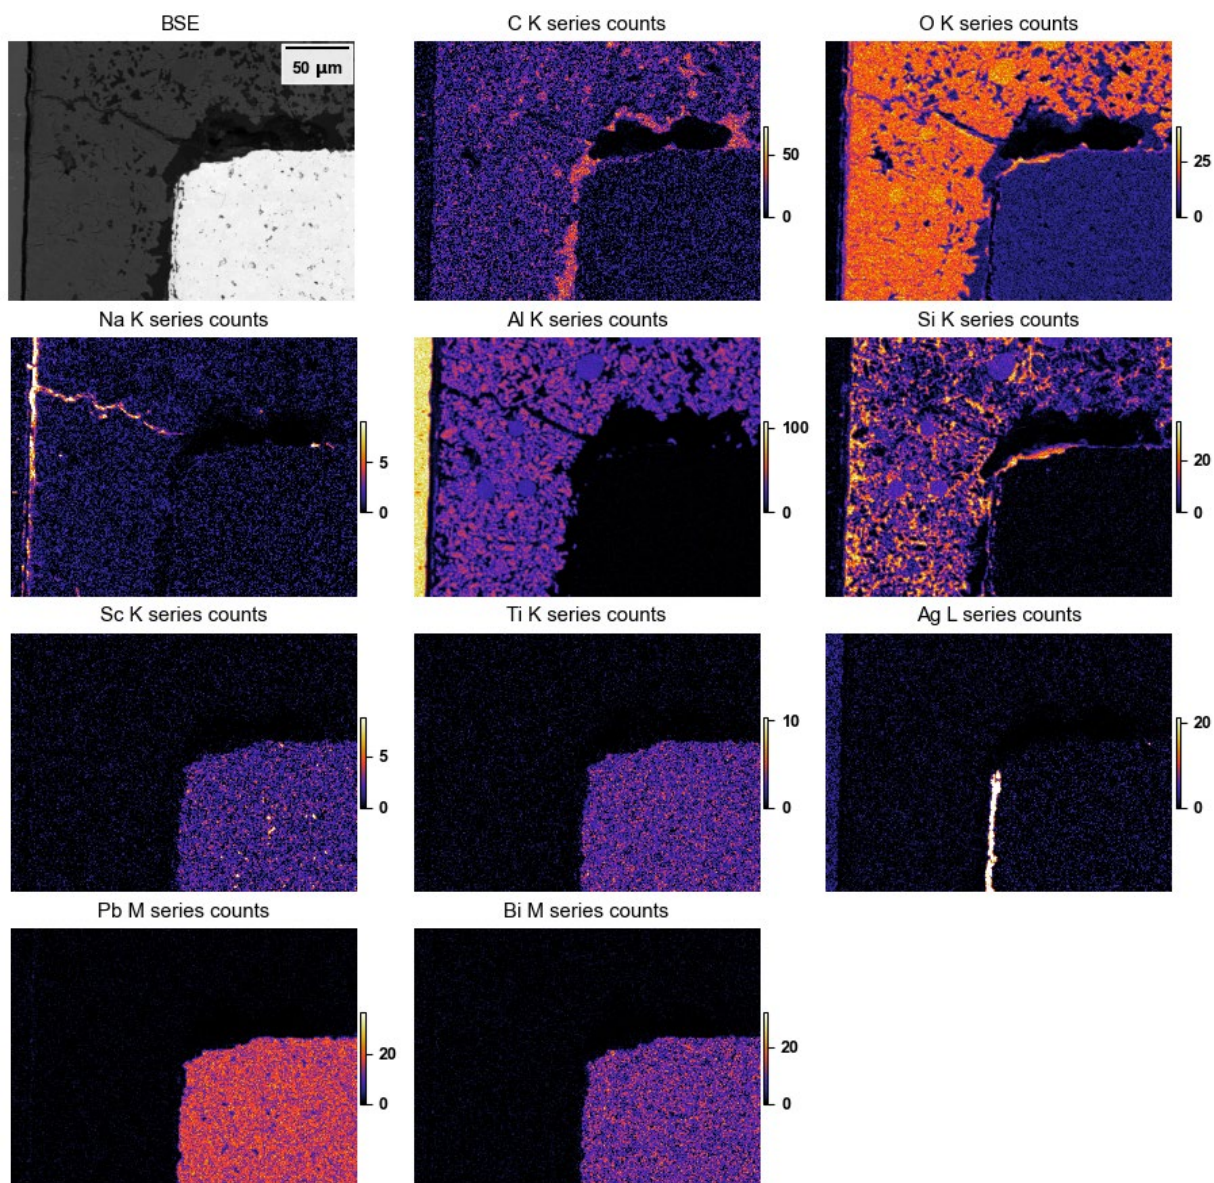
Figure 19. EDS integrated elemental lines extracted from a 10 kV spectrum image from Unirradiated Sample 11.

Figure 20. EDS integrated elemental lines extracted from a 10 kV spectrum image from Unirradiated Sample 11.

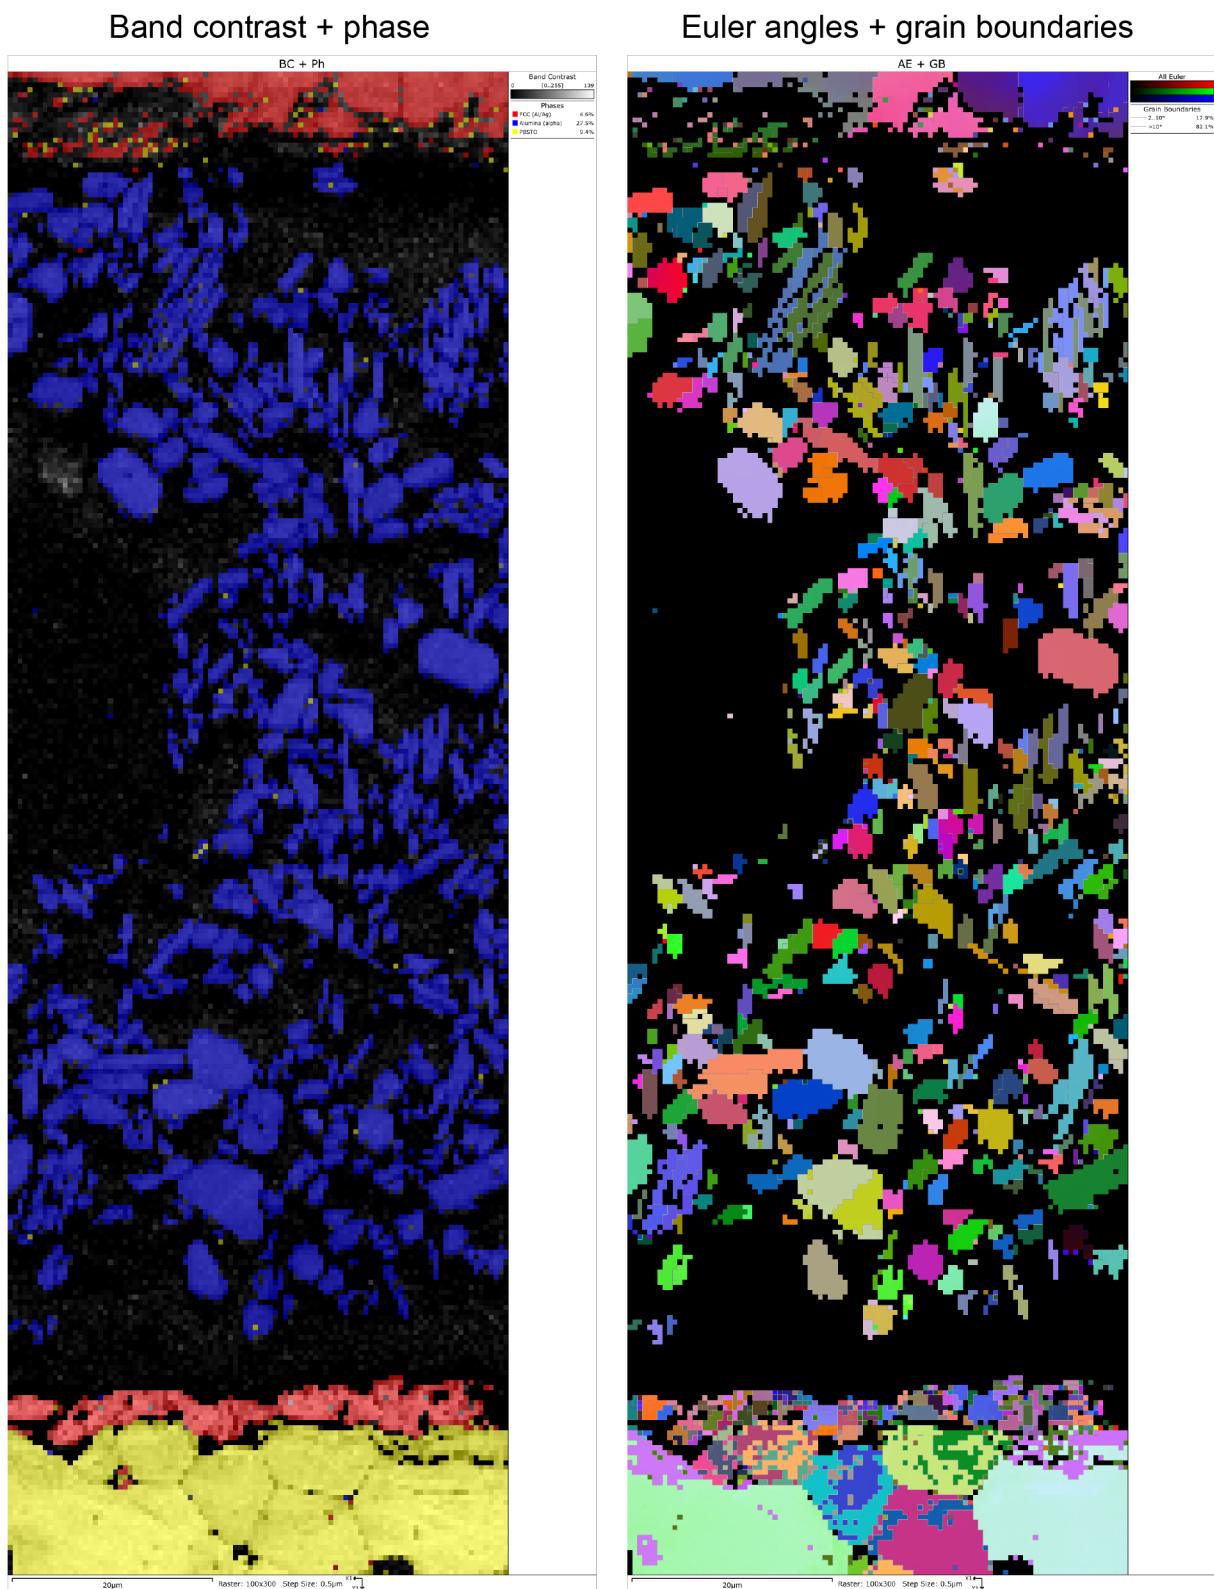
Figure 21. EBSD results from Unirradiated Sample 11. Red phase: FCC, Al or Ag. Blue phase, Al_2O_3 . Yellow phase: PBSTO (Pb-Bi-Sc-Ti-O).

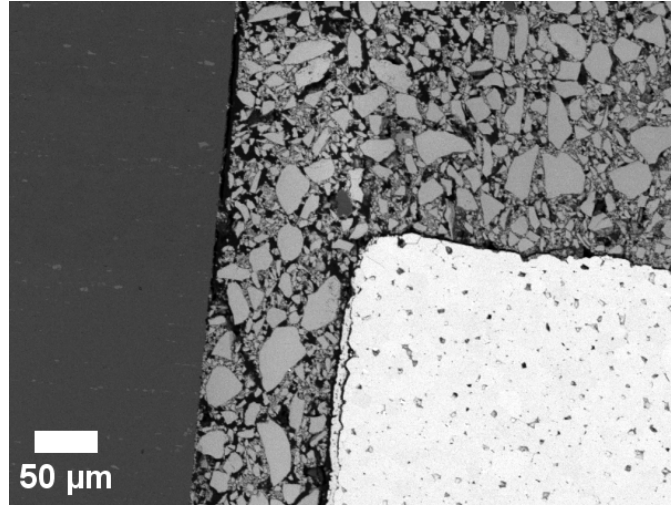
Figure 22. Backscatter electron image of Unirradiated Sample #12, showing details of the bond and piezoceramic.

Unirradiated Sample 12 shows a zirconia bonding layer; EBSD identified this is tetragonal, but again, electron scattering is less reliable than X-ray scattering and this identification is tentative. The bonding layer is dense and highly crystalline, Figure 22. The BSE image and X-ray maps are in Figure 23 and show the Zr-rich structure. The EBSD, with the unknown phase indexed to tetragonal P 4/mmm zirconia, is in Figure 24.

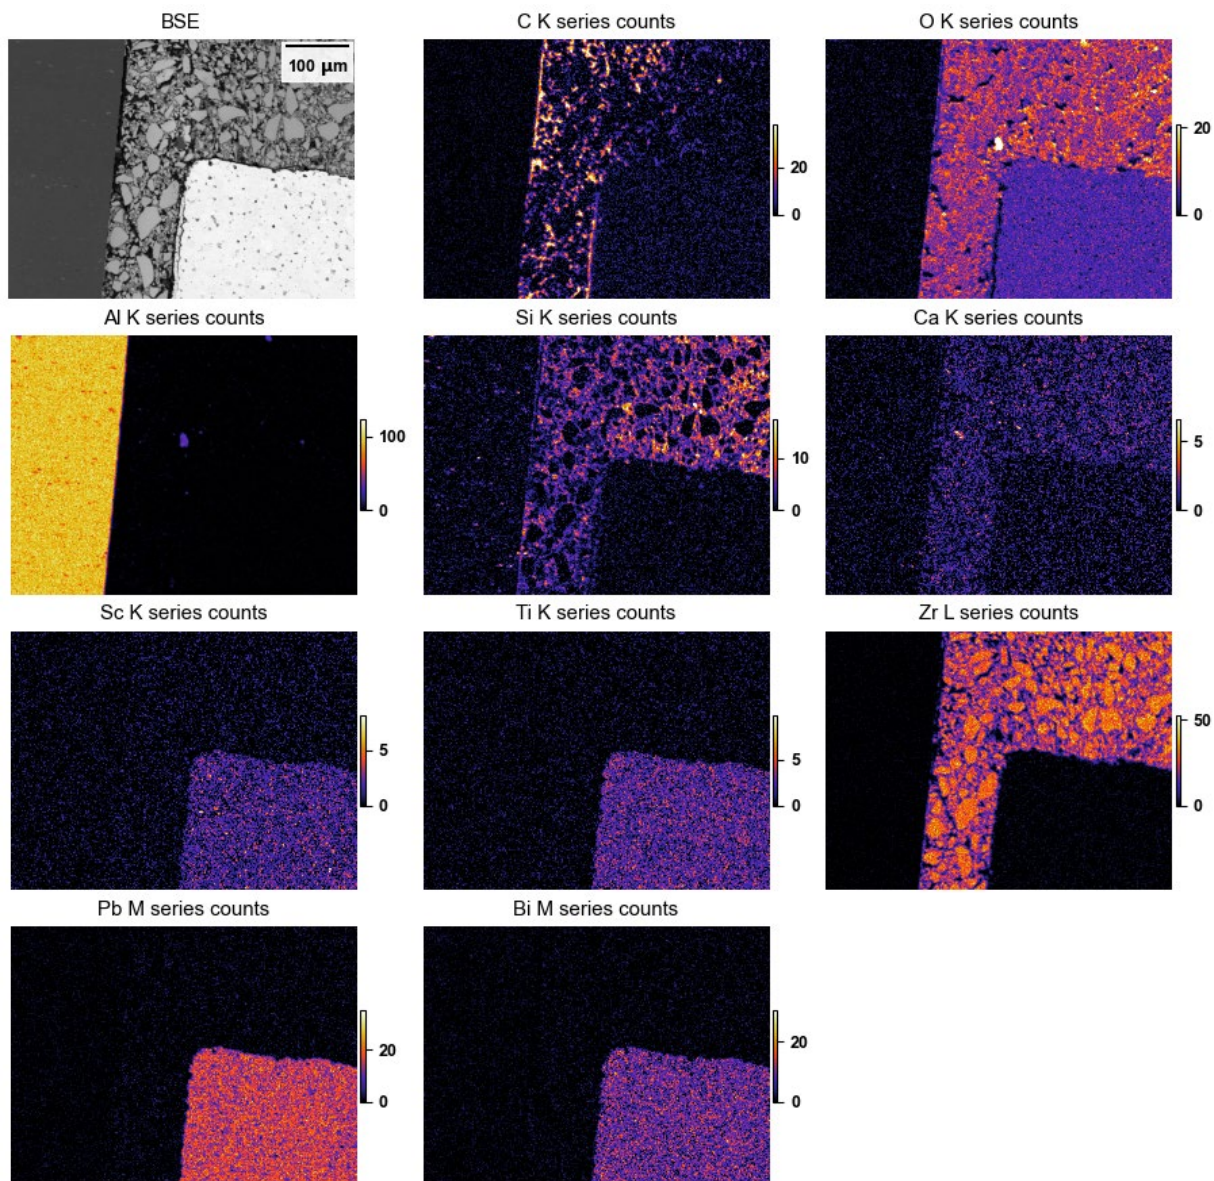
Figure 23. EDS integrated elemental lines extracted from a 10 kV spectrum image from Unirradiated Sample 12.
