**MILESTONE REPORT ON MICROSTRUCTURE OF IRRADIATED SENSORS AND
COUPLING ADHESIVE BONDS**

NSUF Milestone Report M3UA-22OR0803012

This report describes the ORNL aspects of an NSUF project in collaboration between EPRI, ORNL, and NCSU. Preliminary characterizations at ORNL LAMDA laboratory on piezoelectric sensors and bonds before and after NCSU PULSTAR reactor irradiation. Five pre-irradiation and seven post-irradiation samples have been examined by scanning electron microscopy and related methods so far. Samples consisted of (Pb,Bi)(Sc,Ti)O₃ or LiNbO₃ ceramics. Bonding layers consisted of epoxy, zirconia, alumina, aluminosilicate, or a complex soda-lime type slurry.

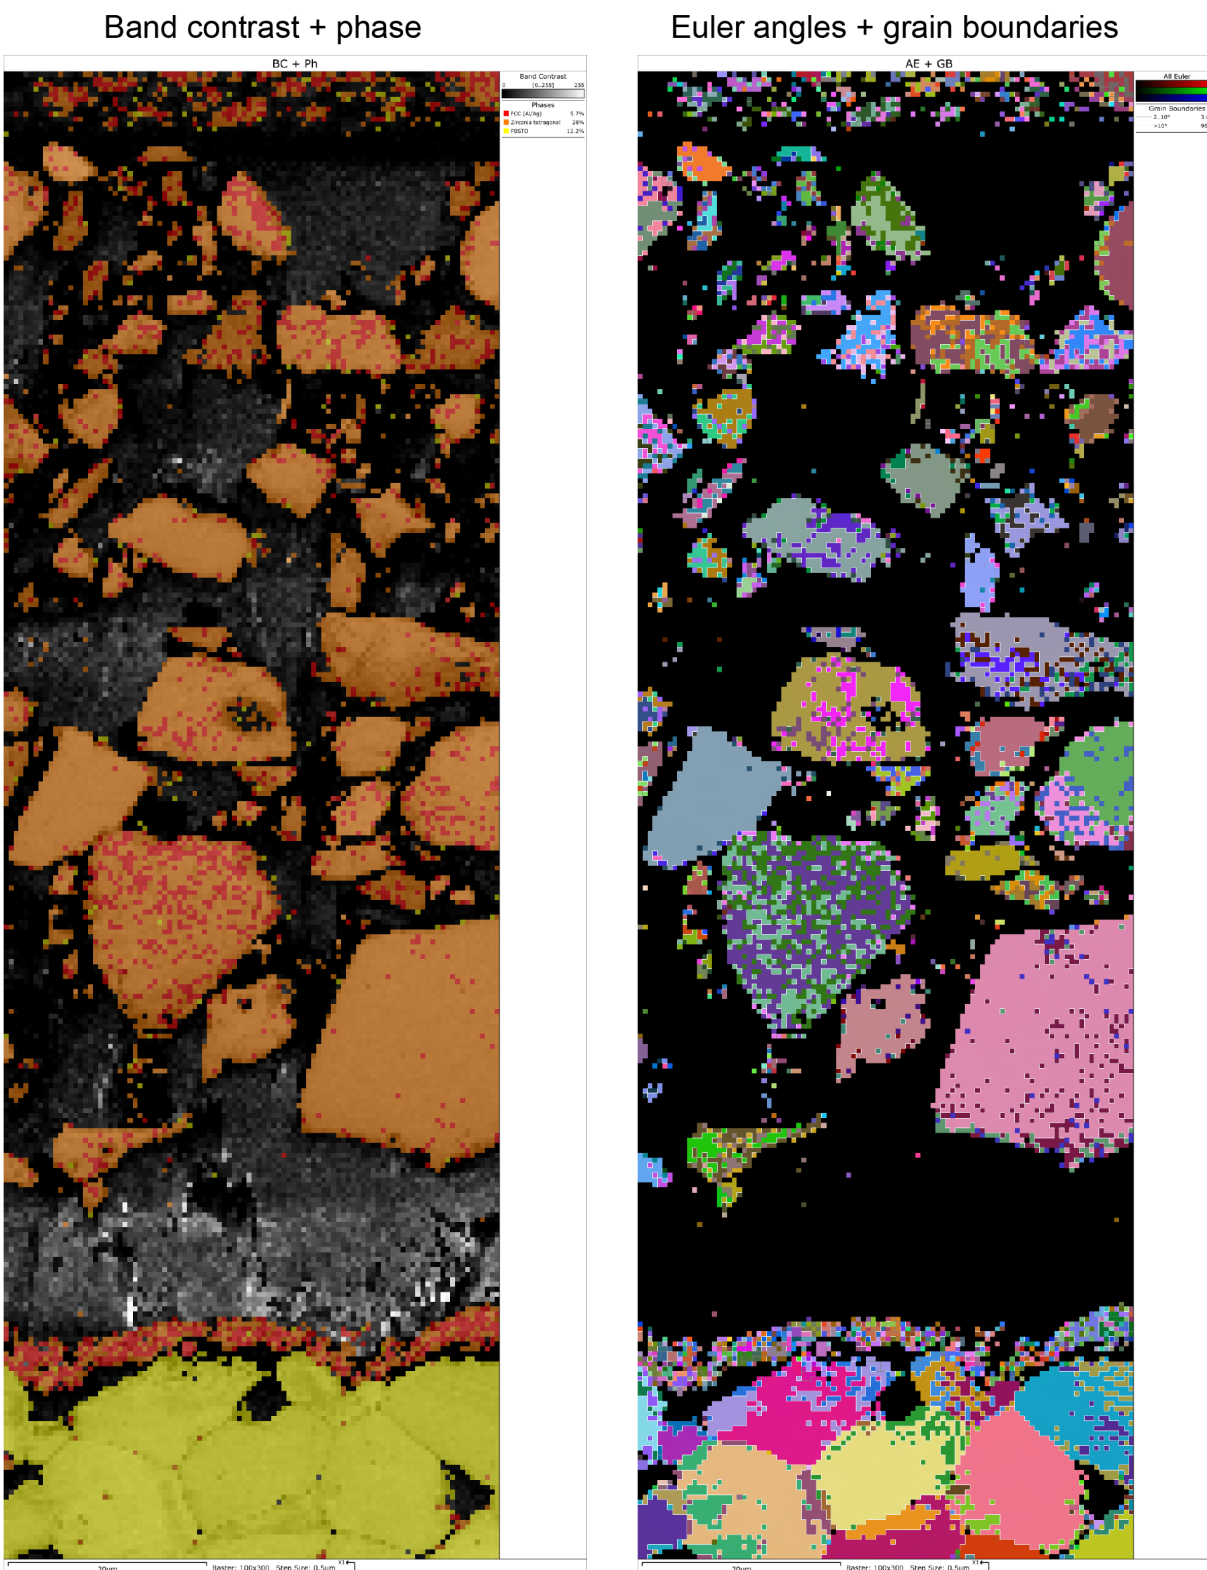
Figure 24. EBSD results from Unirradiated Sample 12. Red phase: FCC, Al or Ag. Orange phase, tetragonal zirconia. Yellow phase: PBSTO (Pb-Bi-Sc-Ti-O).

Unirradiated Sample 12 shows a zirconia bonding layer; EBSD identified this is tetragonal, but again, electron scattering is less reliable than X-ray scattering and this identification is tentative. The bonding layer is dense and highly crystalline, Figure 22. The BSE image and X-ray maps are in Figure 23 and show the Zr-rich structure. The EBSD, with the unknown phase indexed to tetragonal P 4/mmm zirconia, is in Figure 24.

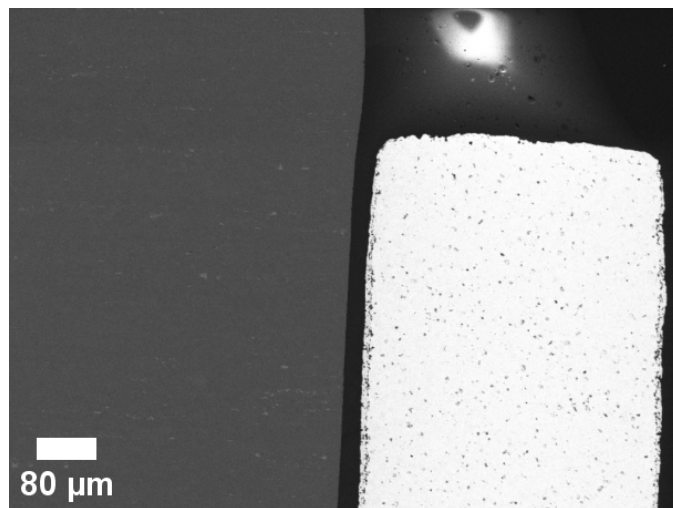
Figure 25. Backscatter electron image of Unirradiated Sample #13, showing details of the bond and piezoceramic. The bright area is charging.

Unirradiated Sample #13 showed an epoxy bonding layer, and the layer was C-O rich with some S, which is interpreted as a low-temperature-setting S-rich epoxy. The amorphous, featureless epoxy is seen in Figure 25. There is a bright area and some distortion of the image due to the highly insulating epoxy charging up under the beam, despite a thin layer of evaporated carbon. The EDS data, consistent with the other datasets and the epoxy bond, are seen in Figure 26. Because EBSD, by definition, can only analyze crystals, the epoxy was not examined via EBSD.

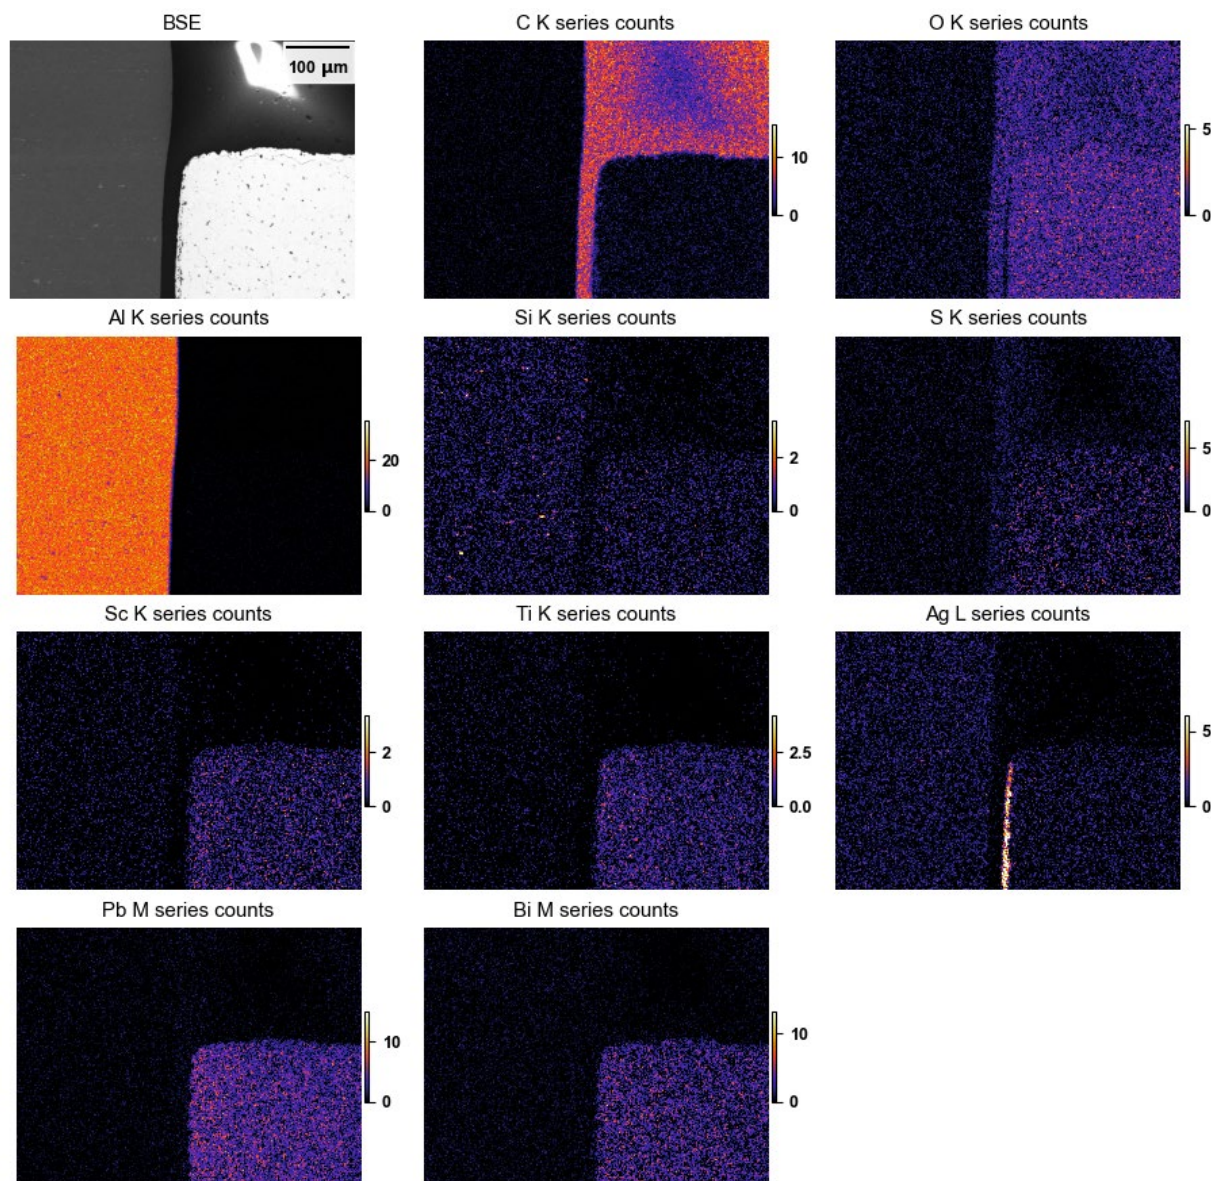
Figure 26. EDS integrated elemental lines extracted from a 10 kV spectrum image from Unirradiated Sample 13.

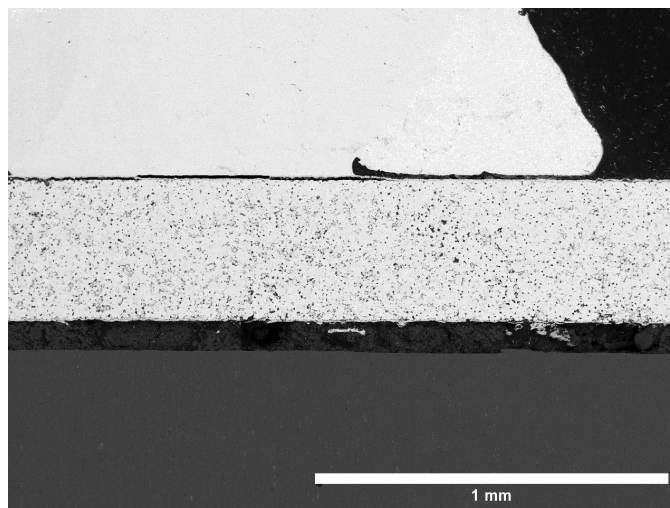
Figure 27. Backscatter electron image of Irradiated Sample #1, showing details of the bond and piezoceramic. The large feature at the top is the solder ball.

Irradiated Sample #1 showed the PBSTO piezoelectric layer and the Al-Si-Na-K-O bonding layer, Figure 27. The EDS maps indicate a mixed Al-Si-K-Na-O, broadly similar to Unirradiated Sample #1, Figure 28 and Figure 29. Gross differences between Unirradiated Sample #1 and Irradiated Sample #1 are not observed, indicating no gross changes between the specimens. EBSD data will be obtained in the future

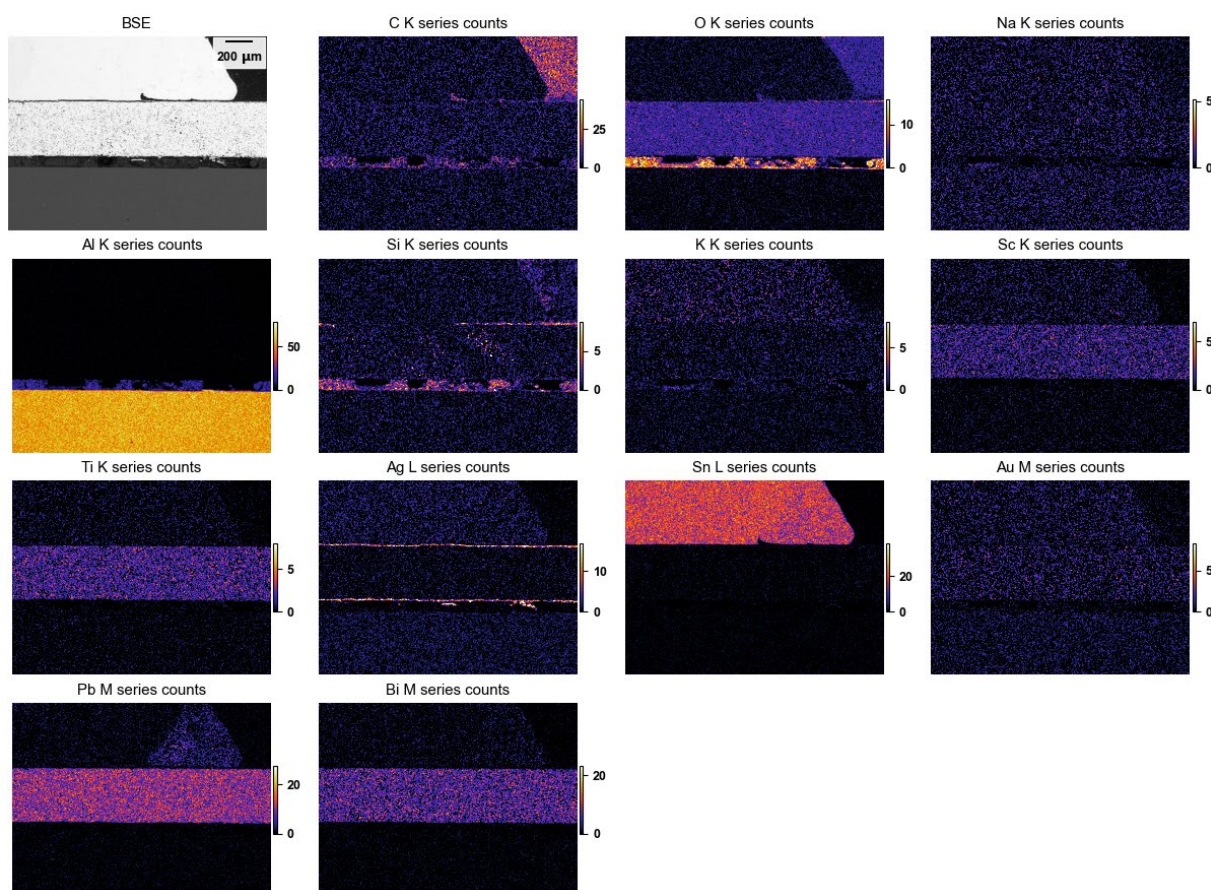
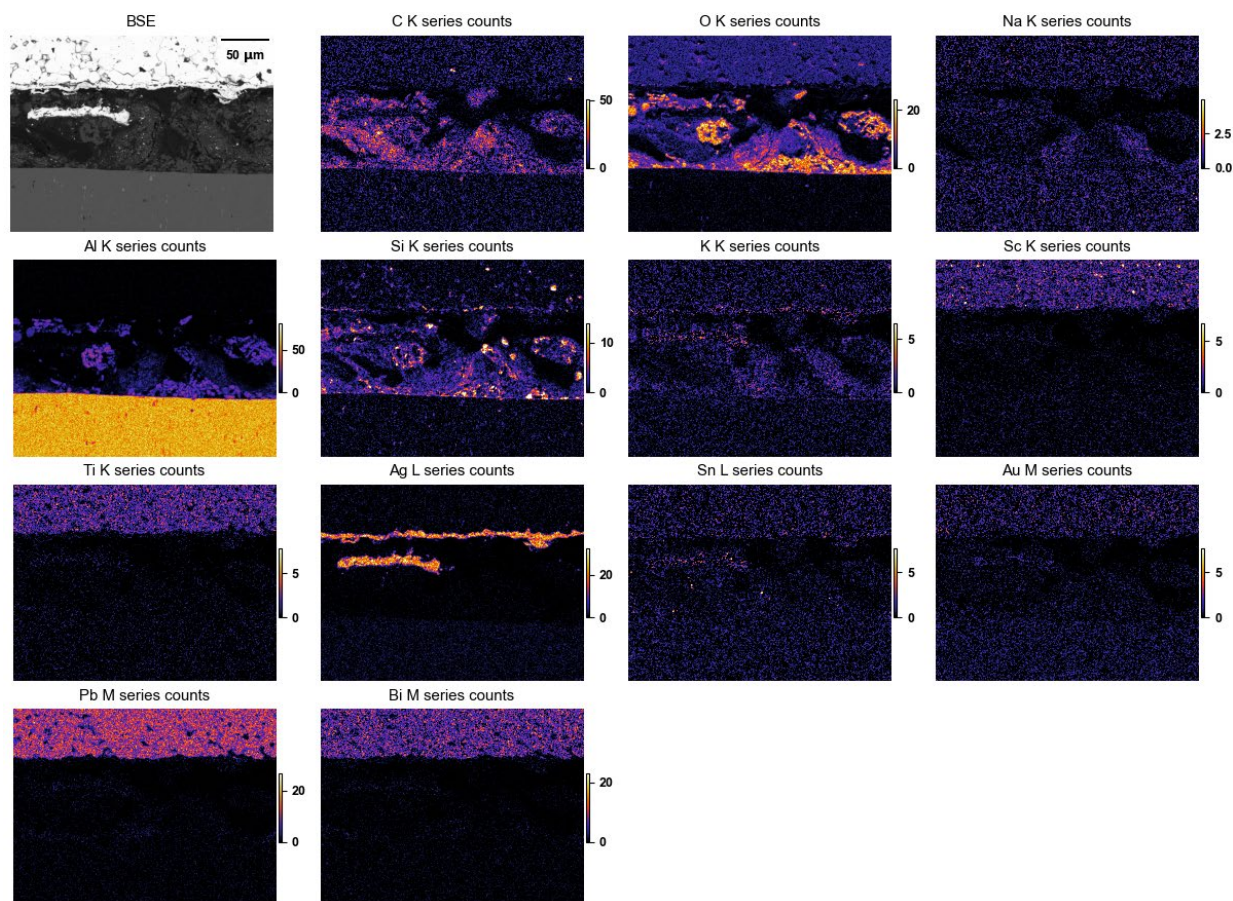
Figure 28. EDS integrated elemental lines extracted from a 10 kV spectrum image from Irradiated Sample 1.

Figure 29. EDS integrated elemental lines extracted from a 10 kV spectrum image from Irradiated Sample 1.

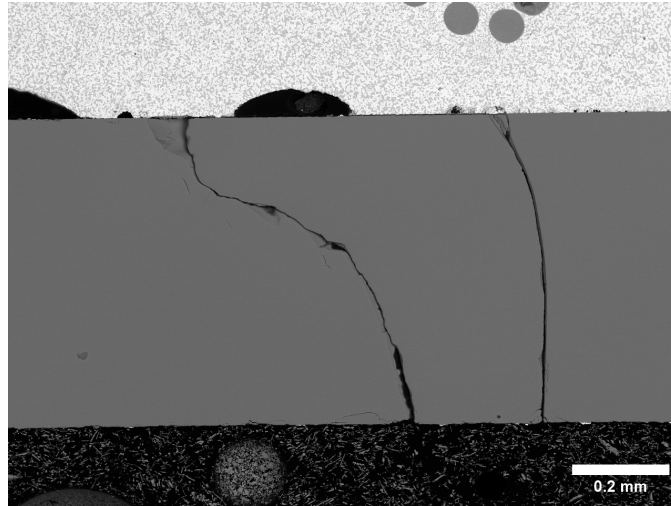
Figure 30. Backscatter electron image of Irradiated Sample #3, showing that the piezoceramic broke off the bond during transport. The black region at the bottom is conductive epoxy. The bright region at the top is the solder ball.

Irradiated Sample #3 showed Nb-O by EDS and is presumed LiNbO_3 ; Li is essentially undetectable with standard SDD detectors. This sample arrived at ORNL LAMDA from NCSU PULSTAR broken off its substrate, so analysis of the bonding is not possible. The ceramic itself also showed cracks. The electrodes appear to be AuCr rather than Ag. This indicates significant brittleness in the layer.

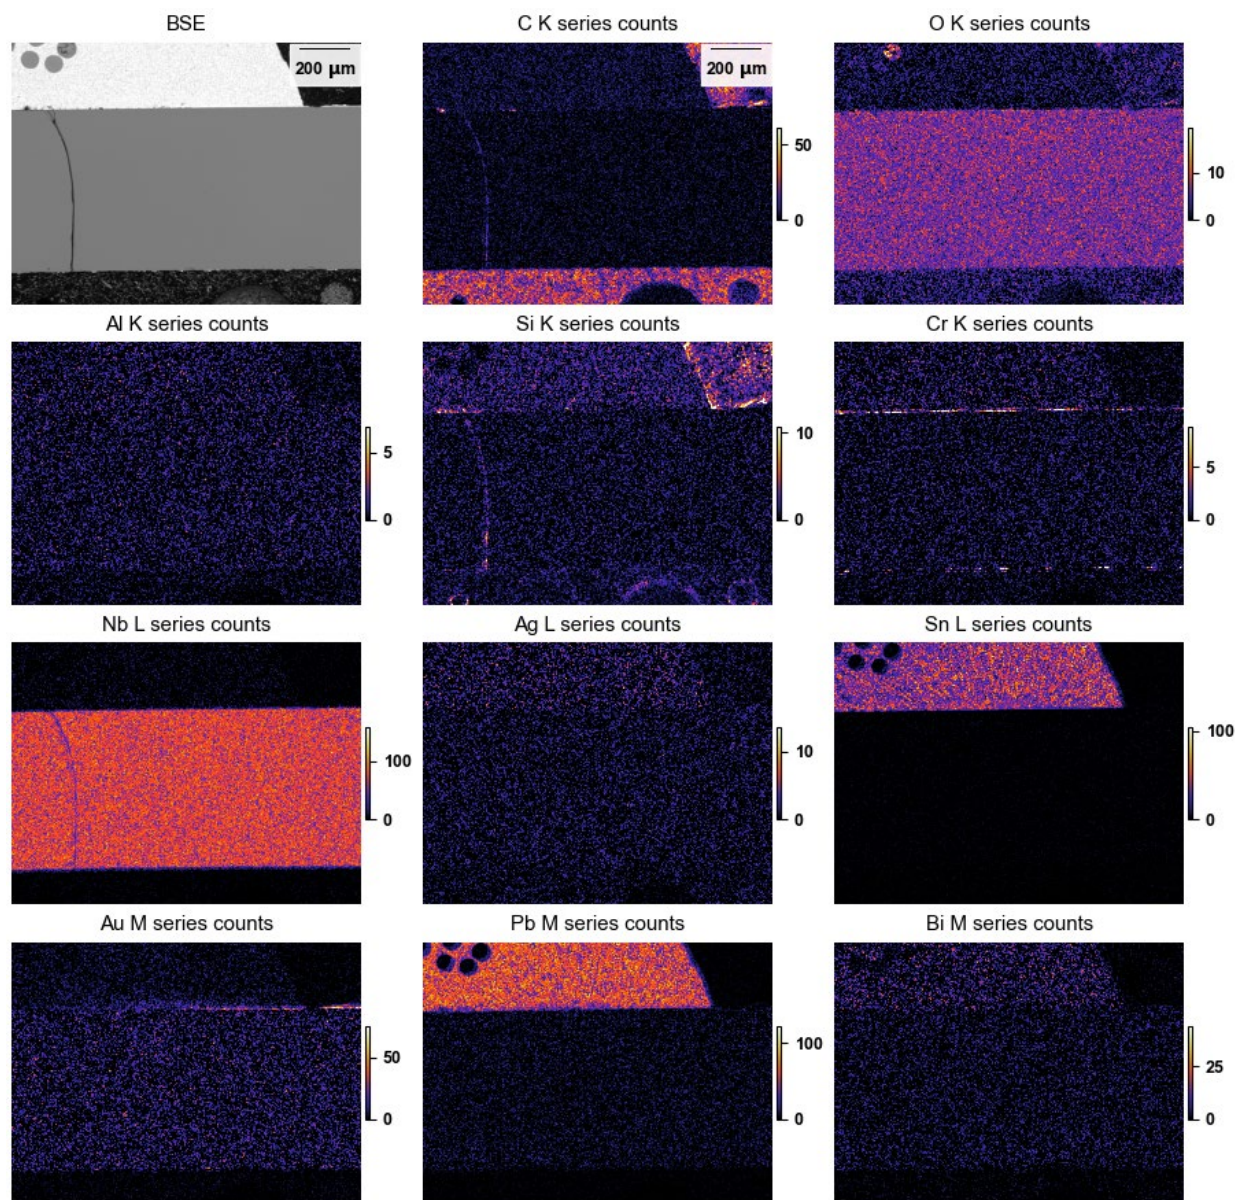
Figure 31. EDS integrated elemental lines extracted from a 20 kV spectrum image from Irradiated Sample #3.

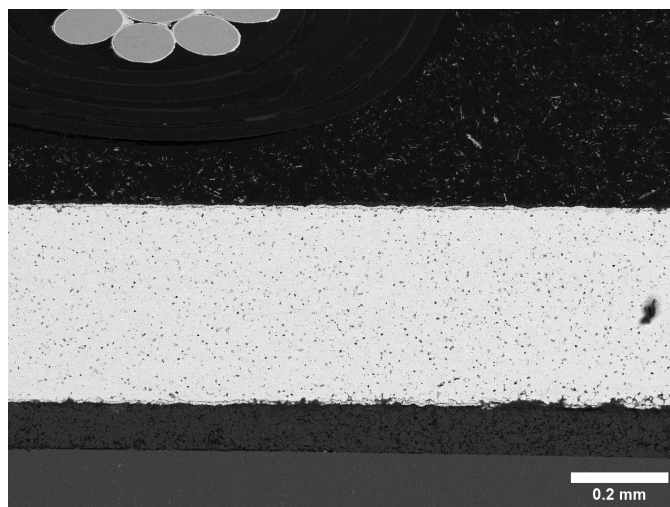
Figure 32. Backscatter electron image of Irradiated Sample #4, showing details of the bond and piezoceramic. The large feature at the top is a contact wire attached to the solder ball and cutting the plane of polish.

Irradiated Sample #4 was PBSTO with a highly crystalline and dense Al-O primary bonding layer that contained some Na and Si; this is grossly similar to Unirradiated Sample #5, Figure 32. However, this sample grew complex Na-O “flowers” at the piezoelectric/bonding layer interface, Figure 33. EDS, Figure 34, shows the bonding layer is similar to Unirradiated Sample #5, except for the Na-O rich flowers sprouting from the bond / piezoceramic interface.

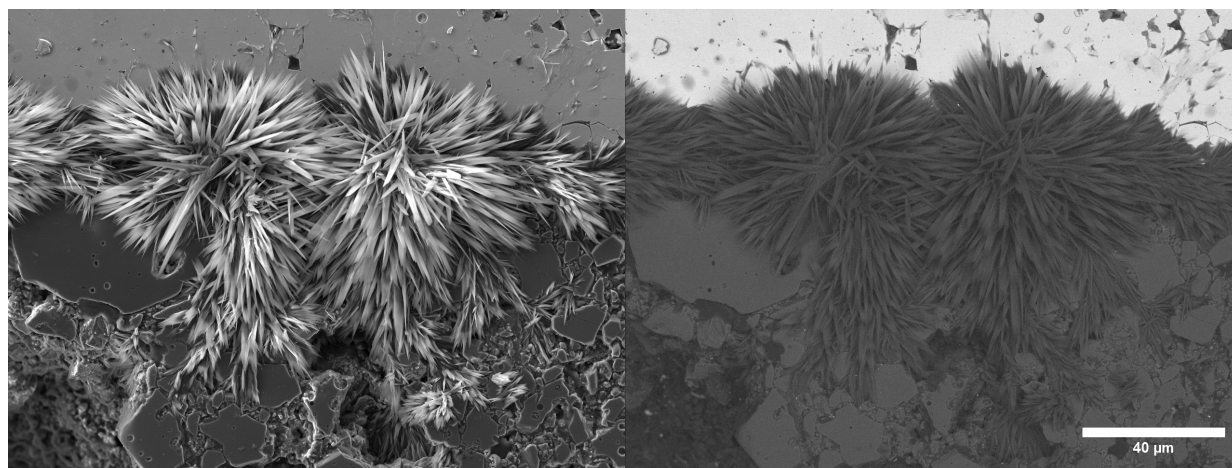
Figure 33. Secondary electron (left) and backscatter electron (right) image of Irradiated Sample #4, showing the Na-O “flowers” growing at the bond / piezoceramic interface.

On the one hand, these seems similar to Unirradiated Sample #1, where Na-K-O needles grew across the piezoceramic surface, but is distinct in that the growths are limited to the bond/piezoceramic interface, and do not seem to contain K.

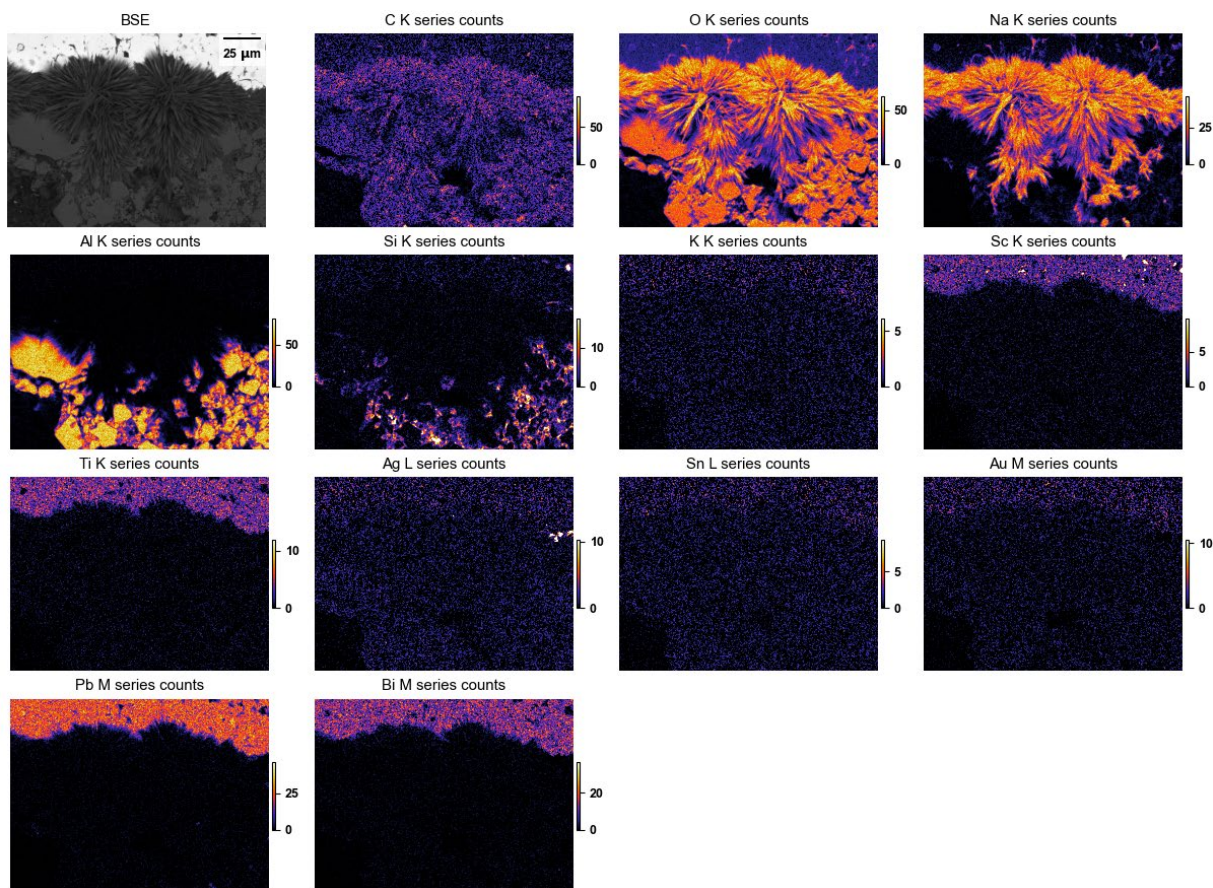
Figure 34. EDS integrated elemental lines extracted from a 10 kV spectrum image from Irradiated Sample #4, showing the Na-O rich growths. Detector is an 12 o'clock high orientation, resulting in shadowing towards the bottom of the image.

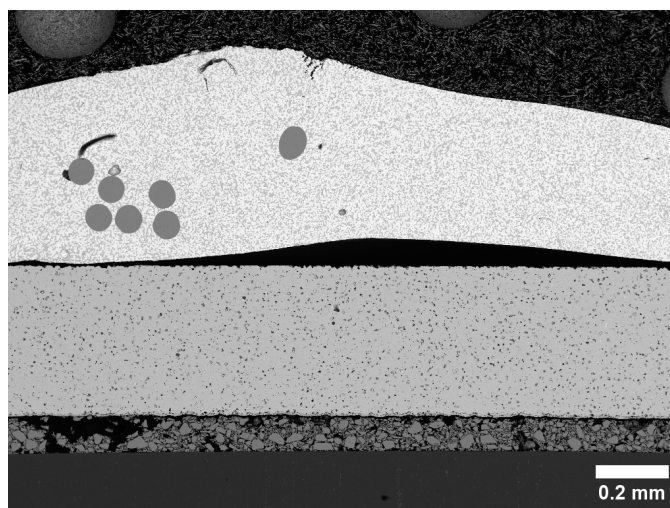
Figure 35. Backscatter electron image of Irradiated Sample #5, showing details of the bond and piezoceramic. The large feature at the top is the solder ball.

Irradiated Sample #5 is PBSTO on a zirconia bond layer, Figure 35. X-ray mapping confirms a Zr-O bonding layer with small amounts of Ca and Si, Figure 36; this is essentially identical to Unirradiated Sample #12. The EBSD of this sample, Figure 37, shows a large amount of misindexing between the Al and ZrO_2 phases; this is because of low pattern quality in the aluminum, perhaps due to irradiation, and due to some pseudosymmetries between the cubic Al and tetragonal ZrO_2 reflectors. Comparison of monoclinic and orthorhombic ZrO_2 solutions vs. tetragonal ($P 4/mmm$) ZrO_2 solutions on a few individual patterns indicate tetragonal is a better match. Overall, EBSD confirms the layer contains blocky, high-quality tetragonal ZrO_2 particles.

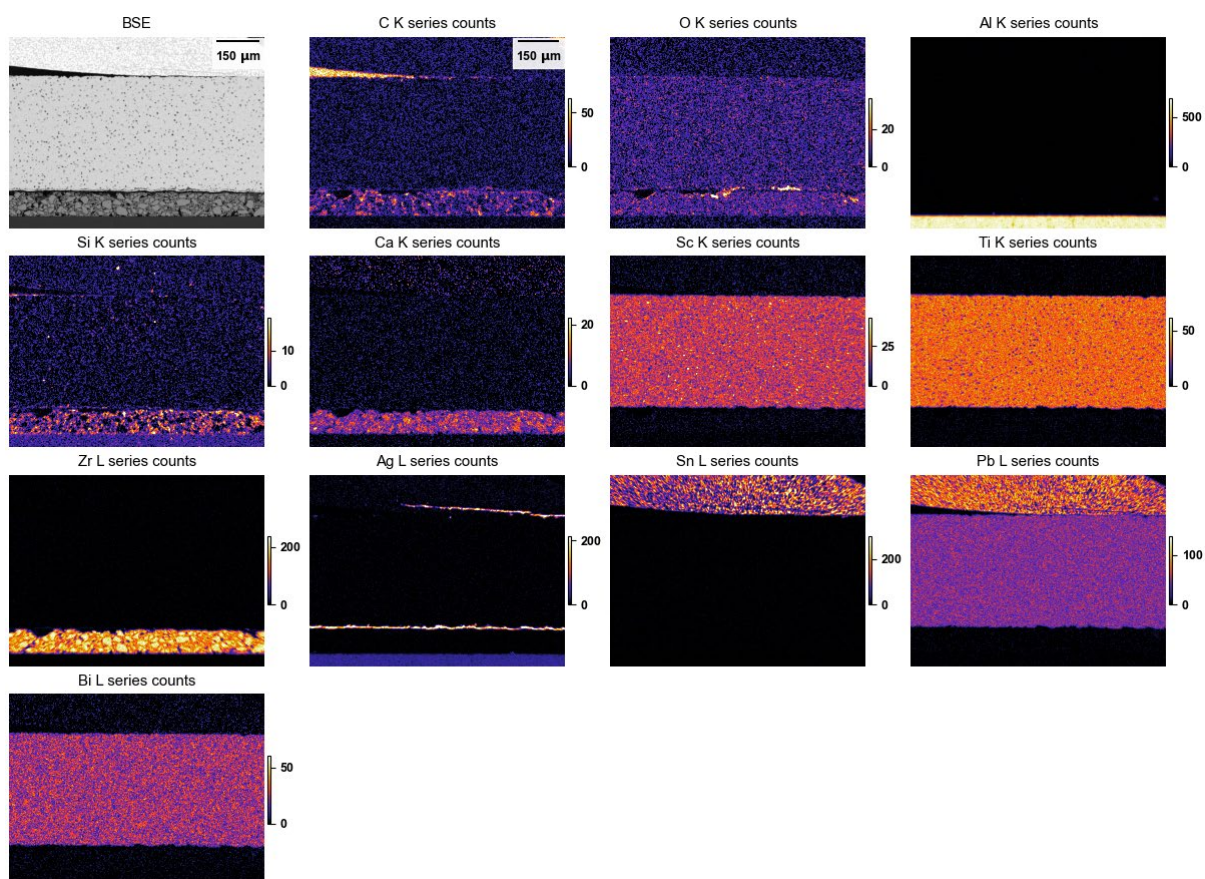
Figure 36. EDS integrated elemental lines extracted from a 30 kV spectrum image from Irradiated Sample #5, showing a solder ball, PBSTO layer, and Zr(-Ca-Si)-O bond.

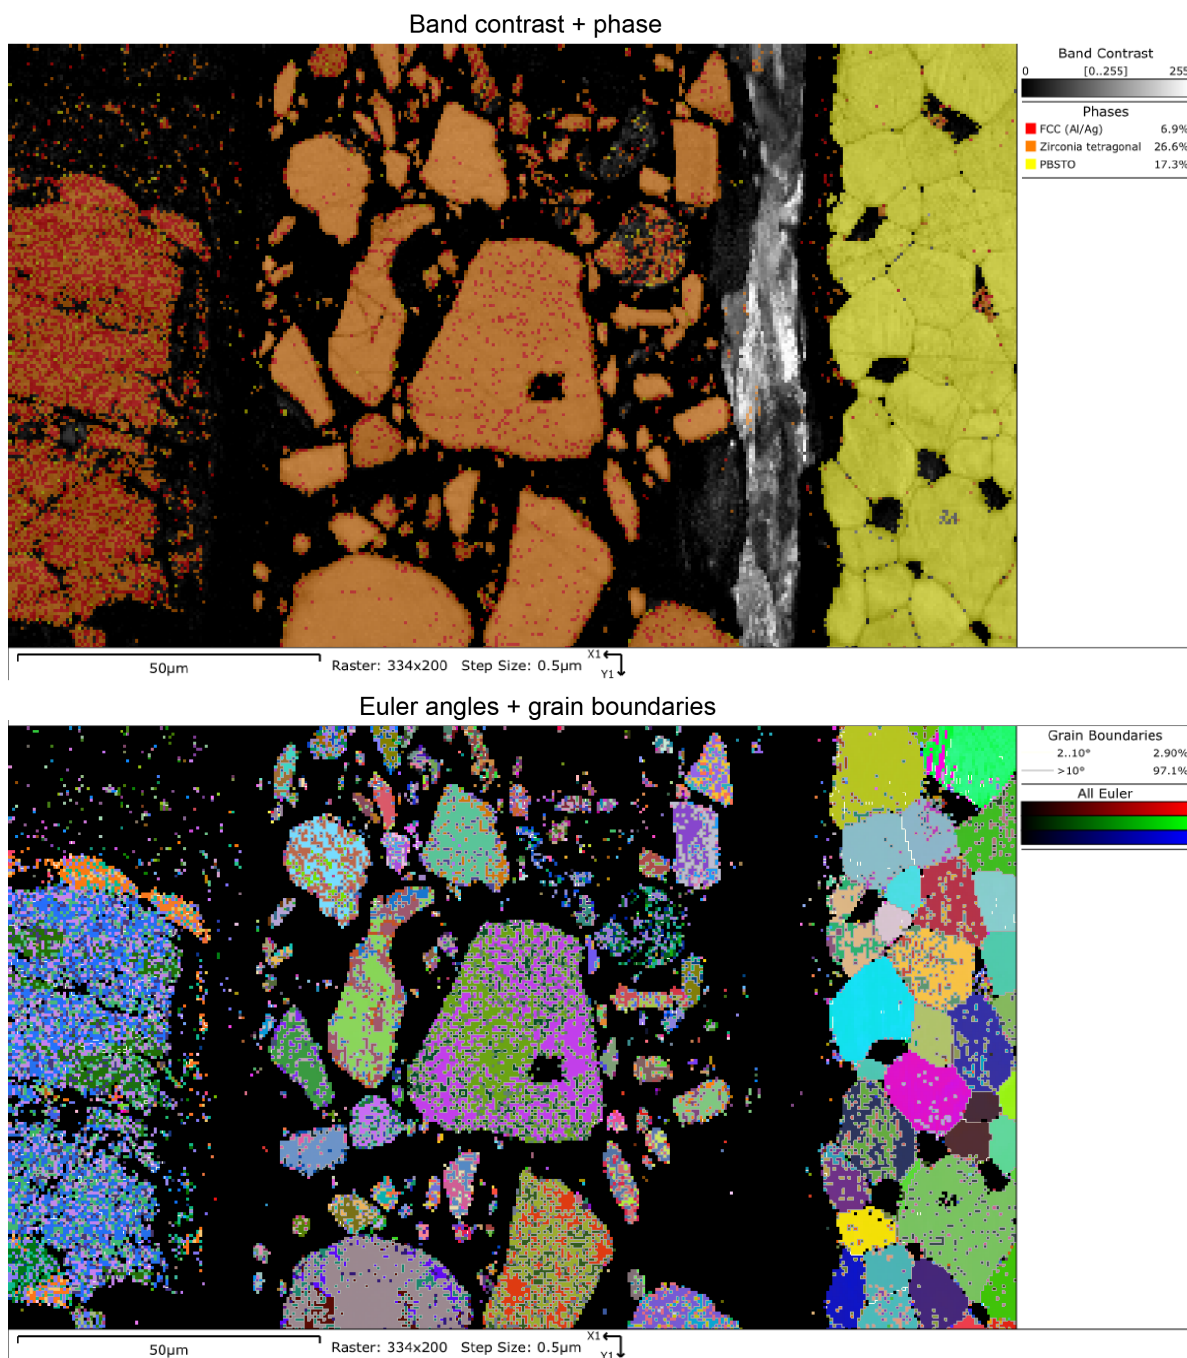
Figure 37. EBSD results from Irradiated Sample #5 Red phase: FCC, Al or Ag. Orange phase, tetragonal zirconia. Yellow phase: PBSTO (Pb-Bi-Sc-Ti-O). Significant orange/red speckle (misindexing) is due to pseudosymmetric reflector positions between $\langle 101 \rangle$ Al and $\langle 100 \rangle$ ZrO_2 and due to poor pattern quality in the irradiated Al.

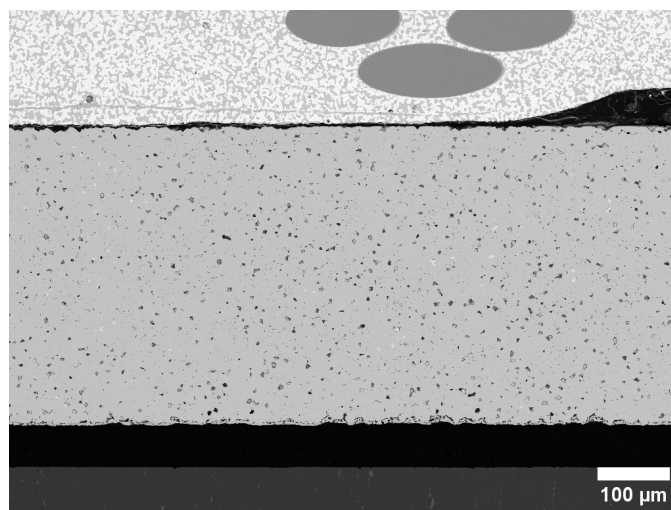
Figure 38. Backscatter electron image of Irradiated Sample #5, showing details of the bond and piezoceramic. The feature at the top is the solder ball.

Irradiated Sample #6 is PBSTO, with an epoxy bonding layer, Figure 38. X-ray analysis found the bonding layer was C-O(-S) rich, consistent again with epoxy, Figure 39.

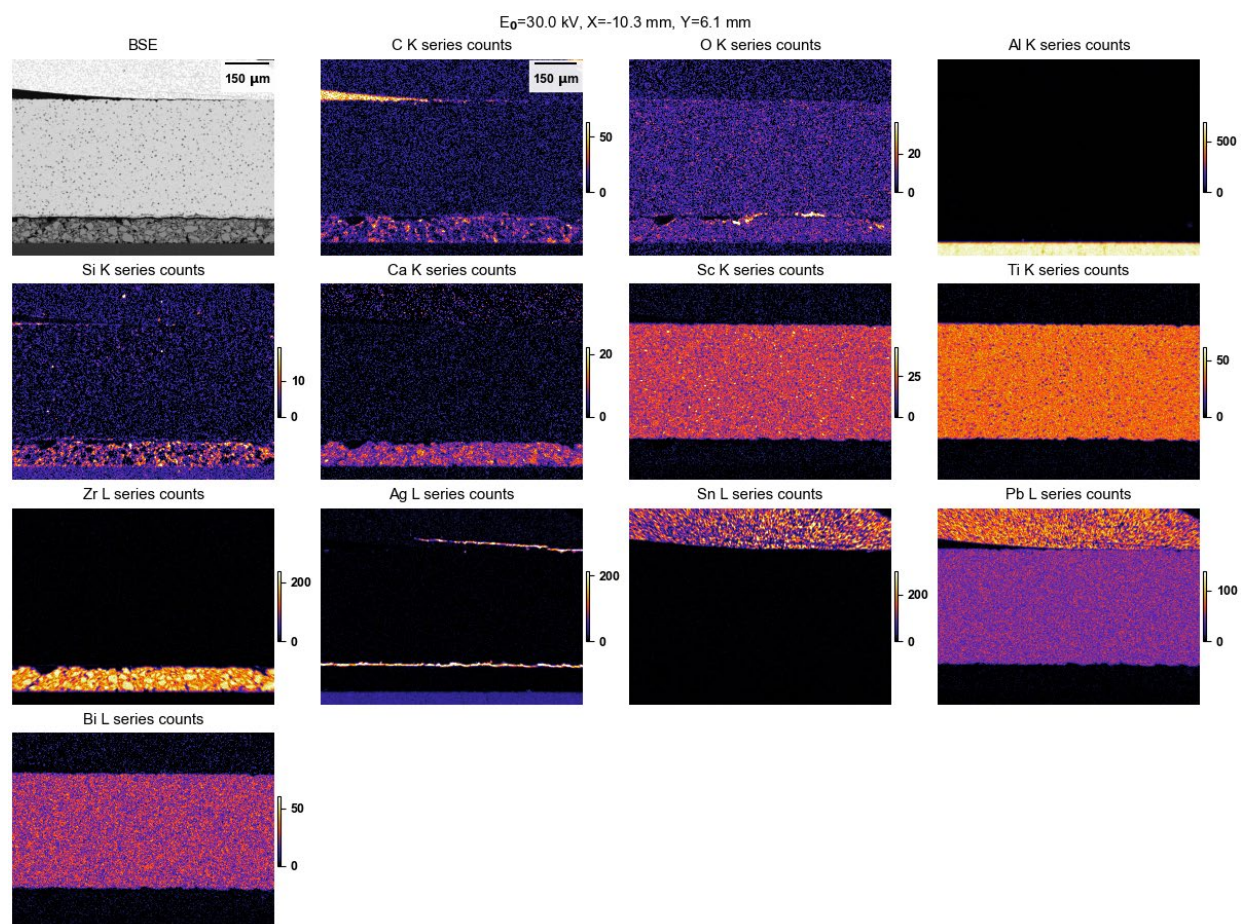
Figure 39. EDS integrated elemental lines extracted from a 20 kV spectrum image from Irradiated Sample #5, showing a solder ball, PBSTO layer, and Zr(-Ca-Si)-O bond.

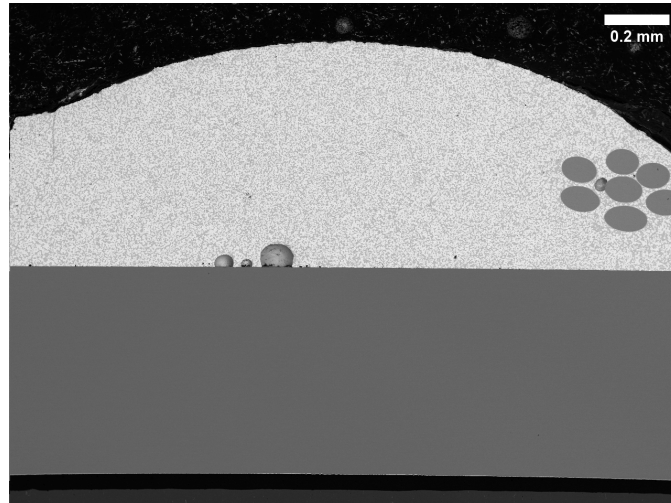
Figure 40. Backscatter electron image of Irradiated Sample #7, showing details of the bond and piezoceramic. The solder ball is at the top.

Irradiated Sample #7 is another Nb-O ceramic, presumably LiNbO_3 , and has an epoxy bonding layer. The electrodes appear to be AuCr rather than Ag. The epoxy is featureless, but appears to have maintained a good bond. The piezoceramic is not cracked, unlike Irradiated Sample #3 above.

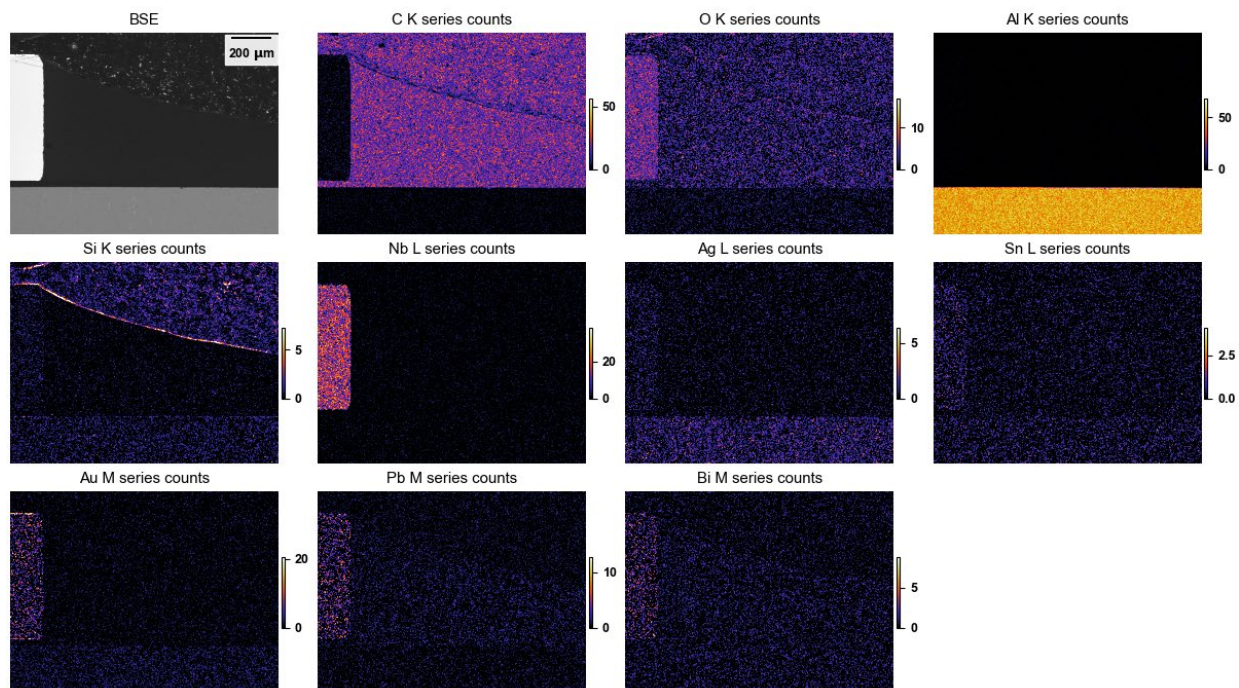
Figure 41. EDS integrated elemental lines extracted from a 10 kV spectrum image from Irradiated Sample #7.

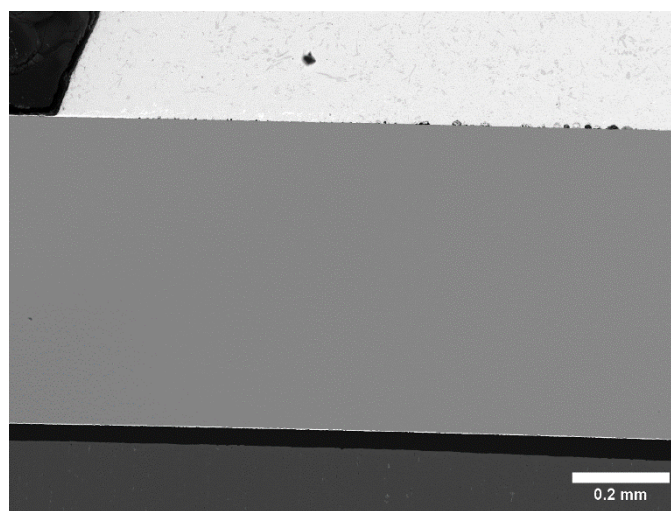
Figure 42. Backscatter electron image of Irradiated Sample #8, showing details of the bond and piezoceramic. The solder ball is at the top.

Irradiated Sample #8 is very similar to Irradiated Sample #7, Figure 42. It is again LiNbO_3 with AuCr electrodes and an epoxy bonding layer; Figure 43. The bond stayed attached and the ceramic does not appear cracked. The main difference between Irradiated Sample #7 and Irradiated Sample #8 appears to be that #7 has a Pb-Sn solder ball, and #8 has a Sn-Cu solder ball.

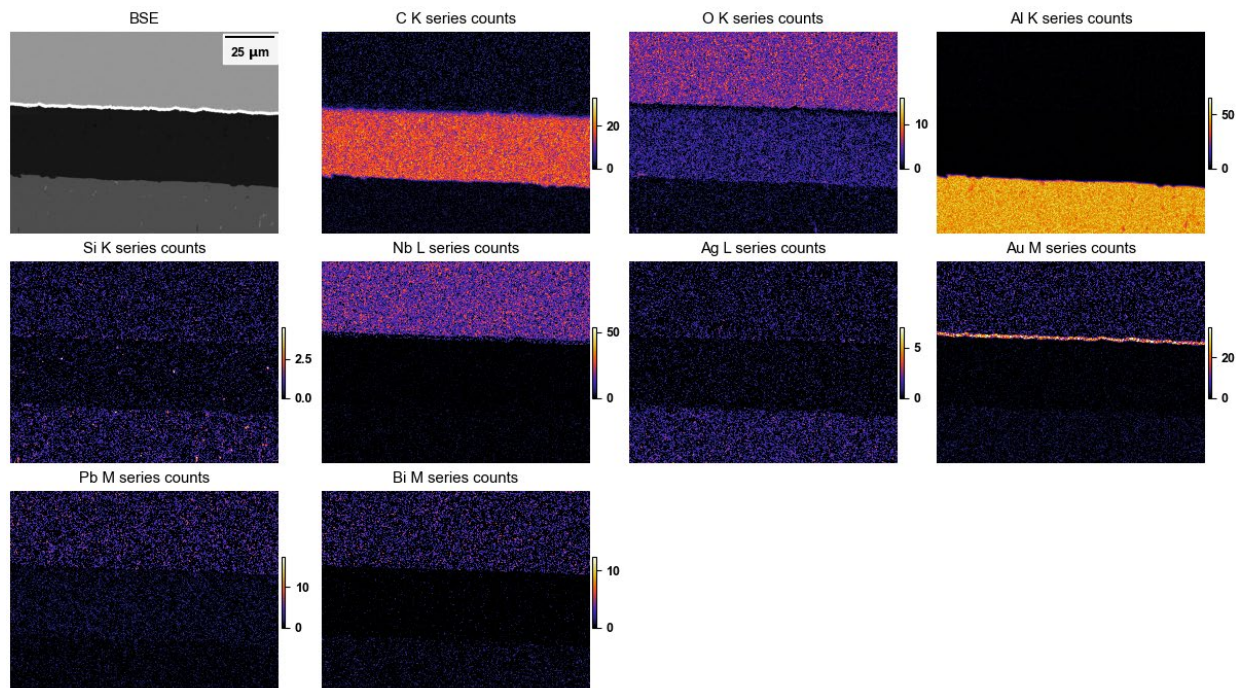
Figure 43. EDS integrated elemental lines extracted from a 10 kV spectrum image from Irradiated Sample #8.
