Sister Rod Destructive Examinations (FY23)

Appendix F: Cyclic Integrated Reversible- Bending Fatigue Tests

Spent Fuel and Waste Disposition

Oak Ridge National Laboratory

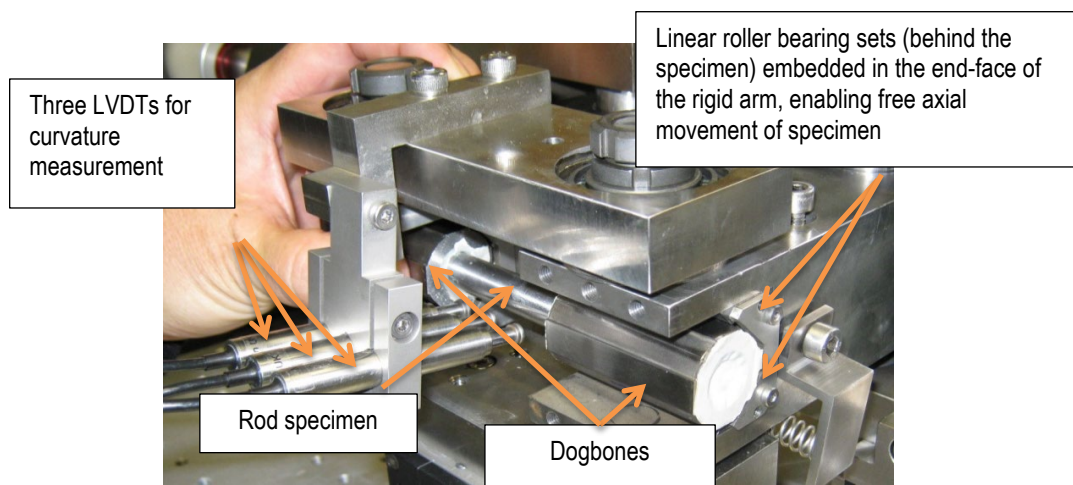
Figure F-3. Image showing the grip design of CIRFT with one end-block removed.

The distances built into the CIRFT machine and the length of the segment dogbone are important because they are used to calculate all load, moment, and curvature values. Important fixed physical distances include the length of the U-frame arms (101.60 mm) and the location and contact geometry of the LVDTs. Also, the motor's recorded stroke length during the test is directly applied in the data reduction, and the SNF rod outer diameter (OD) is used to calculate strain and stress.

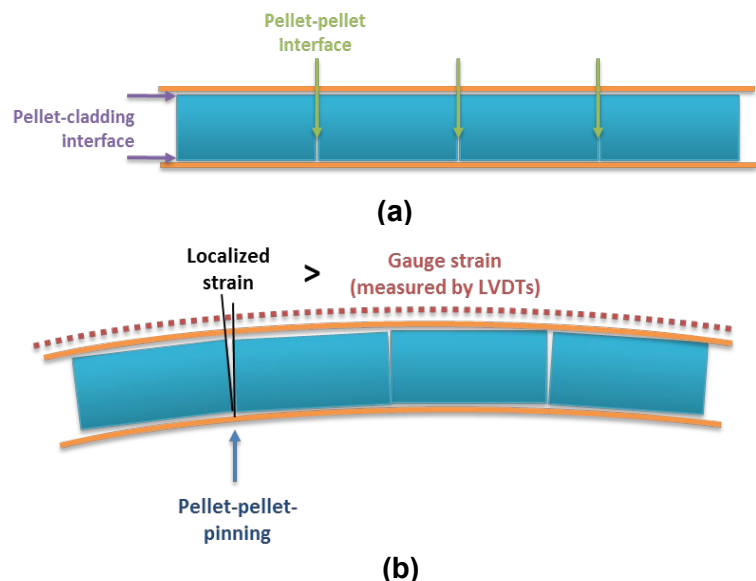
Figure F-6. Cladding and pellet stack (a) in the neutral position and (b) in bending. [F-5]

Although the LVDTs used on the CIRFT device only measure the gross rod deflection within the gauge section, several pellet lengths with several pellet-pellet interfaces are included in the gauge section, and any effects related to the pellet-pellet interfaces are embedded in the CIRFT data. As observed in previous test results, fractures are typically located at the pellet-pellet interfaces, which is consistent with the reduced mechanical cross section and potential interaction between the pellet end and cladding at those locations during bending. This is described by Wang and Wang as a fuel pellet “pinning” effect, as illustrated in Figure F-6.

Wang and Wang investigated the effects on the cladding using finite element analysis (FEA) and found that the localized strain in the cladding at the pellet-pellet-cladding interface region is three to four times higher than that in regions supported by the body of the fuel pellet. This is caused by (1) the interaction of the pellet end with the cladding and (2) the localized axial tension that is applied as the gap is opened.

Wang and Wang further explored the shift in the neutral axis that occurs during pinning. The neutral axis shifts constantly with each cycle, but the maximum strain still occurs at the outer radius of the cladding.

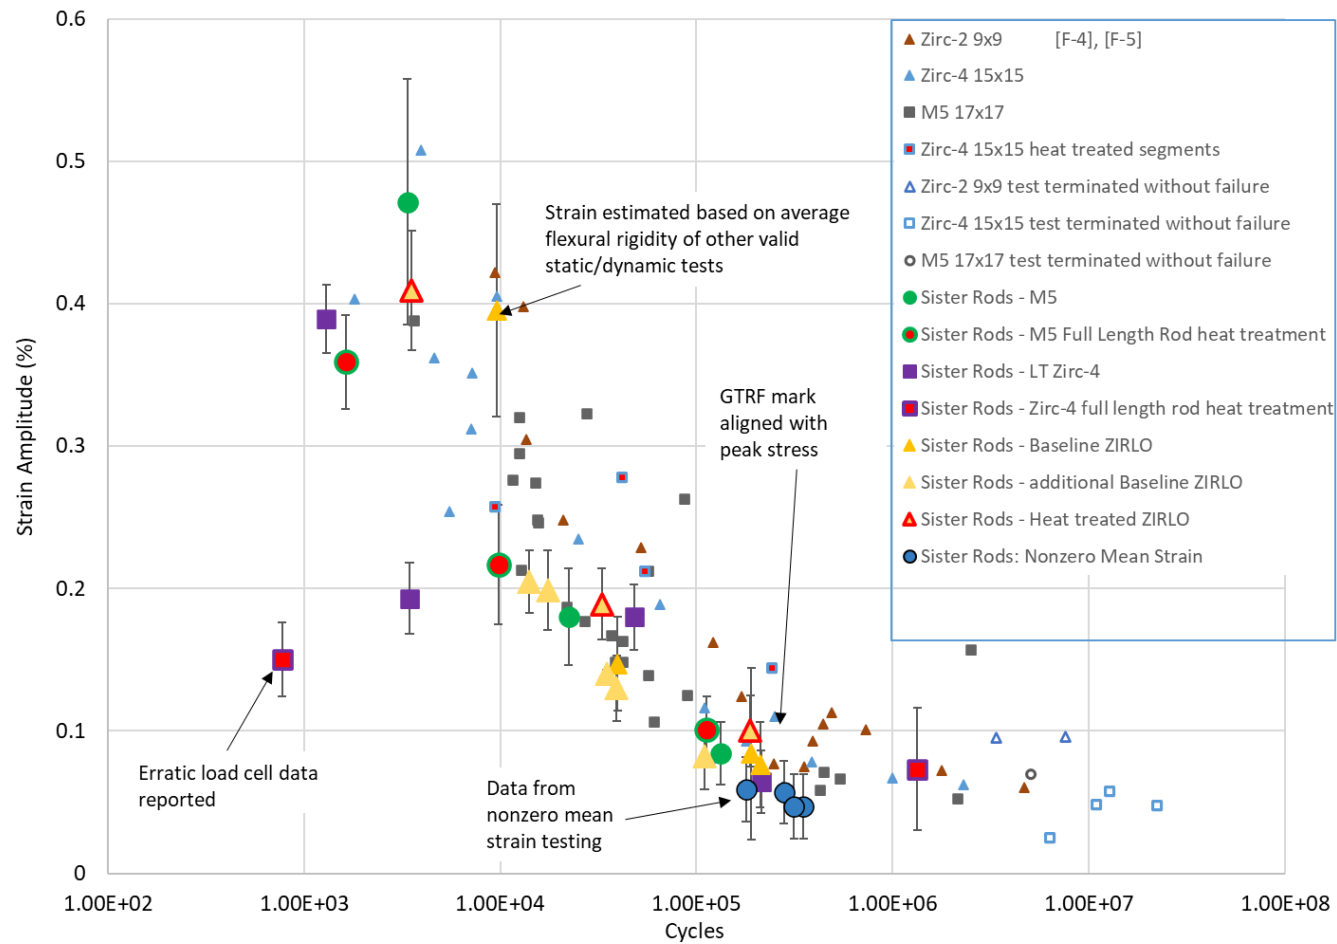
The error bars on the sister rod data represent the calculated uncertainty provided in Table F-13.

Figure F-11. Results of zero and non-zero mean strain CIRFT tests completed to date, strain amplitude vs. cycles to failure.

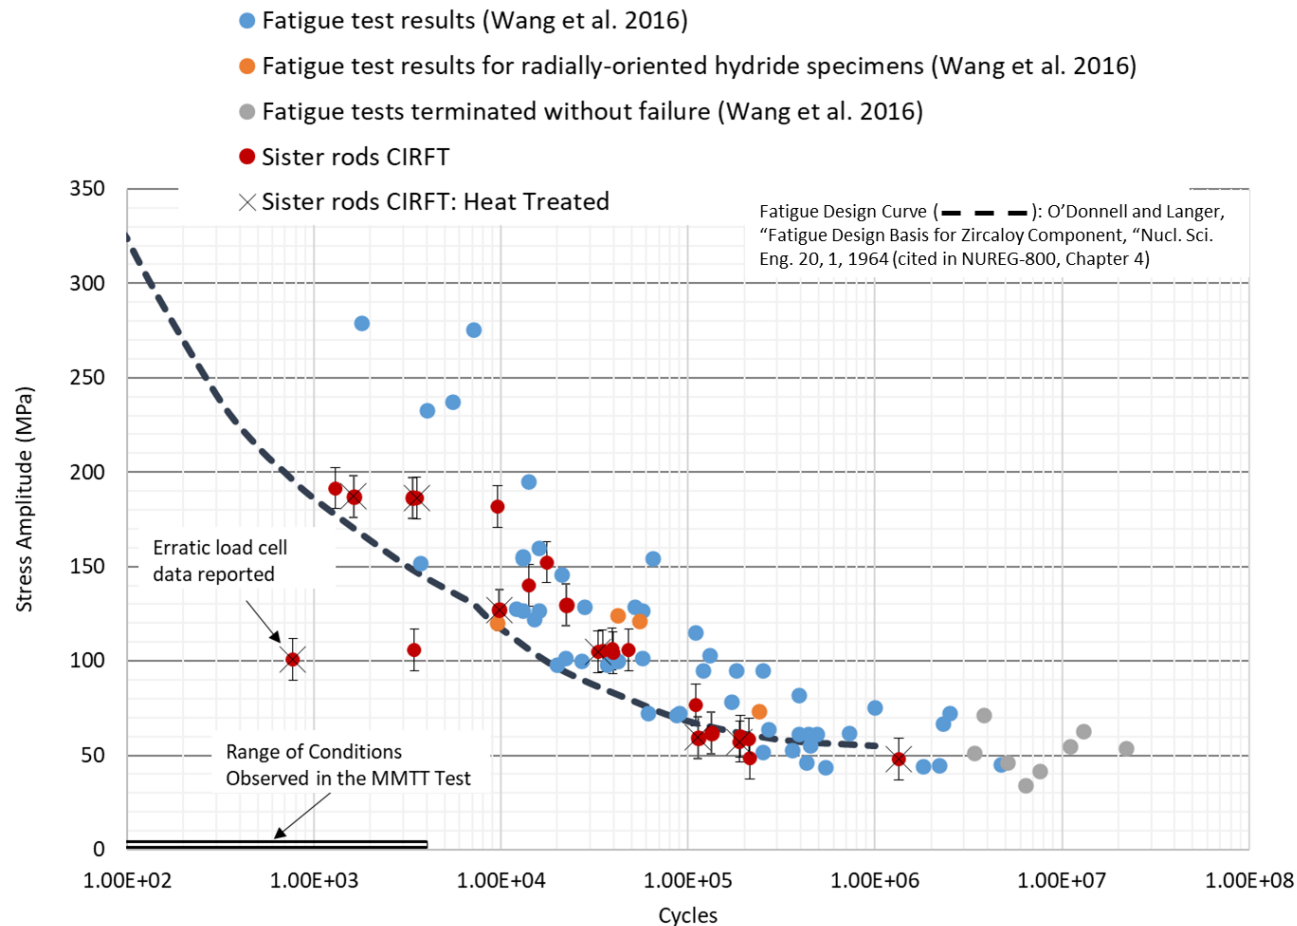
The error bars on the sister rod data represent the calculated uncertainty in Section G-3.5, Appendix G.

Figure F-12. Stress amplitude of the composite rod based on Eq. (F-7) as a function of cycles to failure for the sister rods. The stresses representing the conditions observed in the MMTT test are calculated based on measured strains: 1 MPa for the lower strain of 0.001% (or 10 μ strain), which is the minimum strain of the highest 4,000 cycles observed, and 4.2 MPa for the upper strain of 0.0042% (or 42 μ strain), which is the maximum strain observed during testing at the Transportation Technology Center, Inc. [F-16], [F-17].

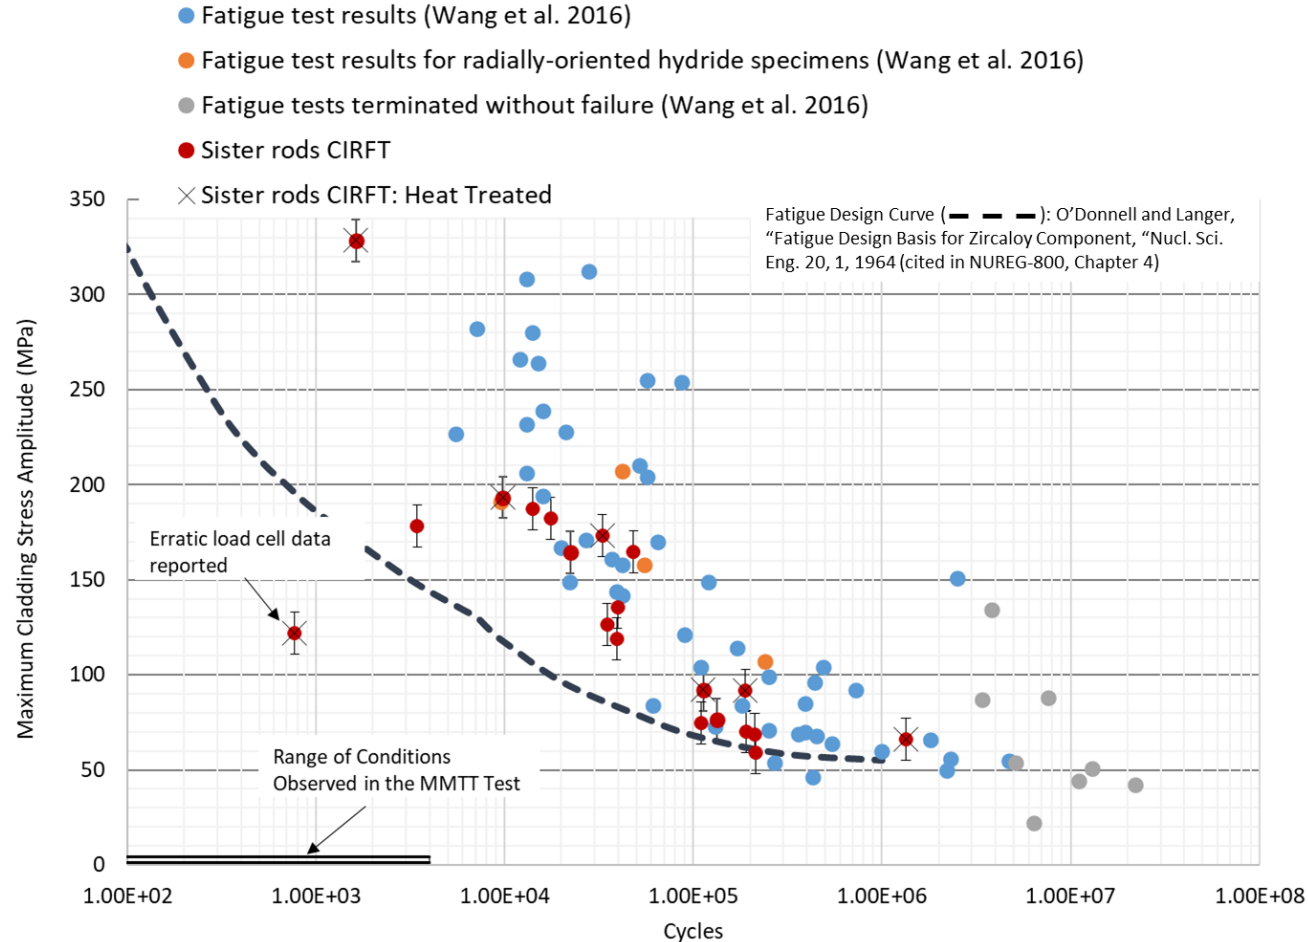
The error bars on the sister rod data represent the calculated uncertainty in Section G-3.5, Appendix G.

Figure F-13. Cladding stress amplitude as a function of cycles to failure for the sister rods. The stresses representing the conditions observed in the MMTT test are calculated based on measured strains: 1 MPa for the lower strain of 0.001% (or 10 μ strain), which is the minimum strain of the highest 4,000 cycles observed, and 4.2 MPa for the upper strain of 0.0042% (or 42 μ strain), which is the maximum strain observed during testing at the Transportation Technology Center, Inc.[F-16], [F-17].

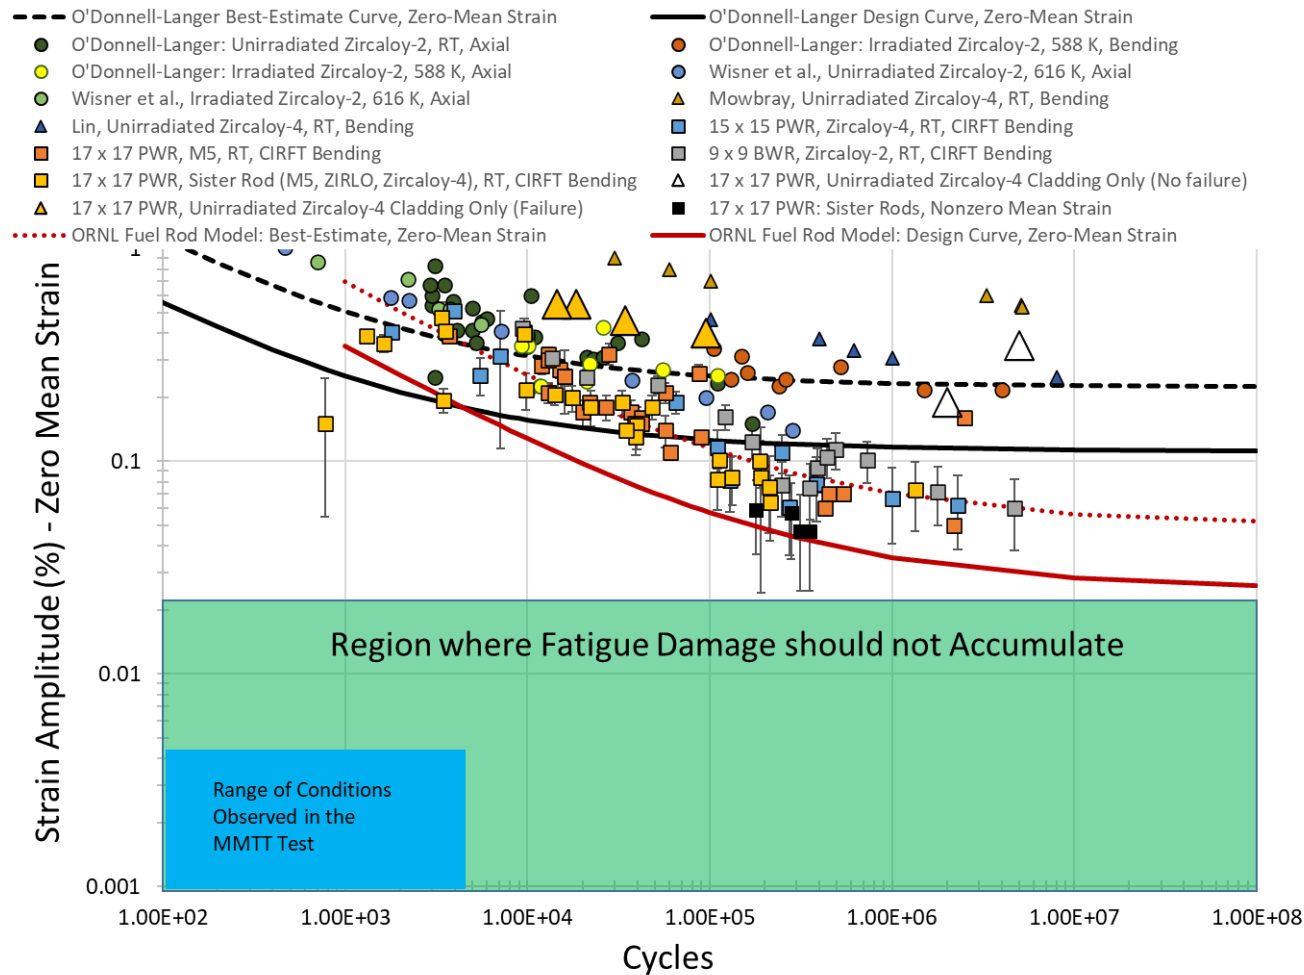
The error bars on the sister rod data represent the 2σ uncertainty provided in Table F-13.

Figure F-14. Strain amplitude as a function of cycles to failure for the sister rods compared with the fatigue data on cladding alloys from Figure F-7 and the proposed ORNL fatigue limit for fuel rods. [F-12] The strains representing the conditions observed in the MMTT test are based on measured strains: the lower strain is 0.001% (or 10 μ strain), which is the minimum strain of the highest 4000 cycles observed, and the upper strain is 0.0042% (or 42 μ strain), which is the maximum strain observed during testing at the Transportation Technology Center, Inc. [F-16], [F-17].

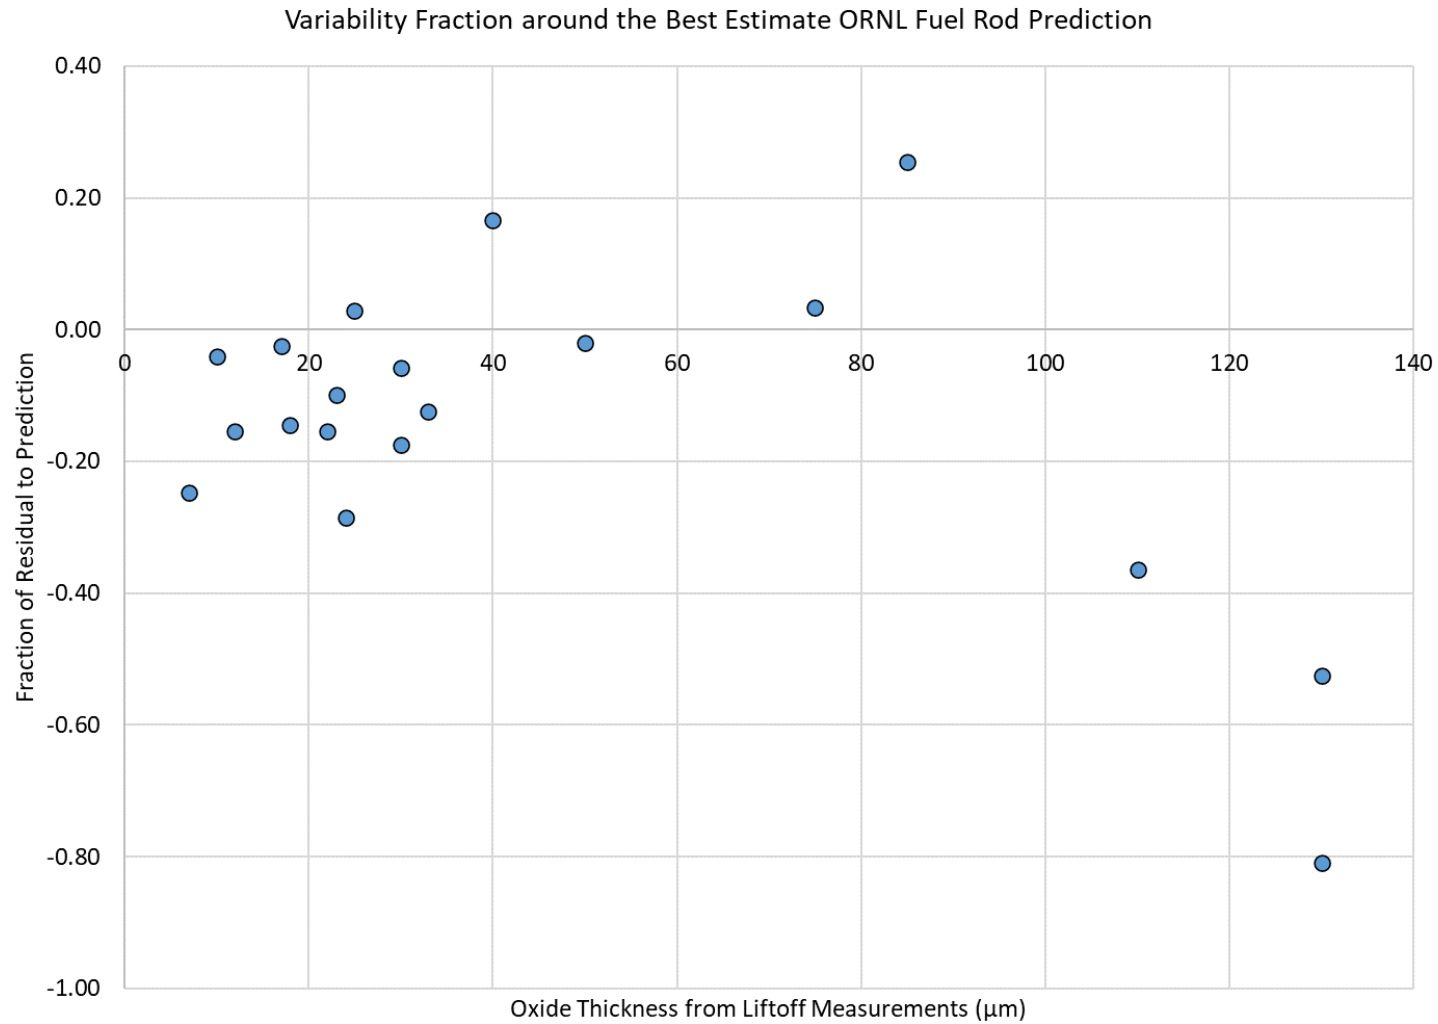
Figure F-15. The fraction of the residual to the ORNL fuel rod model best-estimate predicted strain amplitude ((measured-predicted)/predicted) for the zero mean strain fatigue data as a function of the oxide thickness estimated from the liftoff measurement in Montgomery et al. [F-11].

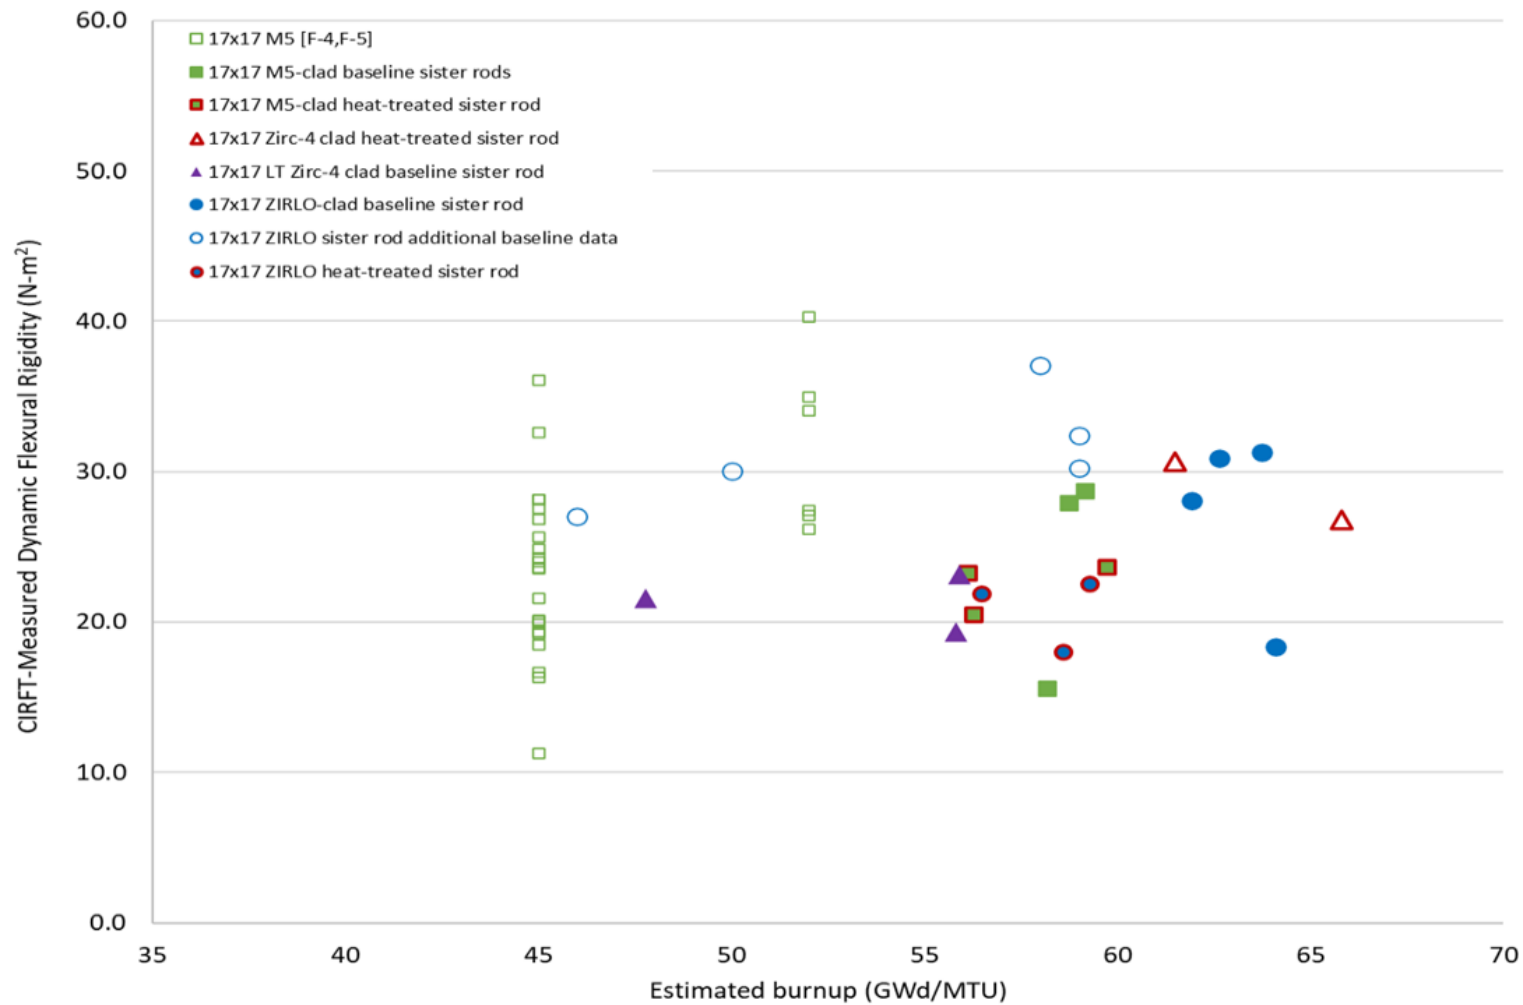
Figure F-16. CIRFT-measured flexural rigidity of the sister rod segments tested as a function of estimated segment burnup plotted with previous CIRFT data.

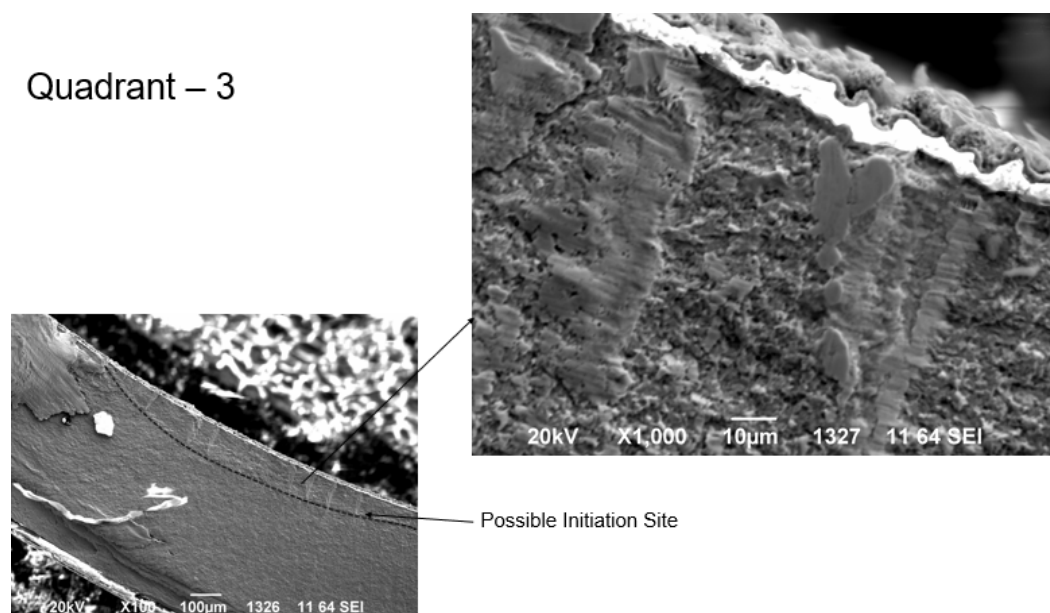
Figure F-44. Images at 100× and 1,000× of quadrant 3 in sample 3D8E14-2963-3116, ~180° from region in quadrant 1 that is suspected to have failed after fatigue test ended.

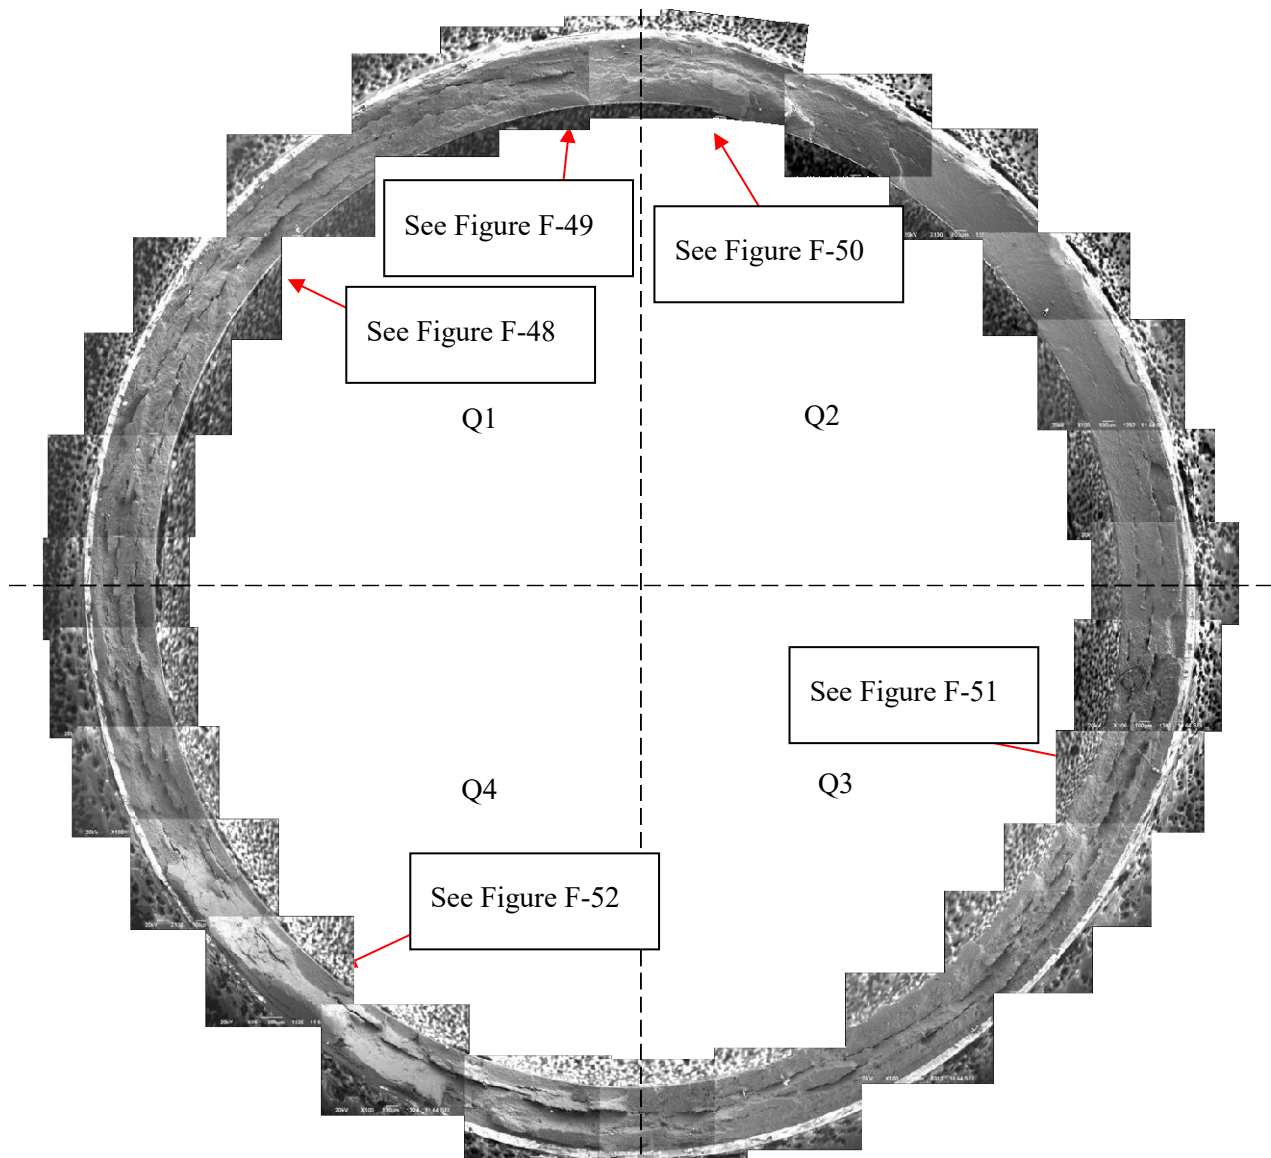
Figure F-47. Montage (100x) of the surface of the fatigue failure in dogbone sample DE50017. The areas identified in the various quadrants were investigated at higher magnification.

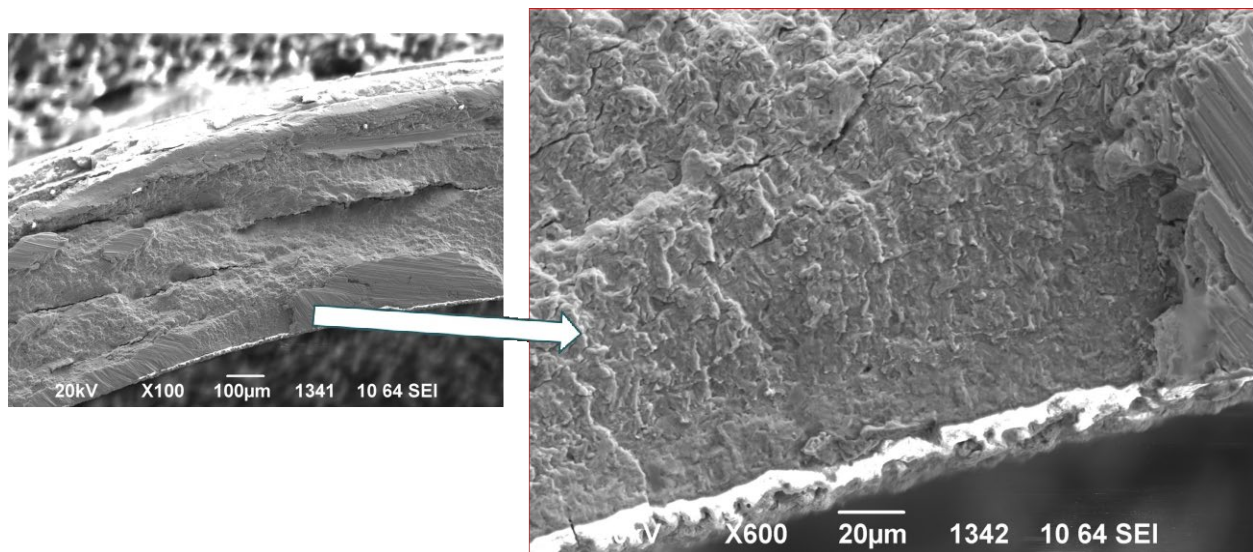
Figure F-49. Fuel-side brittle regions of Q1 (approaching Q2) in sample 3A1F05-2025-2178.

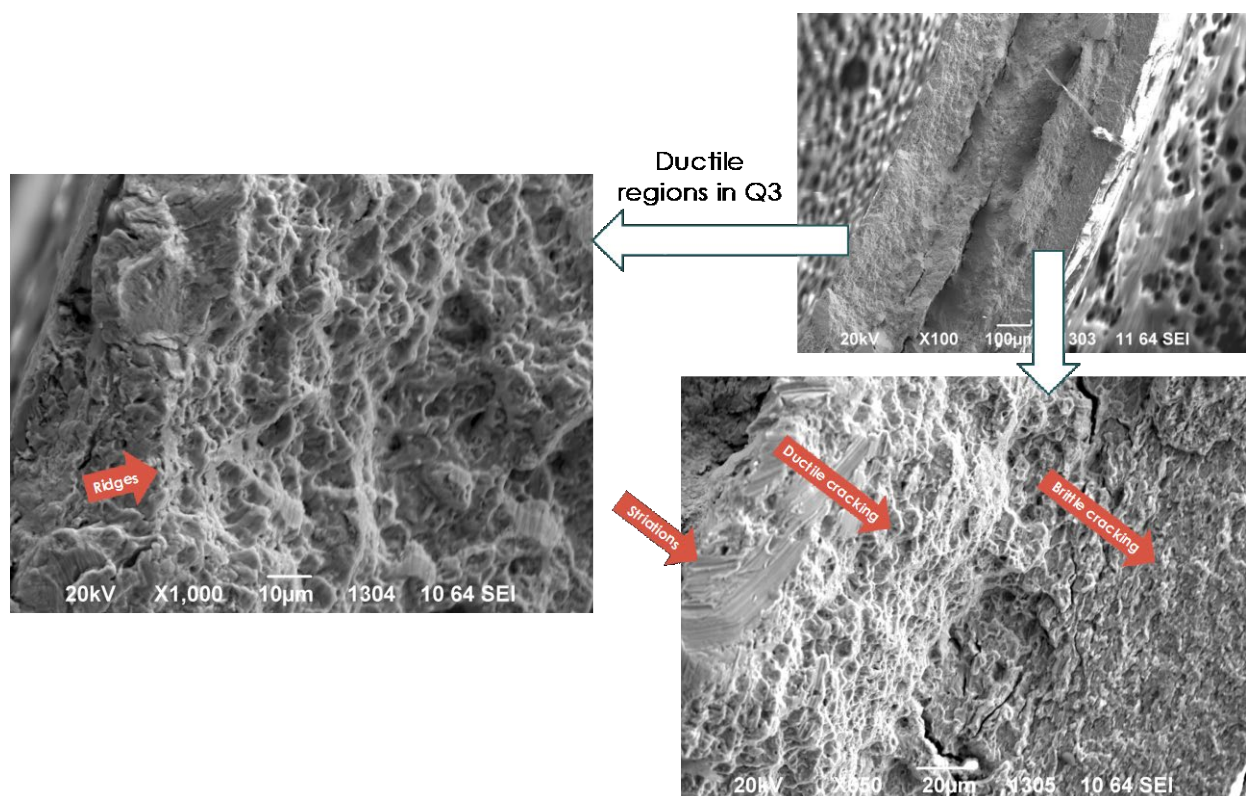
Figure F-51. Ductile fracture regions amidst striations and brittle cracks on Q3 in sample 3A1F05-2025-2178.

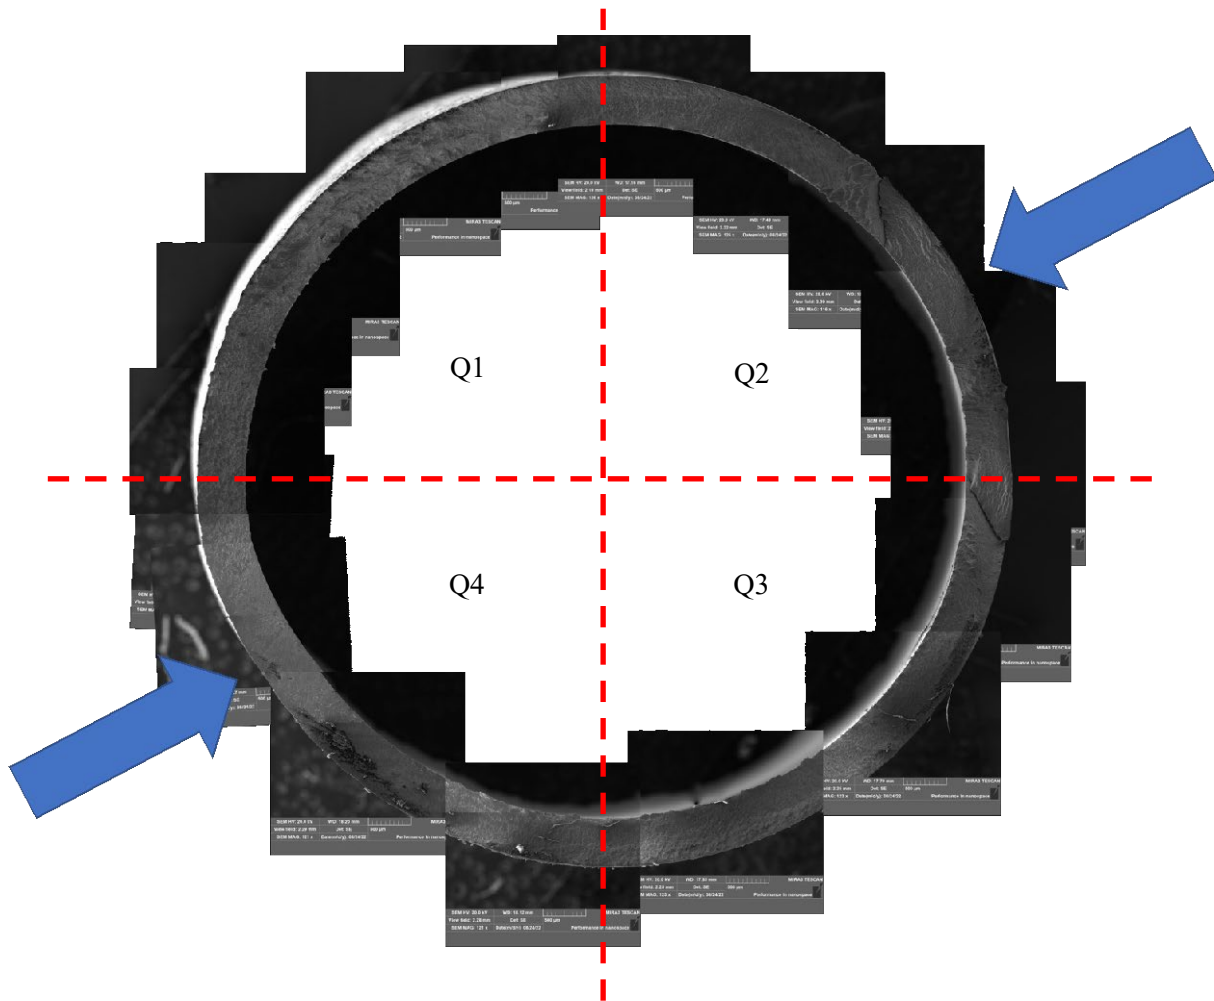
Figure F-53. Montage (100 \times) of the surface of the fatigue failure in dogbone sample Zirc-4-W-4. Arrow marks show regions of high bending strain in the sample.

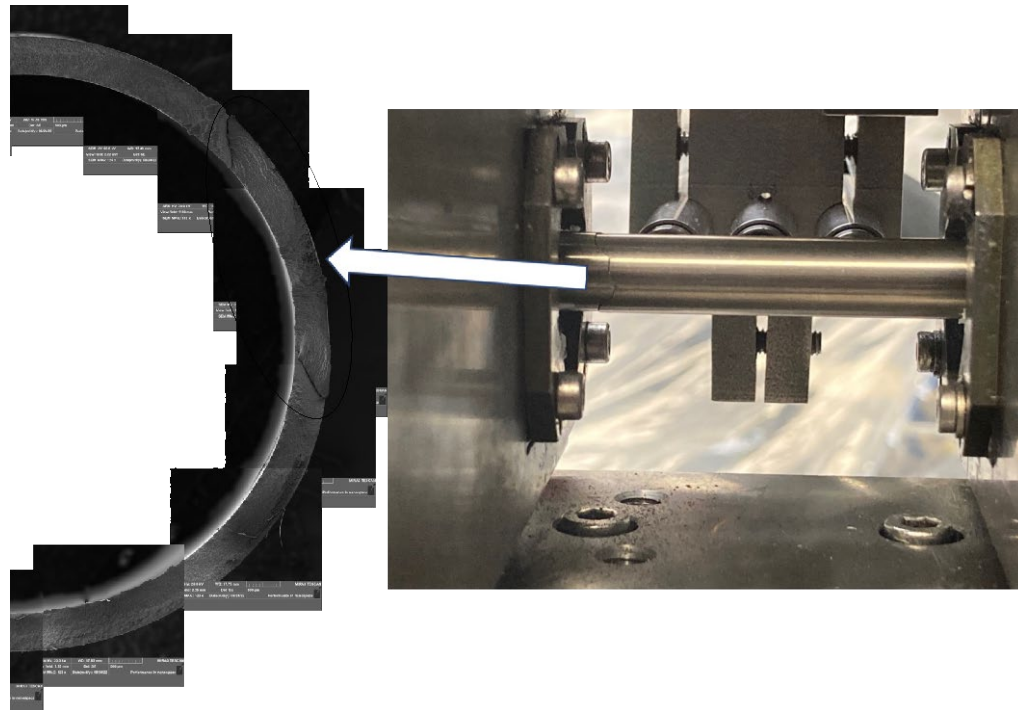
Figure F-54. Top (fracture) view and side view of the fatigue failure region in Q2 and Q3 of sample Zirc-4-W-4.

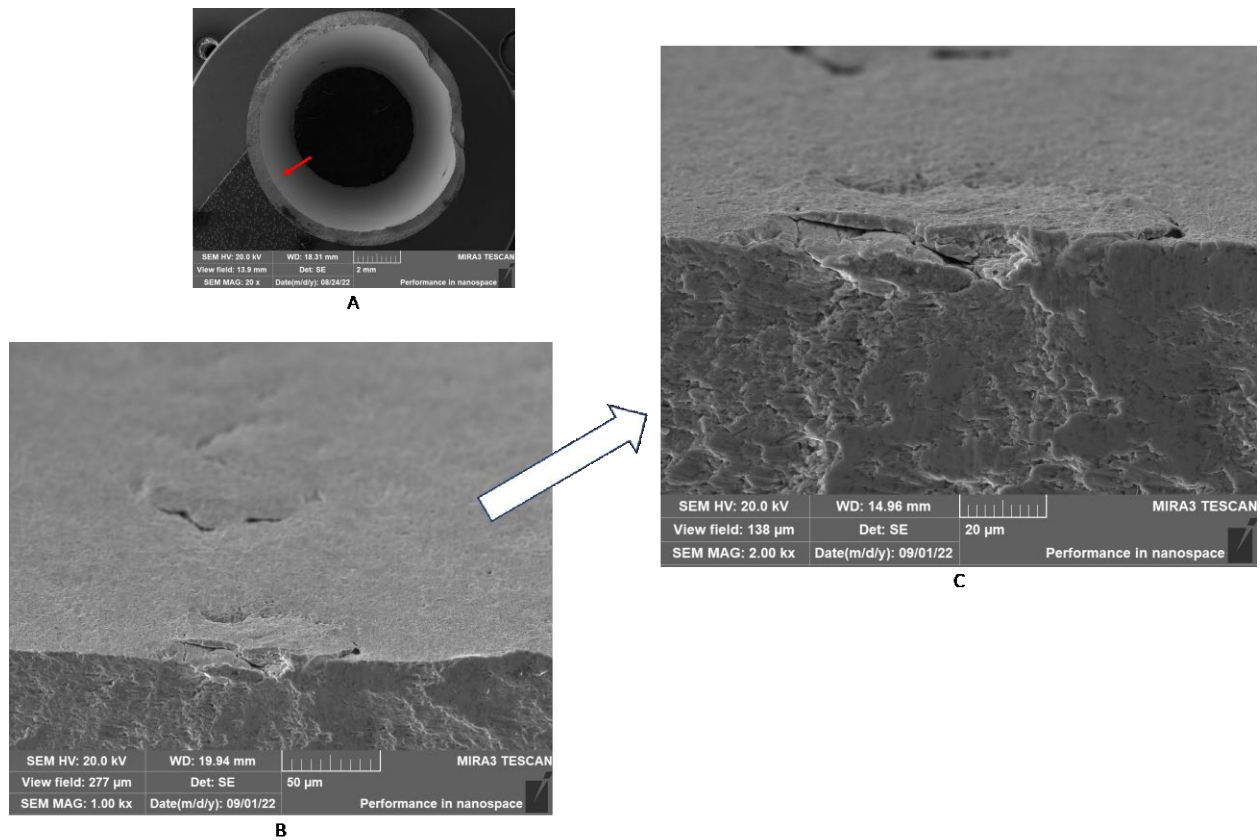
Figure F-56. Tilted image of Figure F-54 revealing the ID side of the fatigue failure initiation site on sample Zirc-4-W-4: (A) location of the region in a low-magnification image of the sample, (B) ID side of the fatigue failure initiation site, and (C) detailed view of the fatigue failure initiation fracture surface.

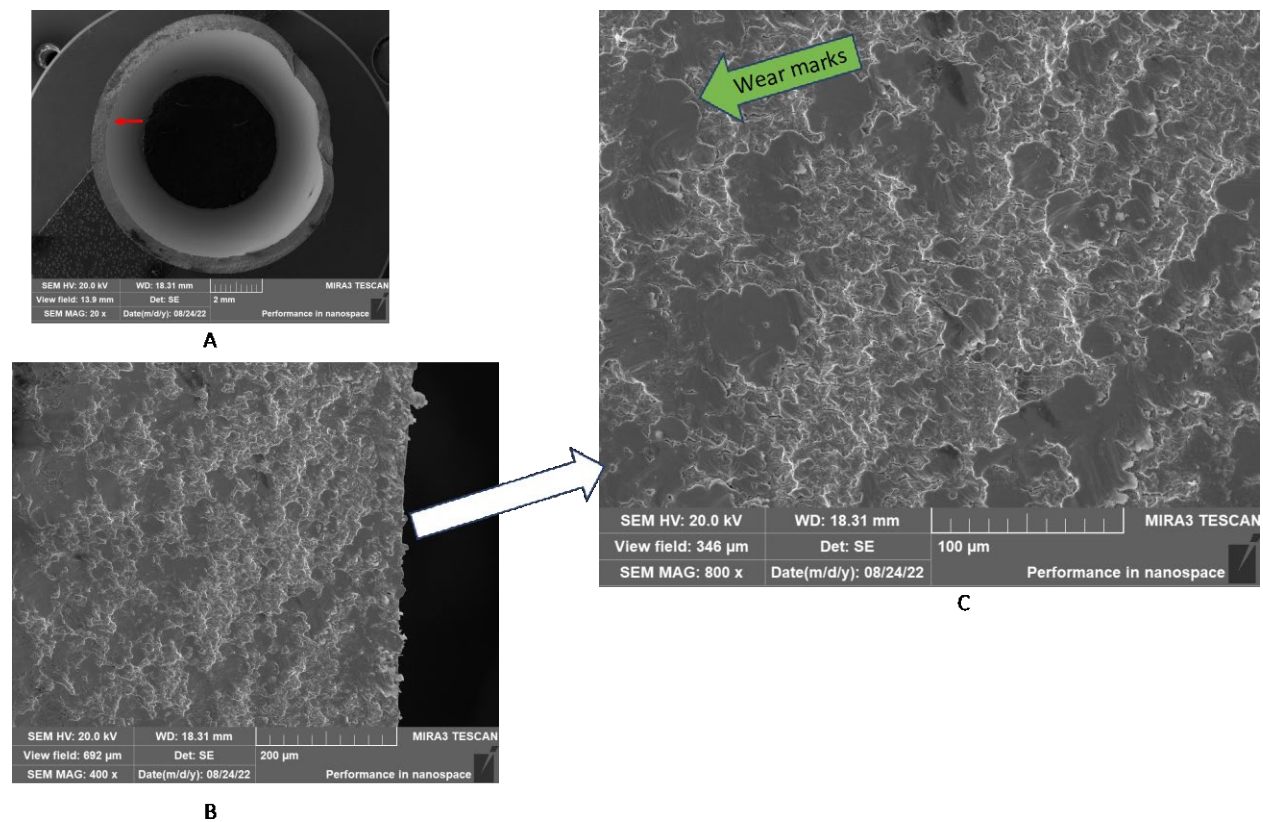
Figure F-57. Brittle fracture regions and potential wear marks of sample Zirc-4-W-4: (A) location of the region in a low-magnification image of the sample, (B) brittle or cleavage-like regions on Q1, and (C) potential wear marks observed between the brittle regions in Q1.

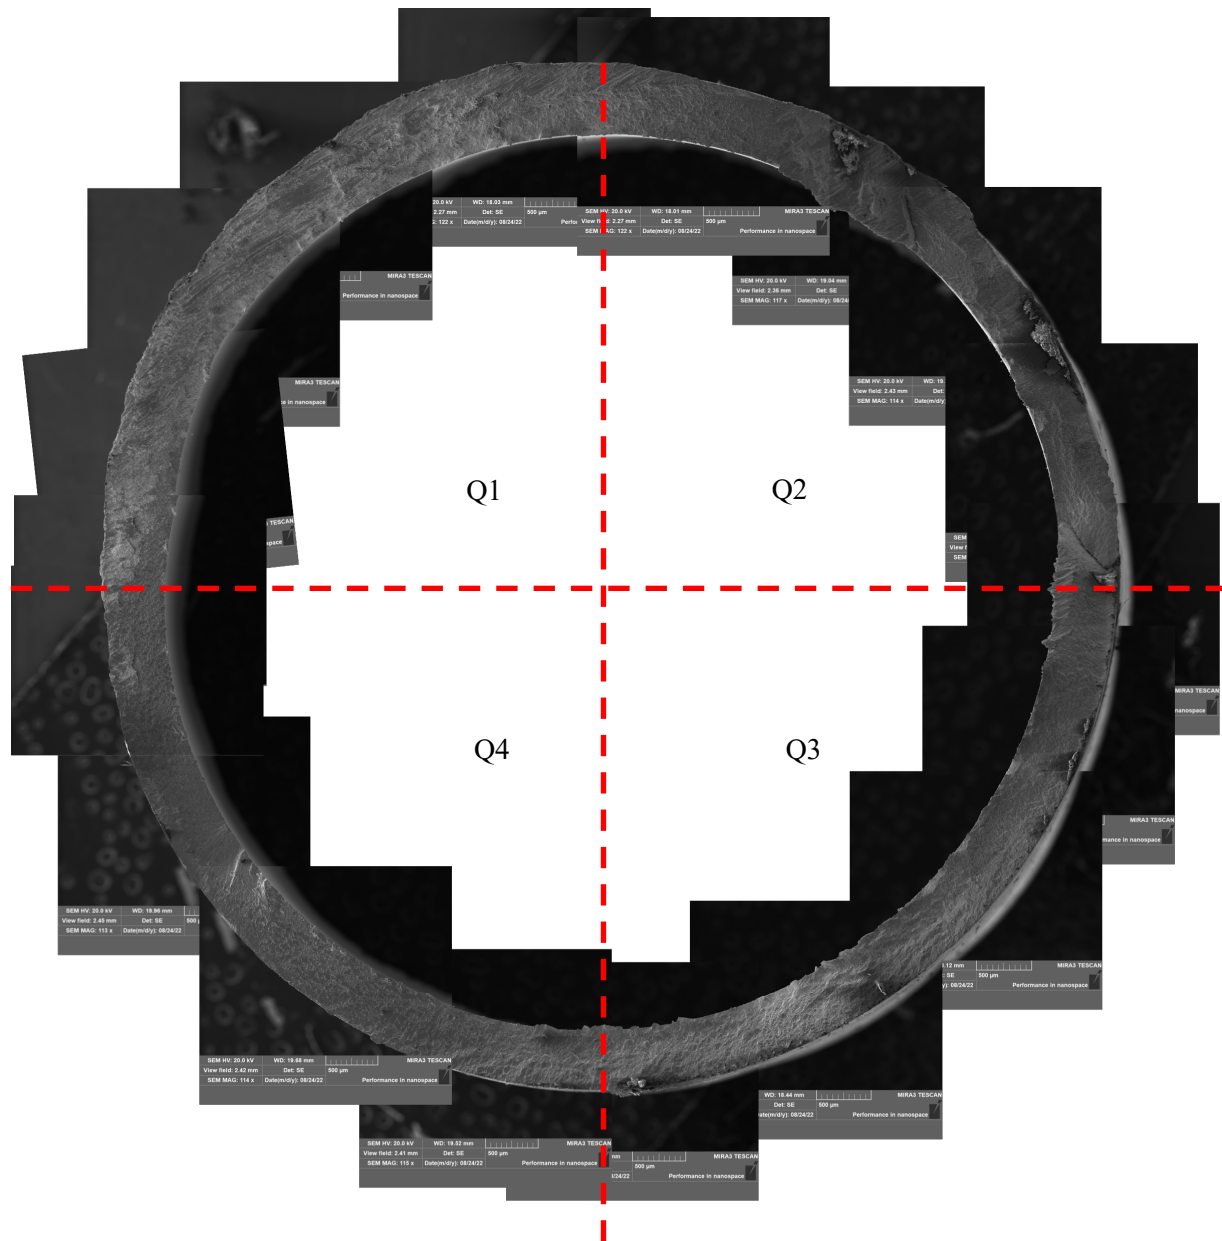
Figure F-58. Montage (100x) of the fatigue failure surface in dogbone sample Zirc-4-W-3.

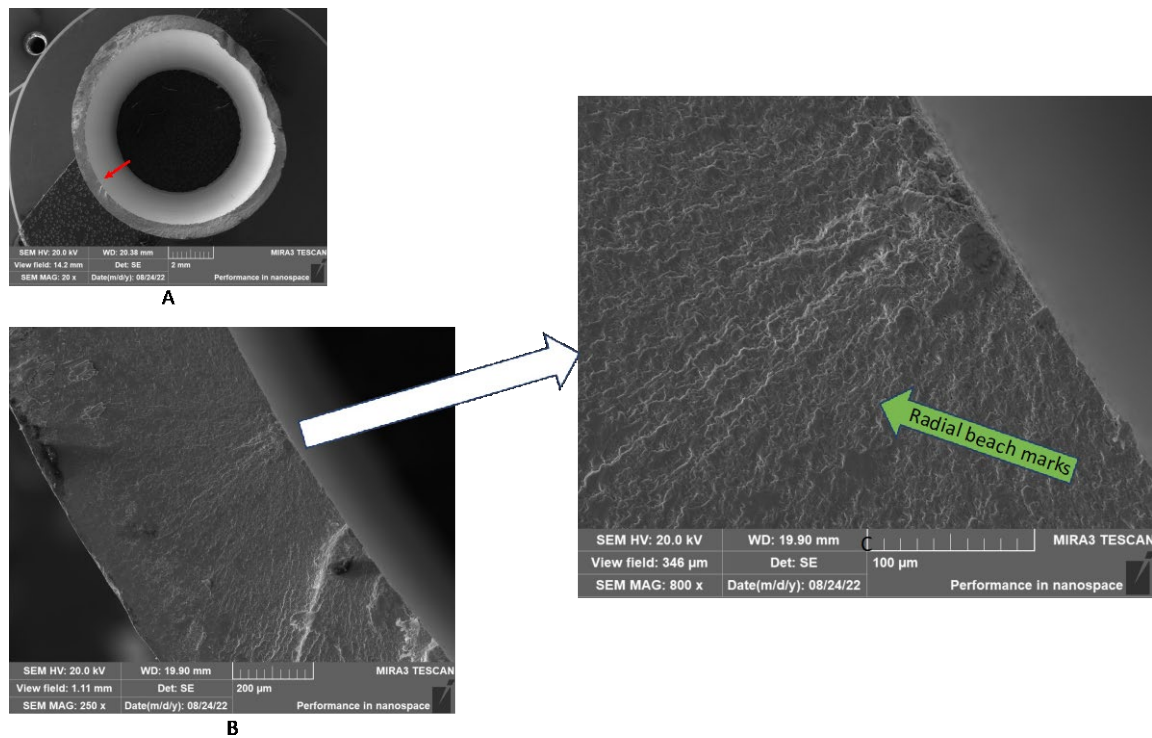
Figure F-60. Fatigue crack initiation region in Q4 of sample Zirc-4-W-3: (A) location of the region in a low-magnification image of the sample, (B) ID side of the fatigue crack initiation site, and (C) detailed view of B.

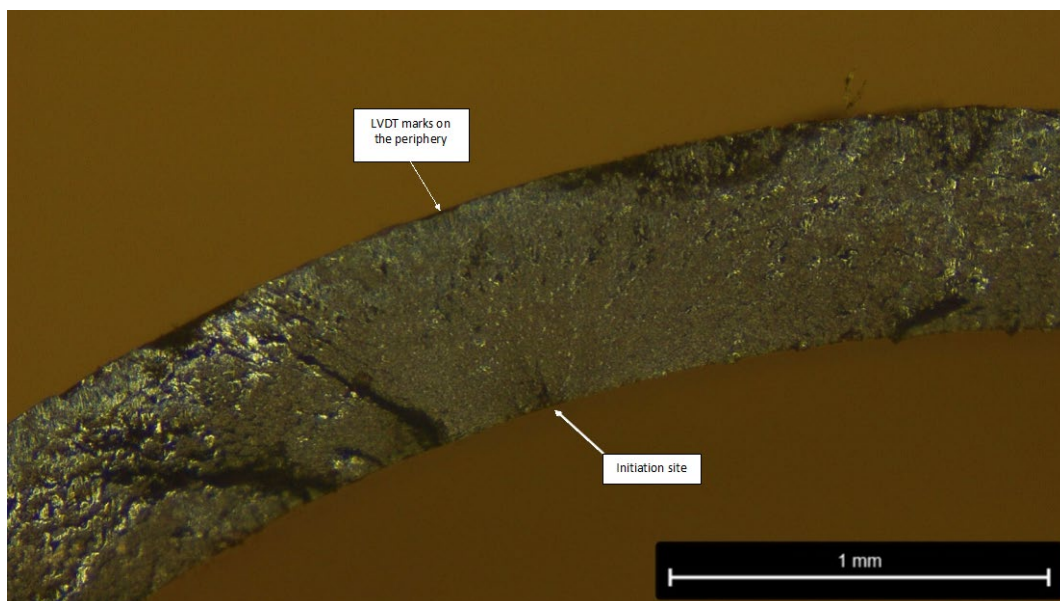
Figure F-61. Optical microscope image of sample Zirc-4-W-3 showing the fatigue failure initiation site; the peripheral region containing the LVDT marks is not visible.

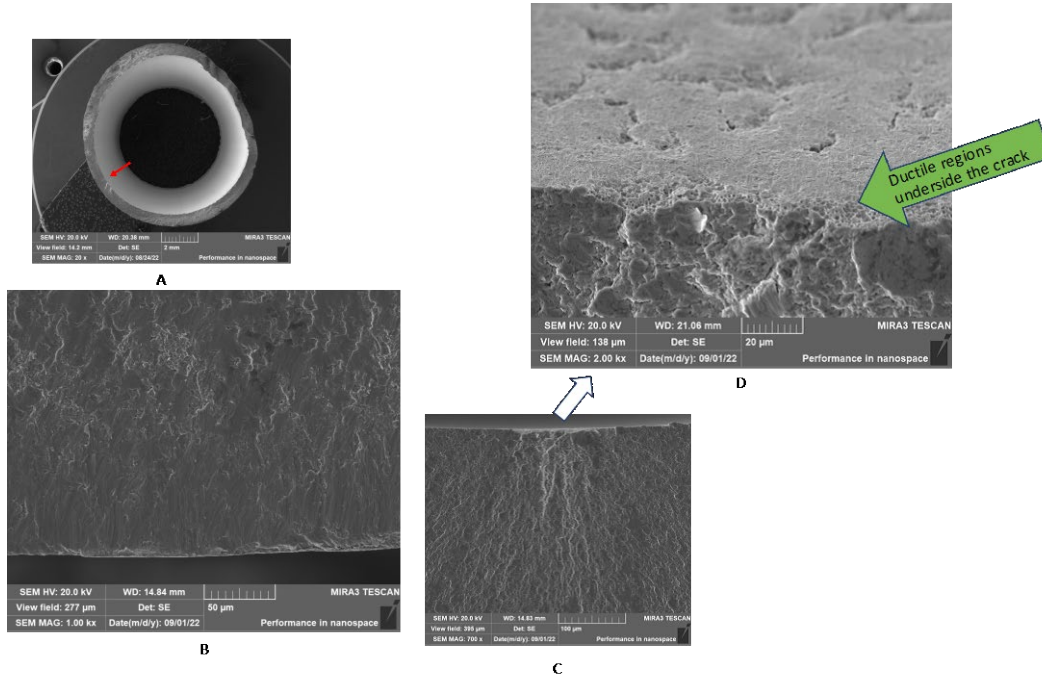
Figure F-62. Tilted SEM image of Figure F-60 revealing the ID side of the fatigue failure initiation site of sample Zirc-4-W-3: (A) location of the region in a low-magnification image of the sample, (B) OD side of the fatigue failure initiation site, (C) ID side of the fatigue initiation site, and (D) inside of the ID side of sample Zirc-4-W-3 at the fatigue initiation site.

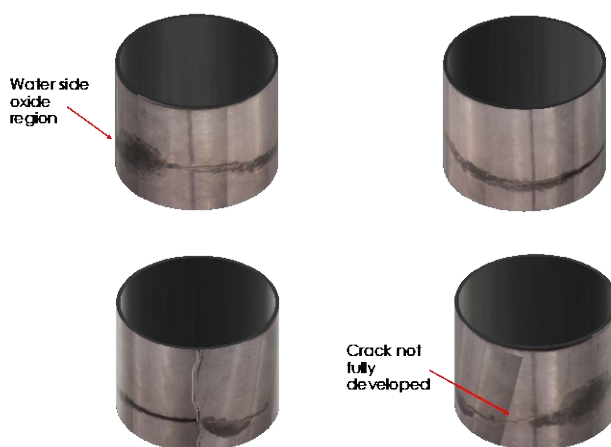
Figure F-65. Images of the circumferential cut-2 from sample 6U3K09-2310-2463 wrapped around a 3D cylinder to show a realistic image.
