Sister Rod Destructive Examinations (FY23)

Appendix F: Cyclic Integrated Reversible- Bending Fatigue Tests

Spent Fuel and Waste Disposition

Oak Ridge National Laboratory

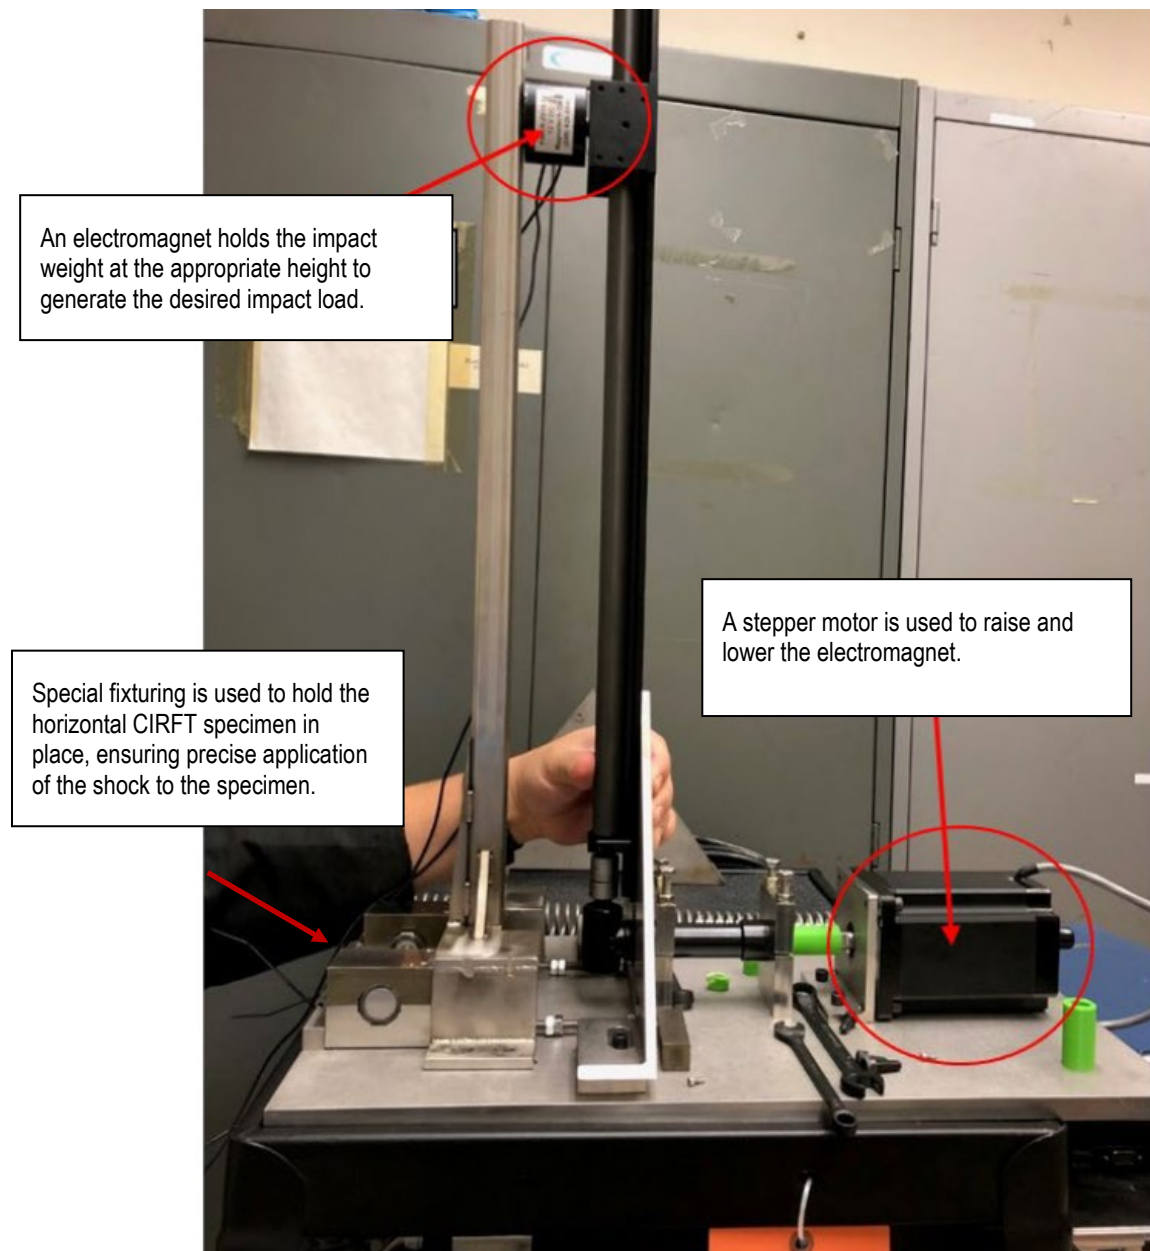
Figure F-66. Cumulative shock fixture developed to apply a normal transport condition shock before fatigue testing.

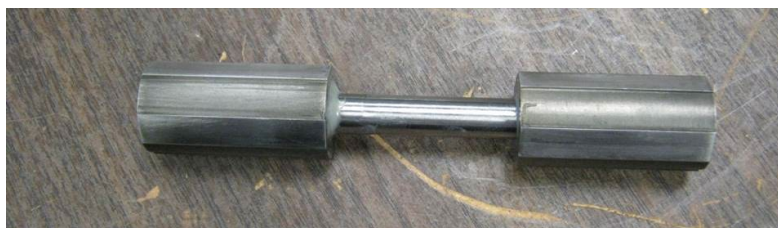
Figure F-72. CIRFT dogbone.

Based on the FEA, the main reason that the target g-load range cannot be achieved has nothing to do with the impactor itself. Rather, the problem is that the target rod segment is very stiff. To prepare the segment for CIRFT testing, it is necessary to install the heavy dogbone grips on each end. Only 50 mm of segment length is exposed for impact, as shown in Figure F-72. The dogbone provides a very stiff target that does not deflect in bending, so any impact will result in a high g-load, even with very low drop height, low impactor weight, and a soft impactor end configuration such as the dimples with a grid wall. With the dogbone as the target, low g-load impacts are not possible with the current fixture.
