Sister Rod Destructive Examinations (FY23)

Spent Fuel and Waste Disposition

***Oak Ridge National Laboratory
Rose Montgomery and
Bruce Bevard***

ORNL/SPR-2023/3192

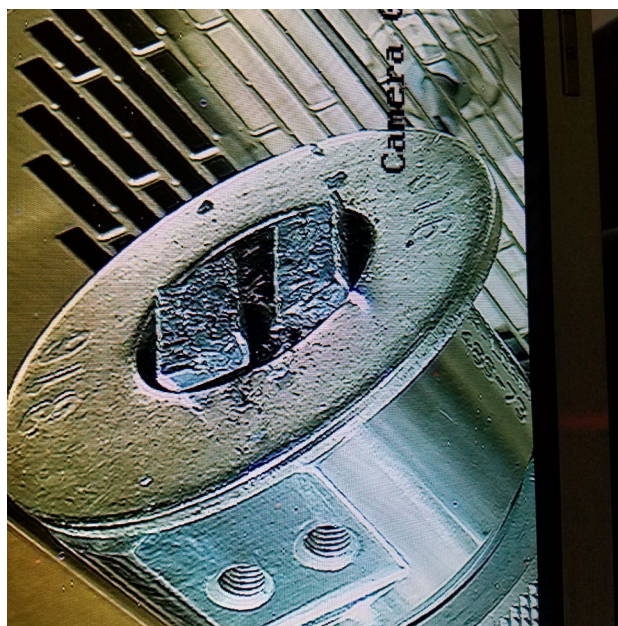
Figure 31. Typical post-RCT appearance.

The RCT specimens are ~25 mm long, as shown in Figure 30, and each specimen should contain two full pellets. Five tests were completed at 200°C and 12 tests were completed at RT, and the results, which have not been corrected for machine compliance, are summarized in Table 18. The specimens typically carried load until at least one cladding fracture developed. Frequently, as shown in Figure 31, the specimen broke into two equal halves.

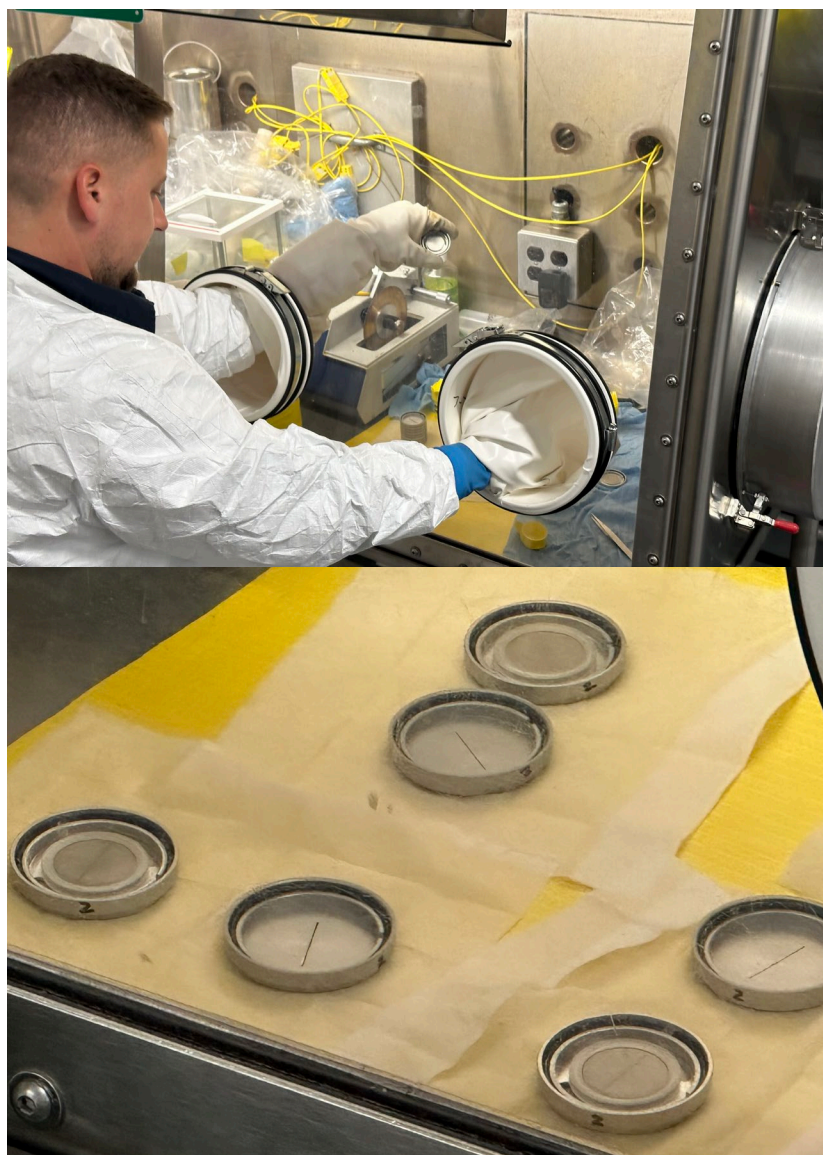
Figure 42. (top) Disassembly of the cascade impactor in a glove box and (bottom) three of the collected specimens with their orifice plates.

The cascade impactor was disassembled and sent for analysis, as shown in Figure 43. The results are expected in early FY24.

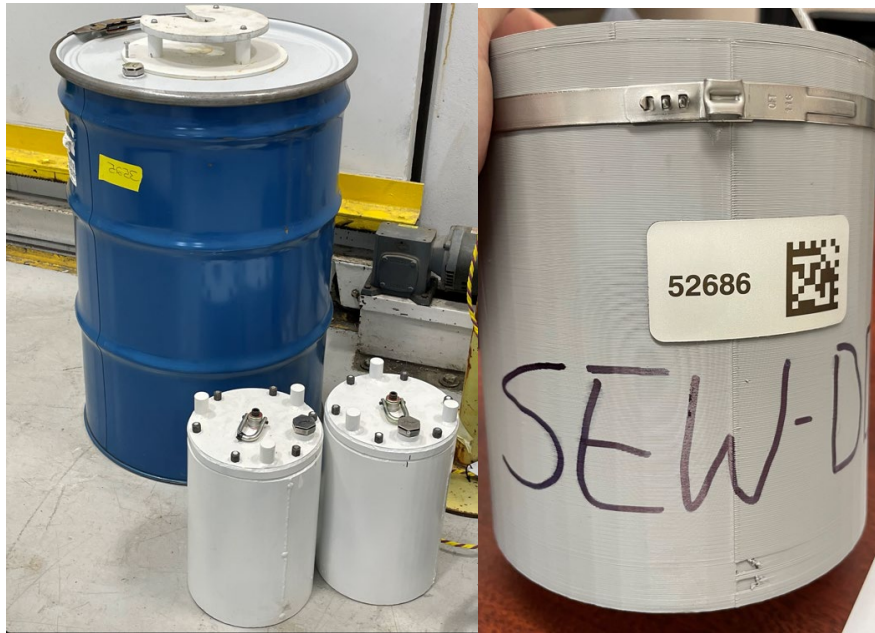
Figure 46. Waste containers used for sister rod wastes: a drum with two shield cans (left) and a vented container for holding sample examination waste (right).
