Plutonium-238 Loadout Calorimeter: Return to Service

Plutonium-238 Supply Program

PLUTONIUM-238 LOADOUT CALORIMETER: RETURN TO SERVICE

Prepared by
OAK RIDGE NATIONAL LABORATORY
Oak Ridge, TN 37831
managed by
UT-BATTELLE LLC
for the
US DEPARTMENT OF ENERGY
under contract DE-AC05-00OR22725

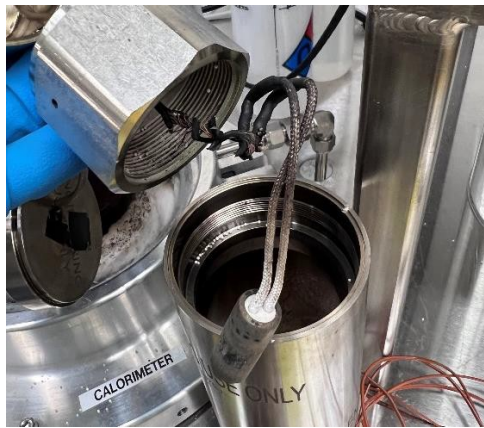
Figure 2. Reference FSO with damaged heater wires.

The reference FSO is an electric heater inside of an ORISC and FSO that was used to simulate a real ^{238}Pu -filled FSO. It was supplied with a known wattage and was used to confirm the calibration of the calorimeter. All the TCs are type K, and the bare junctions were taped to the metal surface in each location. The heater cable was found to be shredded in July of 2023, as shown in Figure 2.

The cable was damaged by rubbing against the internal threads in the through-hole on the lid of the FSO/ORISC assembly. Over time, the threads destroyed the heat shrink, which allowed the wires to create a direct short in the circuit, melting the heat shrink casing and creating the temperature spike seen in the data analysis. This damage to the heat shrink was determined to be the root cause of the fault incident.

- The threads were machined out of the threaded hole at the top of the FSO and ORISC assembly to ensure that they would not fray the cable over time.
- The heater TC was replaced with a new one and new high-heat tape was used to hold it in place.
- The alumina beads were replaced with new, equivalent, alumina beads.
- A new heater was installed into the ORISC and the ends were crimped and heat-shrunk to replace the failed heater.
- A maximum allowable sample cup temperature cutoff of 100°C was added to the Yokogawa program to prevent future failures due to overheating (the maximum sample cup temperature during normal testing was determined to be 87.5°C).
- Ambient temperature logging was added to the Yokogawa program.
- The water level was confirmed to be at the correct level.
- The sample cup insulation was replaced.
