Nuclear Science and Technology Division

**Corrosion Test Results for Inconel 600 vs
Inconel–Stainless UG Bellows**

Date Published: August 2002

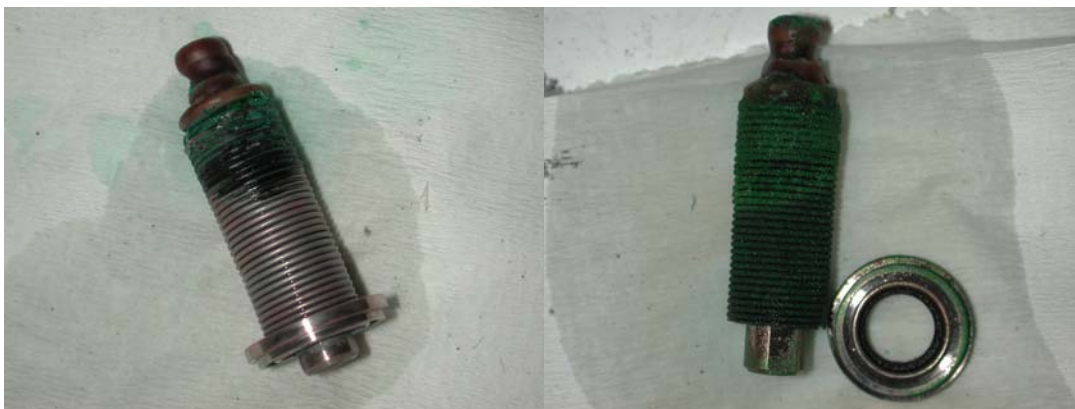
Fig. 6. Comparison of bellows A (left) and B (right) after 32 h of HF exposure.

Except for one of the bellows, the results from the short-term (1-week) test were good. The bellows in question, bellows B, experienced catastrophic failure after only two cycles. The bellows came apart between the convolutions just above the flange (see Fig. 6).

Both parts of the bellows assembly were returned to the vendor for analysis, and it was determined that a stainless steel bellows had been inadvertently welded to an Inconel flange. Figure 2 shows the effect of aqueous HF on stainless steel (i. e., on the chemically similar 254 SMO). The vendor is currently investigating how this stainless steel bellows could have been shipped as an Inconel bellows.
