ORNL/TM-13759
SNS/TSR-0097

SCREENING TEST RESULTS OF FATIGUE PROPERTIES OF TYPE 316LN
STAINLESS STEEL IN MERCURY

Date Published: March 1999

Prepared for the
U.S. Department of Energy
Spallation Neutron Source
SNS/TSR-0097

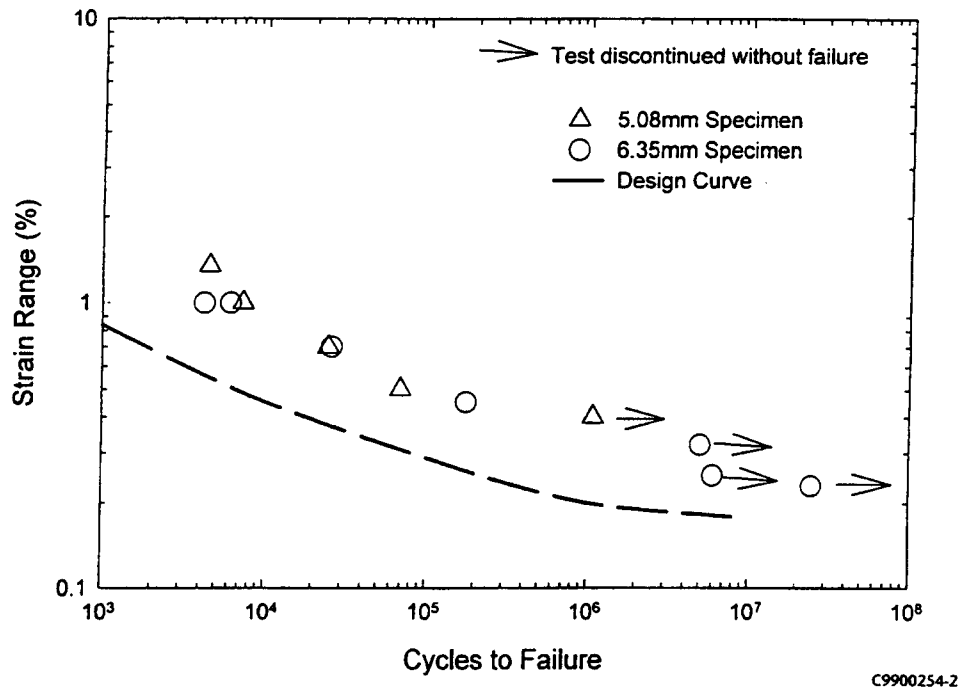
Fig. 3. Room temperature fatigue data for tests in air on mill annealed 316LN used in this study.
