Oak Ridge  
National Laboratory

# **RESULTS OF CHARACTERIZATION TESTS OF THE SURFACES OF A COMMERCIALY CARBURIZED AUSTENITIC STAINLESS STEEL**

**December 2003**

**K. Farrell**

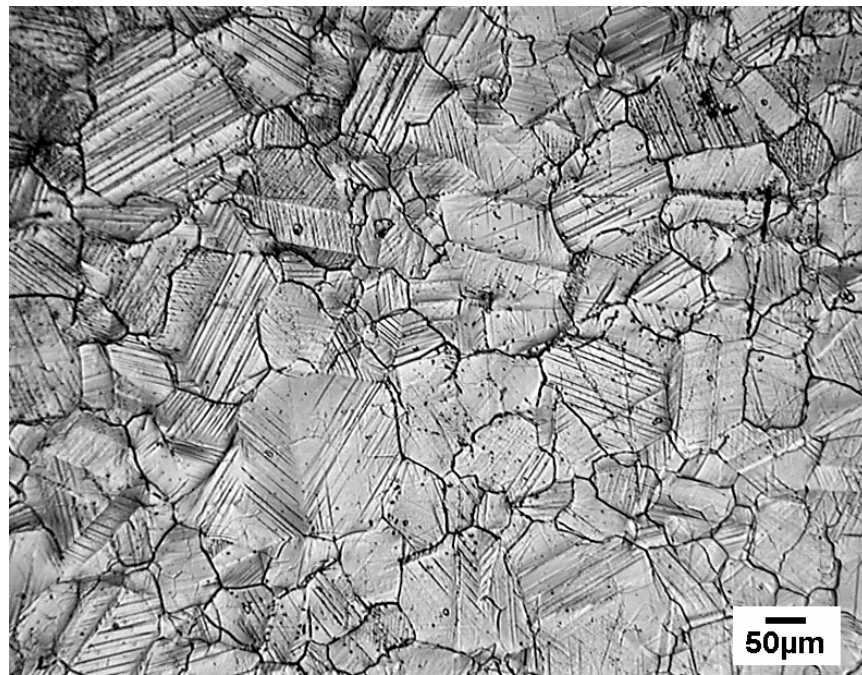
Before Kolsterising<sup>®</sup>, the as-polished, exterior flat surface of the disk was mirror smooth and no microstructural features could be discerned except for some inclusions. After the Kolsterising<sup>®</sup> treatment, the surface was heavily wrinkled, Fig. 1. Grain boundaries were strongly demarked

*Fig. 1. Distorted surface after Kolsterising<sup>®</sup>.*

and the grains contained extensive, coarse parallel slip and/or mechanical twin lines indicating the occurrence of considerable plastic deformation during Kolsterising<sup>®</sup>. The shapes of the grains were not noticeably different from annealed grains. These features were seen without the aid of metallographic etching; they are revealed by surface relief alone. According to Bodycote, plastic

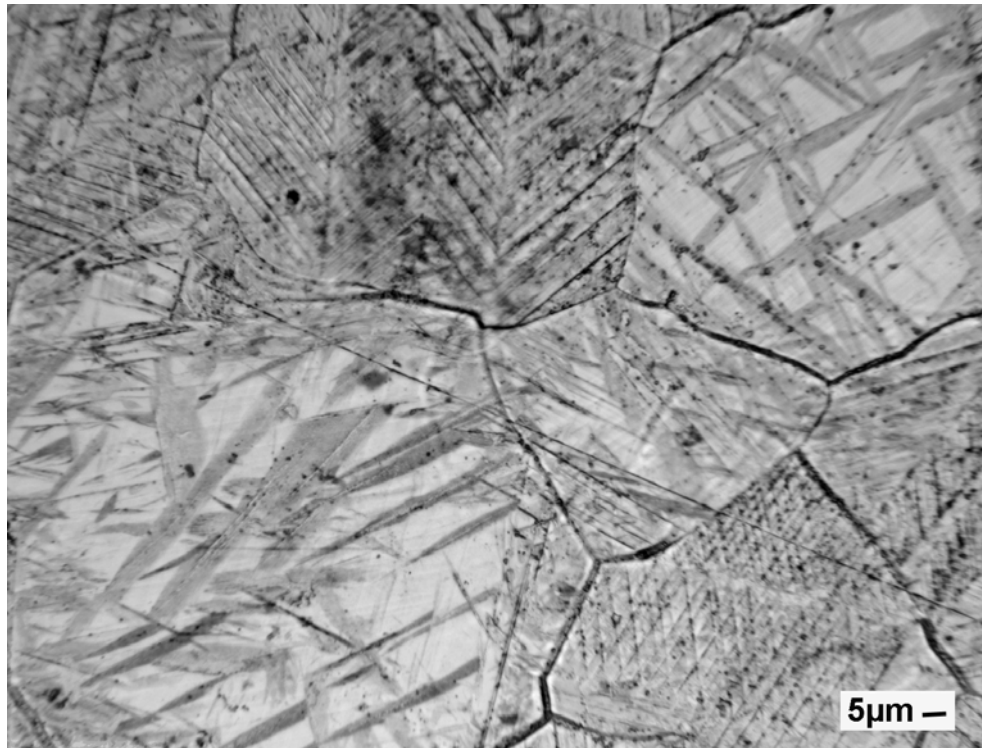
deformation of the surface does occur during Kolsterising<sup>®</sup>. Closer examination of the deformed surface revealed the presence of a thin, discontinuous, spiny-like structure, almost hidden by the deformation bands. This structure was detected in all grains but was prominent in only few of them, as in the several lighter toned grains seen at higher magnification in Fig. 2. The structure is distinguished by the facts that its spines are shorter than the width of the grain and they lie in at least four orientations. In contrast, the deformation bands are linear and narrow, they usually span the full width of the grain, and they lie in only one or two directions except where they are perturbed by the presence of annealing twins. This reclusive, spiny feature is considered in more detail in section 3.8.

*Fig. 2. Spiny structure in the deformed surface.*

This phase can be seen at the surface in the left side of Fig. 9. It is the spiny phase noted in section 3.1. The more uniform dark phase on the surface at the right of Fig. 9 is deformation bands. The spiny phase has not been reported by Bodycote, nor was it seen in the surface of the 316L steel, Fig. 10. At first, it was thought that the phase might be martensite caused by plastic deformation of the surface during Kolsterising<sup>®</sup>. It is known that straining, either elastic or plastic, of Fe-Ni-Cr austenite can cause the formation of martensite [2,3]. However, the propensity for martensite formation declines markedly with temperature above room temperature, and is reduced by austenite stabilizing elements such as carbon. Since the Kolsterising<sup>®</sup> treatment is conducted at temperatures below 300°C, and presumably as close to 300°C as possible to maximize the penetration of carbon, it is unlikely that martensite will form during Kolsterising<sup>®</sup>. Nevertheless, plastic deformation and martensite may occur during cooling from the Kolsterising<sup>®</sup> temperature. A phase similar to  $\alpha'$ -martensite has been reported in the surface layer of 316 austenitic steel carburized in a methane gas plasma at 400-600°C [4], but was not detected in other work conducted under the same conditions by the same authors on 316 and 304 steels [5].

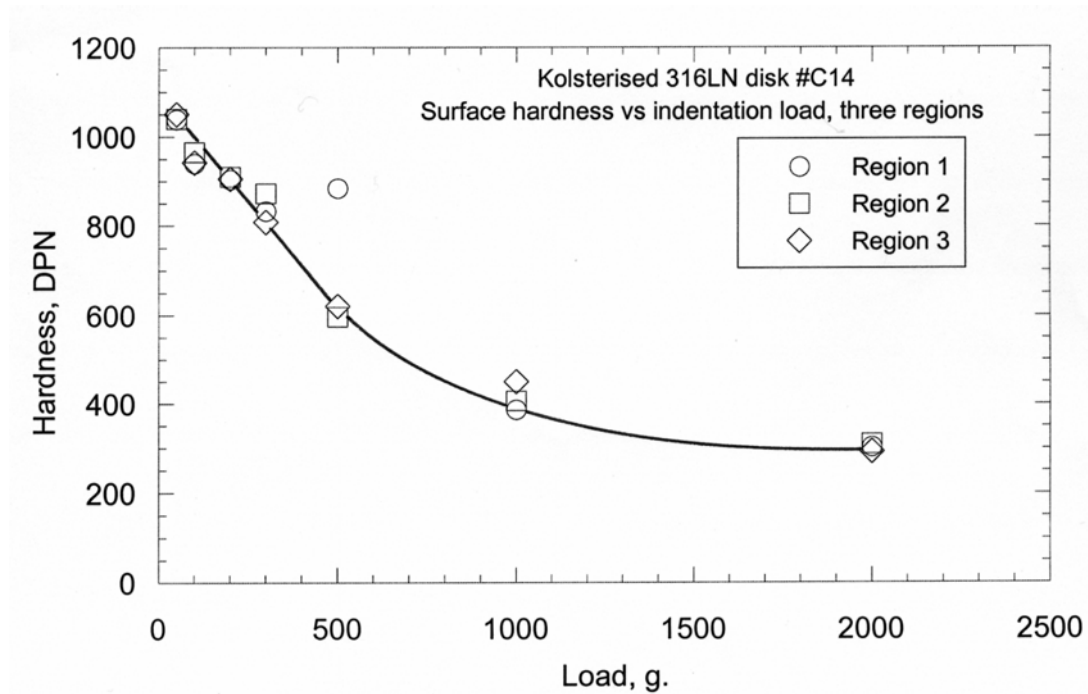
For the areal tests the disk was secured, with the originally as-polished surface facing up, to a flat, metal block using double-sided adhesive tape. Three regions on the face were chosen at random, and in each region seven tests were made at different loads between 50 and 2,000g. The results are shown in Fig. 3. They indicate good reproducibility from one region to another, implying no areal variation. They also show, very clearly, that with increasing load the contribution of the layer to the composite hardness is reduced as more and more of the softer substrate is sampled. The average hardness measured at 50g load is 1040 DPN, in agreement with Bodycote's hardness of 1000-1200 DPN for Kolsterised austenitic stainless steel. The average hardness at 2000g load is 301 DPN versus 259 DPN measured for the untreated material, indicating only modest detection of the presence of the Kolsterised layer at high loads.

*Fig. 3. Surface hardness as a function of indentation load at three randomly chosen regions on Kolsterised disk C14.*

The hardness value at zero depth in Fig. 5 is the average of the 50g values made directly on the front surface in Fig. 3. This subterfuge is necessary because the hardness at, or very close to, the very edge of the piece can not be measured with accuracy by the cross section technique because the indentation breaches the edge of the piece. For a hardness of 1040 DPN, the diagonal width of the hardness impression at 50g load is  $9.5\mu\text{m}$ . Since the diamond pyramid deforms a much larger area than the area of the impression, any hardness measurement attempted within about  $10\mu\text{m}$  of the edge of the specimen will cause the edge to barrel outwards. This lack of support will give a larger indentation and an erroneously low hardness value. The barreling is often not easy to discern because of the small size of the indentation and because the Kolsterised surface is not microscopically flat. Indentations that were obviously barreled were ignored. Nevertheless, the bunched data points around 700 DPN indicate that barreling has imposed a ceiling on the hardness measurements for depths up to about  $15\mu\text{m}$ . Presumably, the hardnesses at depths up to  $10\mu\text{m}$  or so are actually higher than 700 DPN. At greater depths beyond  $15\mu\text{m}$ , where the measurements are more reliable, the hardness decreases to the substrate value at a depth of about  $40\mu\text{m}$ , in fair agreement with Bodycote's  $33\mu\text{m}$  profile. Although these measurements do not duplicate the full shape of Bodycote's  $33\mu\text{m}$  profile, they offer no grounds to dispute it, except to ask how Bodycote determined the shape in the 0- $10\mu\text{m}$  region. Perhaps a Knoop type indenter was used, which would allow a closer working distance to the edge.

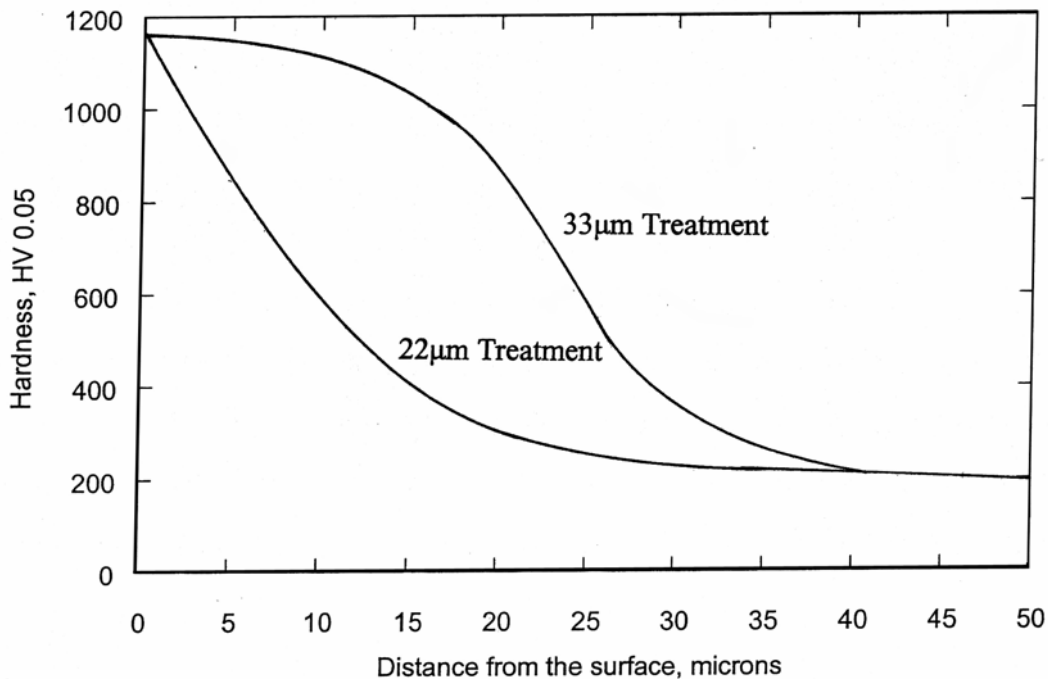
Since the Kolsterised layer is created by inward diffusion of carbon, there will be a concentration gradient of carbon in the layer, declining from a maximum at the surface to almost zero at the diffusion front. Likewise the hardness, which is supposedly governed by the concentration of carbon, will decrease with depth within the layer. To map such depth variation, a cross section piece is cut perpendicular to the treated surface and hardness measurements are made at small load at carefully measured distances below the specimen surface across the thickness of the layer and into the immediate unhardened host metal. Examples of hardness-depth profiles determined at 50g load for two Kolsterising<sup>®</sup> treatments, 22 $\mu$ m and 33 $\mu$ m, in 316 austenitic stainless steel and published by Bodycote are reproduced in Fig. 4.

*Fig. 4. Bodycote's hardness-depth profiles for Kolsterised 316 stainless steel.*

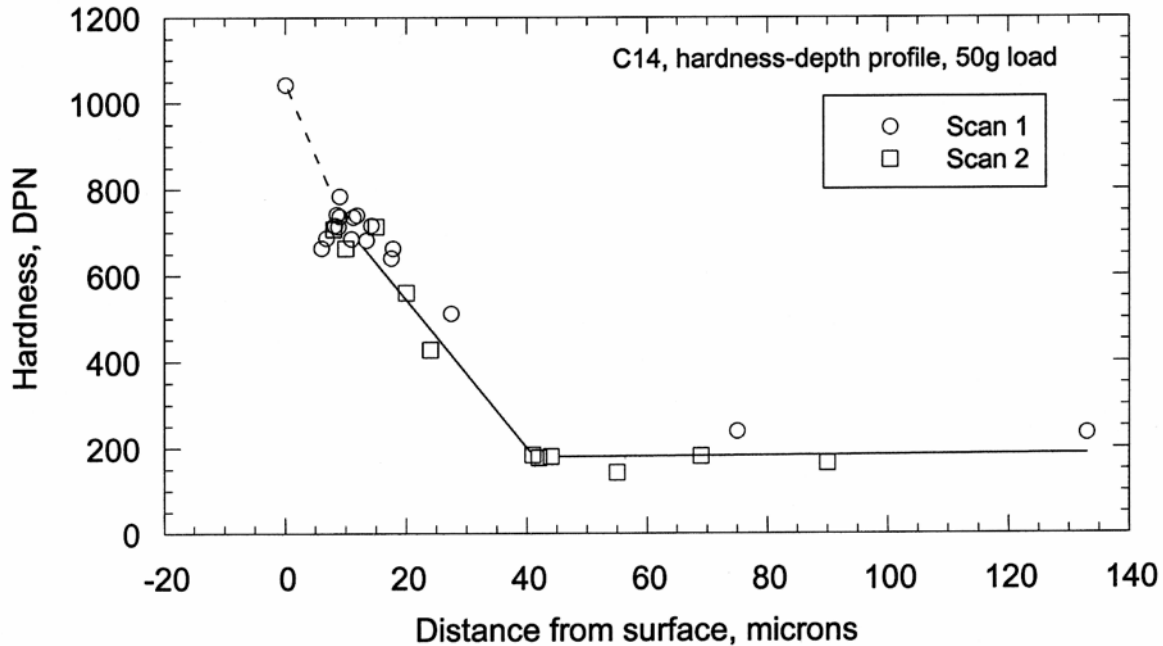
For the present determination of the hardness profile through the thickness of the disk, a chordal slice was cut from the disk and was mounted in cold-setting epoxy with the cut edge facing up. It was then polished to a mirror finish. Using a load of 50g, hardness impressions were made along a line lying at small angle to the specimen surface and passing across the Kolsterised layer into the parent metal. That way, the indentations could be made close to the surface but with sufficient separation between successive indentations that they did not interfere with one another. The combined results from two traverses are displayed in Fig. 5.

*Fig. 5. Disk C14; hardness-depth profile for a 50g load.*

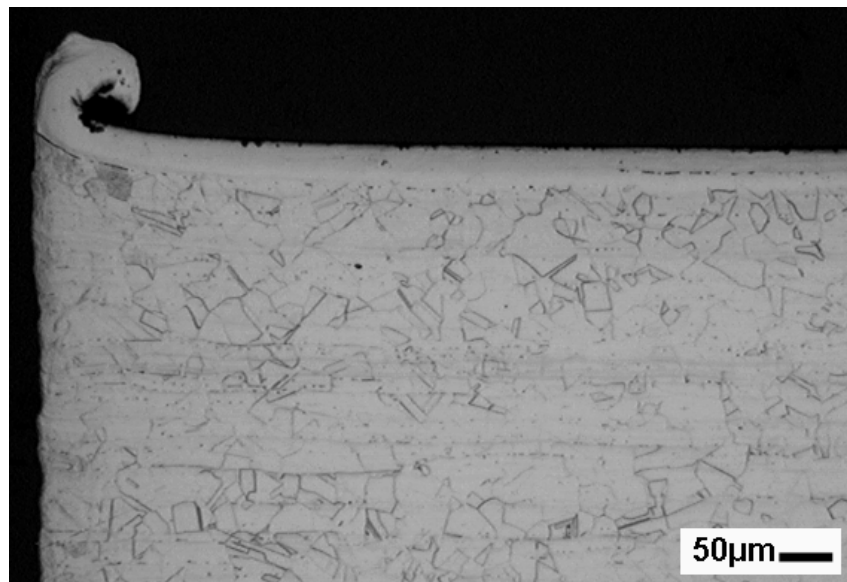
of the indenter, and the extent of the cracking should increase with the severity of the penetration. The scrutiny revealed that the indentations were surrounded by lightly dished regions containing fresh slip lines, signifying that plastic deformation of the layer occurred during the hardness test. Cracks were observed in only 2 out of 59 impressions and were accompanied by substantial plastic deformation. The cracks were few and small and were made under large loads of 1,000 and 2,000g, which are considered to be extreme tests of the integrity of the layer. The cracks were small, very narrow, irregular, and discontinuous. They were located at the rim of the impression and just inside it, where tensile forces would be greatest. Another indirect observation of toughness was made on different specimens cut from a relatively large piece of Kolsterised 316L stainless steel that was hardened to the same degree as disk C14. There it was found in a number of instances when the cutting tool approached the Kolsterised layer from its underside, that the tool did not cut cleanly through the layer but tore through it, creating a burr that was forced back on itself through angles greater than  $90^\circ$  to form a cantilevered curlicue, as illustrated in Fig. 6. Such curlicues indicate considerable tolerance of plastic deformation in the layer. These combined observations of high hardness, good ductility, and significant resistance to crack propagation are testimony that the Kolsterised layer is tough, not brittle.

*Fig. 6. Curlicue of Kolsterised layer formed by action of a cutting tool pushing up from the lower left corner of the field.*

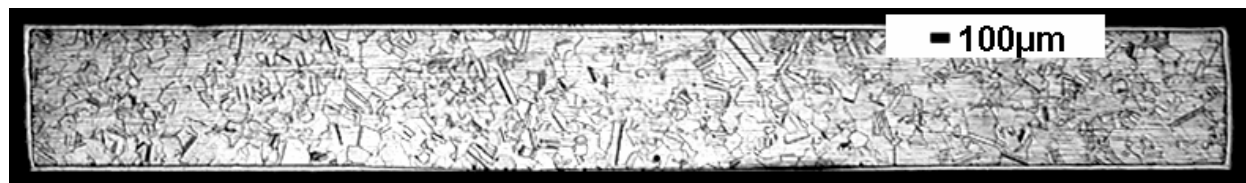
on the Kolsterised layer. The layer remained featureless; no trace of the grain boundaries was discernible in it. The unetched layer contrasted sharply with the etched substrate and could be seen with the naked eye as a thin white skin around the specimen, shown in Fig. 7 at low magnification after swabbing in Glyceregia solution (30 parts each glycerol and HCl and 10 parts HNO<sub>3</sub>). This resistance of the Kolsterised layer to etching agrees with Bodycote's claim of improved corrosion resistance.

*Fig. 7. Etched cross section through the Kolsterised specimen.*

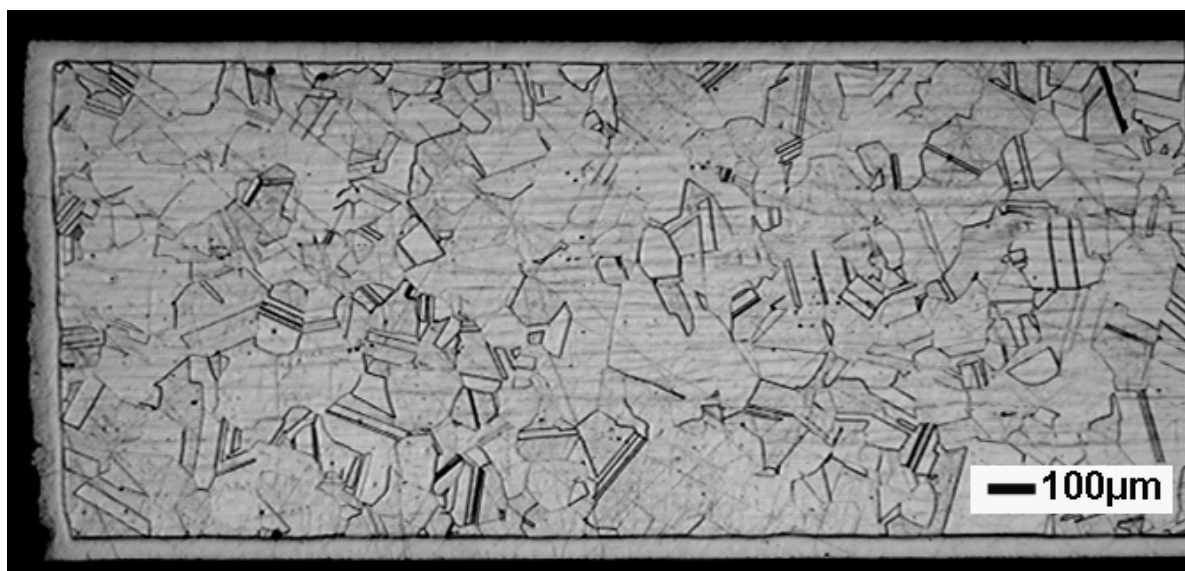
*Fig. 8. Variation in thickness and surface roughness of Kolsterised layer at edge of piece.*

$38 \pm 2 \mu\text{m}$ . On the short, as-machined edges, the layer thickness varied between 55 and  $77 \mu\text{m}$ . The outer surface roughness was fairly smooth on the as-ground and prepolished surfaces but was much rougher on the as-machined edge surfaces, Fig. 8. The Kolsterising treatment is normally conducted on specimens piled randomly in wire mesh baskets. So it is quite possible that the thin, dished region in the layer on the prepolished surface could be due to shielding by a neighboring piece during Kolsterising<sup>®</sup>. No explanation is offered for the increased thickness and roughness at the edges of the piece. These thickness measurements are summarized in Table 1, together with data for weld H4 from Section 4.2.

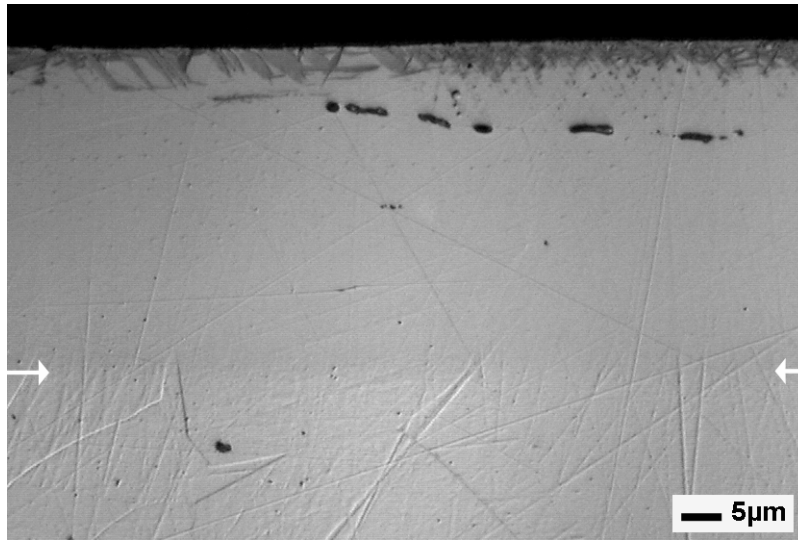
completely within the layer and lying at a small angle to the surface is shown in Fig. 9. The position of the penetration front of the layer is indicated in this figure and in later figures by the white arrows. The stringer is more heavily etched than stringers in the substrate.

*Fig. 9. Etched inclusion stringer in Kolsterised layer in disk C14.*

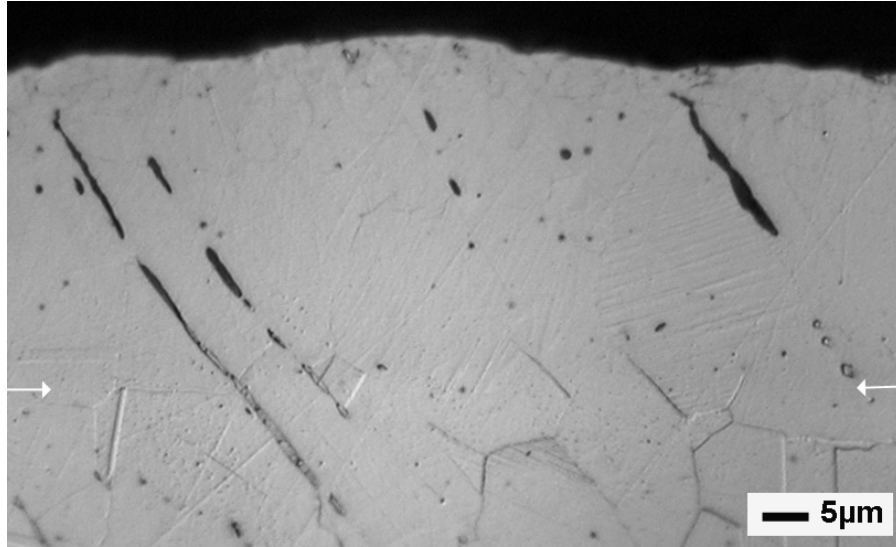
Preferred etching of inclusions in the Kolsterised layer is demonstrated more persuasively in Fig. 10, which is a piece of a different steel, a 316L grade containing many inclusion stringers, that has been Kolsterised like disk C14. In this case, the stringers lie at a steeper angle to the surface and some of them are partially within the Kolsterised layer and partially within the substrate. The inferior corrosion resistance of the stringers in the Kolsterised layer is demonstrated by the fact that those portions of the stringers within the substrate are lightly etched whereas the portions of the same stringers lying within the Kolsterised region are eaten away. Clearly, the Kolsterising<sup>®</sup> treatment had an adverse effect on the corrosion resistance of the inclusion stringer. This did not happen with all stringers, so presumably their susceptibility to corrosive attack is dependent on their structure and chemical composition.

*Fig. 10. Enhanced etching of inclusion stringers crossing the Kolsterised layer in 316L steel.*

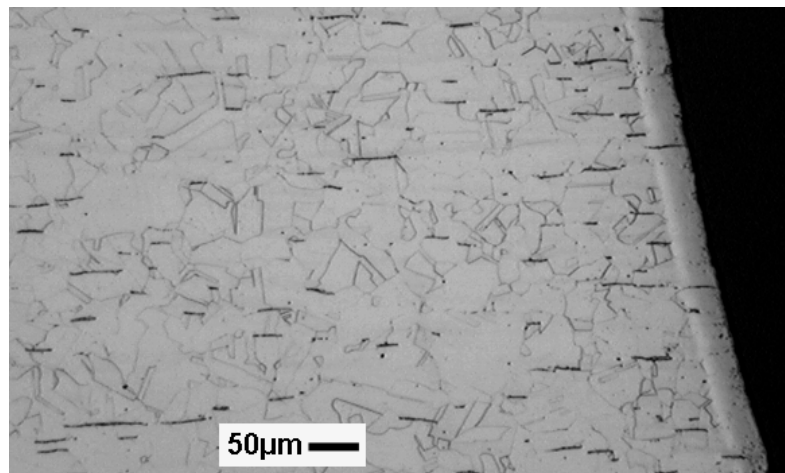
Another notable feature of inclusion stringers is that they can be quite long, much longer than the thickness of a Kolsterised layer. When oriented at suitable angle, they can make unbroken paths through the layer. An example, taken in the same 316L steel as in Fig. 10, is given in Fig. 11.

*Fig. 11. Inclusion stringers traversing a Kolsterised layer in 316L austenitic steel.*

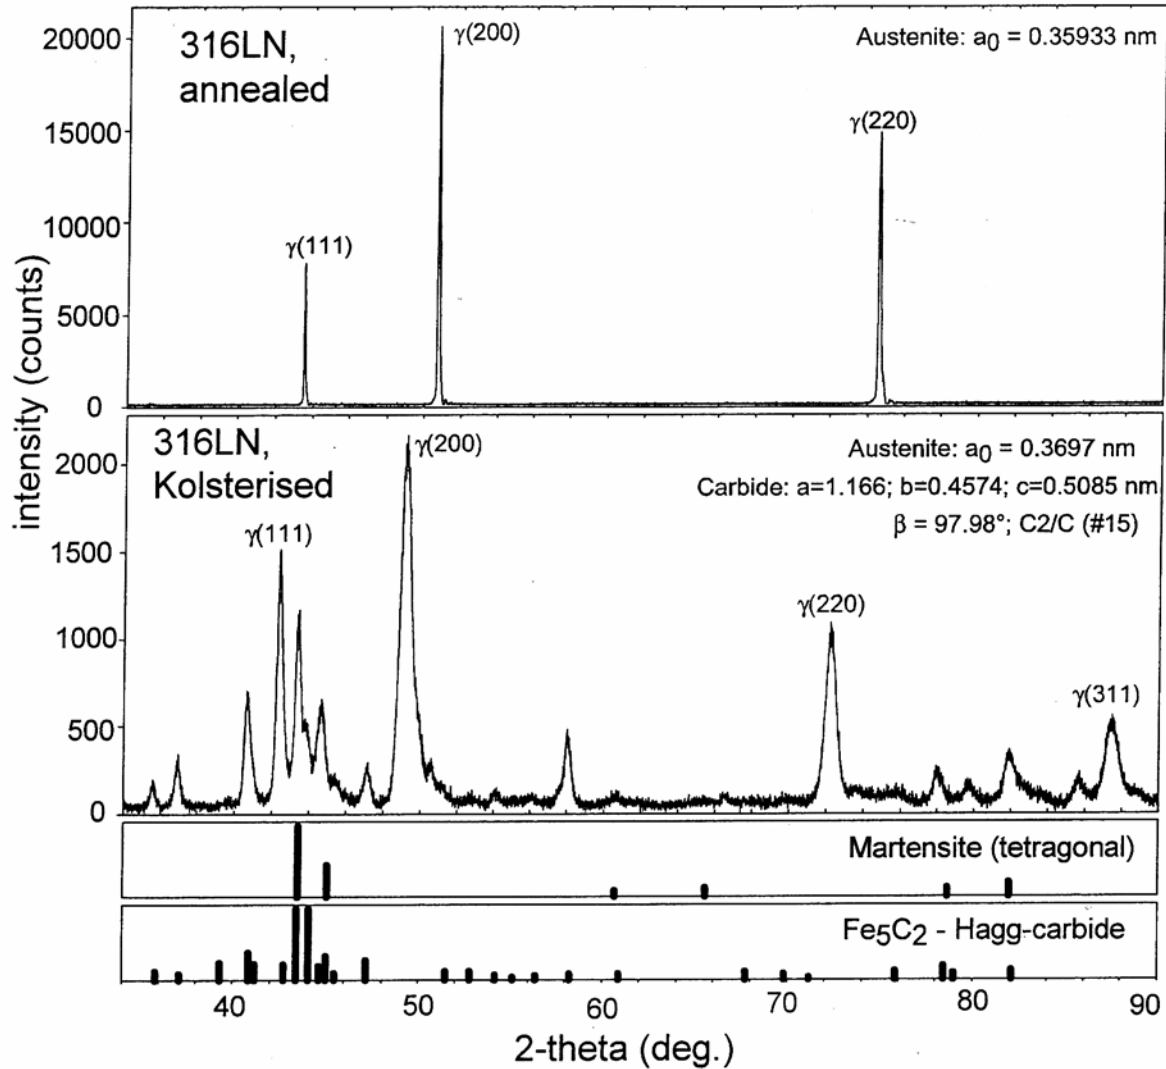
To identify the spiny phase, X-ray diffraction analyses were made on the outer face of the as-Kolsterised surface and on an annealed, non-Kolsterised, control specimen of the 316LN steel. The intensity peaks are shown in Fig. 12. Several features emerge from comparison of the two spectra. First, Kolsterising<sup>®</sup> has introduced many more peaks. Second, the austenite peaks in the Kolsterised specimen are much broader and are shifted to lower angles than those in the annealed specimen. Analysis of the data indicated that the Kolsterised surface contained roughly equal parts of expanded austenite phase and a carbide phase. The diffraction pattern from the carbide phase coincided most closely with  $\text{Fe}_5\text{C}_2$  Hagg ( $\gamma$ ) carbide. However, the lattice parameter of the phase was closer to  $\text{Mn}_5\text{C}_2$ . Two small lines were not assignable to  $\text{Fe}_5\text{C}_2$ . One of these coincided with a line for  $\text{Cr}_7\text{C}_3$ , but no other supporting lines were found for  $\text{Cr}_7\text{C}_3$  and therefore it was assumed that the chromium carbide phase was not present. The boxes at the base of Fig. 12 display the locations and scales of standard lines for martensite and  $\text{Fe}_5\text{C}_2$ . All of the standard  $\text{Fe}_5\text{C}_2$  lines are found in the spectrum from the Kolsterised specimen except for one at 39°. With regard to martensite phase, the search for it was thwarted by the fact that the positions of the martensite lines coincide with some of those for  $\text{Fe}_5\text{C}_2$ . Thus, the presence of martensite can not be verified nor rejected on this X-ray evidence. The carbide phase has many more lines than the martensite, and there is no question of its presence. From lattice parameter measurements the carbide phase appeared to be free of stress.

Fig. 12. X-ray diffraction peaks from the surface of 316LN steel before and after Kolsterising®.

The broadening and shifting of the primary reflections for the austenite phase in Fig. 12 are evidence of distortion and expansion of the phase. Plastic distortion will widen the peaks, and expansion of the austenite lattice will displace the peak positions to smaller angles. Plastic distortion was undoubtedly present, as evidenced by the slip lines in Fig. 1. Large increases in lattice parameter,  $a$ , were measured. These increases will cause stresses and strains in the Kolsterised layer. At the surface, the austenite between the particles of the carbide-like phase had an in-plane lattice parameter,  $a_{in}$ , of 0.3681 nm and an out-of-plane value,  $a_{out}$ , of 0.3695 nm. The lattice strain is  $\epsilon = (a_{in}/a_{out}) - 1$ , which gives a value of -0.0038. The lattice stress is  $\sigma = \epsilon Y / (1 + \nu)$ . Using a Young's modulus,  $Y$ , of 193 GPa and a Poisson's ratio,  $\nu$ , of 0.3, the residual stress is estimated to be minus 550 MPa. This residual compressive stress is much larger than the normal yield strength of 205 MPa for annealed 316LN steel [6] and it explains why the Kolsterising® process induces gross plastic deformation at the surface. Although plastic deformation widens

the austenite peaks in Fig. 12 it will not change the lattice parameter of the austenite. The observed expansion of the lattice is due to absorption of carbon in supersaturated solid solution. Published data [5] relating lattice parameter to dissolved carbon concentration for 316 stainless steel carburized with up to 2.5 wt%C at 450-500°C shows a linear function,  $a = 0.3597 + 0.0054C$ , where  $C$  is wt% carbon. In the present work, the average value measured for the expanded austenite at the surface is 0.3688nm, which corresponds to a carbon concentration of 1.68 wt% in solid solution in the austenite. This is much smaller than the 6-7wt%C claimed by Bodycote.

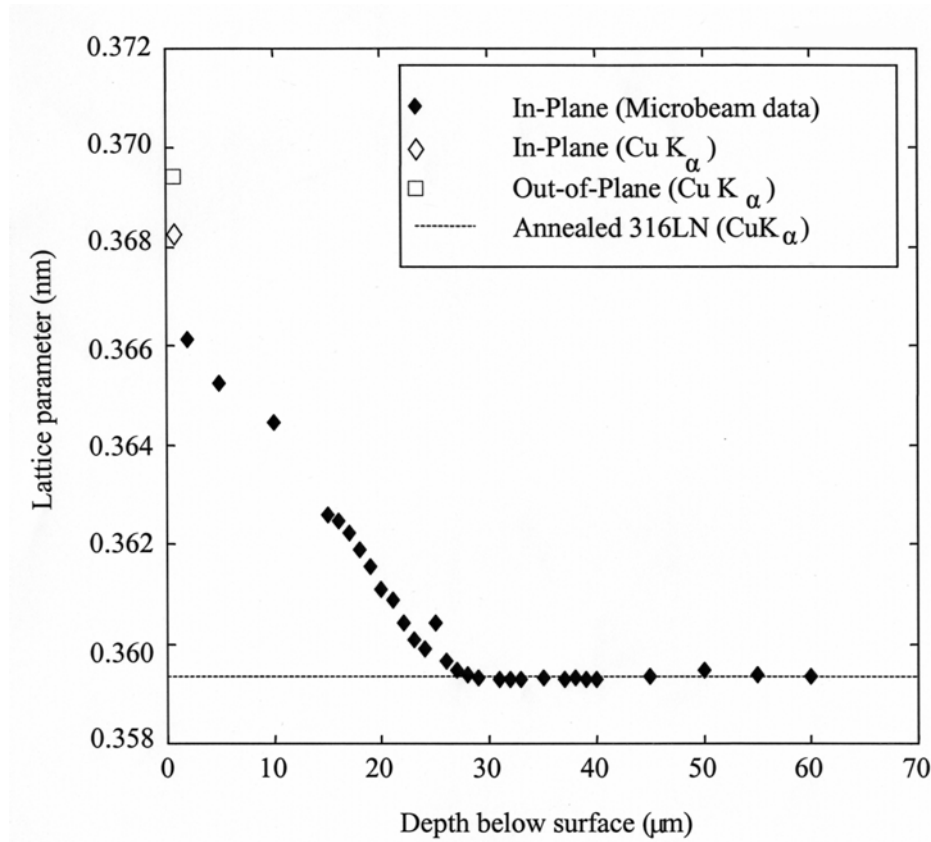
The depth dependence of the expanded lattice parameter of the austenite in the Kolsterised layer was explored by analysis of the energies of the reflected beams using a small X-ray beam spot in the Synchrotron Light Source at Argonne National Laboratory. To eliminate grain-to-grain variation the measurements were made on a single large grain that intercepted the surface. The results are presented in Fig. 13. They show that the expansion of the austenite lattice parameter is a maximum at the surface and progressively decreases with depth into the layer, reaching a value of 0.3595nm for the annealed substrate steel at a depth of about 30μm. The shape of this profile is similar to the hardness-depth profile in Fig. 5.

Fig. 13. Variation of the austenite lattice parameter with depth.

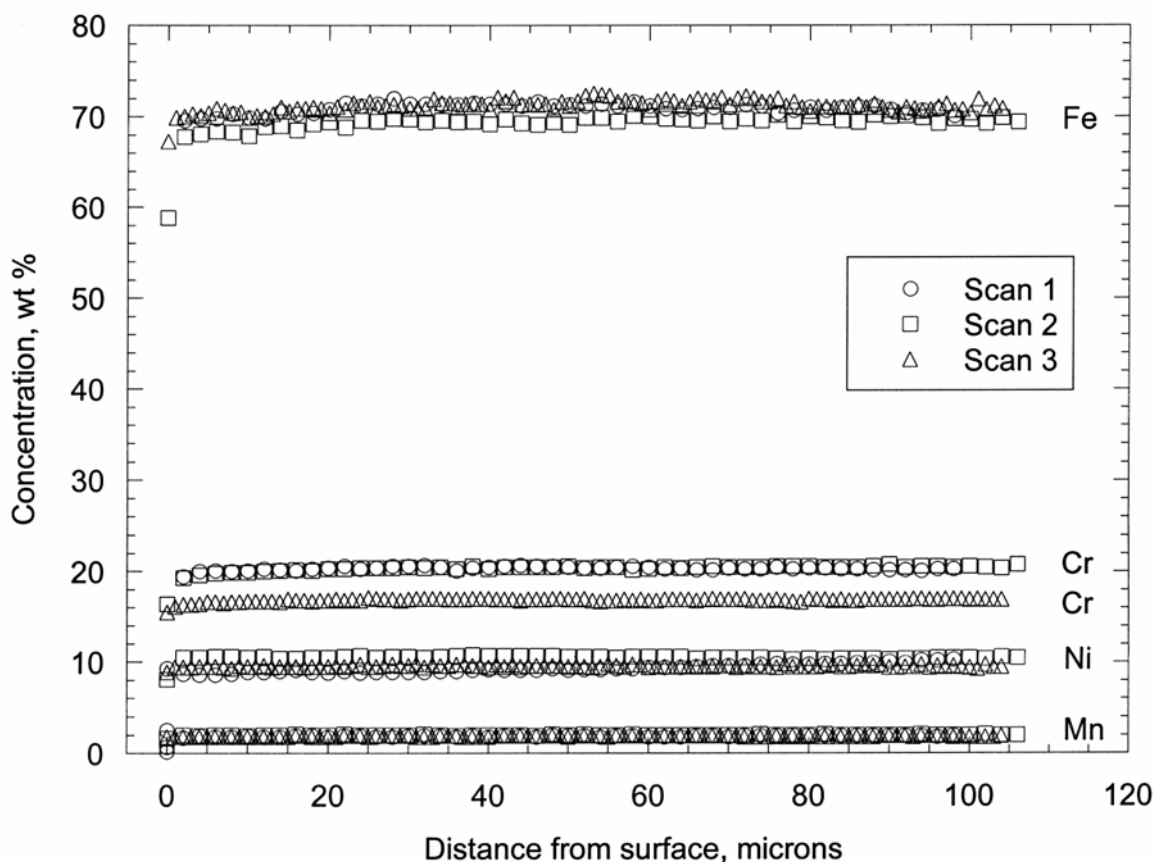
Chemical compositions as a function of depth were determined using an electron beam probe. This technique bombards the surface of the specimen with electrons and analyses the characteristic X-rays emitted by the surface atoms. The analyses were made on the polished cross section, each scan starting at the edge of the Kolsterised surface and traversing the layer into the substrate. Three scans were made at randomly selected locations. Composition profiles for the major metallic alloying elements of the steel are given in Fig. 14. It is evident that the relative concentrations of the original alloy elements in the steel did not change over most of the depth in the Kolsterised layer. However, at shallow depths of 0-2 $\mu\text{m}$  or so, all the elements show small reductions in concentrations of a few percent. These reductions are mostly recovered at depths of about 5 $\mu\text{m}$ , followed by asymptotic recovery to the base alloy compositions at depths of about 10 $\mu\text{m}$ . This recovery pattern is most obvious in the Fe data which has the highest concentration values. These small decreases in major alloy elements at shallow depths can be accounted for by the carbon concentration profiles presented in Fig. 15. The carbon

*Fig. 14. Electron microprobe analyses of major metallic elements through the thickness of the Kolsterised layer at three locations.*

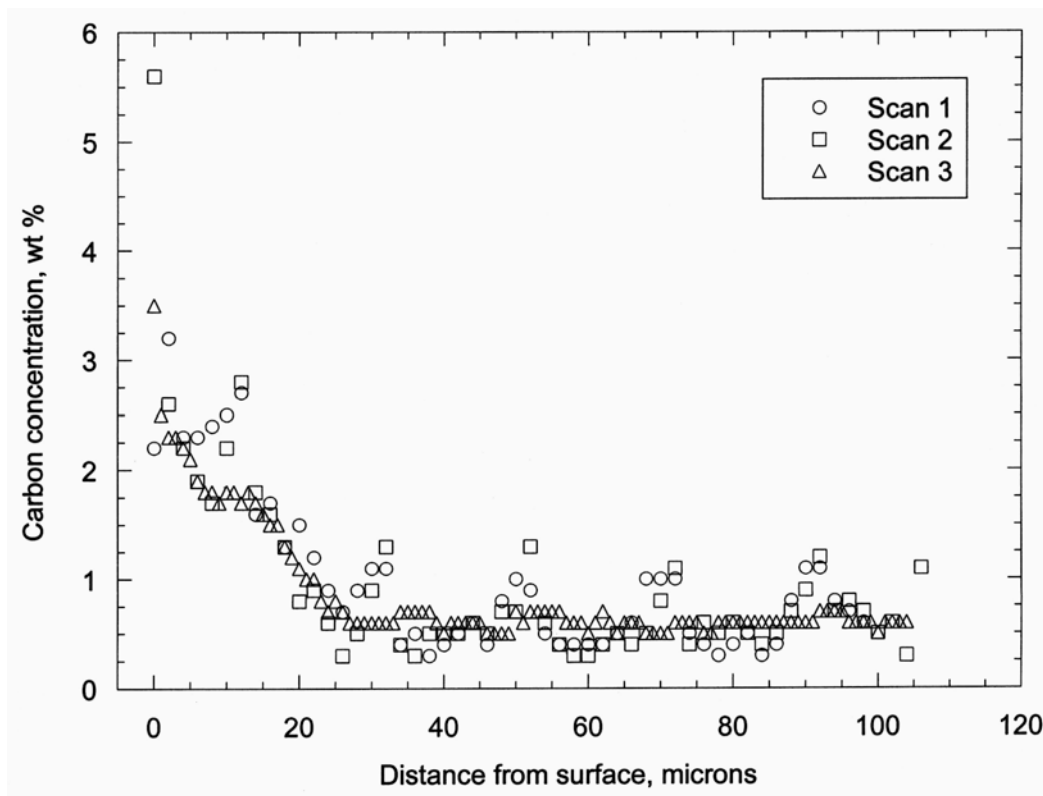
concentration of the base 316LN steel before Kolsterising<sup>®</sup> is 0.030wt%. The carbon depth profiles are confounded by carbon contamination at about 0.5wt% level from oils in the probe's

vacuum system, and by inexplicable ripples in the data. The ripples are smallest in scan 3 where it is clear that the carbon concentration is largest at the very surface and decreases with depth to the base value at 25-30 $\mu\text{m}$ . The maximum carbon level at the Kolsterised surface, less the contamination background, is about 5wt% for scan 2, which has the largest decreases in the major metallic alloying elements, and is 2.5-3wt% for scans 1 and 2. The overall shapes of the carbon profiles with depth are similar to those for the hardness-depth profiles and the austenite lattice parameter-depth profile. The large variation in carbon concentration for the scans in the near-surface regions can be attributed to random sampling of the mixture of expanded austenite and the discontinuously distributed  $\text{Fe}_5\text{C}_2$  phase by the electron beam. The austenite phase at the surface contains about 1.7%C according to section 3.9, and the carbide phase should have a stoichiometric carbon concentration of about 7.9wt%. The sample volume from which X-rays are

*Fig. 15. Electron microprobe analyses of carbon through the thickness of the Kolsterised layer at three locations.*

emitted under the electron beam is a cubic micrometer or more, which would undoubtedly encompass fractions of the carbide phase. Thus much of the 2.5-5wt%C found at the surface may derive from the  $\text{Fe}_5\text{C}_2$  located in the outer surface region.

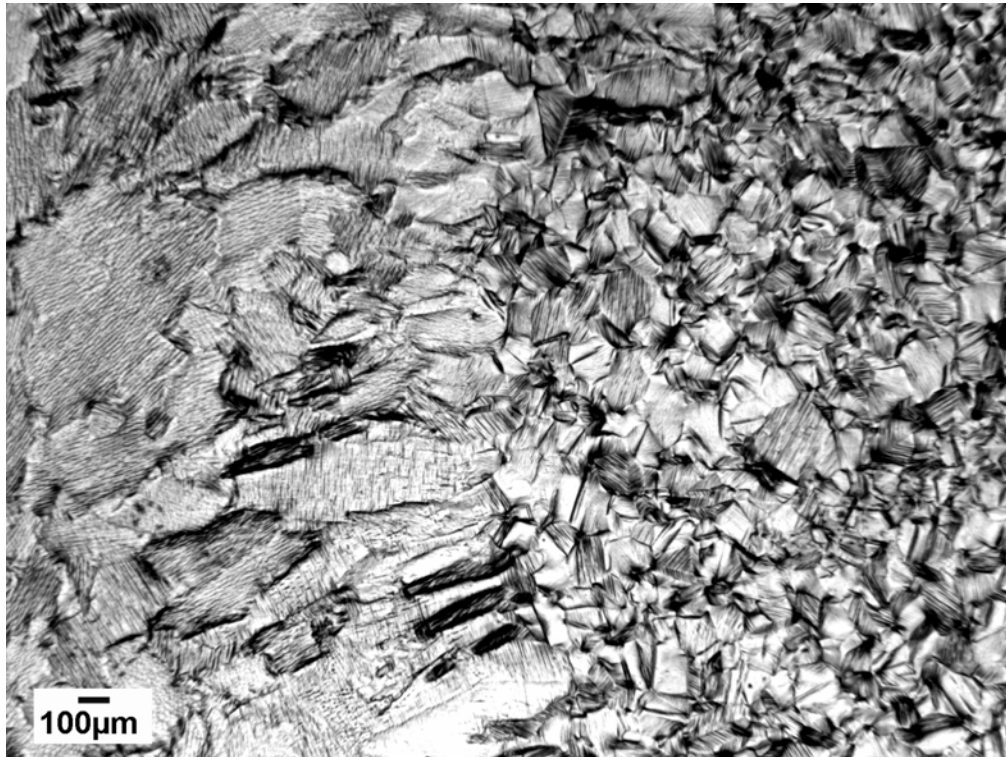
The surface of the TIG weld, which was ground and polished to a  $0.25\mu\text{m}$  finish before Kolsterising<sup>®</sup>, became distorted during Kolsterising<sup>®</sup>. Fig. 16 shows the fusion line

*Fig. 16. Distortion of originally polished surface of TIG weld H4.*

region with the large weld grains on the left and the smaller grains of the base metal on the right. Weld metal and base metal are both distorted.

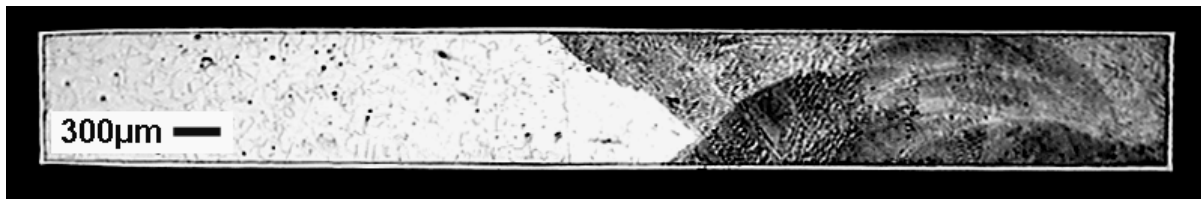
A portion of the Kolsterised weld was examined in cross section, Fig. 17. The microstructure of the weld was quite different from the bland equiaxed austenite grains of the base metal. The weld grains were lamellar and contained thin, elongated areas of a discontinuous phase. The

*Fig. 17. Polished and etched cross section through the Kolsterised weld.*

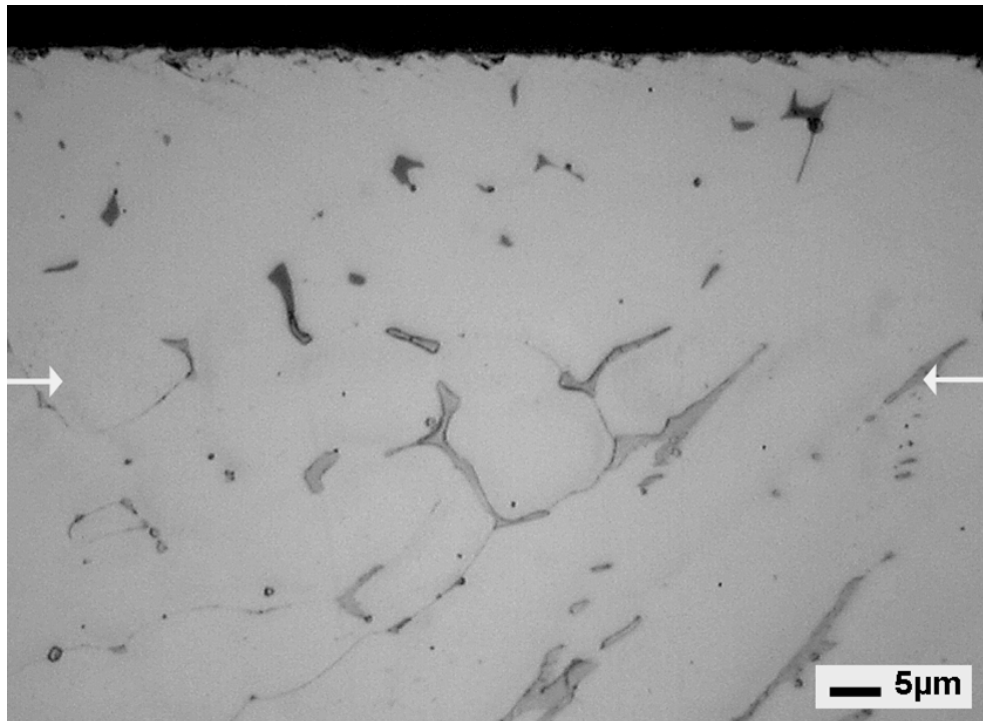
morphology and general appearance of the phase, Fig. 18, is characteristic of the delta ( $\delta$ ) ferrite phase usually found in fusion welds in austenitic steels [7,8]. The  $\delta$ -ferrite phase encompassed by the Kolsterised layer tended to be more prone to attack by the etchant than the  $\delta$ -ferrite phase in the substrate weld material. This observation agrees with Bodycote's advisory that Kolsterising<sup>®</sup> may not bestow corrosion resistance on the  $\delta$ -ferrite and duplex structures of austenite and  $\delta$ -ferrite may not deliver uniformity of properties in the Kolsterised layer. The thickness of the Kolsterised layer on the weld was uniform at about 37 $\mu\text{m}$ , versus about 40 $\mu\text{m}$  for the layer on the base metal. Large thickness variations like those seen in the unwelded C14 disk were not found.

*Fig. 18. Preferred etching of the  $\delta$ -ferrite phase in the Kolsterised portion of the weld.*

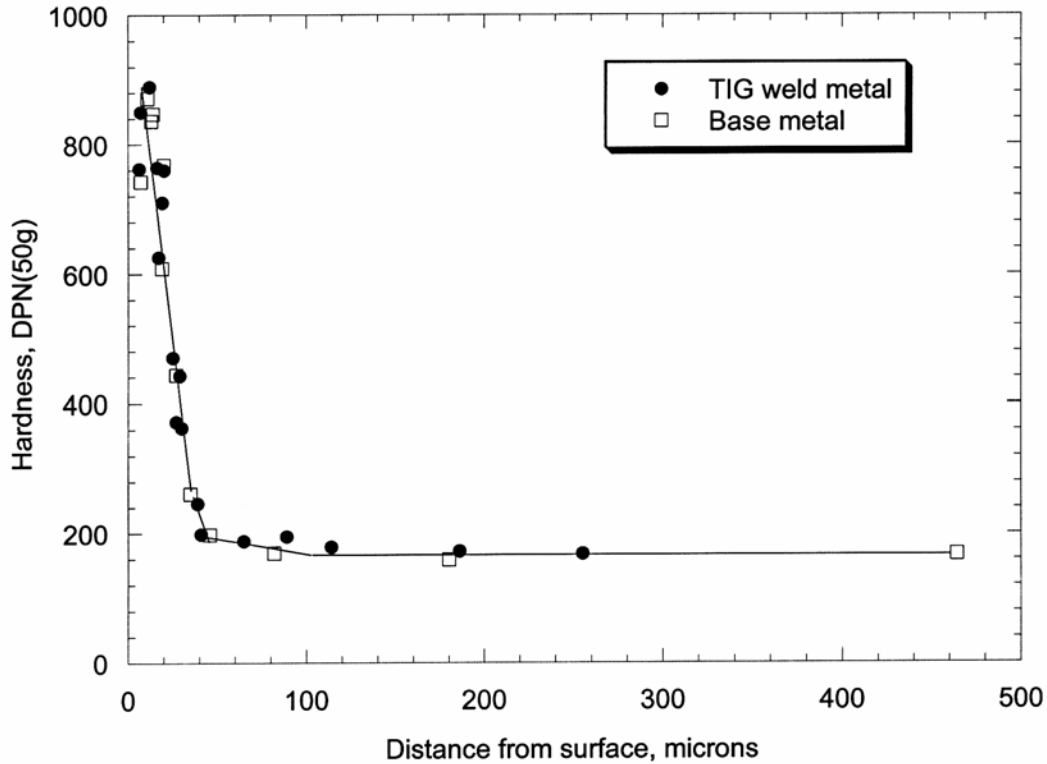
Results of hardness-depth profiles measured on the cross section piece of H4 across the thickness of the Kolsterised layer and into the substrate, one at the weld and the other on the base metal, are shown in Fig. 19. The two sets of data follow a single profile, of similar shape to the profile described earlier for specimen C14. One conclusion from the single curve presentation in Fig. 19 is that in spite of the presence of  $\delta$ -ferrite the weld has the same hardness as the base metal. This agrees with a report [7] that despite differences in crystal structure and chemical composition

*Fig. 19. Through-depth hardness profiles in welded specimen H4.*
