Characterization of Cassini GPHS Fueled Clad Production Girth Welds

Engineering Technology Division

**CHARACTERIZATION OF CASSINI GPHS FUELED CLAD
PRODUCTION GIRTH WELDS**

Date Published: March 2000

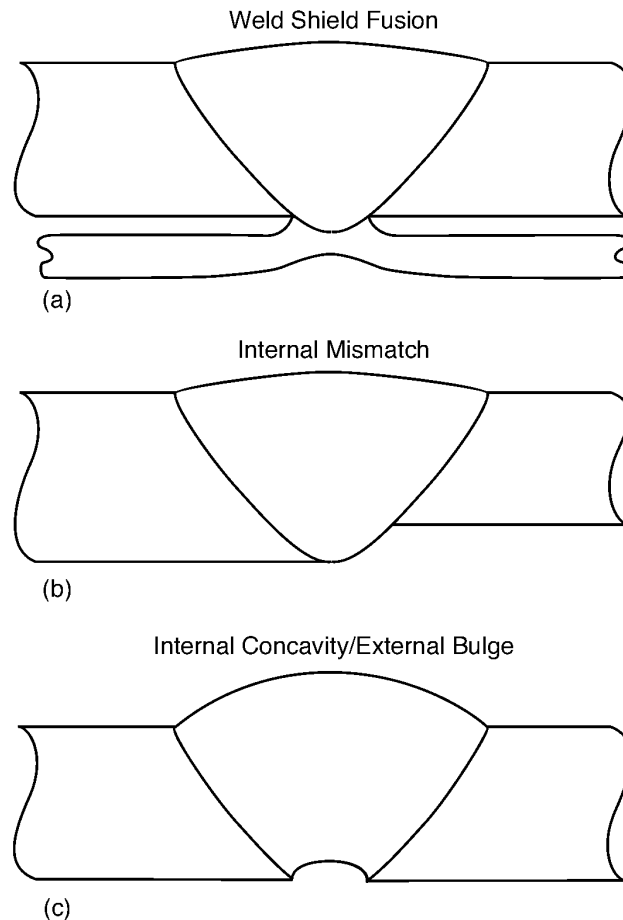
Fig. 6. Geometric weld anomalies.

Three conditions, which can be termed geometric weld anomalies, are capable of producing ultrasonic signals that are difficult to distinguish from those produced by the defects discussed above. These anomalies, shown schematically in Figs. 6(a)–(c), do not normally compromise the weld's integrity insofar as the minimum wall thickness requirement is met. However, the existence of these types of anomalies was responsible for a significant complication in the NDE of the Cassini girth welds.

The first of these anomalies, weld shield fusion, shown in Fig. 6(a), results when the molten metal on the root side of the weld puddle touches and fuses to the iridium foil weld shield. This condition, although normally intermittent, can extend for a significant portion of the capsule circumference. The ultrasonic signals returned by the corners that are formed by the intersection of the weld root and the shield are identical to those from a planar weld defect.

maximum/minimum tolerance stack-up is situated directly across the joint, a condition such as that shown in Fig. 6(b) can result. Once again, a corner that can produce a relatively large ultrasonic return is created.

The most commonly occurring nonrelevant condition was weld shield fusion, shown schematically in Fig. 6(a). The mechanism for the creation of weld shield fusions has been touched on previously. A more detailed analysis of the problem follows.

As Fig. 6(a) shows, the geometric reflectors produced by weld shield fusion are displaced from the weld centerline. By using a time-of-flight analysis on the reflected signal, it was possible to determine the distance of a reflector from the weld centerline. However, this technique was not developed with sufficient confidence to provide unequivocal identification of weld shield fusions in time for Cassini production inspection.

geometric reflector has a unique profile, as illustrated in Fig. 6(a)–(c), they are easily identifiable with high-resolution radiography.

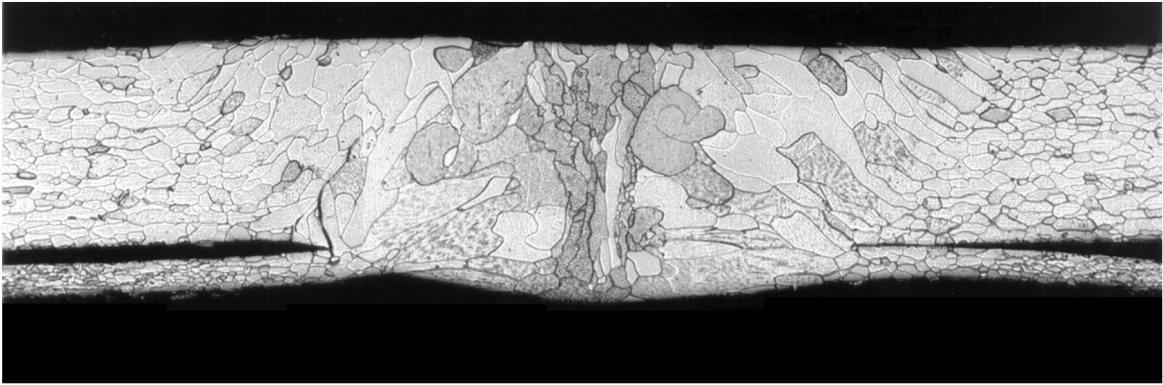
Fig. 21. Transverse cross section of a weld shield fusion (47×).

Because of the $\pm 8.1\%$ wall thickness variation in the cups mentioned earlier, it was necessary to develop a welding procedure that ensured slight overpenetration for the thickest portions of the cup walls. Thus, conditions were conducive to weld shield fusion, especially in instances of minimal radial gap and/or off-center pellet/shield positions. In fact, during the course of welding procedure and NDE development, weld shield fusion was found to be a common occurrence. It ranged in severity from a mild sticking-type adherence (like a diffusion bond) over a short distance to complete fusion, such as that shown in Fig. 21, which could extend for a significant distance. In contrast, the configuration of an unfused weld shield is shown in Fig. 22. The entire range of weld shield fusions produced definite ultrasonic signals, many of which were above the rejection level. The frequency of weld shield fusions verified that the weld shield performed its intended function of preventing contact of the weld root with the fuel pellet.

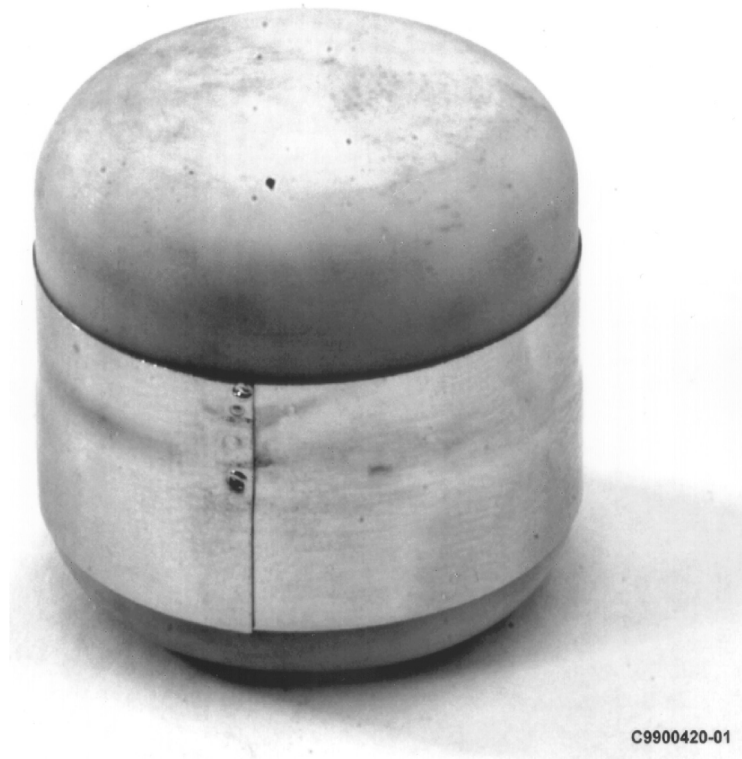
Fig. 23. Alumina simulant pellet with Type II shield laser welded tight around it.

A possible improvement to weld shield installation would be to wrap the Type II shield very tightly around the fuel pellet and keep it that way. This would maximize the spacing of the shield away from the weld root. An example of an approach to this is shown in Fig. 23 in which a Type II weld shield has been laser welded tightly around a simulant fuel pellet.
