Methodologies for Evaluation of Corrosion Protection for Ductile Iron Pipe

June 12, 2019

Materials Science and Technology Division

Prepared by
OAK RIDGE NATIONAL LABORATORY
Oak Ridge, TN 37831-6283
managed by
UT-BATTELLE, LLC
for the
US DEPARTMENT OF ENERGY
under contract DE-AC05-00OR22725

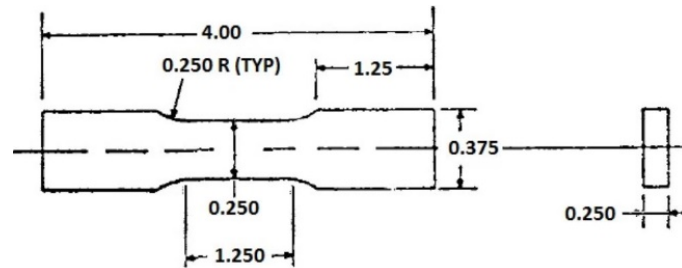
Figure 2.3. Dimensions of dog-bone test specimen.

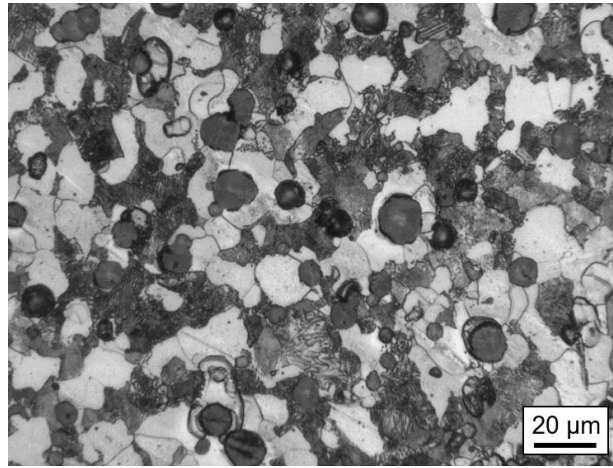
**Figure 2.5. Light microscopy image of 2% Nital etched DIP (Manufacturer A) sample.**

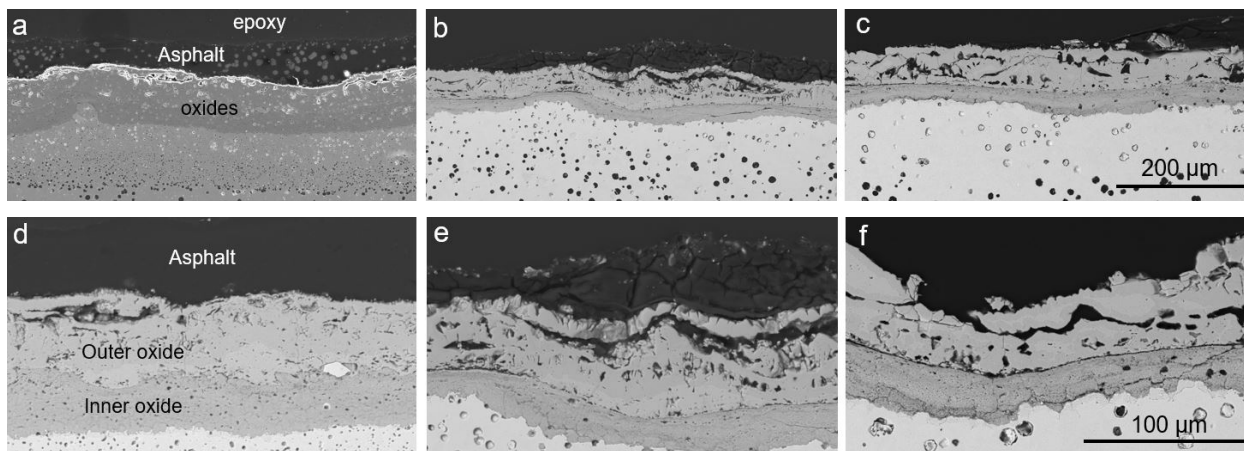
Figure 2.6. SEM images of cross-sectioned DIP in as-received condition from DIP manufacturers (a,d) C, (b,e) A and (c,f) B. Image (a) is a secondary electron (SE) image, while (b–f) are back-scattered electron (BSE) images.

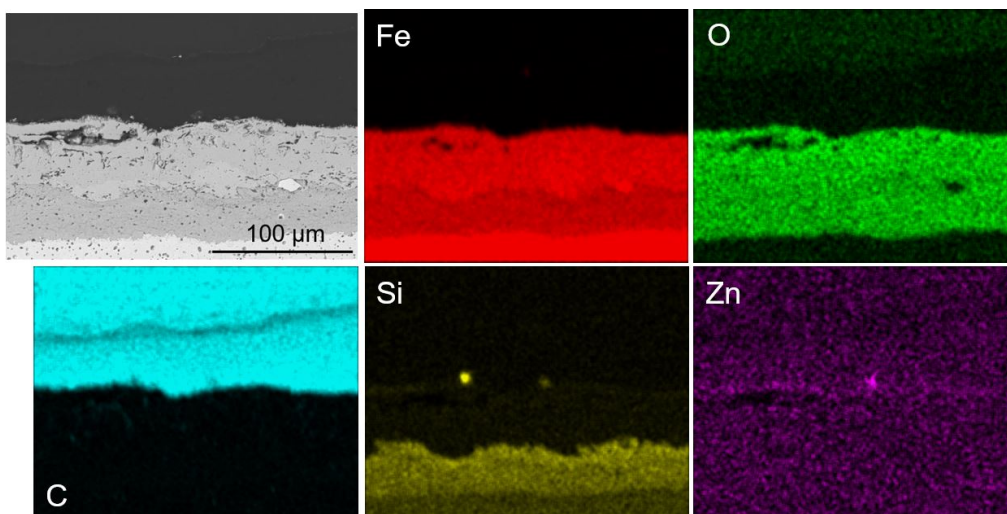
Figure 2.8. SEM/EDS elemental mapping on cross-sectioned DIP (Manufacturer C) in the as-received condition. Upper left is the SE image along with five maps from that region.

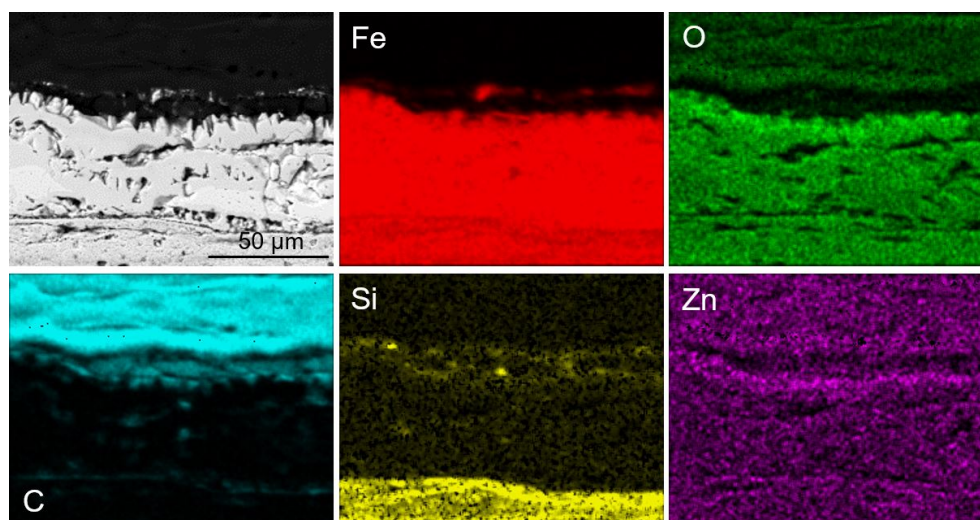
Figure 2.9. SEM/EDS elemental mapping on cross-sectioned DIP (Manufacturer A) in the as-received condition. Upper left is the SE image along with five maps from that region.

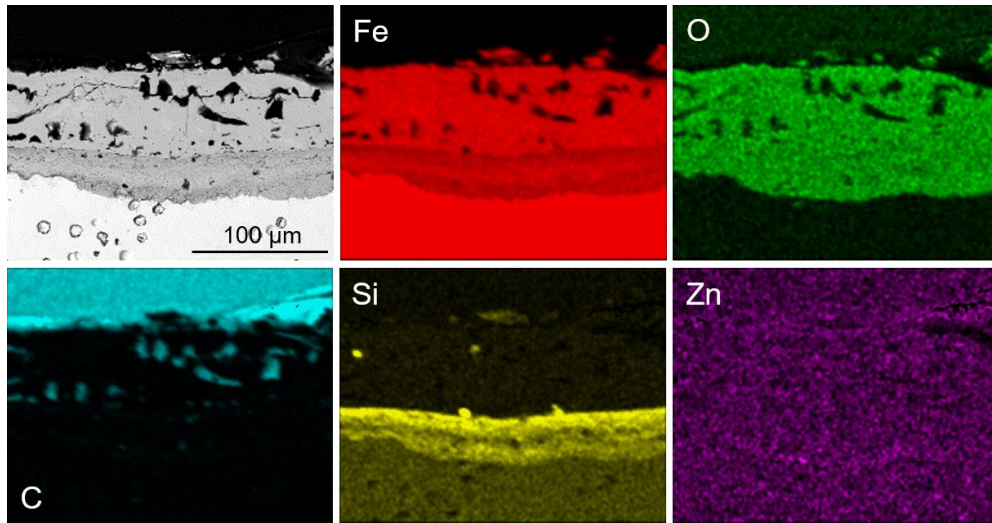
Figure 2.10. SEM/EDS elemental mapping on cross-sectioned DIP (Manufacturer B) in the as-received condition. Upper left is the SE image along with five maps from that region.

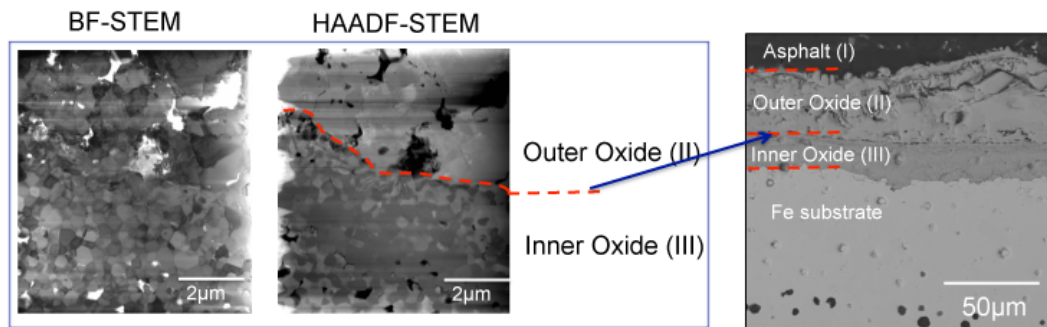
Figure 2.12. BF and HAADF S/TEM images (left and middle) of inner/outer oxide interface in as-received DIP (Manufacturer A). The boundary of two oxides is outlined by red broken line in the HAADF image, and both S/TEM images were taken from the location pointed in SEM-BSE image (right).

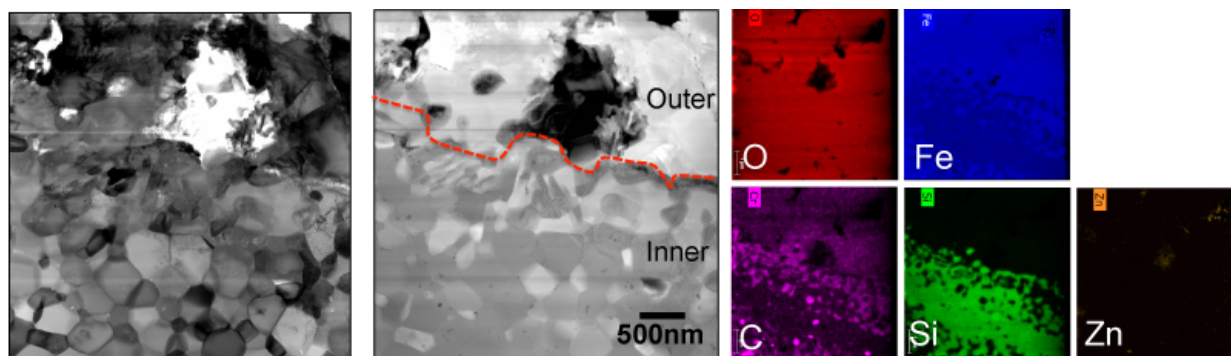
Figure 2.13. BF and HAADF S/TEM images at the same location shown in Figure 2.12 (left and middle), TEM-based EDS mapping for O, Fe, C, Si, and Zn (right).

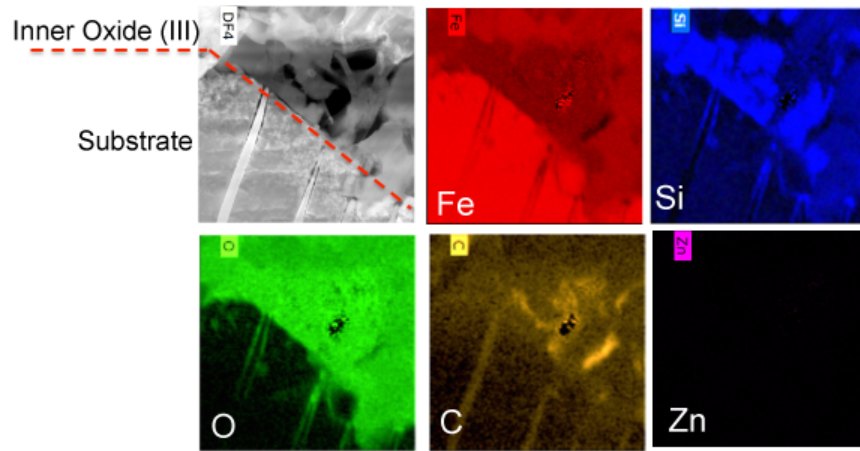
Figure 2.14. HAADF S/TEM image and TEM-based EDS mapping of inner oxide/substrate interface in as-received DIP (Manufacturer A). The interface is outlined by a broken red line in the HAADF image.

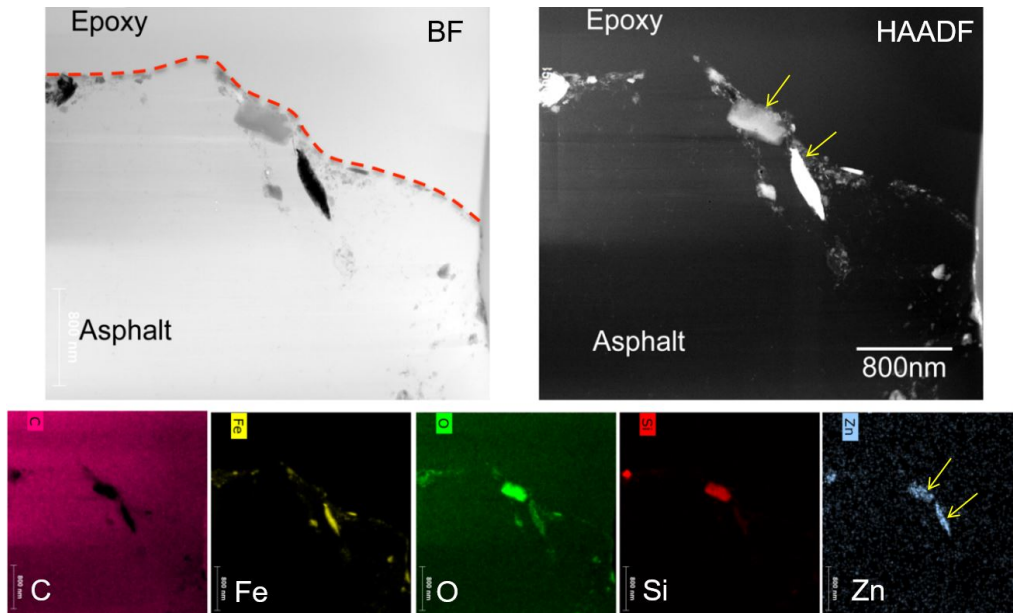
Figure 2.15. BF and HAADF S/TEM images of asphalt layer (top) and TEM-based EDS mapping for C, Fe, O, Si, and Zn (bottom) in as-received DIP (Manufacturer A).

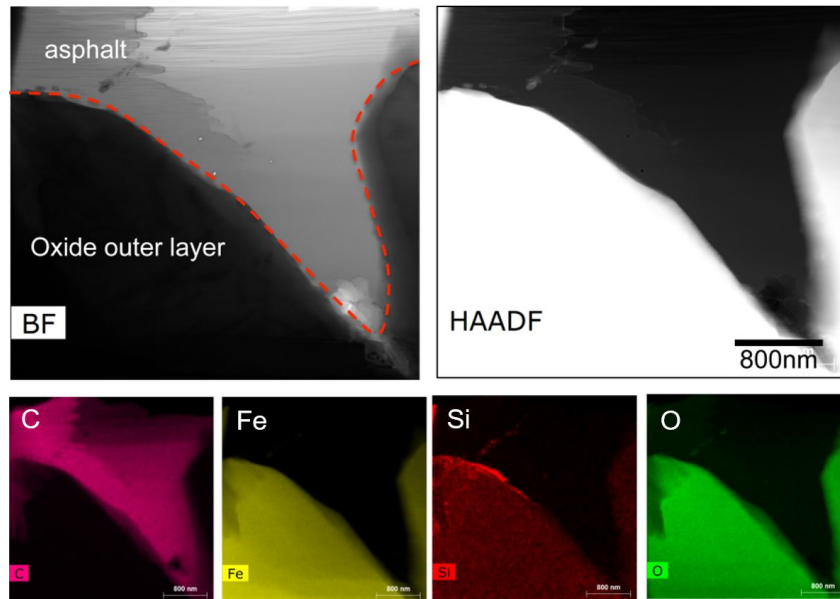
Figure 2.16. BF and HAADF S/TEM images of asphalt/outer oxide interface (top) and TEM-based EDS mapping for C, Fe, Si and O (bottom) in as-received DIP (Manufacturer A).

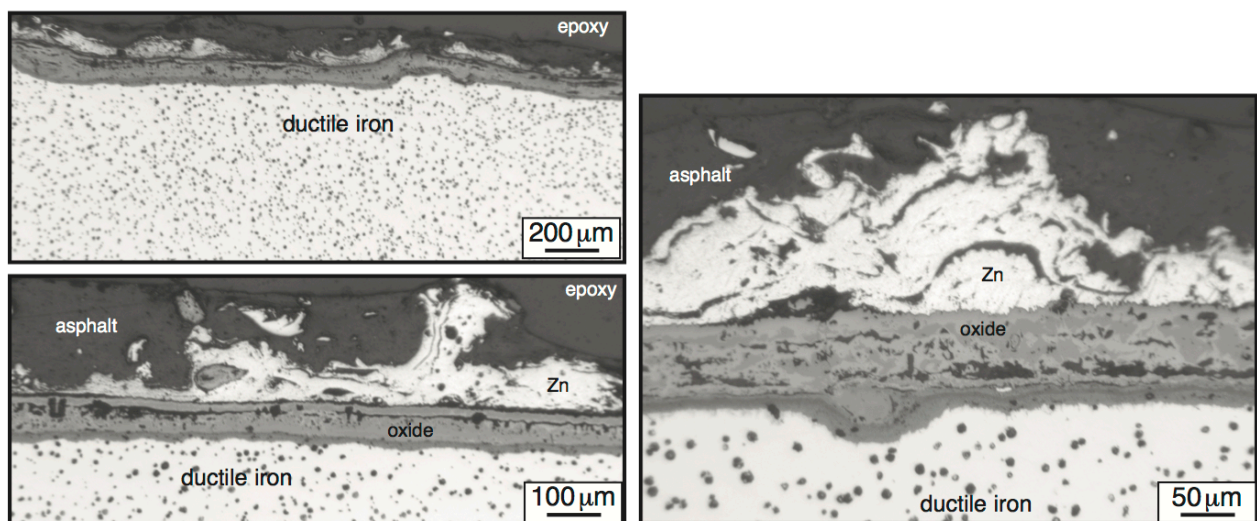
Figure 2.17. Light microscopy of a zinc-coated specimen from a domestic DIP manufacturer. Three different locations are shown from one pipe at different magnifications.

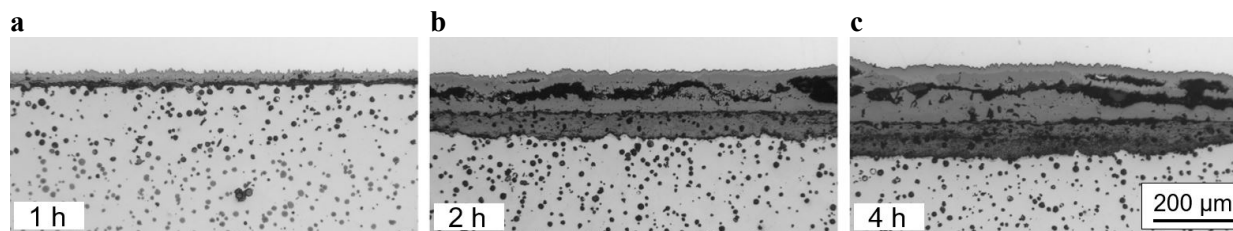
Figure 2.19. Light microscopy images of laboratory-fabricated oxide on DIP (substrate from Manufacturer A) after ambient oxidation at 950°C for (a) 1 h, (b) 2 h, and (c) 4 h.

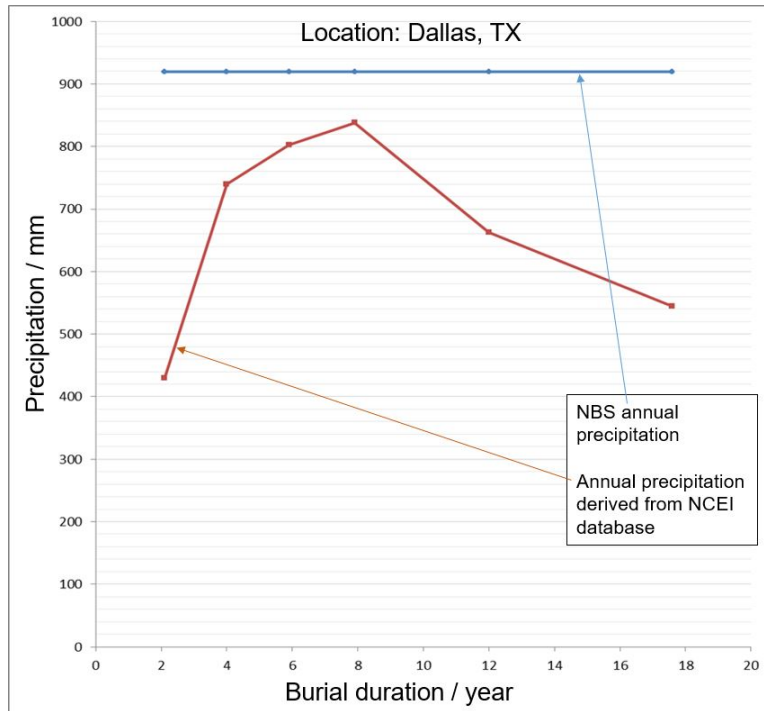
Figure 3.3. Comparison of annual precipitation at Dallas, TX: the average value of NBS study and the derived values from NCEI weather data.

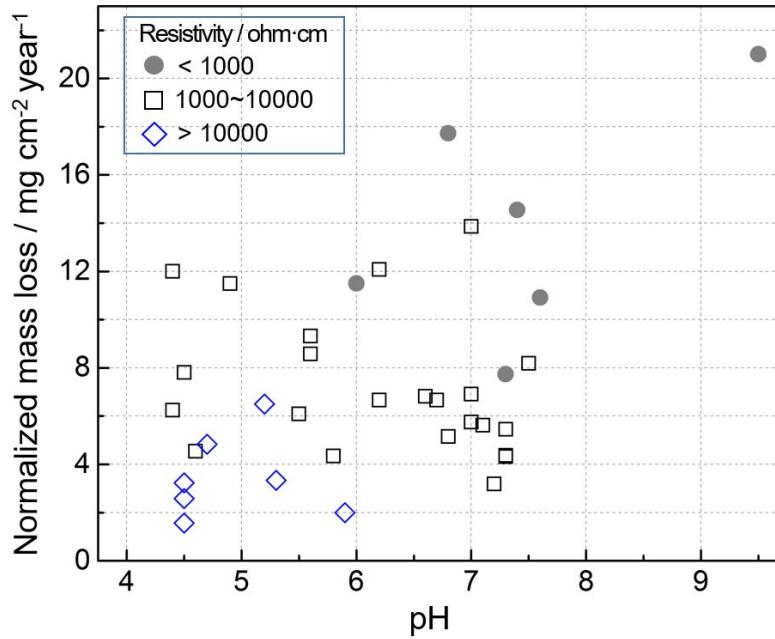
Figure 3.5. Normalized mass loss vs. soil pH plot from 36 data selected from the NBS corrosion dataset. The normalized mass loss values presented here are the average of maximum and minimum mass loss data divided by the test duration (10 to 33 years) and also marked with three symbols for different soil resistivities.

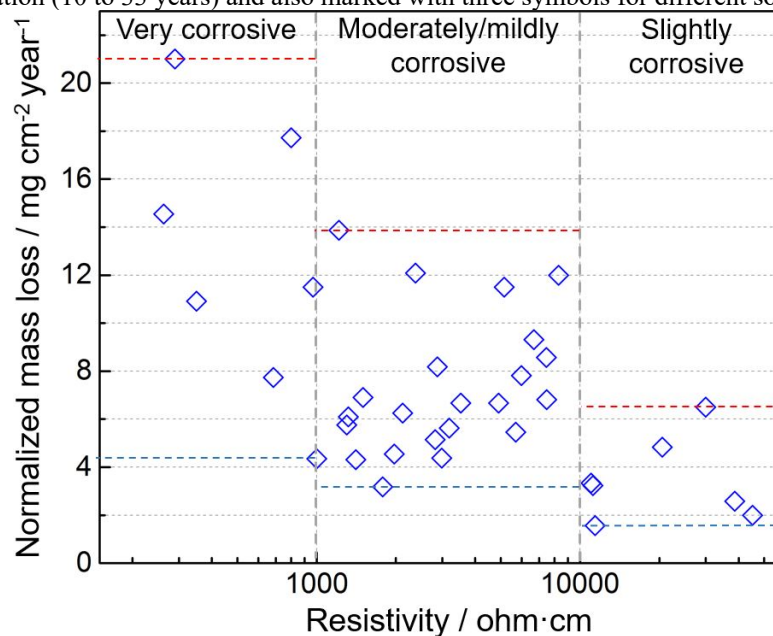
Figure 3.6. Normalized mass loss vs. soil resistivity plot from 36 data selected from the NBS corrosion dataset.

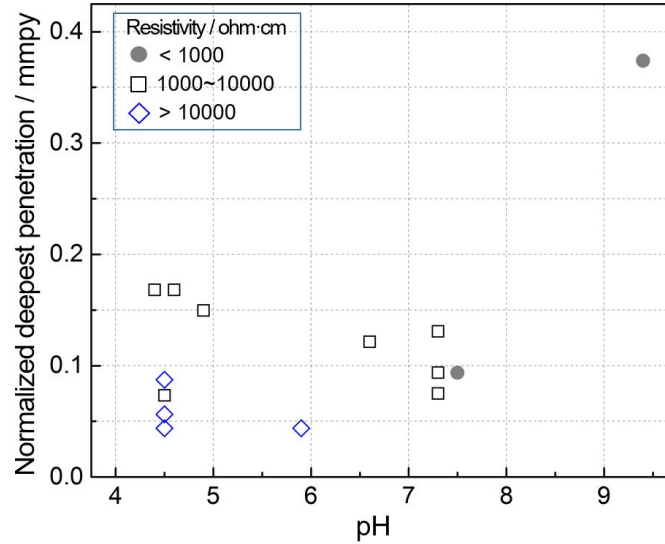
Figure 3.7. Normalized deepest penetration vs. soil pH plot from 14 data selected from the NBS corrosion dataset. The normalized penetration values presented here are the average of maximum and minimum penetration data divided by the test duration (10.7 to 16 years) and also marked with three symbols for different soil resistivities.

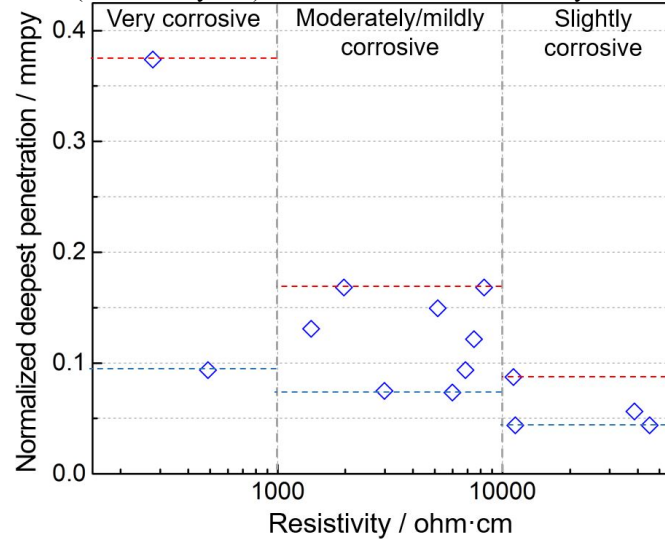
Figure 3.8. Normalized deepest penetration vs. soil resistivity plot from 14 data selected from the NBS corrosion dataset. Three corrosivity levels were determined by the USBR technical memorandum based on soil resistivity, and the normalized penetration data are the same as the data presented in Figure 3.7.

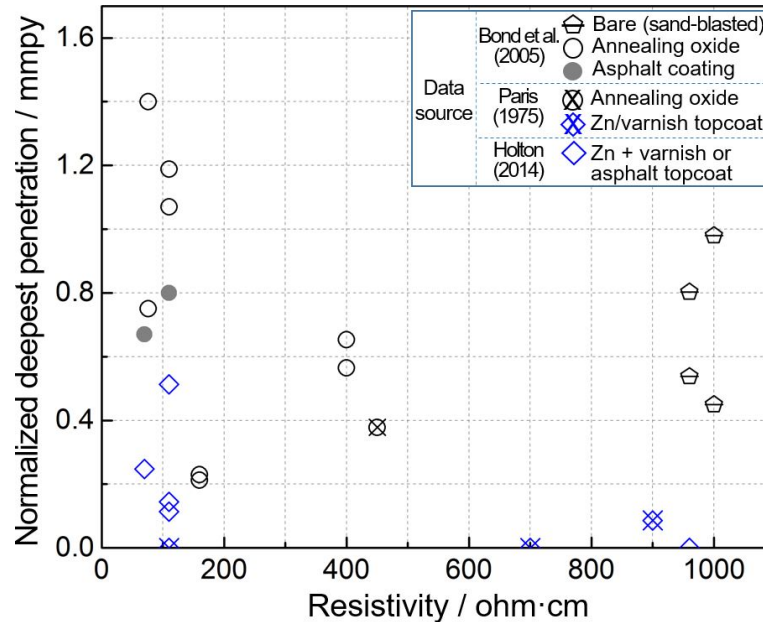
Figure 3.9. Normalized penetration of iron pipes (ductile and cast) measured for different surface conditions. The deepest penetration data collected from three sources (Bonds 2005, Paris 1975, Horton 2014) are normalized by the test duration (8 to 25 years), and the thickness of varnish or asphalt was >1 mm.

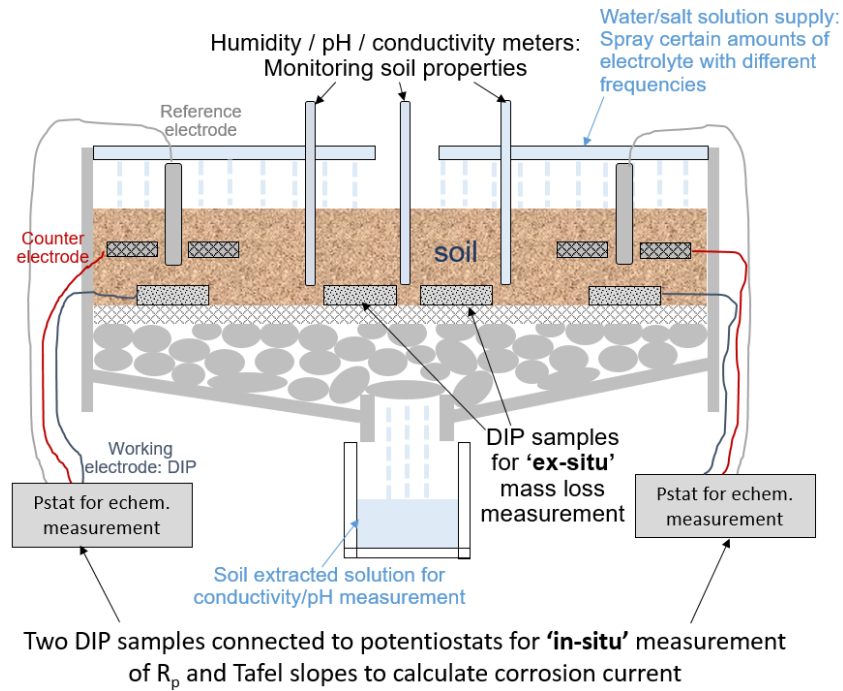
Figure 4.3. Suggested design of a soil corrosion testing frame.

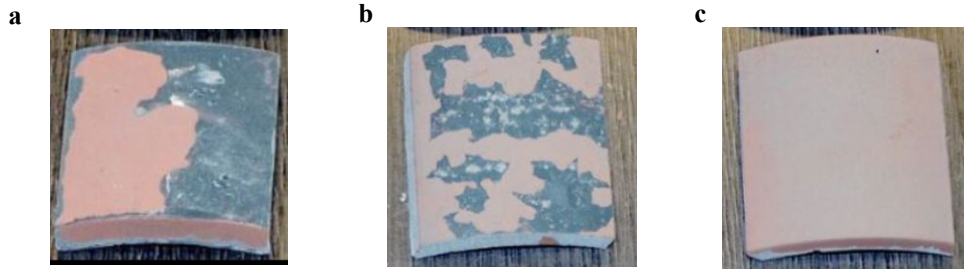
Figure 5.1. Appearance of laboratory-oxidized DIP samples: (a, b) partial spallation of black scale with reddish oxide surface underneath and (c) full spallation of black scale exposing reddish oxide surface. The specimens shown are 4–5 cm in width and length.

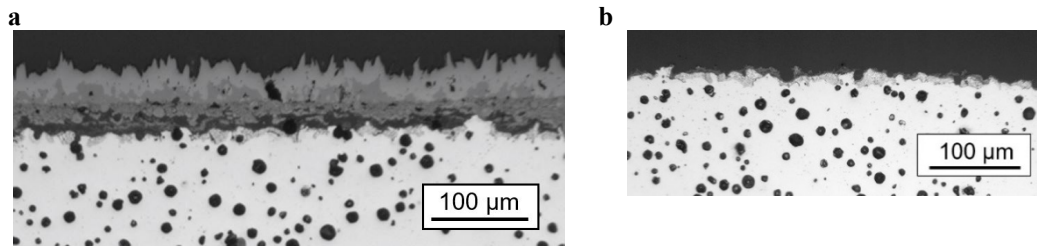
Figure 5.2. Light microscopy cross-section images of oxidized DIP samples (a) without oxide spallation and (b) with oxide spallation.

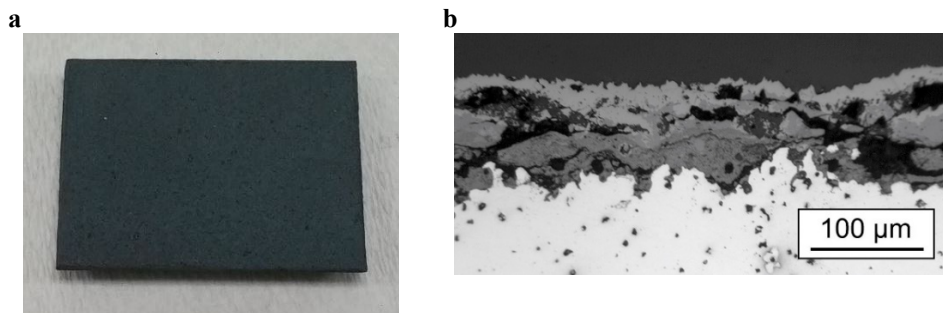
Figure 5.3. Laboratory-oxidized DIP with sandblast: (a) appearance of dark-gray oxide on a DIP sample measuring approximately $3.5 \times 4.5 \text{ cm}^2$ and (b) cross-section light microscopy image of oxide layer formed on a sandblasted surface.

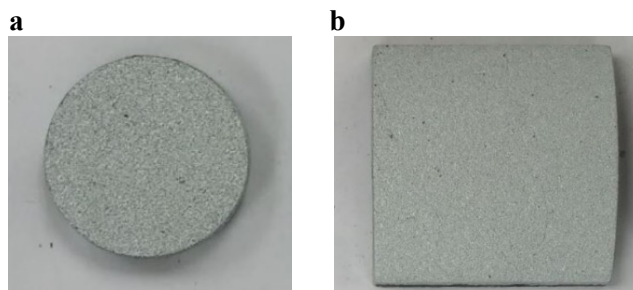
Figure 5.4. Zn coating formed by thermal spray on laboratory-oxidized DIP (substrate from Manufacturer C): (a) circular coupon (1" diameter), (b) DIP sample with each side measuring $\sim 4.5\ \text{cm}$.

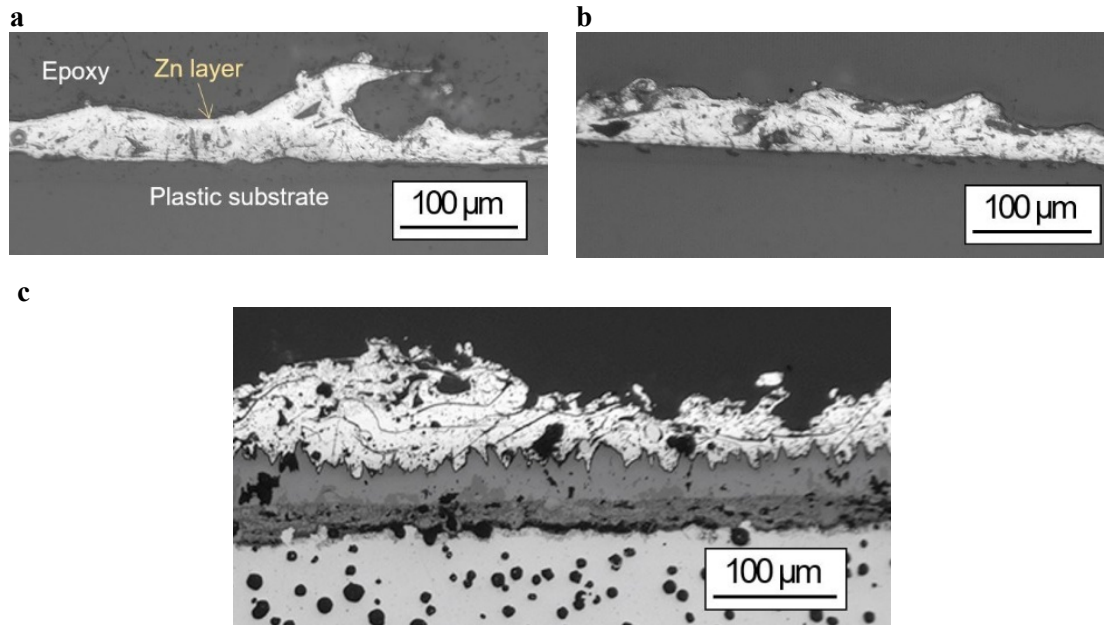
Figure 5.7. Cross-section light microscopy images of Zn coating formed by (a,b) a manufacturer and (c) this work.

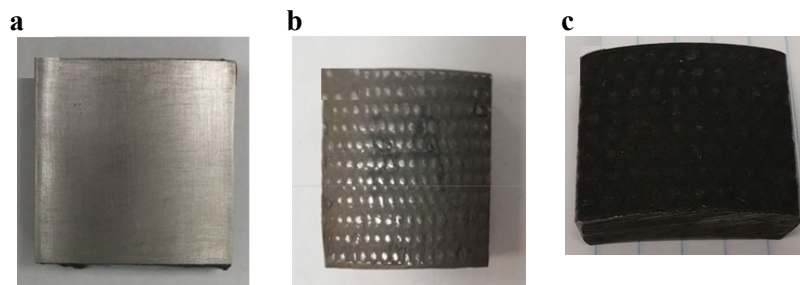
Figure 5.8. Images of DIP samples with each side 3.5–5 cm long: (a) bare surface, (b) manufacturer oxide, and (c) asphalt topcoat.

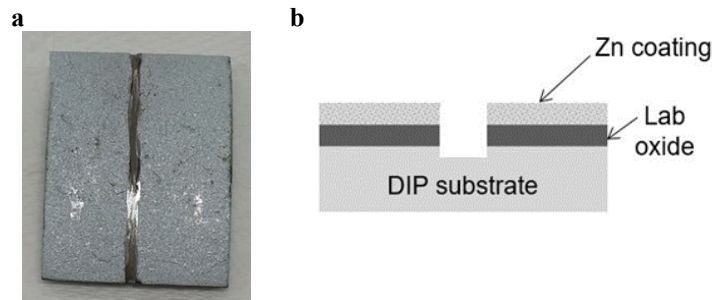
**Figure 5.9. Zinc-coated DIP with a linear scribe (~5 mm wide) exposing DI substrate: (a) appearance of a sample with sides 3.5 and 5.5 cm long and (b) schematic of scribe cross section.**

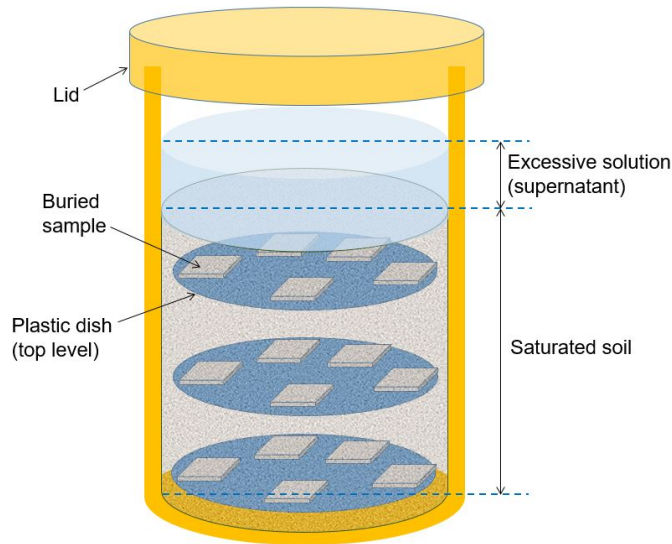
Figure 5.12. Schematic of DIP samples buried in a saturated soil mixture. The bin capacity is $\sim 18,930 \text{ cm}^3$ (5 gal).

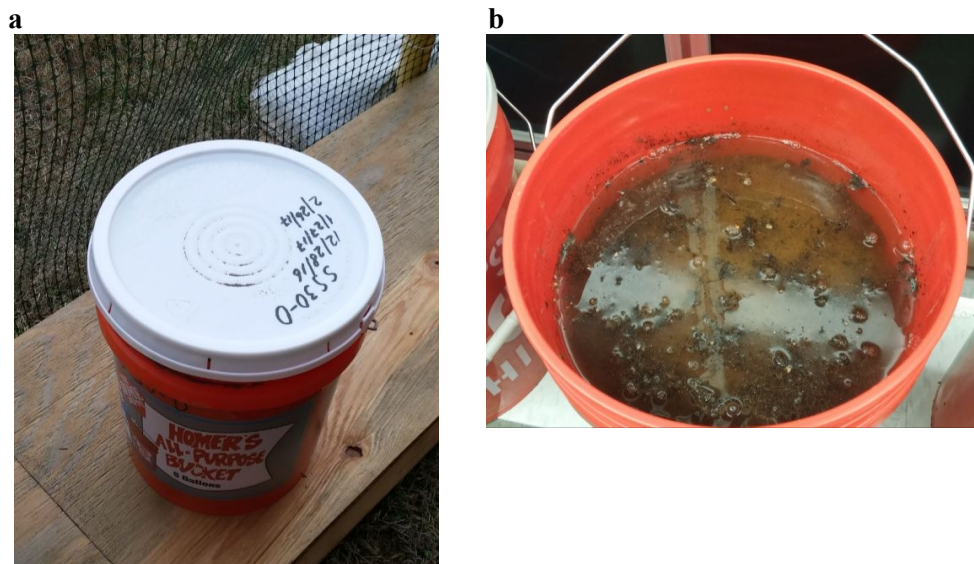
Figure 5.13. Accelerated corrosion testing in saturated soil: (a) soil bucket placed outdoors and (b) saturated soil with excessive solution layer.

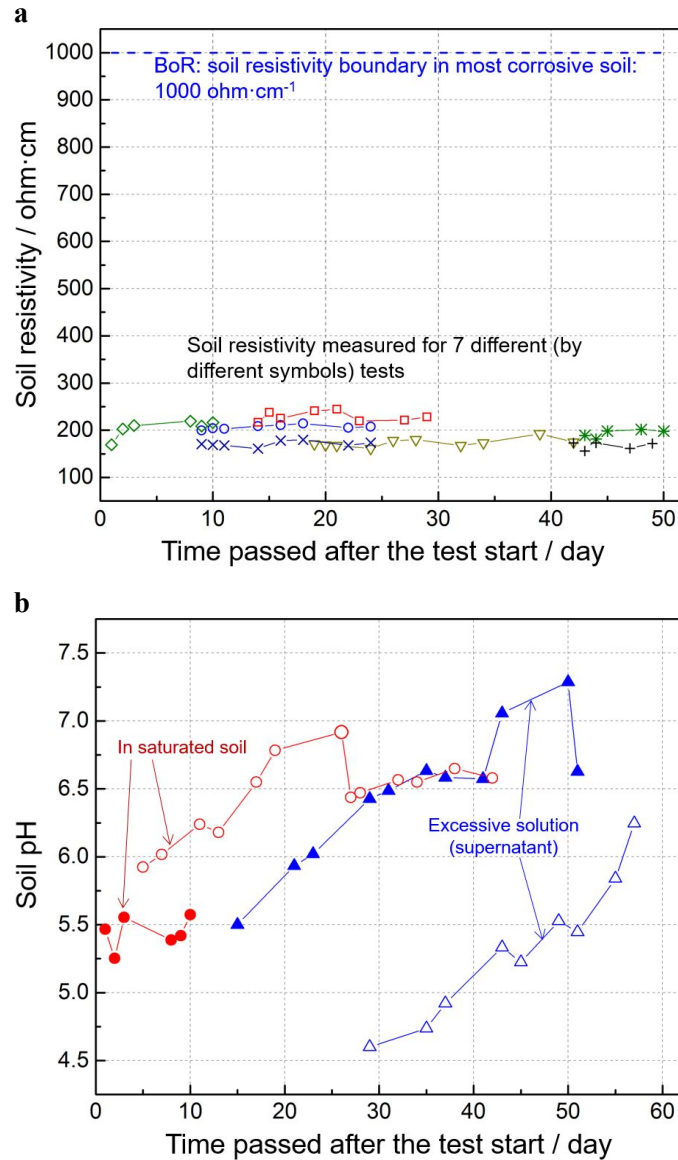
Figure 5.14. Monitoring of measured (a) resistivity and (b) pH in saturated soil and excessive solution with increasing testing time.

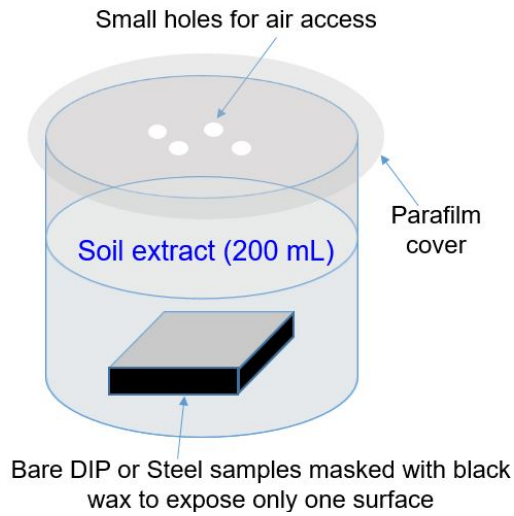
Figure 5.15. Schematic of immersion test for DIP and steel samples; the samples were immersed for 30 days.

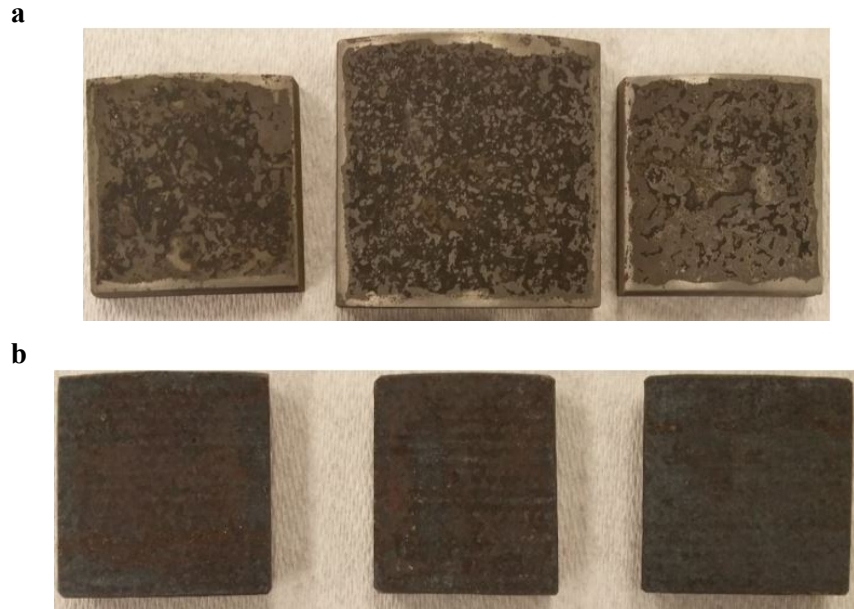
Figure 5.16. DIP samples after non-acid cleaning: (a) bare and (b) asphalt-coated; the sides of DIP samples are 3.5 to 5 cm long.

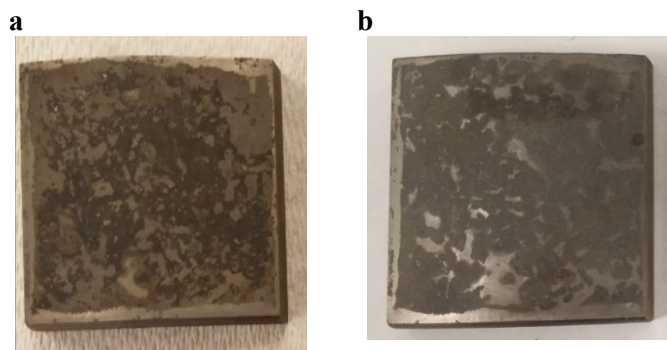
Figure 5.17. Manufacturer A DIP samples (pre-test condition: bare) cleaned by (a) non-acid cleaning and (b) non-acid + acid cleaning. The sides of DIP samples are ~4.8 cm long. The mass loss resulting from the removal of the pre-existing surface layers was corrected by different methods, which are summarized in Table 5.6.

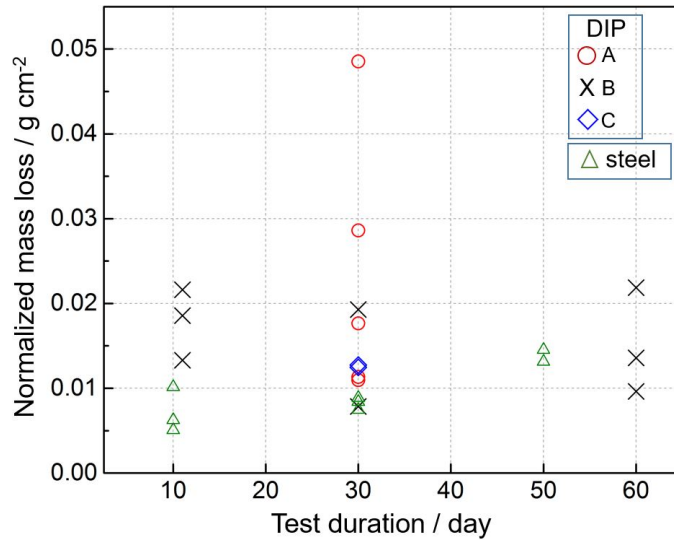
Figure 5.18. Normalized mass loss of bare DIP and steel samples with increasing test duration.

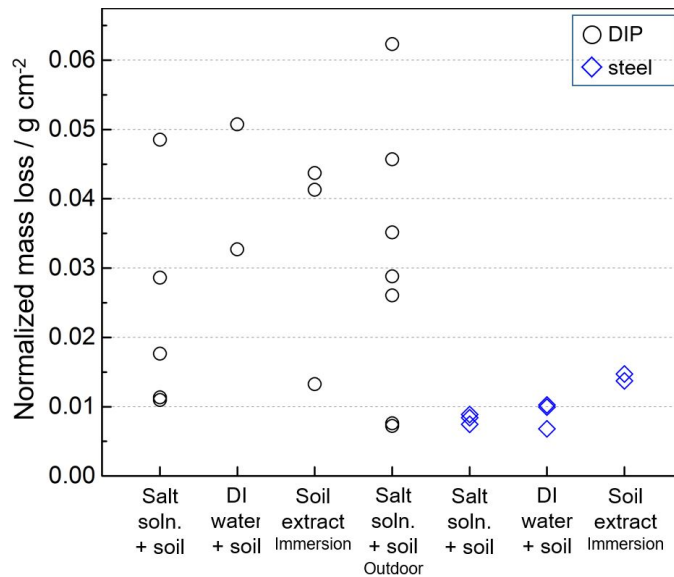
Figure 5.19. Normalized mass loss of bare DIP and steel samples after 30 day tests in different conditions.

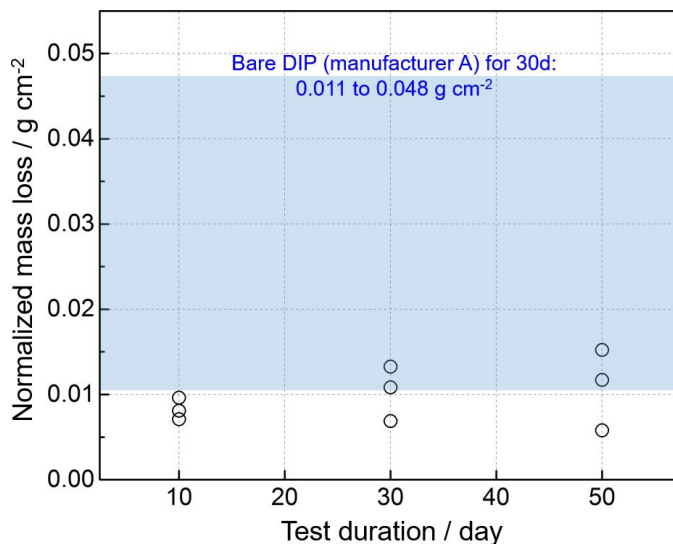
Figure 5.20. Normalized mass loss of Manufacturer A DIP with manufacturer (annealing) oxide. Shaded region indicates the distribution of mass loss measured in bare DIP.

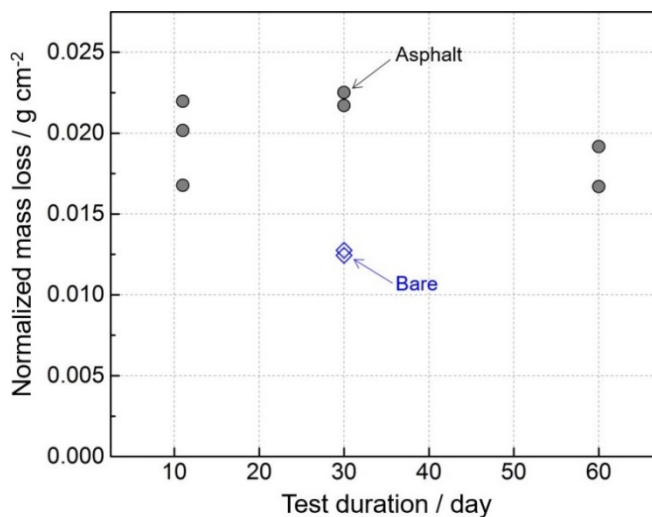
Figure 5.21. Normalized mass loss of DIP (Manufacturer C) in bare and as-manufactured (asphalt + oxide) conditions.

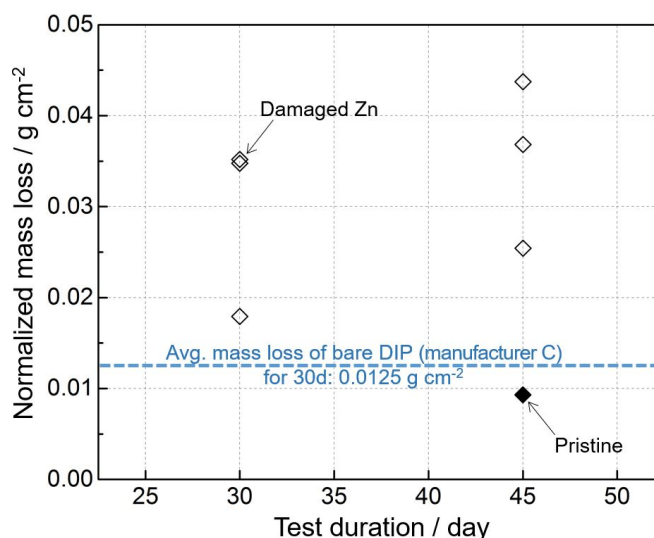
Figure 5.22. Normalized mass loss of DIP with pristine and damaged Zn coatings. The thick broken line indicates the average mass loss measured from bare DIP. *DIP with simulated FBE coating and polyethylene encasement*

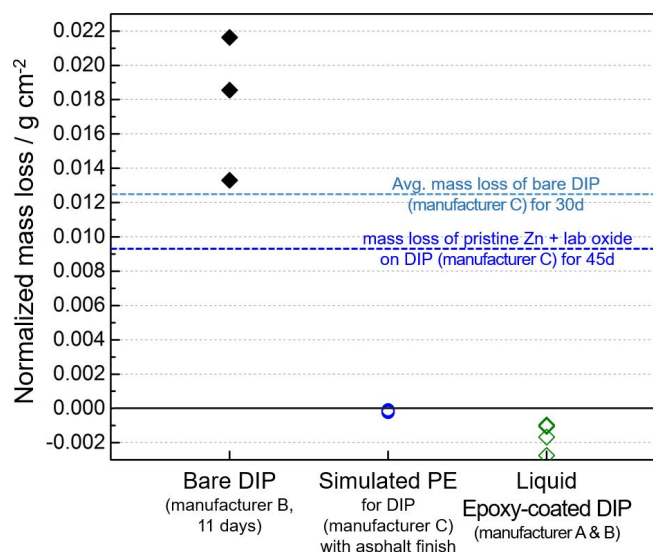
Figure 5.23. Normalized mass loss of DIP protected by simulated polyethylene encasement (PE) and liquid epoxy coating after the 10 day test. Mass losses of DIP in bare and pristine Zn-coating conditions are also plotted/designated for comparison.

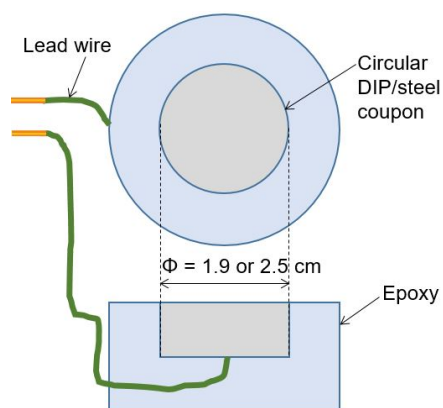
Figure 5.24. Schematic of epoxy-mounted ductile iron/steel electrode.

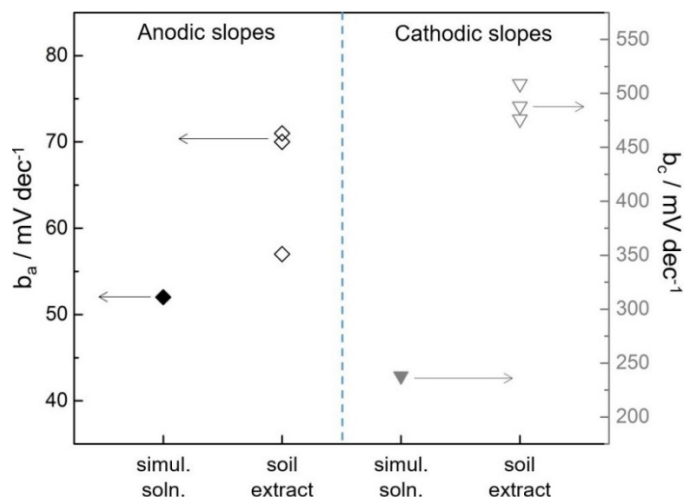
Figure 5.31. Anodic and cathodic slopes of DI in soil-simulating solution and soil extract. The full polarization curves for Tafel analysis were collected without initial cathodic polarization, and the scan range was 200 mV below/above OCP. Software-assisted Tafel analysis also provided estimated corrosion currents, which are compared for different conditions in Figure 5.32. In soil-simulating solution, DI exhibited a lower corrosion rate than steel. The corrosion rate of DI was higher in soil extract than in soil-simulating solutions. This was unexpected because soil-simulating solution had a higher ionic concentration and conductivity as shown in Table 5.7. This may suggest a saturation in the corrosion rate, where the increasing ionic concentration and conductivity no longer contribute to corrosion kinetics. Instead, other organic and inorganic species that were not detected in the soil extract may have influenced the higher DI corrosion current. Further investigation is needed to specify the aqueous species in soil extract that may be causing a higher corrosion rate.

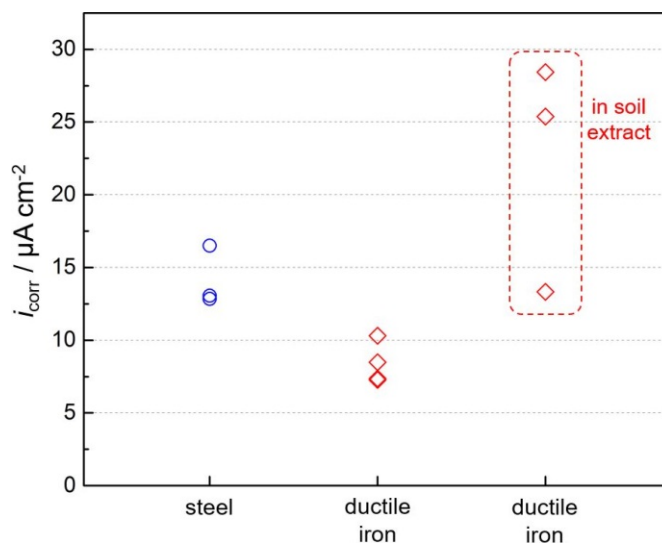
Figure 5.32. Corrosion currents of DIP and steel estimated by Tafel analysis in soil-simulating solution and soil extract. The data in the broken box are corrosion currents of DI in soil extract. Polarization resistances of DIP and steel were also estimated by EC-Lab software for the full polarization curves used for Tafel analysis. An example software-assisted estimation of polarization resistance is shown in Figure 5.33. Polarization resistance (R_p) and corrosion current (I_{corr}) are inversely proportional and correlated by the equation:

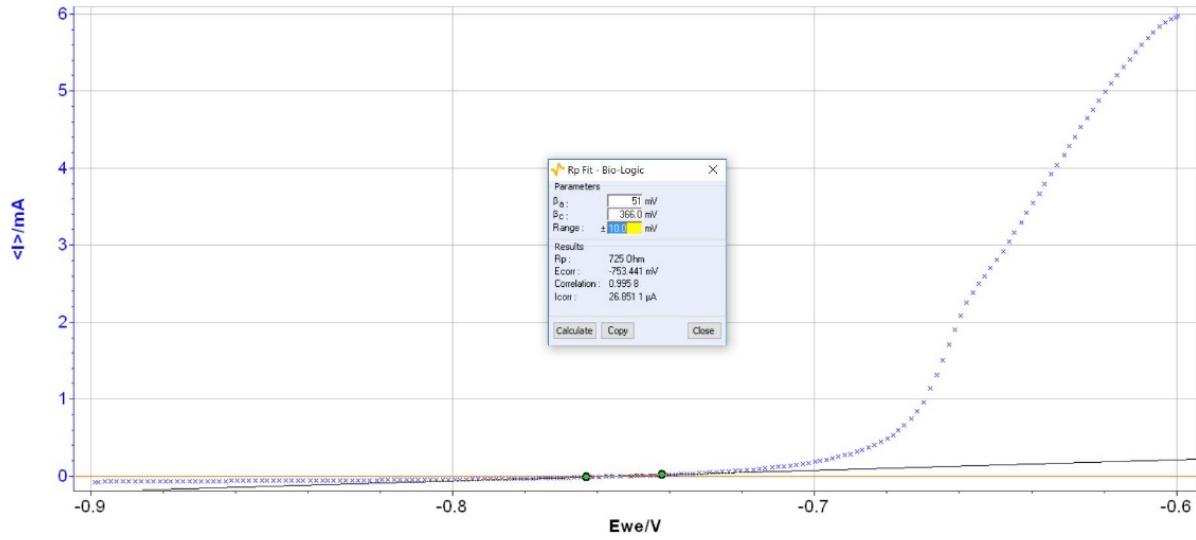
Figure 5.33. A snapshot of software-assisted estimation of polarization resistance in a full polarization curve of DI in soil-simulating solution. Note that the current scale is linear.

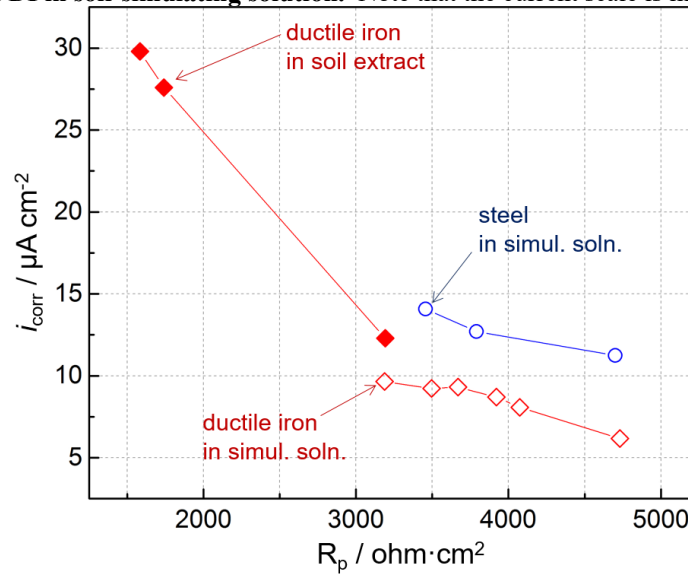
Figure 5.34. Estimated polarization resistance and corrosion current of DIP and steel in soil-simulating solution and soil extract.

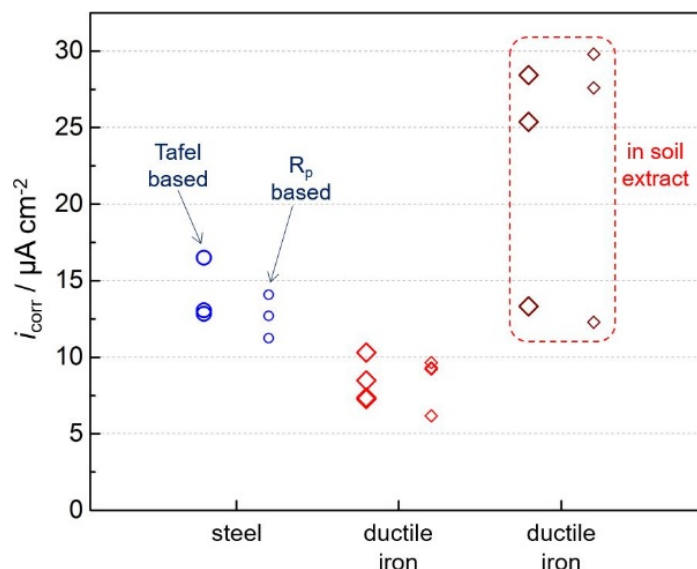
Figure 5.35. Comparison of corrosion currents estimated by Tafel- and polarization resistance-based analyses in soil-simulating solution and soil extract (data in the broken box).

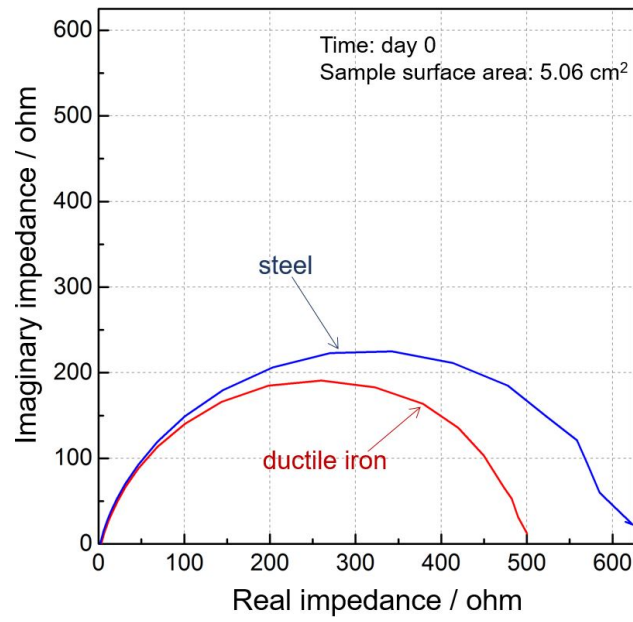
Figure 5.36. Nyquist plots of DIP and steel in soil-simulating solution.

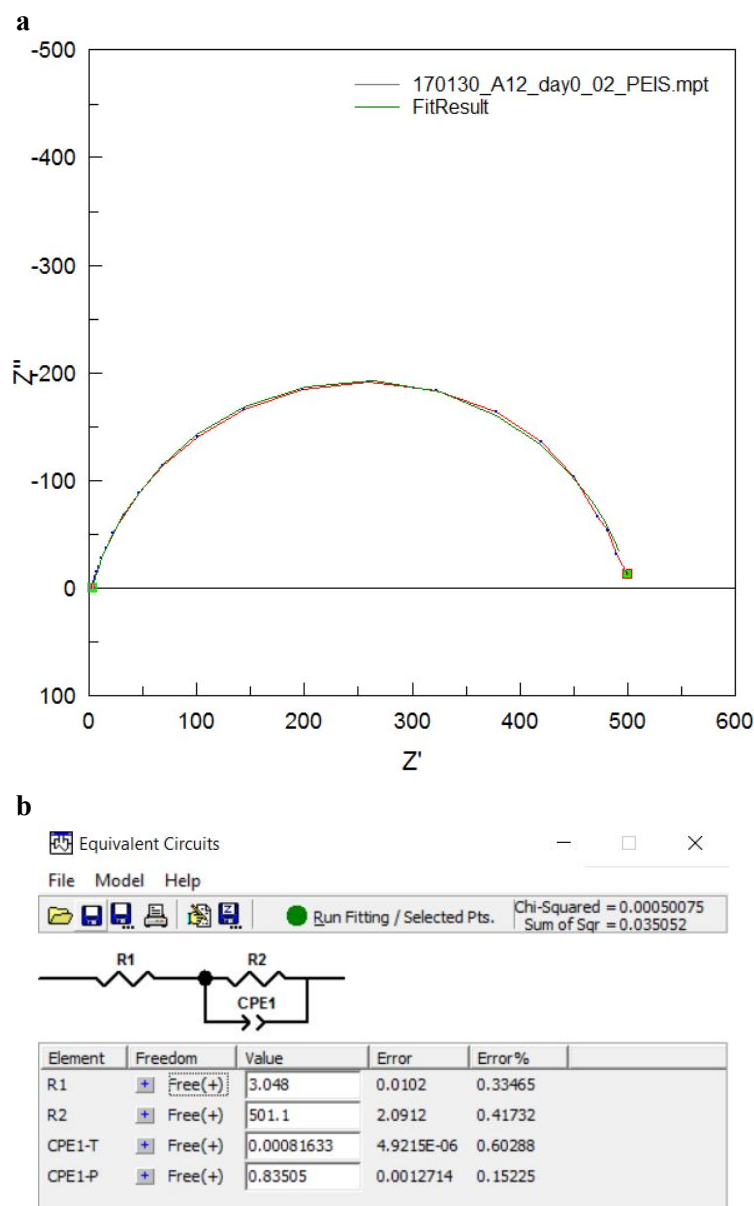
Figure 5.38. Software-assisted fitting of Nyquist plot: (a) a snapshot of fitted plot and (b) fitted values of circuit element.

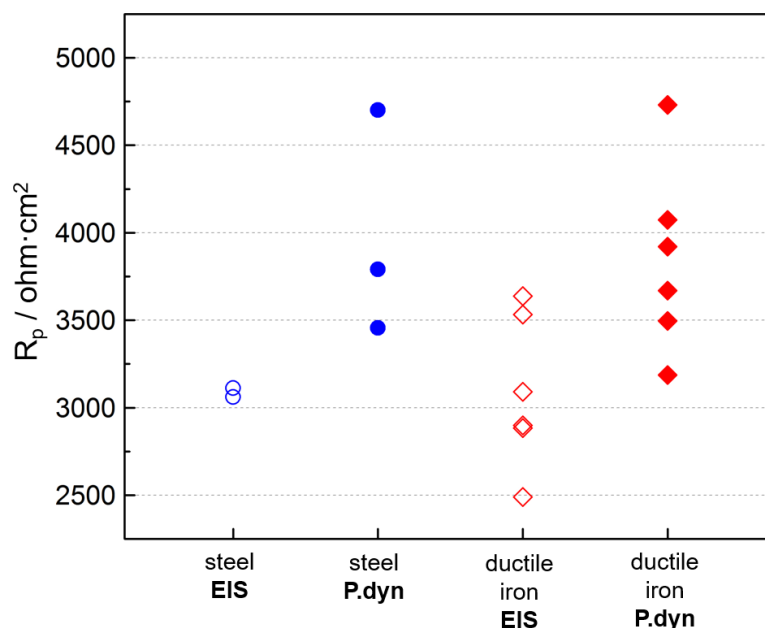
Figure 5.39. Polarization resistance of DIP and steel in soil-simulating solution determined by fitting: (a) Nyquist plots and (b) polarization curves from EIS and potentiodynamic (P.dyn) techniques.
