Methodologies for Evaluation of Corrosion Protection for Ductile Iron Pipe

June 12, 2019

Materials Science and Technology Division

Prepared by
OAK RIDGE NATIONAL LABORATORY
Oak Ridge, TN 37831-6283
managed by
UT-BATTELLE, LLC
for the
US DEPARTMENT OF ENERGY
under contract DE-AC05-00OR22725

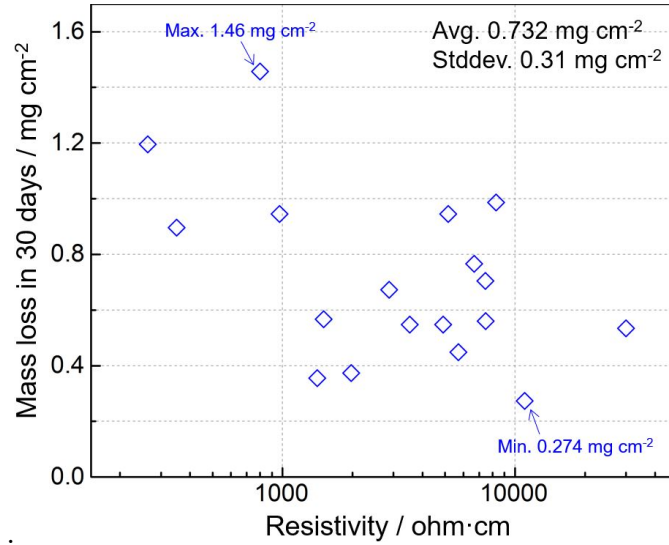
Figure 5.41. Mass loss vs soil resistivity plot of 17 data selected from the NBS corrosion dataset. The maximum value is more than 4 times larger than the minimum value. The average and standard deviation of all mass loss data are also noted on the plot.

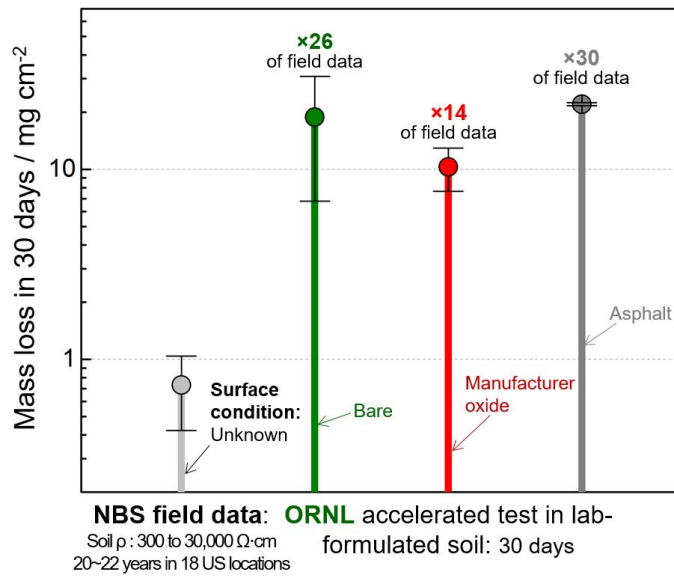
Figure 5.42. Comparison of 30 day mass loss values measured in this work (ORNL accelerated test) and estimated from NBS corrosion database.
