# **Effect of Intake Air Filter Condition on Vehicle Fuel Economy**

**February 2009**

Prepared by  
OAK RIDGE NATIONAL LABORATORY  
Oak Ridge, Tennessee 37831-6283  
managed by  
UT-BATTELLE, LLC  
for the  
U.S. DEPARTMENT OF ENERGY  
under contract DE-AC05-00OR22725

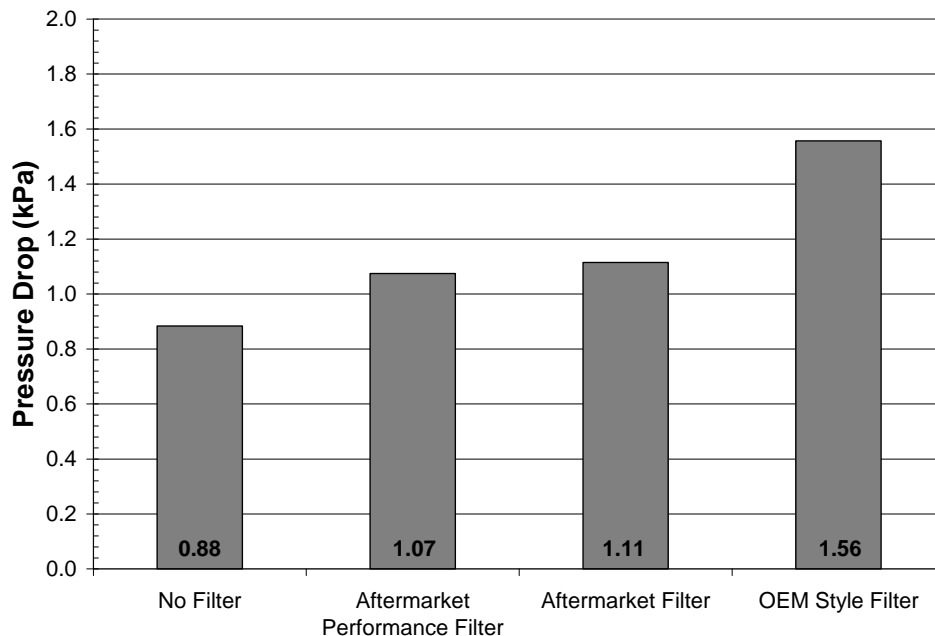
**Fig. 3.1. Maximum Outlet DP for 2007 Buick Lucerne baselined clean air filters.** Initial testing done to baseline multiple clean air filters.

Four filter setups, an OEM filter, an aftermarket filter, a performance aftermarket filter, and no filter, were tested, using the 2007 Buick Lucerne as the test vehicle, to determine a baseline and the filter to be used for the remainder of the testing. Each setup was tested over the WOT cycle described previously. It was observed that the OEM filter resulted in a higher Outlet DP than the aftermarket filter and the performance aftermarket filter, as is shown in Fig. 3.1. The aftermarket filter was chosen for the test process due to its lower initial Outlet DP compared to the OEM filter and because it is more common than the performance aftermarket filter; thus, it allowed us to explore the largest clean-to-clogged difference for a commonly used air filter. No measureable differences were observed in vehicle performance with these filters over the CRC E-60 WOT test cycle.

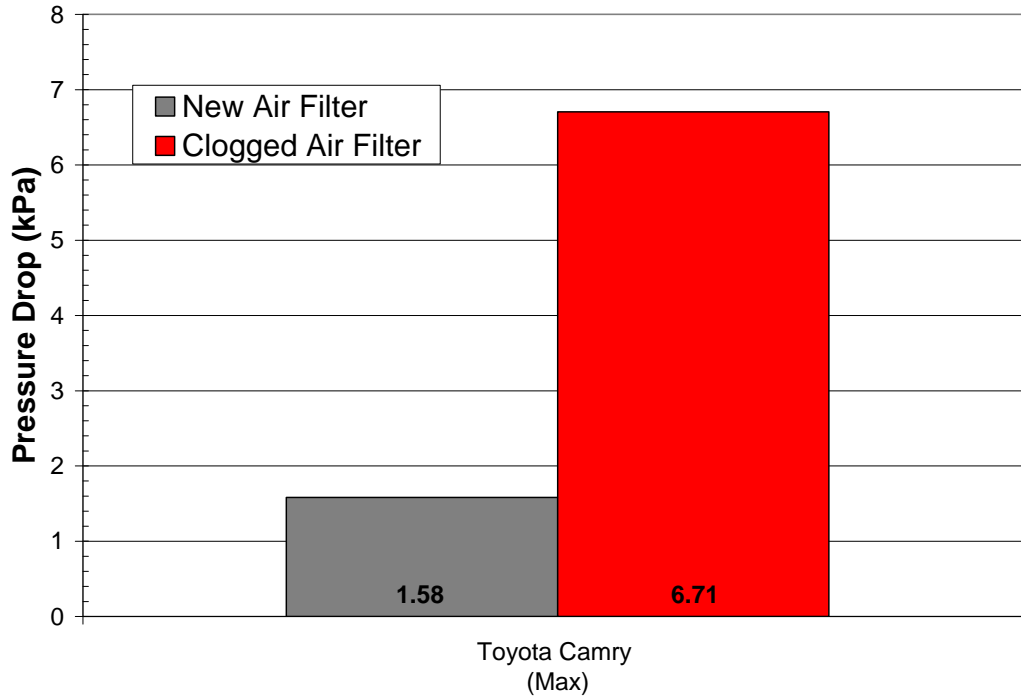
**Fig. 3.3. Average maximum Outlet DP for the 2003 Toyota Camry during the CRC E-60 WOT tests.**

For the 2003 Camry, which was equipped with a 2.4L I4, the clogged filter created an Outlet DP in excess of 6.2 kPa for the CRC E-60 WOT tests (Fig. 3.3), while the new filter produced less than 1.7 kPa under the same acceleration conditions. For the SS WOT tests (Fig. 3.4), the clogged filter created an Outlet DP in excess of 4.2 kPa, while the new filter generated approximately 0.5 kPa under the same acceleration conditions. The data in Fig. 3.3 represent the Camry's average maximum Outlet DP recorded for the WOT accelerations during the CRC E-60 WOT section of the test.

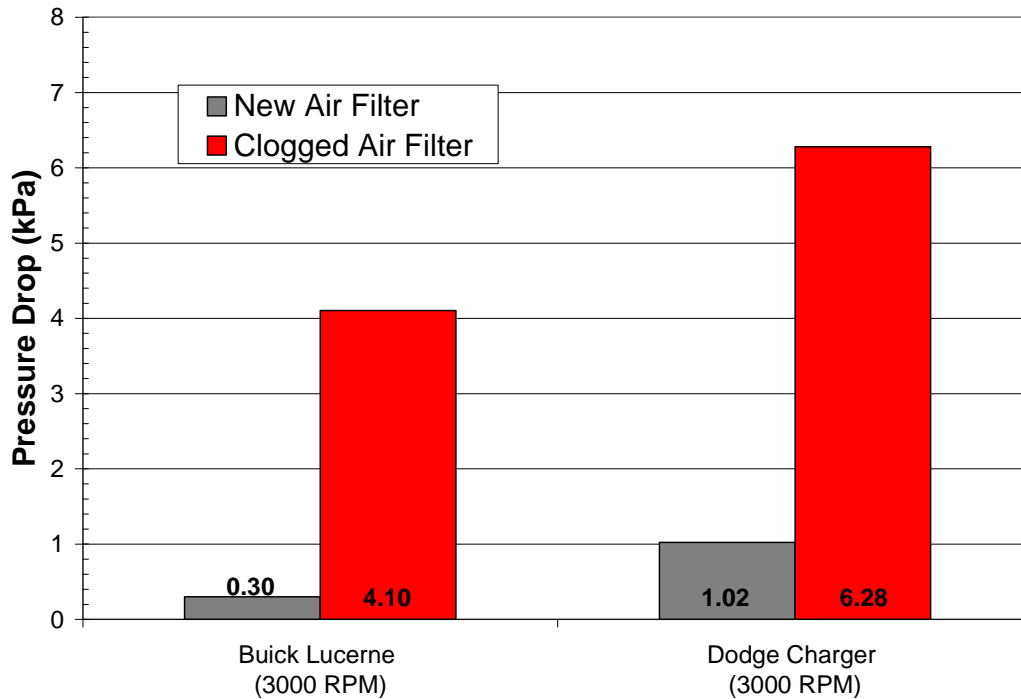
**Fig. 3.4. Average Outlet DP at 3000 RPM during the CRC E-60 WOT tests.**

Because the peak Outlet DP for the Charger and Lucerne were outside the range of the sensor in the clogged state, the average of the Outlet DPs at 3000 RPM, recorded for each of the WOT accelerations

during the CRC E-60 WOT section of the test, was used to compare these vehicles, as shown in Fig. 3.4. The Outlet DP values for the SS WOT tests were all within the range of the sensor and are shown in Fig. 3.5.

For the Lucerne, the Outlet DP at 3000 RPM during the initial acceleration of the CRC E-60 WOT tests was in excess of 4 kPa for the clogged filter and less than 0.4 kPa for the new filter (Fig. 3.4). During the SS WOT tests the clogged filter created an Outlet DP in excess of 5.7 kPa, while the new filter Outlet DP was less than 0.9 kPa (Fig. 3.5).

For the Charger, the Outlet DP at 3000 RPM during the initial acceleration of the CRC E-60 WOT tests was in excess of 6.2 kPa for the clogged filter, while that for the new filter was less than 1.1 kPa under the same acceleration conditions (Fig. 3.4). During the SS WOT tests the clogged filter created an Outlet DP in excess of 7.2 kPa, while the new filter Outlet DP was less than 1.2 kPa under the same acceleration conditions (Fig. 3.5).

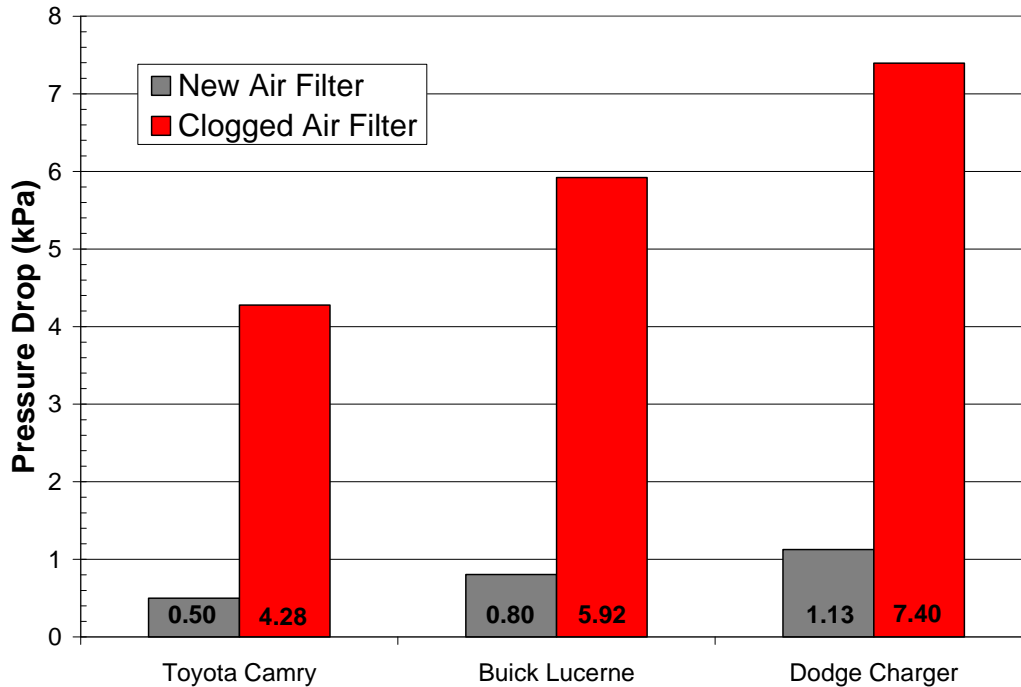
**Fig. 3.5. Average maximum Outlet DP for SS WOT tests.**

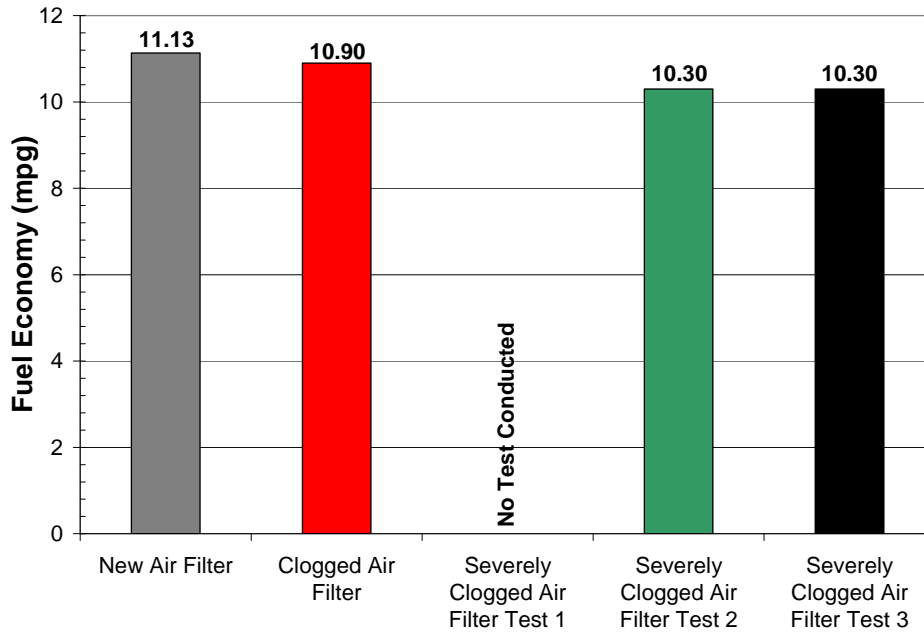
**Fig. 3.19. FTP fuel economy for 1972 Pontiac Grandville.**

For each of the tests simulating severely clogged filters, fuel economy was calculated for the FTP and HFET cycles. However, due to the nature of the cold FTP tests that were being conducted, time constraints did not allow for the vehicle to be prepared for a cold FTP for the Severely Clogged Air Filter Test 1 setup. Each incremental increase in restriction resulted in an incremental decrease in fuel economy for the HFET, but FTP fuel economy was not affected as severely by the restriction. Figure 3.19 shows the FTP fuel economy for the different stages of testing. Figure 3.20 shows the same information for the HFET.

The initial change in fuel economy from the new air filter to the clogged air filter resulted in an FTP fuel economy decrease of 2.1%. The HFET fuel economy initially decreased 2.5% from the new air filter to the clogged air filter.
