ORNL/TM-2010/191

**An Innovative Technique for Evaluating the Integrity  
and Durability of Wind Turbine Blade Composites  
FY2010 Report**

**Jy-An John Wang and Fei Ren**

Date Published: September 2010

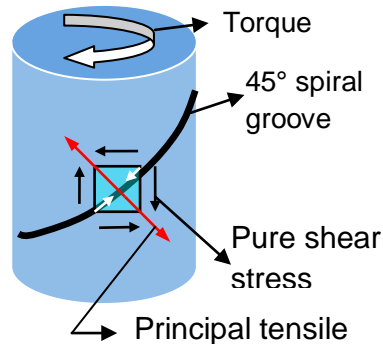
Figure 1. SNTT configuration.

The SNTT test method uses a round-rod specimen having a V-grooved spiral line at a 45° pitch (Figure 1), subjected to pure torsion. When the grooved specimen is sectioned into segments perpendicular to the groove line, each of the segments can be viewed as a CT specimen with a notch. Since all the imaginary CT specimens are bonded side-by-side seamlessly, the compatibility condition is automatically satisfied, and remains in place before and after application of torsion loading. In the absence of the V-groove, the stress state of a generic element in a round bar under pure torsion can be depicted as tension (normal to the 45° pitch) and compression (tangential to 45° pitch) of equal magnitude. When a notch is introduced (Figure 1), a tri-axial tensile stress field will evolve in the neighborhood of the notch root area. This observation has been experimentally and analytically validated [Wang 2000, 2002b]. Therefore, when a V-grooved spiral line with a 45° pitch is machined on the surface of the specimen, the grooved line effectively becomes a Mode I crack mouth opening.

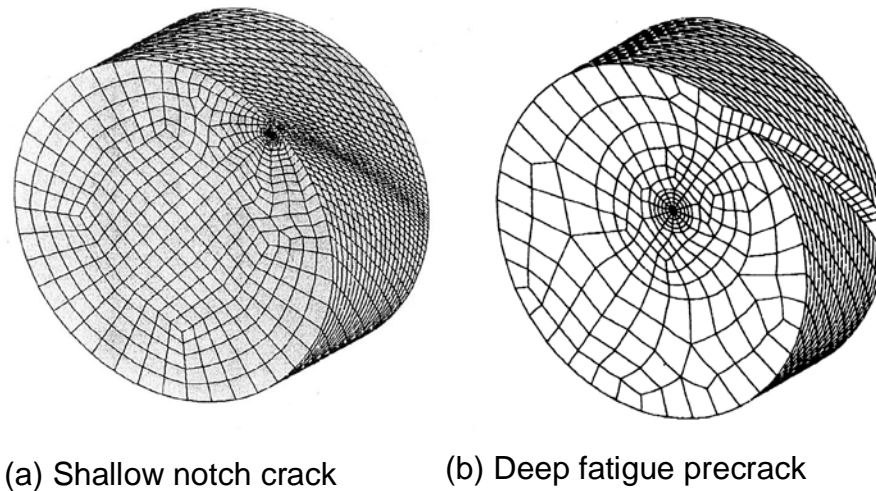
Figure 2. SNTT FEM Models.

Due to the 3-D non-coplanar crack front of the SNTT configuration and the lack of closed form solutions,  $K_{IC}$  of the SNTT method was evaluated using 3-D finite element analysis and derived from minimum strain energy density criterion [Sih 1974] or J-Integral based on the domain integral method [Wang 2000, 2002b]. Typically, a finite element model shown in Figure 2a is used for brittle SNTT specimens, such as concrete, with shallow crack fronts and while the model shown in Figure 2b is used for ductile specimens. The SNTT FEM model normally contains about 8,000 20-node quadratic brick elements with reduced integration and 35,000 nodes.

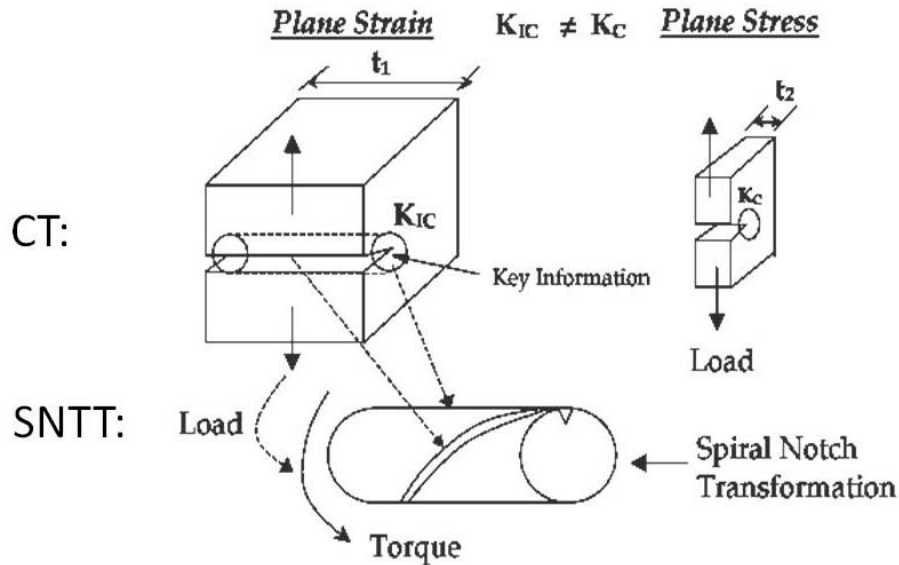
Figure 3. Specimen size effect.

The CT specimen, as shown in Figure 3, has been widely used in existing fracture toughness test methods because the general consensus indicates it is the next-best basic configuration that nearly conforms to the strict requirements of the classical theory of fracture mechanics. Despite the simplification, the theoretical conditions (i.e., the conditions required to achieve uniformly distributed applied stress over the thickness and plane-strain condition) can never materialize as long as free surfaces exist at both ends of the specimen. The end effects will be further amplified when the thickness decreases to a thin plate, as shown in Figure 3. Another dilemma is that an increase in specimen thickness will automatically accompany an increase in specimen length and width in order to maintain specimen rigidity under load. Miniaturization is an important

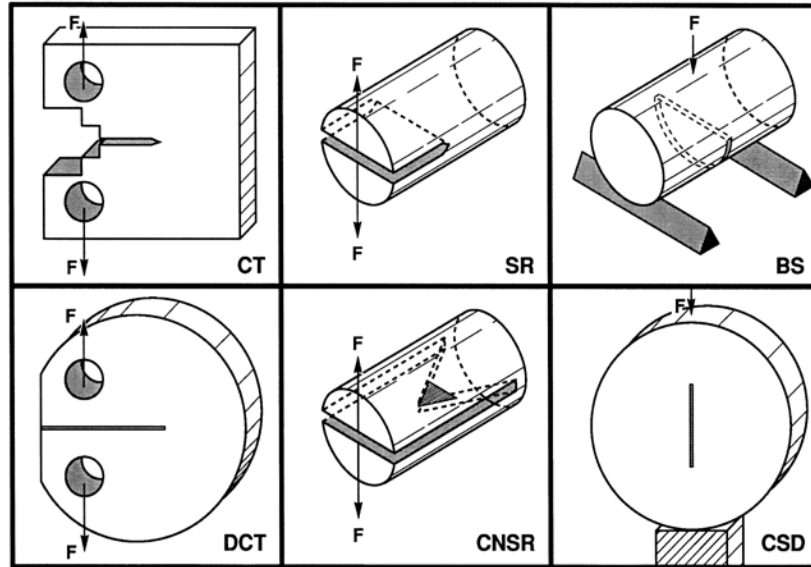
CT: Compact Tension; SR: Short Rod; BS: Bending Short Rod; DCT: Disk shape CT; CNSR: Chevron Notched Short Rod; CSD: Central loaded Short Disk.

Figure 4 illustrates the fracture toughness testing methods for brittle materials (such as graphite or carbon composite), which indicates that a test specimen machined with a deep notch is required. However, for the SNTT method only a shallow surface notch is required for testing of brittle materials. This will further reduce the specimen size as compared to a conventional test as shown in Figure 4.

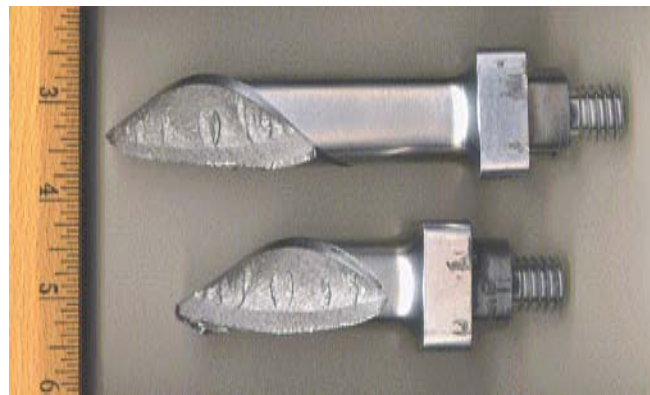
Figure 5. SNTT sample made from aluminum 7475-T7351

Because of the plane strain and axisymmetric constraint and the uniformity in the stress and strain fields of the SNTT configuration, the crack front must propagate perpendicularly toward the specimen axis and along the conoids. Post-mortem examination verified such crack propagation behavior (see Figure 5) which was also verified from epoxy fatigue precracked samples.

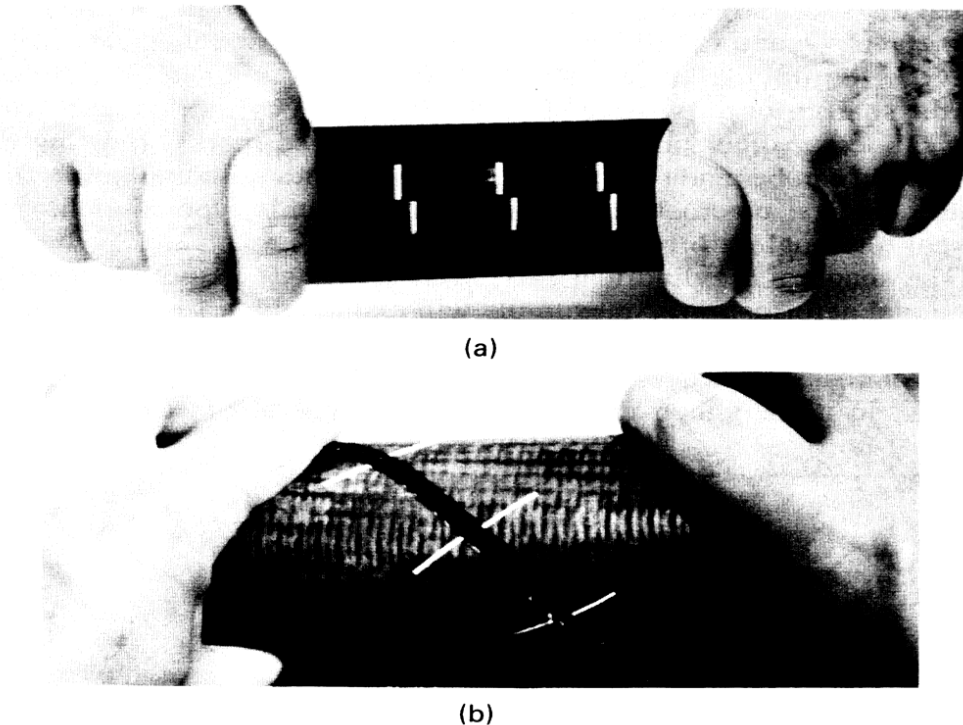
Figure 6. Illustration of SNTT approach using a radiator hose.

In a recent study of mixed-mode fracture [Li 1996], utilizing a complex test set-up with a specially machined CT specimen, test results indicate that mixed-mode (Mode I + Mode III) toughness and tearing modulus reduced to 50% and 30%, respectively, compared to those under Mode I only for the ductile materials. Therefore, the implication or the potential of the synergistic impact due to the combination of flexural normal stress (Mode I fracture) and the torsion shear stress (Mode III fracture) to the fracture toughness for the composite materials needs a close look. As for the brittle materials, the Mode I is still the dominate failure mode, such as for epoxy materials, as revealed from the current study on the epoxy materials. In applying the SNTT approach for the mixed Mode I + Mode III failure study, this can be achieved by simply varying the pitch angle of the spiral notch. A radiator hose was used to illustrate the SNTT approach under pure torsion loading Figure 6. As shown in Figure 6a, a slit was cut along the principal shear direction, i.e., along 0 or 180°, and the deformation appears to be pure shear Mode III failure. As shown in Figure 6b if a slit was cut along 45° angle, along the principal tensile stress orientation, the deformation appears to be opening Mode I failure. Therefore, by varying the pitch angle, Mode I and Mode III loading can be achieved with a SNTT sample under pure torsion loading.

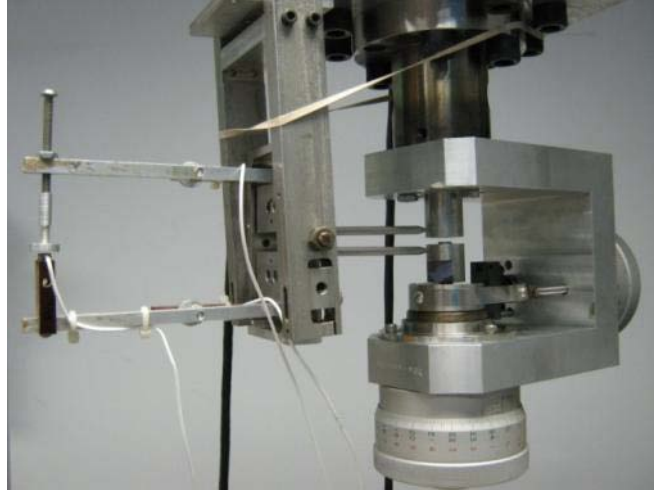
Figure 8. Calibration of the biaxial extensometer.

An in-house built biaxial extensometer was utilized for displacement measurements (Figure 7). The extensometer consists of three pairs of capacitive sensors used to measure the relative displacement of the two probe pins both in the axial direction and torsional directions. Prior to testing, the extensometer was calibrated with a biaxial extensometer calibration block (Figure 8).

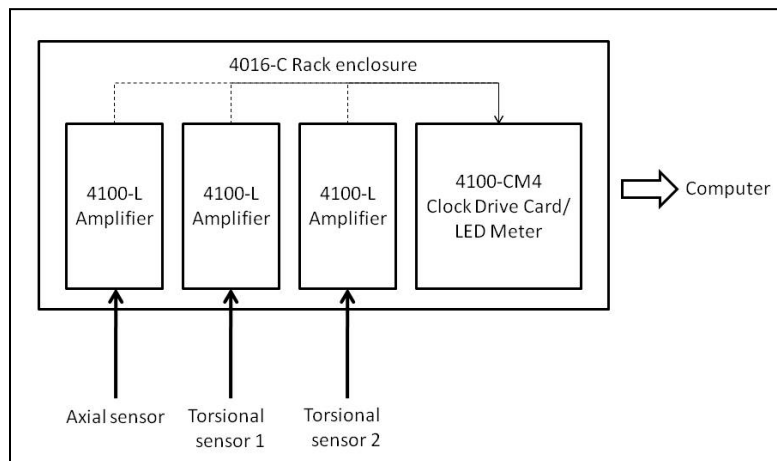
Figure 9. Block diagram of the capacitive data acquisition system.

The data acquisition system consists of three capacitive amplifiers (Model 4100-L, Capacitec Inc. Ayer, MA, USA) and a clock drive with LED meter (Model 4100-CM4, Capacitec Inc. Ayer, MA, USA), all enclosed by a rack enclosure (Model 4016-C, Capacitec Inc. Ayer, MA, USA). The Capacitec system is connected to a computer by coaxial cables for data recording (Figure 9).

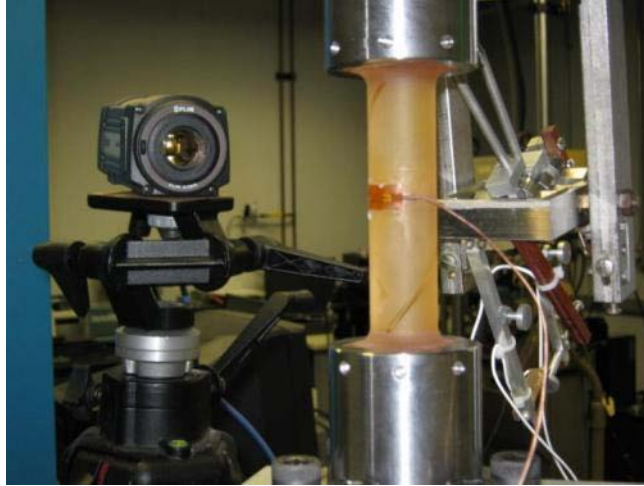
Figure 10. The IR imaging system used to monitor SNTT samples.

In order to monitor and record the in-situ temperature on the sample surface during SNTT testing, an infrared imaging system (Model A325, FLIR Systems, Boston, MA, USA) has been set up (Figure 10). In addition, thin film thermocouples (CO1-K, Omega Engineering, Inc. Stamford, CT, USA) are also used as a temperature reference.

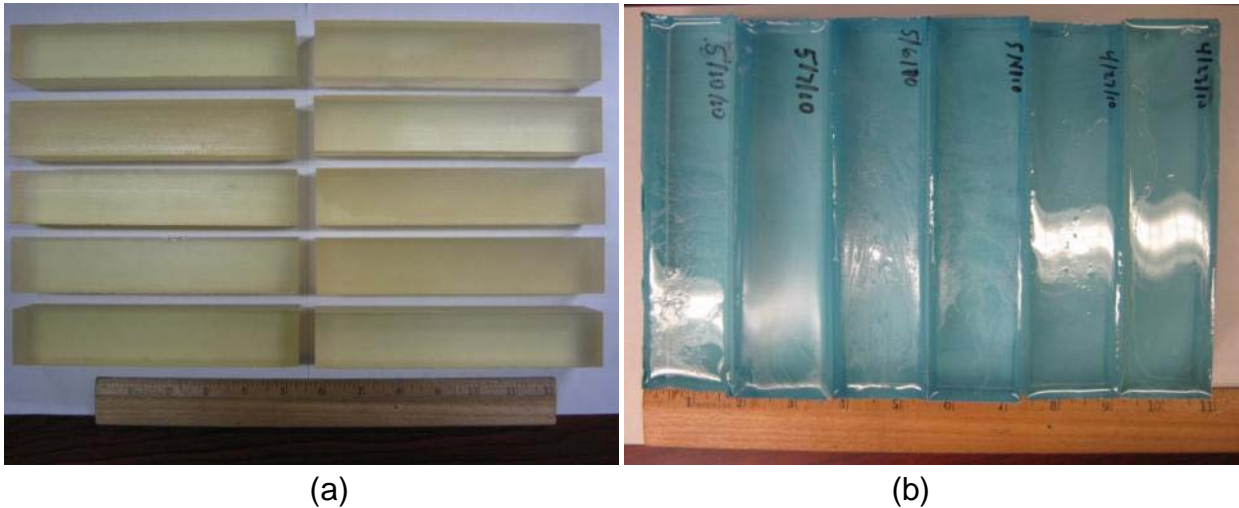
Figure 11. Pictures showing raw epoxy materials received from (a) Gougeon Brothers, Inc. and (b) Molded Fiber Glass Companies.

Raw epoxy materials were obtained from two of our industrial partners: Pro-Set® epoxy, Gougeon Brothers (GB), Inc. Bay City, MI; and Hexion® Epikote™ MGS® epoxy, Molded Fiber Glass Companies (MFG), Ashtabula, OH (Table 1) (Figure 11). Basic mechanical properties, as provided by the vendors are summarized in Table 1 and the chemical compositions for each epoxy system are listed in Table 2.

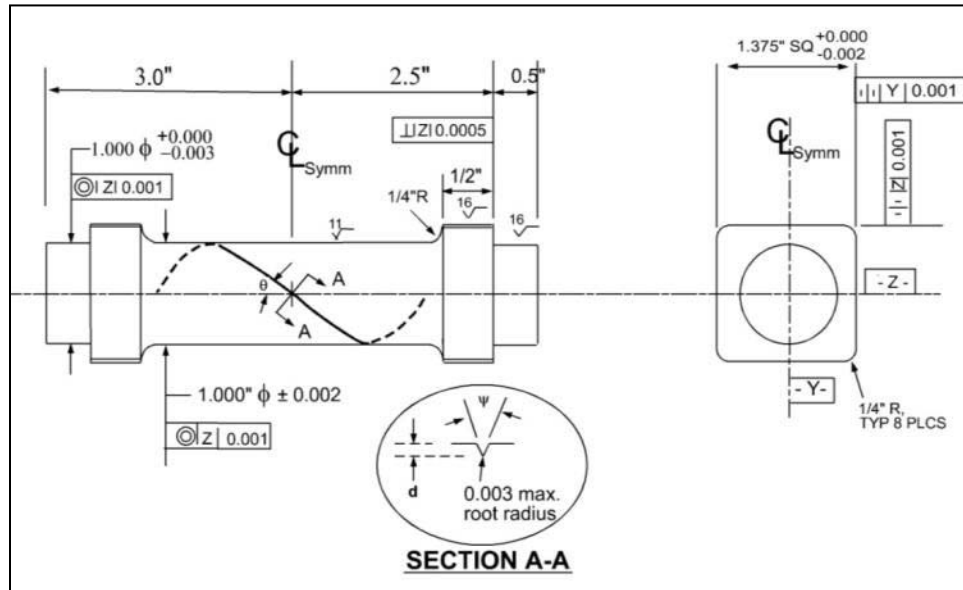
Figure 12. SNTT sample geometry.

and  $20^\circ$ . When  $\theta = 45^\circ$ , the principal stress  $\sigma_1$  (tensile) is perpendicular to the notch, and the associated failure mode will be Mode I (tensile opening mode). When  $\theta < 45^\circ$ , the notch is subject to a mixed loading of Mode I and Mode III (tearing mode, torsional shear mode). Figure 13 shows some pictures of SNTT epoxy samples. To date (by August. 24<sup>th</sup> 2010), a total number of 31 epoxy samples were fabricated (Table 3).

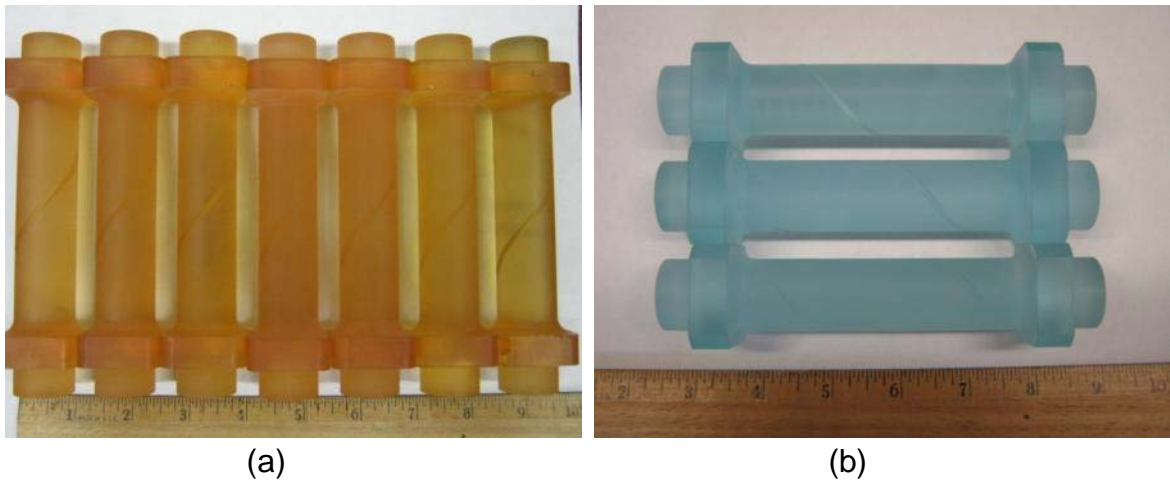
Figure 13. Pictures showing machined samples made from epoxy materials provided by (a) Gougeon Brothers, Inc. and (b) Molded Fiber Glass Companies.

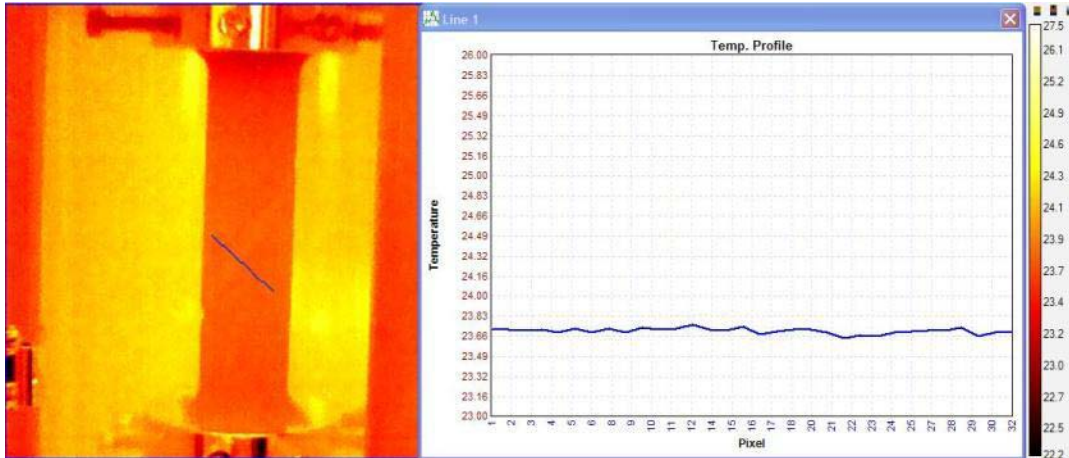
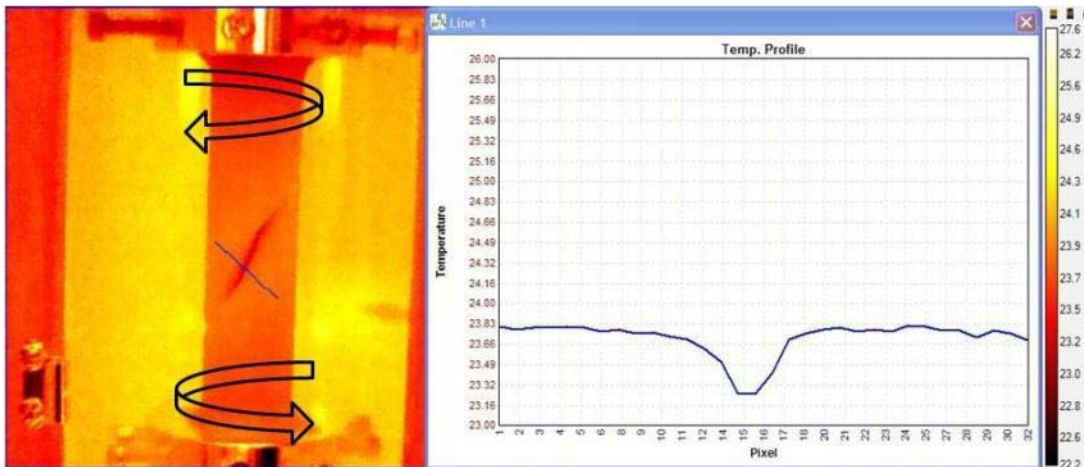
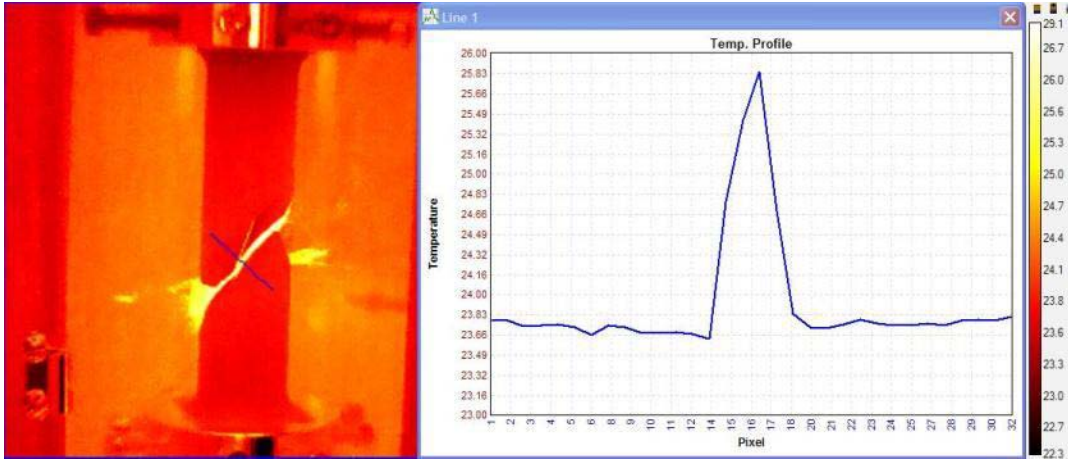
Using an infrared camera, the in-situ fracture process of epoxy samples during SNTT was examined. Figure 15 shows IR images and temperature profiles across the notch, as marked with blue line in Fig. 14, obtained from sample GB2-6 during monotonic loading.

The qualitative and quantitative measurement of temperature profiles obtained from this study proved to be very useful in SNTT failure characterization. However, accurate measurements require knowledge of surface emissivity, which is not only dependent on the material itself, but also on the surface roughness and the local curvature. Nevertheless, the preliminary IR results verified that the notch groove was subject to tensile states while under SNTT pure torsion loading (Figure 15b).

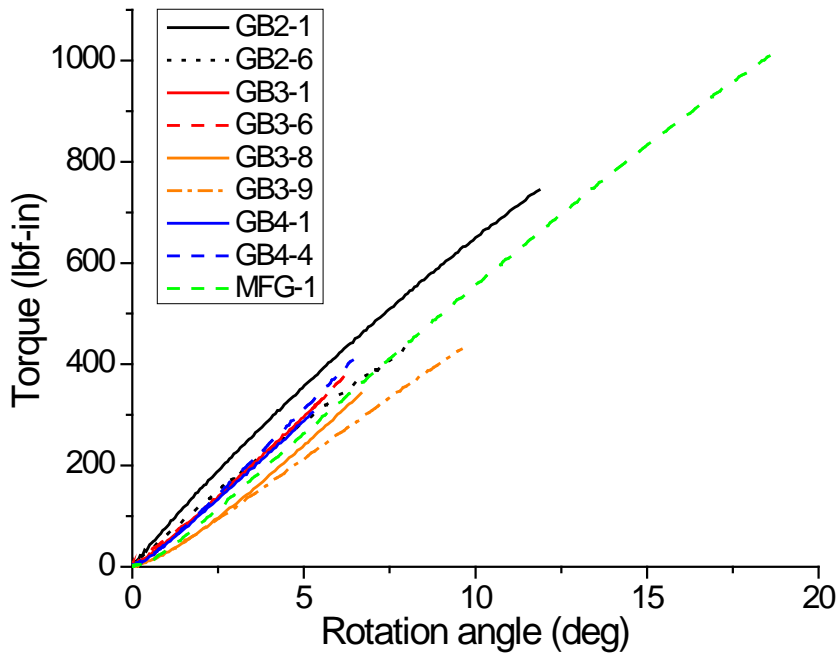
Figure 16. The torque-rotation plots of tested SNTT samples

For tested epoxy samples, torque versus rotation angle curves showed typical brittle fracture behaviors with nearly linear load-displacement relationships (Figure 16). All samples failed near or below 400 lbf-in, except for the MFG-1 sample and two samples GB2-1 and GB2-6 that were made from toughened epoxies.

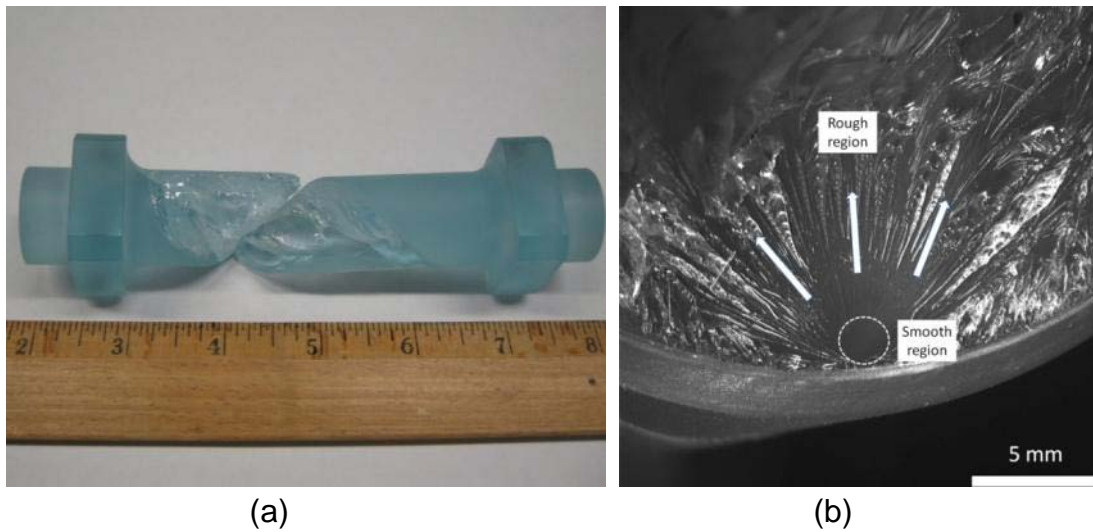
Figure 17. Pictures showing (a) the fractured MFG-1 sample, and (b) its fracture surface.

The smooth region, sometimes called “mirror” [Araki 2002], was likely formed as a result of slow unstable crack growth, this subsequently transformed to a rough region due to fast unstable crack growth [Owen 1975]. The rough region was sometimes termed as hackle [Phillips 1978, Yamini 1979] similar to those observed in glassy materials [Quinn 2007]. The ridged features in the rough region could be caused by secondary fractures as a result of the increased propagation speed of the primary crack [Owen 1975].

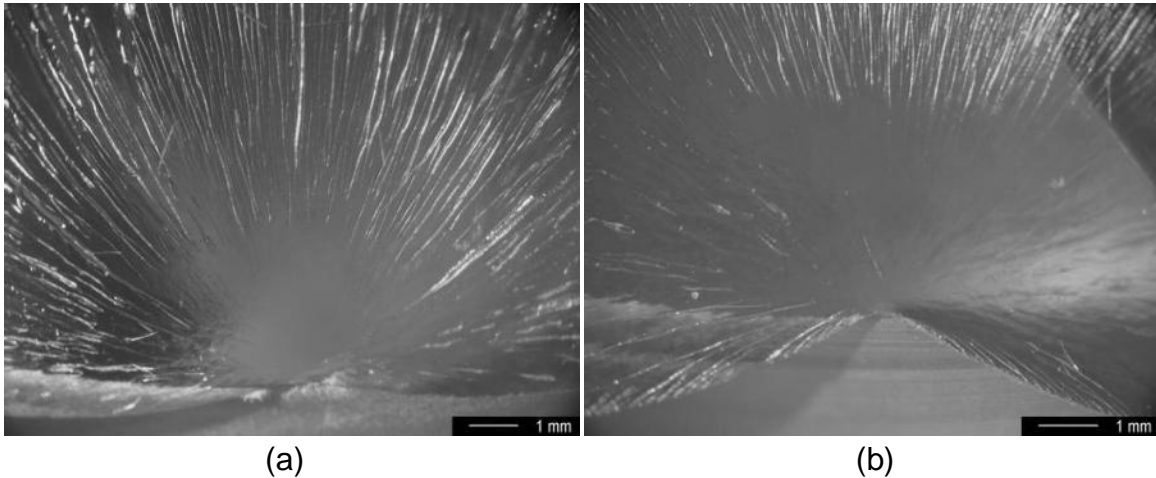
Figure 18. Images showing the fracture surfaces of (a) GB2-1 and (b) GB2-6.

The fracture torque of GB2-6 was 447 lbf-in, about 42% lower than the fracture torque of GB2-1 (774 lbf-in) because the notch depth of GB2-6 was nominally 0.3" while that of GB2-1 was 0.1" nominally (Table 4).

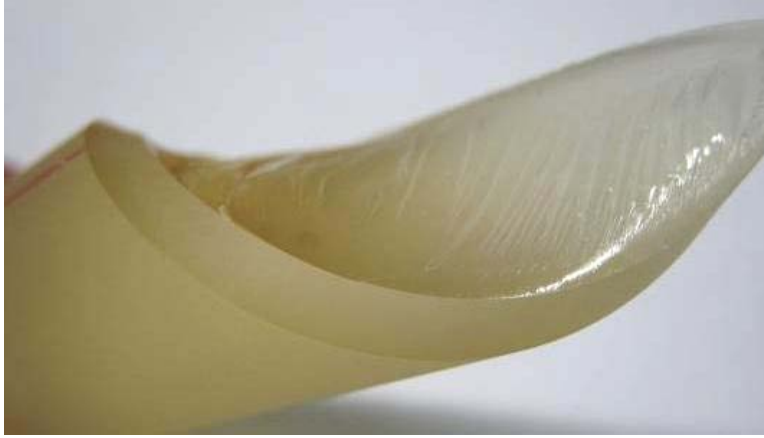
Figure 20. Picture showing one fractured half of sample GB3-1.

Samples GB3-1, GB3-6, GB4-1, and GB4-4 all had a pitch angle of  $45^\circ$  (Table 3), and their fracture surfaces resemble the “ $45^\circ$  spiral planes”. In another good example, Figure 20 shows the fracture surface of GB3-1, which initiated exactly along  $45^\circ$  spiral notch line.

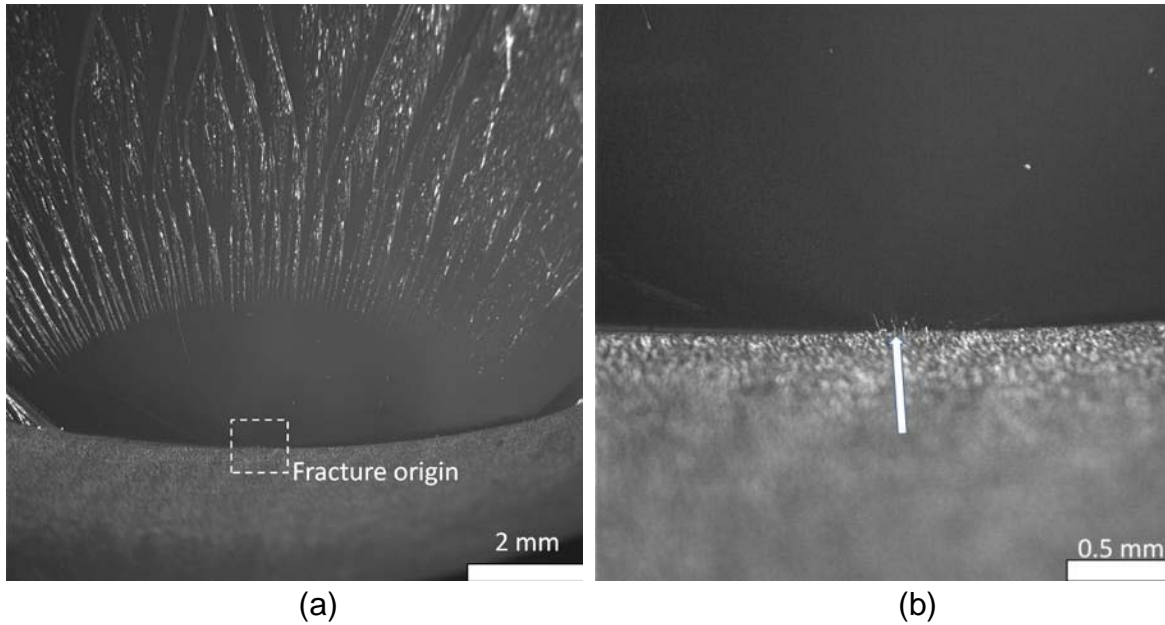
Figure 21. Images showing (a) the fracture surface and (b) the fracture origin of sample GB3-1.

small fraction of the entire fracture surface (Figure 21a), implying that under monotonic loading a crack would grow unstably shortly after its formation.

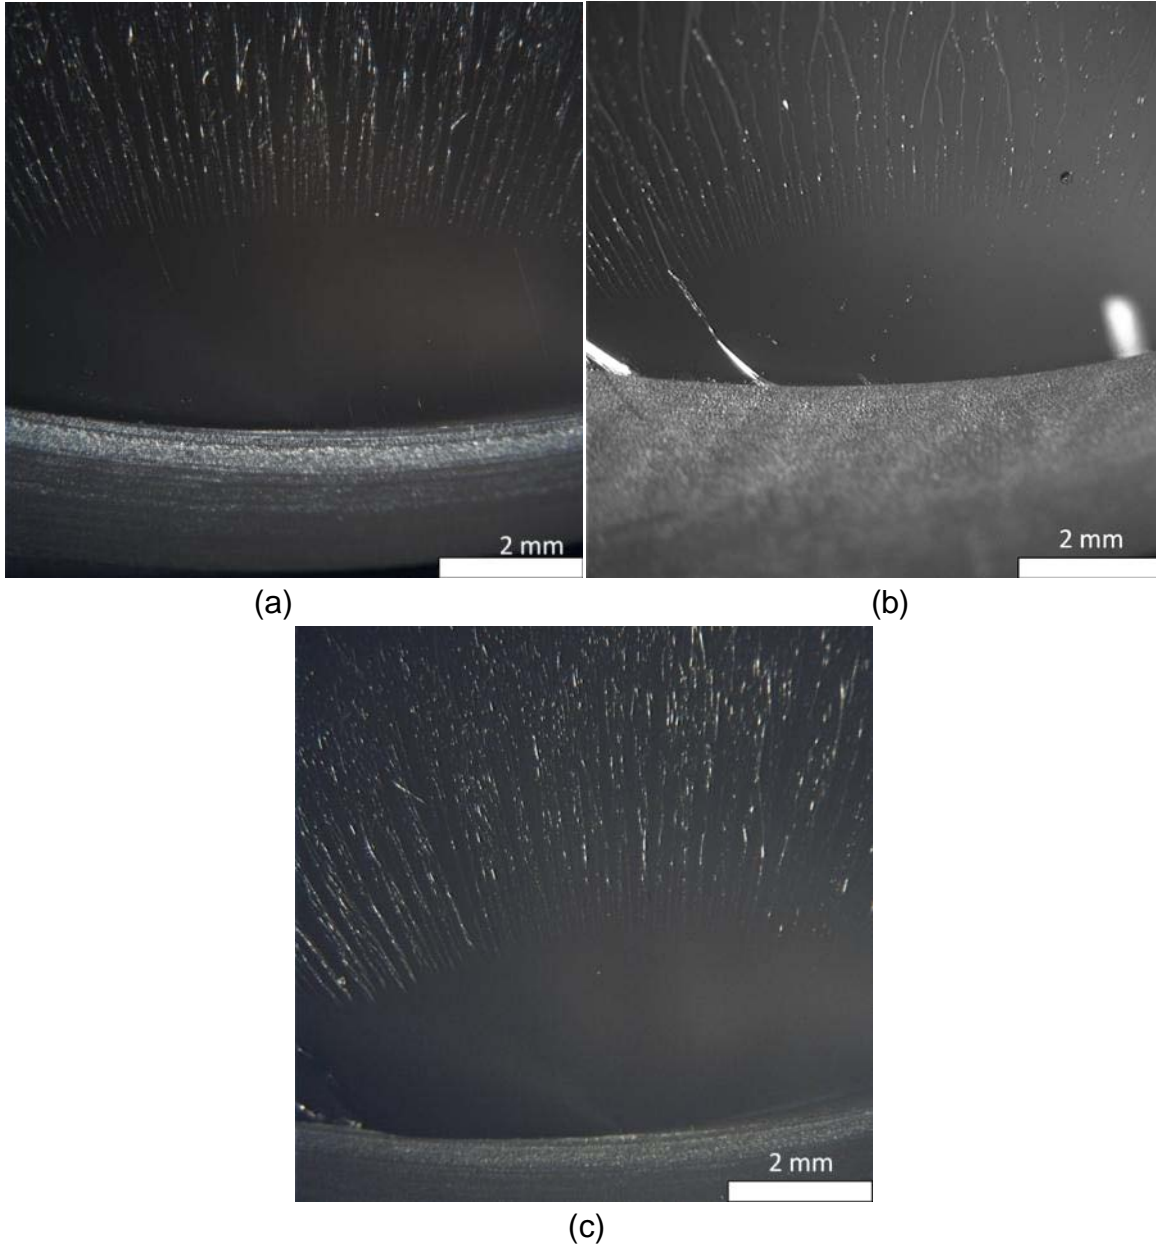
Figure 22. Images showing fracture surfaces of (a) GB3-6, (b) GB4-1, and (c) GB4-4.

The fracture surfaces of GB3-6, GB4-1, and GB4-4 showed similar morphology to that of GB3-1 (Figure 22). GB3-1 and GB4-1 had comparable fracture torques (Table 4) due to their similar geometry. GB3-6 and GB4-4 exhibited higher fracture torques due to their smaller notch depth (0.1") than that of GB3-1 and GB4-1 (0.115") (Table 3). It is noted that the notch opening angles were different as well (45° versus 90°, see Table 3) and that the effect of the notch opening angle on fractures will be explored in the future.

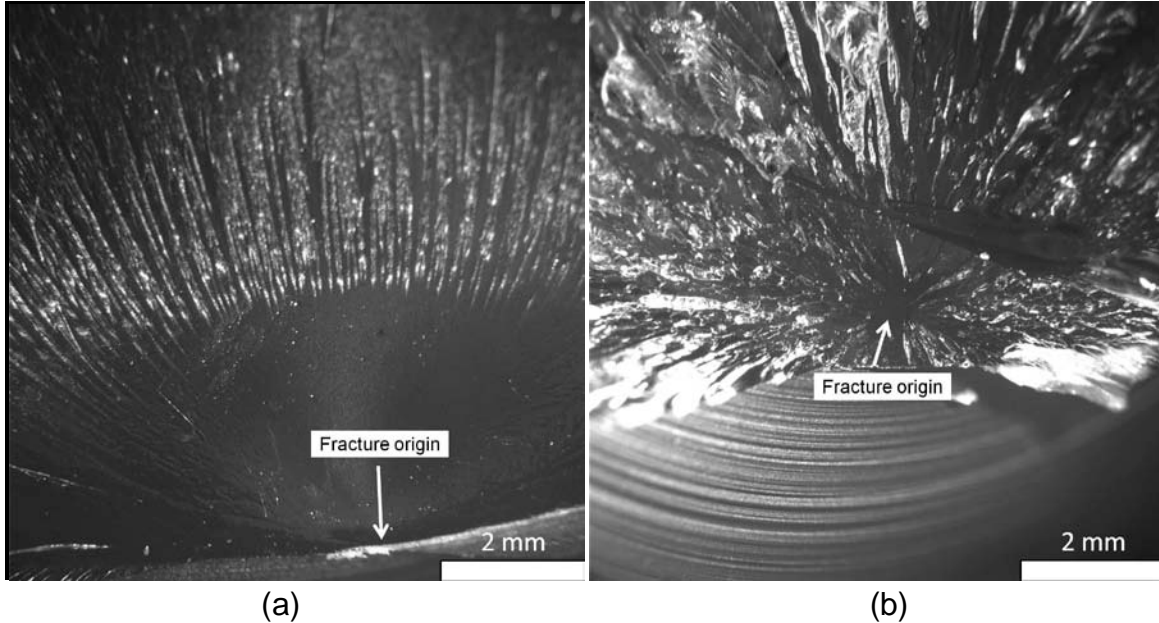
Figure 23. Images showing the fracture surfaces of (a) GB3-8 and (b) GB3-9.

than on the surface (Figure 23b). Based on this finding, the notch root of GB3-8 was sharpened using a razor blade prior to testing. The resulting fracture surface of GB3-8 showed a similar appearance to those with V-shaped grooves (Figure 23a) with a fracture torque of 343 lbf-in (Table 4).

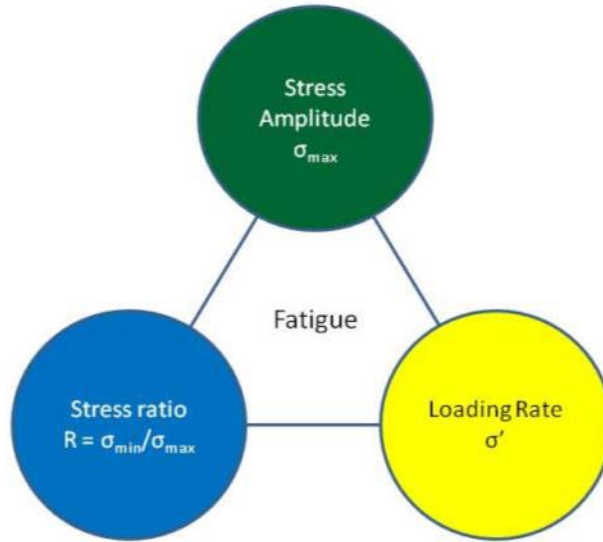
Figure 24. External factors influencing the fatigue behavior of materials.

In addition to the intrinsic material properties, the fatigue behavior of polymeric materials is also influenced by loading conditions, such as stress amplitude ( $\Delta\sigma = \sigma_{\max} - \sigma_{\min}$ ), stress ratio ( $R = \sigma_{\min} / \sigma_{\max}$ ) and thus the mean stress, and loading rate ( $\sigma' = d\sigma/dt$ ) (Figure 24). In order to develop an effective protocol to induce a controllable crack growth, pilot testing was carried out where the epoxy samples were tested under different fatigue loading conditions (Table 4).

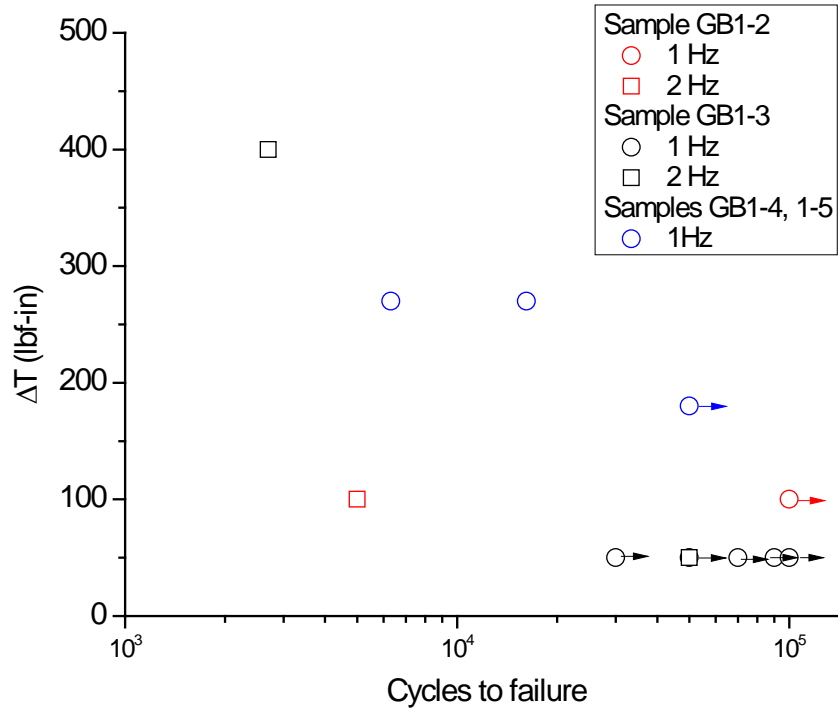
Figure 25. Fatigue S-N plots of samples from GB batch 1.

normally has lower thermal conductivity (compared to that of metallic materials, higher rate loading will further increase the temperature gradient near the crack tip region. The lower localized temperature profile at the crack front will certainly increase the localized constraint leading to lower fracture toughness and thus less fracture resistance.

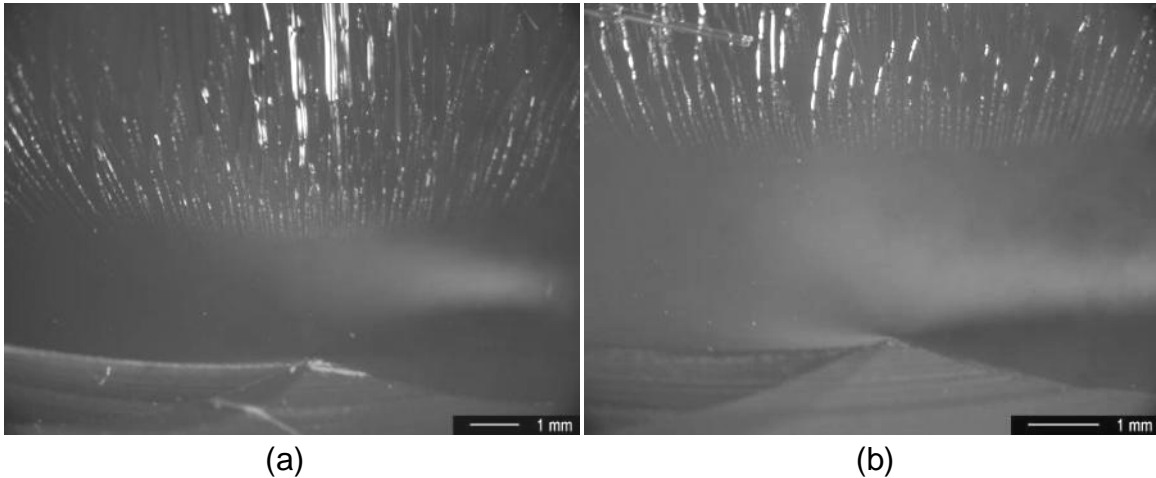
Figure 29. Images showing the fracture surfaces of (a) GB2-3 and (b) GB2-4.

Samples of the second batch from Gougeon Brothers were made from toughened epoxies (Table 1). Prior to fatigue testing, the notch roots of GB2-3, GB2-4, and GB2-5 were sharpened with a razor blade by manually sliding the blade along the spiral notch. GB2-3 fractured after 100 cycles between 30 and 300 lbf-in with a frequency of 2 Hz; while GB2-4 fractured after 1660 cycles between 30 and 300 lbf-in with a frequency of 1 Hz (Table 4). The short fatigue life of these two samples was perhaps a result of increasing constraint due to notch root sharpening. No fatigue region was observed on samples GB2-3 or GB2-4 (Figure 29).

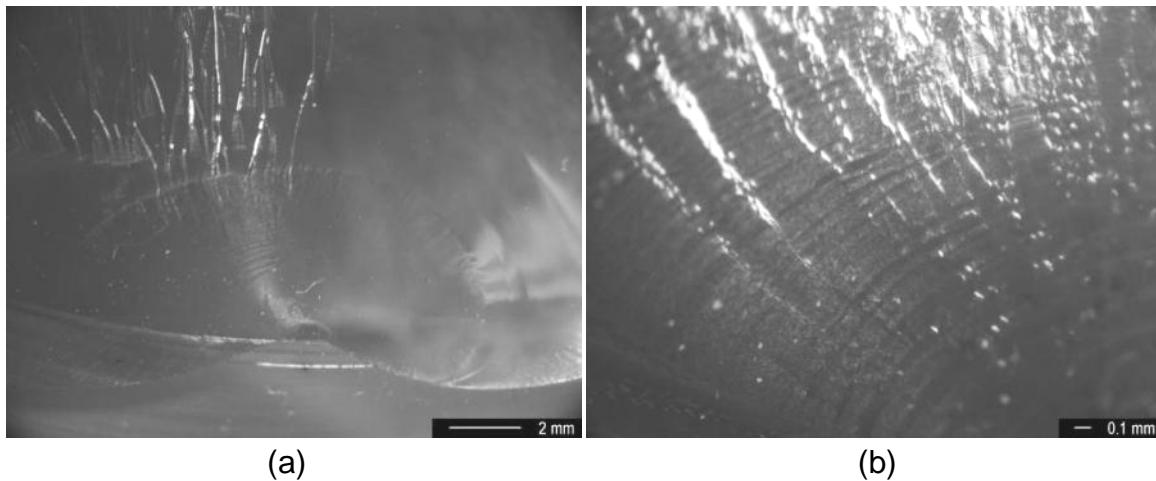
Figure 30. Images showing (a) the fracture surface of GB2-5 and (b) the crack propagation striation lines.

The semi-elliptical region, similar to Figure 30, was also observed by other researchers on fracture surfaces subject to rotary-bending fatigue [Nagasawa 1995] and uniaxial fatigue [Tao 2007] of epoxy materials. In addition, Tao *et al.* observed striation lines with a spacing of a few microns on the stable fatigue crack propagation zone in uniaxially fatigued epoxies [Tao 2007]. The boundary between the fatigue crack growth region and the smooth region (Figure 31b) corresponds to the transition from stable crack growth to unstable crack propagation.

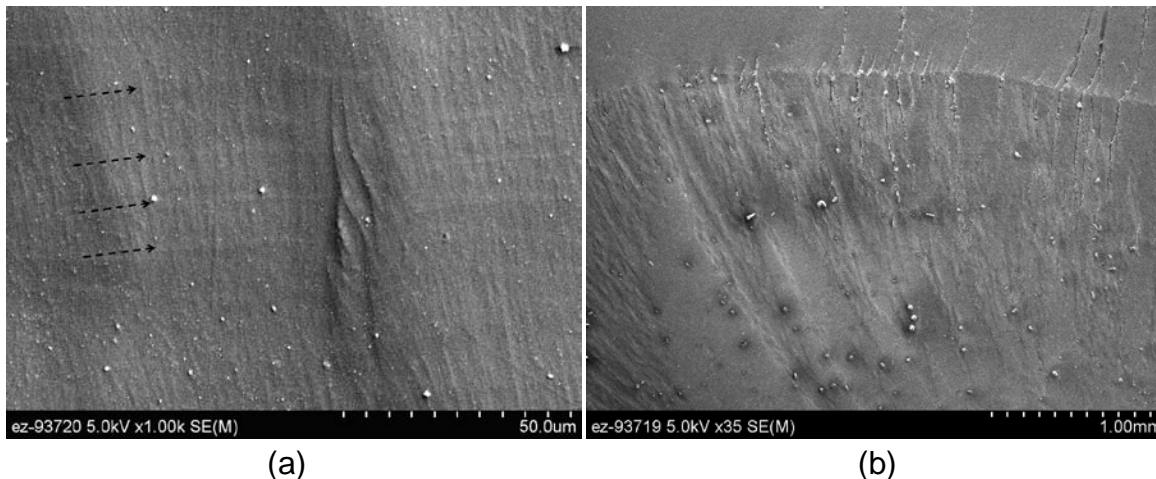
Figure 31. SEM image of the striation lines observed in GB2-5.

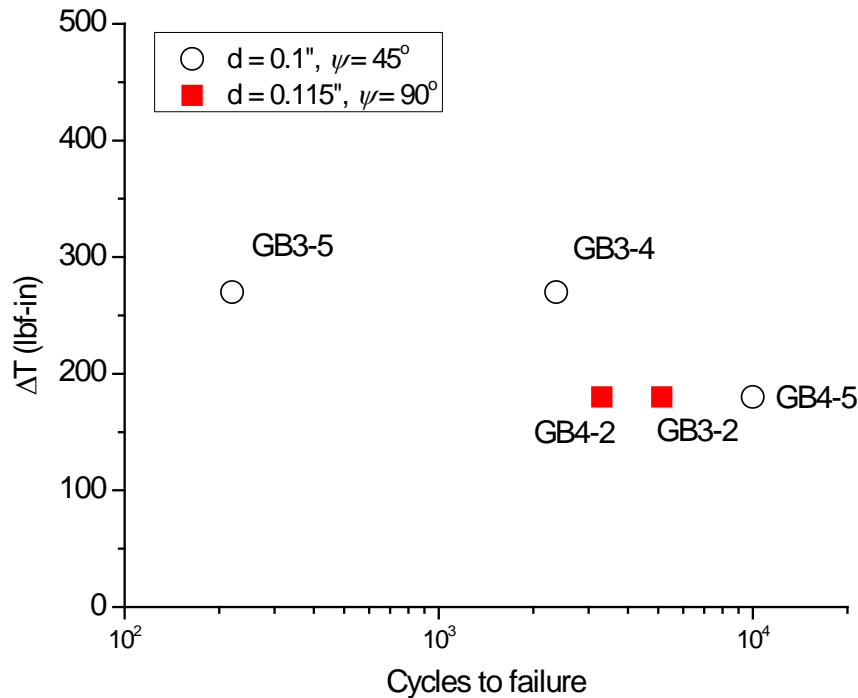
Figure 32. Fatigue S-N plots of samples from GB batch 3 and batch 4.

32). When compared to GB4-5, both GB3-2 and GB4-2 had shorter fatigue life (Figure 32), likely due to increased constraint induced by their deeper notches. GB3-5 was fatigued between 30 and 300 lbf-in with a frequency of 1 Hz. However, it is not clear why it fractured after only 220 cycles (Figure 32) while GB3-4 fractured after 2369 cycles when subjected to identical fatigue conditions. One possible explanation is that a surface flaw due to machining existed near the notch line region in the sample prior to fatigue. In fact, no crack growth region could be identified on the fracture surface of GB3-5 (Figure 33). In any event, the fatigue life difference between 220 cycles and 2369 cycles may well due to material inhomogeneity or anisotropy.

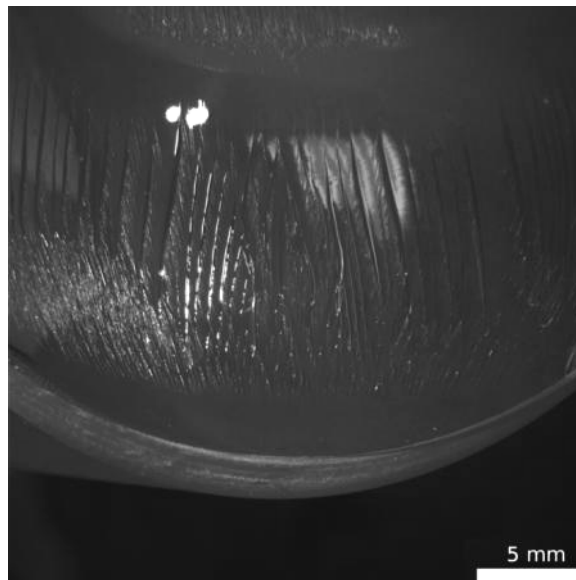
Figure 33. Fracture surface of GB3-5.

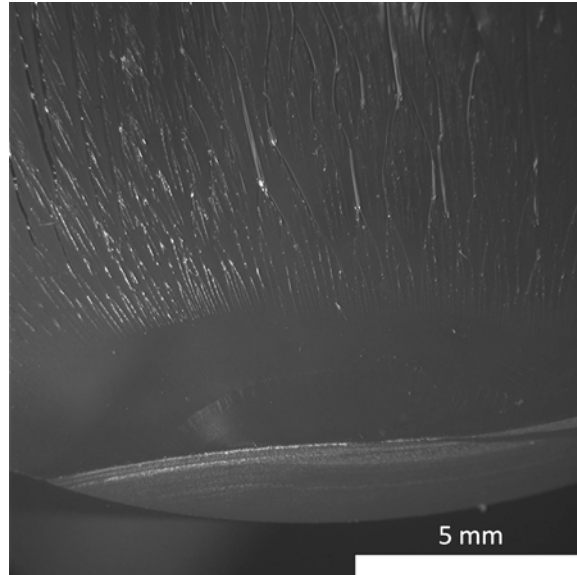
Figure 34. Fracture surface of GB3-4.

The fatigue regions on Mode I samples were expected to be a uniform band along the notch groove. However, the fatigue regions observed on the fracture surfaces of GB3-4 (Figure 34) and GB4-5 (Figure 35) were both long semi-ellipses. This deviation could be attributed to machining errors resulting in a pitch angle which deviated from  $45^\circ$ . It is interesting to point out that a broad striation line was observed on sample GB4-5 (Figure 35b). It is unclear the cause of this striation band, therefore it will require further investigation.

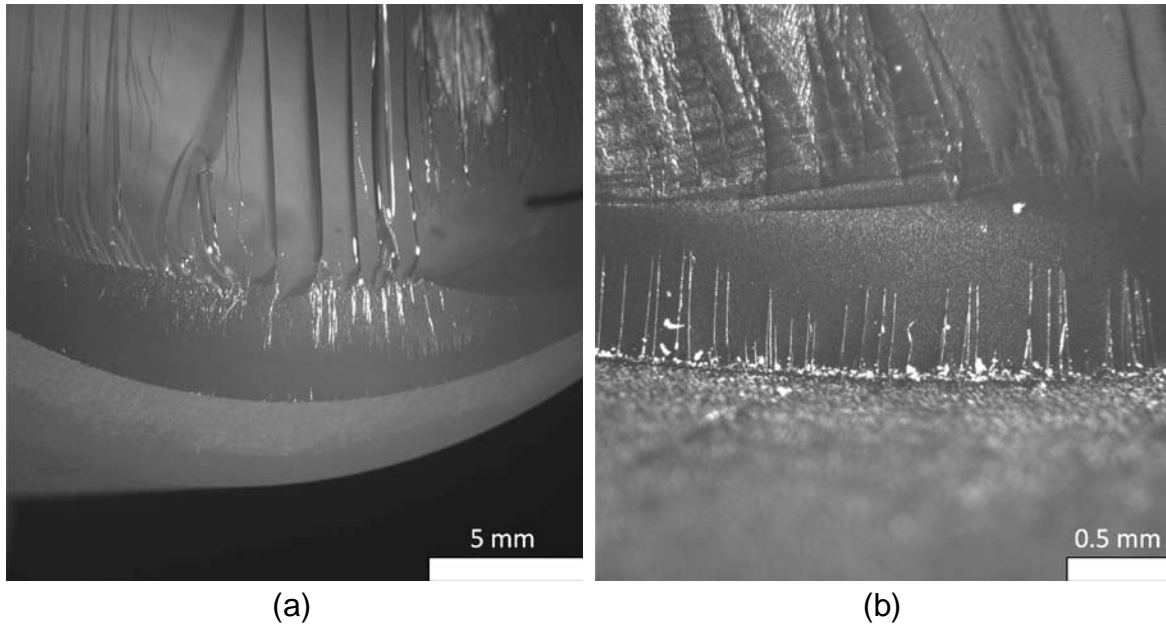
Figure 36. Images showing the radial markings along the groove line of GB3-2.

In contrast, uniform smooth bands (the smooth regions) were clearly seen on samples GB 3-2 and GB4-2 (Figure 36 and Figure 37). Higher magnification images of the smooth regions showed parallel markings with comparable lengths formed at a right angle to the notch roots which extended into the smooth regions (Figure 36b). These markings were observed in fatigued polyester resins and were attributed to stable fatigue crack growth [Owen 1975]. The fatigue regions on GB3-2 and GB4-2 agreed well with the expectation that a uniform fatigue growth occurs on a Mode I sample.

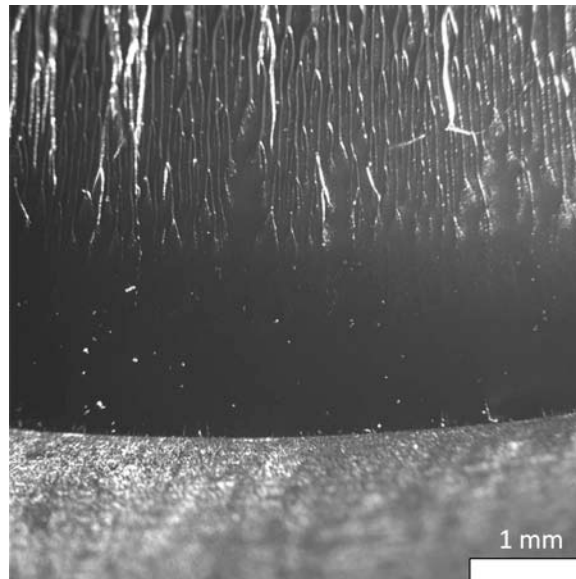
Figure 37. Images showing the uniform crack growth along notch line of GB4-2.

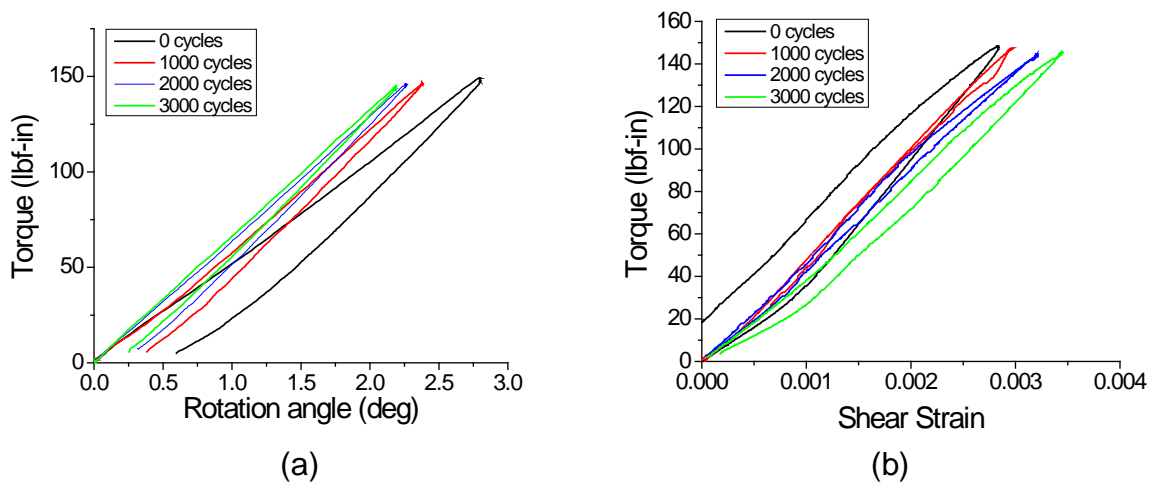
Figure 38. Effect of fatigue on stiffness of sample GB3-2 as measured from (a) load cell and RVDT, and (b) load cell and biaxial extensometer.

In contrast, a decrease in slope was observed in the extensometer measured data (Figure 38b). This seemed contradictory to the RVDT data. The RVDT measured the overall rotation of the entire sample, including the notched and un-notched regions; while the extensometer recorded the relative gage length displacement between the two probe pins across the notch. Therefore, the data measured by the extensometer is thought to give a more accurate estimate regarding localized deformation due to crack growth. Thus, the slope decrease in Figure 38b was a combined result from both crack growth induced compliance increases and hardening induced compliance decreases.

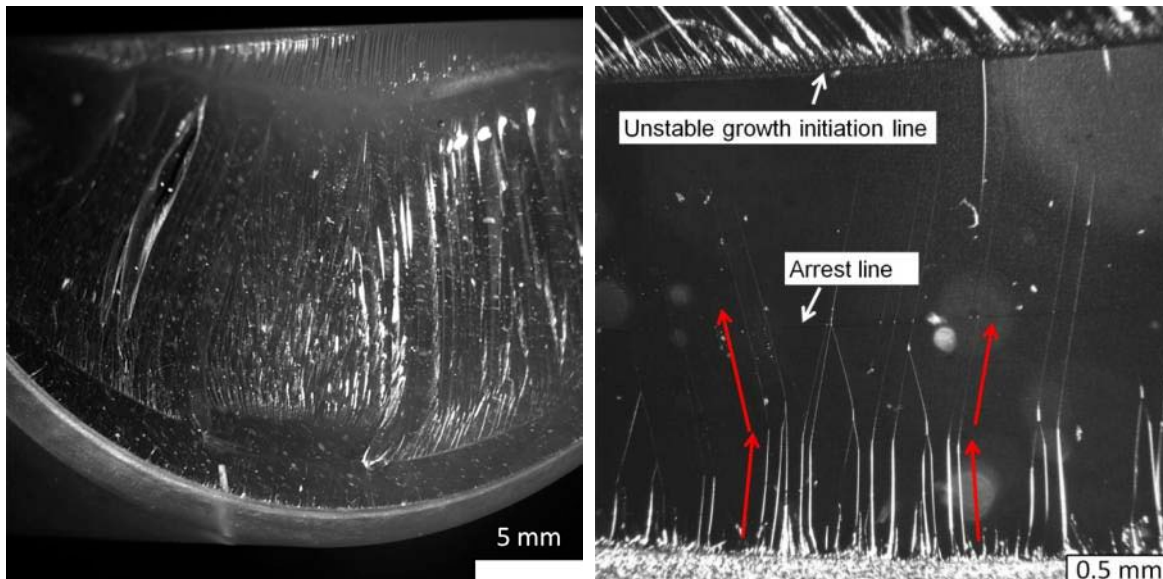
(a) (b)  
Figure 40. Images showing the fracture surfaces of MFG-3.

addition, parallel river markings, characteristic of stable crack growth were also seen (Figure 40b). The river markings initially grew perpendicular to the notch root, but then deflected at approximately 0.7 mm into the sample at two different angles (Figure 40b). This interesting behavior perhaps was related to some preferred stress directions and will be further investigated in the future.
