ORNL/TM-2010/191

**An Innovative Technique for Evaluating the Integrity  
and Durability of Wind Turbine Blade Composites  
FY2010 Report**

**Jy-An John Wang and Fei Ren**

Date Published: September 2010

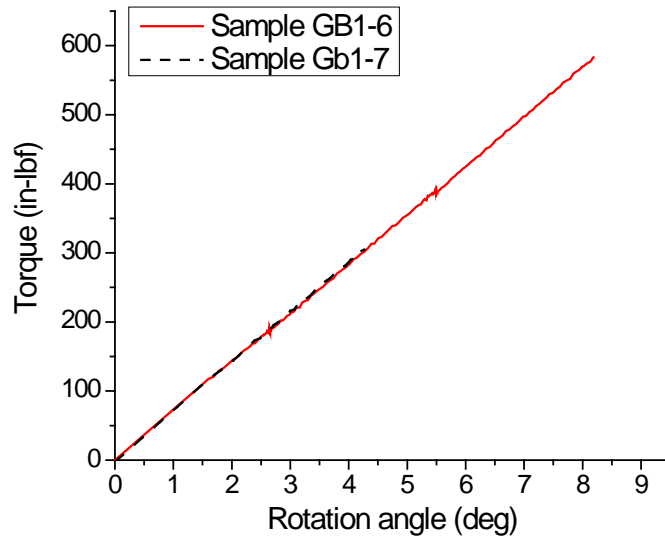
Figure 41. Monotonic loading curves of GB1-6 and GB1-7 after fatigue.

Samples GB1-6 and GB1-7 were fatigued for 5500 cycles and 260,000 cycles, respectively. Their final monotonic loading curves are compared in Figure 41. Both samples showed linear elastic behavior and almost identical slopes (Figure 41). However, the fracture torque of GB1-6 was 596 lbf-in, approximately 67% higher than that of GB1-7, which fractured at 357 lbf-in (Table 4). It was probable that the lower fracture torque of GB1-7 was due to a deep pre-crack as a result of longer fatigue cycles.

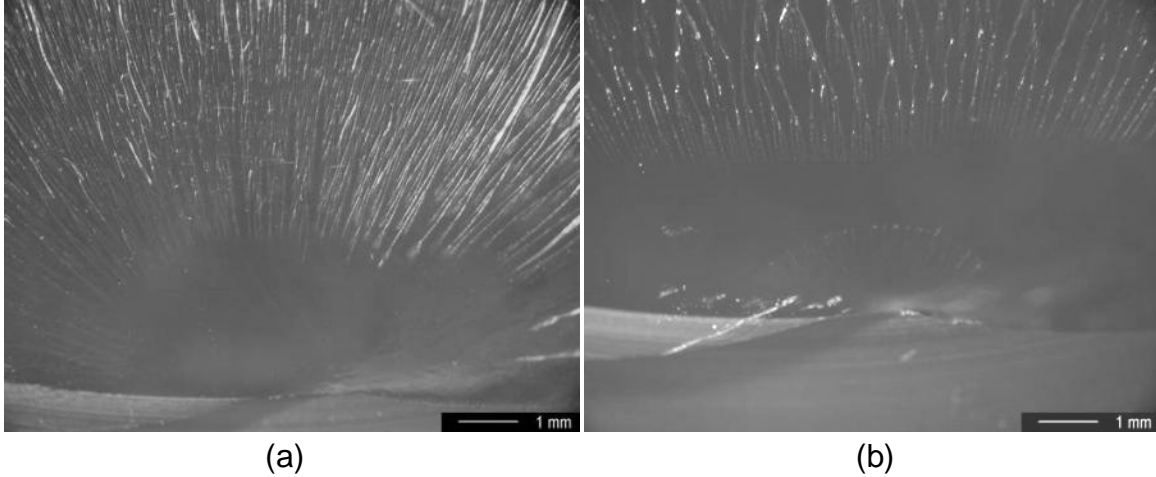
Figure 42. Fracture surfaces of samples GB1-6 and GB1-7.

Fractographic analysis showed that no significant fatigue region could be identified on sample GB1-6 (Figure 42a); while in contrast a clam-shell fatigue region was observed on GB1-7, which could explain its lower fracture torque compared to GB1-6.

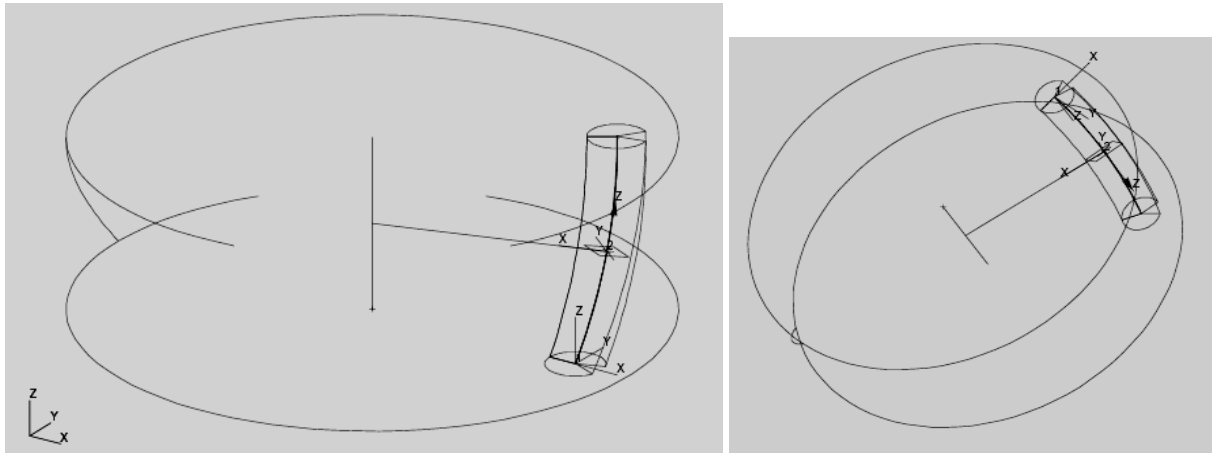
Figure 53. Schematic diagram of SNTT mesh design that allows the crack propagation to be perpendicular to the central axis of the SNTT samples.

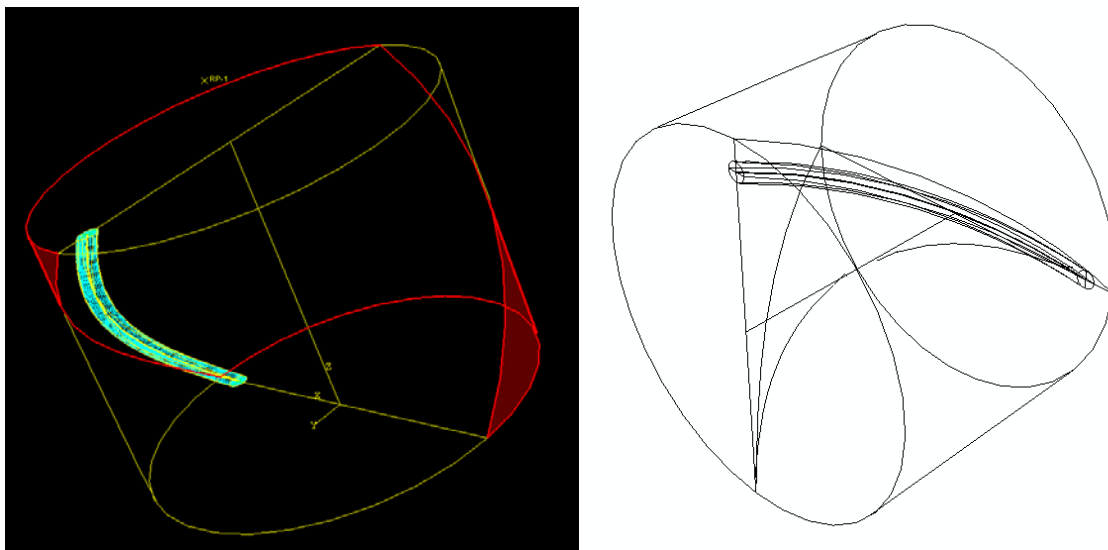
Figure 54. Schematic diagram of SNTT mesh design partition surfaces.

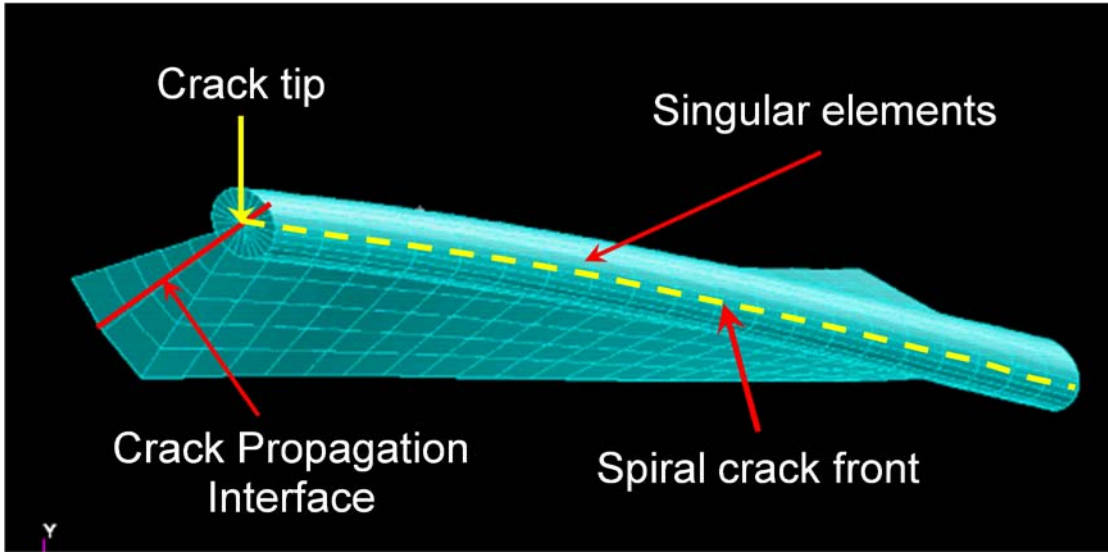
Figure 55. FEM mesh around crack front and crack tip, including the mesh boundary designed along the orientation of crack propagation.

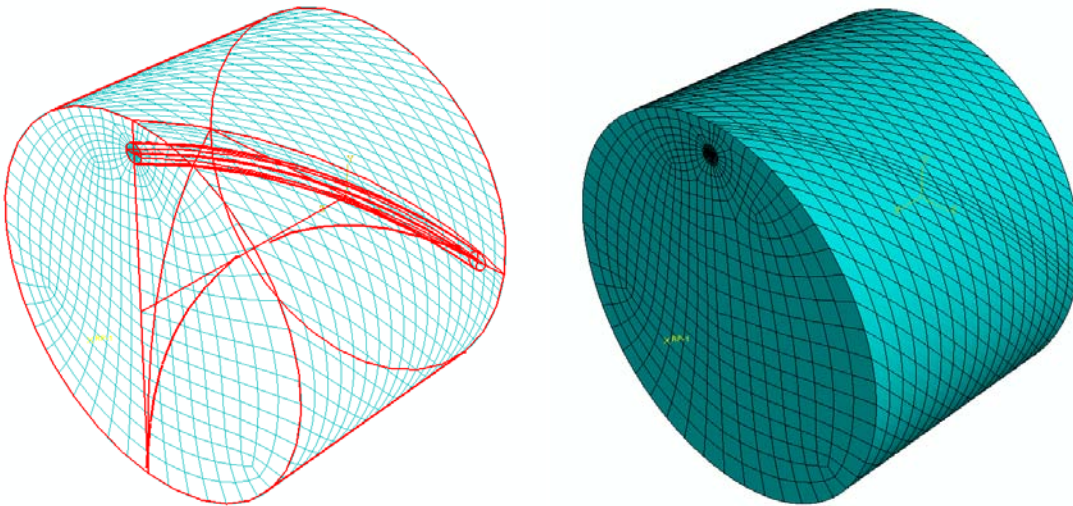
Figure 56. The FEM model designed for SNTT epoxy samples.

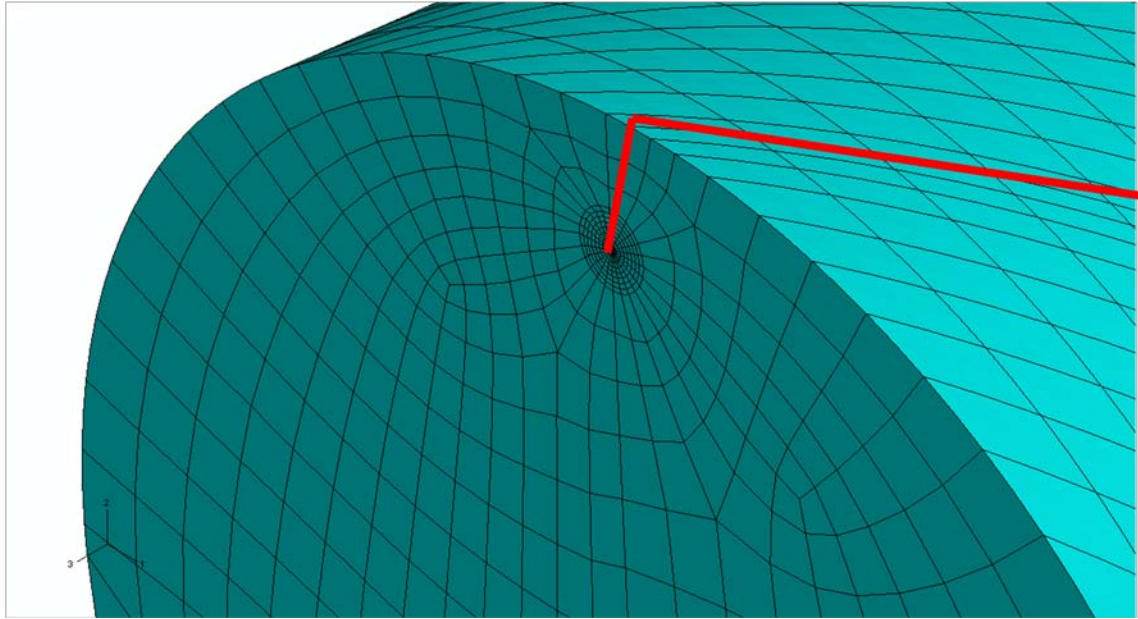
Figure 57. The enlarged view of FEM model for SNTT epoxy sample, where the red lines indicates the crack seam region.
