Tennessee Valley Authority's Campbell Creek Energy Efficient Homes Project: 2010 First Year Performance Report July 1, 2009–August 31, 2010

November 2010

Prepared by
OAK RIDGE NATIONAL LABORATORY
Oak Ridge, Tennessee 37831-6283
managed by
UT-BATTELLE, LLC
for the
U.S. DEPARTMENT OF ENERGY
under contract DE-AC05-00OR22725

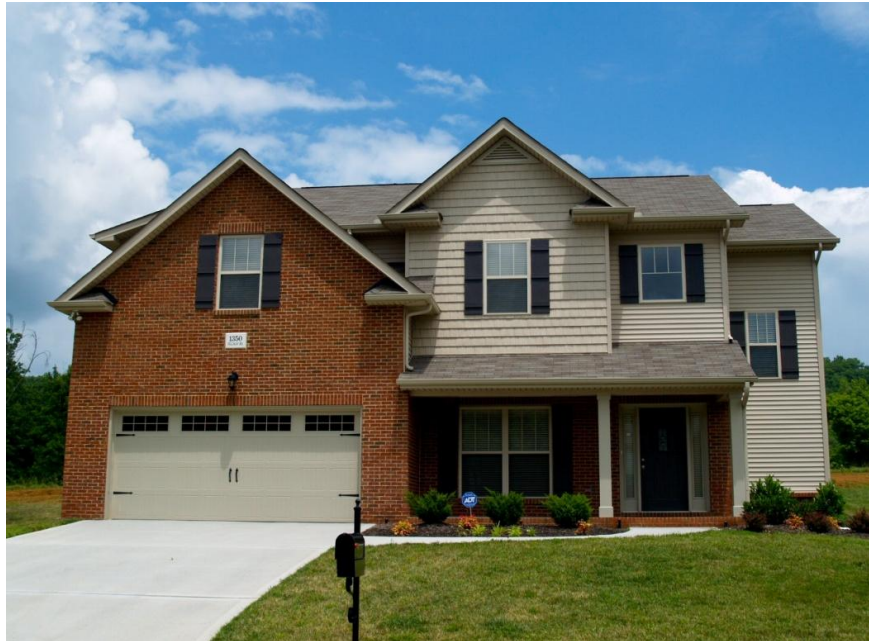
Figure 35. Picture of south elevation of CC2 from the street in July 2009.

CC2 is a 2400-ft², two-story dwelling (Figure 35). The front of the house faces the south. The floor plan shown below has three bedrooms, bonus room, living-dining room, kitchen, laundry room, two-and-a-half bathrooms, and an attached garage. The walls and roof are made of typical 2 × 4 frame construction. The walls are rated R-13 with the attic ceiling at R-30. The slab is insulated along the perimeter with 1 in. thick × 24-in. horizontal R-5 extruded polystyrene on all sides except that adjacent to the garage (Figure 36).

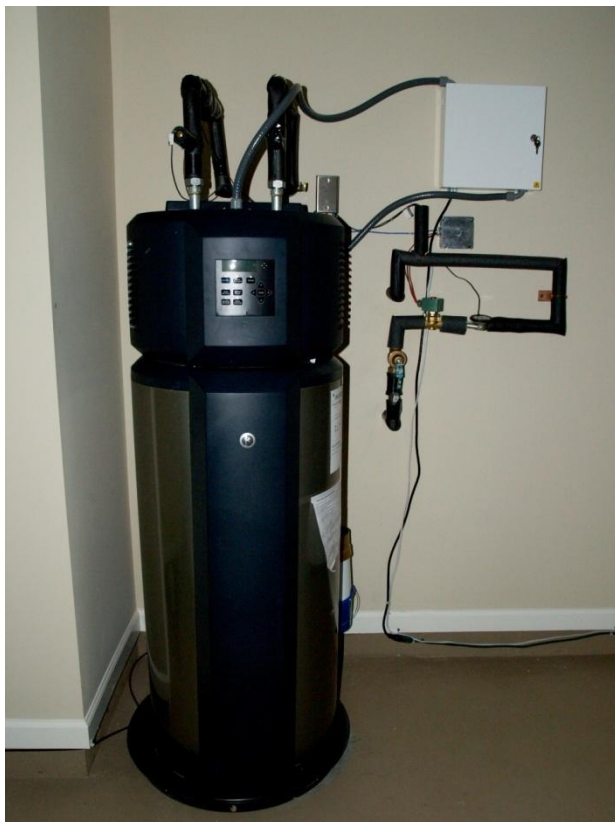
Figure 38. The GE Hybrid Electric Water Heater in the unconditioned garage.

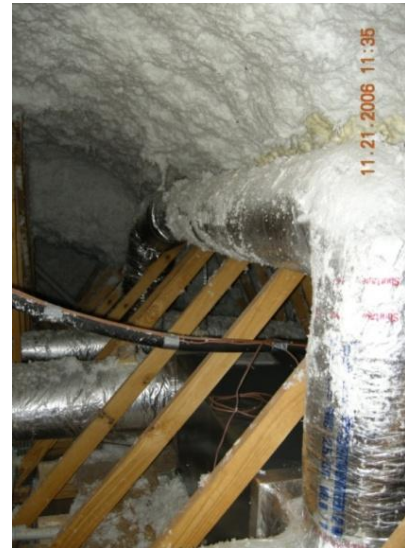
Figure 37. The three-ton HVAC unit in the conditioned, sealed attic space.

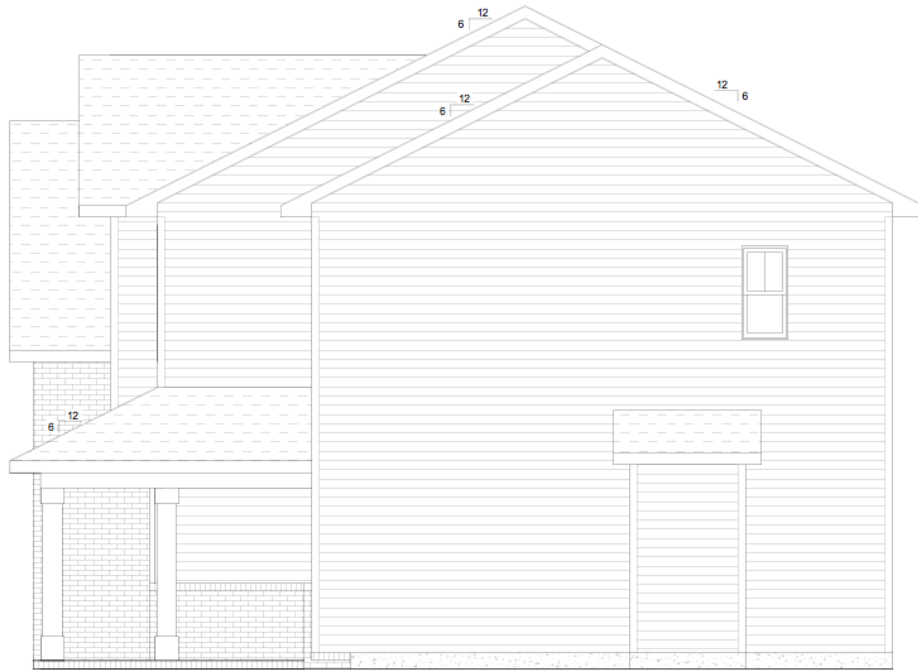
Figure 43. East elevation of CC1 and CC2. The front porch provides some shading to the windows in the first-floor living areas.

Figures 41 through 44 show the four elevations of CC1 and CC2.

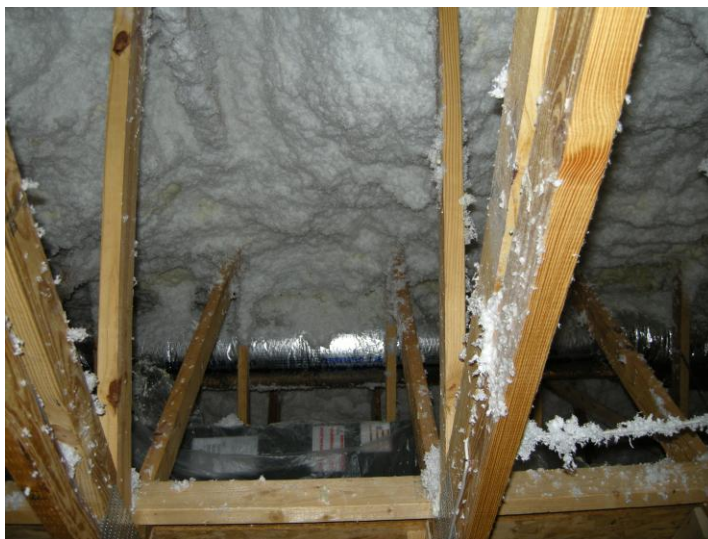
Figure 49. Need 90 degree angle to spray Spider foam.

Spider needs to be sprayed perpendicular to the surface, if obstacles are in the way like ducts, shown in Figure 49, other methods were implemented; i.e., netting, hand packing; 2 in. of Spider gave us a total attic ceiling insulation level of in situ measured R-30. Other interesting lessons learned are shown in Figures 50–56.

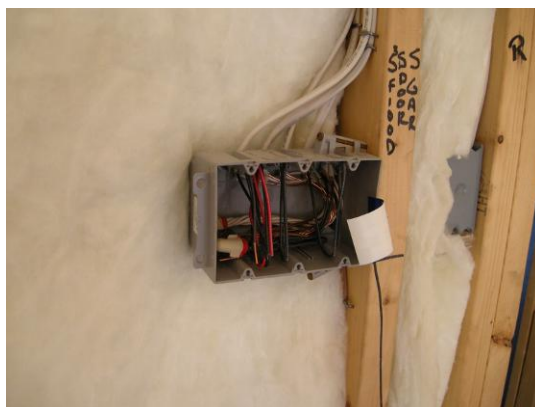
Figure 50. Switches on wall between garage; compressing insulation and no air seal.

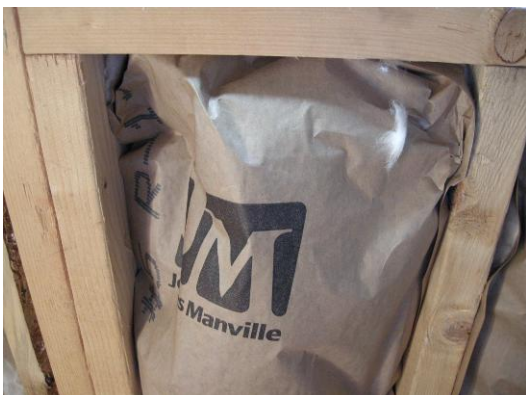
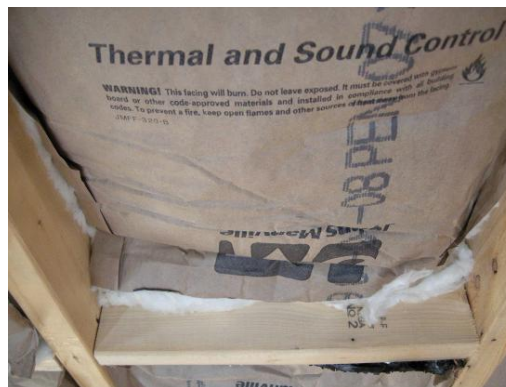
Figure 51. Retrofit House batts not installed as well as CC1.

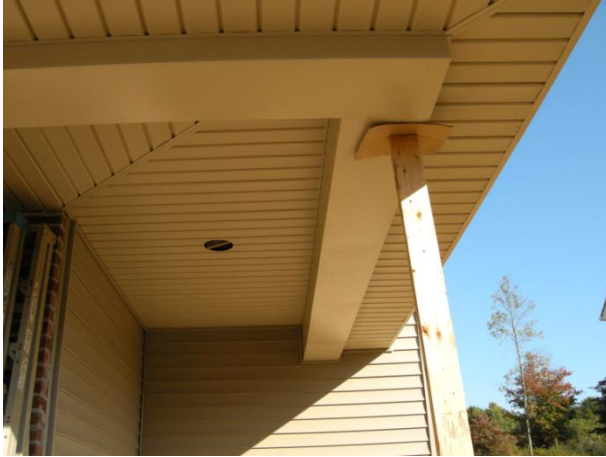
Figure 52. Front Porch Box Beam from the outside.

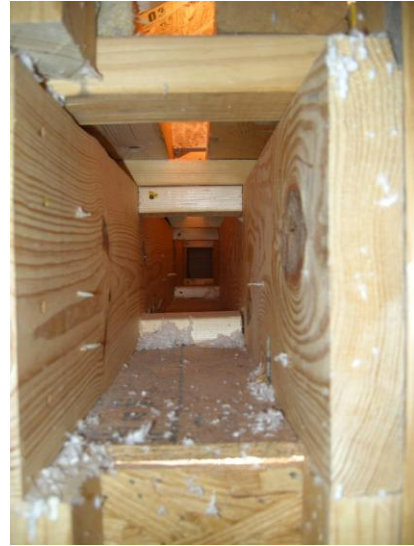
Figure 53. Box Beam runs right into the house.

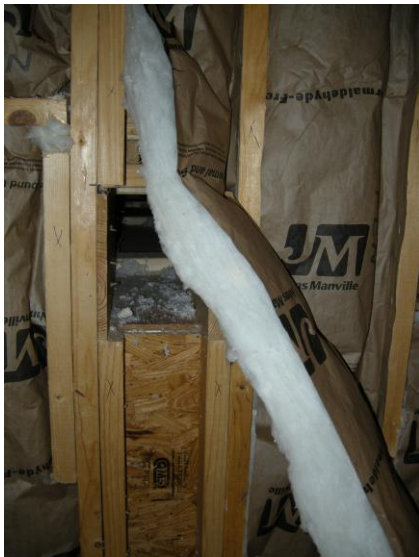
Figure 54. Porch box beam on the inside; run right into the house.

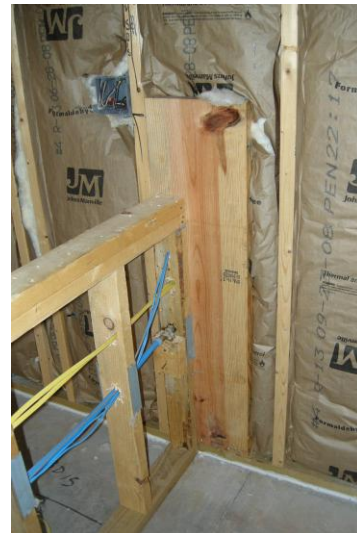
Figure 55. Block cavity to prevent proper insulation in the wall.

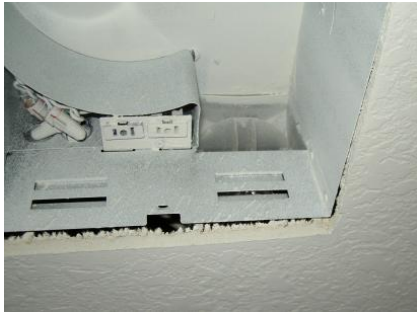
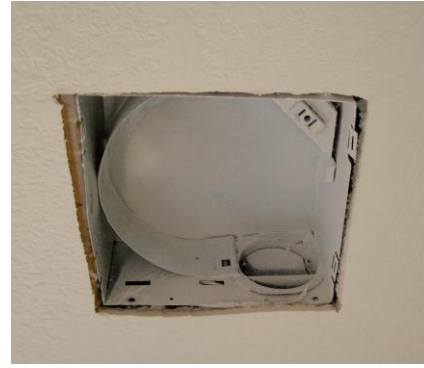
Figure 56. Bath exhaust fans; painted open or shut in this house.

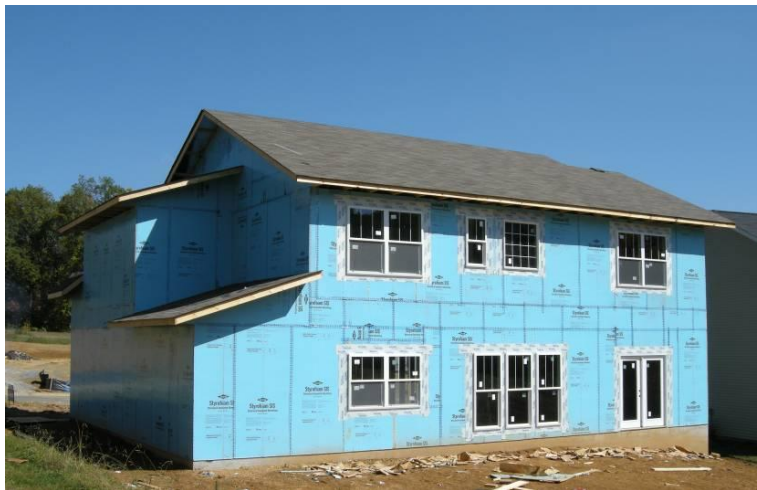
Figure 57. The south elevation of CC3 during construction.

The Campbell Creek CC3 south elevation is shown during construction in Figure 57. The back of CC3 faces 26 degrees west of true south.

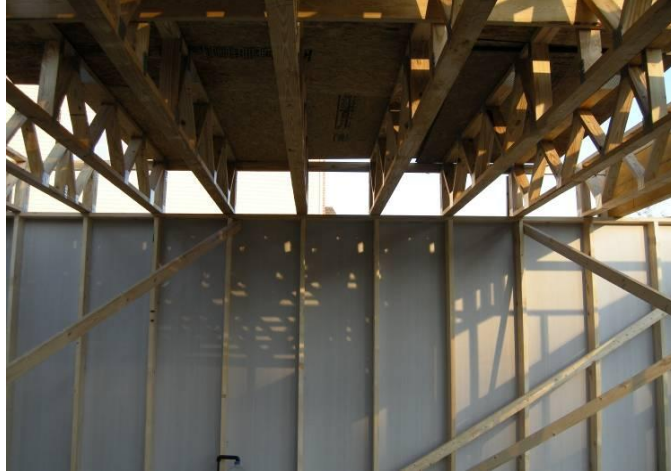
Figure 58. First-floor framing aligned with the second-floor trusses. Note single top plate.

The floor plan has three bedrooms, two and a half baths, living room, dining room, kitchen, laundry room, and bonus room. The wall construction is optimum-value framing consisting of 2×6 's on 24 in. centers, DOW SIS, 1 in. of closed-cell spray foam, and the remainder of the interior cavity shown in Figures 58–60 filled with Spider blown-in fiberglass.

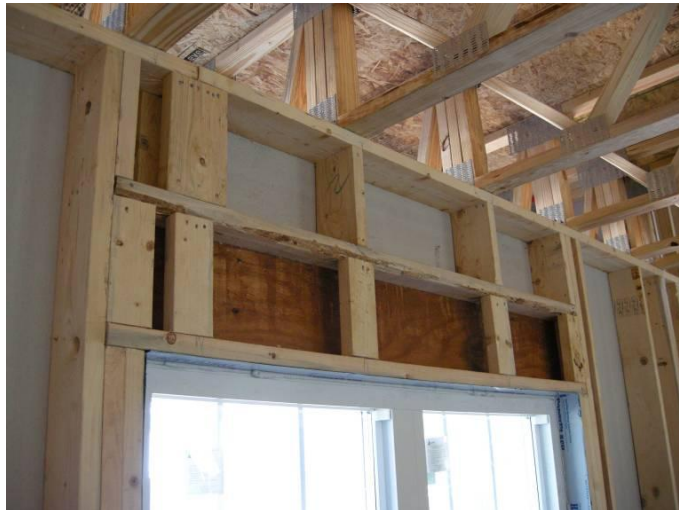
Figure 59 shows the single laminated-veneer-lumber structural header, allowing longer window and door opening spans than standard dimensional lumber, as well as more insulation.

Figure 59. Advanced header framing of CC3.

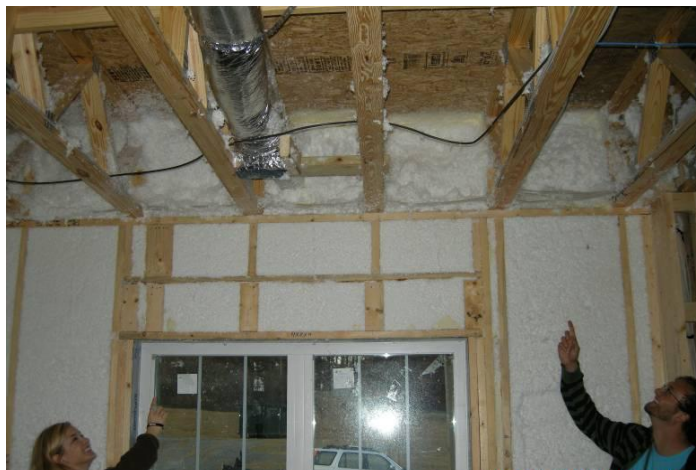
The cantilevered floor over the front porch was sprayed on all interior surfaces with at least 1 in. of foam and the remainder of this cavity space was filled completely with Spider (Figure 60) to avoid convective heat transfer. Also shown are the insulated header and wall cavities.

Figure 60. Insulation under the cantilevered floor.

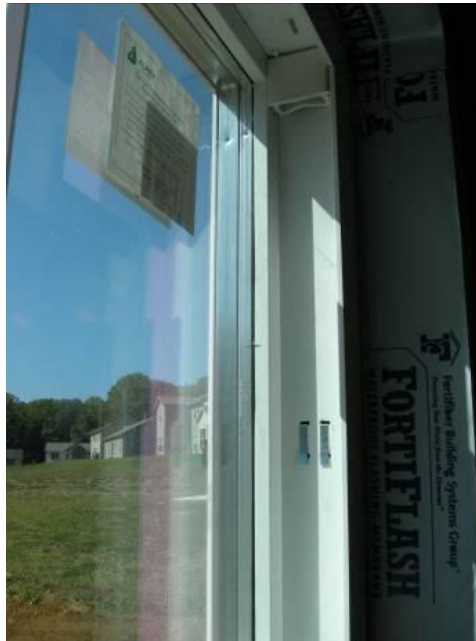
Figure 61 shows the triple-pane windows used in CC3. These windows, provided by Serious Materials of California, have a U-value of 0.15 and SHGC of 0.26.

Figure 61. Triple-pane windows from Serious Materials.

The National Fenestration Rating Council recommends that windows for all-electric houses in mixed-humid climates and having energy costs around \$0.09/kWh should have an R-value of at least 0.34 and a solar heat gain coefficient no higher than 0.33. The visible transmittance for the windows used in CC3 was 0.47. The warranty on the test house windows, which is not prorated, guarantees to the purchaser of windows installed as new construction or as replacements that Serious Materials, Inc. will repair or

replace any defective materials for as long as the homeowner resides in the home. Serious Materials, Inc. (<http://www.seriousmaterials.com/>) specifically designed its 500-series single-hung vinyl windows with foam-insulated frames and triple-layer panes for the test houses. Serious Materials estimated installed cost of the 16-window package for CC3 at \$10,000 in 2008. A more recent cost for the windows of \$8.30/ft² above the cost of CC1 windows was obtained in September 2009. This is a \$2,465 cost difference between the windows in CC1 compared to the triple layer window package in CC3. If interior window trim is used, jamb extensions should be ordered installed on the windows. This will speed the window installation on site.

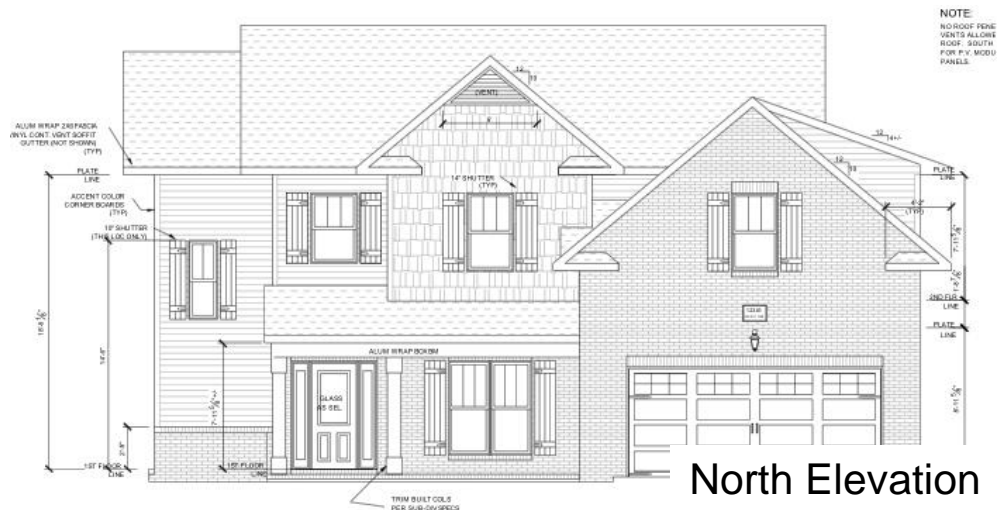
Figure 64. North elevation of CC3. The space under the front porch is insulated with 1 in. of spray foam insulation and the remaining area with blown-in fiberglass (Spider).

Figures 64 through 67 show the four elevations of CC3 (produced by Larry Northcutt, River Chase Construction). CC3 has the same layout as CC1 except that two windows are relocated to the south (which saved 27 kWh/year). The additional 8 in. to the overhang on the south elevation saved 2 kWh/year. Exterior shading is a much smaller issue because of the high-performance windows on this house.

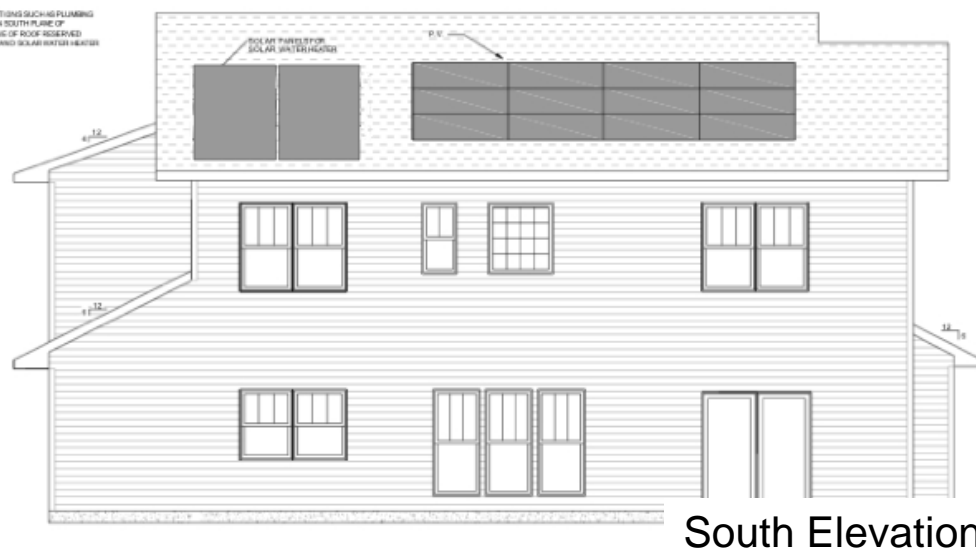
Figure 65. South elevation of CC3. The solar thermal collectors for the solar water heater are on the left and the PV modules on the right of the south-facing roof. Most of the windows are on the south side, providing great daylighting. There remains sufficient space to double the number of 208-W PV modules on the roof to 24 (an increase from 2.5 kW_{peak} to 5.5 kW_{peak}).

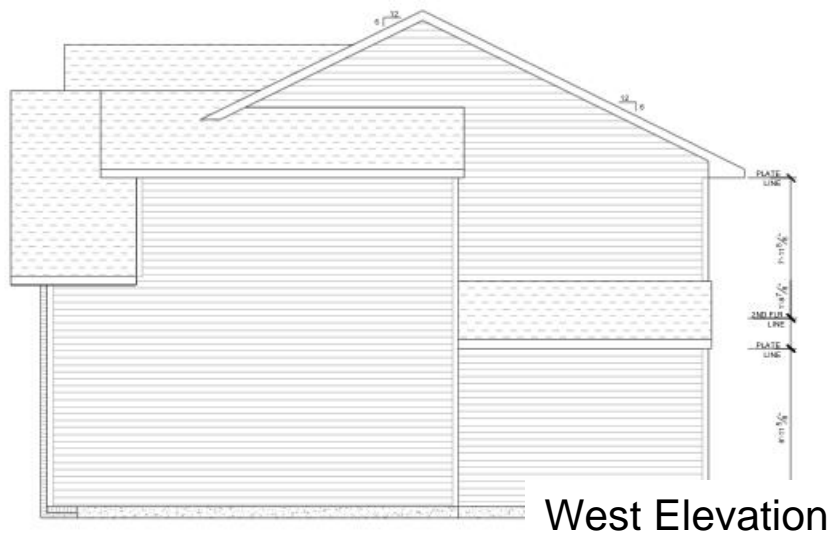
Figure 67. West elevation of CC3. One 3×5 window originally on the west side of CC1 design is moved to the south elevation.

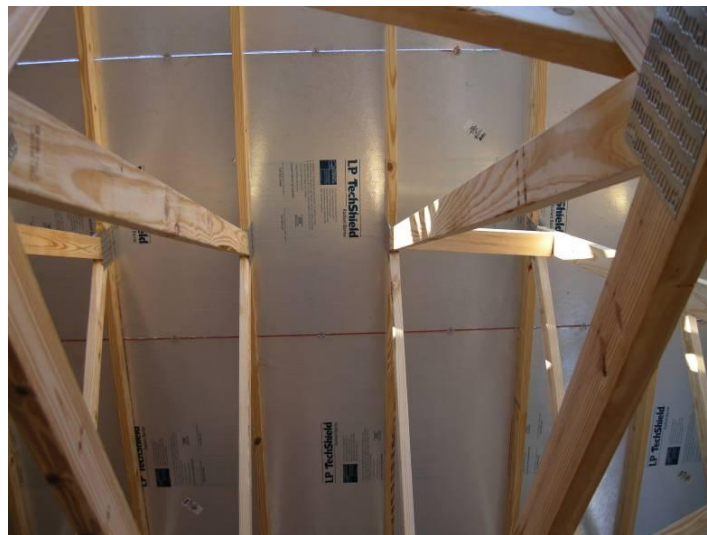
The roof of CC3 is constructed on a 2 × 4 truss system with three-quarter-inch OSB and LP Techshield Radiant Heat Barrier laminated to the underside. Next #30 asphalt-impregnated roofing paper was weather-lapped on the roof as soon as the sheathing was installed (ASTM 4869 Type II). The roofing system on CC3 is a 3-tab composite shingled roof. Figure 71 depicts the radiant barrier used under the roof sheathing. To help

Figure 71. LP Techshield radiant barrier roof sheathing.

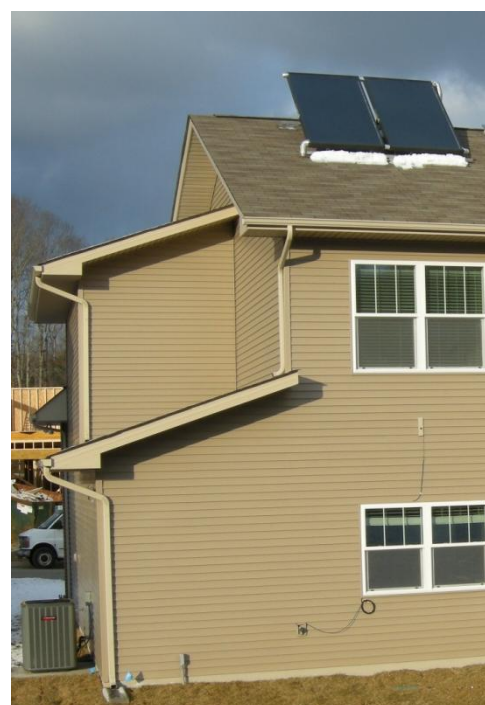
Figure 75 shows the solar water heater collectors that were installed on CC3 by Sustainable Future (<http://sustainablefuture.biz/>) of Knoxville, Tennessee. Including the cost of the 85-gal storage and drain back tanks, this system had a total cost of \$10,333 in 2008. This two-panel system meets the Solar Rating and Certification Corporation standard. The two panels are angle mounted at 40° to the composite shingled roof as shown in Figure 77. The roof slope is 23°. Instead of using a smaller PV module to power the DC circulation pumps; this system uses a SolVeloX heat exchanger pumping system to control the entire pumping operation. The storage tank used is an 85-gal electric water heater by Rheem Marathon, Model Number MR85245 B. This tank has an EF of 0.92.

Figure 75. Solar water heating system was installed by Sustainable Future, Knoxville, Tennessee.

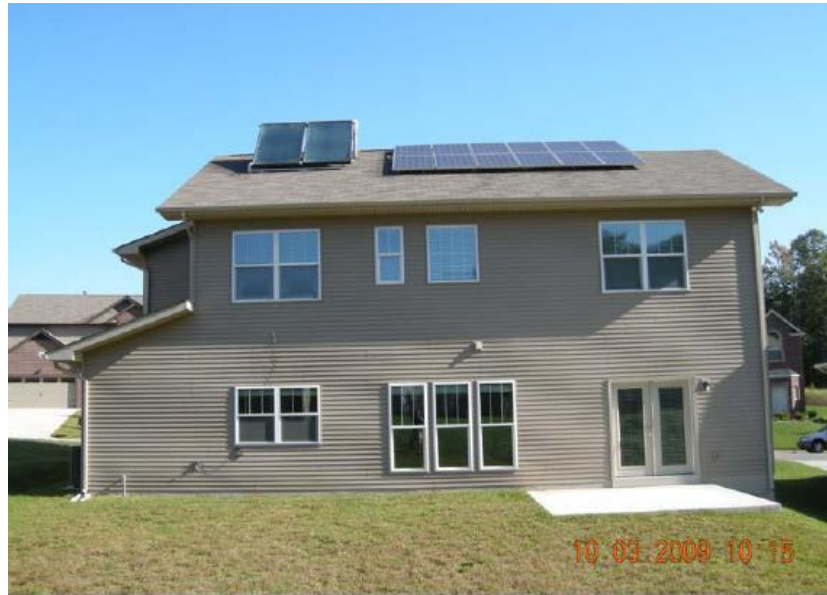
Figure 77. Twelve 208-W PV modules installed on the south-facing roof by Big Frog Mountain.

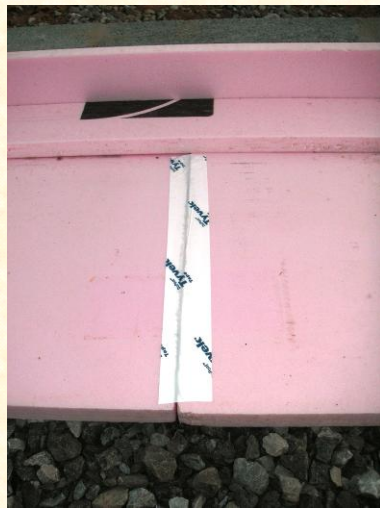
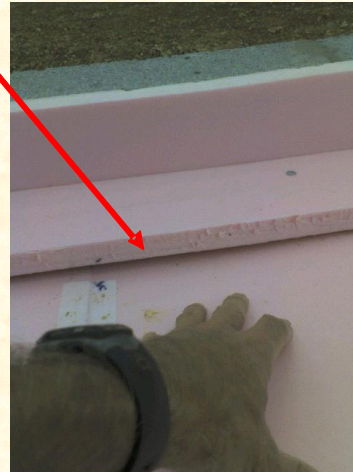
Thermal short

Figure 79. Slab insulation thermal short.

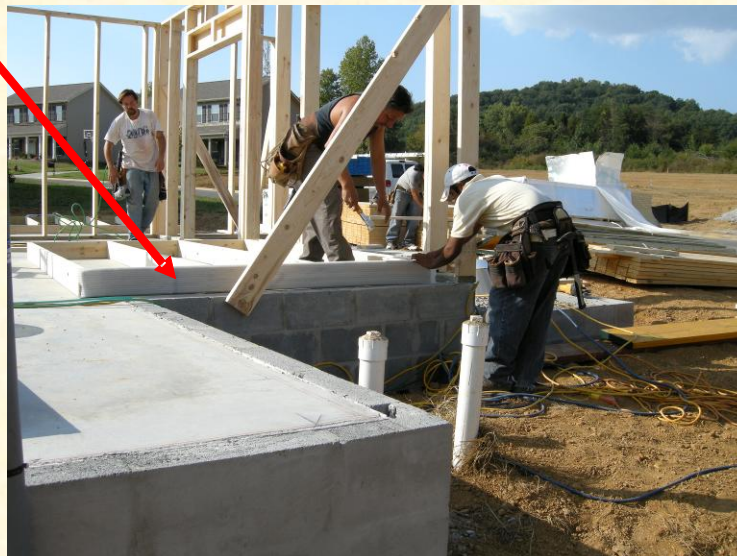
Before the wall is pushed up; 1. staple sill seal to pressure treated bottom plate

Figure 80. Sill seal sandwich step one.

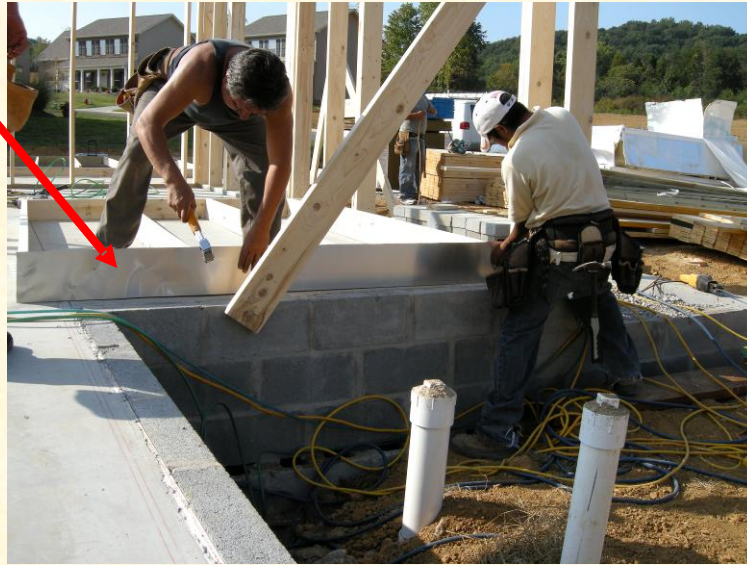
2. Staple 6 in. aluminum flashing

Figure 81. Sill Seal Sandwich step 2.

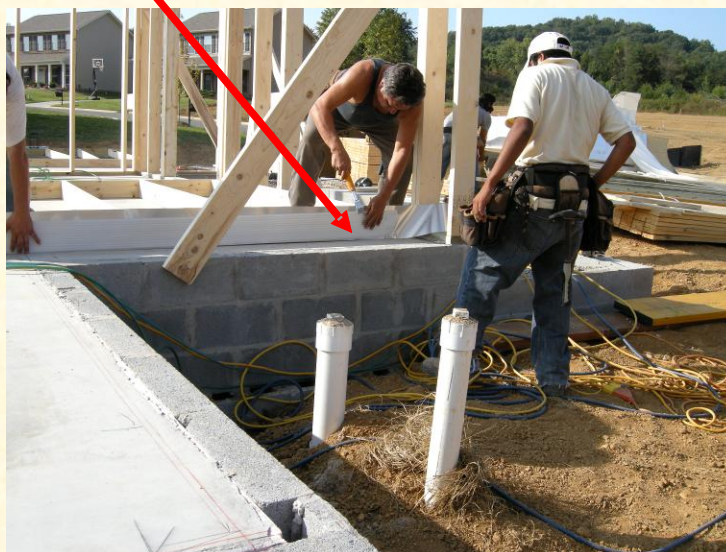
3. Staple second layer of sill sealer

Figure 82. Sill seal sandwich step 3.

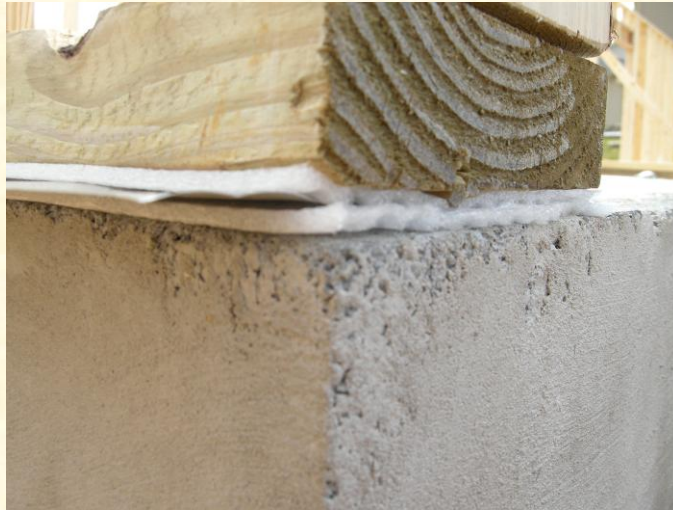
Air seal, termite barrier and capillarity break sandwich

Figure 83. Sill seal sandwich.

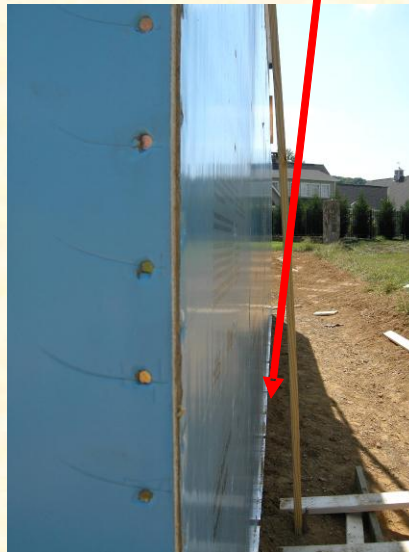
Flashing makes nice kick out at bottom of wall for the drainage plane

Figure 84. Wall base plate flashing kickout.

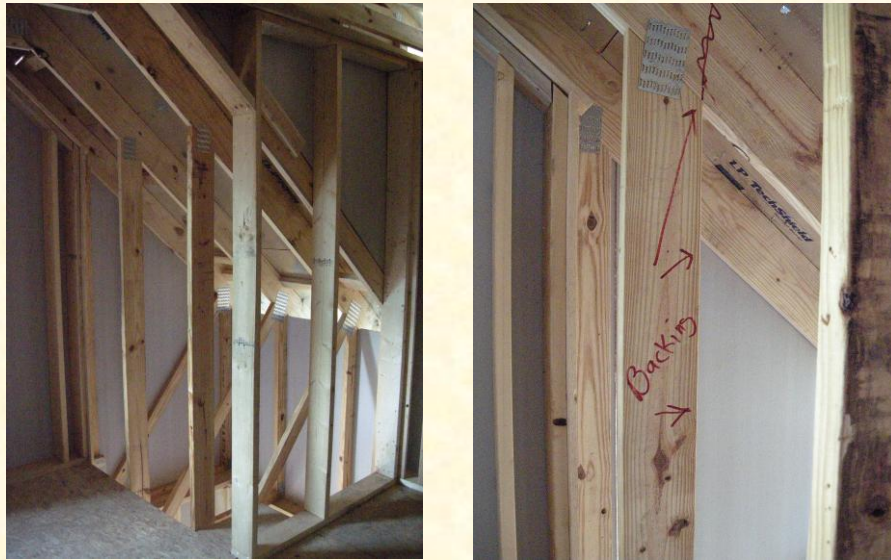
Knee walls; Classic over sight

Figure 85. Knee wall begging for backing.

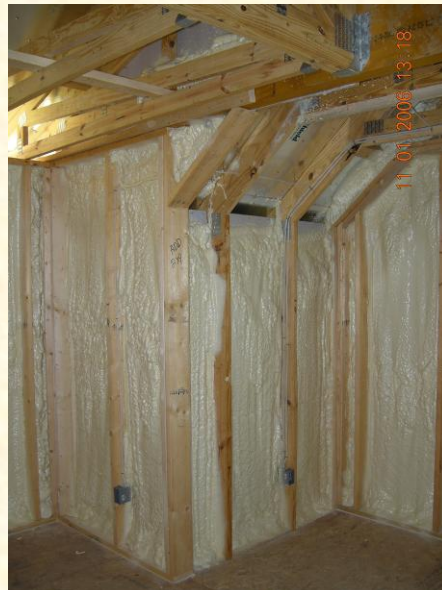
Bonus knee walls all foamed up ready for Spider

Figure 86. Foam sealed knee wall.

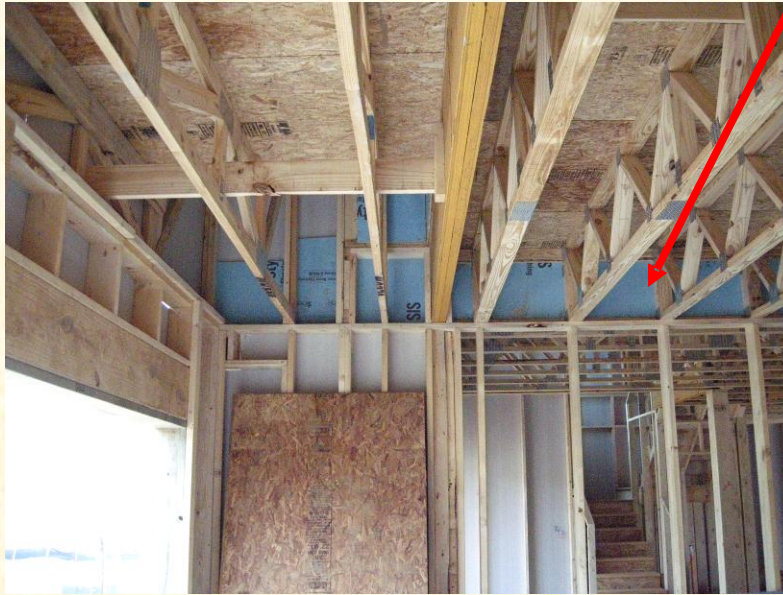
Blocking between garage and dining

Figure 87. Floor joist blocking between the garage and conditioned space.

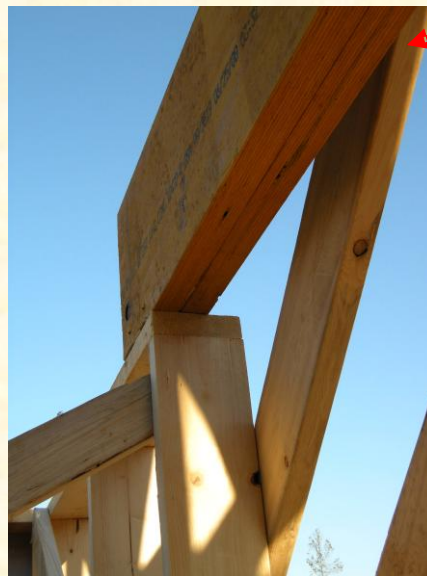
Bonus drywall ceiling, right under LVLs

Figure 88. Hard to insulate thermal short caused by structural detail.

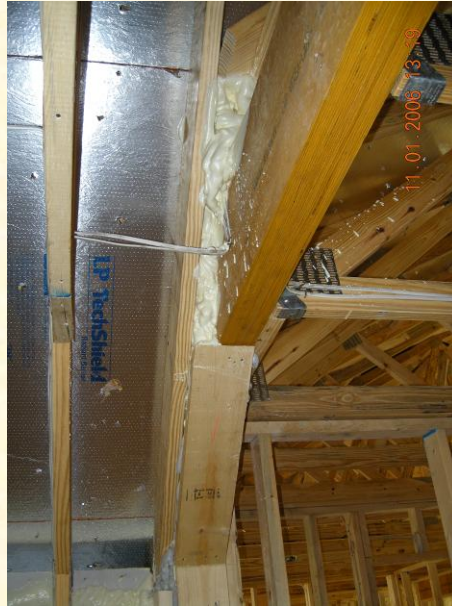
Foam works well on these tight spots

Figure 89. Foam helps in hard to get at potential air leakage point in Bonus room.

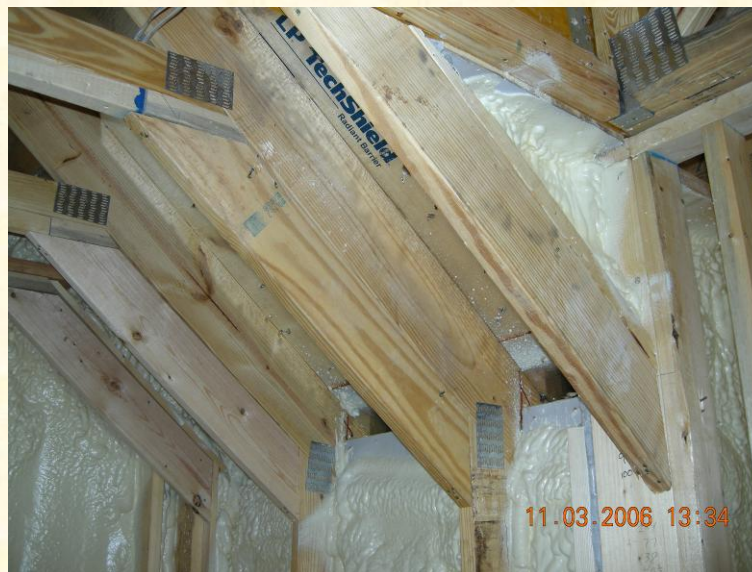
Added 2X6s to allow R-41 in the Bonus Room cathedral ceiling

Figure 90. Cathedral ceiling cavity depth extensions allow for greater insulation thickness.

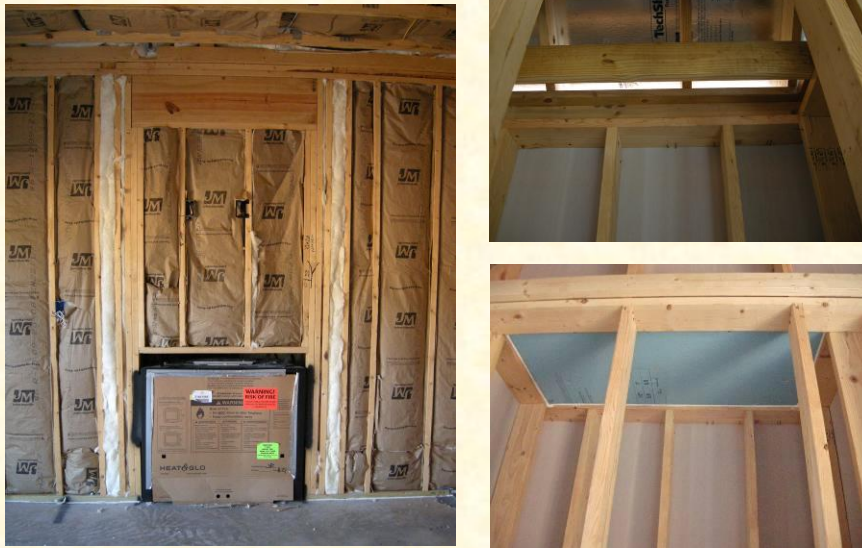
Fireplace chase blocking added to stop air leakage

Figure 91. Fireplace chase needs added airtightness and insulation consideration.

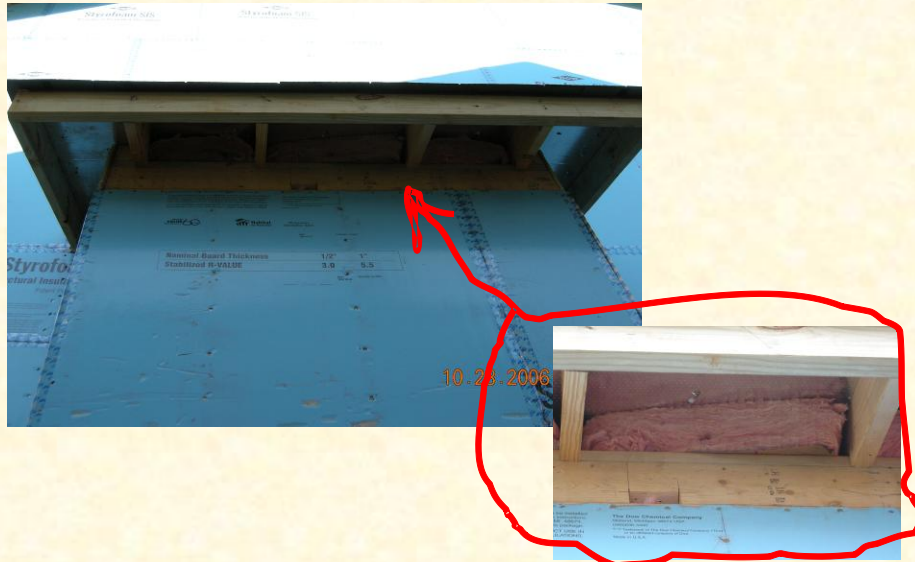
Behind the fireplace chase

Figure 92. Looking up into the soffit of the fireplace chase with added insulation.

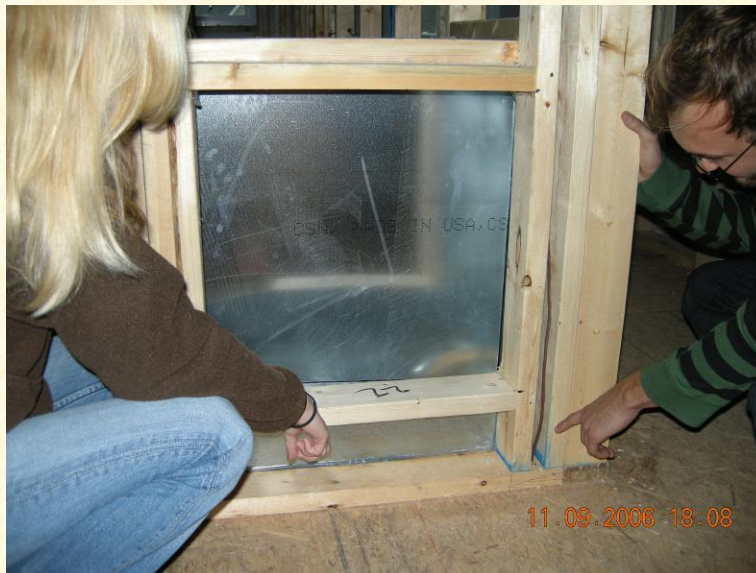
Return duct all continuous sheet metal

Figure 93. Very common return duct installation bad practice.

Lesson 6. Avoid the HVAC return register air gap.

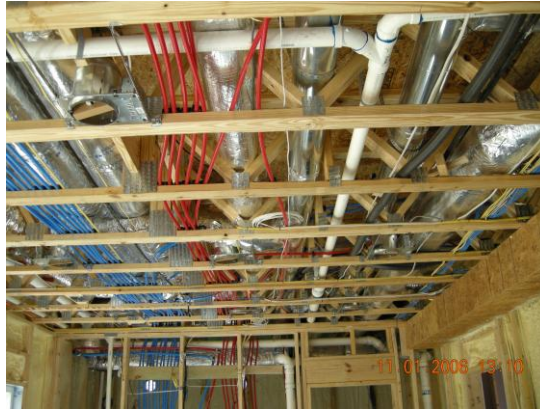
Figure 94. Ceiling between floors coming out of the mechanical room in CC3.

Lesson 7. Optimum value floor joist duct design required.

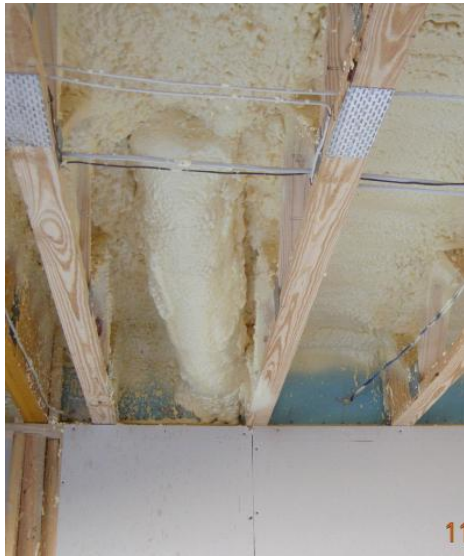
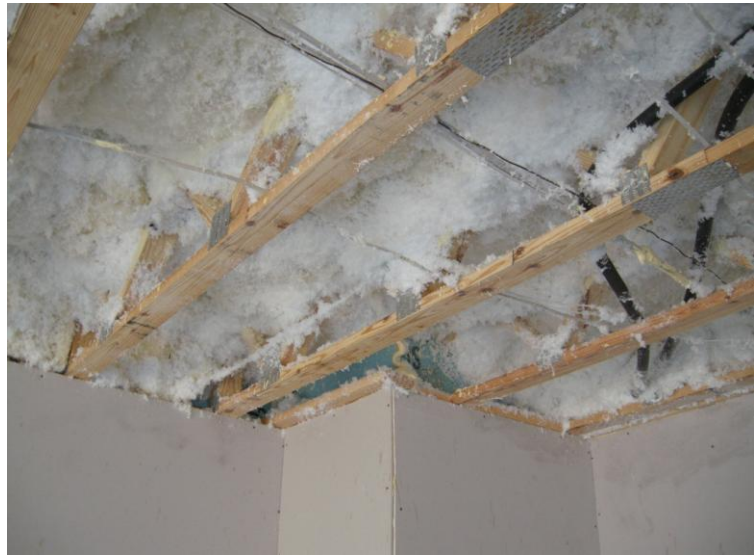
Lesson 8. Backup insulating and air sealing duct runs in unconditioned spaces.

Figure 95. Proper insulation and air sealing in bonus room floor above the garage.

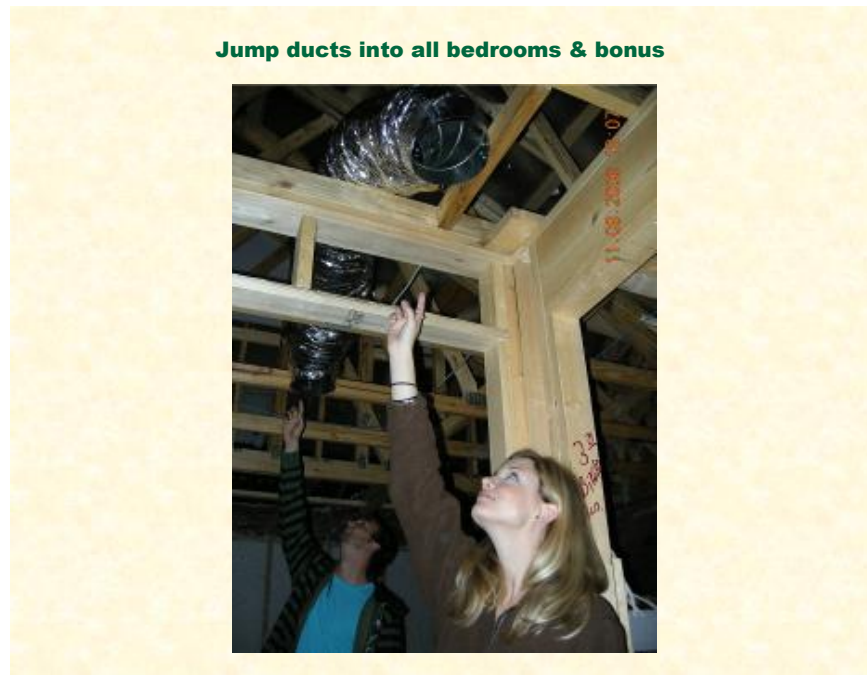
Lesson 9. Jump ducts yes but avoid air leaks into unconditioned attic spaces and discontinuity in uniform attic floor insulation.

Figure 96. Jump ducts relieve unwanted pressure imbalance when bedroom doors are closed.

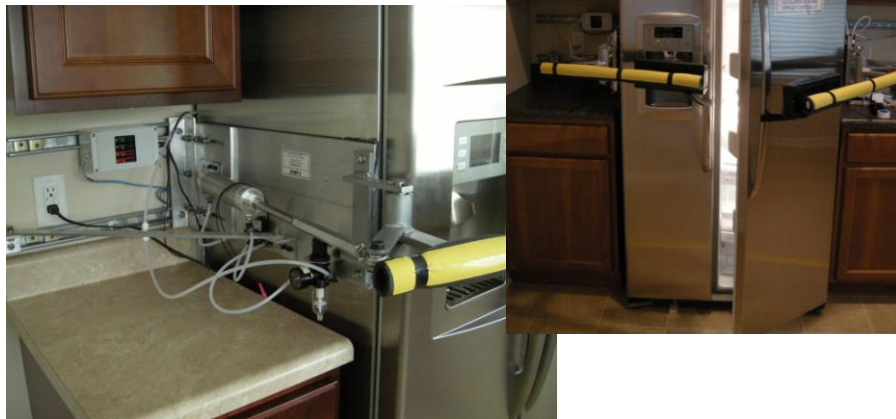
Both the freezer and refrigerator doors are opened and closed by a pneumatic system consisting of an air compressor, an electrically controlled valve and pneumatic piston with an arm and hinge for opening the doors. The electrically controlled valve is wired to a relay that is controlled with the LabVIEW® program. When the relay is open the door is closed; when it is closed the door is open. A picture of the refrigerator door opener is shown in Figure 100. This robotic refrigerator door opener has been very reliable and gets most of the attention from guests who are touring the research houses.

Figure 100. Refrigerator and Freezer door opening apparatus.
