Smart Infrared Inspection System Field Operational Test

June 2011

Prepared by
OAK RIDGE NATIONAL LABORATORY
Oak Ridge, Tennessee 37831-6283
managed by
UT-BATTELLE, LLC
for the
U.S. DEPARTMENT OF ENERGY
under contract DE-AC05-00OR22725

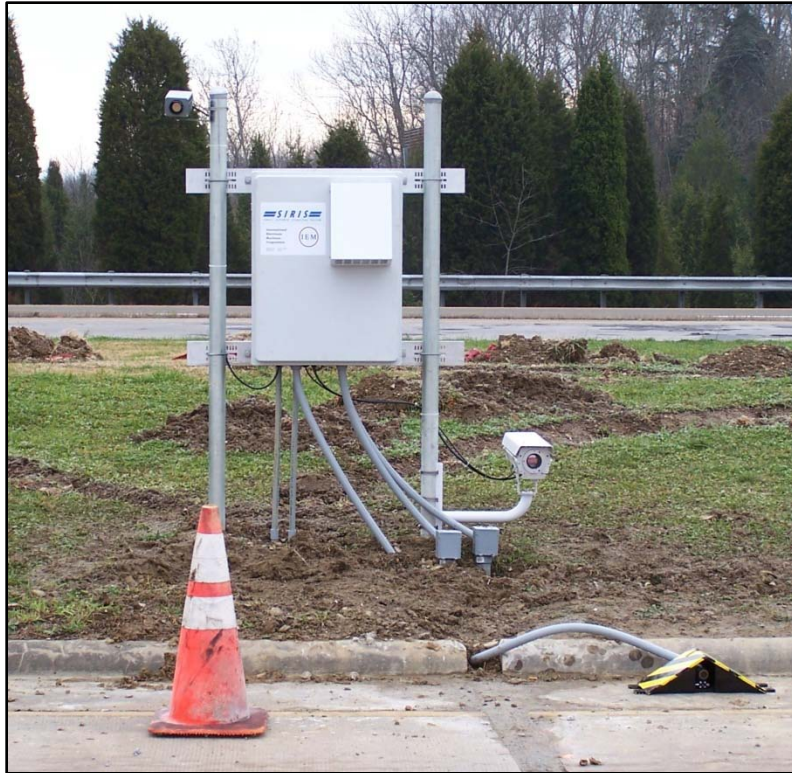
Figure 1. Driver's side components of the SIRIS system.

- Two thermal infrared cameras, one on either side of the lane;
- One visible camera;
- One vehicle presence detection sensor;
- Wheel triggers;
- Roadside electronics for system control and power management;
- Cross lane cabling for remote camera system;
- Fiber cable from roadside to in-scale-house computer;
- Computer system and monitor;
- SIRIS software to evaluate vehicles and to make notification when vehicles with the following conditions were detected:
 - Unusually cool brakes,
 - Overheated brakes,
 - Overheated tires, and
 - Overheated wheel bearings.

The roadside SIRIS components are shown in Figure 1 and Figure 2.

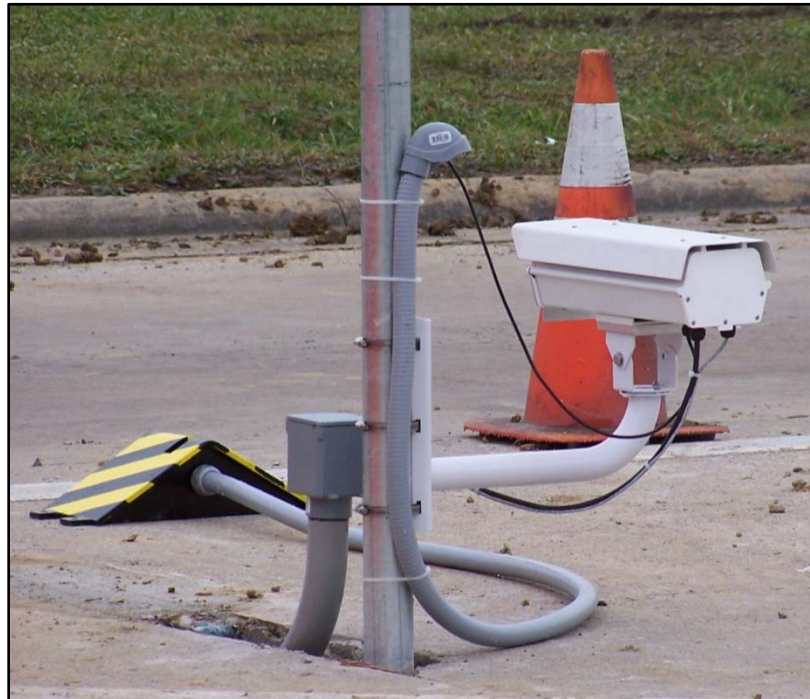
Figure 2. Passenger side components of the SIRIS system.

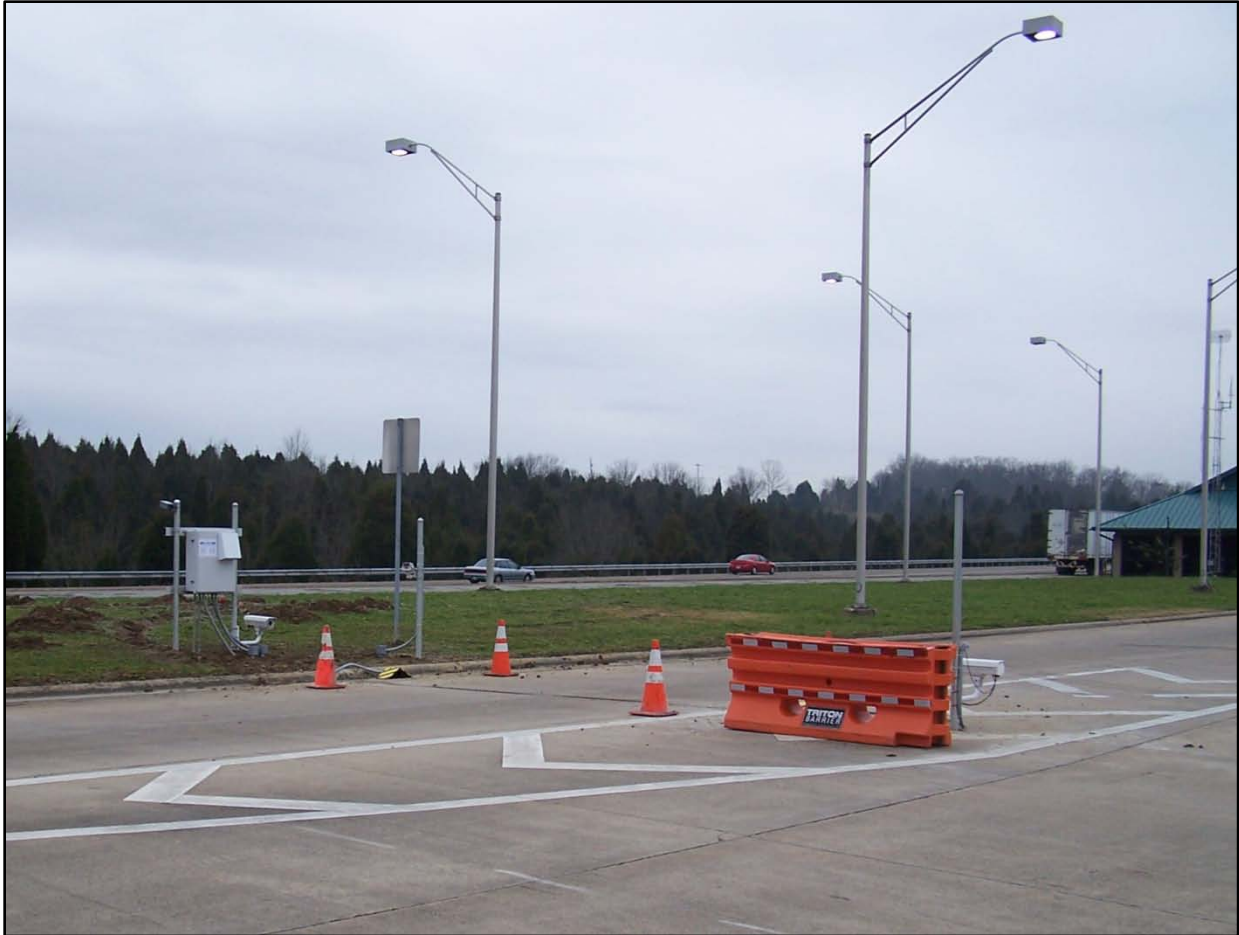
The SIRIS system was located on the entrance ramp to the pit scale as shown in Figure 3. This location is approximately 200 feet from the IS building, allowing for wide-load vehicles exiting from the parking area to turn back onto the pit scale without the danger of damaging the SIRIS equipment.

Figure 3. Location of SIRIS system.

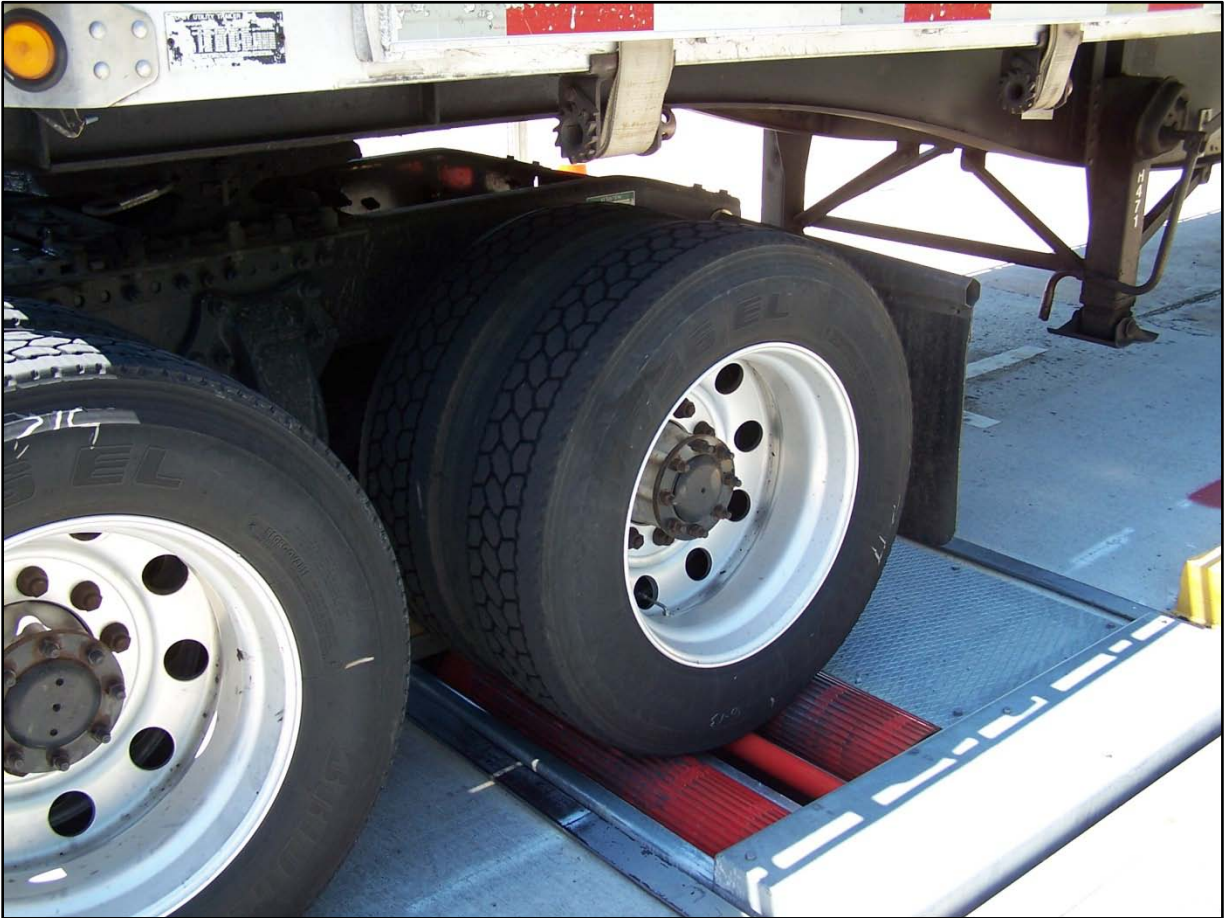
The PBBTs are devices that can evaluate the current brake efficiency of a vehicle by measuring brake forces developed as the vehicle engages in a braking event while stationed on the device. Since the Greene County IS has an in-ground roller dynamometer PBBT (see Figure 4), testing was also conducted to determine if any correlation existed between SIRIS flags and a PBBT inspection.

Figure 4. Performance based brake tester, located at Greene County Inspection Station.

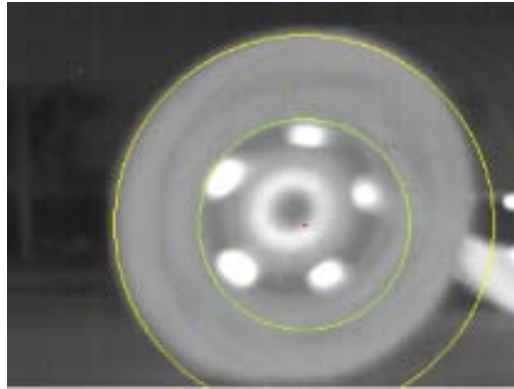
The reliability of SIRIS is related to the quality of the image and individual temperature regions (i.e. tire, brake, and bearing). These temperature regions are referred to as regions of interest (ROIs). If the ROI is off-center (see Figure 5) or not detected at all (see Figure 6), the temperatures from those regions are not usable; therefore, wheel-ends with ROI problems were not included in the analysis.

Figure 5. Wheel-end with ROI problems.

Typically, ROI problems are caused by speeding vehicles, obstructed camera views, and hardware malfunctions. Table 3 shows the percentage of all wheel ends that had a ROI problem associated with them.

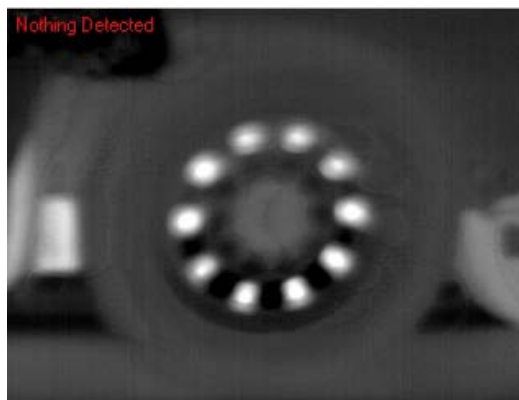
Figure 6. Wheel-end with no ROI detected.

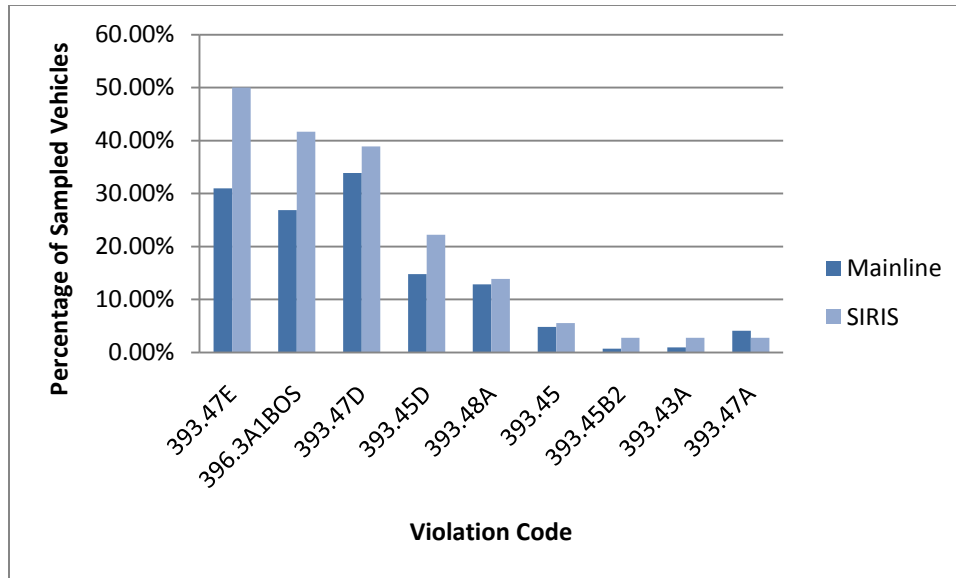
Figure 7 and Figure 8 below show the relationship of violation occurrences per vehicle for SIRIS-flagged vehicles and all 413 vehicles that were inspected, including vehicles flagged by SIRIS as having potential violations. As seen in both figures, SIRIS did an excellent job of flagging vehicles with defects. In general, the percentage of vehicles that had specific violations is greater for SIRIS flagged vehicles than vehicles that were not flagged by SIRIS. The amount of tire violations was not significant, however, it is likely that the same relationship would be observed if more vehicles were flagged and inspected.

Figure 7. Brake violation correlation.

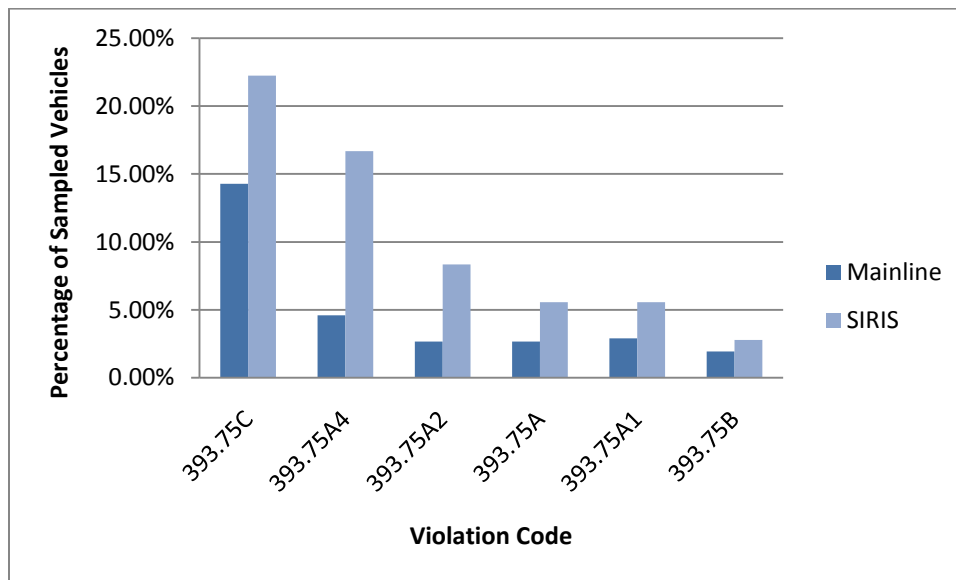
Figure 8. Tire violation correlation.

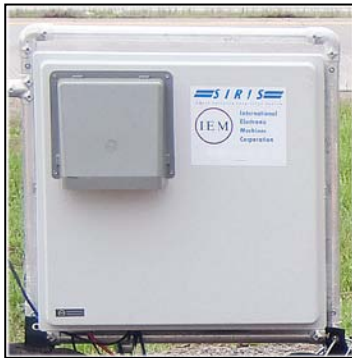
The Main Unit is a rugged case that holds the operating computer for the system components. This computer is linked to User Interface computer housed in the scale house or other protected structure. The User Interface computer collects data, issues alerts and displays the User Interface.

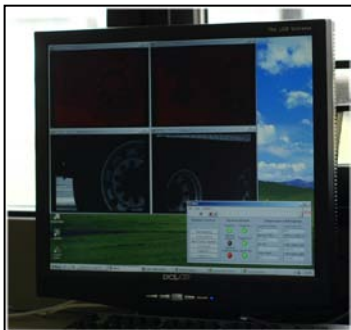
User Interface Computer

The User Interface computer is housed within the inspection facility and displays the data gathered from the passing vehicles. The User Interface is described in detail below.

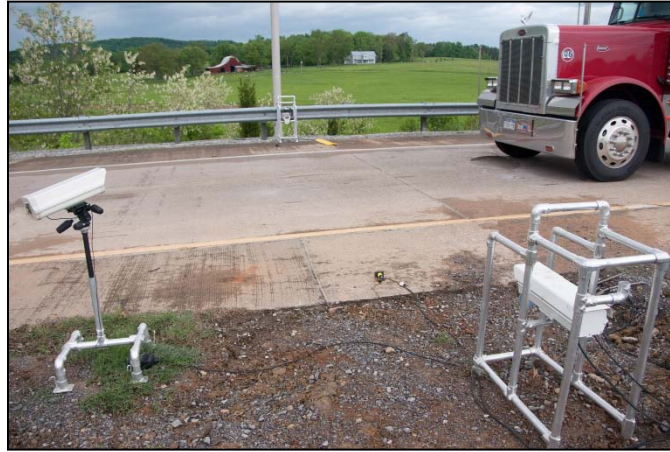
As a vehicle enters the system, the Ultrasonic Detector triggers the system to begin measuring. Starting the system is detailed in the Getting Started Section.

The Vehicle Camera takes a photo of the front of the vehicle as it is triggered by the ultrasonic detector.

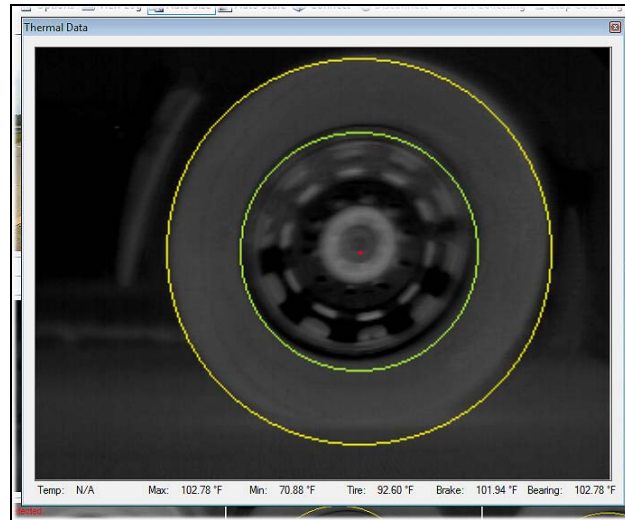
REGIONS OF INTEREST

SIRIS maps the Regions of Interest. To the operator, these areas are designated with circles for the tire, brakes, and bearings. Within these regions of interest, SIRIS measures the temperatures as compared to the other components and the ambient temperature. It applies the criteria of its programming and flags any component that is outside of these measurements. This process is accomplished within milliseconds.

SIRIS measures the thermal data for each outside wheel on both the left and right sides of the vehicle. The data is collected from three areas of the wheel which the system identifies as Regions of Interest (ROI). These regions are the hub, rim, and tire. The software represents these areas on the images on the User Interface as a yellow circle for the tire, green circle for the rim, and a red dot for the hub.

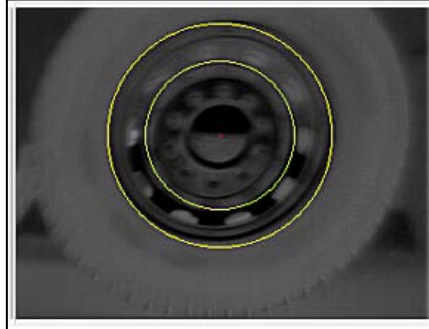
- **ROI Misidentified** – As in this photo, the system may misinterpret the image and identify the regions incorrectly. In this example, the tire region is identified as the rim and the brake region is identified as around the hub. In this case, any alerts would most likely be incorrect.

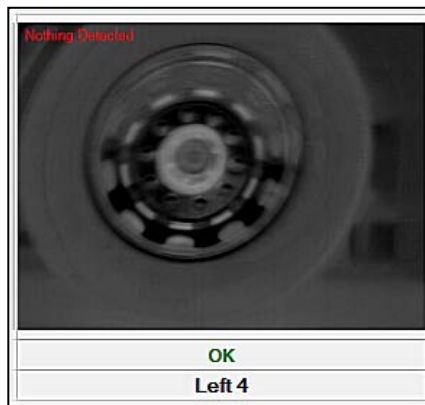
- **No ROI Identified** – If the wheel image is not fully in the frame or if the image is significantly out of focus, SIRIS may not be able to identify any of the regions. The system will mark the image as 'Nothing Detected' as in the example on Page 8.

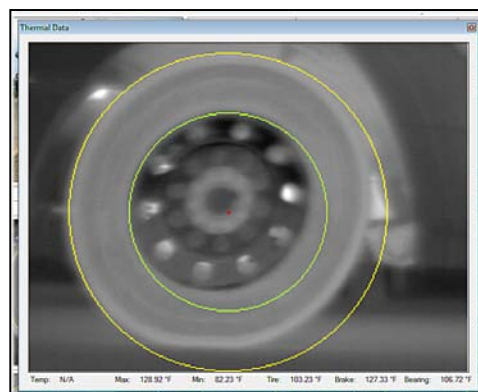
- **Skewed ROI** - Out of focus images may also result in a skewed ROI. In some cases, the ROI is not centered on the wheel but is still covering a majority of it. In this case, the thermal data is usable and correct.

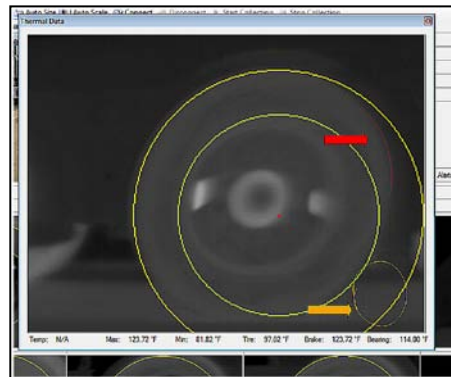
If the ROI is too skewed, it will cover more of the surrounding truck or the road rather than the wheel. In this case, the data is not usable and any alerts should be disregarded.

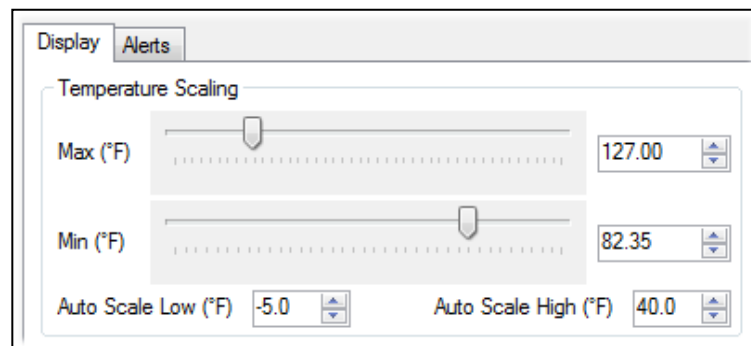
Temperature Scaling allows the operator to change the look of the displayed images by manually making them darker or lighter in appearance. Later in this section, Auto Scale is described which instructs the machine to scale the images according to the Auto Scale Low and High settings. Temperature scaling should be used to enhance an image for the operator as needed.

The screenshot shows a software interface with two tabs: 'Display' and 'Alerts'. The 'Display' tab is active. Under the 'Temperature Scaling' section, there are two horizontal sliders. The top slider is labeled 'Max (°F)' and has a value of 127.00. The bottom slider is labeled 'Min (°F)' and has a value of 82.35. Below these sliders, there are two more controls: 'Auto Scale Low (°F)' with a value of -5.0 and 'Auto Scale High (°F)' with a value of 40.0. Each of these four controls has a small up/down arrow button next to its numerical value.

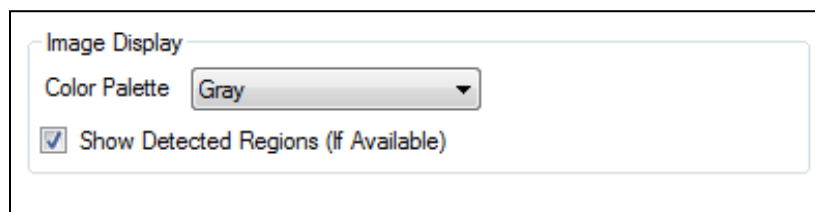
Show Detected Regions: Regions of Interest, covered earlier in this manual, are denoted by a yellow and green circle and a red dot on the displayed images. This feature can be turned off by un-checking this box. Turning off the “Show Detected Regions” feature will not affect the operation of the SIRIS system. Before turning off this feature, please read the section on Tire, Brake and Bearing Alerts in this manual.

The screenshot shows a software interface with a tab labeled 'Image Display'. Below the tab, there is a 'Color Palette' dropdown menu currently set to 'Gray'. Below the dropdown, there is a checkbox labeled 'Show Detected Regions (If Available)' which is currently checked.

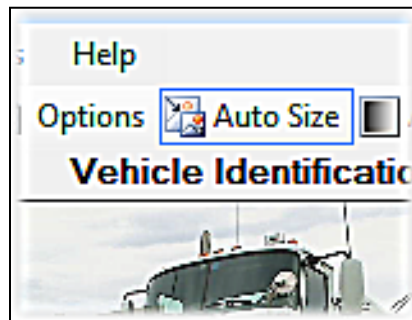
The visual alert for SIRIS consists of a flashing orange bar on the top and bottom of the image display area. The operator can disable the visual alert by un-checking the “Borders Flash Orange” box. Turning off the visual alert will not affect the operation of SIRIS.

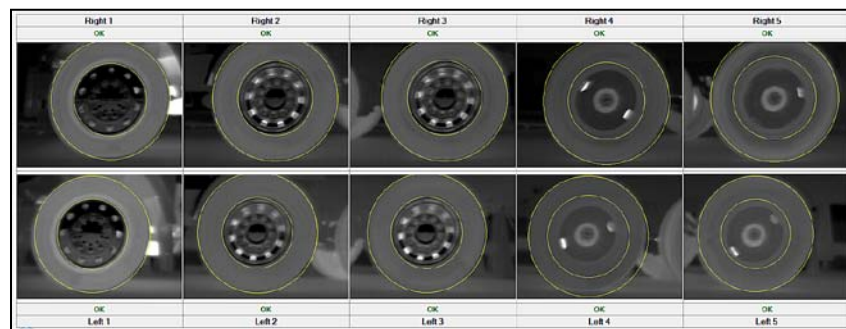
COLLECTED DATA BOX

Each vehicle that passes through the system generates an inspection report. The Collected Data Box displays all files for the current or loaded session. Each vehicle is displayed with its photo, recorded time, vehicle number, number of axles, and the status which will be Completed, Alert, or Incomplete.

An operator can view the wheel images for a vehicle by clicking on its photo. Information on clearing this data collection can be found in the Tools description.

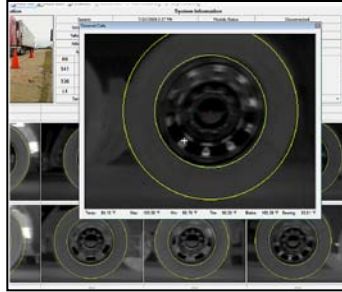
IMAGE DISPLAY AREA

The Image Display Area is located in the lower half of the User Interface. The images that are generated by SIRIS are shown here with the determined Regions of Interest (if enabled and available) and any issued alerts.

The operator can get more detailed temperature information by single clicking on an image. This will open up a new window with a close up view of that tire. By moving the pointer around on the image, the operator can see the temperature reading taken by SIRIS for any specific point. You can close the thermal data window by double clicking on the image or on the red 'x' in the right hand corner.

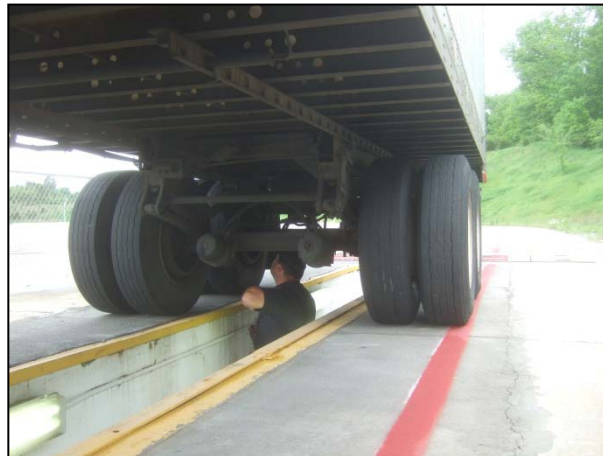
It is recommended that vehicles with brake alerts be sent for a Level 1 inspection. There are exceptions to this where the operator can see that the alert is not a true brake problem. These exceptions can be seen in certain patterns, explained below, that show a driver preference instead of a brake error.

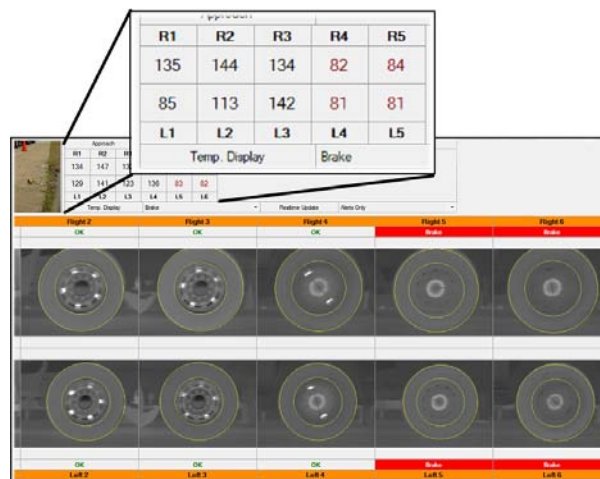
- All brakes are colder as compared to ambient – This may indicate that the vehicle has just started on its journey and has not yet applied the brakes enough to heat them up.
