# **Comparative Study of Vented vs. Unvented Crawlspace in Identical Side-by-Side Homes in the Mixed Humid Climate**

**October, 2011**

Prepared by  
OAK RIDGE NATIONAL LABORATORY  
Oak Ridge, Tennessee 37831-6283  
managed by  
UT-BATTELLE, LLC  
for the  
U.S. DEPARTMENT OF ENERGY  
under contract DE-AC05-00OR22725

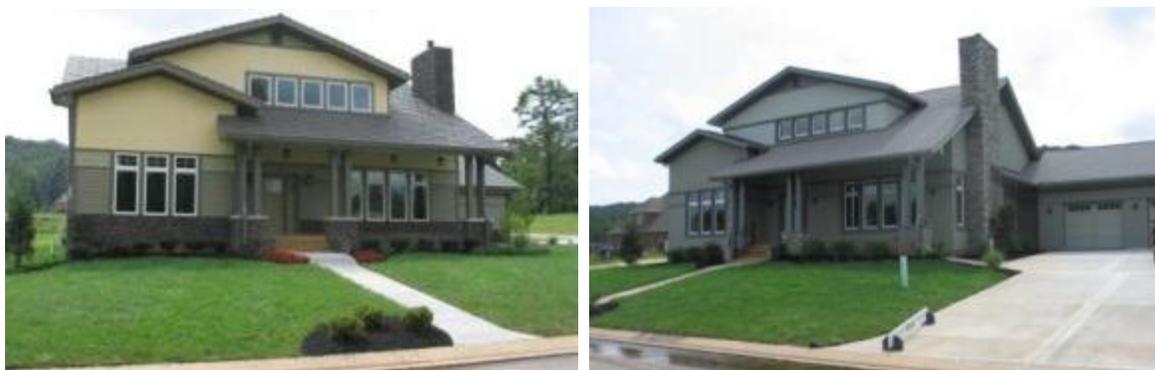
**Figure 1. WC3 (left) with vented crawlspace and WC4 (right) with insulated and sealed crawlspace.**

Figure 1 shows the outside front views of WC3, built with a conventional vented crawlspace, and WC4, built with a sealed crawlspace. An oriented strand board (OSB) subflooring was used in the two homes, with a tongue-and-groove joint to improve the airtightness. The subflooring is a pre-engineered panel designed and treated for low water absorption and warp characteristics. The ventilated crawlspace in WC3 has two R-16 fiberglass batts installed in the floor chase cavities above the crawl, while the crawlspace in WC4 is sealed and insulated with 1.5 inch thick foil-faced (Thermax) polyisocyanurate board insulation on the interior side of the block wall. Figure 2 shows the footer construction in WC3 and WC4. The exterior of the masonry block forming the crawlspace on both homes was waterproofed using an emulsion-based asphalt coating (Figure 3). A channel of washed crushed stone backfill was installed on both the inside and the outside of the footer and a drainage pipe was installed that sloped away from the footer and was exposed to daylight.

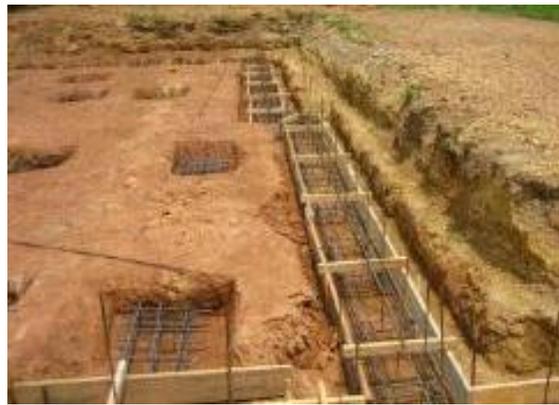
**Figure 2. No. 4 rebar used in construction of footer in WC3 and WC4.**

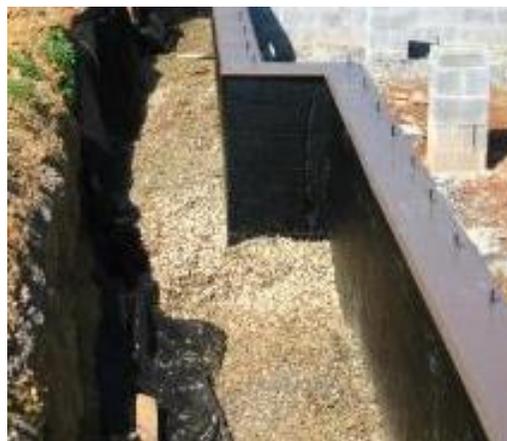
**Figure 3. Tremco waterproofing on the exterior of the concrete masonry unit (CMU) crawlspace wall.**

On the exterior wall of both houses, stack stones were installed up to the termite barrier of through-the-wall aluminum flashing, which was sandwiched between the 8 inch 2-hollow core concrete masonry block wall and the base plate. A 20 mil (0.02 inch) liner covers the floor of both crawlspaces and is taped to a 10 mil wall liner in WC4 only. WC3 crawlspace walls contain eleven vents, each about 15.5 inch by 7.5 inch, yielding a total vent area of 8.9 ft<sup>2</sup>. The wall liner in WC4 was adhered to the masonry block using a low-VOC polyurethane caulk and stopped about 3 inches below the sill plate to allow for termite inspections. DOW's Thermax™ rigid polyisocyanurate foam insulation (R<sub>US</sub> -9.8) was glued to the wall liner using a polyurethane caulk adhesive. R<sub>US</sub>-10 was a code requirement for the Tennessee Valley region in October 2010. WC4's crawlspace also incorporates a dehumidifier and is semi-conditioned through an air supply duct from the supply plenum that discharges into the crawlspace. Photographs of the crawlspaces in WC3 and WC4 are shown in Figure 4. The insulation and sealing features were installed by Bennie Marshall of Your Crawlspace Inc. ([www.yourcrawlspace.com/](http://www.yourcrawlspace.com/)).

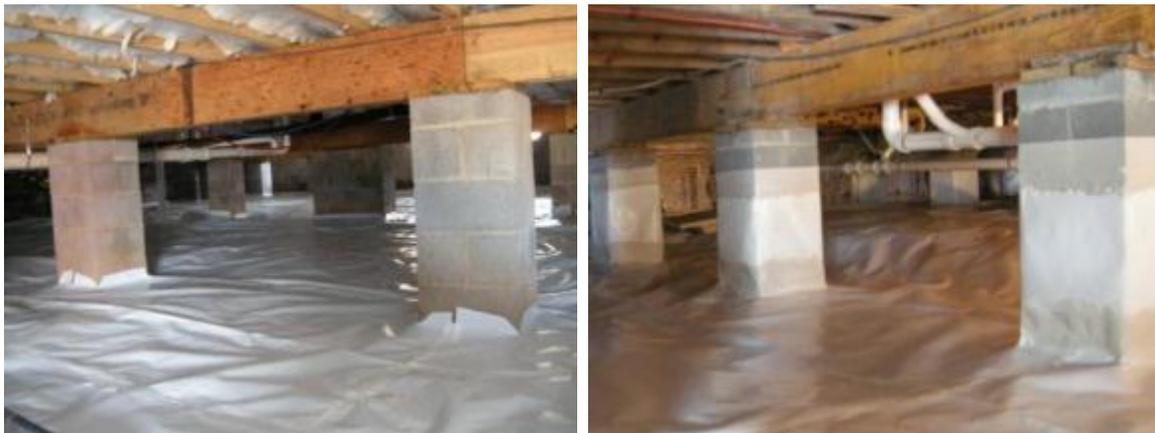
**Figure 4. Vented crawlspace in WC3 (left); walls insulated and sealed in WC4 crawlspace (right). Notice that there are no ducts in either crawlspace.**

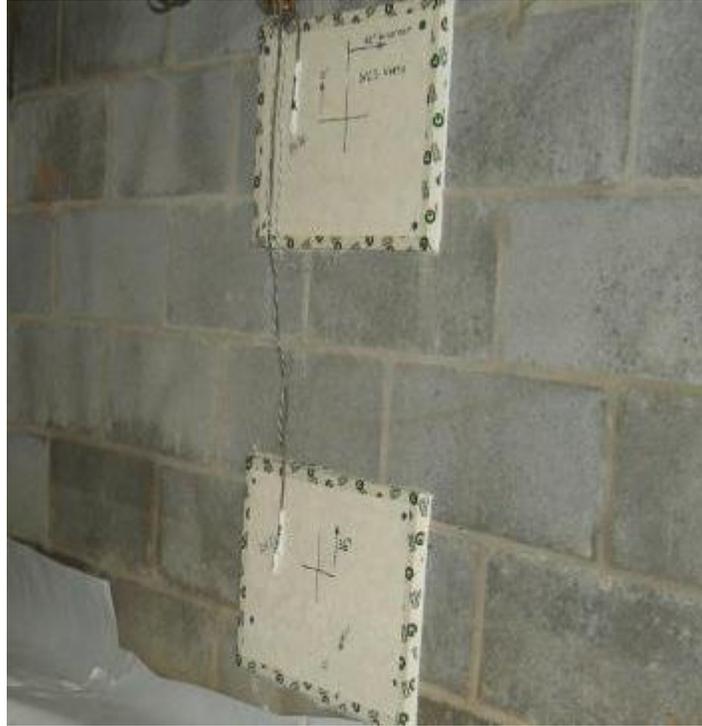
As indicated in Table 1, the east and north walls of the two crawlspaces were instrumented with thermistors and humidity sensors inside and outside the masonry walls, both above- and below-grade. In the WC4 crawlspace, thermistor and humidity probes were also installed on the foam surface facing the crawlspace interior. Heat flux transducers were installed on the interior surfaces of the masonry wall, in WC3 using ½ inch gypsum board and in WC4 between the foam sheet and the masonry wall. The ½ inch gypsum boards and the foam sheets had square slots routed on their surfaces to house the inlaid HFTs to ensure good contact with the masonry walls and prevent the formation of air pockets. Figure 9 shows the installation of HFTs in WC3, with “+” signs marking HFT locations. The T/RH combination probes (in white) can also be seen on top of the gypsum board surface.

**Figure 9. Sensor installation on the WC3 crawlspace masonry wall.**

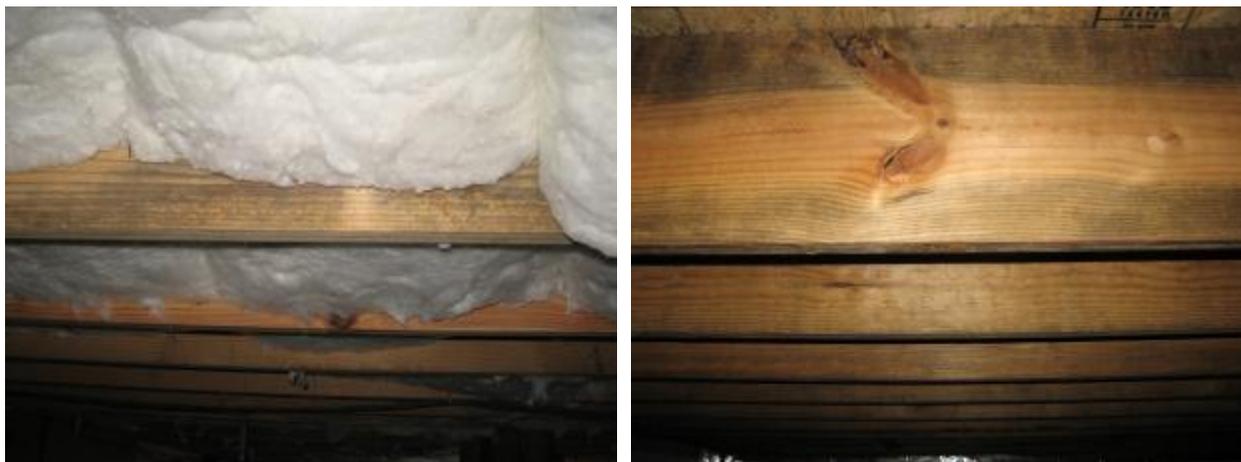
Figure 29 shows a visual comparison of the joists in the WC3 and WC4 crawlspaces after the end of the evaluation period. Some discoloration was visible on a number of joists in both crawlspaces. Overall, the joists in WC3 crawlspace did not appear to be worse than the WC4 joists. There was some powdery deposit on a few joists in the WC3 crawlspace, seen in the left panel in Figure 29, which could indicate a mold-related problem. It should be noted that, early in the construction period, mold growth was observed and mitigated in WC4 crawlspace. The two crawlspaces will continue to be monitored for another year, with a close focus on the subfloor joists for mold growth.

**Figure 29. Visual comparison of WC3 (left) and WC4 (right) crawlspace joists in September 2011.**
