An Innovative Technique for Evaluating the Integrity and Durability of Wind Turbine Blade Composites - Project Final Report

ORNL/TM-2011/449

**An Innovative Technique for Evaluating the Integrity and
Durability of Wind Turbine Blade Composites
FY2011 Project Report**

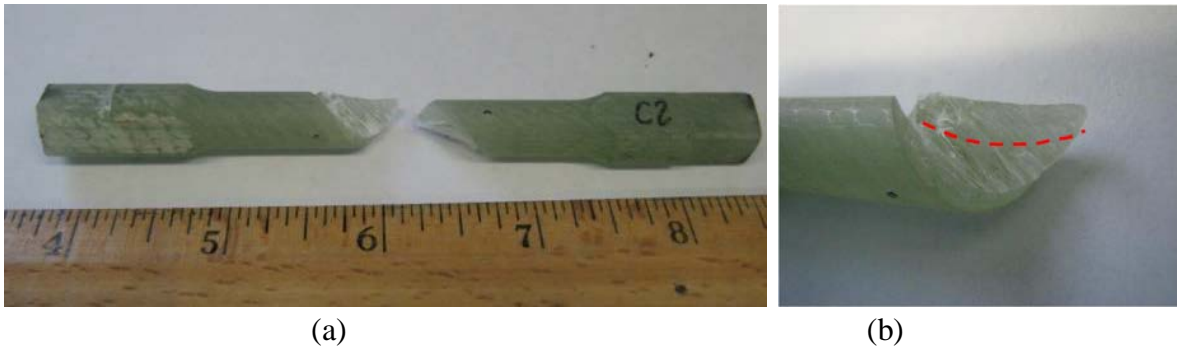
Figure 50. Pictures of a failed C-type sample (#C-2).

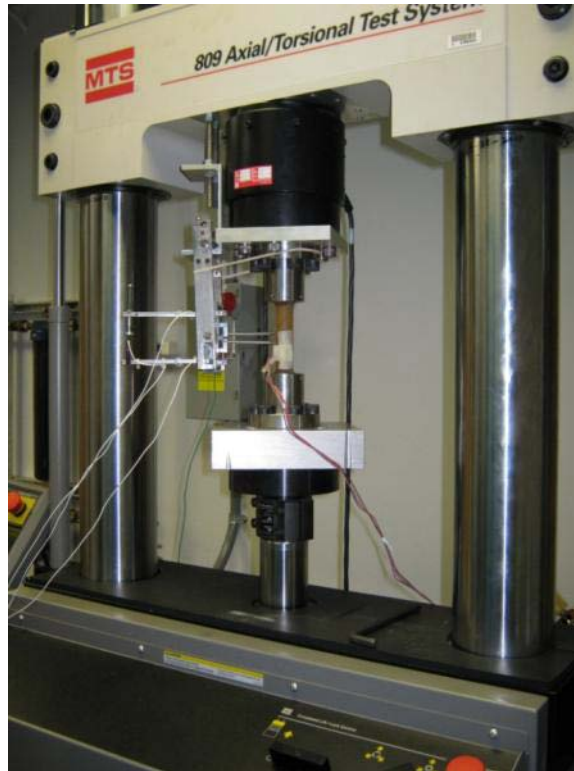
Figure 7. MTS 809 Axial/torsional test system used for SNTT.

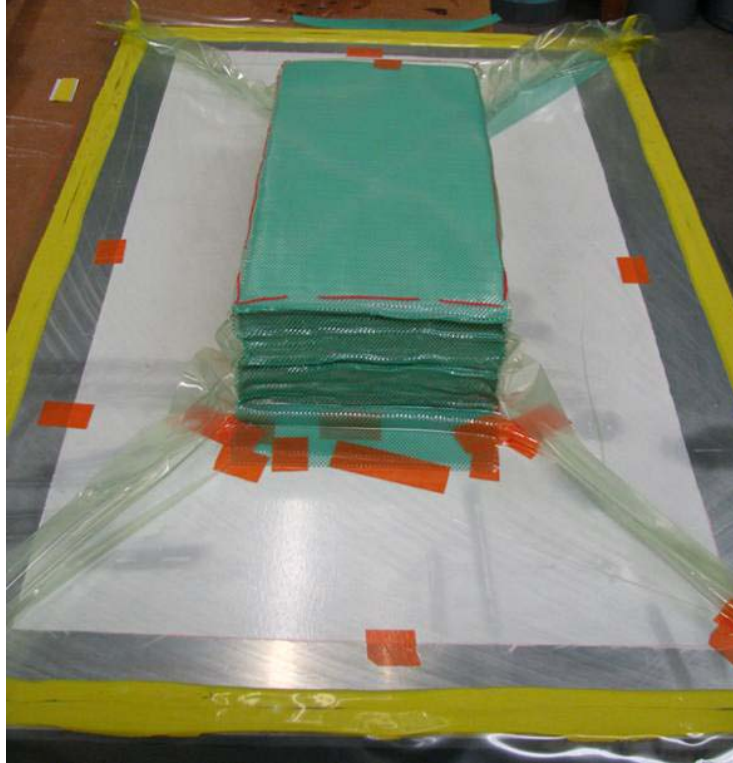
Figure 23. Infusion setup for 4"-thick composite laminate.
