Case Studies of Duct Retrofits and Guidelines for Attic and Crawl Space Duct Sealing

November 2011

Prepared by
OAK RIDGE NATIONAL LABORATORY
Oak Ridge, Tennessee 37831-6283
managed by
UT-BATTELLE, LLC
for the
U.S. DEPARTMENT OF ENERGY
under contract DE-AC05-00OR22725

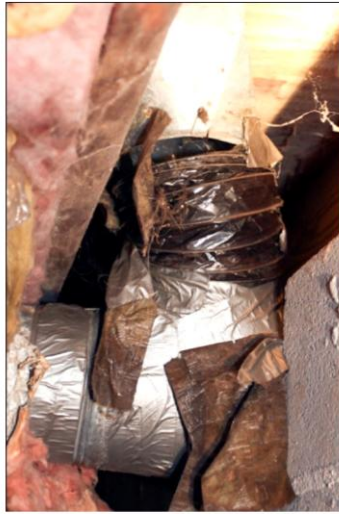
Figure 1b. Flex supply branch disconnected from floor boot, in crawl space. Notice duct tape around elbow.

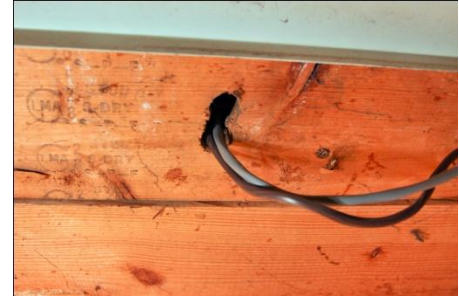
Figure 1c. Thermostat wires coming through return chase and into wall cavity to thermostat. This is causing the return to pull air from wall cavity and potentially from the hot attic above return.

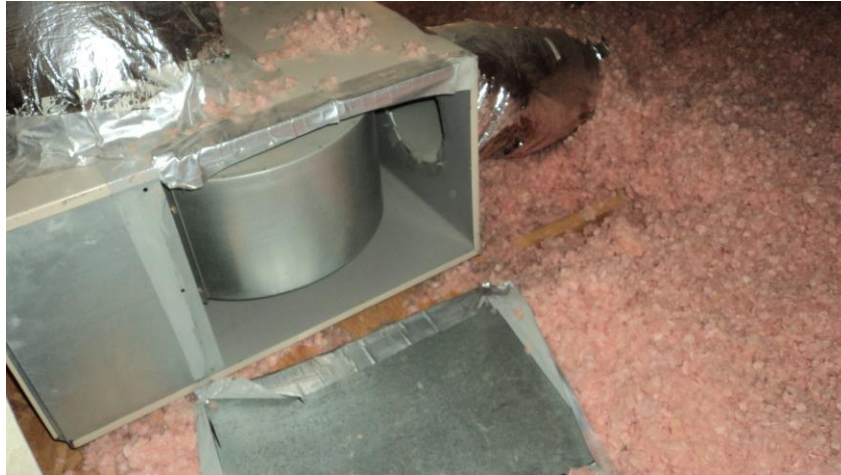
Figure 2. Air handler door has fallen off, letting insulation circulate through HVAC system. The door should have been mechanically fastened in combination with a gasket to prevent unhealthy air from the attic from being sucked into the return duct. Photo taken by Rex Dockery, CSG.

Figure 2 shows another example of what energy auditors see. The air handler door has fallen off into the fiberglass attic insulation, allowing the insulation to circulate through the HVAC system and enter the home's living area through the registers.

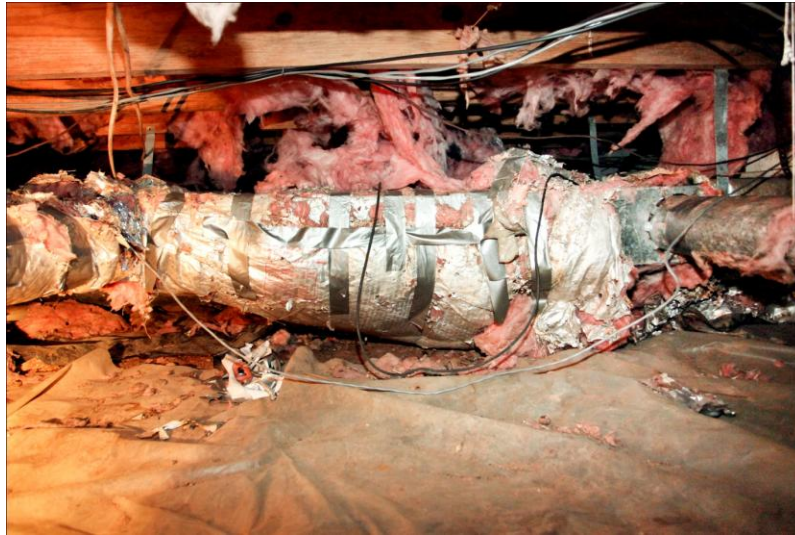
Figure 3. State of ducts in the Candlewick house crawl space before retrofit.

had holes in them that were made by the local wildlife (Figure 3). Measures to correct these problems were at the top of the TVA auditor's list because their payback would potentially be the greatest of all the recommended energy retrofits.

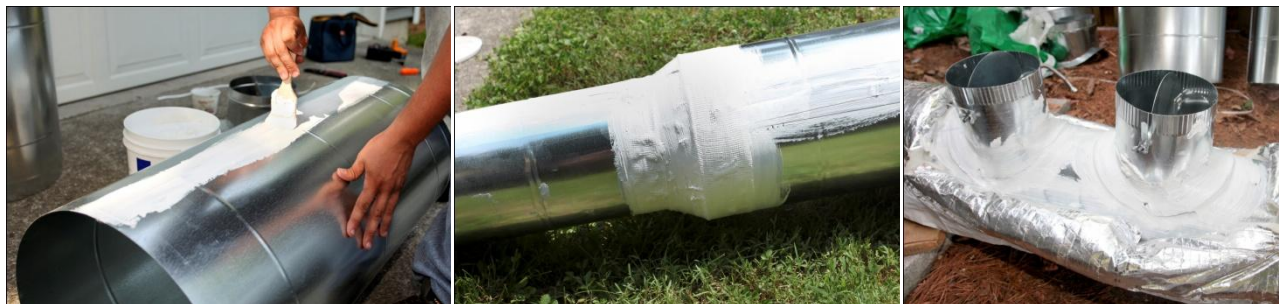
Figure 5a. Round hard duct supply trunk. Pittsburgh seam is reinforced with sheet metal screws, then seam and screw heads are taped over with a rubber adhesive cloth tape, and finally mastic is applied over the tape and to one tape width on either side of tape.

Figure 5b. Reducing flange in supply trunk. Joints and seams are screwed together, then fiberglass mesh tape is applied. Next mastic is applied over the mesh tape and to one tape width on each side.

Figure 5c. Take-offs are screwed to supply trunk, then mastic is used to seal take-offs to trunk.

The return duct was replaced with a flex return. In Figure 5, images showing good duct sealing practices for the supply trunk are presented. Figure 5a shows the round sheet metal supply trunk being sealed. Longitudinal seams, called Pittsburgh seams, run horizontally on the hard duct sections and are important because they hold the duct pieces together. These seams should not leak under pressure. The duct sections come flat and can be put together at the job site; the sheets are rolled into a tube and snapped together. The Pittsburgh seam is reinforced with sheet metal screws, then the seam and screw heads are taped over, and finally mastic is applied over the tape and to a tape width on either side. Figure 5b shows a reducing flange in the supply trunk. Joints and seams are screwed together, and then fiberglass mesh tape is applied. Next mastic is applied over the mesh tape and to one tape width on each side. Figure 5c shows the take-offs on the supply trunk. They are screwed to the supply trunk (where a foam gasket is sandwiched between the take-off and trunk), mastic is then used to seal the take-offs to the trunk (an added measure because the gasket will degrade over time), and then insulation is added and the insulation facing is taped.

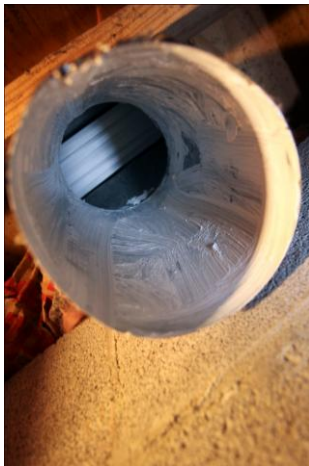
Figure 6a. Mastic applied to inside of hard duct connection (from boot to flex connection in crawl space). This practice seals any seams in the connection between the boot and hard duct.

Figure 6 shows details of air-sealing the existing boots in the floor. Figure 6a shows water-based mastic applied to the inside of a hard duct connection from the boot in the floor above. This practice seals any seams in the connection between the boot and hard duct, which is sometimes easier to do from inside the house than from outside. Figure 6b shows mastic on the inside of the boot below the floor supply register (picture is taken from inside the house). It is better to use water-based mastic than solvent-based mastic inside the home because of the high content of volatile organic compounds in solvent-based mastic. Always read the material safety data sheet to ensure that hazards are controlled and the product is used safely.

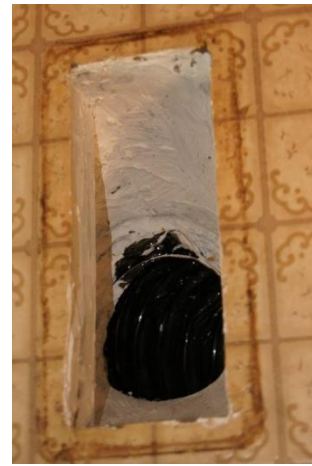
Figure 6b. Mastic on inside of boot (looking from inside the home).
