Deep Residential Retrofits in East Tennessee

April 2012

Prepared by
OAK RIDGE NATIONAL LABORATORY
Oak Ridge, Tennessee 37831-6283
managed by
UT-BATTELLE, LLC
for the
U.S. DEPARTMENT OF ENERGY
under contract DE-AC05-00OR22725

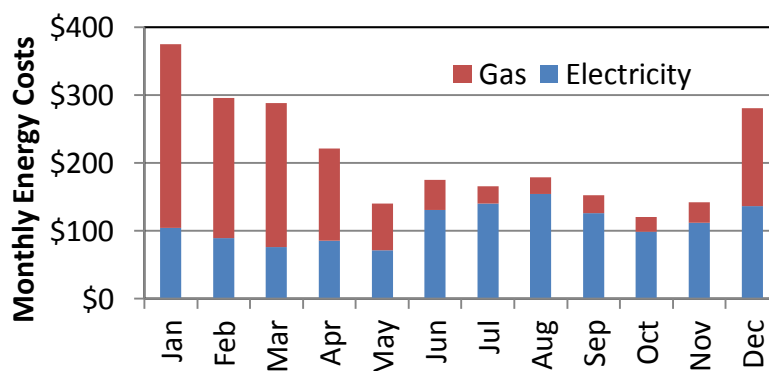
Figure 1: Baker monthly energy costs.

Energy bills from January 2008–December 2008 are shown in Figure 1. With an annual cost of \$2,535 and site energy use of 128 MMBtu (13,720 kWh and 816 therms), energy consumption of this home is about half that of an average home of similar size in the Southeast.* This is due in large part to the size of the home with respect to number of occupants and is not necessarily an indicator of the home's energy efficiency.

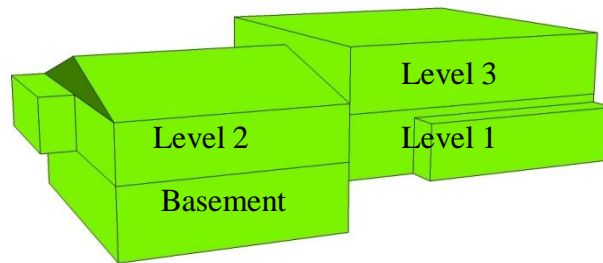
Figure 2: Baker envelope profile.

An illustration of the building envelope is shown in Figure 2. The basement has a concrete floor and uninsulated concrete block walls. The band joist is uninsulated. The walls of levels 2 and 3 are wood framed with R-11 cavity insulation. Level 1 has concrete block walls furred with 2 × 4 studs laid on the wide end against the block with 1.5 in. batt insulation and drywall over the furring strips. There is an architectural feature on the front of level 1 (see Figure 2) with a flat cathedral attic and soffit vents that have a direct path into the space between level 1 and level 3. The attic above level 3 has R-30 insulation on the attic floor. Level 2 has a cathedral ceiling with R-19 insulation. Level 2 has a knee wall, shown in dark green, which faces the attic above the garage. The knee wall has R-9 fiberglass batt cavity insulation.

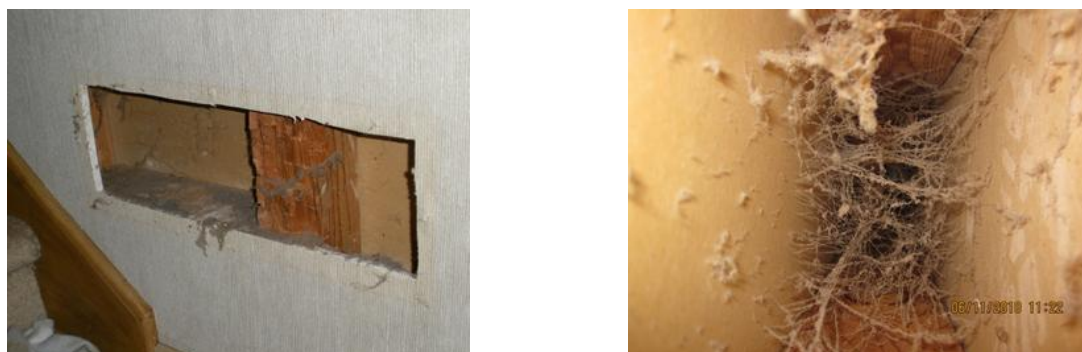
Figure 3: Wall cavities are used as return paths for the Baker HVAC system.

Conditioned air is provided by a 4-ton capacity heat pump with an efficiency of 10 seasonal energy efficiency ratio (SEER) and 7.7 heating season performance factor (HSPF). The unit is equipped with a hydronic gas backup system. The mechanical equipment is located in the conditioned basement. The ductwork is in the basement, walls, and above the tile drop ceiling in level 1, with visible ductwork having R-4 insulation. Wall cavities are used as return ducts in much of the home (see Figure 3). Duct leakage to the outside was not able to be measured because the duct system was too leaky. For modeling purposes, the duct leakage is estimated to be 35% of the HVAC fan flow (360 cfm/ton). In the case of Baker, this is 504 cfm₂₅.

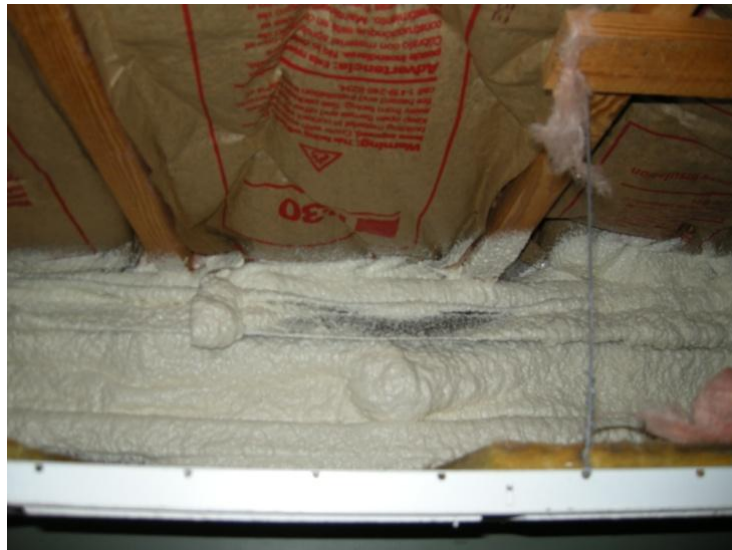
Figure 4: Sealing conditioned space from flat attic on first floor. Spray foam can be seen on the perimeter between the drop ceiling and the flat attic ceiling rafters. Notice the R-30 batts between the rafters.

As can be seen in the recommended retrofit list in Table 1, air sealing and insulating the envelope were at the top of the list. The homeowner chose to tackle the pressure and thermal boundary as well as the HVAC replacement all with the same HVAC contractor. The contractor increased the attic insulation to R-38 with fiberglass batts and insulated the attic knee wall to R-19 with fiberglass batts and house wrap installed over the knee wall assembly. The contractor air sealed and insulated the basement band joists to R-22 with R-19 fiberglass batts and R-3 foam board. The basement ceiling was also air sealed. The band joist between the first and second floors, which is accessible by a drop tile ceiling, was insulated with ½ in. foam board (R-3) and 1 in. of spray foam (R-6) for a total R-value of R-9. The contractor also caulked the windows. The flat cathedral attic on level 1 needed to be isolated from the conditioned space because the soffit vents were letting in outside air to the space between levels 1 and 3. To isolate this area from the conditioned space, the perimeter was sealed with closed cell foam and R-30 batt insulation was installed on the ceiling of the attic space (see Figure 4). The perimeter between the drop ceiling and the bottom of the floor joists was sealed and insulated with ½ to 1 in. of closed cell foam.

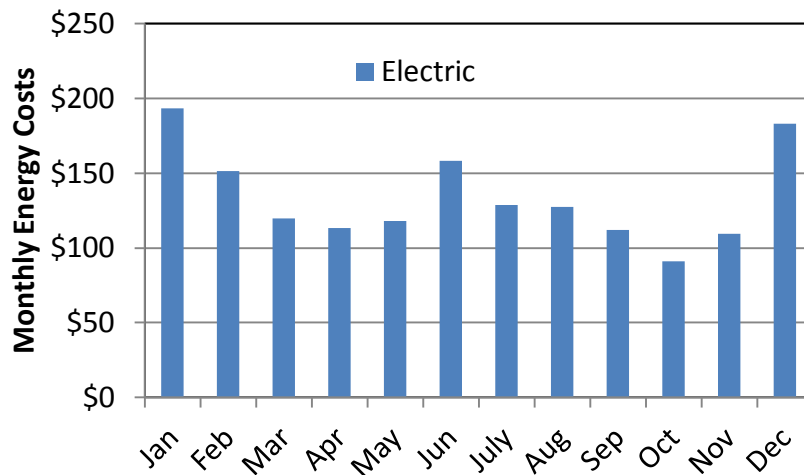
Figure 5: Monthly energy costs for the Country home.

The family's energy costs from January 2009 to December 2009 are shown in Figure 5. With a total annual cost of \$1,605 and annual site energy of 62 MMBtu (16,190 kWh), the family's energy costs are much lower than the average annual site energy consumption for a typical home in the Southeast of this size (116 MMBtu*).

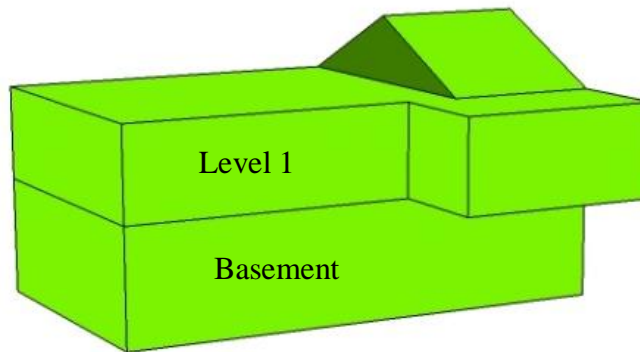
Figure 6: Illustration of Country's building envelope.

Figure 6 shows an illustration of the envelope profile for Country. The basement walls are cinderblock and are framed with 16-in. on center 2 × 4 studs with R-11 cavity insulation and covered with drywall. The band joist between the basement and level 1 is not insulated. The crawlspace ceiling has R-19 insulation. The exterior framed walls of level 1 have R-13 insulation and ¾-in. foam board insulation underneath the vinyl siding cladding. There is a cathedral ceiling in the living room of level 1, creating a knee wall shown in dark green in Figure 6. The attic is vented and is insulated on the floor to R-19, and the attic knee wall has R-13 insulation.

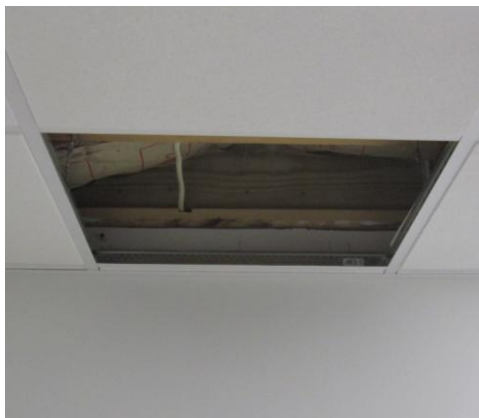
Figure 7: Uninsulated band joist.

Figure 7 shows the uninsulated band joist between the basement and first floor. It is accessible through the drop ceiling in the basement.

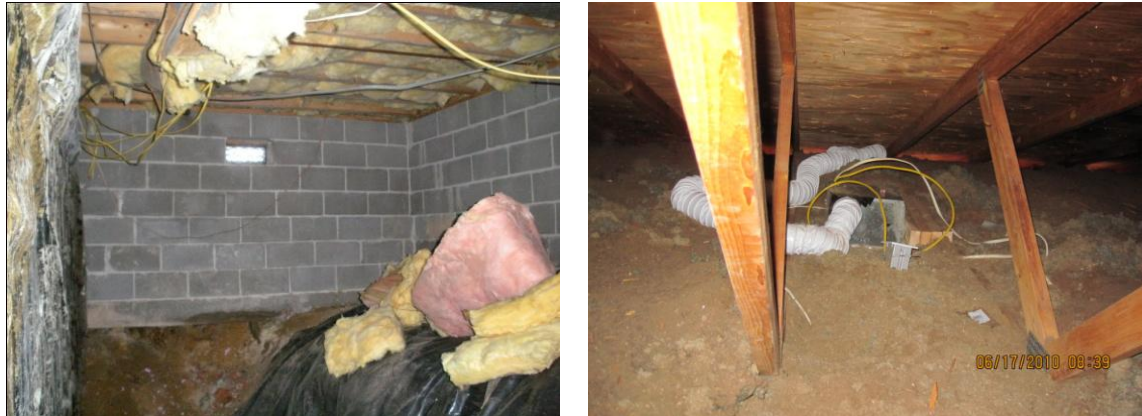
Figure 8: State of insulation in crawl space and attic.

Figure 8 shows the state of the insulation in the crawl space ceiling, which is underneath the kitchen, and the state of the attic insulation. The crawlspace insulation is not performing as it should because much of it has fallen down. The insulation in the attic is about R-19 and should be at least R-38.

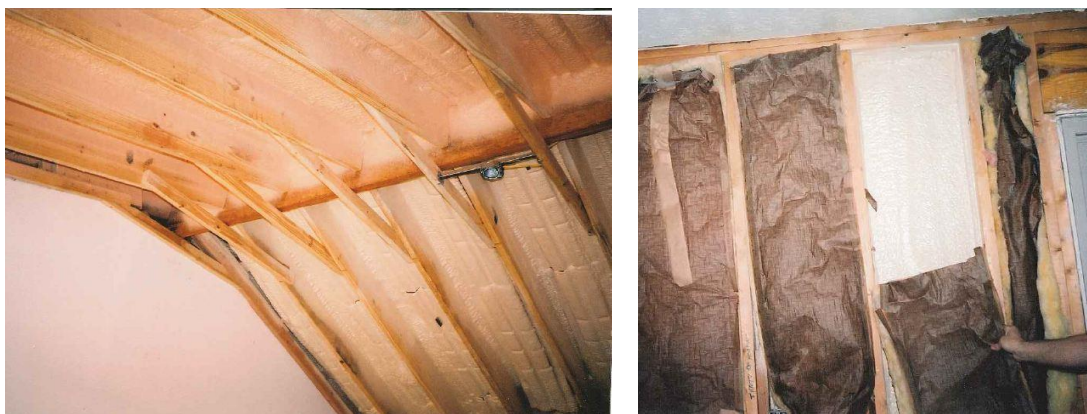
Figure 9: Spray foam insulation on the living room cathedral ceiling and the kitchen walls.

The first job that was done by the homeowner was repairing the cathedral ceiling in the living room. The drywall and roof decking had to be removed. The cathedral ceiling and the 2 × 6 kitchen walls were sealed with 2 in. of closed cell spray foam, and then R-13 batts were installed for a final R-value of about R-24 (Figure 9). The attic floor was sealed and fiberglass insulation was blown in for a resulting insulation value of R-50. The crawlspace ceiling was flashed with spray foam.

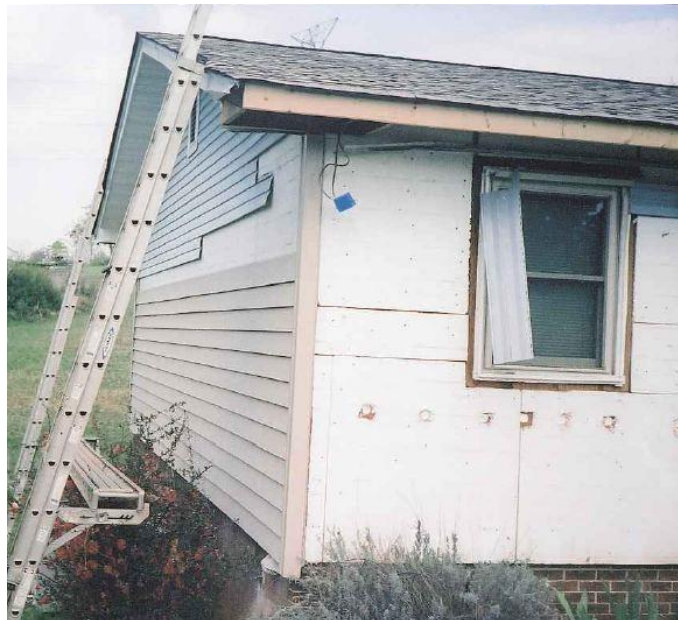
Figure 11: Holes can be seen in the exposed wall where the foam was injected into the wall space. The existing foam board insulation can also be seen.

The exterior walls that were not accessible (as the kitchen walls were) were insulated using a drill and fill method with an open/closed cell hybrid foam insulation (Figure 11). It is difficult to determine the resulting R-value of this method, but it is estimated the new cavity insulation was increased to R-14. According to the manufacturer, when the product is applied to a wall with existing insulation, the product mostly increases the air tightness of the wall rather than increasing the R-value. New siding was also installed on the home. After the old siding was removed $\frac{3}{4}$ - in. foam board (R-4) was found on the home. The new aluminum siding that was installed had 1.5 in. of form-fitting insulation (R-5.3). The windows of the home were replaced with units with a U-factor of 0.3 and a solar heat gain coefficient (SHGC) of 0.2.

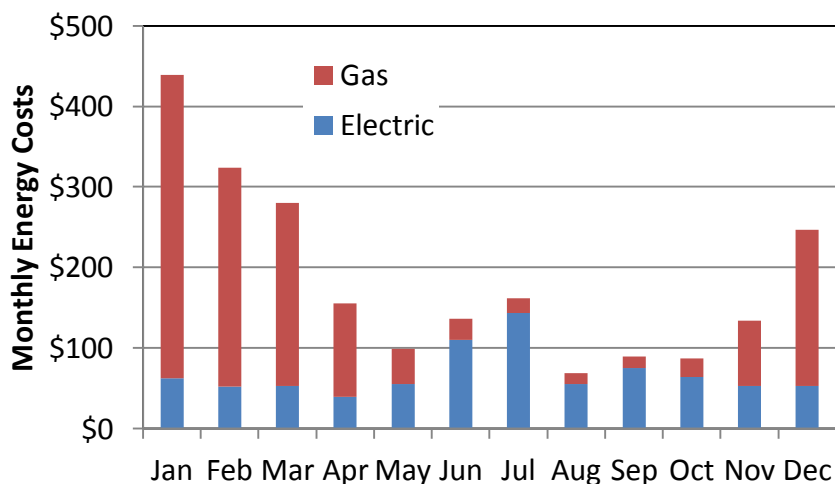
Figure 13: Summit monthly energy costs.

Figure 13 shows the energy costs of the Summit house from January 2009 to December 2009. The total energy costs were \$2,223 (126 MMBtu of site energy). In contrast, a typical home in the Southeast of this size is expected to have an average annual site energy consumption of 147 MMBtu.* Hence, the energy costs are slightly lower than the average home of this size in the area. The homeowners were planning to renovate the house before retiring and attended a presentation describing energy retrofits. After the presentation, the scope of the project changed and they decided to proceed with deep energy retrofits while renovating, chasing after a net-zero energy home.

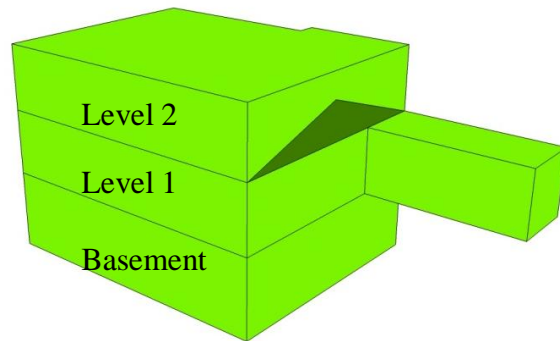
Figure 14: Illustration of Summit's building profile.

The building envelope of the Summit house is bounded below by a basement and a vented crawlspace under the office behind the garage. The basement walls and ceiling have no insulation. The crawlspace ceiling also does not have any insulation. Level 1 and 2 exterior walls have R-13 insulation except the level 1 walls adjacent to the garage, which have no cavity insulation. The vented attic has an average of R-30 insulation on the floor. The attic knee wall has no insulation. The interior ceiling height for this home is 8 ft for both the first and second level, and 9.5 ft for the basement. Shown in Figure 14 is an illustration of the home's envelope profile. The dark green colors represent the attic knee wall.

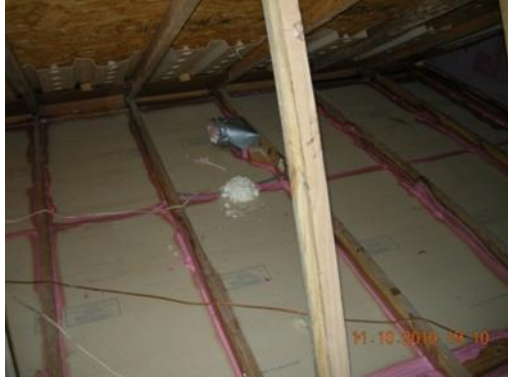
Figure 15: Pink latex foam sealing the attic floor.

The homeowners of the Summit house exceeded the recommended retrofits in many cases. The attic was vacuumed of the old insulation and the entire attic floor was sealed with pink latex foam (as seen in Figure 15) and then fiberglass insulation was blown in to R-60. The attic knee wall was sealed with an air barrier wrap, and insulated with 2-in.-thick foam panels to R-10. The walls between the home and garage were found to have no insulation. The drywall was removed on the garage adjacent walls, and they were sealed and then fiberglass batts (R-19) were installed in the wall cavities. Then 2 in. of foam panels (R-10) were installed before the drywall was reinstalled on top of the foam. Before the new siding was installed, ½-in.-thick structural insulated sheathing (R-2.74) was installed. The band joist between the basement and first floor was sealed and insulated to R-10. The crawlspace walls were insulated with fiberglass batts to R-10. The south facing basement wall, the only framed non-block wall in the basement, was sealed with latex foam and then insulated to R-19. The above-grade portion of the block basement wall was insulated on the outside with 2-in. extruded polystyrene foam panels (R-10) covered in ½-in. thin-brick veneer, as shown in Figure 16. The windows were replaced with units of U-factor 0.2 (0.1 for quad pane window installed in living room) and SFGC of 0.35.

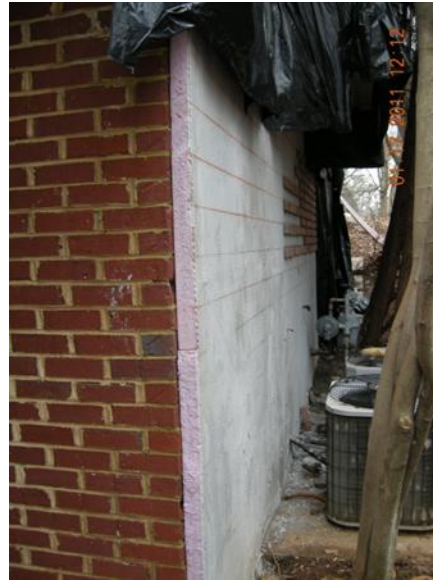
Figure 16: Above-grade basement walls shown during retrofit with foam board and the thin brick veneer being installed.

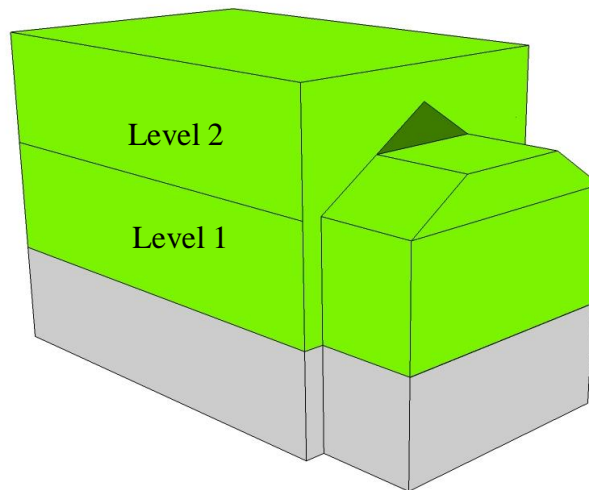
The pre-retrofit building envelope is shown in Figure 17. The building envelope is bounded below by the unconditioned basement. There is no pressure or thermal barrier on the framed basement ceiling between the basement and level 1, and there is no insulation on the brick basement walls. The exterior walls of the first and second floor have no insulation. The attic floor has minimal insulation that is ineffective, having only an average R-value of R-7. There is a cathedral ceiling above the sunroom that has no insulation. There are also major infiltration issues in the attic floor and soffits, as can be seen in Figure 18.

Figure 17: Gaiter initial envelope profile. Dark green indicates a knee wall. The grey walls represent the below-grade walls of the basement. Although this space is not conditioned, it is part of the thermal/pressure envelope.

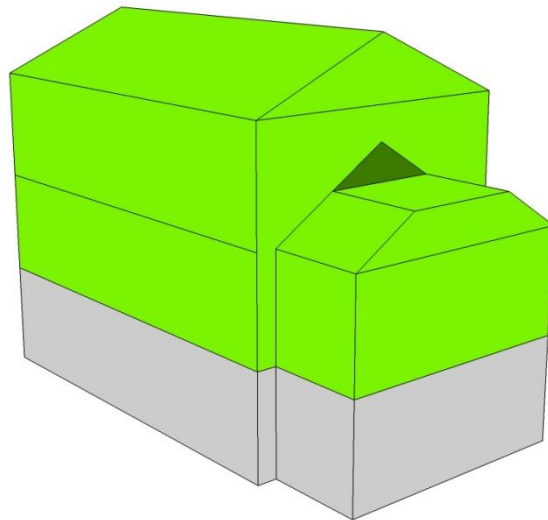
Figure 19: Post-retrofit envelope of the Gaiter home. Dark green indicates a knee wall.

The brick basement walls were not insulated because of bulk moisture issues that first need to be addressed. The south facing basement wall is the only basement wall that is framed and not brick. This wall was sealed with ½ in. of closed-cell spray foam and insulated with un-faced fiberglass batts (R-13). No drywall was installed over these walls, so the cavities are open to the basement; this results in a total R-value of R-16 for the framed basement wall. The band joist that was accessible from the basement was sealed and insulated with 1 in. of closed-cell foam to R-6. The basement ceiling was not sealed or insulated. Since this home was a gut retrofit, the building cavities were easily accessible. Because of this, the walls were flashed with 1 in. of closed-cell foam over which fiberglass batts (R-13) were installed to bring the wall assemblies to R-16. The roof deck was foamed with 1 in. of closed-cell spray foam over which 8 in. of open-cell foam was applied. This brought the roof deck insulation to R-34. The ridge and soffits were stuffed with fiberglass batts and then foamed over with closed-cell foam. The cathedral ceiling above the sunroom was sprayed with 4 in. of closed-cell foam, resulting in an insulating value of R-24. Figure 19 shows the post-retrofit envelope profile of the home after the attic roof deck was sealed.

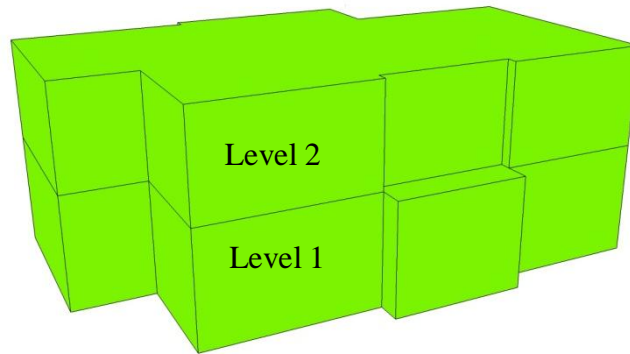
Figure 20: Pre-retrofit envelope of the Green home.

The building envelope is bounded below by a basement/crawlspace. There is no insulation on the basement and crawlspace walls or ceilings. The home has balloon framing, so the basement is intimately connected to the attic. This feature makes air sealing a significant task. The walls were assumed to have about R-5. The vented attic tops the building envelope, which has no insulation. Figure 20 below provides a 3-D visual of the home, illustrating the pre-retrofit envelope profile.

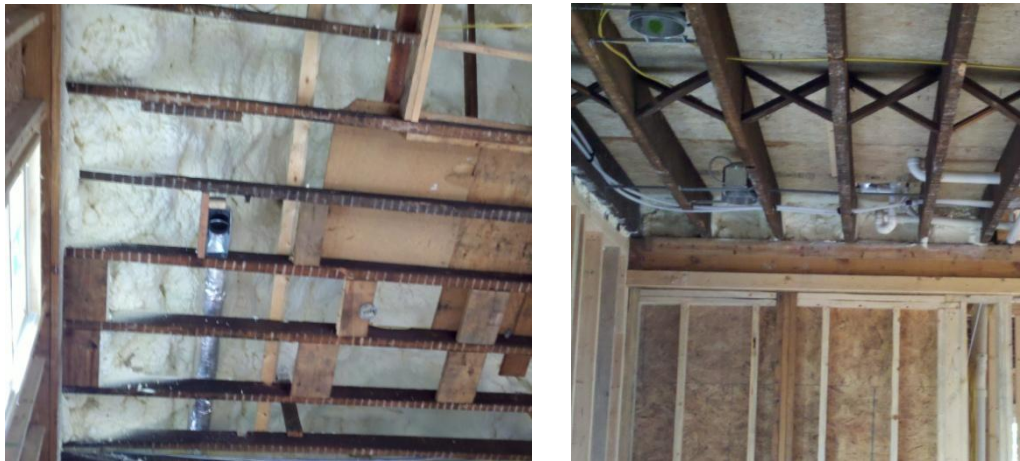
Figure 22: Sealed attic and the insulated band joist between floors.

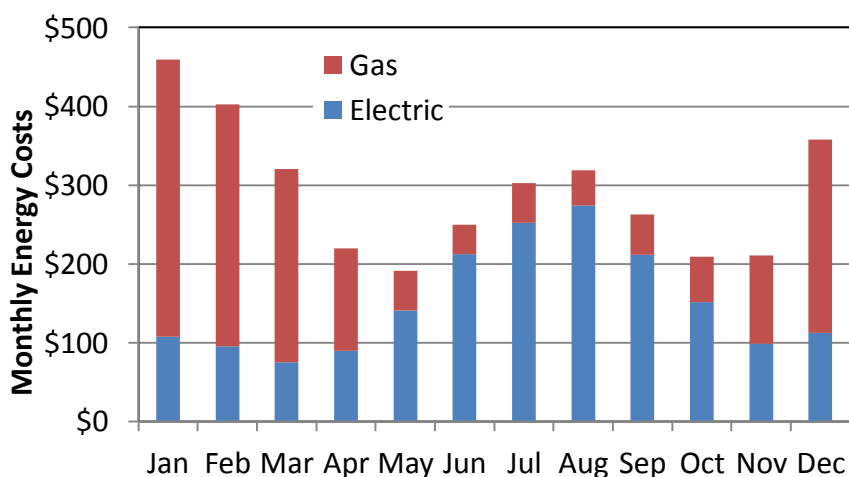
Figure 23: Eagle energy costs for 2009.

Figure 23. With a total annual cost of \$3,504 (226 MMBtu of site energy), the family's energy costs are higher than the average annual site energy consumption for a typical home in the Southeast of this size (203 MMBtu*).

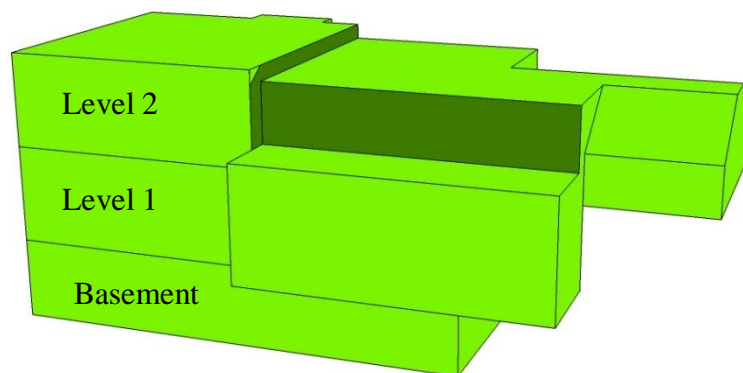
The Eagle home has a conditioned basement used for storage and a vented crawlspace. The basement walls are cinderblock and are not insulated. The crawlspace and basement framed ceilings have R-15 cavity insulation. The above-grade exterior walls are insulated to R-11, and the vented attic is insulated to R-19 on the attic floor. Figure 24 shows the envelope profile of Eagle. The windows in the home are double pane with vinyl frames or single pane with wood frames. The home has a whole house fan that is not used. There is a room over the garage with no insulation in the framed floor cavities. There are also uninsulated attic knee walls and a laundry chute that is open to the attic. Figure 25 shows both of these features.

Figure 24: Envelope profile of Eagle. The dark green shade indicates knee walls.

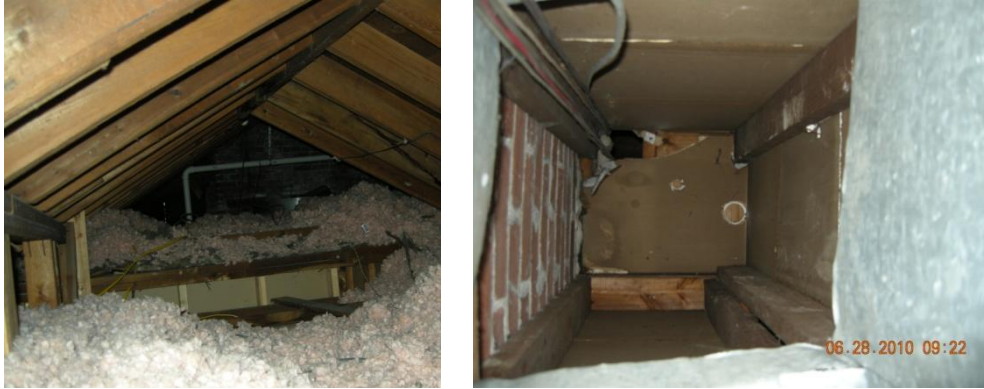
Figure 25: Uninsulated attic knee wall and laundry chute open to attic.

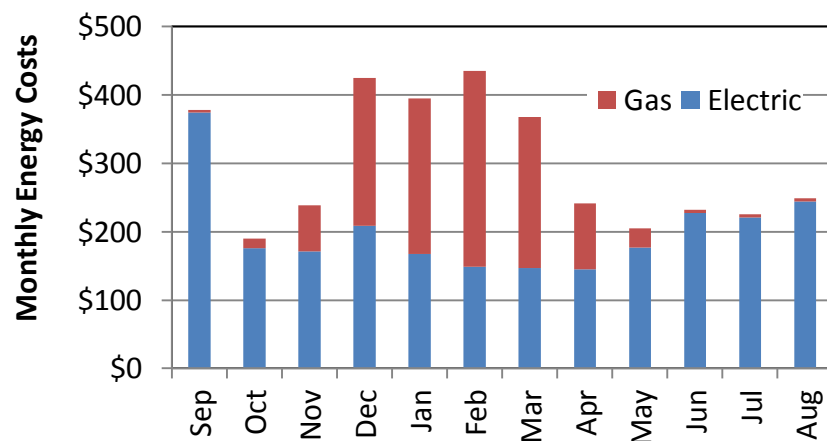
Figure 26: Scenic monthly energy costs.

The family's energy costs from September 2008 to August 2009 are shown in Figure 26. With a total annual cost of \$3,580 (163 MMBtu of site energy), the family's energy costs are lower than the average annual site energy consumption for a typical home in the Southeast of this size (205 MMBtu*).

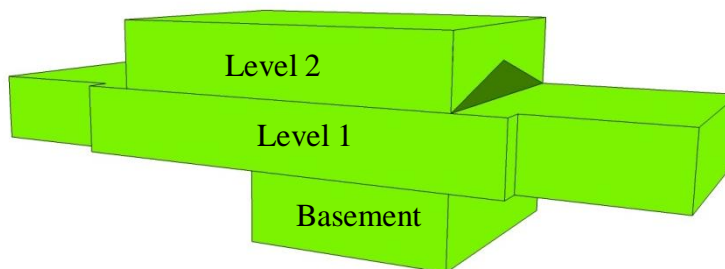
Figure 27 shows the envelope profile of the Scenic home. Scenic's lower boundary is made up of the insulated basement/crawlspace framed ceiling with R-15 cavity insulation. The above-grade walls are insulated to R-13. The home is capped with a vented attic with 5–7 in. of rock wool with insulation values from R-15 to R-21 on the attic floor. The general state of the insulation in the home is poor. Figure 28 shows the insulation in the attic and crawlspace that sparsely covers the thermal boundary. The knee wall is insulated to R-13. Scenic also has a room over the garage. The garage ceiling is insulated to R-15.

Figure 27: Scenic envelope profile. The dark green represents knee walls.

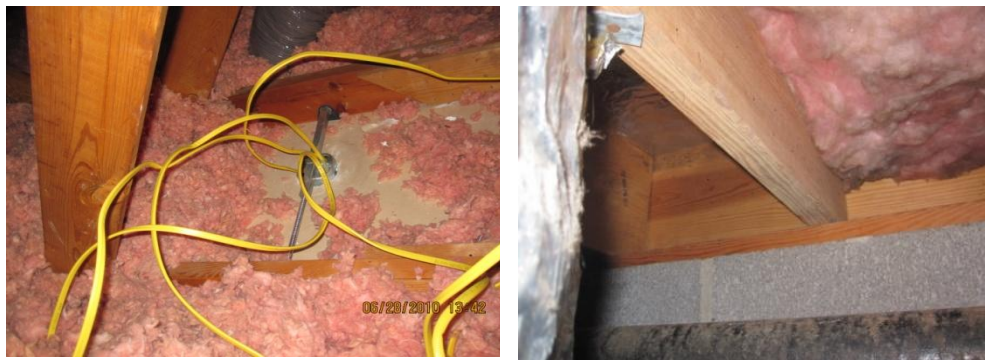
Figure 28: Insulation in the attic and crawlspace ceiling in the Scenic home is sparse.

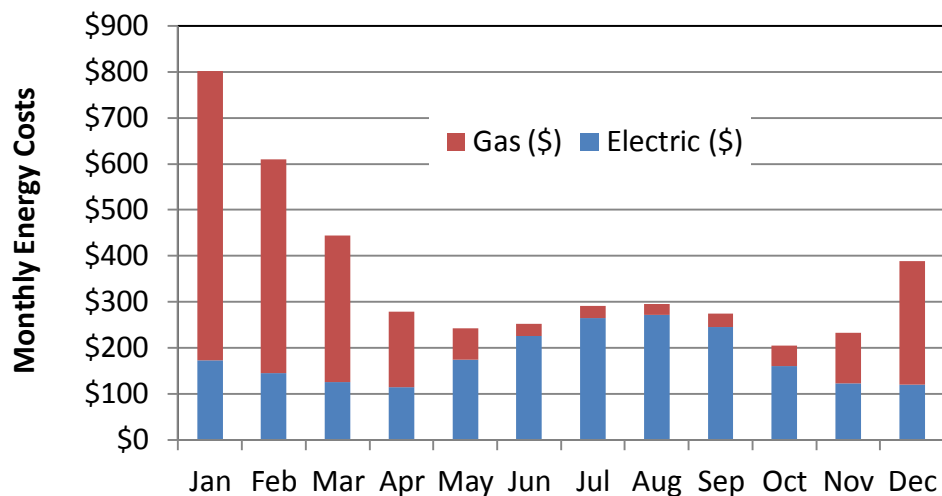
Figure 29: Old Tavern monthly energy costs.

The family's energy costs from January 2009 – December 2009 are shown in Figure 29. With a total annual cost of \$4,317 (232 MMBtu of site energy), the family's energy costs are higher than the average annual site energy consumption for a typical home in the southeast of this size (179 MMBtu^{*}).

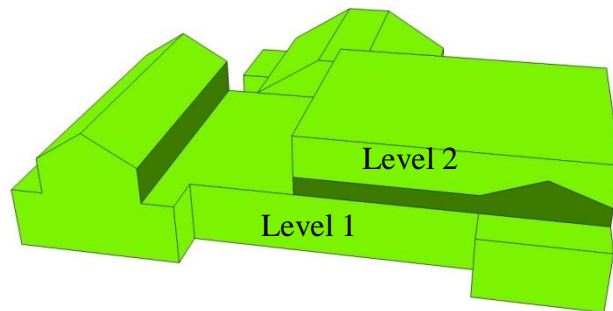
The pre-retrofit envelope boundary of Old Tavern consists of a vented crawlspace with R-11 insulation on the crawlspace framed ceiling, above-grade walls with R-11 insulation, and a traditional vented attic insulated on the floor to R-19. A sketch of the pre-retrofit envelope profile of Old Tavern is shown in Figure 30. A room over the garage has insulation in the framed floor cavities of R-11. The home has slightly insulated attic knee walls (R-2) and an open chase that connects the living space to the attic, as shown in Figure 31.

**Figure 30: Old Tavern pre-retrofit envelope profile.
Dark green represents knee walls.**

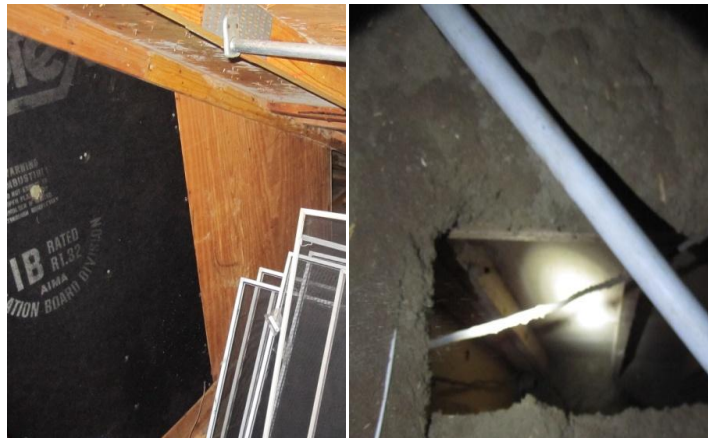
Figure 31: Uninsulated attic knee wall and unsealed attic chase.

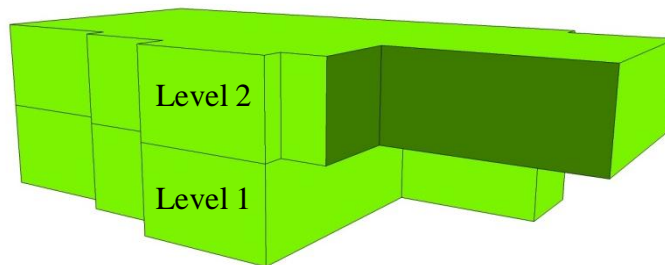
Figure 33: Capital pre-retrofit envelope profile. The dark green represents knee walls.

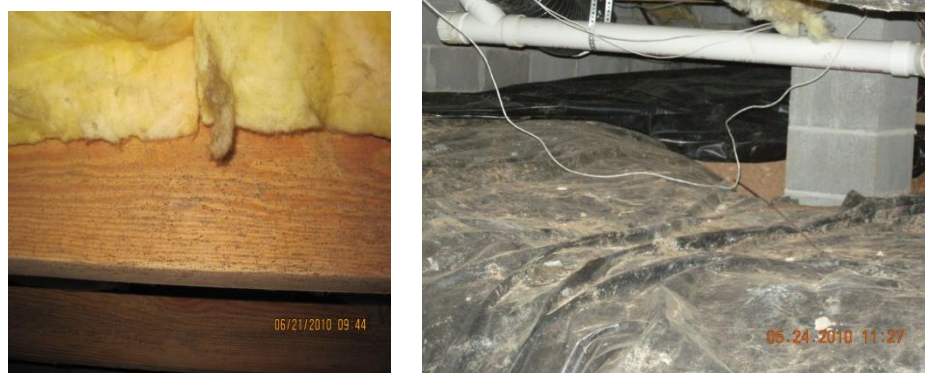
Figure 34: Moisture issues are apparent in the crawlspace of Capital.

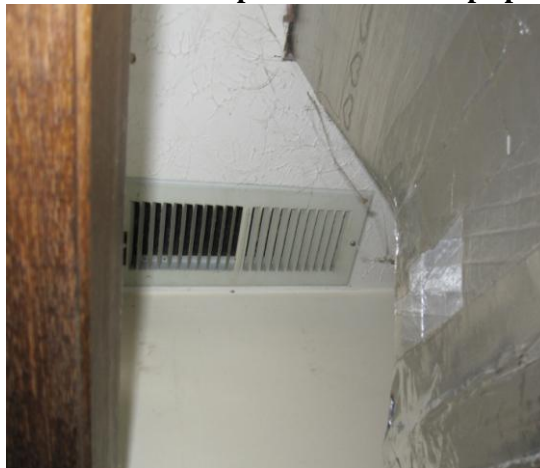
Figure 37: Combustion air vent from mechanical closet leading to vented attic.
