Developing Fatigue Pre-crack Procedure to Evaluate Fracture Toughness of Pipeline Steels Using Spiral Notch Torsion Test

**Materials Science and Technology Division
Oak Ridge National Laboratory**

ORNL/TM-2012/337

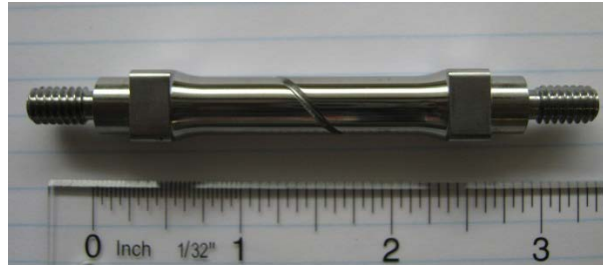
Figure 2. The geometry of the machined X52 SNTT samples

SNTT samples were machined according to the geometry shown in Figure 2. The samples were 0.375" (9.53 mm) in diameter with a gauge length of 0.942" (23.92 mm). A V-shaped spiral groove was machined on the sample surface with a pitch angle θ . When $\theta = 45^\circ$ the notch root is subject to an effective Mode I loading; and when $\theta \neq 45^\circ$, the notch root is then subject to a mixed loading of Mode I and Mode III. Examples of machined epoxy samples are shown in Figure 2b.

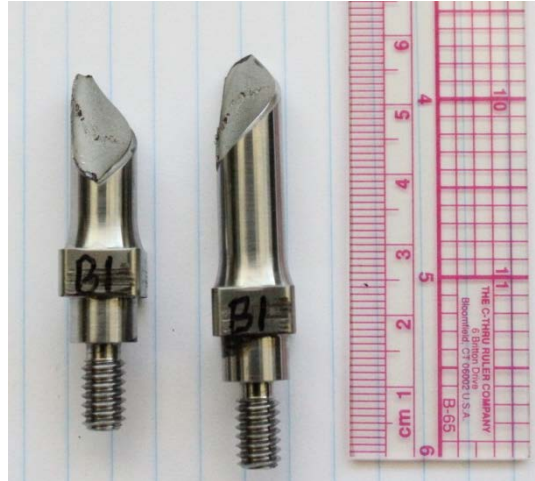
Figure 39. Failed B1 specimen in X52 base steel series.

The failed B1 samples were characterized using an optical camera (Canon EOS rebel T2i, Lake Success, NY), which captured optical images of the specimen (Figure 39a) and the fractured surfaces (Figure 39b). From Figure 39a, it can be seen that the B1 sample split into two halves during the cycle fatigue process. The failed surfaces were smooth and rotated along spiral grooves. During examination of the failed surface, it was noticed there were some defects located within the X52 base material (Figure 39b). This will have to be taken into account in future X52 material development.

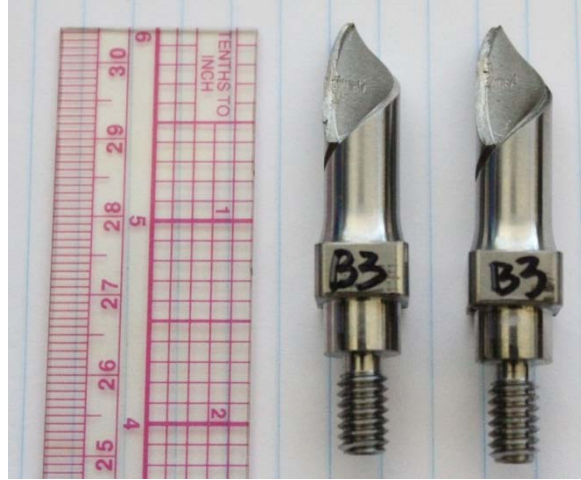
Figure 43. The failed B3 specimen in X52 base steel series.

The images of the failed B3 samples are shown for a specimen that sample split into two halves after the monotonic loading tests (Figure 43). In Figure 44a and Figure 44b, defect areas can be observed among the smooth fatigue areas for the base material sample, and a monotonic loading area can be clearly detected beyond the fatigue crack front. The half in Figure 44b was observed using an optical microscope (SZH10, Olympus, Japan). The defect area and surrounding fatigue area in the failed B3 sample can be clearly detected in Figure 45. Three locations in this sample were selected for further scanning microscopy analysis (discussed in a later section).

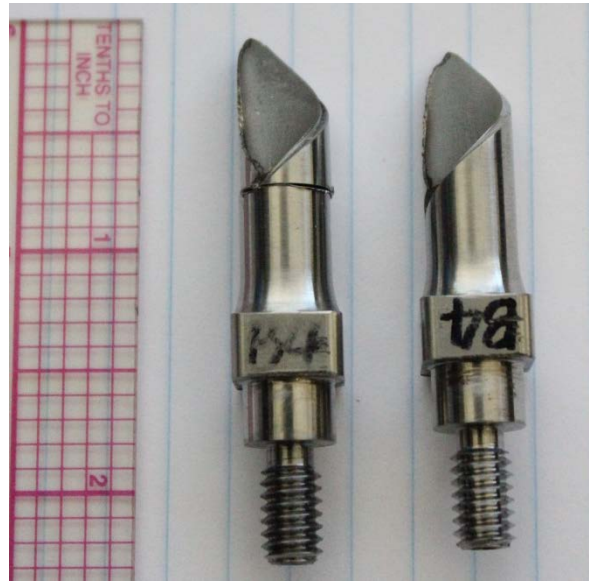
The images of the failed B4 sample appear in Figure 51, again splitting into two halves during the fatigue process. In Figure 52a, the fatigue crack front extends to the edge of the SNTT cylinder. There were no similar defect areas compared to those observed in sample B1 and B3. An addition cut was performed to one of the split halves to examine the crack penetration status on the edge of the spiral notch. No clear crack penetration was observed in the cross-section.

Figure 51. The failed B4 specimen in X52 base steel series.

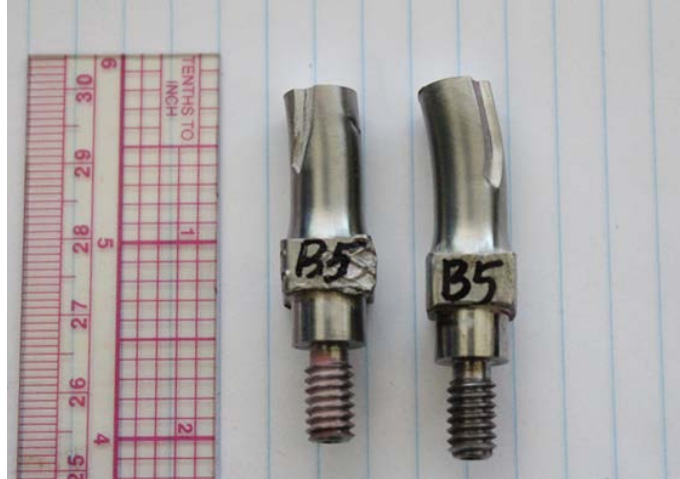
The images of the failed B5 sample are shown in Figure 53. After the initial cyclic loading process, the B5 sample was submerged into liquid nitrogen for 5 minutes. In order to cause B5 failure, significant torque was applied with a torque wrench, assuming that the sample would fail like a brittle material. The B5 sample did not fail even though the sample was subjected to strong twisting, as can be observed from the dented area and the stretched spiral groove. An addition cut was performed in the middle section of the twisted B5 sample. No clear crack penetration was observed.

Figure 53. The failed B5 specimen in X52 base steel series.

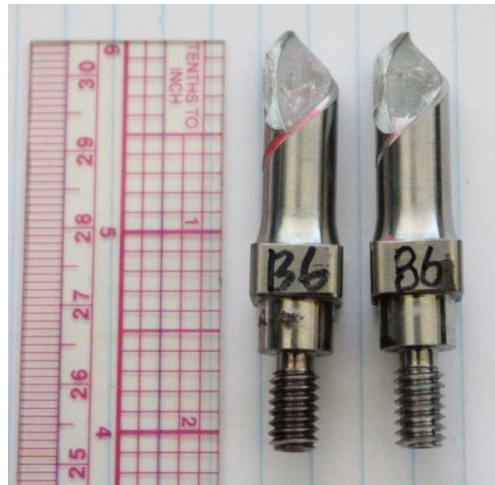
Figure 54. The failed B6 specimen in X52 base steel series

The images of the failed B6 sample were shown in Figure 54. After the initial cyclic loading process, dye penetrant (Magnaflux, Glenview, IL) was sprayed into the cracked B6 sample (Figure 55). The fatigue precrack test stopped when the dynamic torque was around lbf-in. Then the loading–unloading test was performed to characterize the mechanical behavior of the B6 sample, as described below.

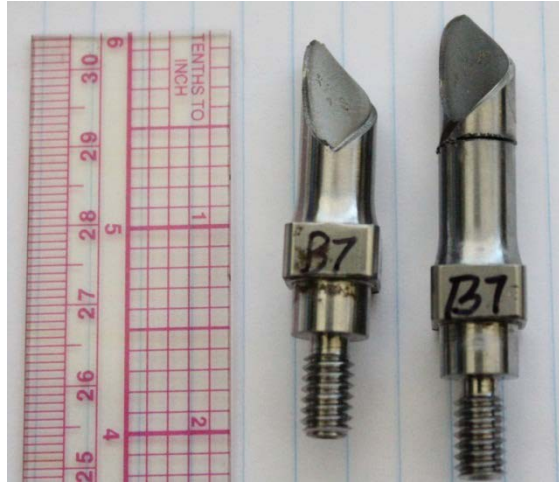
Figure 57. The failed B7 specimen in X52 base steel series

The images of the failed B7 sample, which split into two halves during the fatigue process, are shown in Figure 57. In Figure 58a, the fatigue crack front extends to the edge of the SNTT

cylinder. There are similar defect areas in this failed sample compared to those observed in samples B1 and B3. An additional cut was made in one of the split halves to examine the crack penetration status on the edge of the spiral notch. No clear crack penetration was observed in the cross-section.

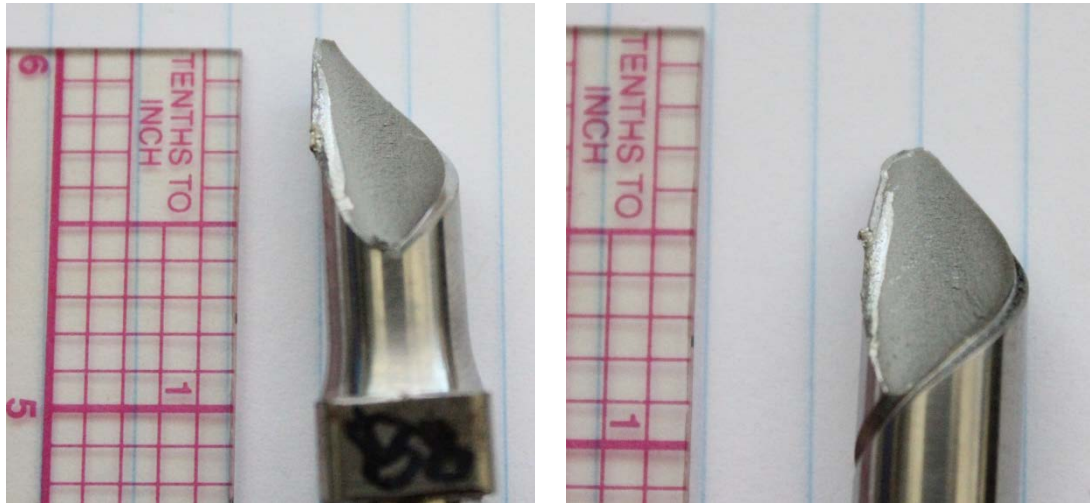
Figure 60. The failed B8 specimen with higher resolution (a) one half of failed sample; (b) the other half of the failed sample.

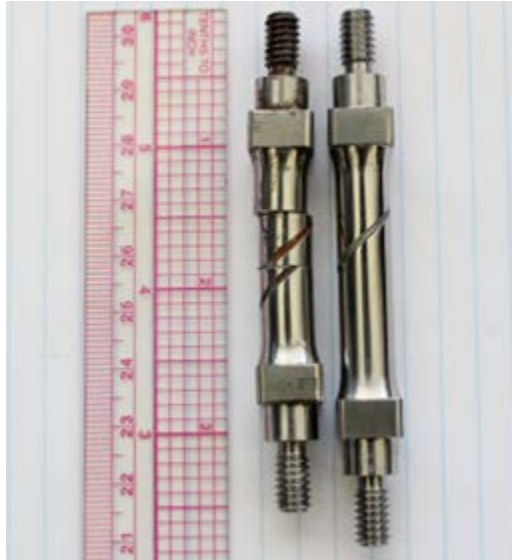
Figure 64. The failed B9 specimen in X52 base steel series.

When the program ended, the sample was cut into parts using a diamond saw Labcut 1010 (Extec, Enfield, CT) to check the actual crack depth. Various locations along the specimen axis were selected for cross sections check. When the cross section is in the middle section of the SNTT specimen, cracks could be observed clearly. However, no clear cracks could be observed to when the cross sections located close to the square ends of the SNTT sample. The assembled length of B9 parts is shorter than the original sample since one segment is with Ohio State University for characterization.

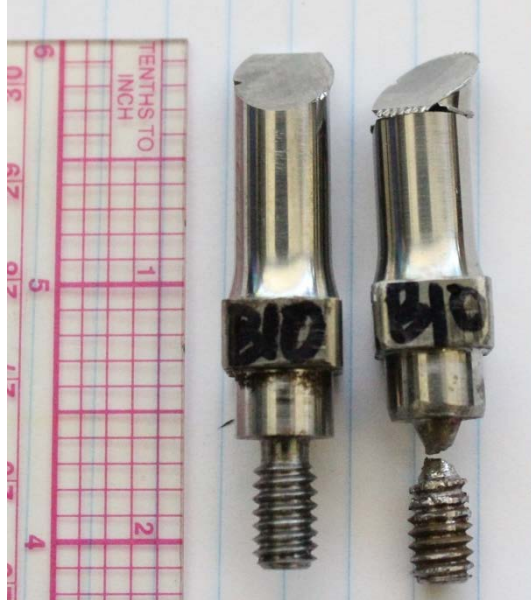
Figure 67. The failed B10 specimen in X52 base steel series.

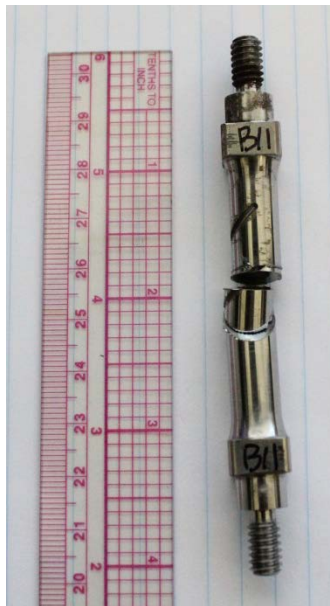
Figure 71. The failed B11 specimen in X52 base steel series.

When the program ended, the sample was cut into parts using a diamond saw Labcut 1010 (Extec, Enfield, CT) to check the actual crack depth. The middle section was cut in an angle of 45 degree with respect the cylindrical axis; while another cut was performed perpendicular to the cylinder axis above the previous cut (Figure 71). In the middle-section skew cut (Figure 72), the measured ratios of crack depth to diameter were 0.31 and 0.30 on both sides. In the cut perpendicular to the cylindrical axis, no clear cracks were observed in the cross section.

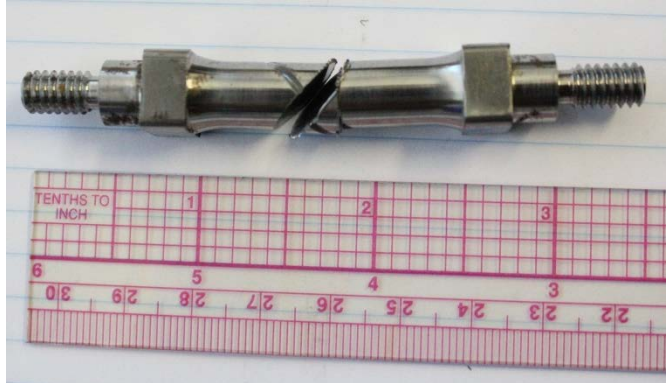
Figure 74. The failed B12 specimen in X52 base steel series.

When the program ended, the sample was cut into parts using a diamond saw Labcut 1010 (Extec, Enfield, CT) to check the actual crack depth. A cut was performed perpendicular to the cylindrical axis in middle section; while another cut was performed at angle of 45 degree to the cylinder axis above the previous cut (Figure 74). In the middle-section cut (Figure 75), the measured ratios of crack depth to diameter were 0.14 and 0.14 on both sides. In the skew-cut (Figure 76), the measured ratios of crack depth to diameter were 0.13 and 0.13 on both sides.

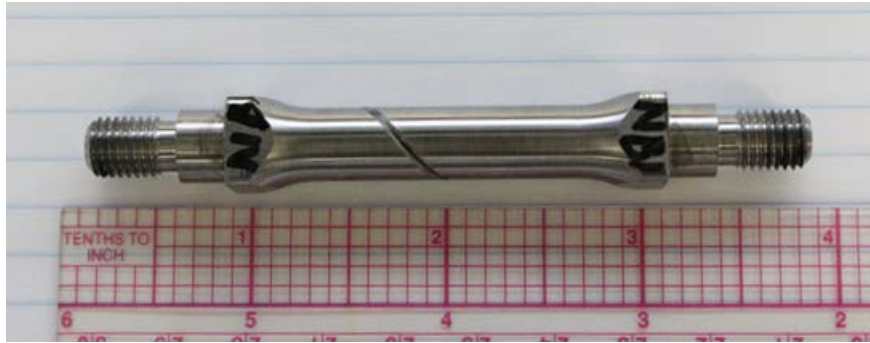
Figure 79. The precracked SNTT X52 steel sample NB01.

The gauge slope evolution process in sample NB01 was shown in Figure 78. It shows that the slope stayed almost in the same level before the count 11. Then the crack penetrated effectively between count 11 and 29. The program ended soon after this jump since the end rotation angle reached the critical angle limit. After count 29, the slope measurement stayed in the same level. Based on the data in Figure 32, the estimations of corresponding crack penetration ratios were also included, of which the final penetration in sample NB01 was ~0.40.

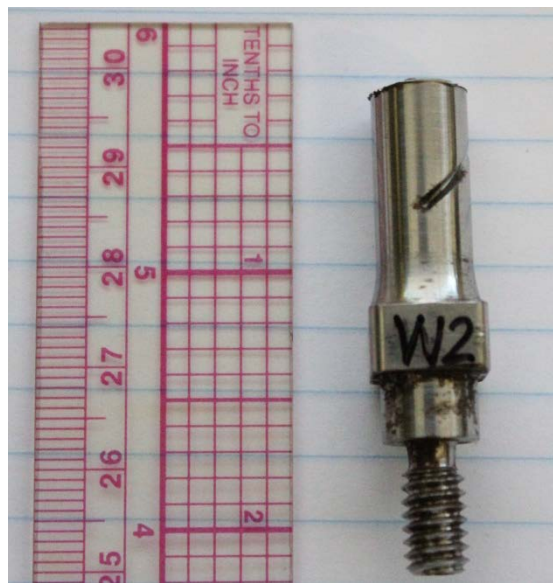
Figure 104. The failed W2 specimen in X52 welded steel series.

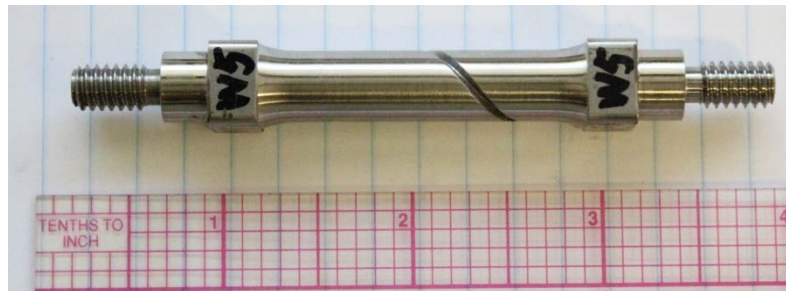
Figure 112. The fatigue precracked SNTT welded material sample W5.

Cracks have been introduced to the SNTT W5 sample during the cycle fatigue process. It is ready for fracture toughness measurement by coupling acoustic emission or biaxial extensometer techniques (Figure 112).

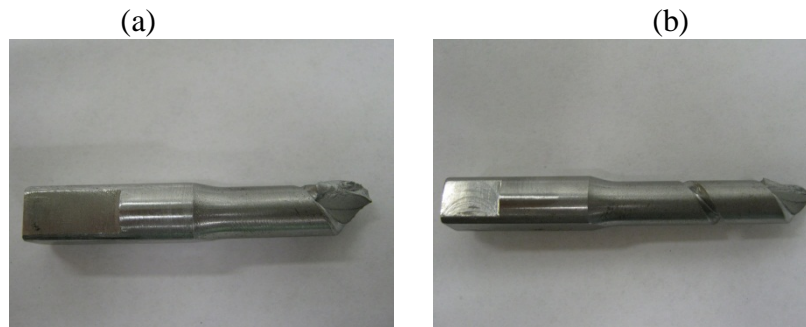
Figure 127. Failed SNTT specimen X80B05: (a) one half; (b) the mating half.

X80B05 sample split into two halves at failure (Figure 127). By checking the local view of the fracture surface (Figure 128), distinctive areas could be found for fatigue or monotonic loading process, similar to the situation shown in X52 sample. Optical images of the fracture surfaces were shown in Figure 129, from which the notch-to-diameter ratio was ~ 0.66 .
