ORNL Parking Structure Mitigation Report

Oak Ridge National Laboratory

September 2012

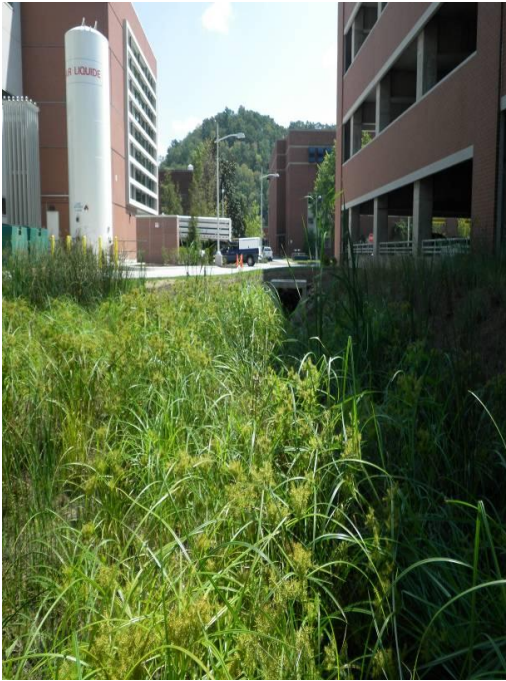
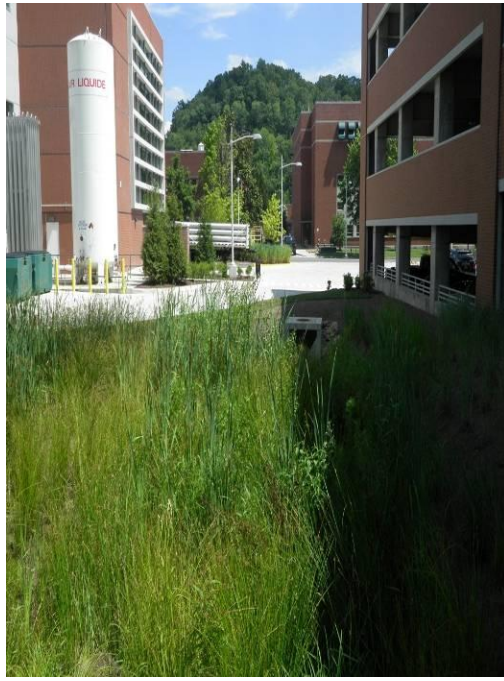
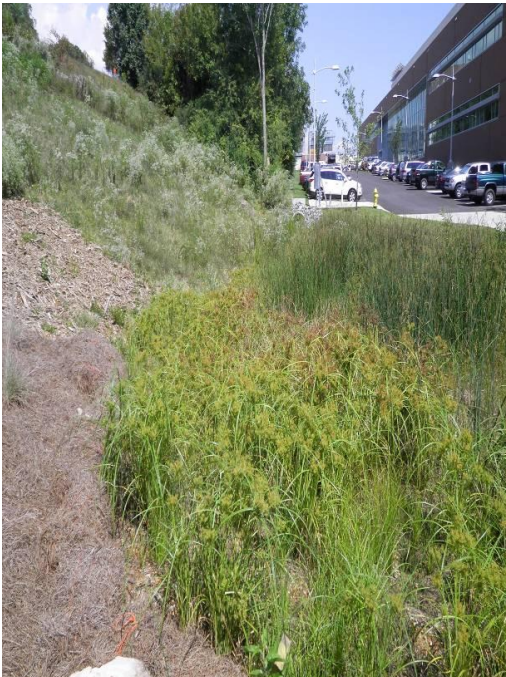
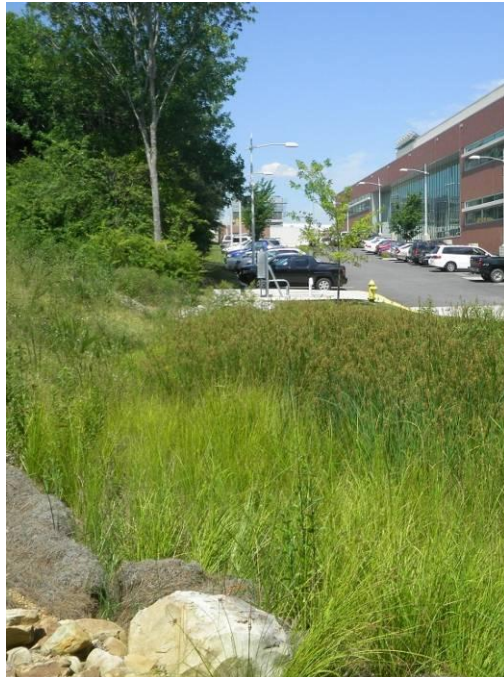
Figure 1. Photographs of P2 Wetland in 2011 and 2012.

Figure 1 shows photographs comparing the condition of the P2 wetland between 2011 (soon after mitigation) and 2012. The wetland continues to support good vegetation coverage.

After Mitigation (September 12, 2011)

Current Appearance (June 12, 2012)

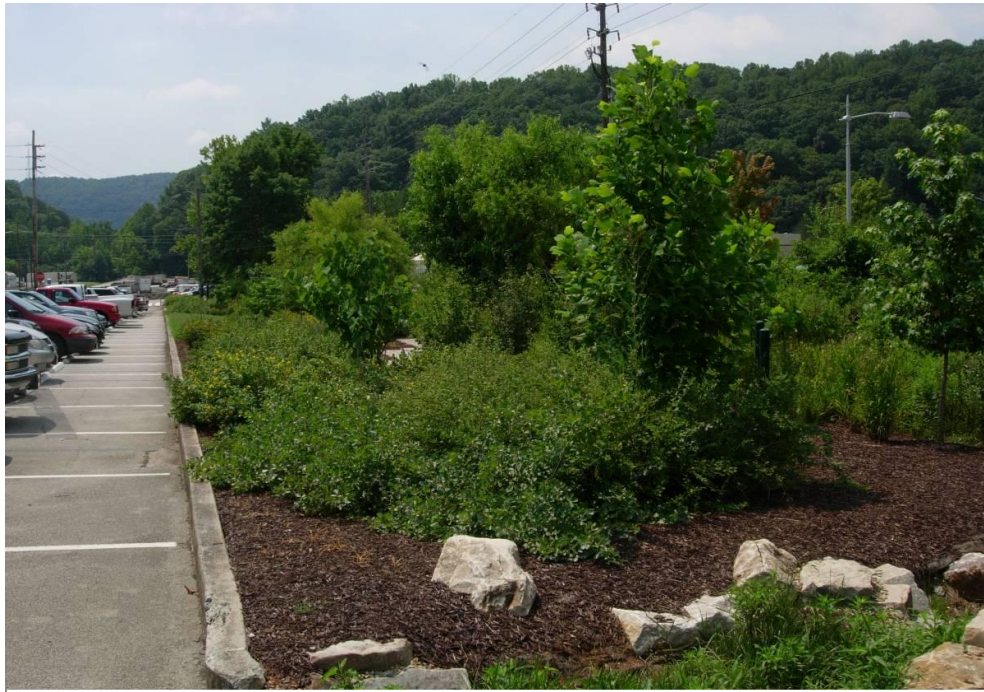
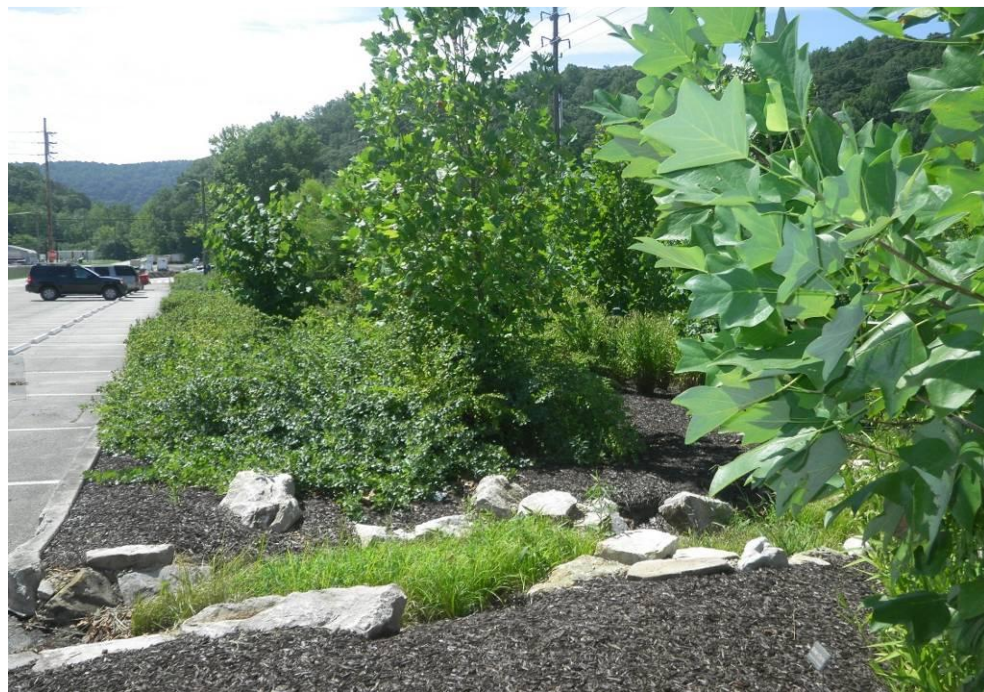
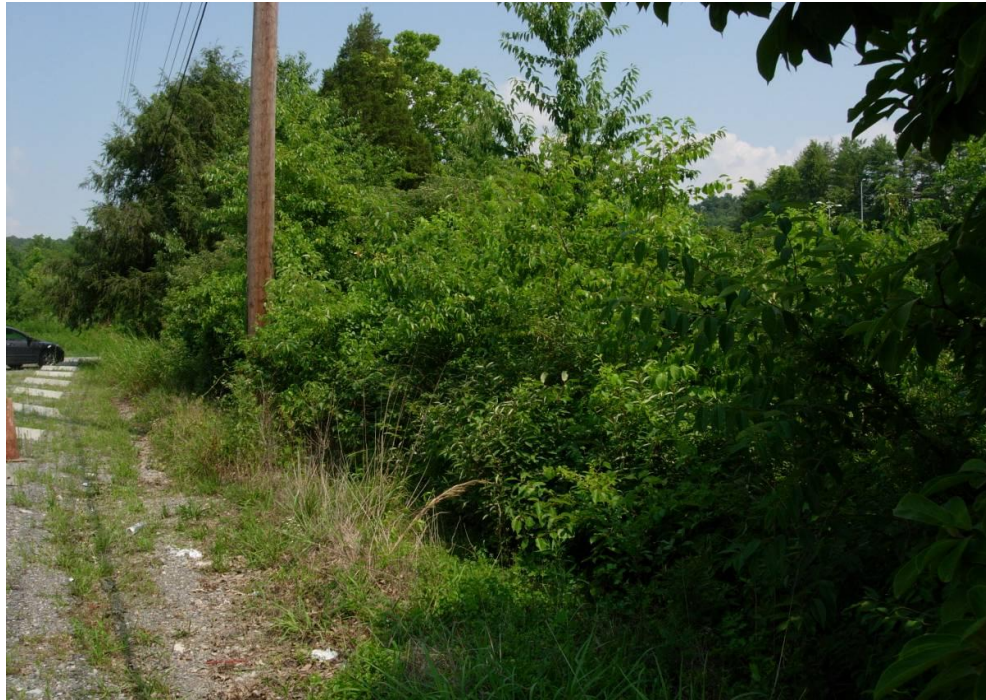
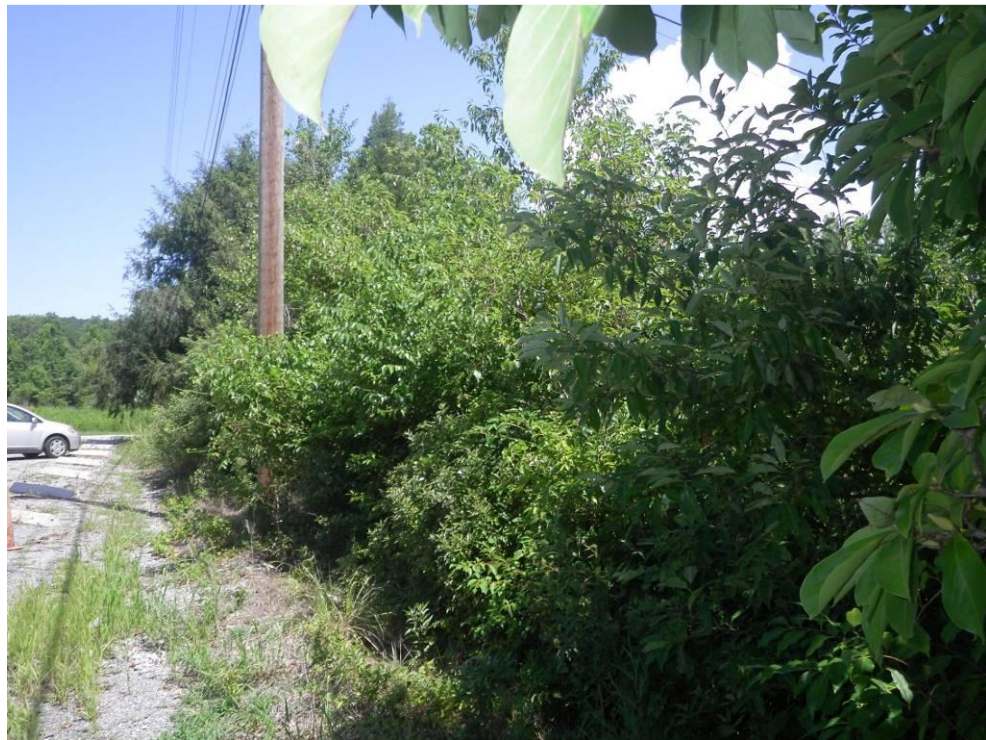
Figure 2. First Creek Riparian Zones.

Left/East Site (2011)

Left/East Side (2012)

Right/West Site (2011)

Right/West Side (2012)

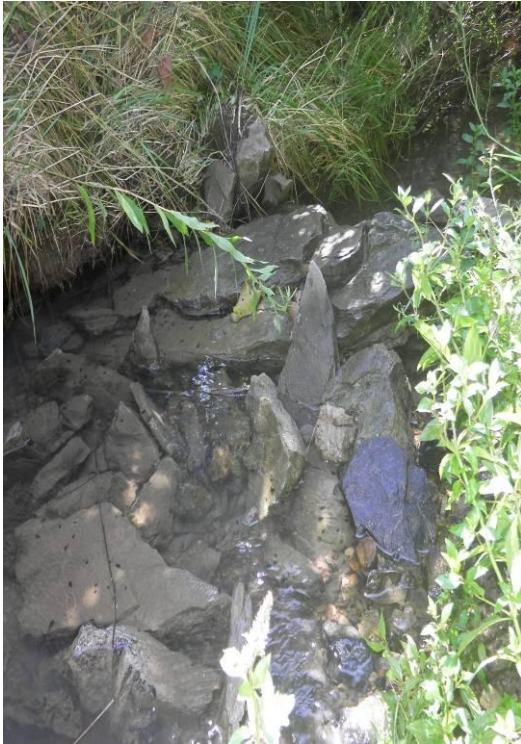
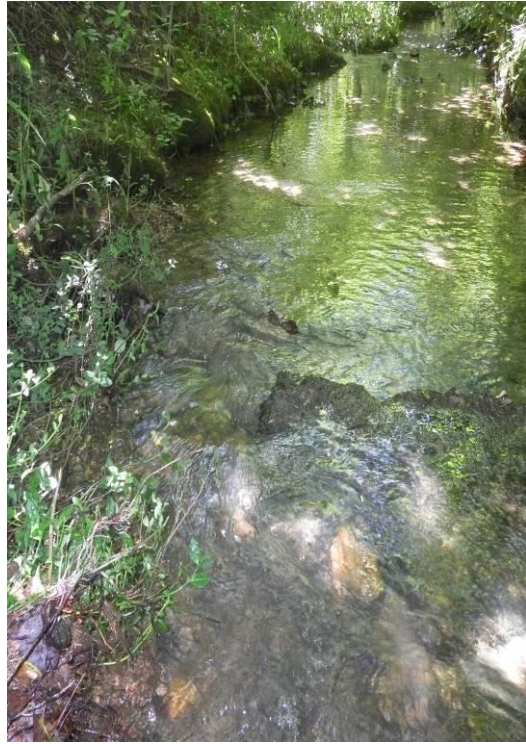
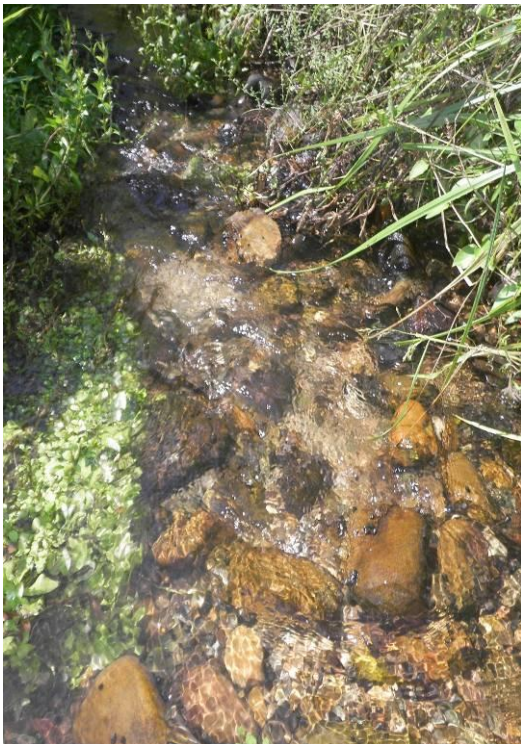
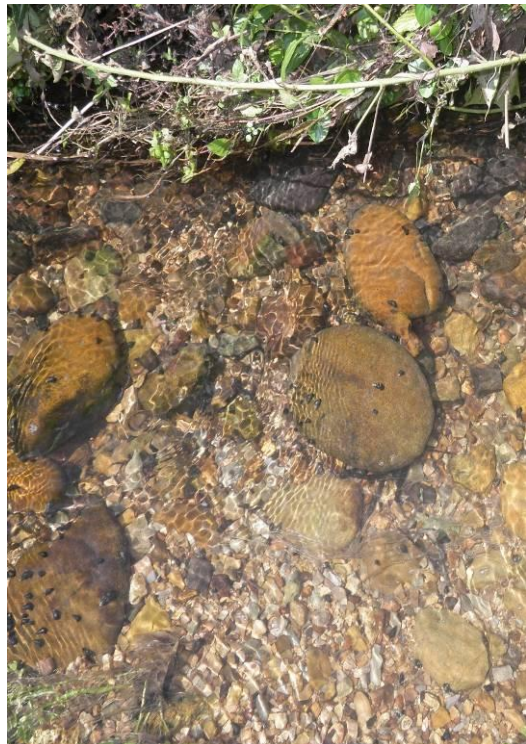
Figure 3. Select Habitat Attributes of the First Creek Reach in 2012.

1. Epifaunal Substrate/Available Cover – This reach of First Creek scored in the low optimal range for epifaunal substrate/available cover. It is estimated that approximately 70% of the substrate is favorable for epifaunal colonization and fish cover. This particular reach provides numerous riffles, undercut banks, cobble, larger rocks, falls and overhanging branches. The area is somewhat lacking in presence of logs and snags.

2. Embeddedness – This reach scored in the lower optimal range for embeddedness. This means that gravel, cobble and boulder particles are 0-25% surrounded by fine sediment. Gravel, cobble and boulder particles were <25% surrounded by fine sediment for most of the length of the First Creek reach. The reach contained a variety of rock and cobble sizes with some good layering and crevices for cover.

3. Velocity/Depth Regime - The First Creek reach scored in the mid-optimal range for velocity/depth regime. This means that all 4 velocity/depth regimes (slow deep, slow-shallow, fast deep and fast-shallow) were present.

Epifaunal Substrate (favorable)

Velocity/Depth Regime (fast-deep)

Frequency of Riffles (very frequent)

Embeddedness (low sediment)

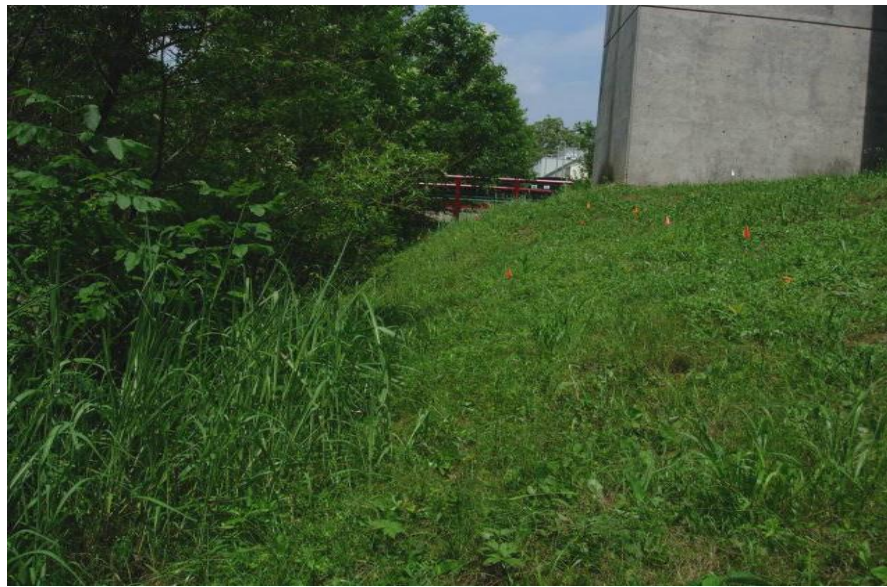
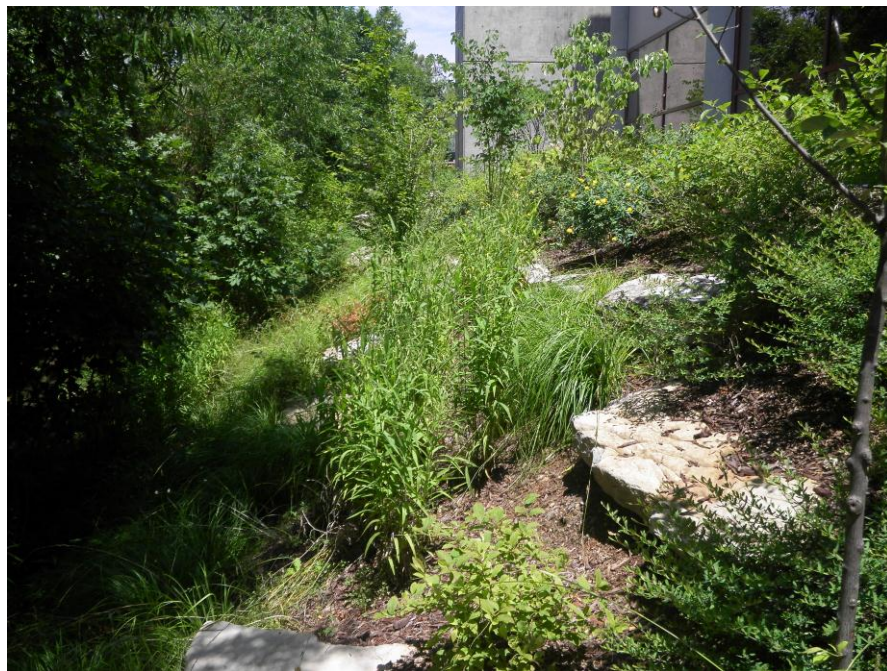
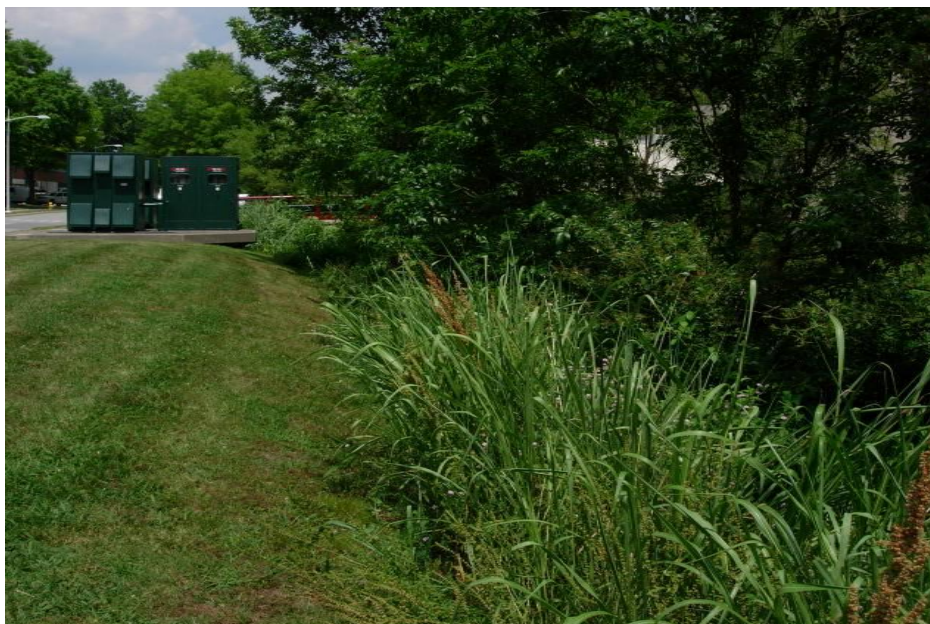
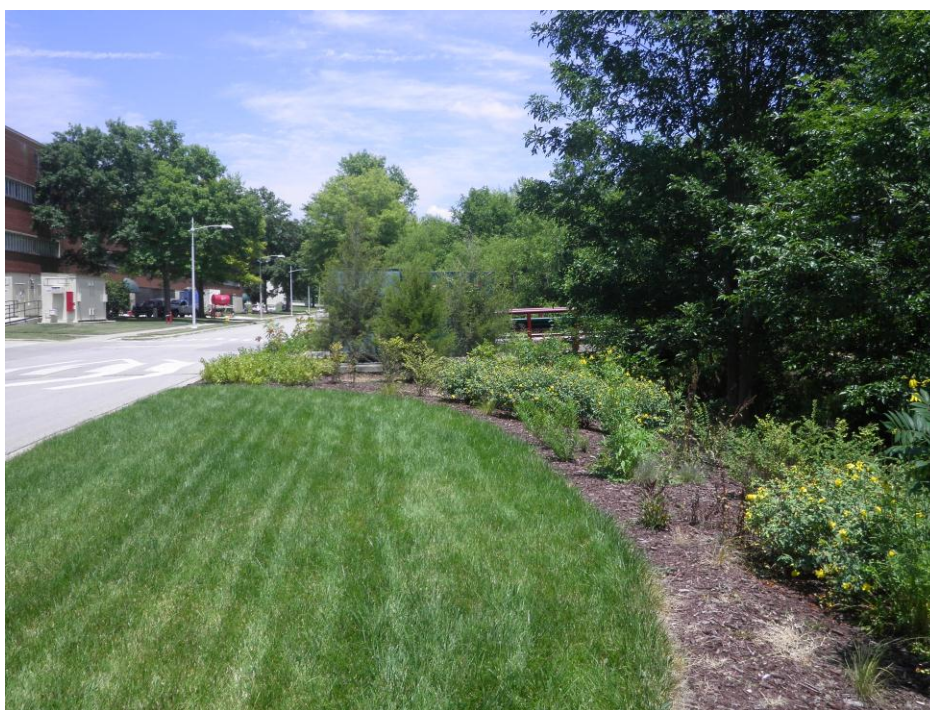
Figure 4. White Oak Creek Riparian Zones (2011 [pre-mitigation] and 2012).

Left/South Side (pre-mitigation - 2011)

Left/South Side (post-mitigation - 2012)

Right/North Side (pre-mitigation - 2011)

Right/North Side (post-mitigation – 2012)

The results of habitat measurements conducted along this reach of White Oak Creek in 2011 showed that the creek provided average overall habitat in the pre-mitigation condition and was in a non-impaired state, a rating that was maintained in 2012. Epifaunal substrate was somewhat lacking in the presence of logs and snags; however, the creek provided numerous riffles, some undercut banks, a variety of particle sizes and overhanging branches. One velocity/depth regime (fast-deep) was missing from the reach. Channel alteration from past development of the area was evident along some areas of the reach. Vegetative protection at the banks was compromised by the presence of invasive plant species (i.e., winter creeper, Japanese honeysuckle, Nepal grass, and Johnson grass) in 2011. However, significant improvements were noted in 2012 due to removal of invasives and replacement with native plants during mitigation. Narrow riparian zones were a significant weakness on the site prior to mitigation, mainly due to the existence of adjacent areas that contained large areas of low turf grasses and weedy species. Although riparian zone width is restricted on the north side by an existing paved road and on the south side by a building, modifications made to the site with the mitigation planting has resulted in a significant increase in the width and quality of the vegetative riparian zone.

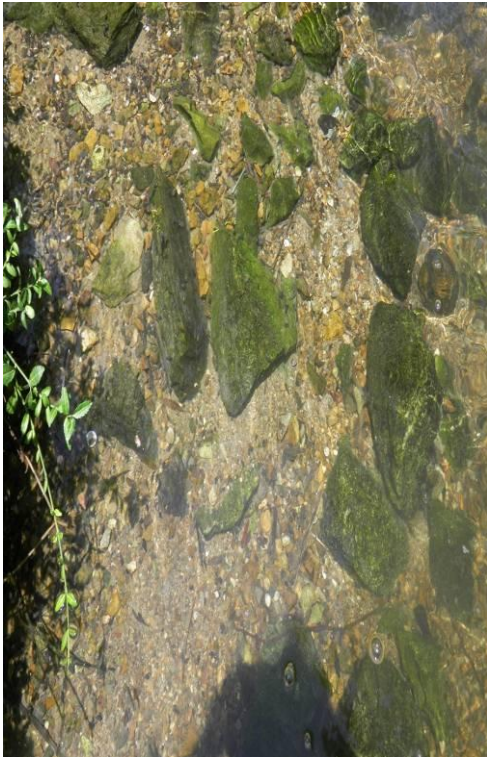
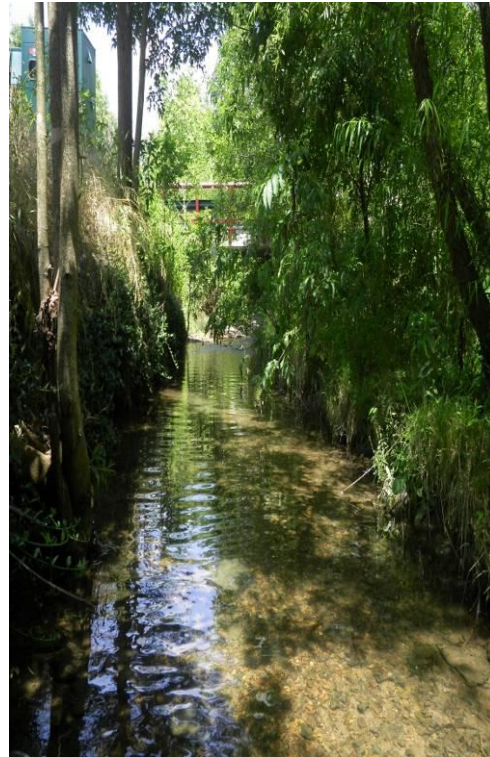
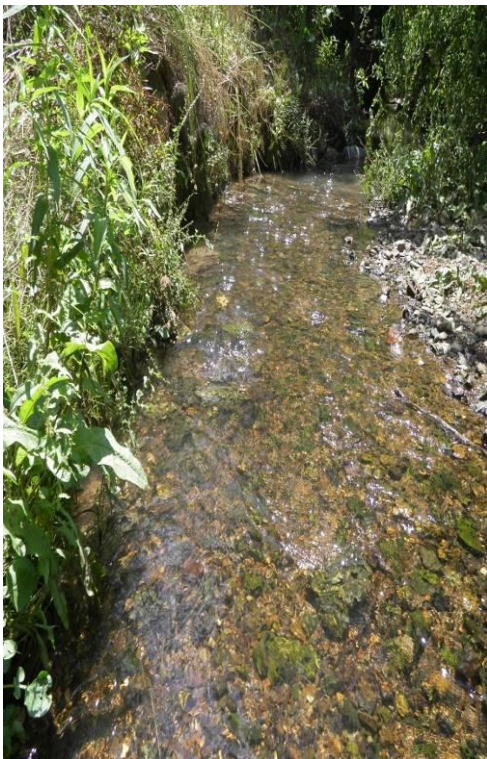
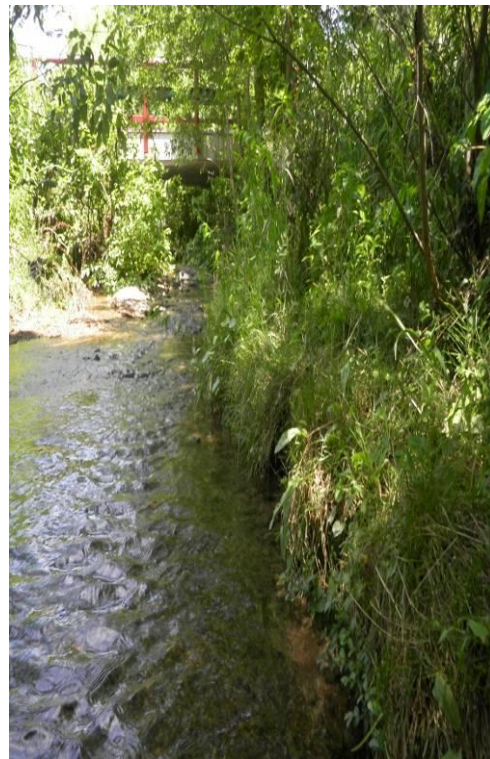
Figure 5. Select Habitat Attributes of the White Oak Creek Reach in 2012.

5. Channel Flow Status - The White Oak Creek reach scored in the mid-optimal range for channel flow. This means that the water reaches the base of both lower banks, and a minimal amount of channel substrate is exposed. Good bank to bank flow was noted in most all locations along the White Oak Creek reach, with no noticeable locations where this wasn't the case.

8. Bank Stability (conditions of banks) - The White Oak Creek reach scored in the lower optimal range for bank stability, for both banks. This means that banks are stable where evidence of erosion or bank failure is absent or minimal, with little potential for future problems. This reach showed little to no evidence of erosion or bank failure.

Embeddedness
(rocks free from sediment)

Channel Flow Status
(bank to bank flow)

Frequency of Riffles
(relatively frequent)

Bank Stability (stable condition)

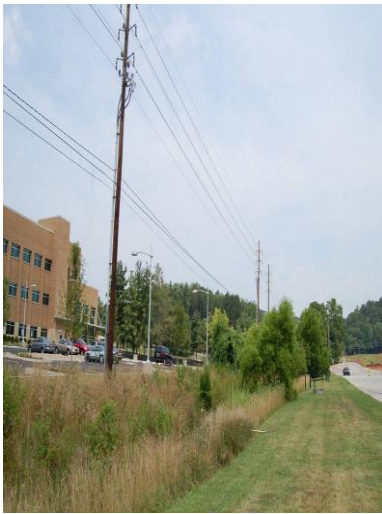
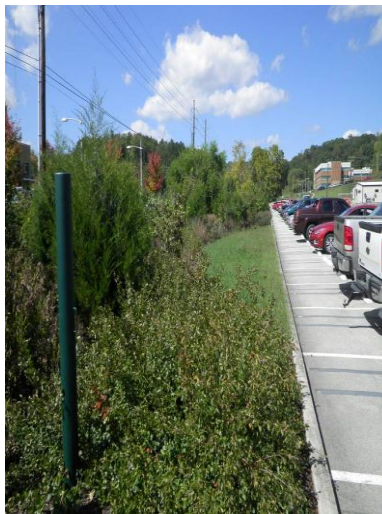
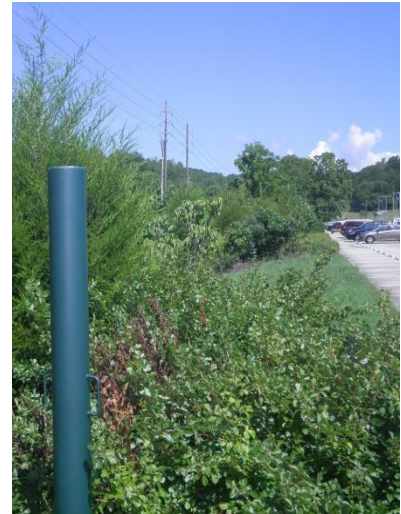
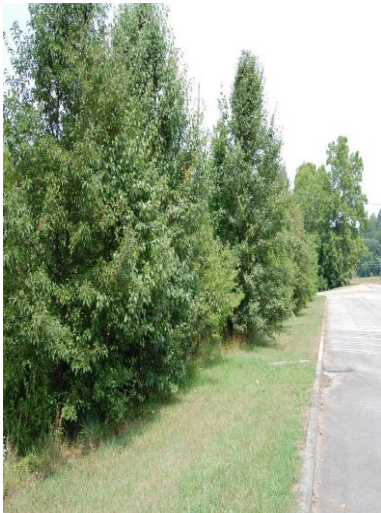
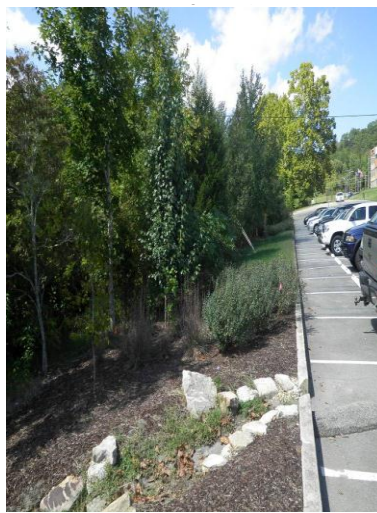
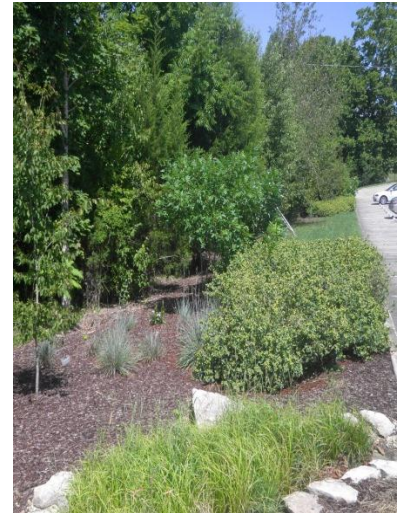
Figure 6. First Creek Reach in 2011 and 2012.

Figure 6 provides a photographic comparison of site condition changes between 2008 and 2012.

Before Mitigation (2008)

After Mitigation (2011)

Current Appearance (2012)

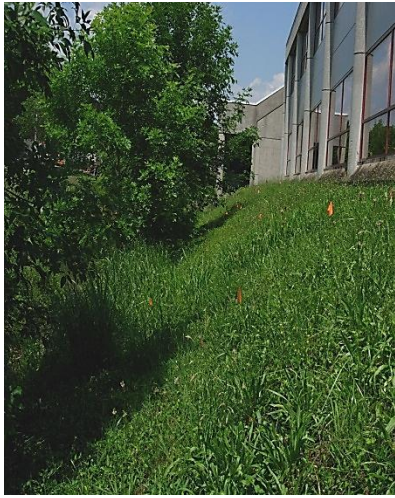
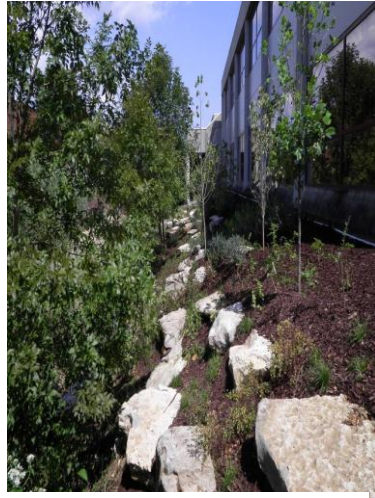
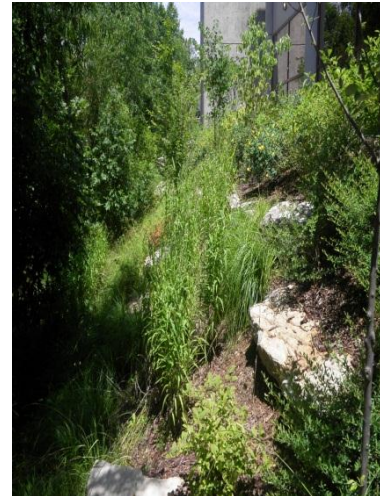
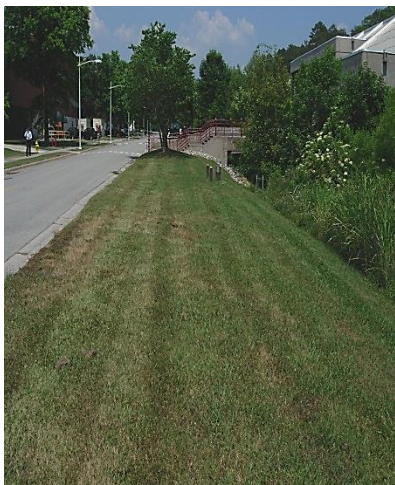
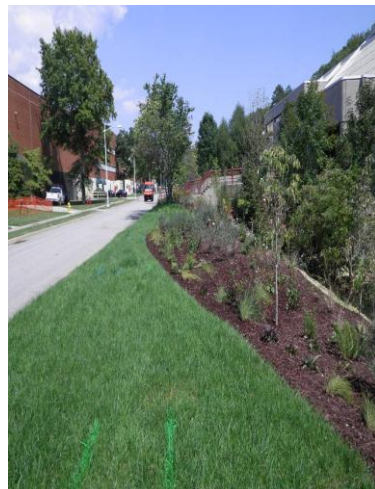
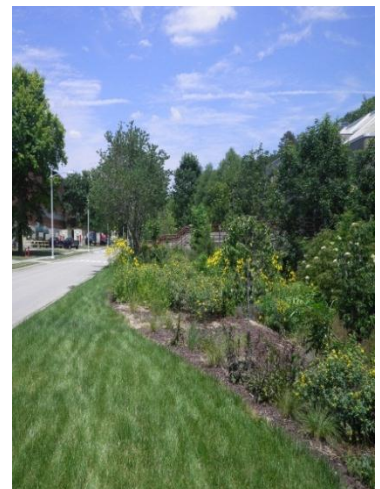
Figure 7. White Oak Creek Reach in 2011 and 2012.

Figure 7 provides a photographic comparison of site condition changes between 2011 and 2012.

Before Mitigation (2011)

After Mitigation (2011)

Current Appearance (2012)
