Improved Processing of High Alloy Steels for Wear Components in Energy Generation Systems, Transportation and Manufacturing Systems

Final Technical Report

**Improved Processing of High Alloy Steels for Wear Components in Energy
Generation Systems, Transportation and Manufacturing Systems**

CPS Agreement No. 20978

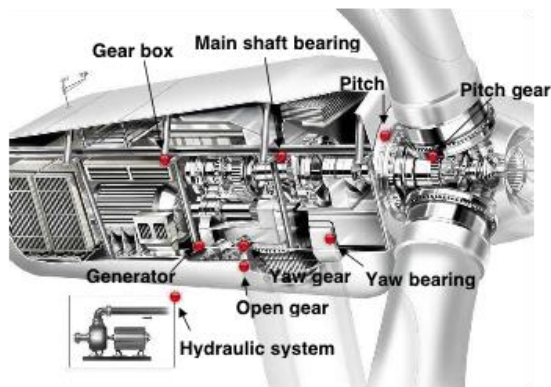
Figure 1. Illustration of the major bearing systems in a wind turbine.

There are multiple bearing systems in a wind turbine, such as the blade bearing, generator, gear box, main bearing, yaw bearing, and hydraulic system, as illustrated in **Figure 1**. Mechanical failures for wind turbines in the field are usually gear/bearing related, and a typical failure can cost \$200,000 to \$400,000. This cost drives a strong demand for advanced bearing steels with higher strength and wear-resistance.

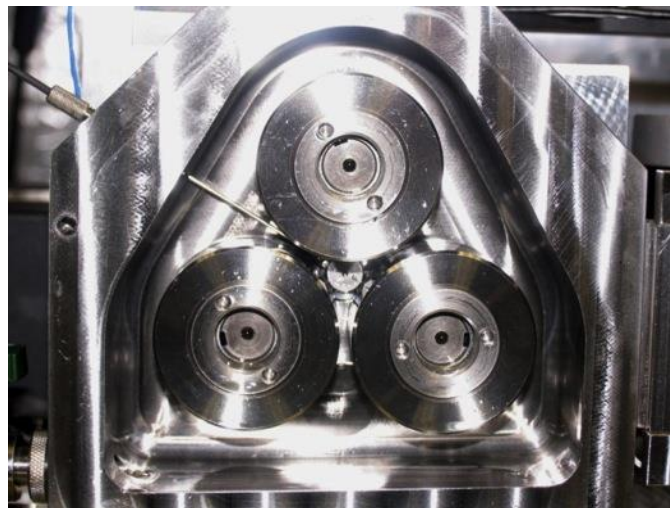
Figure 3. Cluster to rollers surrounding a smaller central test roller (chamber door open). The temperature probe enters the chamber from the upper left.

The basic components of the machine are twin motors, a torque-monitored drive train, and a specimen chamber (**Figure 3**) that holds three outer rollers and in a smaller inner roller the test specimen of interest. Exclusive of the computer, the machine is approximately the size of a large refrigerator and weighs approximately 170 kg (375 lb). The maximum applied load to test specimens is 1250 N and the maximum surface speed between rollers is 4.0 m/s. The maximum lubricant temperature is 135 °C. Conditions from pure slip to nearly pure rolling without slip are achievable by adjusting the relative rotational speeds of inner and outer rollers. Two software applications were included. One

Micro-pitting may precede more deleterious forms of surface damage, like macro-pitting and spalling, and is therefore of interest to bearing and gear designers. A new micro-pitting test rig from PCS Instruments (UK) was obtained for this project. Experiments using dummy steel specimens were conducted in order to develop a suitable test protocol for the project. In the meantime, a series of twenty test specimens of heat treated steels (52100, M50, M62, 440C, and 440XH) were precision-machined to fit the PCS test rig. The specimen and fixture geometry is shown in **Figure 3**. The

central roller, approximately 12 mm in diameter is trapped between three outer disks producing three contact stress cycles for each rotation of the inner roller. The relative speed of the inner roller and disks is chosen to provide a desired amount of slip. Friction, torque, oil temperature and wear are recorded.

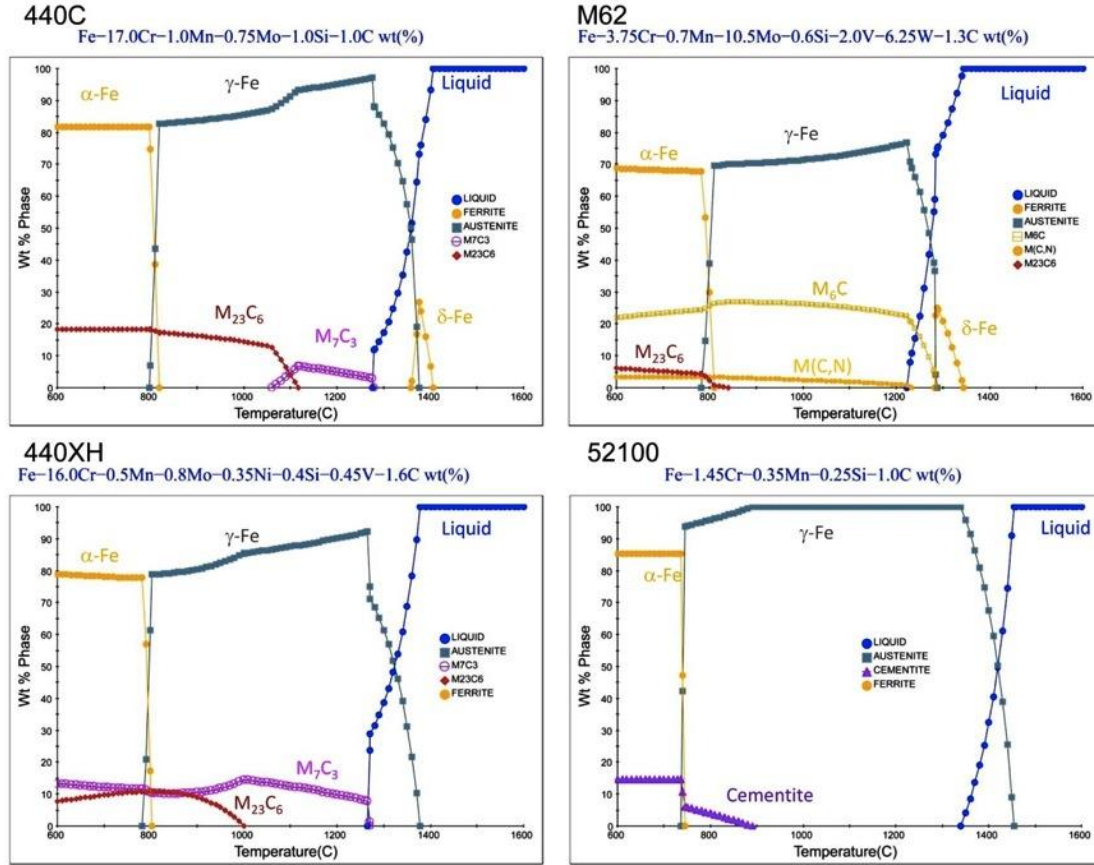
Figure 4. Calculated phase equilibrium of the alloys (440C, 440XH, M62, and 52100) by JMatPro. Note that the calculation result of M50 was similar to that of 52100, although the predicted carbides were not Fe_3C but M_{23}C_6 (10%) + M_6C (4%) + $\text{M}(\text{C},\text{N})$ (2%) at 600°C.

Theoretical phase equilibrium of the alloys calculated from JMatPro (a computational thermodynamic calculation tool) is shown in **Figure 4**. The equilibrated second-phase carbides at 600°C are quite different with each alloy: 18% of $M_{23}C_6$ in 440C; 12% of M_7C_3 plus 8% of $M_{23}C_6$ in 440XH; 22% of M_6C plus 6% of $M_{23}C_6$ plus 4% of $M(C,N)$ in M62; 14% of Fe_3C in 52100, and 10% of $M_{23}C_6$ plus 4% of M_6C plus 2% of $M(C,N)$ in M50 (not in the figure). The 600°C temperature graphs, in the predictive model were used to mimic tempered conditions of bearing steels. The M62 alloy shows the largest total amount of second-phase carbides, and the 52100 the lowest, among the alloys studied. JMatPro does not predict the size and distribution of equilibrium phases, only the amount. These calculated results were consistent with the microstructure characterization and XRD analysis of the samples after hardening/ tempering heat-treatments. Calculations show that some fine carbides in 440C, 440XH and M62 formed by the rapid solidification of the gas atomization process do not completely dissolve at temperatures very close to the melting point of these alloys.

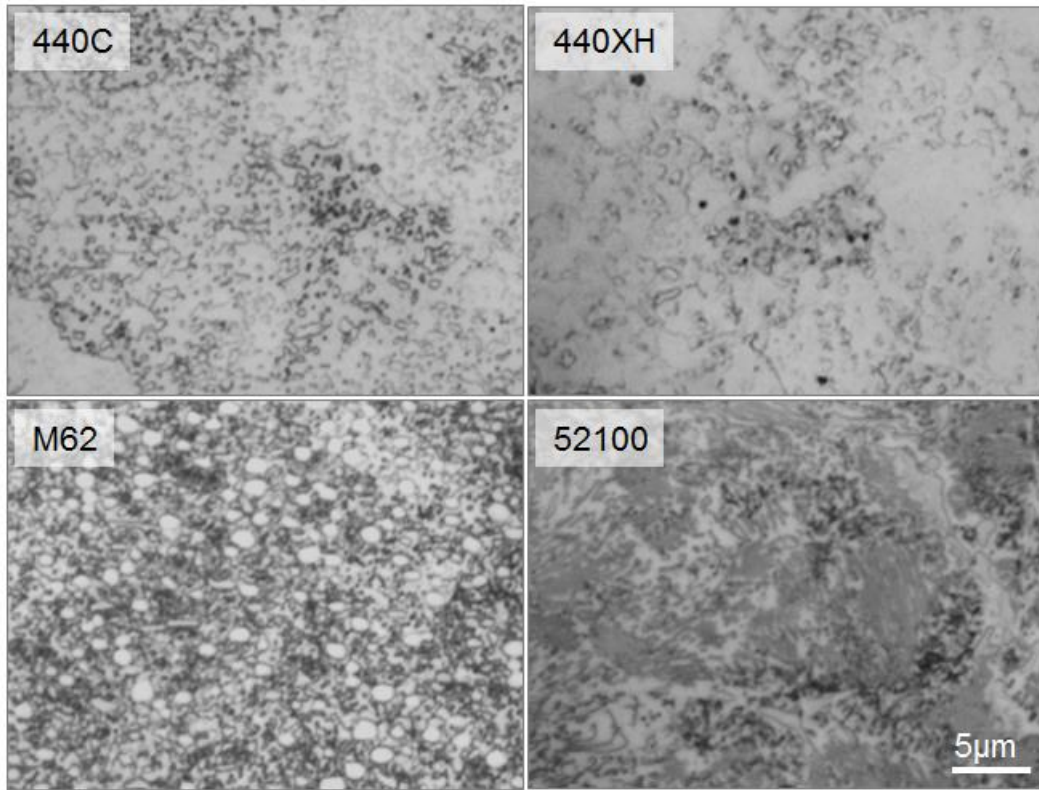
Figure 5. Optical micrographs of the as-received materials.

Microstructures of the materials before and after heat-treatment are shown in **Figure 5** and **Figure 6**, respectively. The 440C and 440XH samples showed spherodized carbides, presumably $M_{23}C_6$ (M: mainly Cr), in the as-received materials which were coarsened after the heat-treatment. The matrix of the 440C and 440XH samples after heat-treatment exhibited a bainitic microstructure with a commensurate hardness increase over the as-received material. The M62 sample showed spherodized carbides, presumably M_6C (M: mainly Mo and Fe), with almost no size and morphology changes before and after the heat-treatment. The matrix of the M62 sample exhibited slight changes in the etched contrast after the heat-treatment, although it was difficult to identify the microstructural feature with the resolution of optical microscope. The microstructure of as-received 52100 material showed a typical air-cooled microstructure consisting of perlite in the matrix together with primary cementite precipitated on the grain boundary. However, after heat-treatment, the microstructure consisted of a martensite matrix with partially transformed perlite (typical oil-quenched microstructure), which showed the formation of spherodized particles in the perlite.

It should be noted that all PM materials show what appears to be some microporosity in the as received HIP'ed condition. This apparent microporosity remains in fully heat treated material but in reality are due to small carbides or small oxides being removed during polishing of the micro samples. The HIP process, with the temperatures and pressure applied to the powder always produces a 100% dense structure. This condition has no effect on the performance of the alloys..

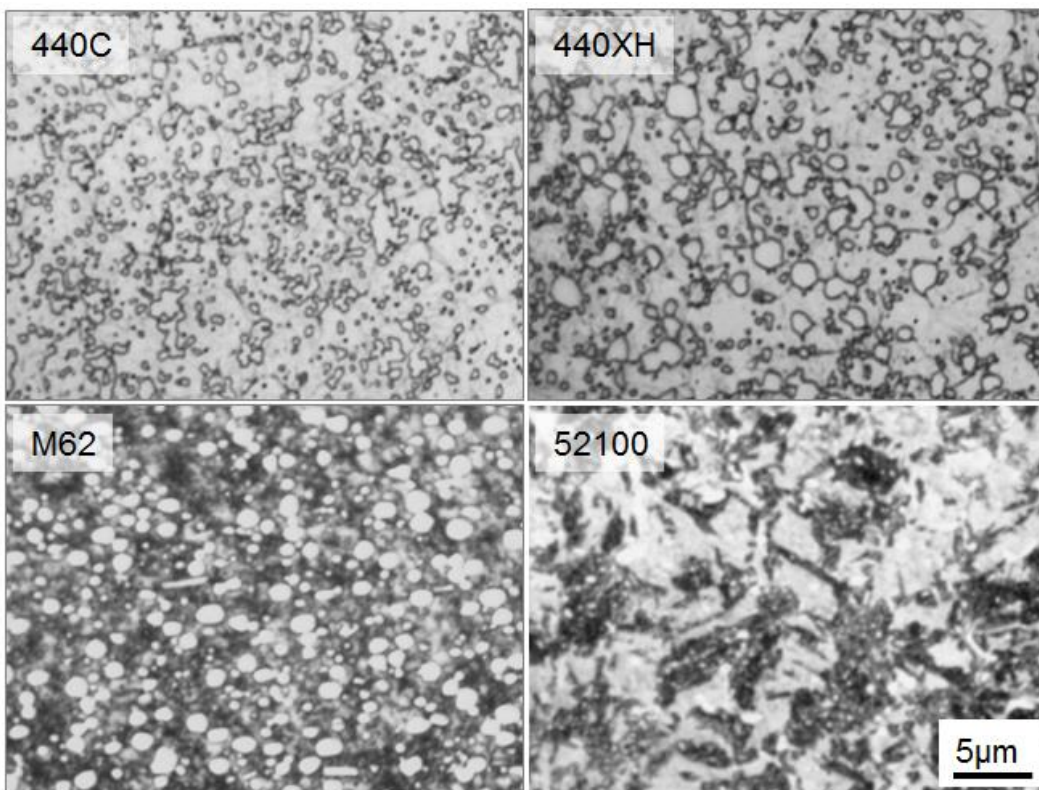
Figure 6. Optical macrographs of the heat-treated materials.

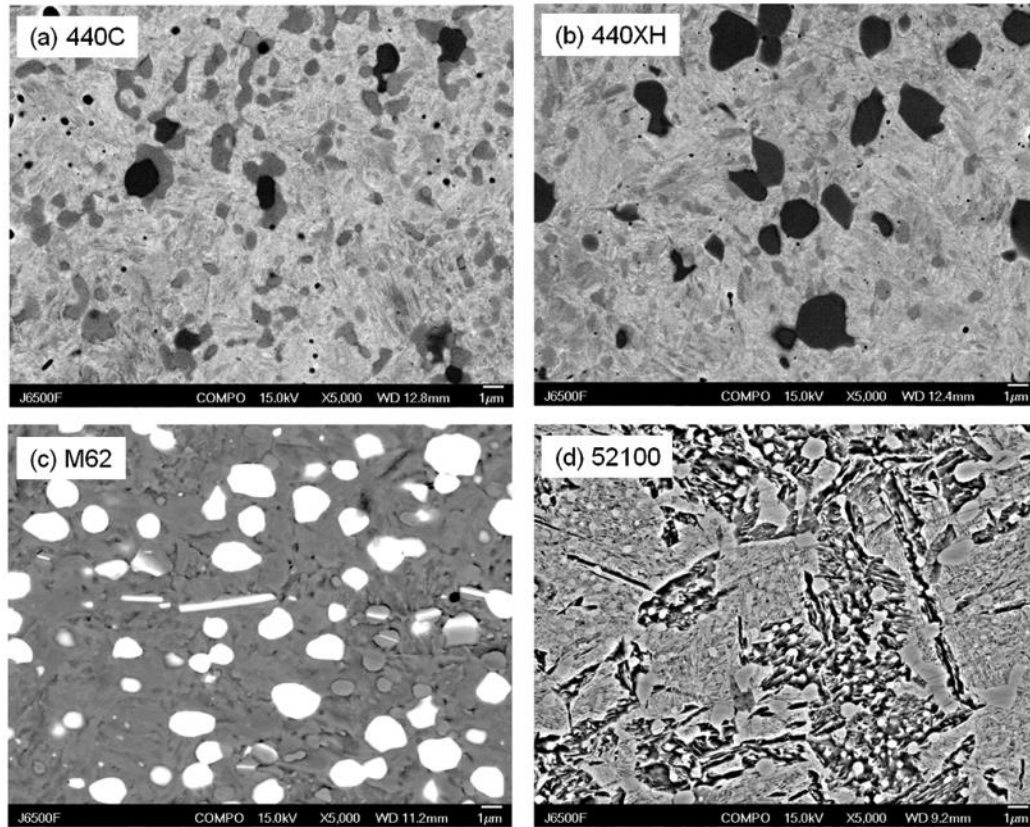
Figure 7. SEM-back scattered electron images of the hardened and tempered specimens.

Further microstructural characterization of the hardened and tempered specimens was conducted by using scanning electron microscopy (SEM) and energy dispersive X-ray spectroscopy (EDS). The 440C and 440XH steels showed similar microstructures containing at least two different second-phases as shown in **Figure 7a** and **Figure 7b**, respectively. SEM-EDS analysis revealed that the dark contrast phases are Cr-rich carbide, possibly M_7C_3 or $M_{23}C_6$, and the light gray contrast phase are Cr-, Fe-, and Mo-rich, possibly $M_{23}C_6$ or σ -FeCr phase. Note that the formation of σ -FeCr is not consistent with the literature [1]. A detailed phase analysis such as X-ray diffraction would be required to positively confirm the carbide stoichiometry but is beyond the scope of this work. The M62 in **Figure 7c** shows three different phases; bright contrast spherical precipitates (Fe-, Mo-, and W-rich, possibly $Fe_2[Mo,W]$ -Laves phase), bright plate shape precipitates (Mo-rich, possibly Mo_2C), and gray contrast precipitates (Fe-, Mo-, V-, and Si-rich, possibly M_6C). All three PM samples showed a second phase pull out porosity less than 500nm in size and a very small volume percent. The 52100 steel in **Figure 7d** showed a duplex microstructure with a typical martensitic microstructure (light gray matrix) and fine perlite microstructure (dark gray area) containing many spheroidized particles with less than 1 μ m size, likely Fe_3C cementite.

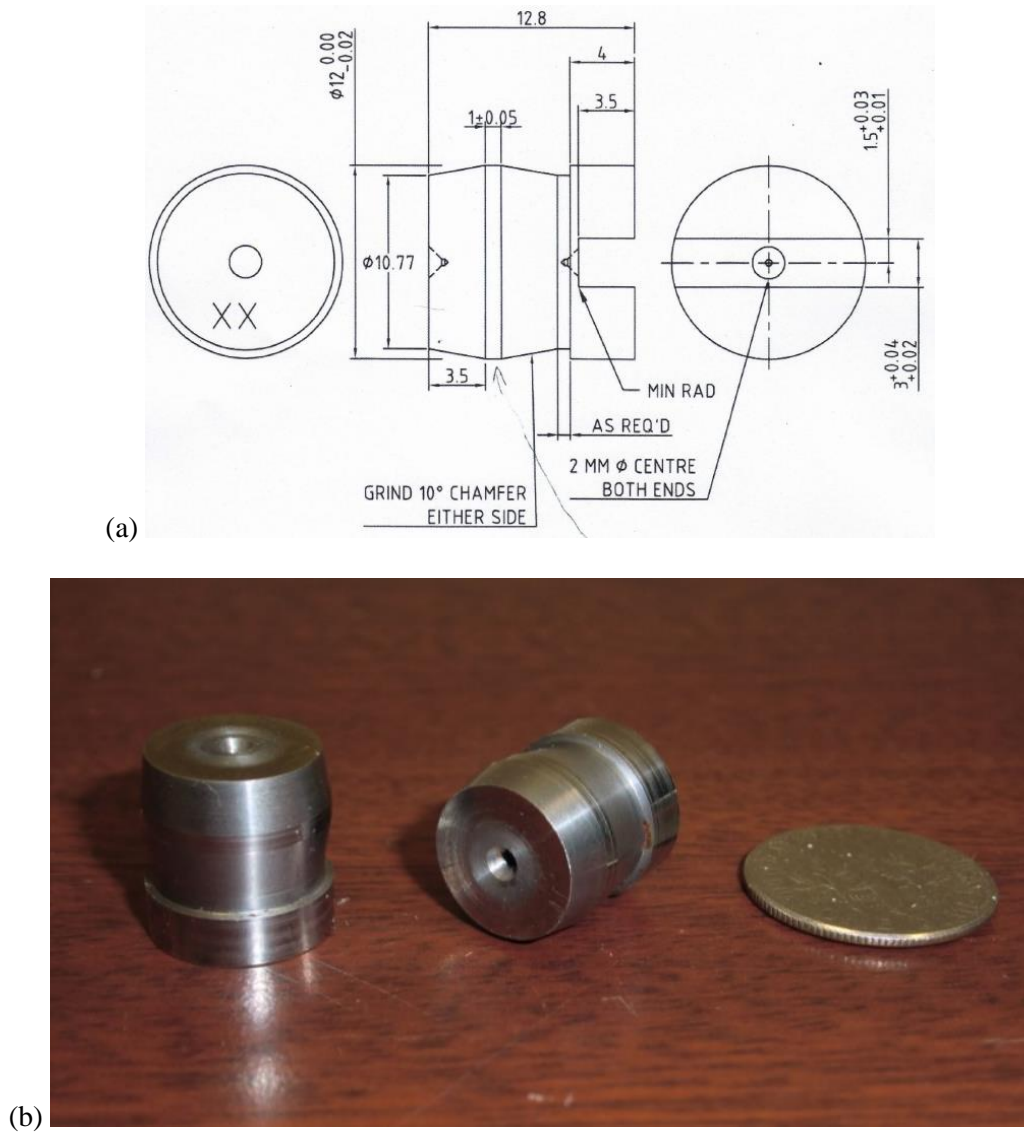
Figure 8. (a) Drawing of the test specimen, and (b) specimens after rough machining.

The micro-pitting specimens were machined from five different materials. **Figure 8** shows the drawing of the specimen, and a picture of the rough-machined specimens. Since the materials were too hard to be machined after hardening (and tempering) heat-treatments, the rough machining was conducted in the as-received (normalized) condition. The rough machined samples had 0.4mm of excess material left to account for final grinding. After the heat-treatment, the samples were ground to final size.

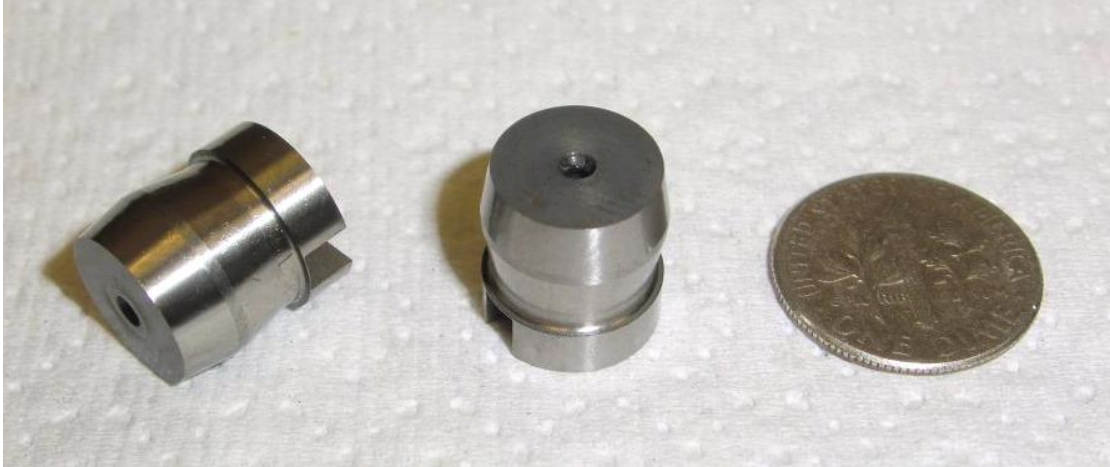
**Figure 9. The test specimen (440XH) after final machining.**

The hardness of the samples before and after the heat-treatment is summarized in **Table 5**. There was no significant difference between the hardness of the small sample heat treatments (**Table 4**) and the specimen heat treatment. The sample after final machining is shown in **Figure 9**.

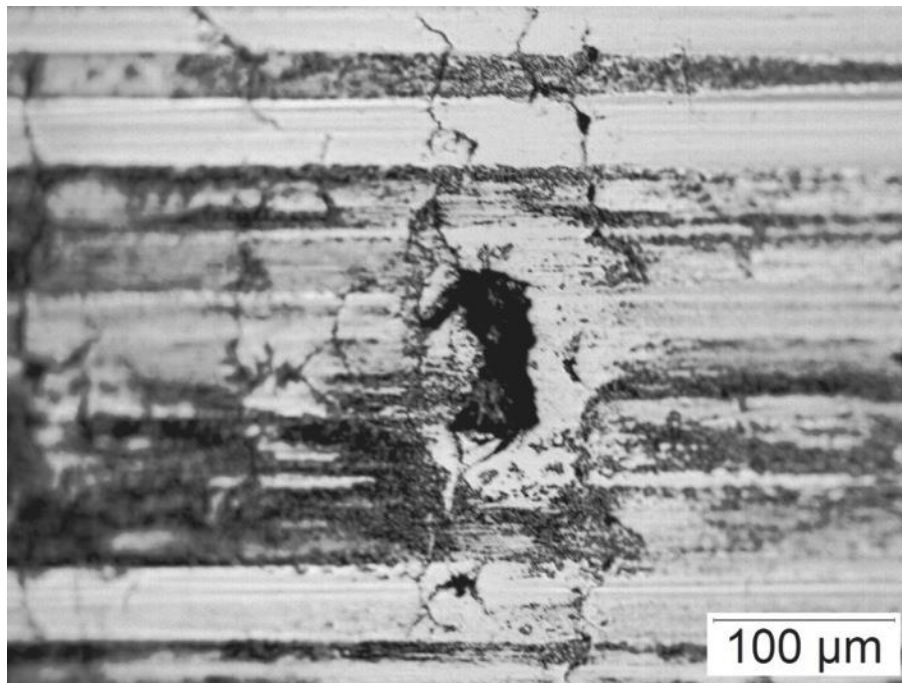
Figure 10. Micropit produced of a steel surface during a preliminary experiment.

A computer program (profile) is generated for each test or portion of each test. This enables tests to consist of a sequence of stages of variable duration. The object is to produce micro-pits on the specimens after a reasonable period of exposure such that the relative resistance to this phenomenon can be determined. **Figure 10** shows a micropit developed during procedure development. It was observed after 1.6×10^6 contact stress cycles. Hairline ‘tensile’ cracks appear perpendicular to the horizontal slip direction that is indicated by the scuffing marks. Coalescing cracks eventually produce loss of material and pits a few micrometers or tens of micrometers across.

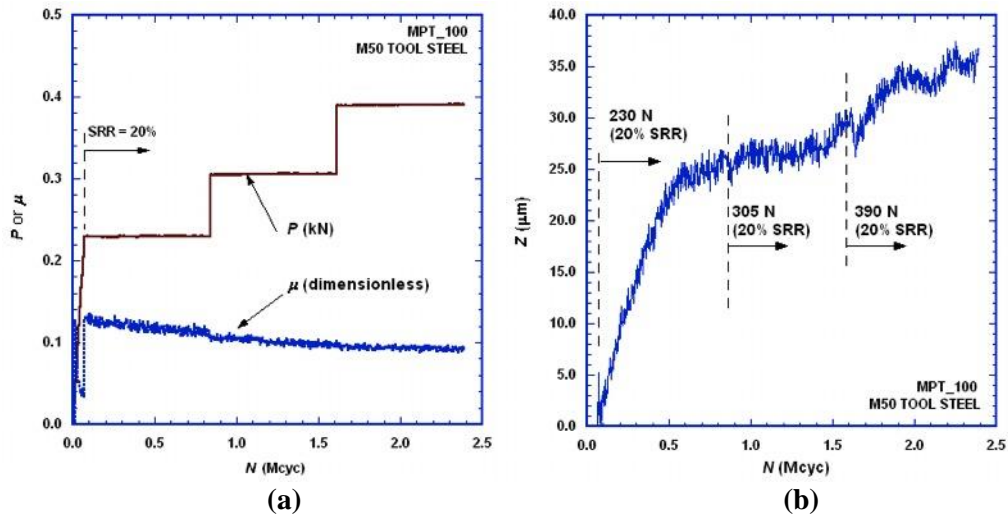
**Figure 11. (a) Load history, corresponding friction coefficient, and (b) wear results for M50.**

All five alloys were micro-pitting tested with the protocol shown in **Table 6**. There were three different stages to apply the different loads (230, 305, and 390N) with a constant rate (3.0 m/s) and slip (20%). **Figure 11** shows the loading steps (loads in kilo-newtons), the corresponding friction coefficient data (**Figure 11a**), and wear results (**Figure 11b**) for the first test run on M50 tool steel. Friction coefficient decreases as the surface runs in. The friction coefficient data was averaged in each step, and used for the discussion later in **Figure 12**. Most wear typically occurs during the first stage of the test because the initial surface runs in and conforms to the counterface. High-spots on the machined roller and disk profiles are quickly worn away. Near the end of the first stage, the wear rate tends to slow down.

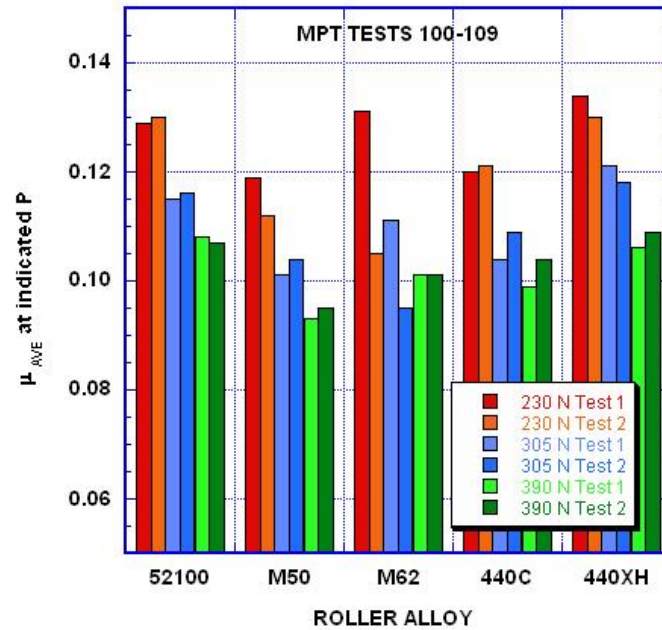
Figure 12. Average friction for each loading step for two tests of each alloy.

Figure 12 summarizes the friction data for all ten micro-pitting tests (repeats for each alloy). All alloys survived the full protocol, and the automated shut-off controls, based on excessive vibration or temperatures exceeding 135° C did not activate. Therefore, none of the alloys exhibited the kind of catastrophic micro-pitting, which would trigger a premature shut-down. The friction coefficients are reported as mean values for each load stage. With a few exceptions, the friction coefficient tends to decrease for each load stage for the five alloys. The relative influence of material properties for the rolling/sliding couple on the friction coefficient is dependent on a combination of factors such as the lubricant properties, the regime of lubrication, and the state of surface roughness. The latter effects are summarized by a parameter called the film thickness to roughness ratio (Λ). This is defined as the ratio of the minimum lubricant film thickness divided by the root-mean-square of the arithmetic average roughness (R_a) of opposing surfaces. As temperature increases, the viscosity of the lubricant decreases, leading to a thinner film and the likelihood of more incidental surface contact, (Λ decreases). From this point of view, the higher the friction coefficient, the more likely that the materials were playing a role in its magnitude. Friction coefficients in the range of 0.08 to 0.2 (typ.) are in the boundary lubrication regime, suggesting that both the lubricant and materials contributed to the friction coefficient. Also note that as wear leads to an increase in surface roughness, the Λ ratio decreases, promoting solid-solid contact and accelerating the degradation. Within the scatter of μ data, no alloy appeared significantly better than the others.

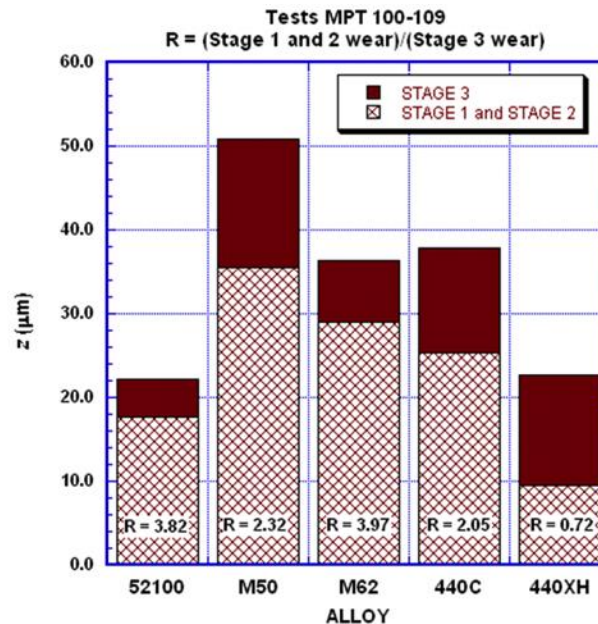
Figure 13. Wear summary for two tests of each alloy (average wear from 2 runs). For all but the 440XH with its higher hardness, the running-in wear dominated Stages 1 and 2 and wear in Stage 3 was lower.

Figure 13 summarizes the wear for stages 1 and 2, for stage 3, and for the entire test, given in terms of specimen displacement, z (μm). Most displacement of the roller/disk couple, associated with wear and conformity of the interface, occurred during the earlier stages of the test despite the lower applied loads. This indicates that running-in of the initial surface finish dominated the wear during the first part of the tests. The 440XH had least initial wear, suggesting that its higher hardness tended to retard the effects of initial wear-in. Note also that there was a greater degree of consistency in z for duplicate tests in Stages 1 and 2, and a much larger variability in repeated tests for Stage 3.

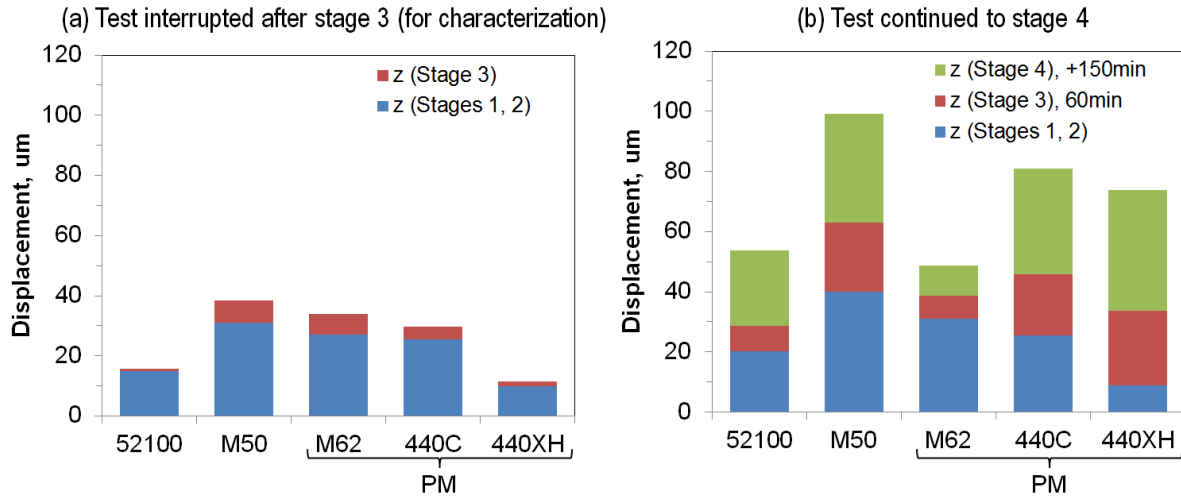
Figure 14. Wear data comparison of (a) the test-interrupted samples for microstructure characterization and (b) the samples continued to stage 4.

Table 7 summarizes the wear data of the alloys in terms of displacement. Two tests were conducted in each material, and one of them was used for microstructure characterization by interrupting the test after stage 3. **Figure 14** shows the wear data comparison of (a) the test-interrupted samples for microstructure characterization, and (b) the samples continued to stage 4. During stages 1 and 2 (which correspond to the lower loading test steps with 230 and 305N, respectively), the displacement seems consistent in each material. The 440XH showed minimum displacement among the samples, the 52100 followed, and the M50 showed maximum displacement, in both **Figure 14a** and **Figure 14b**. However, after stage 3 with 390N loading, the displacement significantly varied in the same materials. The smaller displacements tend to show the material dependence similar to the displacement in stages 1 and 2 (**Figure 14a**). These samples were used for microstructure characterization. On the other hand, the larger displacements after stage 3 do not show any reasonable relationship with the displacements in stages 1 and 2 (**Figure 14b**). Further continuous testing in stage 4 with the same loading resulted in a similar tendency to that in stage 3. It is still unclear whether this reflects the material nature or experimental errors, and it needs to be addressed by conducting additional testing with a different condition.

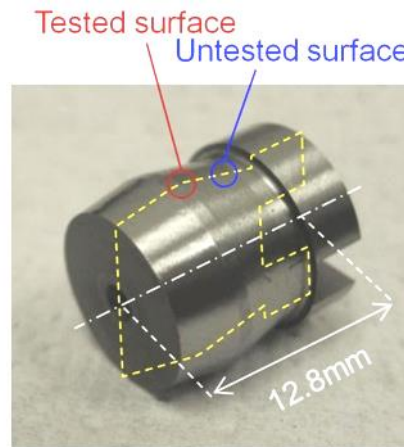
Figure 15. A picture of the sample (440XH) before testing.

Microstructure characterization of the tested samples after stage 3 was completed. The specimen surface and cross-sectional view were observed by SEM (scanning electron microscopes). **Figure 15** shows a picture of the sample together with the indications of the observed portions. A narrow band at the sample ridge corresponds to the tested surface contacted to the alloy steel disks, and the slopes in both sides of the band correspond to the untested surface. The cross-sectional samples were prepared after completing the surface observation. **Figure 16** shows the SEM-SE (secondary electron) images of the sample surfaces, with and without micro-pitting testing. The vertical axis corresponds to the rolling/slipping (tested surface) and machining (untested surface) directions. **Figure 17** shows the SEM-BSE (back-scattered electron) images of the cross-sectional views of the samples, in the same orders of those in **Figure 16**.

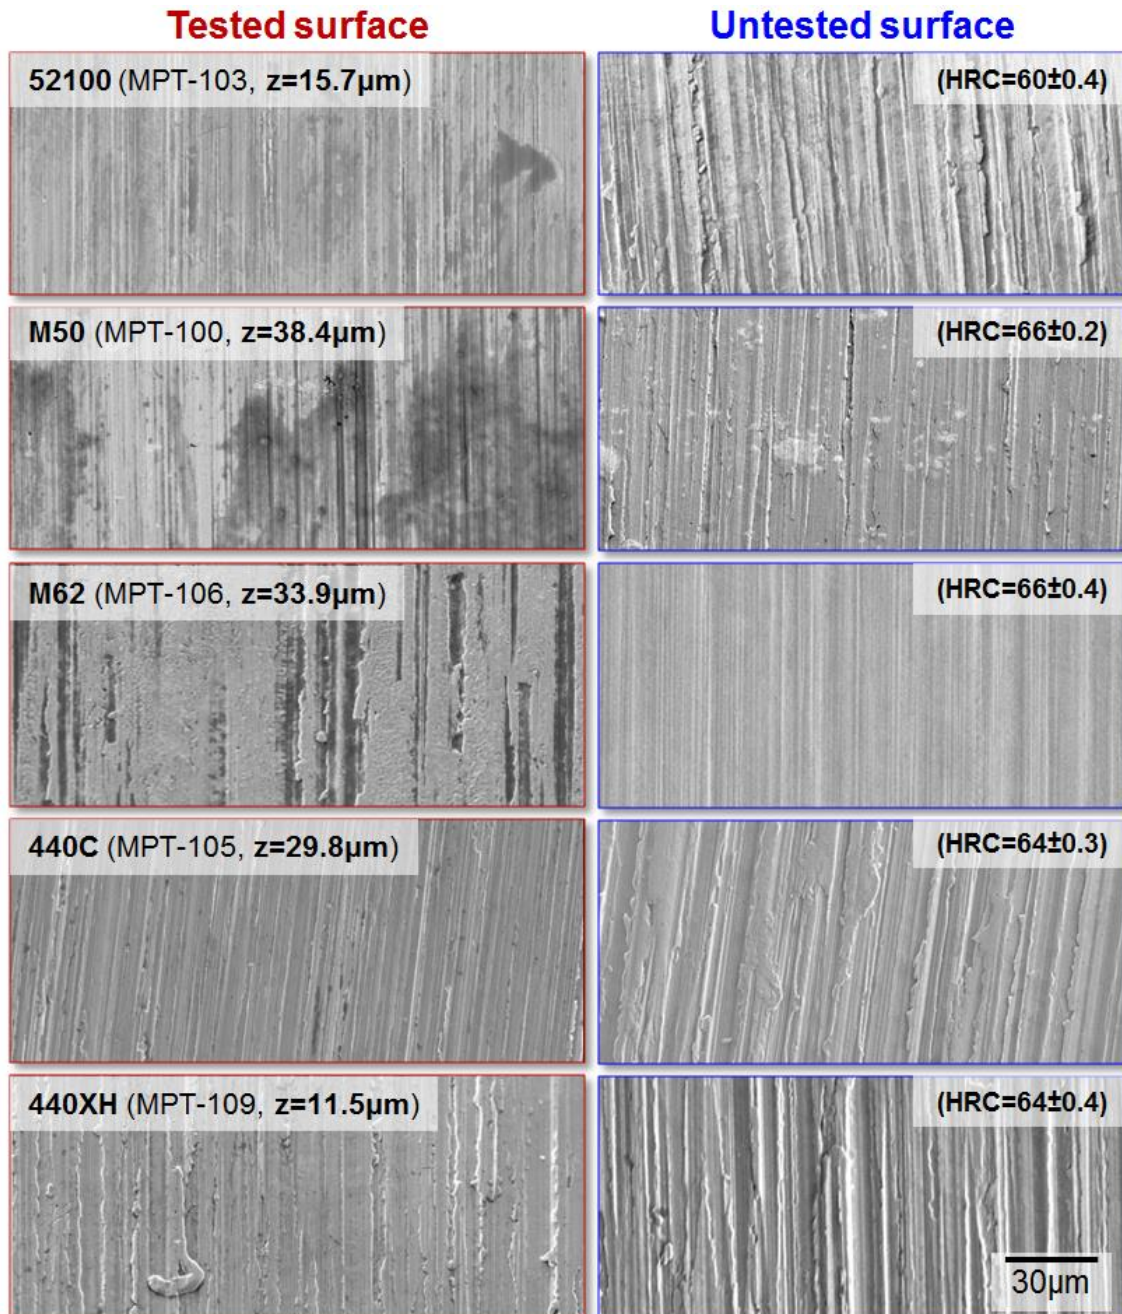
Figure 16. SEM secondary electron images of the sample surface.

The roughness of as-machined (untested) surfaces of the 52100 and 440XH seems very high, the 440C follows, and the M62 and M50 show less roughness. This indicates that the roughness would

depend on the hardness of the materials. However, from the cross-sectional views, the gap of the surface relief between top and bottom is less than $3\mu\text{m}$, so that it is almost negligible compared to the displacement after stage 3 (11.5 to $38.4\mu\text{m}$). All tested surfaces became relatively flat compared to the untested surfaces. The M62 and 440XH showed smeared features on the tested surfaces, indicating that they were plastically deformed. However, there was no significant change in the cross-sectional microstructure near the surface. All PM materials showed cracks inside the matrix after testing, which were initiated from the second-phases or the interphase boundaries. Most of the cracks propagated parallel to the surface, indicating that there may be a work-hardened layer on the tested surface which would fail to cause micro-pitting. Previous macroscopic observation found the micro-pitting feature only on the 52100 and M62. However, no apparent relationship between the wear resistance and microstructure was observed.

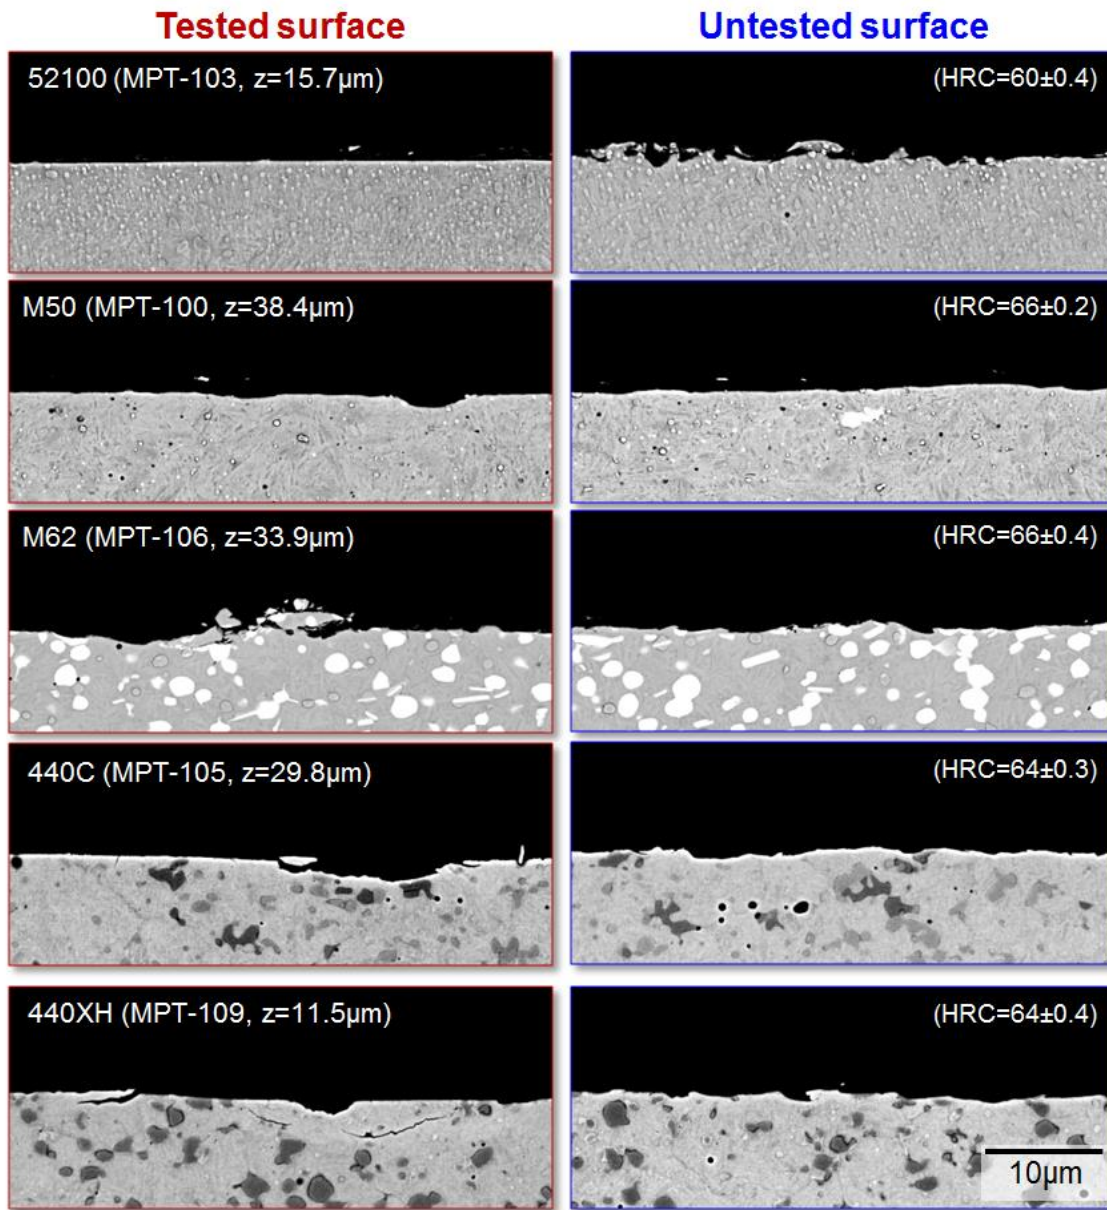
Figure 17. SEM back-scattered electron images of the cross-sectional view.

Most of the tested surface observation suggested that the major wear mode of the present samples was plastic deformation only near the tested surface, which could be due to high slip ratio (20%). In order to observe the micro-pitting-type failure, the test condition needs to be less slip ratio (2-5%) with higher loading, which would give a fatigue on the contact surface to promote micro-pitting.

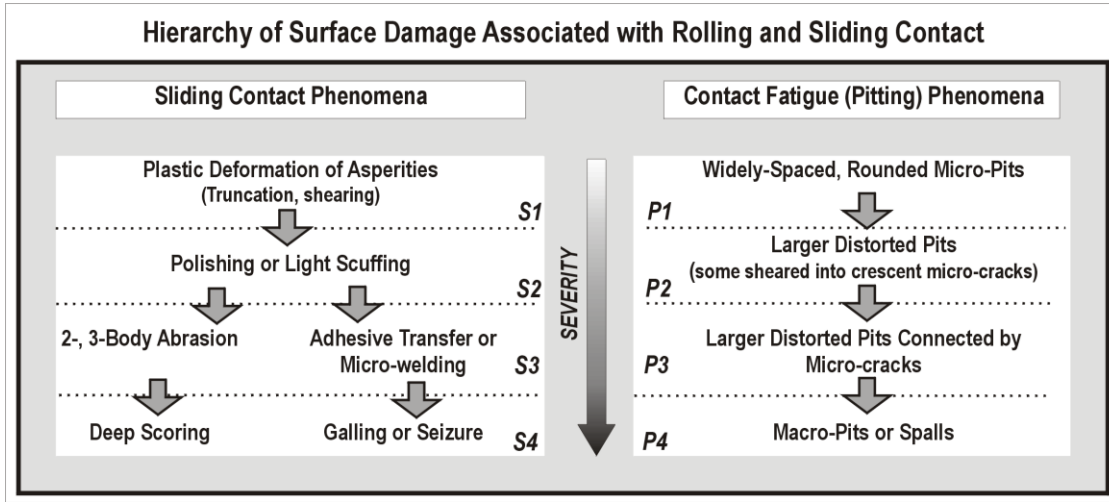
Figure 18. Hierarchy of surface features observed on metallic surfaces subjected to a combination of rolling and sliding.

inadequate. Levels P1-P2-P3 reflect features observed in this work. Level P4 is associated with more gross failures, such as those described elsewhere for spherical roller-type gearbox bearings [4].

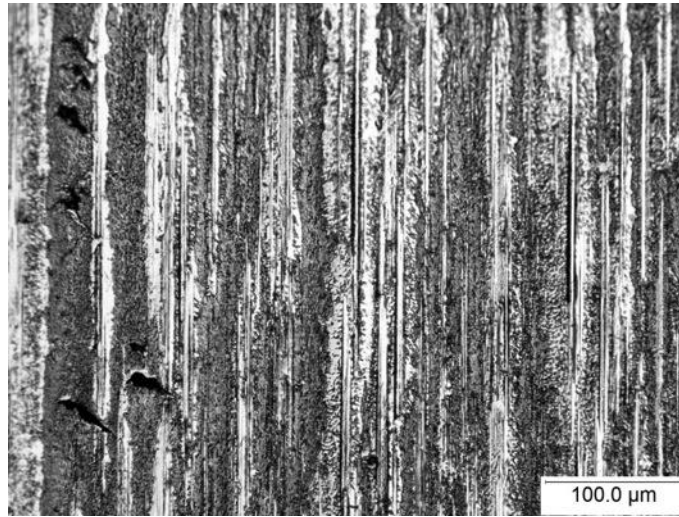
Figure 19. Abrasive wear grooves and a few micro-pits on the surface of an M-50 steel roller.

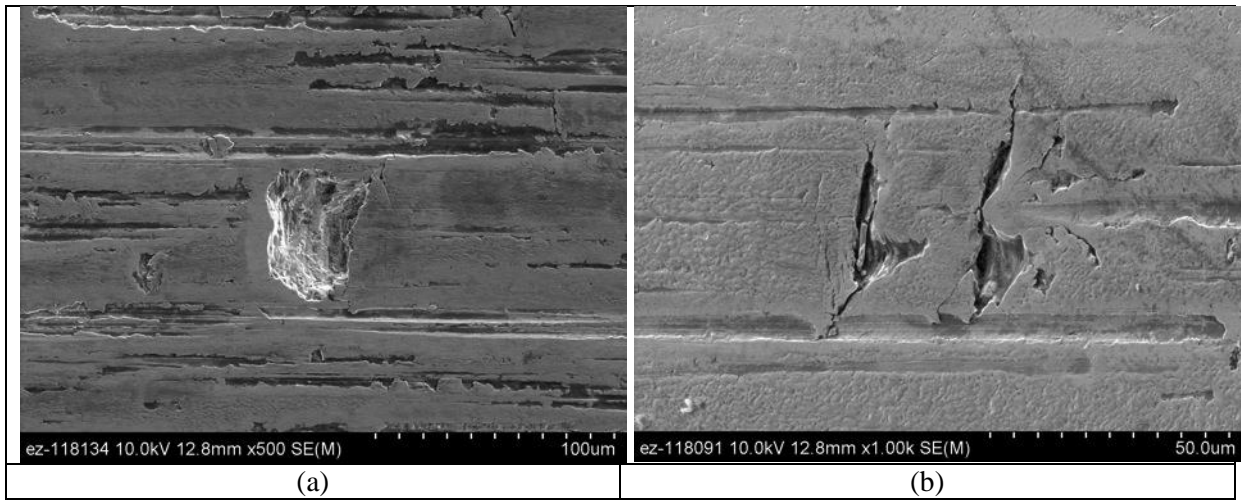
Figure 20. (a) A rounded micro-pit in 440C steel, and (b) distorted micro-pits in M50 tool steel where shear has partly or fully closed them, leaving fine cracks at both ends.

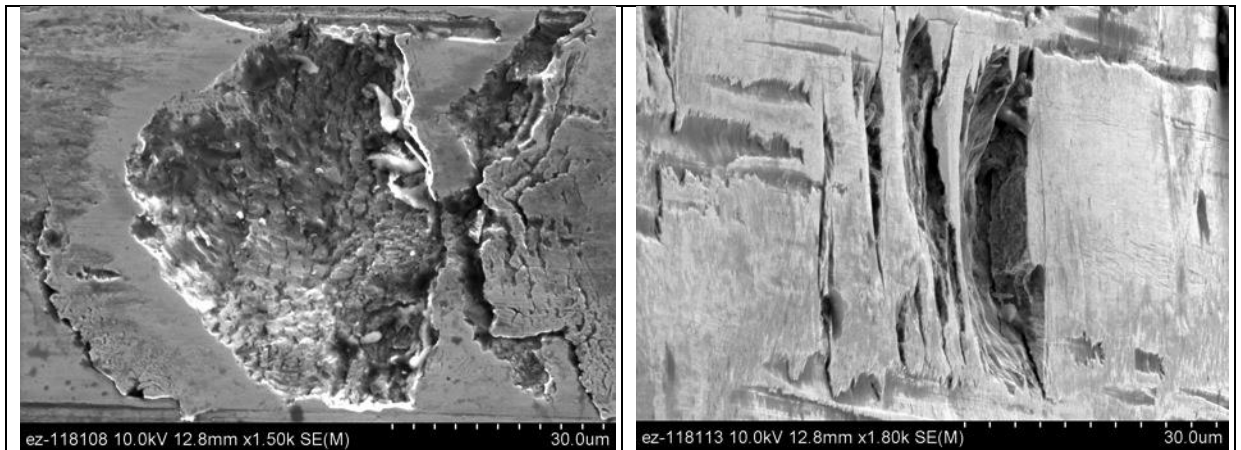
Figure 21. Micro-pit in 52100 showing (a) a blocky network of micro-cracks, and (b), an oblique view of micro-pits in the same steel specimen showing the arc-like shape of a micro-crack that underlies a shelf of material, as seen at the right in the cross-section in Figure 7(a).

micro-pit from the same roller in **Figure 21b**. Corresponding cross-sectional views of these defects in 52100 are shown in **Figure 22**.

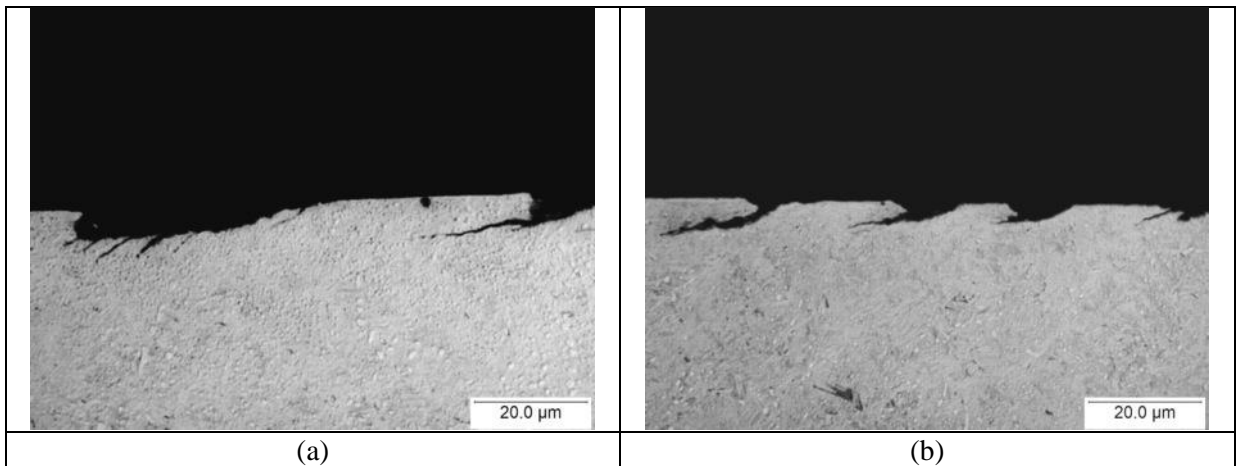
Figure 22. Polished and etched (2% nital) cross-section of the 52100 steel roller showing (a) a series of micro-fractures extending from the bottom of a micro-pit like that shown in Figure 21(a), and (b) a row of micro-cracks underlying the surface. The open end of one such crack can be seen in Figure 21(b). The slip direction was right to left, since the pits open in the tensile field following passage of the contact patch.

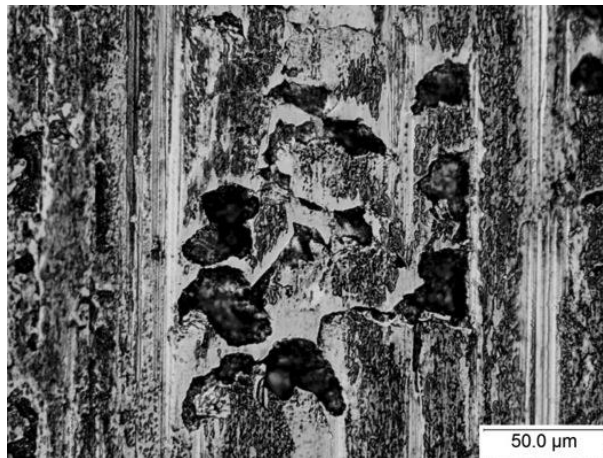
Figure 23. Series of micro-pits on 52100 steel that are connected by micro-cracks. The widths and interior scratches within the abrasive grooves are similar in size to the breadth of the micro-pits suggesting that wear debris from the pits can serve as third-body abrasants.

Like any metal fatigue process, micro-pitting is thought to consist of a nucleation period during which subsurface damage accumulates, then crack initiation, crack propagation, and eventual material loss when cracks break the surface and linkup (see **Figure 23**). The interior walls of micro-pits in several of the alloys contained evidence for fatigue and for the presence of branched networks of micro-cracks that consolidate below the surface prior to the loss of a debris particle that eventually forms a pit. A piece of material about to be lost to form a new pit is shown in **Figure 24**.

The 52100 steel showed the most severe indications of MP, and the pits were beginning to link up, possibly to produce larger spalls (e.g. see **Figure 23**). In contrast, the 440XH alloy, showed less evident micro-pitting (e.g. see **Figure 25**). Alloy 440C was also less MP prone, but there were some areas near the edges of the rollers with minor MP. Interestingly there seemed to be no direct relationship between Rockwell C hardness and MP tendency. Both the softest (52100, ~HRC 60) and the hardest (M50, ~HRC 66) alloys displayed more incidence of MP than the stainless steels which had intermediate hardness (~ HRC 63-64). Carbon content did not seem to correlate with MP either, but the most obvious compositional difference in the steels is that the two 400-type martensitic stainless steels, with their high Cr contents, performed best overall. The 440XH grade contains a finer and more uniform microstructure and that may be one reason why MP nucleation was less prevalent.

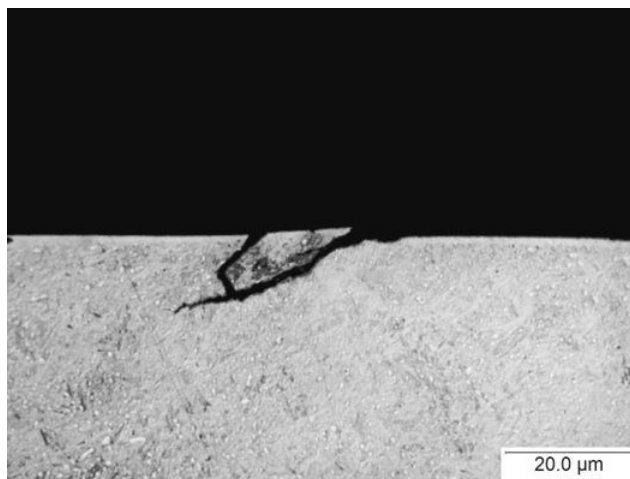
Figure 24. Particle of 52100 steel about to leave the surface to leave a micro-pit behind. (2% nital etch)

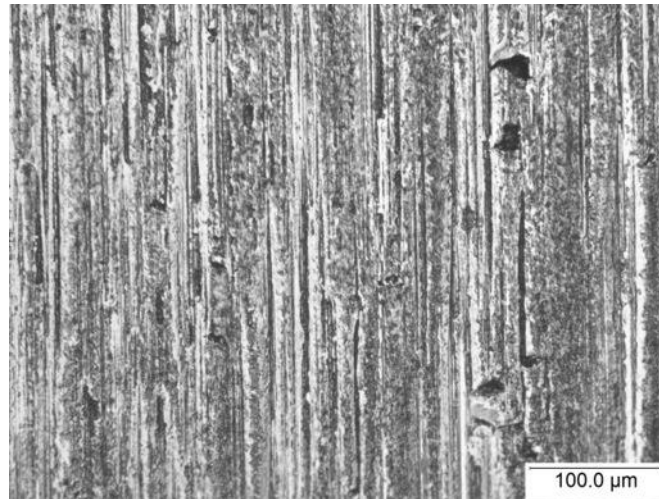
Figure 25. Reduced frequency and size of micro-pits in alloy 440XH.

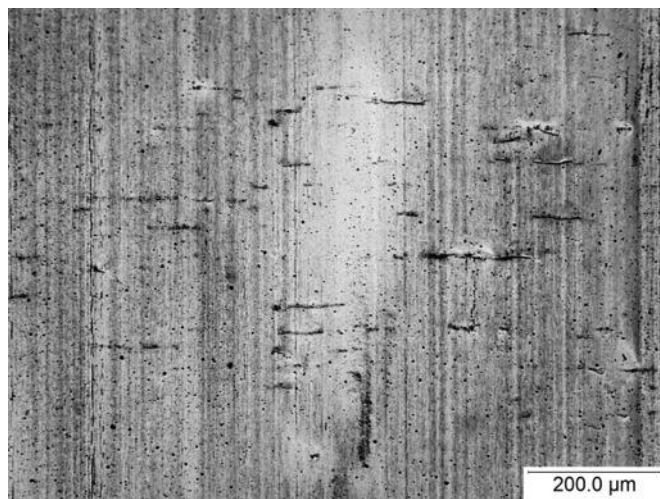
Figure 26. Hairline, transverse cracks suggestive of micro-pitting initiation in the ring specimen used with M-50 rollers.

specimens. For example, the ring used for the 52100 steel which micro-pitted significantly tended to have S3 level abrasive scratches and grooves, but with no clear indications of micro-pitting. In contrast, the test rings used against M-50 steel retained their polished appearance, but did show surface-breaking micro-cracks (**Figure 26**).

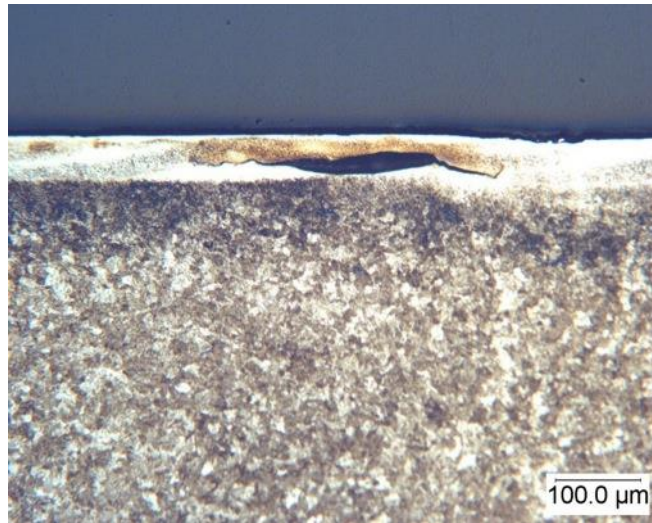
Figure 27. White layer on a bearing steel used in a wind turbine gearbox bearing showing a subsurface void and extending micro-cracks associated with the nucleation of spalls.

In recent years there has been increased interest in the formation of what have been called ‘white layers’ in the zone below contact surfaces (e.g., [5,6,7,8,9,10]). Features that appear white or nearly featureless in polished and etched cross-sections have been observed in conjunction with wear for many years, especially on ferrous materials and in heavily-loaded applications like railroad rails, gear teeth, and highly-stressed rolling elements. Their appearance can vary depending on the materials involved, the severity and geometry of surface contact, and even the type of etchants used to reveal them. In prior work on worn wind turbine bearings [4], relatively thick white layers were easily visible, and many contained networks of fine cracks associated with spalls and other surface damage features (e.g., see **Figure 27**). In the present work, however, etched cross-sections of the test specimens revealed no clear evidence of such layers although there are localized areas in which the near-surface microstructures of the rollers were distorted and sheared (e.g, see **Figure 22**). High magnification optical examination of the most micro-pitting resistant steels (440C and 440XH) revealed micro-cracks emanating below micro-pits that avoided the blocky carbide particles in the microstructure as they propagated through the matrix material (see **Figure 28**). Note that the micro-crack extends below the surface several times the depth of the surface pit, but there is no apparent white layer. Based on the present work, white layers seem less associated with MP, which occurs on the localized asperity level, than with macro-pitting which seems to be associated with more extensive, heavily work-hardened subsurface regions, extending many times the length and breadth of individual features.

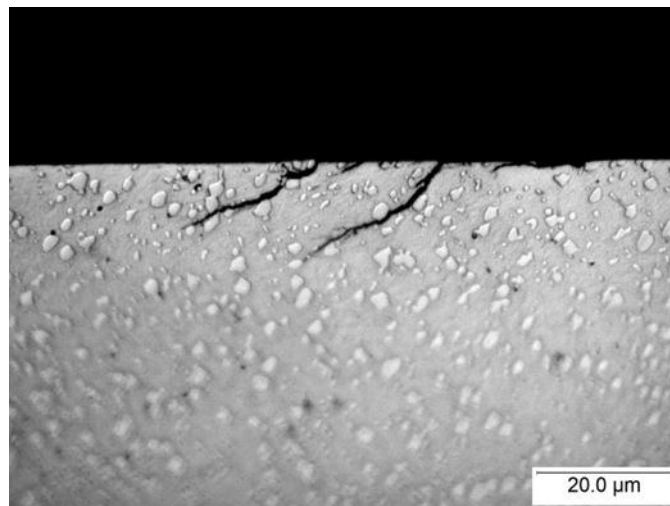
Figure 28. Micro-cracks avoiding carbide particles as they extend from the bottom of a micro-pit. (glyceregia etch)
