Improved Processing of High Alloy Steels for Wear Components in Energy Generation Systems, Transportation and Manufacturing Systems

Final Technical Report

**Improved Processing of High Alloy Steels for Wear Components in Energy
Generation Systems, Transportation and Manufacturing Systems**

CPS Agreement No. 20978

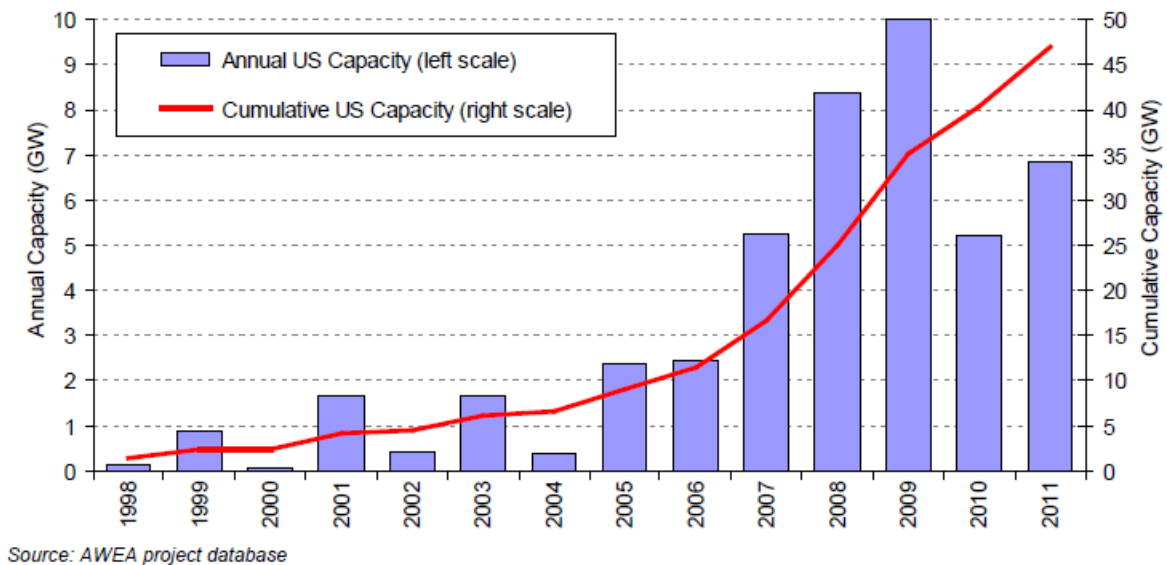
Figure 29. US wind power market growth curve from 1998 to 2011.

For the 60 GW of installed power in 2012 that equates to 0.55 GW of lost generation capacity due to wear. The growth curve for installed wind power generation is shown in **Figure 29** and is expected to continue. Clearly enhanced bearings will have a significant impact on energy savings.
