# **Case Study of the Maplewood Park Multifamily Retrofit for Energy Efficiency**

**December 2012**

**CASE STUDY OF THE MAPLEWOOD PARK MULTIFAMILY  
RETROFIT FOR ENERGY EFFICIENCY**

SOUTHFACE ENERGY INSTITUTE  
241 Pine Street NE, Atlanta, Georgia 30308

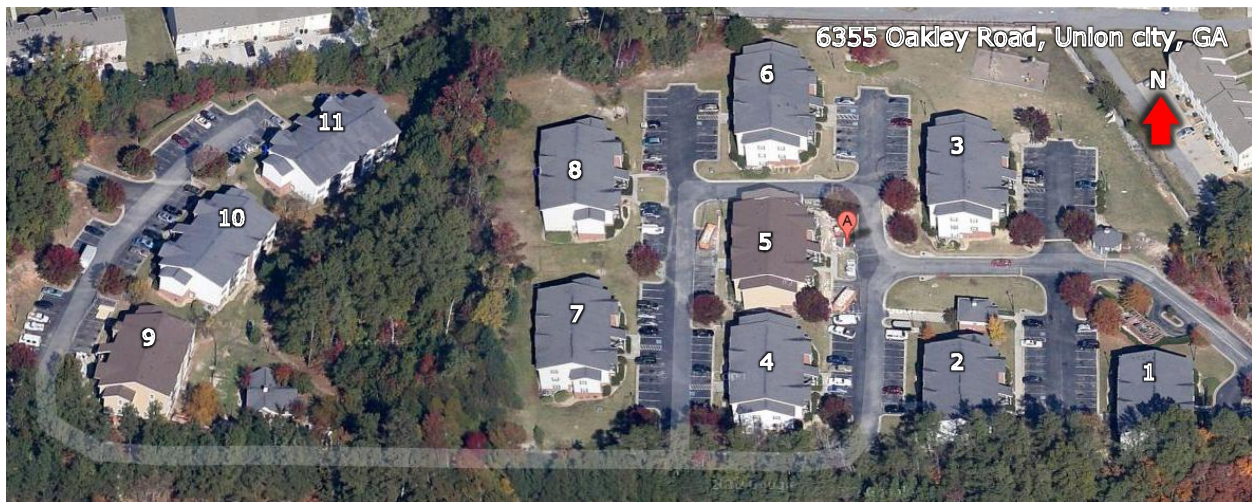
**Fig. 1. Aerial view of Maplewood Park Apartments.**  
(Photo courtesy Google® Earth)

Built in 1993, Maplewood is an apartment complex with 11 buildings, each consisting of 10 units. Fig. 1 shows an aerial view of Maplewood with the building numbers shown on the buildings. Fig. 2 shows a view of Building #7 in Maplewood before renovation. The buildings underwent minor renovations in 2008, during which HVAC systems, appliances, and/or domestic water heater in some units were replaced due to specific system failures.

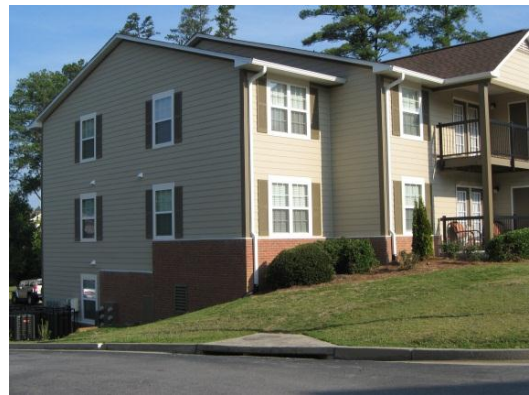
**Fig. 5. New fiber cement siding.**

The vinyl siding was replaced with fiber cement siding and brick veneer was replaced with new brick fascia (Fig. 5). No other changes were made to the walls.

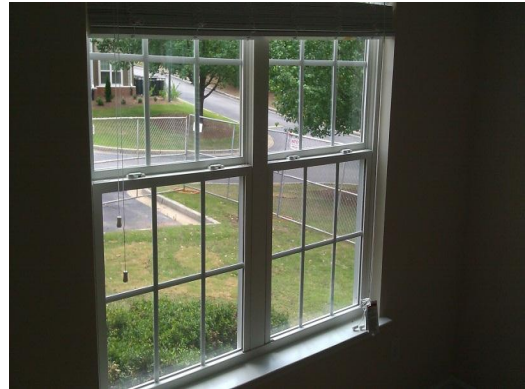
**Fig. 6. New double-pane, low-e, vinyl-frame windows.**

The existing windows were replaced by Energy Star low-e, double pane, vinyl frame windows (Fig. 6) with a rated performance of 0.35 U-factor and 0.27 SHGC. The existing doors were replaced by R-3 insulated core metal doors.

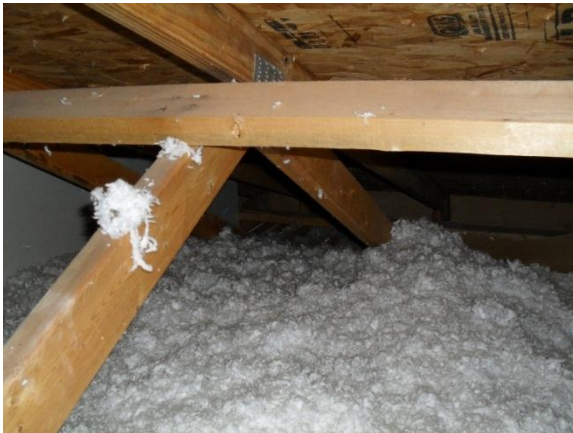
**Fig. 7. Existing R-30 insulation in the attic.**

The vented attic roof of the buildings was constructed of wood frame and had dark asphalt shingle roofing. The original R-19 ceiling insulation in the attic was upgraded to R-30 during the renovation in year 2008 by adding blown-in fiberglass insulation (Fig. 7).

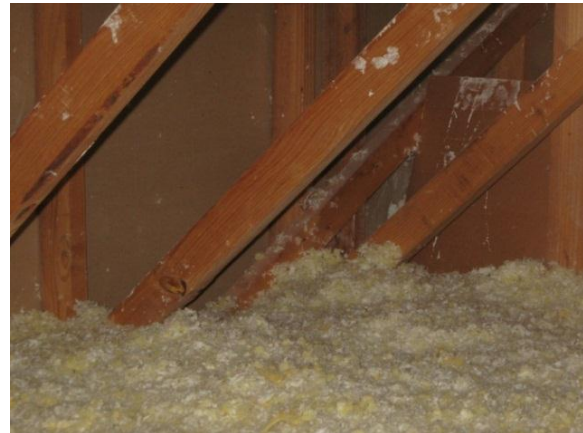
**Fig. 8. Attic insulation upgraded to R-38.**

The attics were upgraded by adding 4 inch of blown-in fiberglass (Fig. 8) to increase the attic insulation value to R-38. The existing roofing was replaced by new dark asphalt shingle roofing. In addition, several service penetrations through the ceiling were air sealed.

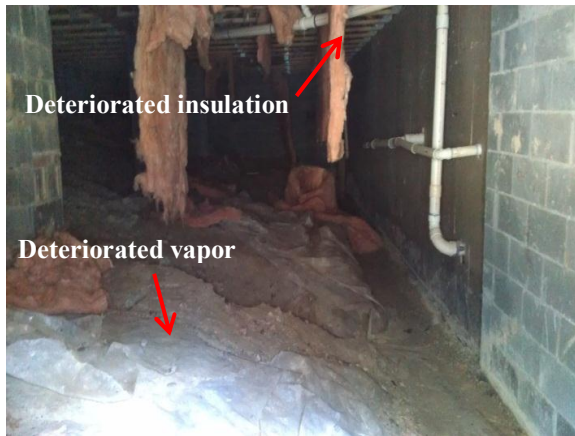
**Fig. 9. Existing insulation and vapor barrier in the crawlspace.**

All buildings had two foundation types: i) uninsulated slab-on-grade floor, and ii) vented crawlspace with concrete block walls, open-web ceiling truss, and fiberglass batt insulation between the ceiling truss. Over time, the batts have fallen down as a result of gravitational pull and gradual wear. Also, the vapor barrier on the crawlspace floor was not providing complete ground coverage and moisture protection (Fig. 9).

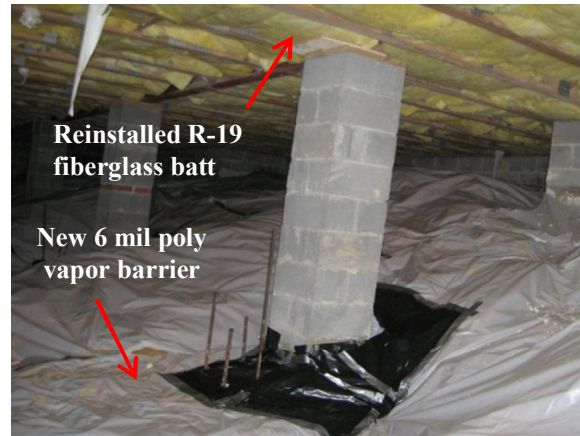
**Fig. 10. New insulation and vapor barrier in the crawlspace**

No changes were made to the slab-on-grade floor. In the vented crawlspace, R-19 fiberglass batt insulation was installed between the ceiling frame and new 6-mil poly vapor barrier was installed over the ground (Fig. 10). The vapor barrier was installed with overlapped seams, brought up to a minimum 6 in. from the ground along the perimeter of the crawlspace walls and piers, and secured in place with mastic and tape.

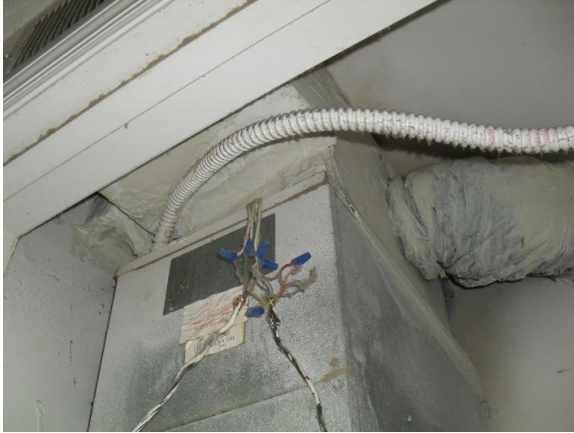
**Fig. 11. Existing indoor unit the air handler.**

Each unit had a dedicated central heat pump system with a rated performance of 12 SEER and 7.5 HSPF<sup>4</sup>. The two-bedroom units (Unit A) were served by 1.5 ton systems and the three-bedroom units (Unit B and C) were served by 2 ton systems. The air handler was located in a louvered closet in either a bathroom (Unit A), the utility room (Unit B), or a bedroom (Unit C) (Fig. 11). Ducts were located in the conditioned space within the dropped soffit. Outdoor condenser unit was installed on a concrete pad at the sides of the building.

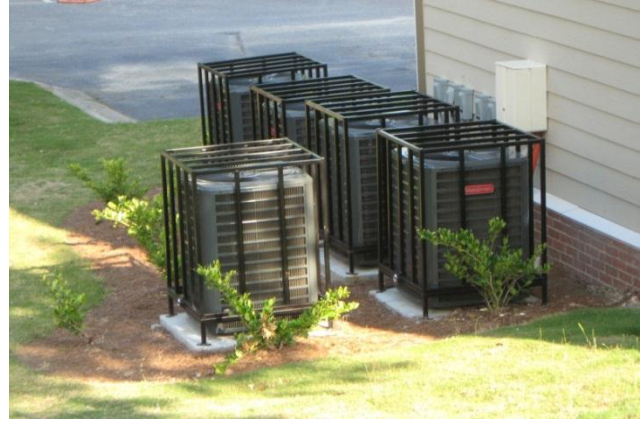
**Fig. 12. New outdoor units of the heat pump.**

The existing heat pump systems were replaced with Energy Star qualified heat pump systems (Fig. 12). Manual-J load calculations were performed for equipment sizing (Table 4). However, the systems selected for the replacement were of the same size as existing systems, which were about 1.5 times oversized. The two-bedroom unit (Unit A) were installed with 1.5 ton systems with a rated performance of 14.5 SEER and 8.3 HSPF. The three-bedroom units (Units B and C) were installed with 2 ton systems with a rated performance of 14.5 SEER and 8.5 HSPF. The inspection report notes that mastic was applied along the seams and joint connections of the ductwork in the air handler. No air sealing was performed for the ducts that were within the dropped soffits.

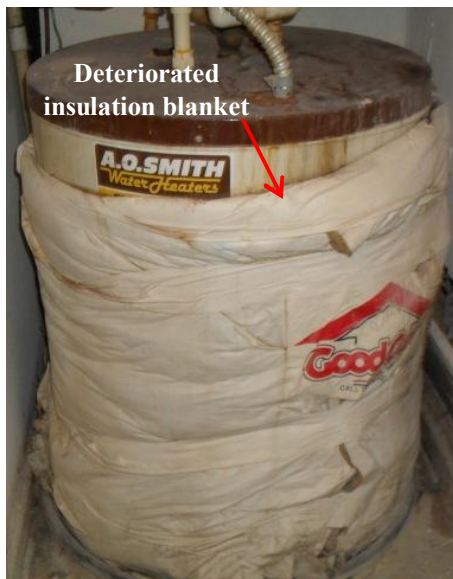
**Fig. 13. Existing domestic water heater.**

All units were equipped with a 40-gal, lowboy electric water heater with a rated performance of 0.90 EF. Some of the inspected water heaters had insulation blankets<sup>5</sup>. All inspected water heaters were in poor condition with signs of corrosion (Fig. 13). All existing water heaters were replaced with new 40-gal electric water heaters with a rated performance of 0.93 EF (Fig. 14).

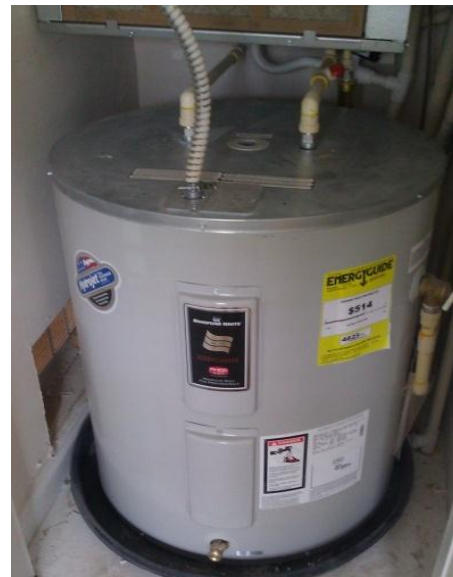
**Fig. 14. New domestic water heater.**

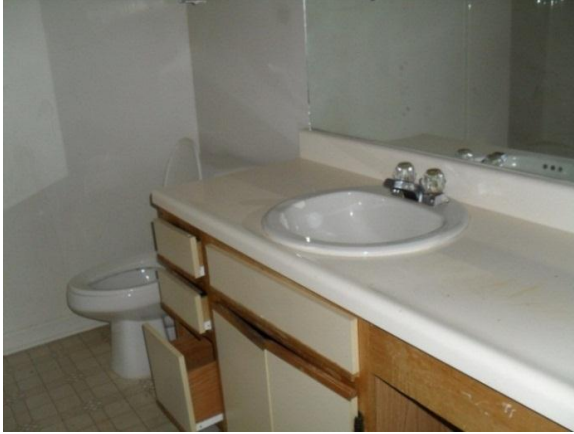
**Fig. 15. Existing plumbing fixtures**

The existing plumbing fixtures in the units included 2 gpm faucets (Fig. 15), 1.6 gpf toilets, and 5.0 gpm showerheads, which were replaced by low-flow plumbing fixtures including 1.5 gpm faucets (Fig. 16), 1.28 gpf toilets, and 1.5 gpm showerheads.

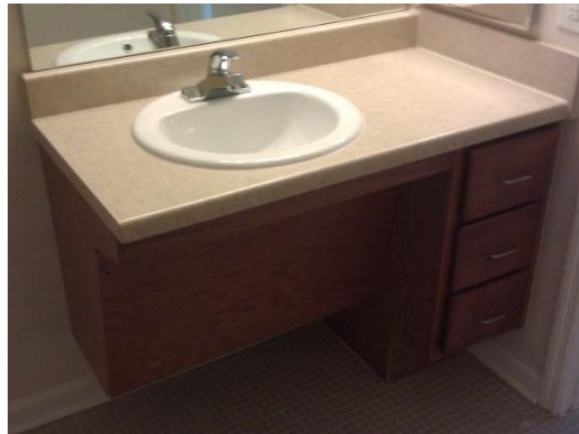
**Fig. 16. New plumbing fixtures**

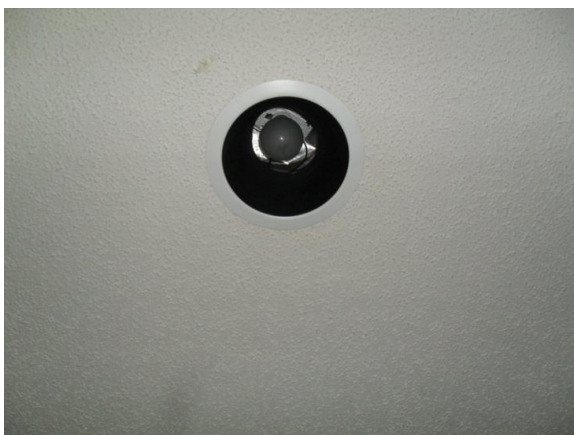
**Fig. 17. Existing incandescent lamp in a recessed lighting fixture.**

The existing lighting included 18-60W incandescent lamps in two bedroom units (Unit A), 21-60W incandescent lamps in three bedroom units (Units B and C) (Fig. 17), and two T12 lamps and a small 15W pin-base tube in the kitchen in all units. The lighting was upgraded to a 100% Energy Star lighting package, which included replacing the existing T12 lamps with new T12 lamps and replacing all incandescent lamps with 13W CFLs (Fig. 18).

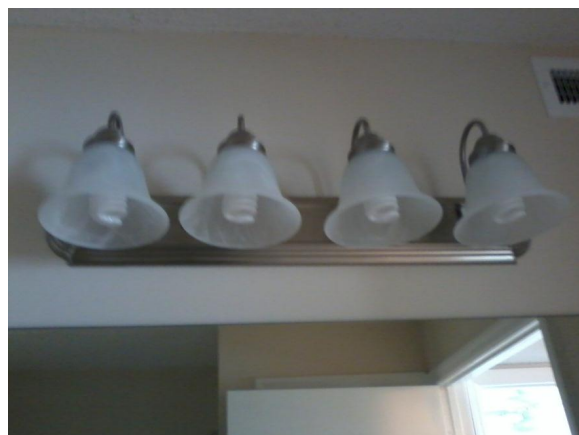
**Fig. 18. New CFLs in a bathroom vanity fixture.**

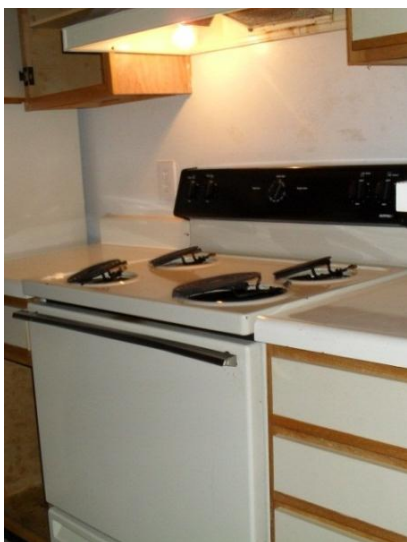
Fig. 19. Existing kitchen appliances

The existing appliances in a unit included a refrigerator, a dishwasher, and an electric range (Fig. 19). The appliances were from various manufacturers with unknown wattage. These appliances were replaced with Energy Star qualified 18 ft<sup>3</sup> refrigerator (388 kWh/year rated energy use) and dishwasher (306 kWh/year rated energy use), and an electric range with two 6 in. (1500 W) and two 8 in. (2600 W) high-speed coil elements (Fig. 20).

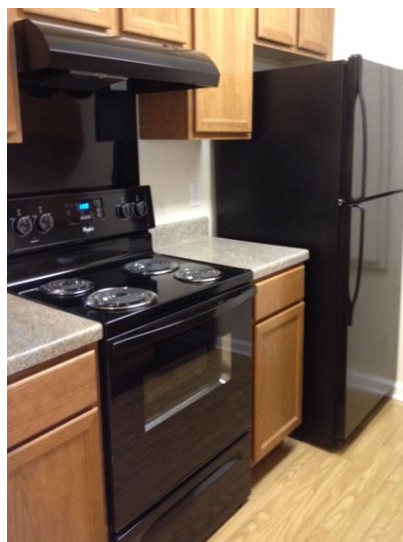
Fig. 20. New kitchen appliances

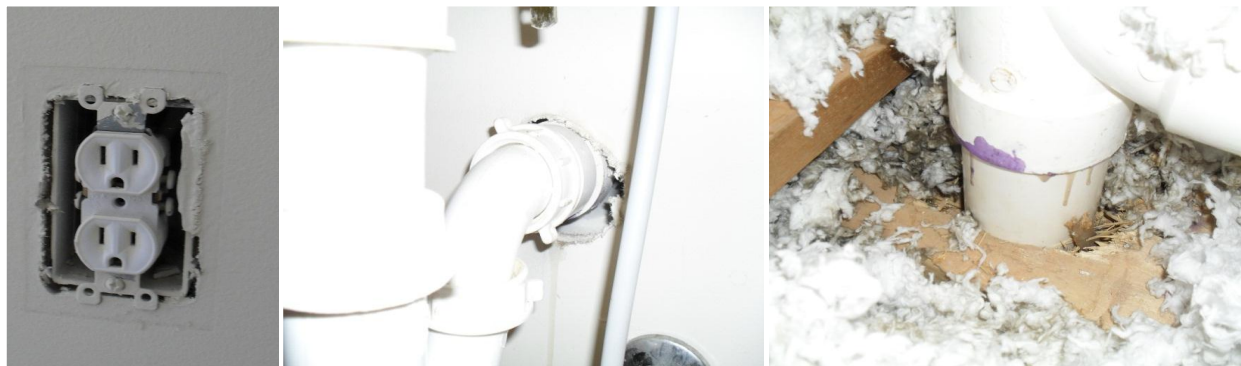
Fig. 21. Pre-retrofit service penetrations through walls and ceiling.

Gaps were found around service penetrations through the walls and ceiling of the units (Fig. 21). Air sealing was performed to fill these gaps. In all units, the floor tiles and carpet were replaced and interior surfaces were repainted with low-VOC paints.

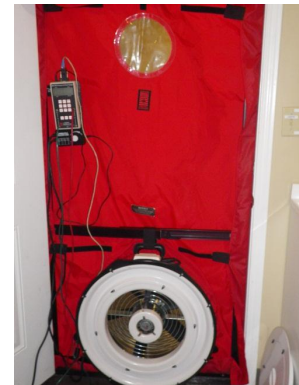
Fig. 23. Blower door setup.

A single point infiltration test measures the air leakage of a unit at a single reference pressure using a blower door fan (Fig. 23). The testing procedures followed RESNET (2011), starting with preparing the building enclosure for testing by closing and latching all exterior doors and windows, opening all interior doors, and shutting down all HVAC and ventilation fans. During the single point test, adjacent units were left in their natural state with no induced pressures or opened windows.

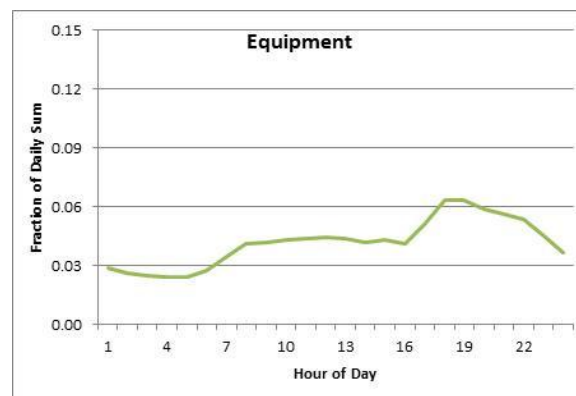
**Fig. F.2. Equipment schedule.**
