***FY15 Status Report:  
CIRFT Testing of Used  
Nuclear Fuel Rods from  
the Limerick Generating  
Station Boiling Water  
Reactor***

*J.-A. Wang, H. Wang, and H. Jiang  
B. B. Bevard  
Oak Ridge National Laboratory*

*April 30, 2015  
FCRD-UFD-2015-000635*

ORNL/TM-2015/171

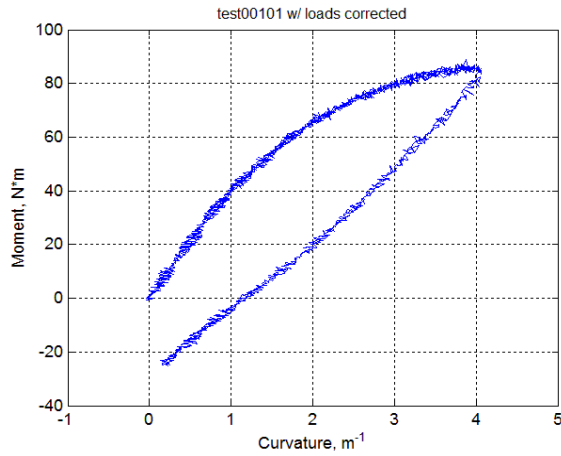
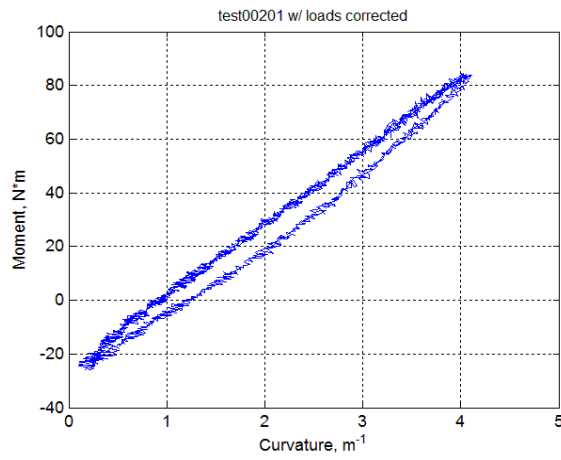
**Fig. 2. Moment-curvature curves in (a) the first loading cycles and (b) the second and third cycles for the LMK01 (574D-A) rod.**

Sample LMK01 survived three loading cycles without any sign of failure. The moment–curvature curves are shown in Fig. 2. There was a significant non-linear deformation after 35 N·m, and the maximum moment at a level of 85 N·m was attained during the initial loading cycle. The subsequent loading cycles did not produce additional deformation, but they introduced a closed hysteresis loop. The maximum curvature under a relative displacement of 24.0 mm at loading points of U-frame (i.e., 12.0 mm at each motor) was approximately  $4 \text{ m}^{-1}$ .

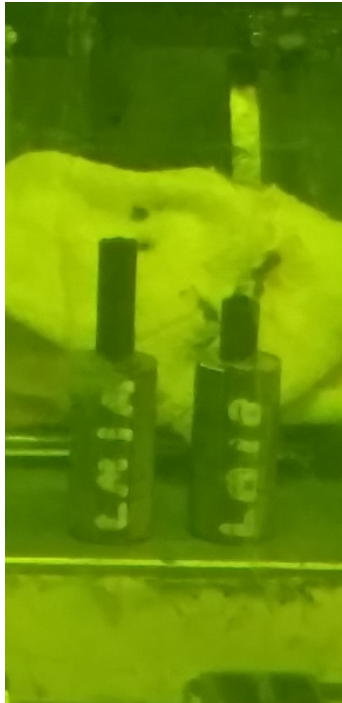
**Fig. 3. Fracture segments for the LMK01 (574D-A) rod that survived two cycles of loading to relative displacement of 24.00 mm with the maximum moment of around 85 N·m in the initial cycle. A follow-up dynamic test was carried out under  $\pm 25.4$  N·m, 5 Hz;  $N_f = 9.4 \times 10^3$  cycles.**

In order to observe the failure mode of the sample, a dynamic test was carried out under  $\pm 25.4$  N·m, 5 Hz. The lifetime of the rod ( $N_f$ ) equaled  $9.43 \times 10^3$  cycles. The rod ultimately failed in the gage section as shown in Fig. 3.

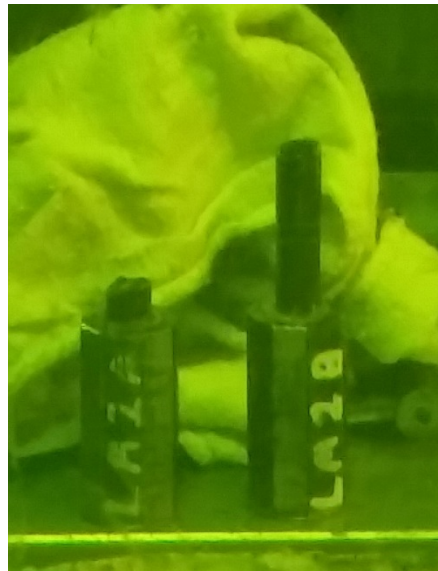
**Fig. 8. Fracture segments for LMK02/575D-A;  
 $N_f = 1.71 \times 10^5$  cycles under  $\pm 12.70$  N·m, 5 Hz.**

The failure was observed in the gage section again as seen in Fig. 8. The feature of fracture surface is not quite clearly observed at this level of resolution.

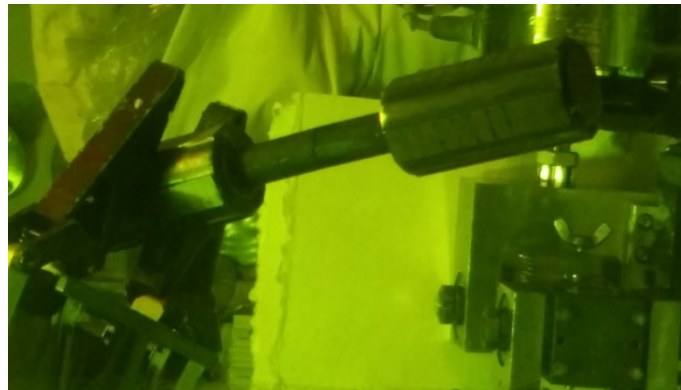
**Fig. 11. Fracture segments for LMK03/575B-A  $N_f = 4.92 \times 10^5$  cycles under  $\pm 10.16$  N·m, 5 Hz.**

The failure occurred in the gage section again as seen in Fig. 11. The failed specimen was manually broken into two pieces for fractographic study. The images of lateral surface and fracture surfaces are presented in Fig. 12. Again, the fracture occurred on the pellet-to-pellet interface. Cracks were developed in pellets and pellets fractured into several large size of fragments that were held in place. No apparent gap can be seen between the pellet and cladding. On the specimen ID side, a gray area can be seen. It cannot be seen if the gray area is a damage area at this magnification level.

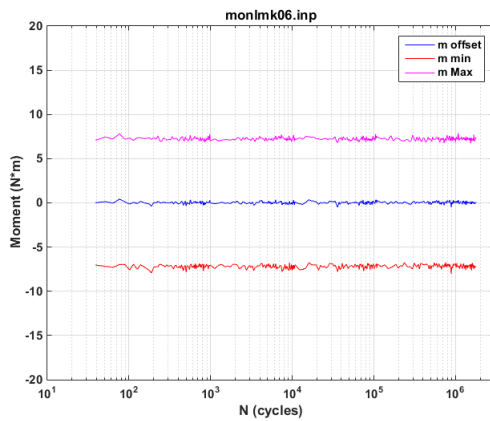
**Fig. 16. Variations of (a) curvature range, (b) applied moment range, (c) flexural rigidity, (d) maximum and minimum values of curvature, and (e) maximum and minimum values of moment as a function of number of cycles for LMK06/575D-E;  $N_f = 1.79 \times 10^6$  cycles under  $\pm 7.62$  N·m, 5 Hz.**

The curvature, moment, and flexural rigidity based on online monitoring data are presented in Fig. 16. The online monitoring showed a flexural rigidity of about  $33 \text{ Nm}^2$ , a little lower than that observed in measurements. Overall, a quite stable rod response was exhibited before the final failure. At the same time, a negative curvature offset of approximately  $-0.075 \text{ m}^{-1}$  was observed from the peak and valley monitoring of waveform.

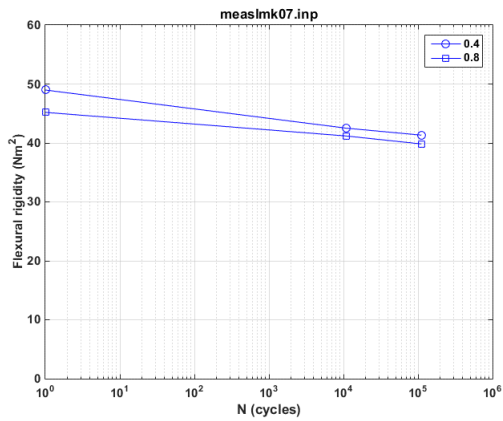
**Fig. 17. Variations of (a) curvature range, (b) moment range, and (c) flexural rigidity as a function of number of cycles for LMK07/575C-A;  $N_f = 1.22 \times 10^5$  cycles under  $\pm 15.24$  N·m, 5 Hz.**

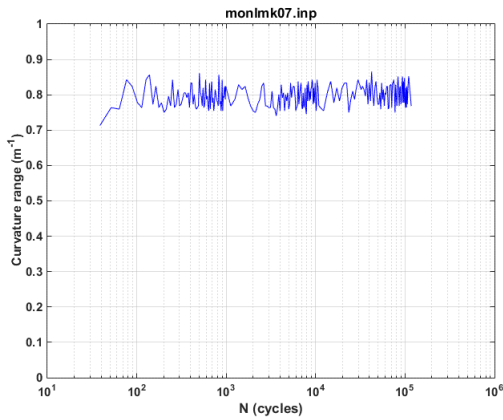
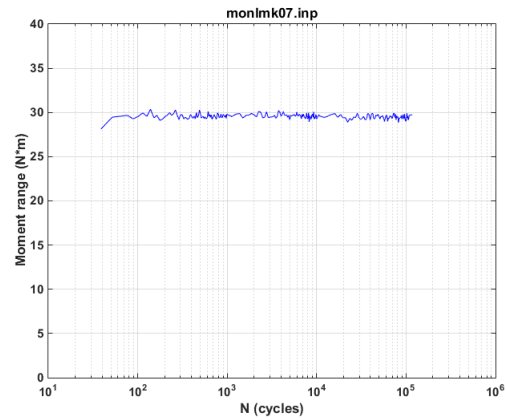
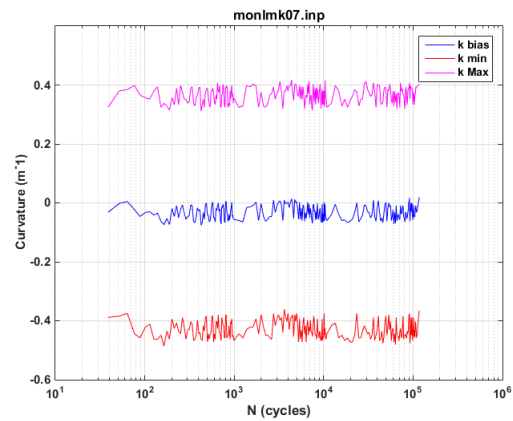
**Fig. 18. Variations of (a) curvature range, (b) applied moment range, (c) flexural rigidity, (d) maximum and minimum values of curvature, and (e) maximum and minimum values of moment as a function of number of cycles for LMK07/575C-A;  $N_f = 1.22 \times 10^5$  cycles under  $\pm 15.24$  N·m, 5 Hz.**

The curvature, moment, and flexural rigidity based on online monitoring data are presented in Fig. 18. The online monitoring showed a flexural rigidity of about 38 Nm<sup>2</sup>, a little lower than that observed in measurements. Essentially, no significant change can be observed with the monitored flexural rigidity over the cyclic testing process, except a little bend down of curve near  $7 \times 10^4$  cycles. At the same time, a little negative curvature offset ( $-0.05$  m<sup>-1</sup>) was observed.

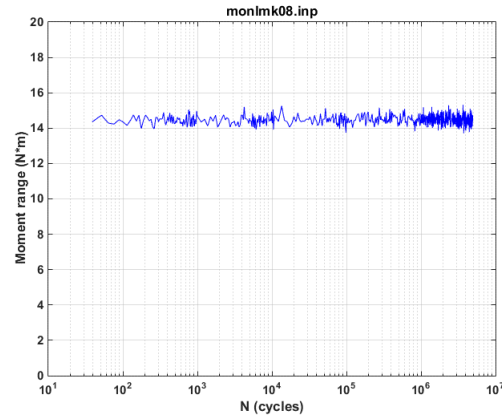
**Fig. 21. Variations of (a) curvature range, (b) applied moment range, (c) flexural rigidity, (d) maximum and minimum values of curvature, and (e) maximum and minimum values of moment as a function of number of cycles for LMK08/575B-D;  $N_f = 4.70 \times 10^6$  cycles under  $\pm 7.62 \text{ N}\cdot\text{m}$ , 5 Hz.**

The curvature, moment, and flexural rigidity based on online monitoring data are presented in Fig. 21. The online monitoring showed a flexural rigidity of about  $36.5 \text{ Nm}^2$ , a little lower than that observed in measurements. This is mainly because different loading conditions were used in measurement and cycling. Overall, a quite steady response was exhibited over the whole cyclic testing period. Meanwhile, a positive curvature offset of  $0.1 \text{ m}^{-1}$  was seen during the cyclic fatigue process.

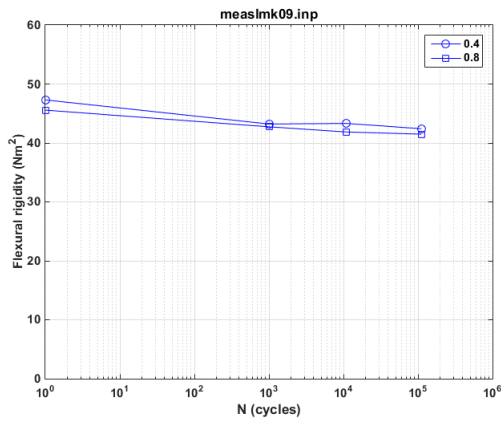
**Fig. 23. Variations of (a) curvature range, (b) moment range, (c) flexural rigidity as a function of number of cycles for LMK09/574D-D. Measurements were made with 0.2, and 0.4 mm relative displacements;  $N_f = 7.31 \times 10^5$  cycles under  $\pm 10.16$  N·m, 5 Hz.**

The test on the LMK09/574D-D rod was conducted under  $\pm 10.16 \text{ N}\cdot\text{m}$ , 5 Hz. The specimen failed at  $7.31 \times 10^5$  cycles. Periodic quasistatic measurements of rod deformation were conducted using two relative displacement levels (0.2, and 0.4 mm) at the selected target number of cycles. The variations of curvature range, moment range, and flexural rigidity as a function of number of cycles are given in Fig. 23. The rigidity of the measurements at two displacements started with 45 to 47  $\text{Nm}^2$  and demonstrated a slight decreasing trend.

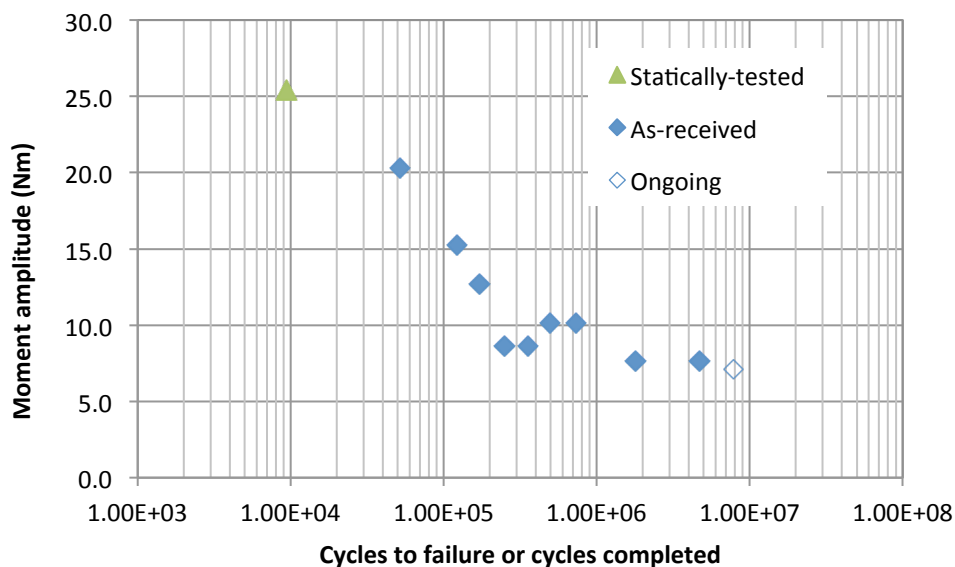
**Fig. 35. Applied moment amplitude as a function of cycles to failure or cycles completed. The data point of pretested is based on a follow-up dynamic test of LMK01.**
