Air Leakage Rates in Typical Air Barrier Assemblies

Prepared by
OAK RIDGE NATIONAL LABORATORY
Oak Ridge, TN 37831-6283
managed by
UT-BATTELLE, LLC
for the
US DEPARTMENT OF ENERGY
under contract DE-AC05-00OR22725

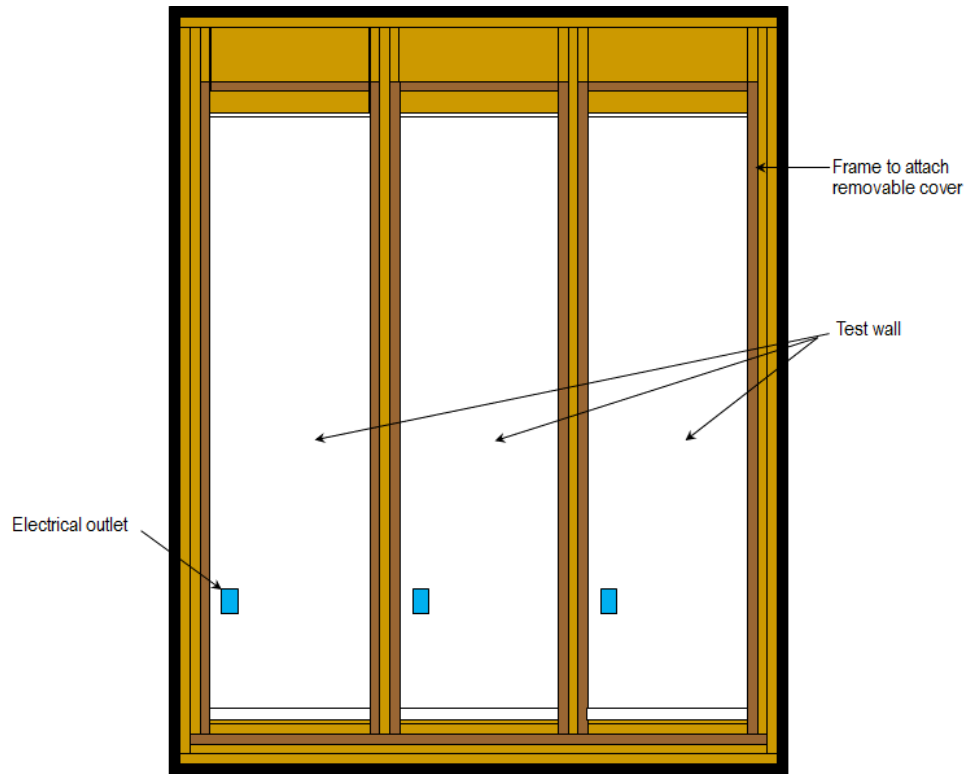
Figure 1. Indoor view of test frame with three test walls.

The airtightness level of walls is highly dependent on the workmanship skills of the installers as well as the condition of the construction materials (e.g., uneven surfaces and rough finishes). To capture the effect of these variables, nine test walls were built for each air barrier type and three technicians took turns assembling the test walls to introduce differences in skills. In order to conduct these experiments in a cost-effective manner, the test frame was divided to accommodate three 2'-0" wide by 8'-0" tall walls as shown in Figure 1. The perimeter of each of these walls was sealed so that air would not flow between walls. Figure 2 illustrates the assembly of the materials as they would be found in actual construction, and how the wall-to-roof and wall-to-foundation joints were incorporated into the test walls. Per Figures 2 and 3, the materials used typically included: ½" drywall, 2×6 studs at 24" on center, R21 unfaced fiberglass batts between studs, 7/16" OSB, air and water barrier, and vinyl siding. The insulation level was selected based on the fact that it is the minimum amount required per the 2012 IECC in walls without continuous exterior insulation in climate zones 3 and above. Indoor electrical outlets had a regular cover plate, outdoor outlets had typical weatherproof covers, and all of the outlets included the receptacle and wiring. Figure 3 also shows that each test wall had an airtight removable cover; these were used to mask the three test walls when measuring the extraneous leakage of the setup, and to mask two of the compartments so airflow rates through the wall of interest could be measured.

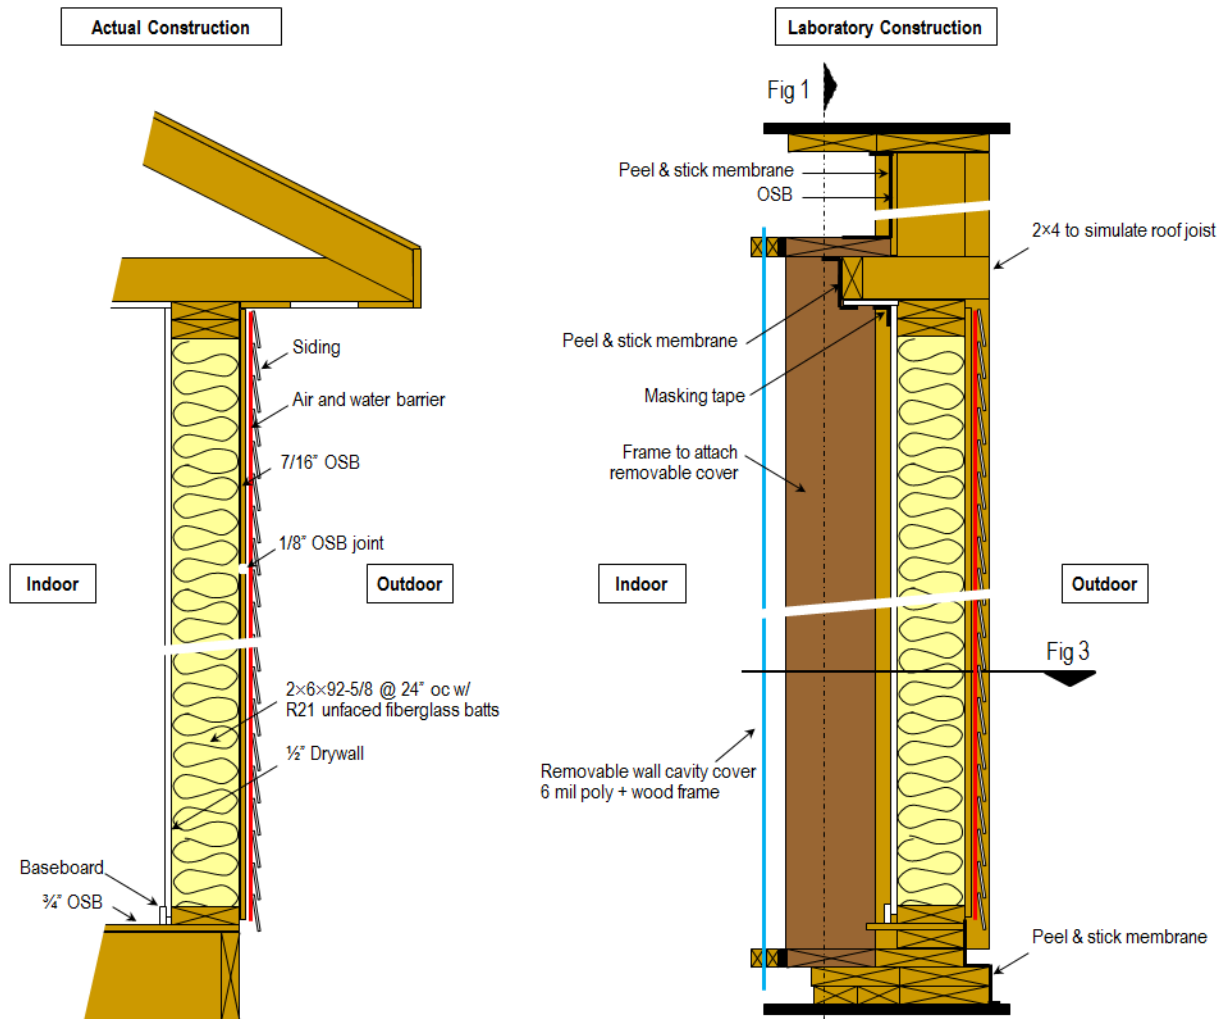
Figure 2. Wall material layout in actual construction and test walls.

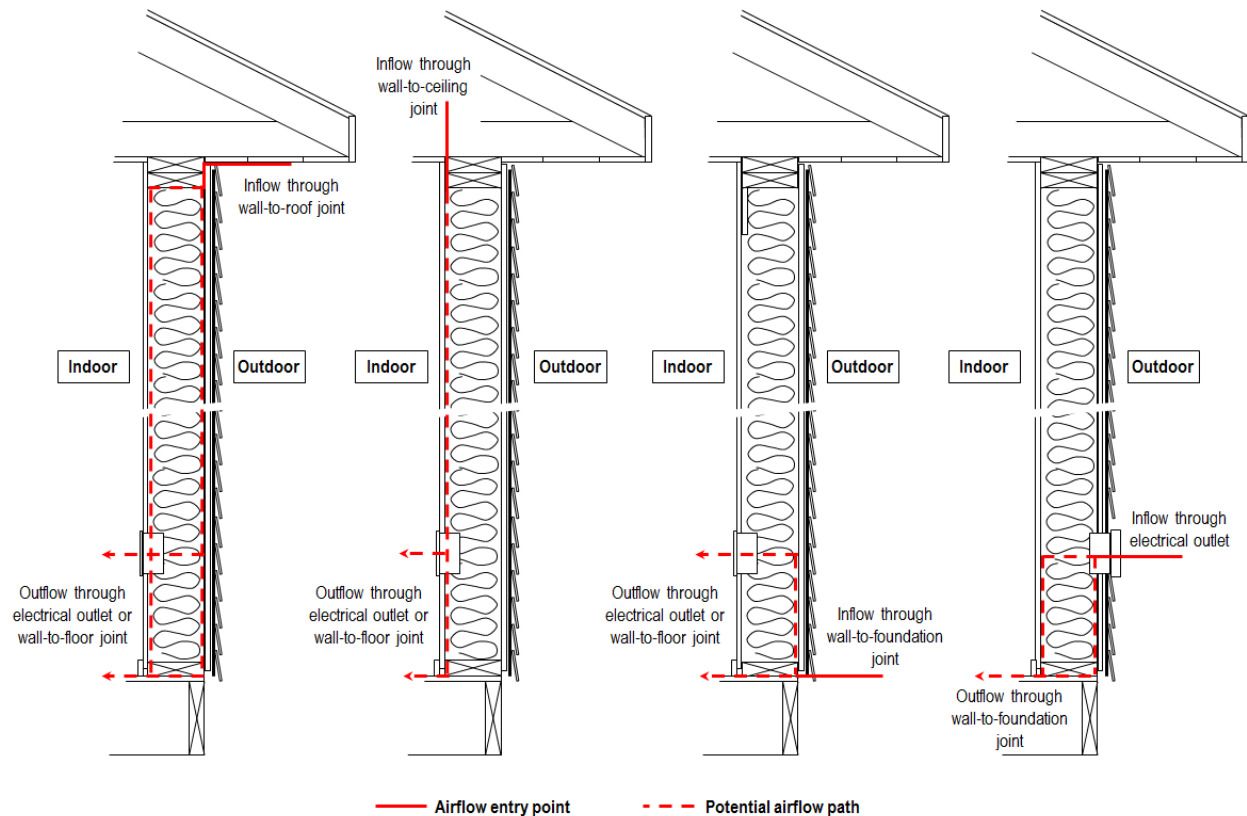
Figure 4 shows the evaluated infiltration paths; these were selected because they are frequently encountered given that air barrier manufacturers usually do not provide clear instructions on how they should be sealed. In these scenarios, airflows were measured from the following entry point locations: wall-to-roof joint, wall-to-ceiling joint, wall-to-foundation joint, and outdoor electrical outlet with weatherproof cover. The inflow area of interest was isolated by sealing the other potential leakage spots with tape. In each of these instances, outflow could have only occurred through the indoor electrical outlet with cover plate or at the wall-to-floor joint because the side edges of the drywall were taped to the test frame and the drywall joints were covered with a fiberglass mesh and compound. Exfiltration rates were also collected from the same four leakage spots as indicated in Figure 5.

Figure 4. Locations where infiltration rates were assessed.

1. Blank the three test walls with the removable covers and measure the extraneous leakage rate of the test setup ($Q_{ext\ setup}$).
2. Remove the cover from the test wall of interest, seal the four leakage locations shown in Figure 4, and measure the wall's extraneous leakage rate ($Q_{ext\ wall\ m}$).
3. Measure the leakage rate through the four locations shown in Figure 4:
 - a. Wall-to-roof joint ($Q_{wr\ m}$)
where $Q_{wr} = Q_{wr\ m} - Q_{ext\ wall\ m}$ [1]
 - b. Wall-to-ceiling joint ($Q_{wc\ m}$)
where $Q_{wc} = Q_{wc\ m} - Q_{ext\ wall\ m}$ [2]
 - c. Wall-to-foundation joint ($Q_{wf\ m}$)
where $Q_{wf} = Q_{wf\ m} - Q_{ext\ wall\ m}$ [3]
 - d. Electrical outlet with weatherproof cover ($Q_{eo\ m}$)
where $Q_{eo} = Q_{eo\ m} - Q_{ext\ wall\ m}$ [4]

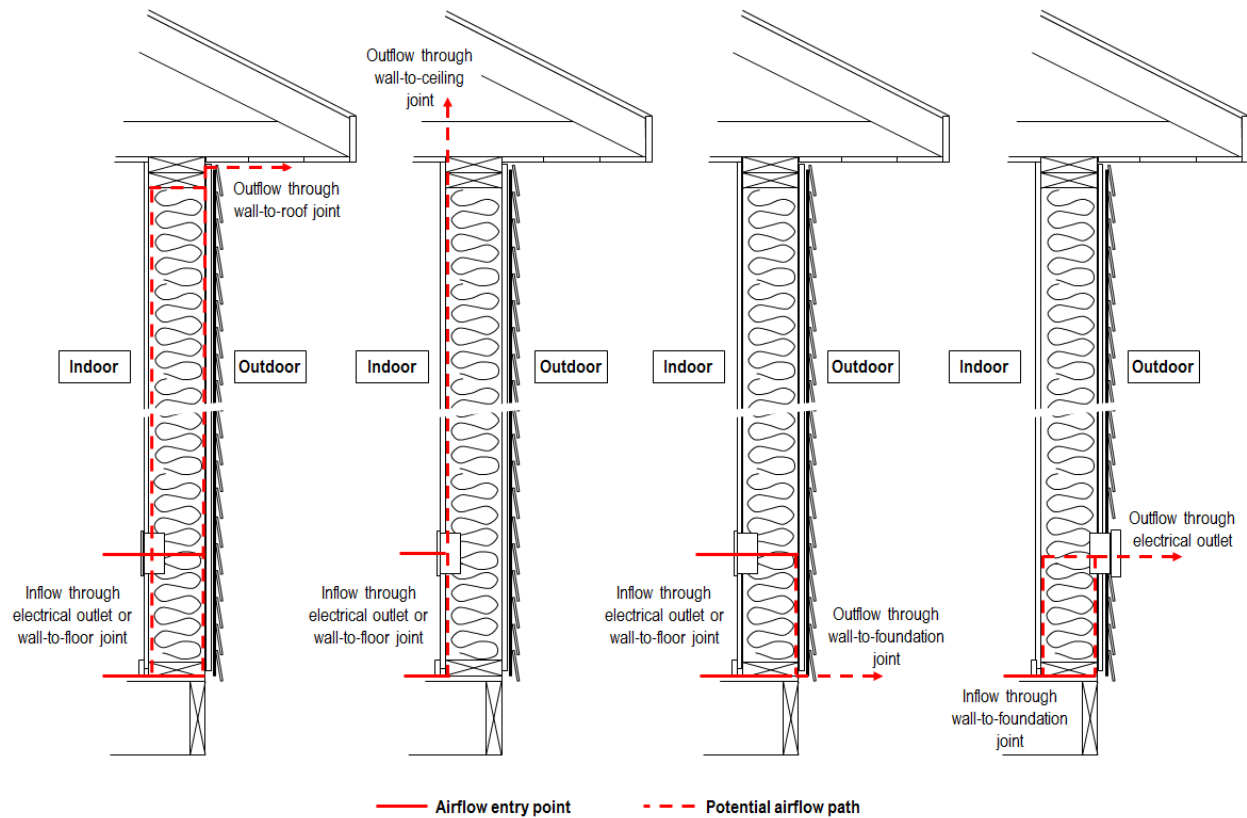
Figure 5. Locations where exfiltration rates were assessed.

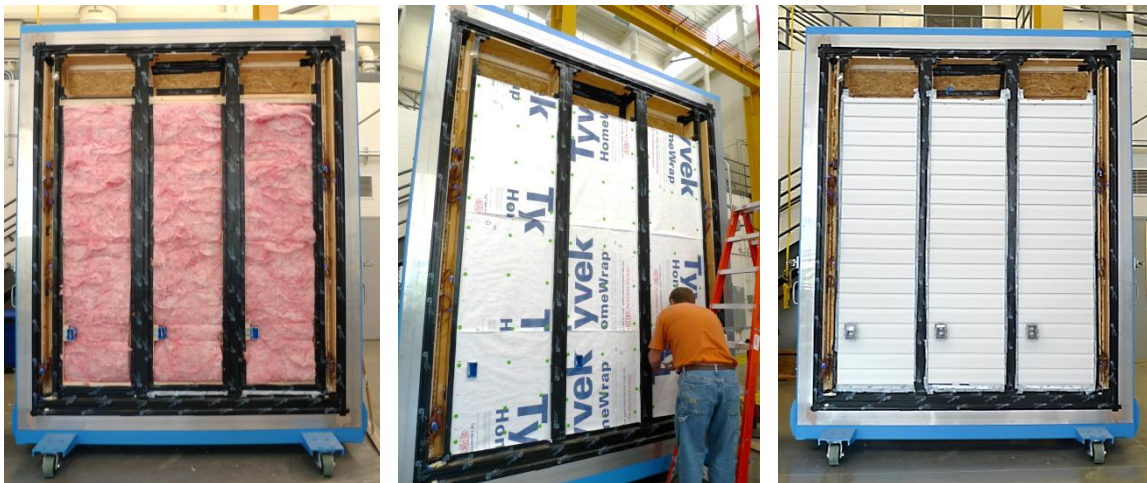
Figure 7. Test walls with mechanically-fastened membrane as the air barrier.

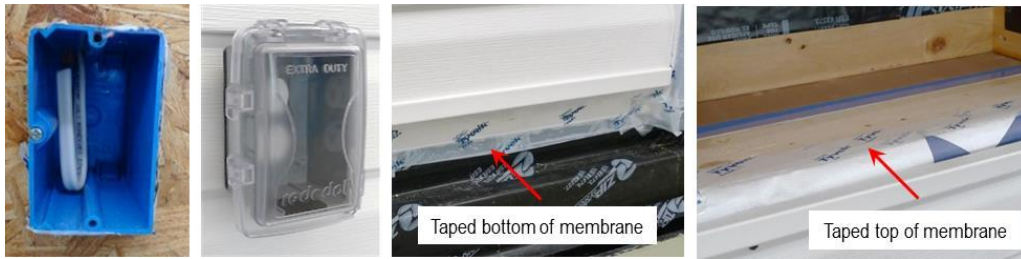
Figure 8. Construction details from test walls with mechanically-fastened membrane.

Liquid flashings are probably the simplest available products that can be used to seal the wall-to-foundation and wall-to-roof joints because they can mold around the odd material layouts that are commonly found at these interfaces (Figures 8, 10, 12). Figures 14 and 15 show other techniques to seal these joints using tape and/or sill foam gaskets (Hun et al. 2014). Similar techniques can be used to reduce airflow at the wall-to-ceiling joint, that is, by placing a gasket or sealant between the drywall and the top plate.

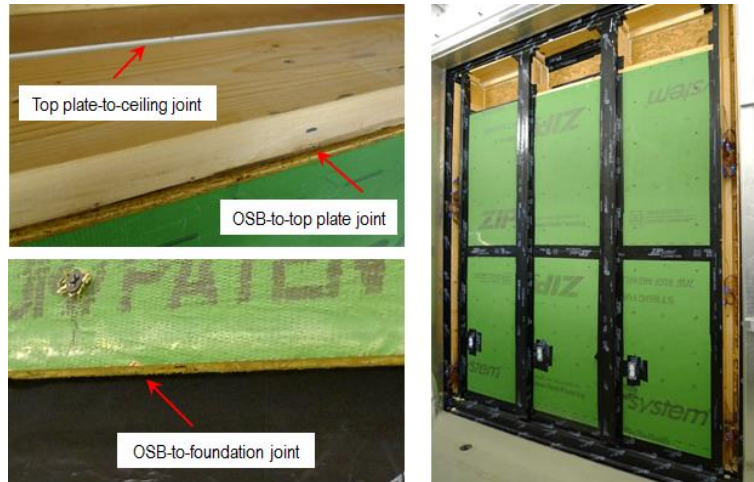
Figure 10. Construction details from test walls with non-insulating sheathing.

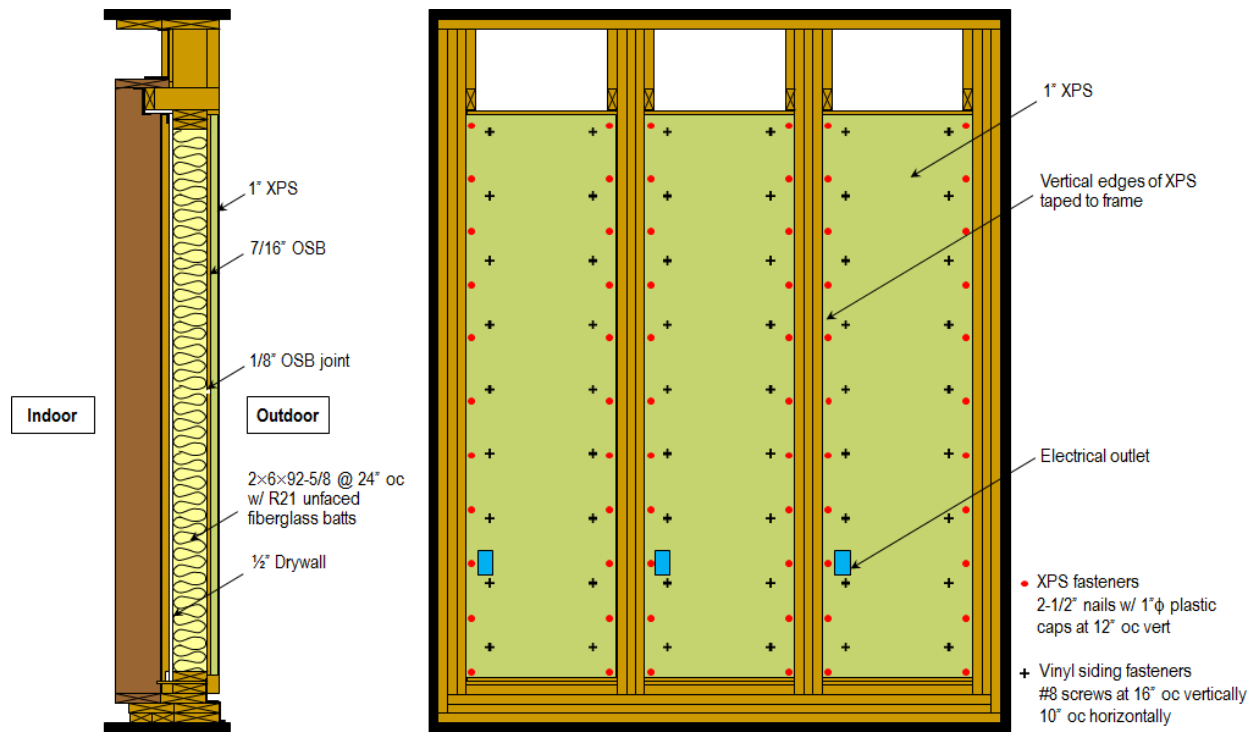
The wall material layout is depicted in Figure 11. The 1"-XPS boards were installed with their long side perpendicular to the ground because this is how they would likely be placed in actual construction. Although the XPS boards did not include a horizontal joint, the OSB behind them did have an untapped horizontal joint at mid height. The insulation boards were attached to the studs using 2-1/2" nails with 1" diameter plastic caps per the manufacturer's instructions, while #8 screws at 8" on center were used with the OSB. The vertical sides of the OSB and XPS were taped to the test frame to simulate horizontal continuity. Only the fasteners for the vinyl siding were installed because it is unlikely that the cladding will affect the air leakage measurements given the rigidity of the OSB and XPS.

Figure 11. Material layout in test walls with insulating sheathing as the air barrier.

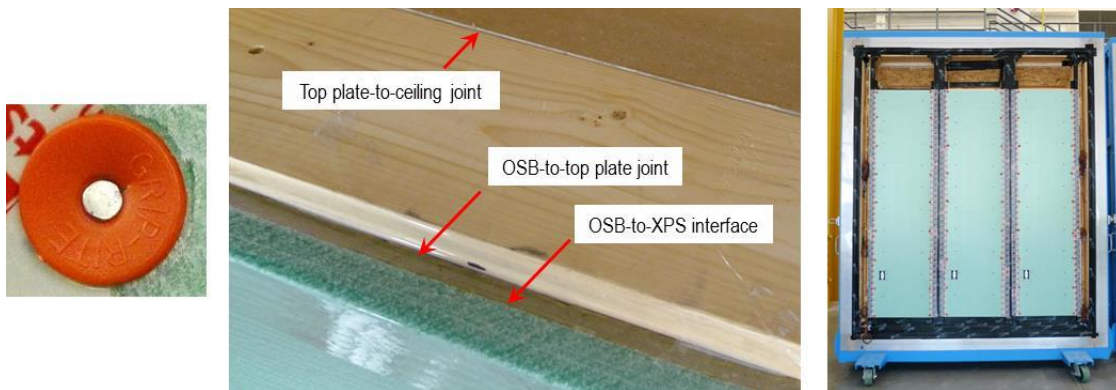
Figure 12. Construction details from test walls with insulating sheathing.

perhaps because the interface between the OSB and the XPS provided for an extra leakage site (Figure 12).

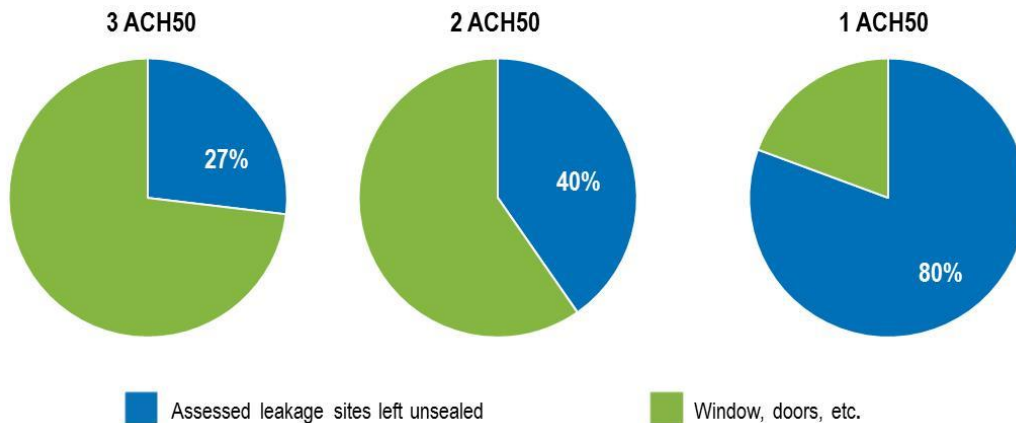
To place the data in Tables 1, 2 and 3 into context, we estimated their contribution to the total air changes per hour at a ΔP of 50 Pa (ACH50). To achieve this, we use as an example a single-story house with a 2,000 ft² footprint, 8 ft ceiling, 16,000 ft³ volume, and exterior wall area of 1,431 ft². The 2012 IECC leakage requirement for homes in climate zones 3 and above is 3 ACH50, which in the proposed scenario is equivalent to 800 cfm50. If we use 0.15 cfm/ft² as the average leakage rate for all of the test walls when all the imperfections are left unsealed ($Q_{unsealed}$ in Tables 1, 2 and 3) and multiply it times the exterior wall area, we find the flow rate through these walls to be 215 cfm50. That is, the leakage rate through the imperfections that were evaluated in this study would be equivalent to 27% of the allowed 800 cfm50. If the house in this example had an ACH50 of 2 because the ceiling or the gaps around windows and doors were better sealed, then $Q_{unsealed}$ could be responsible for about 40% of the total leakage rate. This number increases to 80% if the house has an ACH50 of 1. Figure 13 summarizes these results and clearly illustrates how the contribution from airflows through areas that are not easily tackled by air barrier materials can become relevant to the total leakage of tightly-built homes.

Figure 13. Potential contribution of the air leakage sites that were assessed in this study to the total air changes per hour in a house.

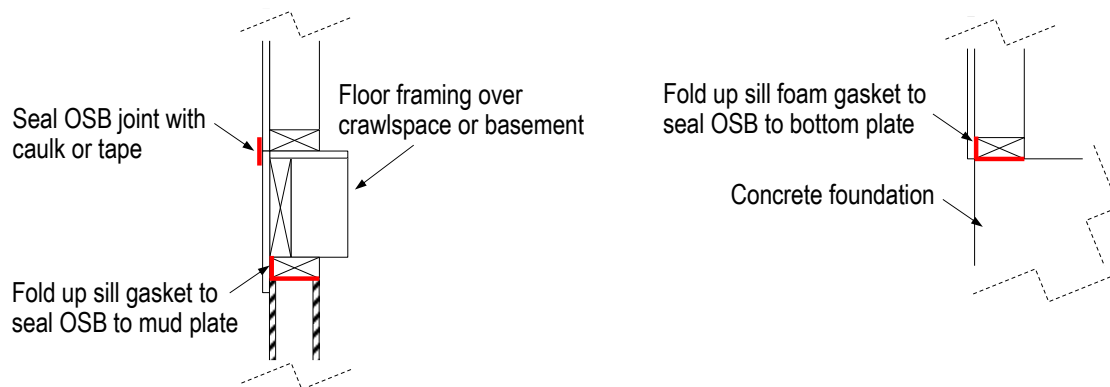
Figure 14. Techniques to seal wall-to-foundation joints (Hun et al. 2014).

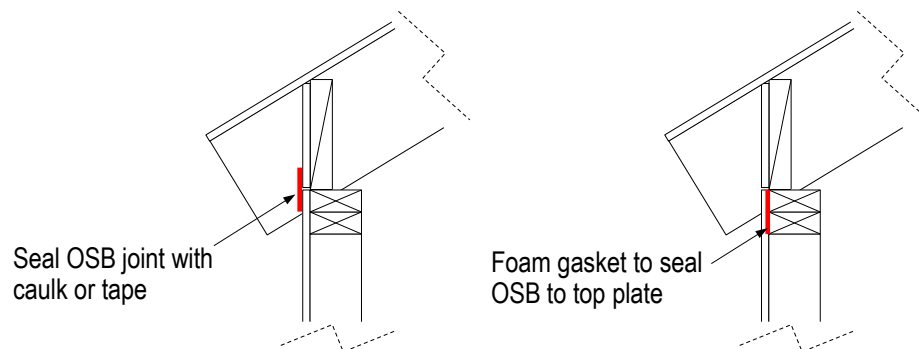
Figure 15. Techniques to seal wall-to-roof joints (Hun et al. 2014).
