# Corrosion Assessment of Candidate Materials for the SHINE Subcritical Assembly Vessel and Components – FY 2015 Report

S. J. Pawel

January 2016

Materials Science and Technology Division

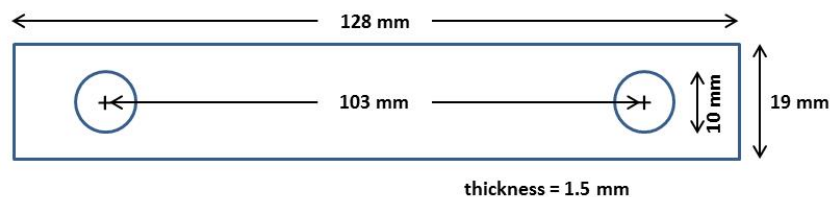
**Figure 1. Dimensions of flat stock panels used to generate U-bend specimens.** The holes for the bolting hardware are centered in both the longitudinal and transverse directions. These dimensions correspond roughly with  $5 \times \frac{3}{4} \times \frac{1}{16}$  in.

The general guidance of ASTM G30 [2] was followed in the preparation and exposure of U-bends in this investigation. Specimens for bend testing were prepared from flat rectangular stock machined to the dimensions indicated in Figure 1. The flat stock was ground to an average surface roughness of  $< 1\text{ }\mu\text{m}$  (about 16 rms). Following initial degreasing in ethanol, the specimens were then bent into the desired “U” shape using the two-stage method. In this method, each specimen was bent partially toward the U-shaped configuration (“legs” of the U not quite parallel) using a fixture designed to deliver a 12.5 mm (0.5 in.) bend radius. Just prior to exposure to the test environment of interest, the specimen was cleaned with acetone, weighed, and bent into the final/complete U-shape. The final bending was accomplished with the aid of a vise holding the open end of the U-shape at the proper dimension (inside surfaces of the “legs” of the U-shape separated by 25 mm) while the stainless steel bolting and Teflon shoulder washers were put in place and tightened. The purpose of the Teflon shoulder washers was to eliminate any dissimilar metal contact between the stainless steel bolting material and the U-bend alloy of interest. In this fashion, the U-bend was prepared for exposure with no relaxation of the elastic portion of the bending stress.

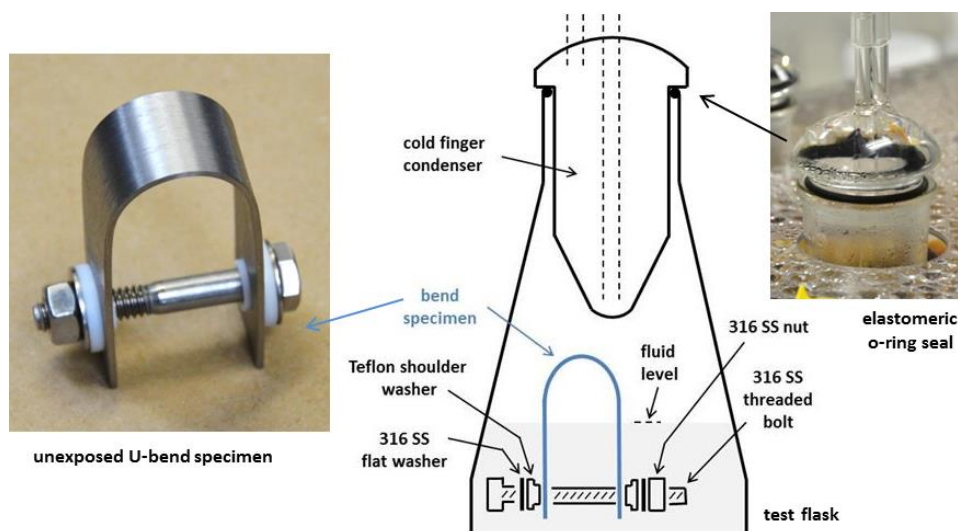
**Figure 2. U-bend test arrangement.** The fully formed U-bend specimen (left) is placed within the flask containing the test solution and the flask fitted with a cold-finger condenser supported by an o-ring.

Following completion of the bending procedure, the fully assembled specimens (Figure 2) were placed within standard 1 L Erlenmeyer flasks for exposure. The flasks were fitted with a cold finger condenser (cooling water kept  $< 30^\circ\text{C}$  by a recirculation unit) supported by a Kalrez o-ring to eliminate evaporation and vapor escape from the flask. The o-rings also served to keep droplets of moisture condensation on the top of the cold finger surface from trickling down the condenser surface and entering the test solution (thus avoiding dilution from this source).

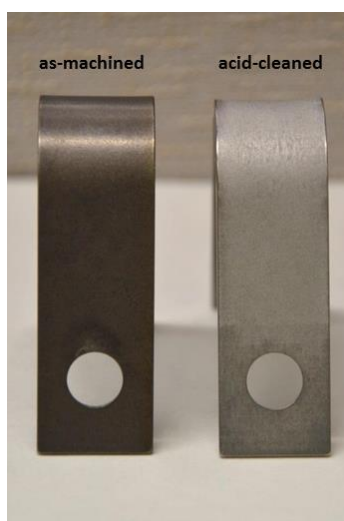
**Figure 3. As-machined (left) and pickled (right) specimens of Zr-4 prior to test exposure.**

Unlike the stainless steel U-bends, which remained bright and shiny following machining and assembly, the as-machined zirconium alloys exhibited a dull brown oxide. The oxide likely formed as a result of modest heating in air generated by the final milling process. This oxide was quite thin and adherent and was not obviously distressed (cracked, spalled) during the process to complete the U-bend assembly. Some zirconium alloy specimens were exposed to the various test solutions in this condition (machining oxide retained), while others were first pickled to remove the oxide prior to exposure in the same test solutions. The pickling procedure (modeled roughly after ASTM B614 [3]) used a solution of 25 ml reagent-grade nitric acid, 3.5 ml reagent-grade hydrofluoric acid, with distilled water to 100 ml total. Following the first stage of bending, oxidized zirconium specimens were ultrasonically soaked in this solution at room temperature for 3–5 minutes. Following similar ultrasonic cleaning in water and acetone, the bending procedure was completed and bolting applied. Figure 3 compares the appearance of the as-machined oxidized surface and a similar pickled specimen of Zr-4 prior to testing.

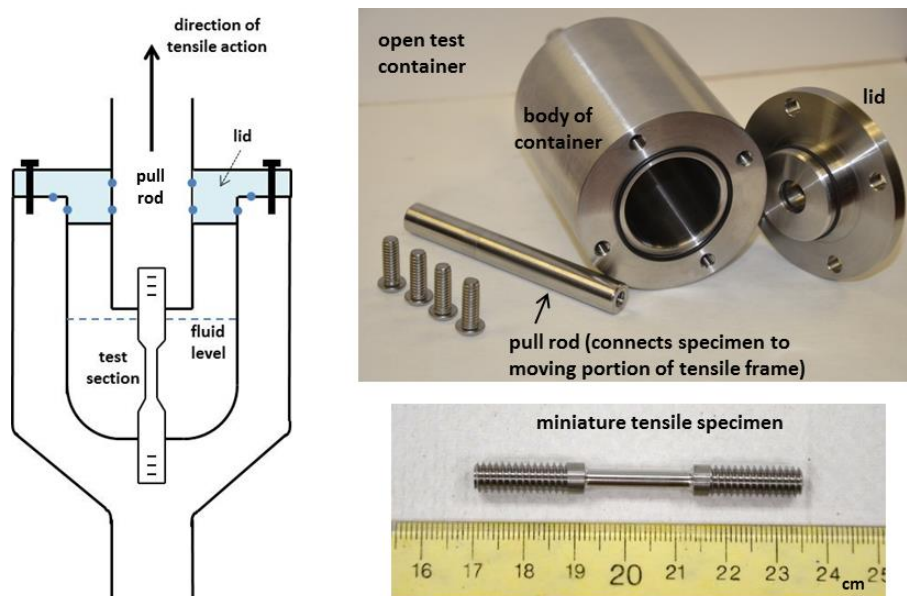
**Figure 4. Schematic test cell with photographs of the test cell components and a miniature tensile specimen used for the slow-strain rate tests.**

Figure 4 shows the test cell arrangement for the SSR experiments. The test vessel was fabricated using 316L stainless steel and was machined from a solid block to eliminate the need for welds and the associated quality control. To satisfy potential safety concerns associated with containment of a radioactive solution, the vessel incorporated a very heavy wall thickness despite the known compatibility of 316L and acidic uranyl sulfate solutions [1]. The tensile specimens were about 65 mm long with a test section (gage length) 20 mm long and 3.8 mm diameter. For each exposure, the specimen was threaded into the bottom of the container, and 50 ml of the test solution of interest was added such that the test section was completely immersed. The container was then sealed, and four Kalrez o-rings at strategic positions prohibited any splash/spill losses or evaporation while permitting linear motion of the pull rod.

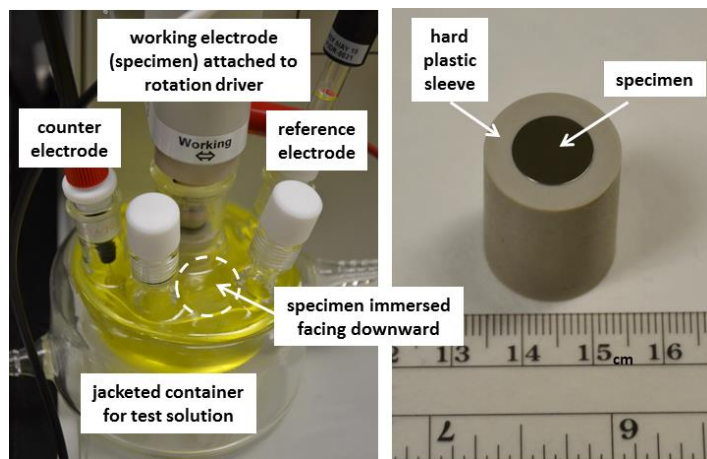
**Figure 5. Electrochemical test cell containing depleted uranyl sulfate solution (yellow) along with a close-up of the rotating disk specimen.**

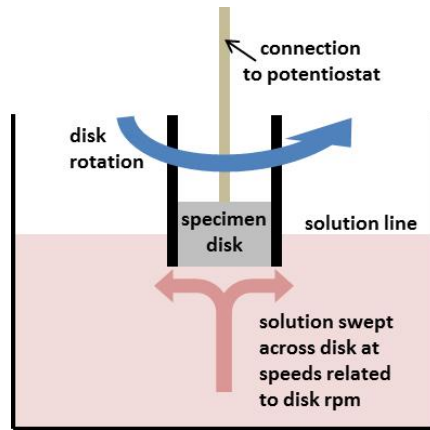
**Figure 6. Schematic representation of the rotating disk electrode arrangement and the fluid motion generated as a function of rotational speed.**

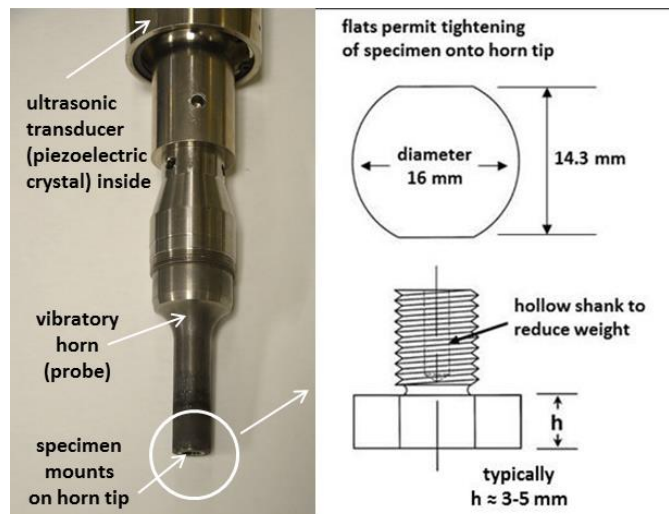
**Figure 7. Key components of a vibratory horn (left) and details of a cavitation test specimen (right).**

Figure 7 shows the key components of the vibratory horn (fabricated using titanium) and a schematic diagram of a test specimen that mounts to the tip of the horn. Each vibratory horn is tuned for a specific specimen weight range (which for this size horn is ~ 5–8 g). Thus, to account for different densities among the various test materials, the dimension “h” shown in Figure 7 is varied to maintain a near-constant mass for each test specimen.

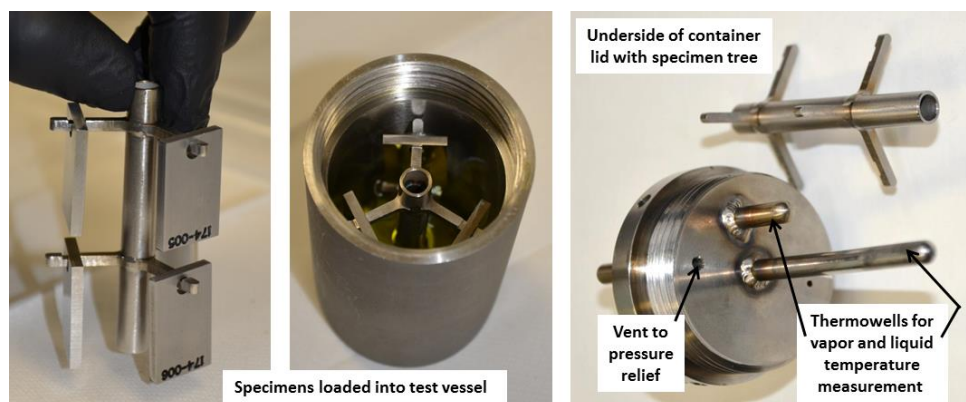
**Figure 8. Views of the specimen “tree” and the HFIR/GIF test container vessel and lid.** The approximate internal dimensions of the vessel are 5 cm diameter and 9 cm tall. The specimen tree slides over the thermowell that reaches the bottom of the container.

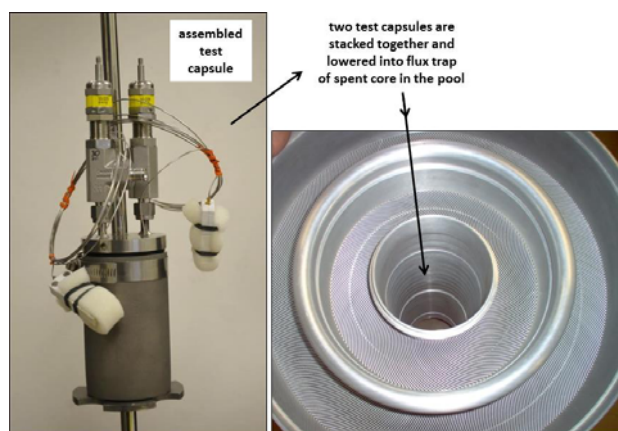
**Figure 9. Fully assembled test capsule prior to placement within an over-pack (left) and a mock flux trap assembly.**

Each test container incorporated two thermowells attached to the vessel lid, one reaching almost to the bottom of the container and one reaching only a short distance from the lid, such that Type-K thermocouples could be used to monitor internal temperatures in the liquid and vapor, respectively. Each vessel lid was also fitted with two ports connected to the internal volume with redundant pressure-relief valves. These were required for safety considerations against the possibility of generating substantially more radiolytic hydrogen and oxygen than predicted by dosimetry estimates. While known not to have superior radiation resistance, a Kalrez® o-ring was also placed at the lid/container interface to ensure complete sealing against vapor loss. After assembly, the test containers were further enclosed within a certified over-pack canister that was inserted into the flux trap (central annulus) of a spent fuel assembly for exposure. Figure 9 shows a fully assembled test capsule (without the over-pack canister) and a mock flux trap to show the annular region into which the test containers with over-packs are positioned.

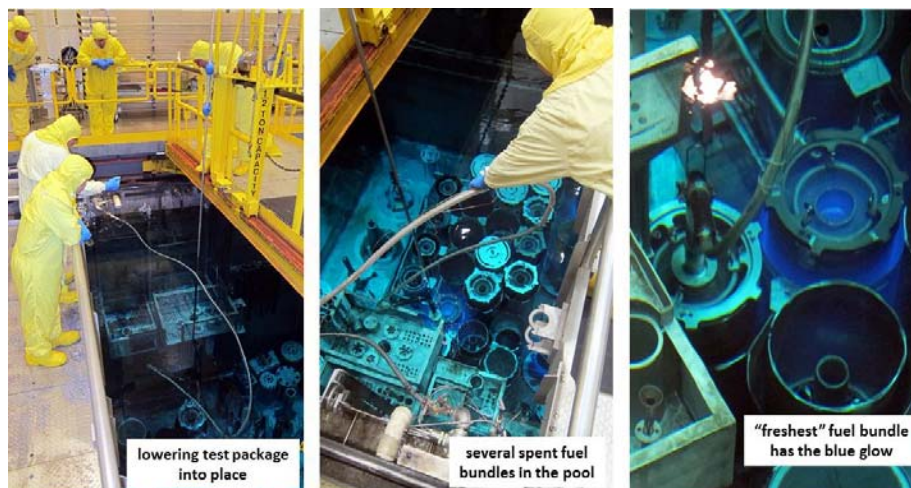
Figure 10. Views of the activity around the spent fuel pool at HFIR during placement of a corrosion test package within a flux trap.

Specimens for exposure were rectangles 30 mm in length, 19 mm wide, and 3 mm thick with a 4.5 mm hole centered near one end. Two test containers were stacked within the flux trap for exposure, placed roughly centered just above and just below the peak flux plane so that the exposures (gamma intensity and dose, temperature) in each container were essentially the same. One container included only stainless steel specimens (one each in liquid and in vapor), and the other container included both zirconium-based alloys and duplicates of the 316L specimens similarly exposed in the other container. An equilibrium temperature of ~ 69°C was reached within an hour or so of insertion, and it decreased slightly (by ~ 2°C) over the week-long exposure. Figure 10 shows various views of the insertion of the test package into the spent fuel pool at HFIR/GIF.

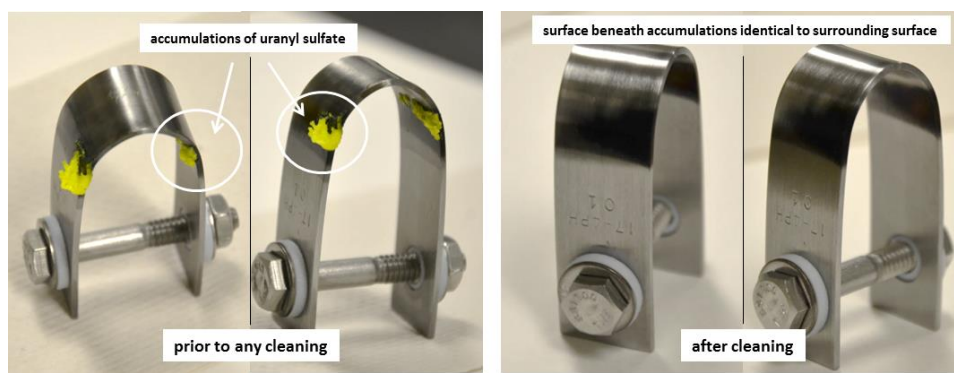
**Figure 11. Representative U-bend specimen immediately upon removal from test flask (left) showing accumulations of depleted uranyl sulfate and the same specimen following cleaning (right).**

For U-bends positioned in the standing orientation, such that the bend apex was exposed above the solution line inside the flasks, modest accumulations of uranyl sulfate were frequently observed on the specimen surface just above the solution line. These accumulations were not particularly adherent, and the remnants that were not dislodged in routine handling were easily washed from the surface with distilled water. Further, no accelerated corrosion (e.g., surface roughening) was observed associated with the area beneath the accumulations, nor any change in the local discoloration characteristics of the specimen. Figure 11 is representative of this observation. Following cleaning (described in Section 2), and careful inspection for cracks with good lighting and a 15× lens, the U-bends were disassembled and the cleaning procedure repeated prior to reweighing the original sample.

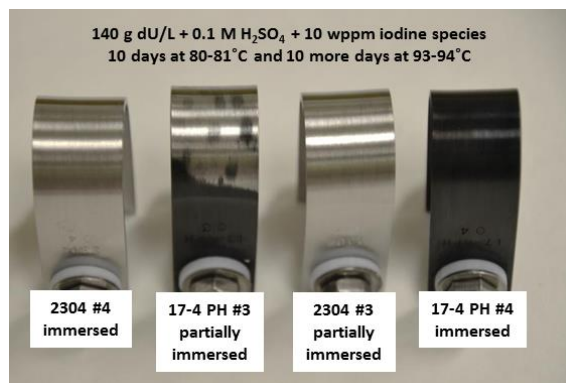
**Figure 12. Post-exposure U-bends of 2304 and 17-4 PH stainless steels showing the contrast in coloration of the surface as a function of alloy type and specimen orientation during the exposure.**

Among the stainless steel U-bend specimens examined, the 17-4 PH alloys were often observed to be discolored to very dark gun blue or black as a result of exposure—predominantly on the immersed surfaces but not exclusively so—in patterns that were essentially identical to those observed on unstressed specimens that were previously evaluated [1]. The thickness of the dark film was not directly measured, but it appeared quite thin in that the original surface profile on the specimen surface remained readily visible and unchanged. Figure 12 shows a representative example of this observation, which compares the post-exposure appearance of 17-4 PH specimens with that of 2304 stainless steel in the same exposure environment. Note that in this comparison, the 2304 specimens appear essentially pristine compared to the 17-4 PH. The dark film on the 17-4 PH specimens—almost certainly an oxide but not analytically identified—was quite resistant to ultrasonic treatments in water and acetone and could not be wiped from the surface using paper towels.

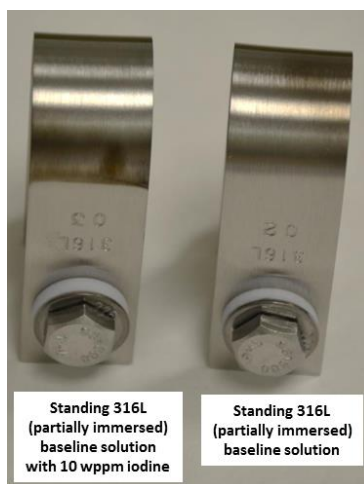
**Figure 13. Post-exposure 316L stainless steel U-bends showing light golden brown discoloration on the bend apex that was exposed above the solution line.** Testing environments included the baseline solution (140 g dU/L + 0.1 M sulfuric acid) and the baseline solution with 10 wppm iodine species added. Both specimens exposed for 10 days at 80–81°C and 10 days at 93–94°C.

Only rarely were 304L, 316L, or 2304 observed to exhibit apparent discoloration at all in the U-bend exposures. This trend was also observed during exposures of the unstressed coupons [1], and in those rare cases a relatively subtle light golden brown was generally observed. Figure 13 shows an example of slight golden brown discoloration observed on type 316L specimens after an extended exposure. Among the limited U-bend exposures of stainless steels such that the bend apex was only partially immersed, the discoloration patterns were identical to those for fully immersed specimens.

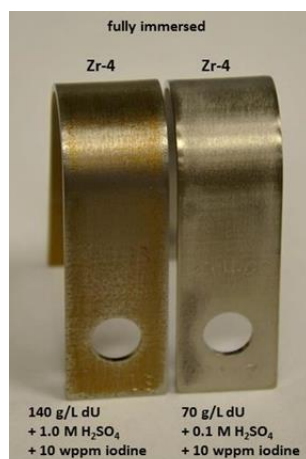
**Figure 14. Post-exposure U-bends of Zr-4 showing variable degrees of development of a golden brown film.**

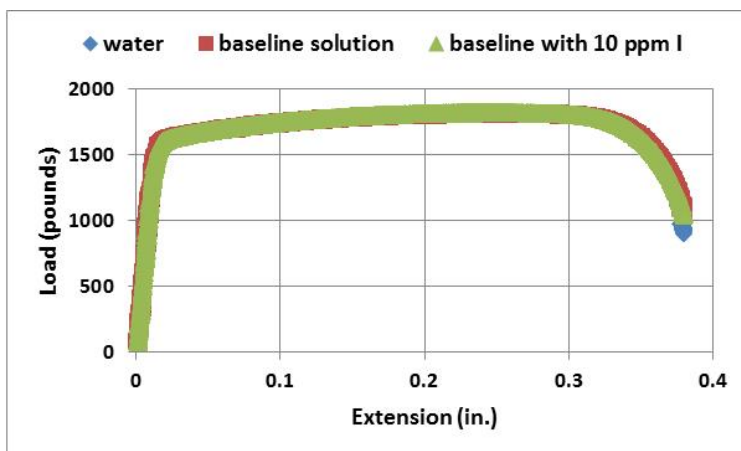
Figure 15. Stress-strain curves for 316L stainless steel as a function of test environment.

acid addition environments—does not enhance the plot as these curves fall identically on top of the others plotted at this scale. Similarly, Figure 16 compares the stress-strain curves for three environments for the Zr-4 alloy. Consistent with the behavior of all the alloys examined, the similarity in these curves suggests no sensitivity to SCC.

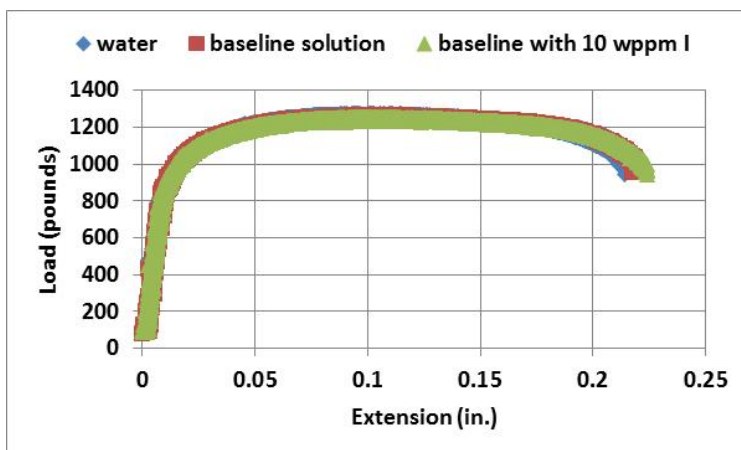
Figure 16. Stress-strain curves for Zr-4 as a function of test environment.

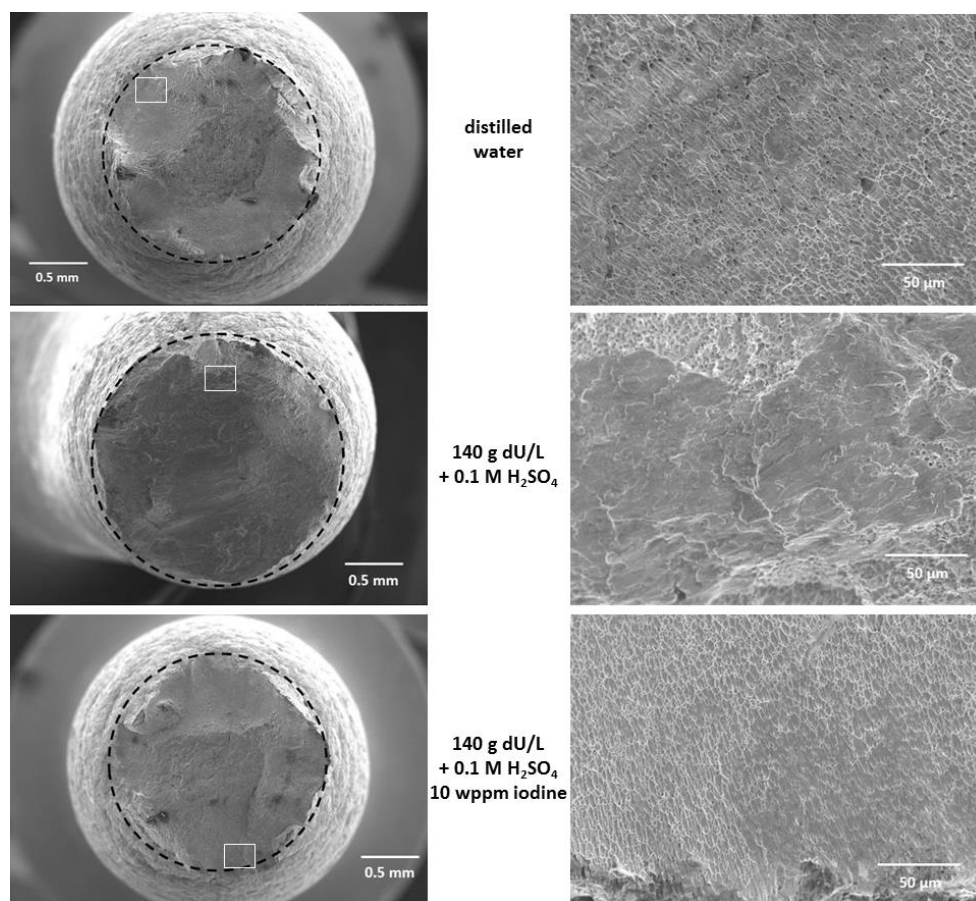
**Figure 17. Fracture surface macrographs (left column) and representative fracture surface detail (right column) for 316L tensile specimens pulled to failure in three different environments. The approximate location of each high-magnification region is shown by the white box on the corresponding macrograph.**

Comparison of the fracture surface characteristics as a function of exposure environment also suggested no sensitivity to SCC among the alloys. A representative comparison for 316L stainless steel, correlating to the same three stress-strain curves shown in Figure 15, is presented in Figure 17. The macrographs indicate very uniform and nearly identical reduction in area—approximated by the dashed black line—for each specimen/environment combination. The edges of each specimen as well as the fracture faces are free of secondary cracks, further indicating no susceptibility to SCC. In addition, the characteristics of each fracture face—in this case, interspersed regions of micro-void coalescence and quasi-cleavage fracture advance—are nearly identical on each specimen, again suggesting the environment has little influence of fracture mechanisms.

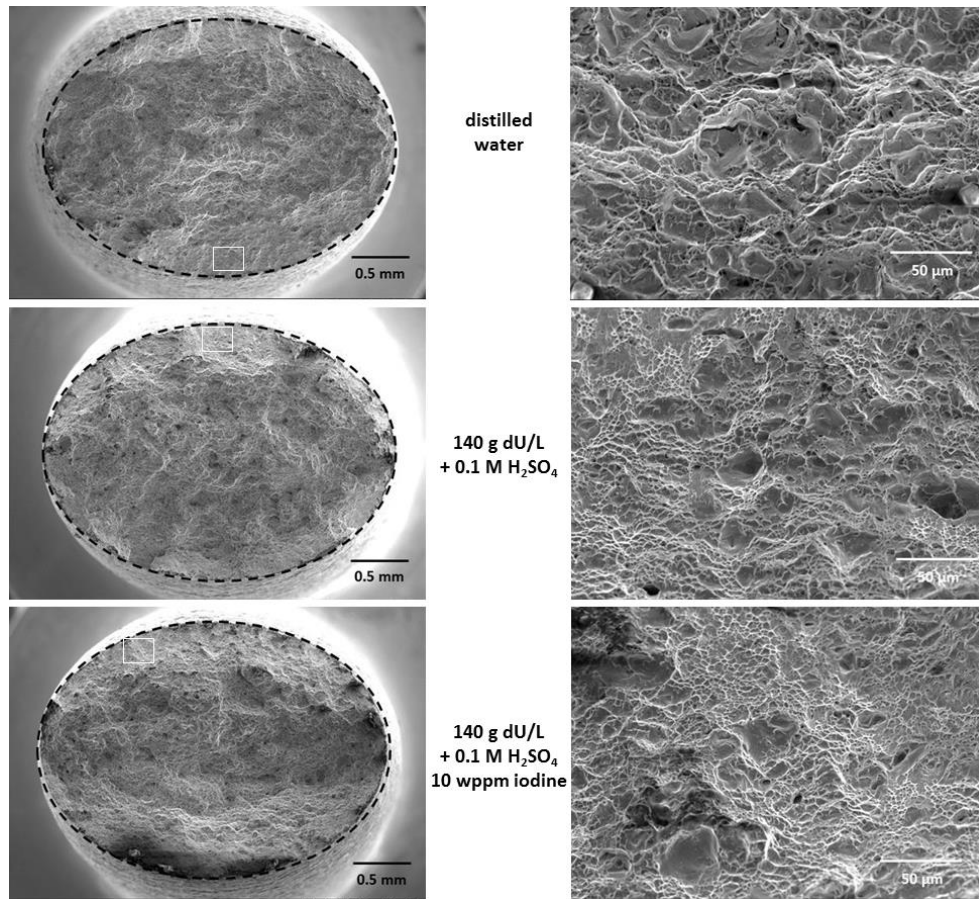
**Figure 18. Fracture surface macrographs (left column) and representative fracture surface detail (right column) for Zr-4 tensile specimens pulled to failure in three different environments. The approximate location of each high-magnification region is shown by the white box on the corresponding macrograph.**

A similar representative collage of fracture information for Zr-4 is presented in Figure 18. As was the case for 316L, the Zr-4 specimens exhibited nearly identical reduction in area, no secondary cracking, and fracture surface details independent of test environment. Compared to the 316L specimens, the Zr-4 specimens exhibited a somewhat oval final fracture area. While not examined in detail, it is suspected that the hexagonal crystal structure of the zirconium alloys and the slight texture in the specimens resulting from the original plate rolling contributed to the lack of uniformity in the reduction in area of the tensile specimens. The difference in the final cross section of the 316L and the Zr-4 specimens is highlighted in Figure 19, which shows (to scale) the relative difference between the original dimensions/shape of the gage section area and the final cross-sectional area. For the three Zr-4 alloys, the final reduction in area was essentially identical; for the 316L, the area reduction was slightly less for the specimen in the baseline solution but not sufficiently to suggest sensitivity to SCC. In all cases of 316L and Zr-4 specimens, the final reduction in area was at least 50% in every environment.

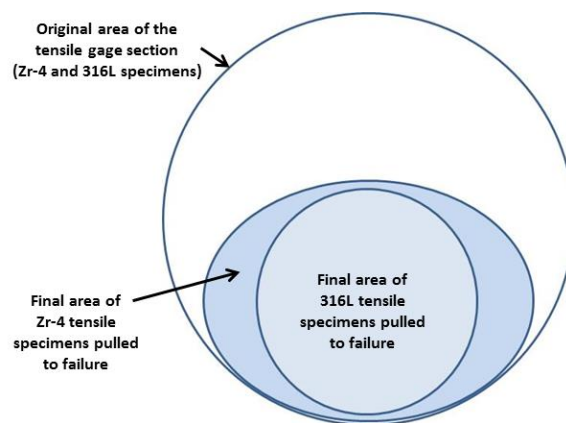
**Figure 19. Schematic representation of the reduction in area for 316L and Zr-4 specimens resulting from the SSR tests.**

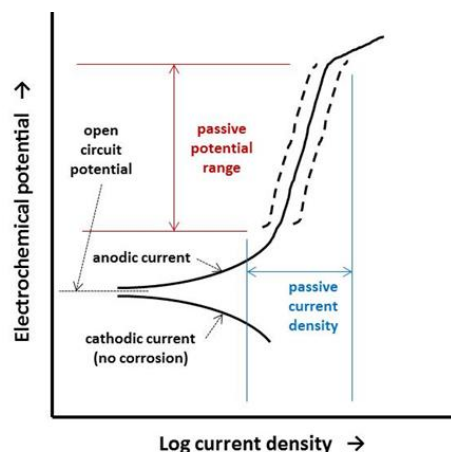
Figure 20. Schematic polarization curve for a material indicating simple passivity.

Figure 20 shows a schematic polarization curve result for a metal displaying very simplified cathodic and anodic (corrosion) reactions. This figure enables identification of the key characteristics of interest in the present investigation of polarization behavior. Typically, the magnitude of the passive current density at any given potential (roughly correlates to corrosion rate in simplified interpretation) and the extent of the passive current region (generally measured in mV) are the most significant features for the purpose at hand, along with the open circuit potential. Figure 21 shows schematic representations of likely changes in the polarization behavior that might result from changes in the environment. For example, loss of passivity or at least increased passive corrosion current as a result of increased fluid velocity is depicted on the left side of Figure 21. While the change indicated is purely schematic, conceptually it suggests that increased velocity perhaps refreshes the concentration of corrodants at the metal surface or adds a modest erosion component to the situation in a way that increases anodic current (corrosion) at nominally passive potentials. Similarly, as potential is increased, passivity can be lost in localized areas, resulting in a curve similar to that shown on the right in Figure 21. This type of behavior often results from pitting or crevice attack of the surface that can be caused by aggressive species in solution disrupting the passive film (halides are a common example) or increasing its solubility in the environment.

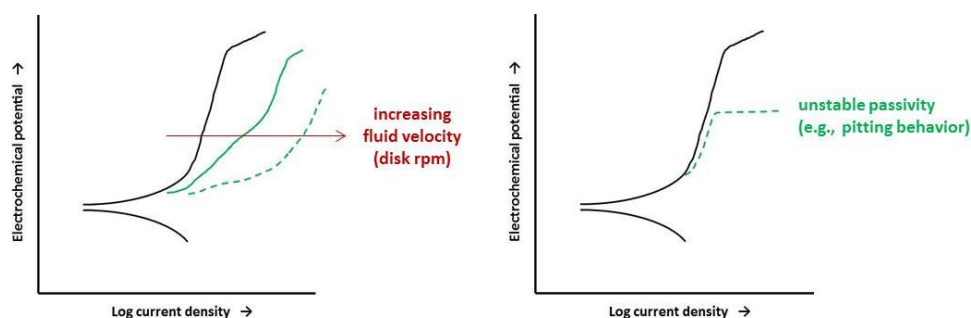
Figure 21. Schematic changes in polarization behavior that might result from increasing fluid velocity (left) or localized corrosion (right).

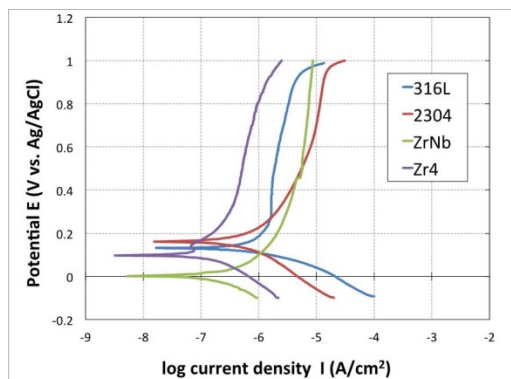
**Figure 22. Comparison of polarization results at room temperature and zero rotational velocity for alloys in 140 g/L dU with 0.1 M sulfuric acid added.**

precisely determined from the polarization curves (equilibrium no longer applies when the potential has been artificially altered), the approximate corrosion rates nevertheless are consistent with values well below  $25 \mu\text{m/y}$ , and that is true for potentials all the way to about 1 V positive to the saturated Ag/AgCl electrode (at which water begins to break down electrochemically), indicating remarkable stability of the passive film on each alloy. Intentional addition of 10 wppm iodine (half as I from KI and half as  $\text{IO}_3^-$  from  $\text{KIO}_3$ ), and perhaps smaller unintentional additions of chloride from the reference electrode (all of which leak a little bit), generated no change in the results indicated by Figure 22.

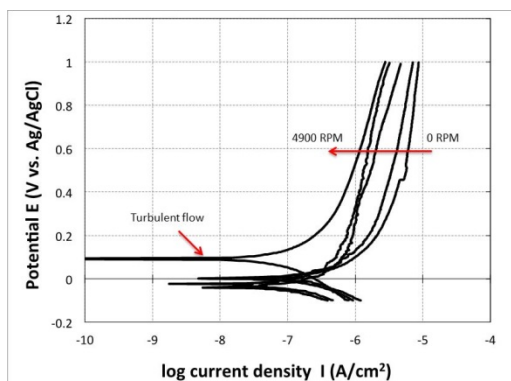
**Figure 23. Polarization curves for Zr-2.5Nb at room temperature as a function of rotational speed of the working electrode.** Individual rpm values incorporated in the plot were 0, 1600, 2500, 3600, and 4900.

Figure 23 contains representative results of all the polarization tests as a function of the rotational speed of the electrode. These specific data, for Zr-2.5Nb in the baseline solution of 140 g dU/L with 0.1 M excess sulfuric acid at room temperature, reveal only decreasing passive current densities as fluid velocity is increased, including the most rapid rate at which turbulent flow was apparent from the unstable formation of cavities/bubbles within the liquid. In contrast to the schematic possibility suggested by Figure 21, no adverse influence of solution velocity was observed for any alloy/environment combination. Further, no pitting (as indicated by the polarization curve or by observation of the post-exposure specimen surface) was detected for any alloy/environment/fluid velocity examined in this effort, including the limited exposures at  $50^\circ\text{C}$ .

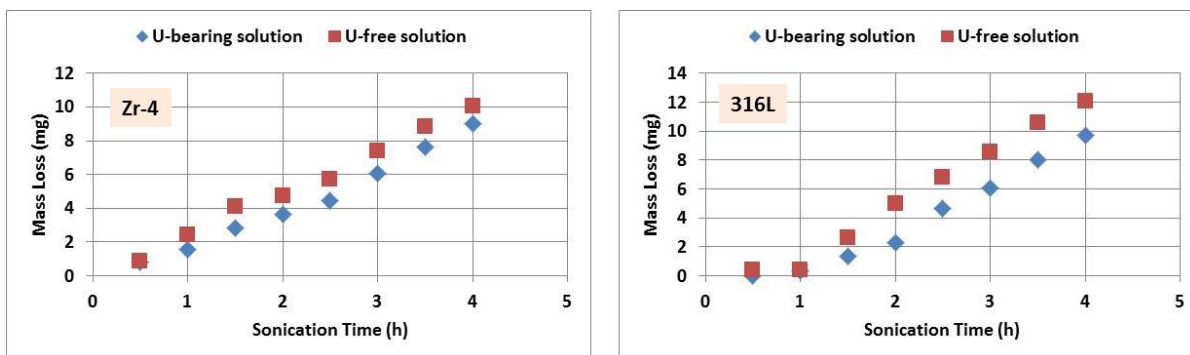
**Figure 24. Weight loss as a function of sonication time for the Zr-4 and 316L specimens.** Note that the total exposure time is actually twice the sonication time, because each exposure results from 10 s of sonication and 10 s of idle time in repeating cycles adding to a total of 1 h. In the previous report [1], the cavitation weight loss plots did not distinguish between sonication time and total exposure time.

The results can be summarized by the graphs in Figure 24, which show the response of Zr-4 and 316L to the cavitation exposure conditions. Of greatest significance is that in both these cases, the “steady state” weight change as a function of sonication time (slope of the virtual curve; following irregular incubation periods, a consistent weight loss rate seems to begin near 2 h of sonication for each alloy) is essentially identical for each material in the uranium-free solution and in the uranium-bearing solution. This indicates that the uranium component of the solution does not add a significant (potentially unanticipated) component to potential cavitation or related velocity effects in solution. As is evident in Figure 24, the total mass loss was actually slightly higher in the uranium-free solution; in fact, this was true for all five alloys examined, although the magnitude of the difference was substantially greater for 2304 and 17-4 PH alloys (as was the steady state weight change as a function of time). It is likely that the slightly higher density of the uranium-free solution is responsible for the generally slightly higher weight loss under cavitation conditions.

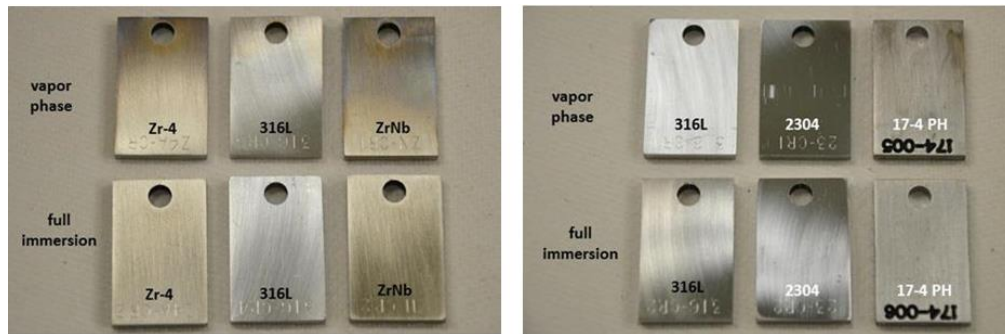
**Figure 25. Post-exposure appearance of the specimens exposed to potential radiolysis conditions.**
