# High Efficiency Water Heating Technology Development – Final Report: Part I, Lab/Field Performance Evaluation and Accelerated Life Testing of a Hybrid Electric Heat Pump Water Heater (HPWH)

**High Efficiency Water Heating Technology Development –  
Final Report: Part I, Lab/Field Performance Evaluation and  
Accelerated Life Testing of a Hybrid Electric Heat Pump  
Water Heater (HPWH)**

Date Published: April 1, 2016

Prepared by  
OAK RIDGE NATIONAL LABORATORY  
Oak Ridge, Tennessee 37831-6283  
managed by  
UT-BATTELLE, LLC  
for the  
US DEPARTMENT OF ENERGY  
under contract DE-AC05-00OR22725

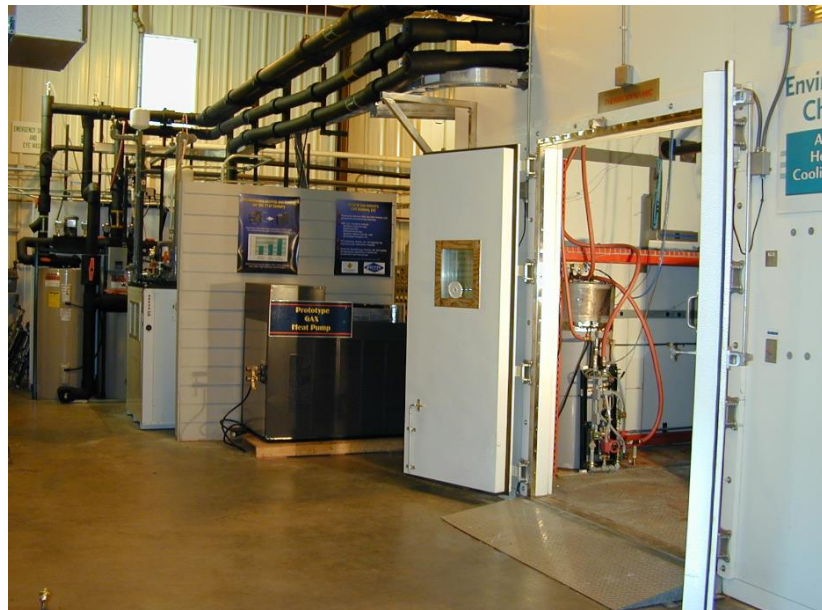
Figure 2. ORNL water heater reliability/durability test stand.

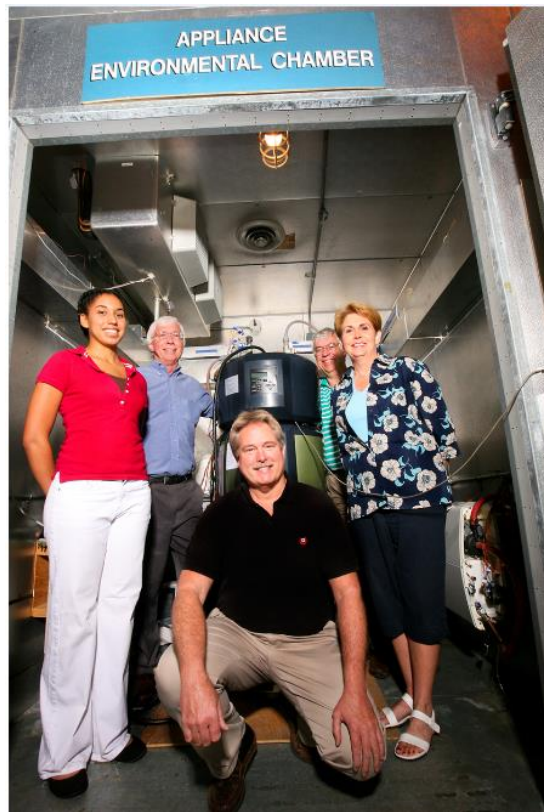
Figure 4. HPWH in small appliance test chamber.

*Energy Factor (EF) and 1<sup>st</sup> hour capacity testing – prior to reliability test start.* Four of the original DG units – 18, 20, 23, and 27 – were subjected to 24-hr standard use and 1<sup>st</sup> hour tests during June and July of 2008 prior to starting the reliability test runs. These tests were conducted using the ambient air [67.5 °F,  $\pm 1^\circ\text{F}$ , dry bulb temperature and 50% RH,  $\pm 1\%\text{RH}$ ], tank entering water [58 °F,  $\pm 2^\circ\text{F}$ ], and tank set point [135 °F] conditions prescribed by the DOE test procedure for electric heat pump water heaters (HPWH) as given in the US Code of Federal Regulations (2010). Testing was conducted in the small, one-room appliance test cell in the ORNL Buildings Technology Research and Integration Center (BTRIC) laboratory, Figure 4. Table 12 provides a list of the instrumentation on the EF test units and on the reliability test units as monitored by the ORNL laboratory data acquisition system (DAS) – note that not all of the reliability test units had all of the instrumentation points given in Table 12. Figure 5 is a screen shot from the DAS control computer used to collect and reduce the lab performance tests covered in this section. In addition to the data monitored by the ORNL DAS several measurements taken by the test HPWH units' onboard control system were also monitored – these are listed in Table 13.
