ORNL/TM-2007/058

**COMPARISON OF CAVITATION-EROSION
RESISTANCE OF CARBURIZED AND
CARBURIZED-PLUS-NITRIDED 316LN
STAINLESS STEEL IN MERCURY**

Prepared for the
U.S. Department of Energy
Spallation Neutron Source

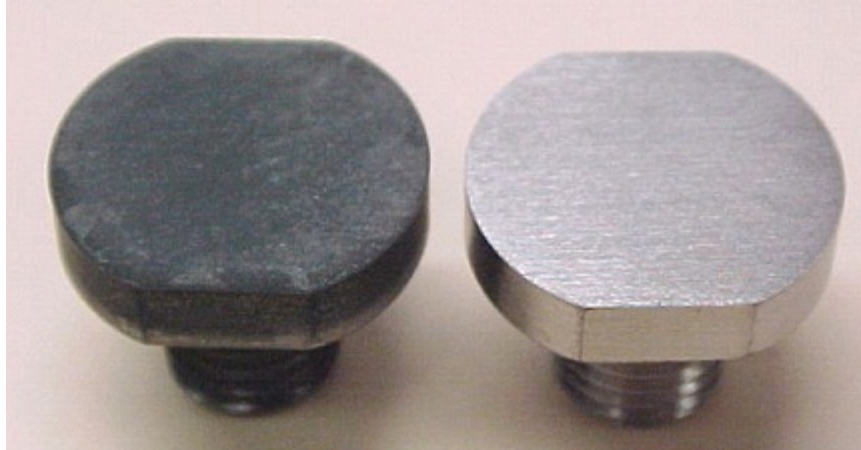
Fig. 1. Appearance of 316LN cavitation buttons prior to sonication. The darkly colored specimen on the left has received both the Kolsterising® treatment and plasma nitriding, while the otherwise identical specimen on the right has received only the Kolsterising® treatment.

plasma nitrided. Figure 1 is a photograph of the as-received test buttons following each of the test treatments.

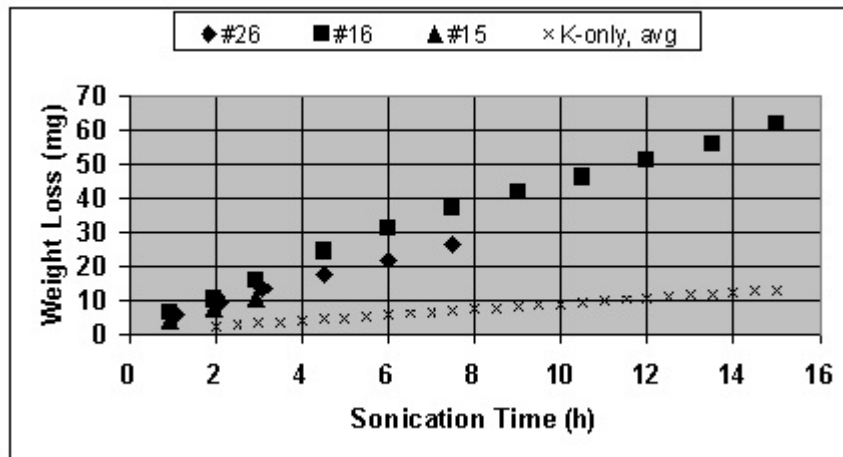
Fig. 2. Weight loss as a function of sonication time in mercury for 316LN specimens receiving the K+N treatment (solid data points representing three different specimens). The data represented by the series of “x” data points represents the average weight loss as a function of time for three identical specimens receiving only the K-layer treatment, for which there is remarkably little scatter/spread in the data.

The weight loss as a function of time for specimens which received the K+N treatment is compared to that for specimens which received only the K-layer treatment in Fig. 2. It is apparent that the weight loss rate at extended exposure times is significantly greater for specimens with the K+N layer (3.2 mg/h) than for the K-layer only specimens (0.8 mg/h), indicating that the cavitation-erosion resistance of Kolsterised® 316LN is negatively impacted by the nitriding process.

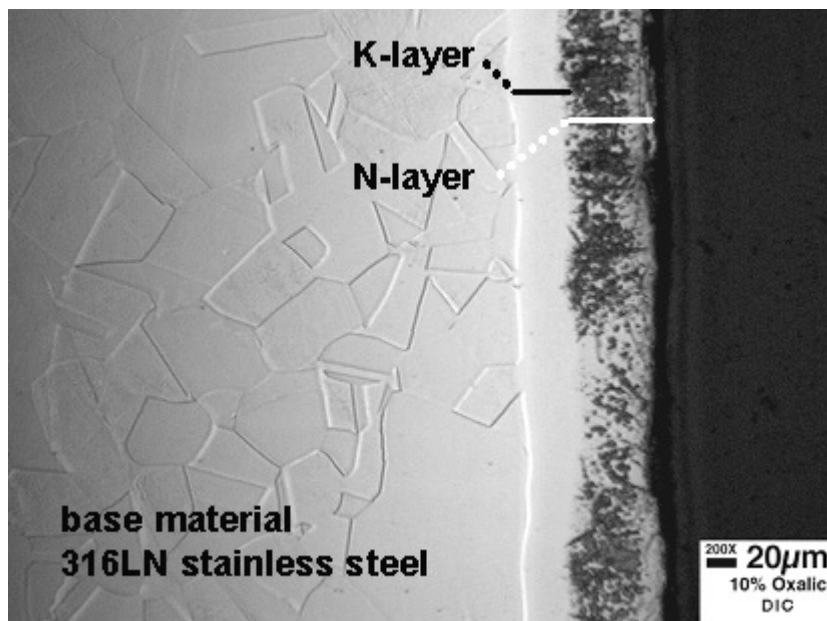
Fig. 3 . Representative cross-section of the side of a test button indicating the thickness and appearance of the as-treated K+N layers. The specimen surface is at right (the mounting epoxy is black).

Figure 3 shows an etched cross-section of the side of a test button which received the K+N treatment. Because this region has not been exposed to sonication conditions (it is the side of the specimen rather than the test face) and because the surface layers at this location have the same thickness and appearance on all K+N specimens independent of exposure time, it is assumed that the surface layers here are representative of the

as-treated condition. Light etching of the cross-section revealed the equiaxed austenite grains of the 316LN base metal appearing in the left half of the photograph. The band of material resulting from Kolsterisation® is labeled “K-layer” in Fig. 3; it appears as a featureless band of relatively uniform thickness (average is 30-35 μm) contiguous with the base material. The K-layer is austenite identical to the base material except that it is dramatically super-saturated in carbon, which has been shown to significantly harden the treated surface.¹ The Kolsterisation® process occurs under low temperature conditions which largely prohibits the formation of chromium carbides, and thus none are revealed by the etching process. Further, the general corrosion resistance of the carbide-free austenite is sufficiently improved by carbon impregnation that the affected material is resistant to the mild etchant used to reveal general structure; as a result, even the grain boundary features like those in the base material remain hidden. Likewise, the band of material resulting from the nitriding process is labeled “N-layer” in Fig. 3; it appears as a generally dark region superimposed on top of the K-layer, and it also exhibits a relatively uniform thickness of 55-60 μm . The nitrided layer contains a significant density of chromium nitride precipitates, which are readily etched by the procedure used to develop the structure in Fig. 3.

The nitrided specimens tend to exhibit cracking within the N-layer which, depending on the orientation of the cracks, can generate spalling of this material from the surface. As a general rule, other than limited flake-type shapes at the outermost surface of the N-layer, relatively little cracking was observed on the sides of the K+N layer specimens. In Fig. 3, note the flake-like shape of material lifting from the surface at the end of the marker identifying the N-layer band.

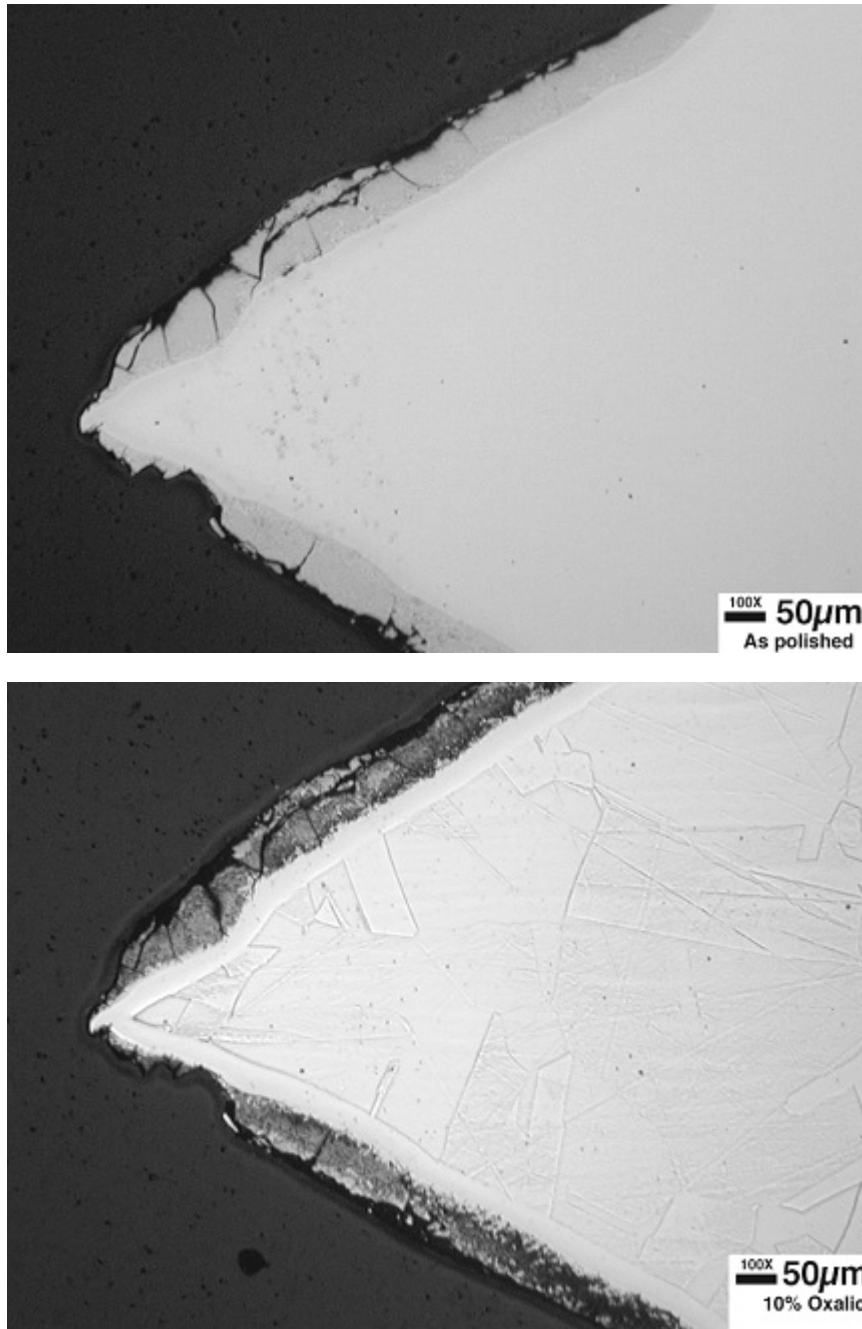
Fig. 4. Cross-section of a threaded portion of a test button showing the same area as-polished (top) and etched (bottom). This particular thread is from the K+N specimen tested for 3 h prior to sectioning for metallography. In both photographs, the mounting epoxy is black.

Cracks within the N-layer are more readily apparent in the views of Fig. 4, which shows a portion of a threaded segment of a test button in cross section. In the top photograph, the as-polished specimen reveals extensive cracking in the surface layer. The bottom photograph is of exactly the same area but includes etching to reveal the relative position of the K- and N-layers. Figure 4, which is representative of threaded areas from all specimens with the K+N layers, makes it clear that the observed cracking is confined to the N-layer only and does not penetrate into the K-layer. Note that in some locations – near the tip of the thread in this particular case – the cracking is sufficient that most/all of the N-layer had been dislodged from the specimen surface over limited areas. Figure 5 is another example showing that cracking of the N-layer is confined totally within the N-layer; in this particular case, note the large number of short cracks in the residual amount of N-layer on a portion of the thread that all terminate precisely at the K-layer boundary.

It was a common observation that N-layer cracking of the magnitude described above (Figs. 4 and 5) was observed only on the threaded portions of the test specimens, and this may suggest that the mechanical loading on the threads when the specimen is fitted into the vibratory horn are in large measure responsible for this damage. The only other location on which significant spallation of the N-layer was observed was the immediate corners of the test button where the test face meets the sides of the specimen. This observation indicates that high residual stresses within the N-layer may be exacerbated by sharp surface contours on the specimens (near threads and other “corner” shapes). That unusual residual stress patterns reside within the N-layer is evidenced by the photographs in Fig. 6, which again show the threaded portion of a test specimen in cross-section. In this case, note the curved fractures with modest branching which is particularly apparent in the higher magnification photograph. Once again, note that the N-layer cracks may approach, but they do not penetrate, the K-layer boundary.

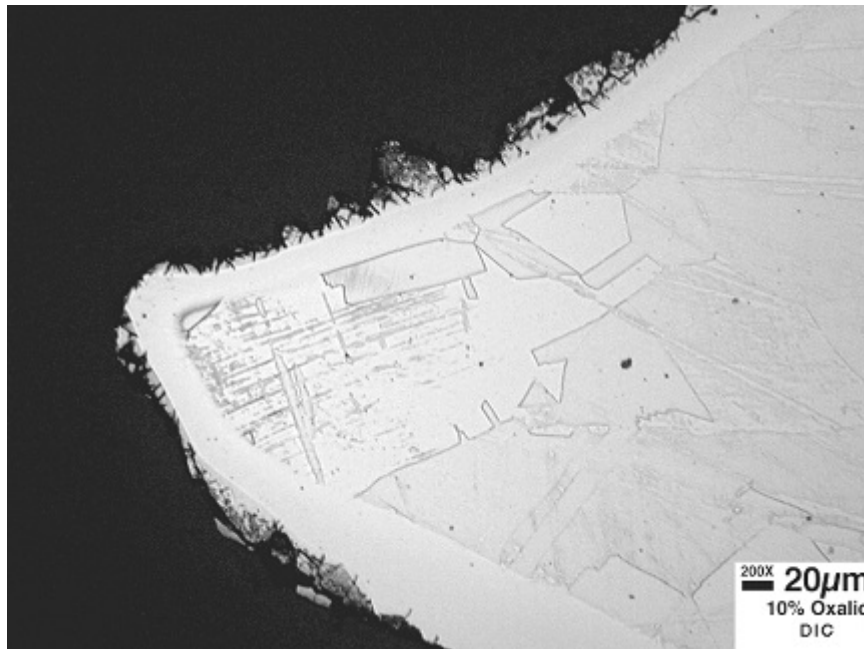
Fig. 5. Cross-section of a specimen thread tip from which most of the N-layer material has spalled. Note particularly along the uppermost portion of the specimen that all the cracks in the residual N-layer terminate precisely at the K-layer boundary. This particular thread is from the K+N specimen sonicated for three hours.

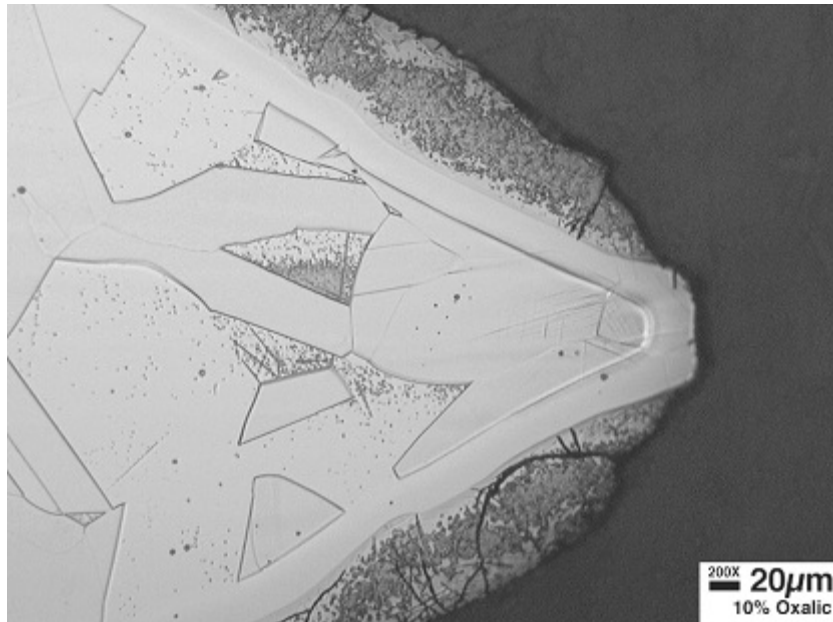
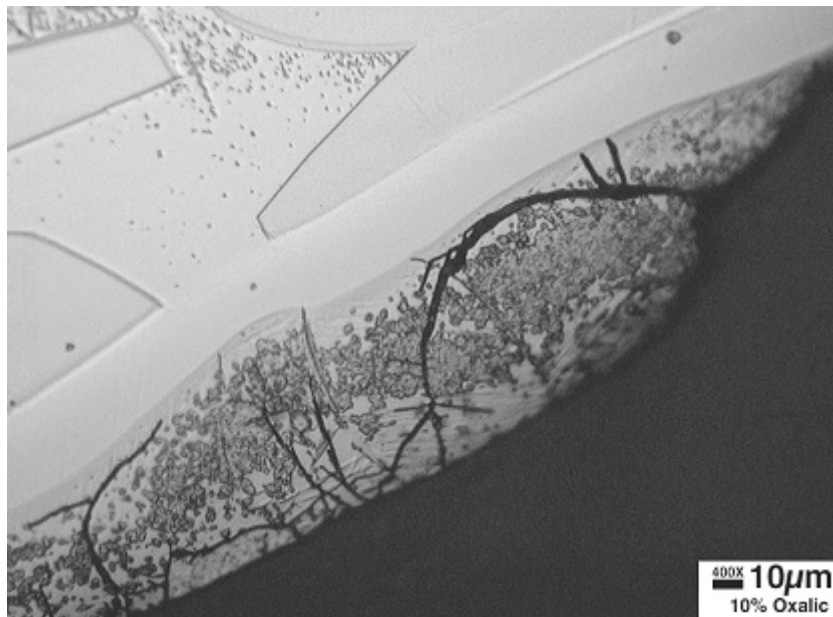
Fig. 6. Cross-section of a specimen thread showing spallation of the N-layer at the tip and curved cracks in the nearby remaining N-layer. This particular thread is from the K+N specimen sonicated for 3 h.

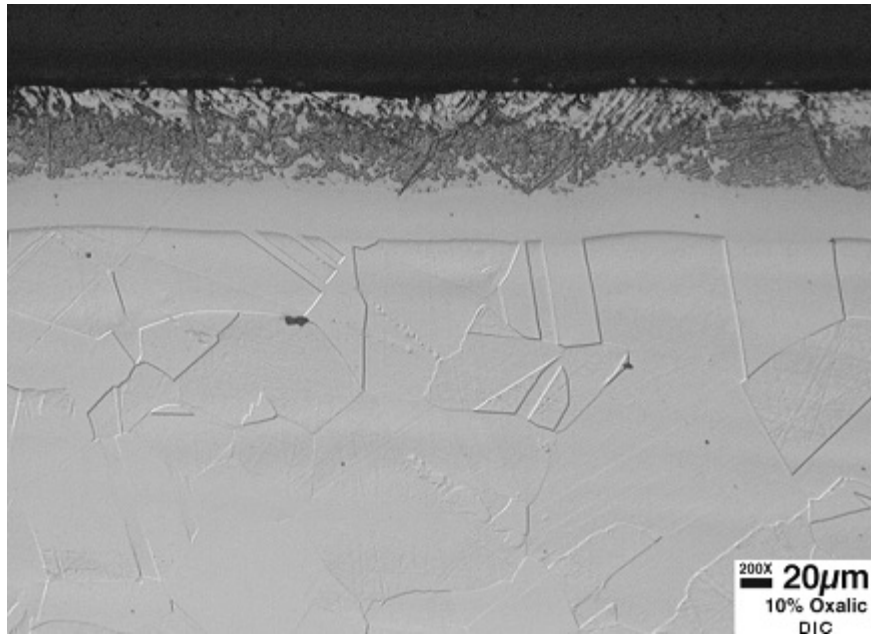
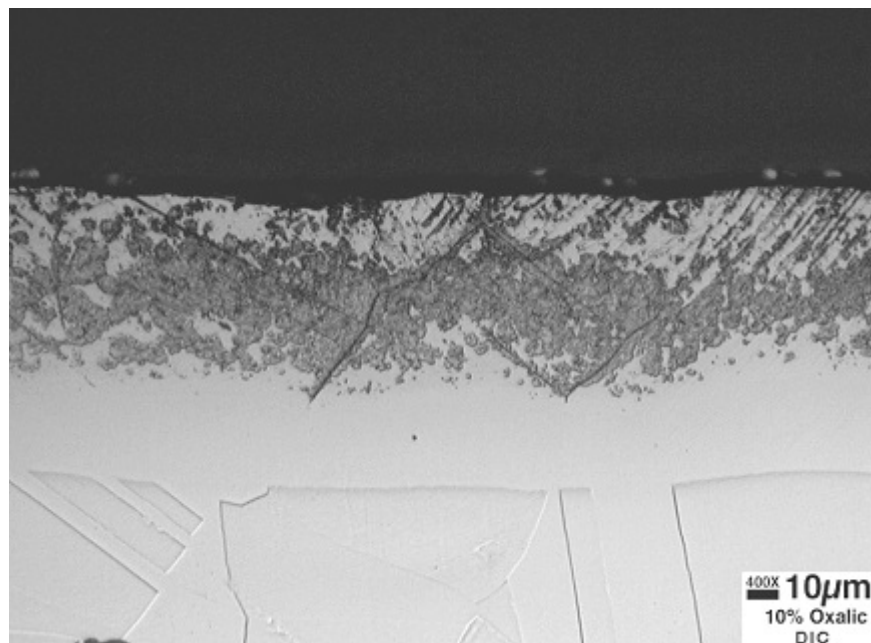
Fig. 7. Cross-section of the test face of a K+N specimen sonicated for 3 h in mercury. The average remaining N-layer thickness for this specimen is about 53 μm . Both photographs are of the same general region, with the lower photograph at higher magnification. The test surface in each case is toward the top of the photograph, and the mounting epoxy appears black.

Figures 7-9 show representative cross-sections of the test surface of the K+N specimens sonicated for 3-, 7.5-, and 15-h, respectively, in mercury at ambient temperature. This series of photographs reveals that the N-layer becomes progressively thinner on the test surface with extended exposure time. However, the N-layer thickness remains constant on the unexposed sides. In all cases, the N-layer exhibits some cracking and/or minor spalling at the various exposure times, but much of this was present in the as-treated condition and remains present on surfaces of the specimen not exposed to sonication conditions (e.g., see Fig. 3). While the N-layer cracking may facilitate some removal of the N-layer on the surface during sonication, it seems unlikely the N-layer cracking is caused by the cavitation-erosion process directly.

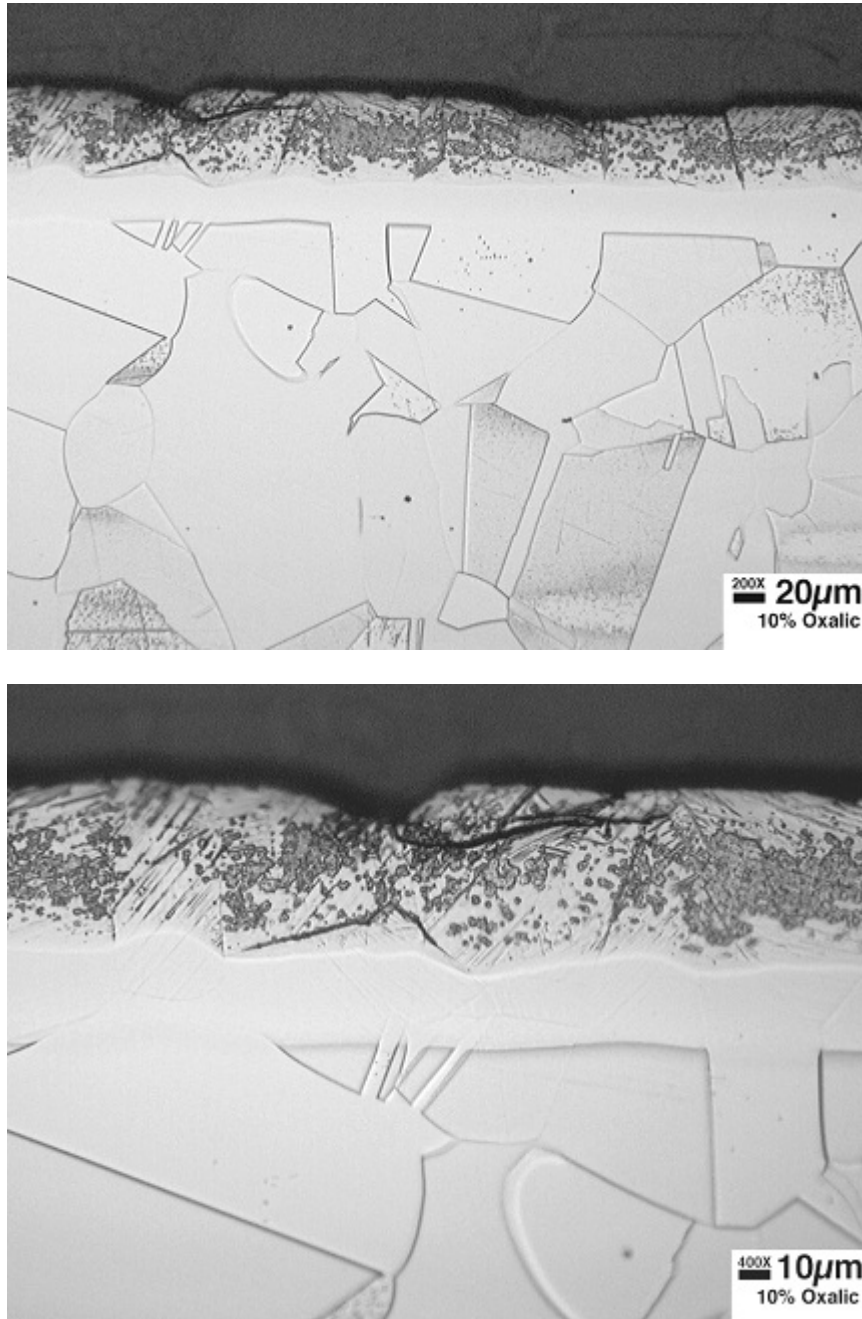
Fig. 8. Cross-section of the test face of a K+N specimen sonicated for 7.5 h in mercury. The average remaining N-layer thickness for this specimen is about 45 µm. Both photographs are of the same general region, with the lower photograph at higher magnification. The test surface is each case is toward the top of the photograph, and the mounting epoxy appears black.

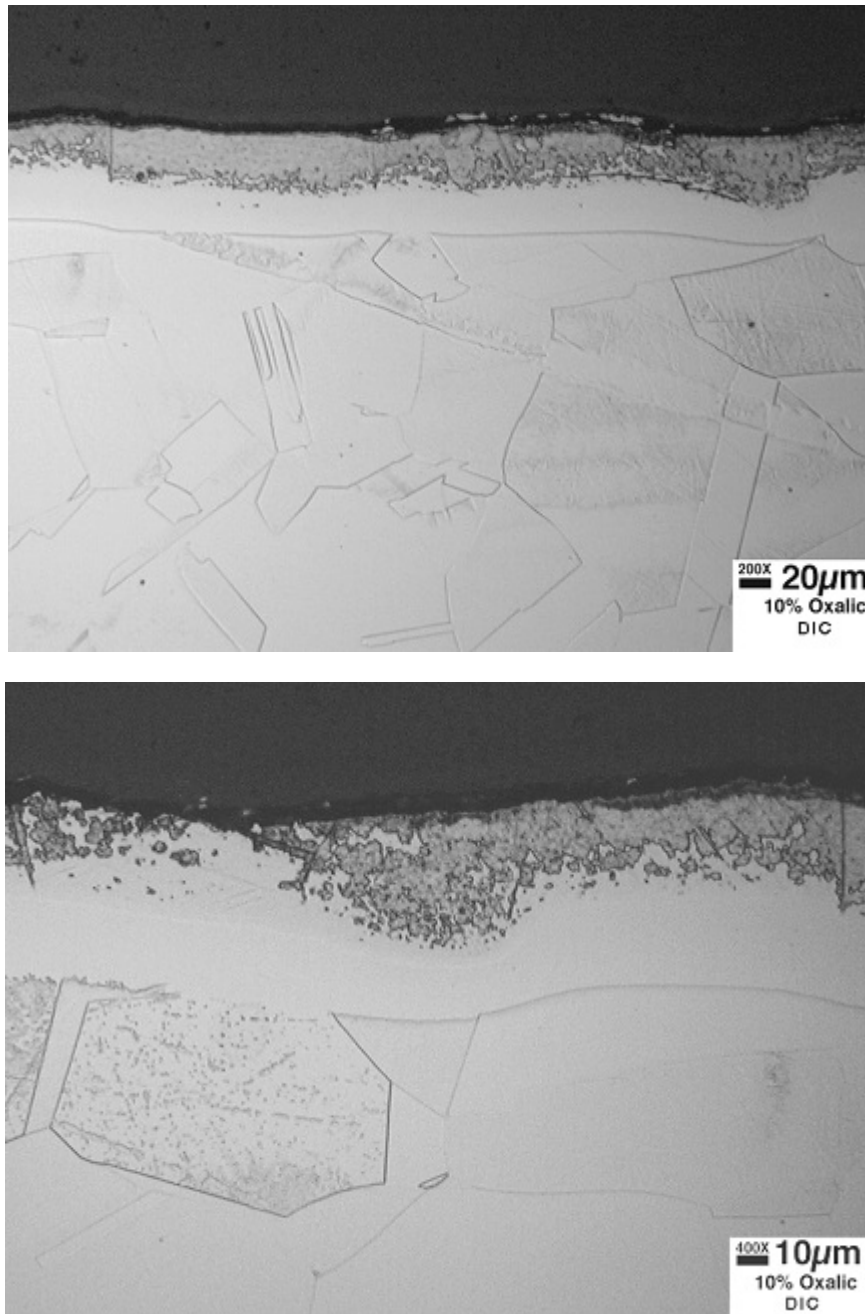
Fig. 9. Cross-section of the test face of a K+N specimen sonicated for 15 h in mercury. The average remaining N-layer thickness for this specimen is about 30 μm . Both photographs are of the same general region (linear feature in N-layer is at left in top photo and at right in lower photo), with the lower photograph at higher magnification. The test surface in each case is toward the top of the photograph, and the mounting epoxy appears black.

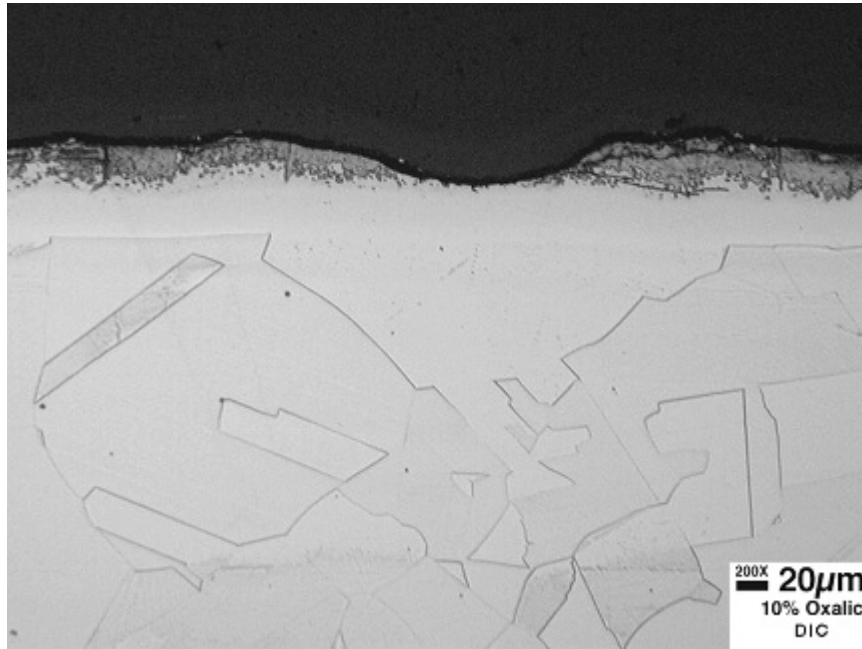
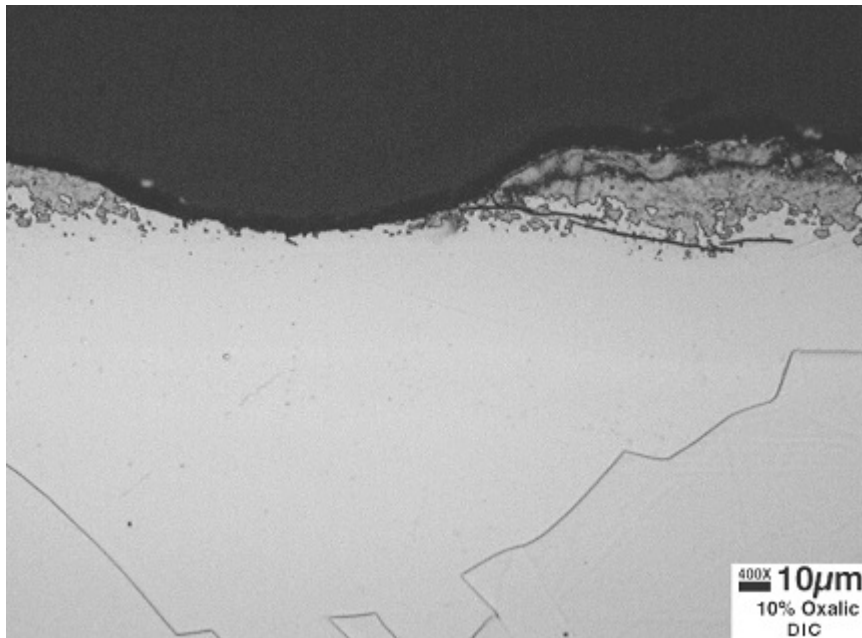
Fig. 10. Cross-section of the test face of a K+N specimen sonicated for 15 h in mercury. These photographs show representative regions in which the N-layer has been removed/compromised via the sonication process.

Figure 10 shows another location on the cross-section of the K+N specimen sonicated for 15 h. In contrast to the comparable views in Fig. 9, which show a continuous but variable-thickness N-layer, Fig. 10 is an example of pit/crater initiation that has compromised essentially the entire N-layer thickness, but not yet penetrated the

K-layer. Pitting/cratering of this type – generally hemispherical shapes – is the primary mode of material removal from 316LN (and similar alloys) that are not treated to harden the surface,²⁻⁴ and this type of pitting may signal the onset of failure of the N-layer material.

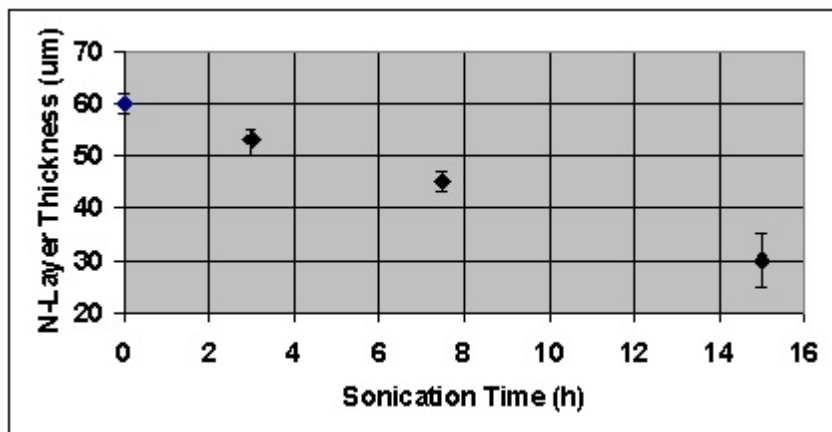
Fig. 11. Remaining N-layer thickness on the test surface as a function of sonication time in mercury at ambient temperature.

Figure 11 plots the average N-layer thickness (pits not considered) as a function of sonication time. While there is some scatter in the individual data points, it is clear that the general trend can be approximated by a thinning rate of about 2 $\mu\text{m}/\text{h}$. Considering a density of $8.0 \text{ g}/\text{cm}^3$ for the 316LN and the layers thereon and 180 mm^2 for a total surface area exposed to sonication, a thinning rate of $2 \text{ }\mu\text{m}/\text{h}$ corresponds to a general weight loss rate of about $2.9 \text{ mg}/\text{h}$ for the K+N specimens. This compares very favorably with the simple weight loss rate calculated from the data in Fig. 2 ($3.2 \text{ mg}/\text{h}$). [Note: the actual density of the N-layer material is likely to be slightly higher than that for 316LN due to the added nitrogen (and perhaps carbon, too). Given that the mass loss observed here was entirely within the N-layer, the above estimate to compare weight loss rate with the metallographic thinning result would be somewhat better if the proper density of the N-layer material were used in the calculation. However, neither this precise number nor its change as a function of position in the layer, is known to the author.] Given that mass losses associated with the pitting (thinning to zero on limited areas) of the N-layer at extended exposure time have not been incorporated into this mass loss rate, this comparison suggests the metallography and weight loss measurements agree within some modest scatter. This further indicates that the spallation of the N-layer observed primarily on the threaded regions did not contribute significantly to the observed mass loss, suggesting most of the damage occurs during specimen treatment and subsequent chasing of the threads in preparation for testing.

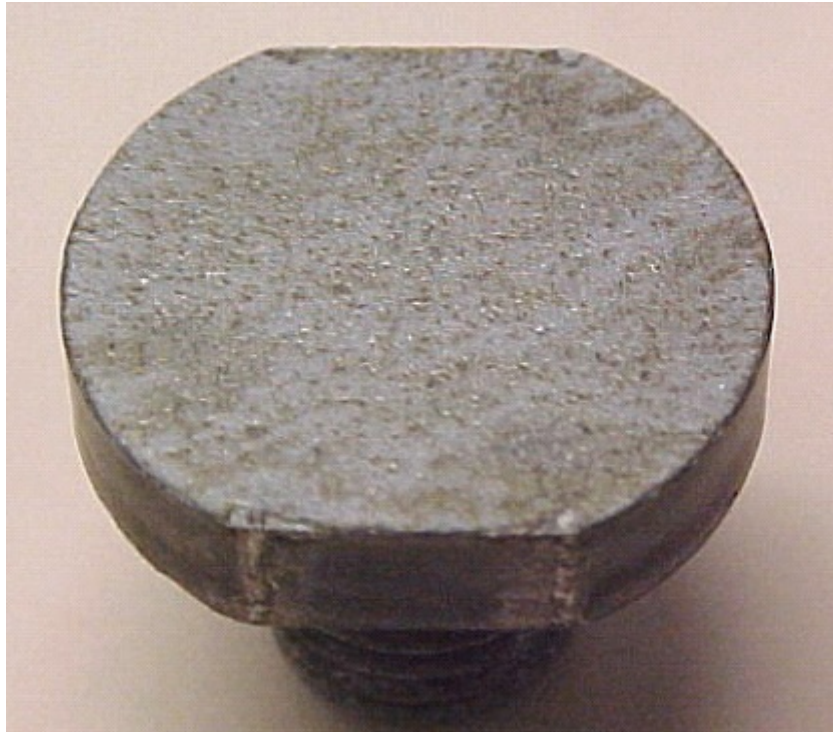
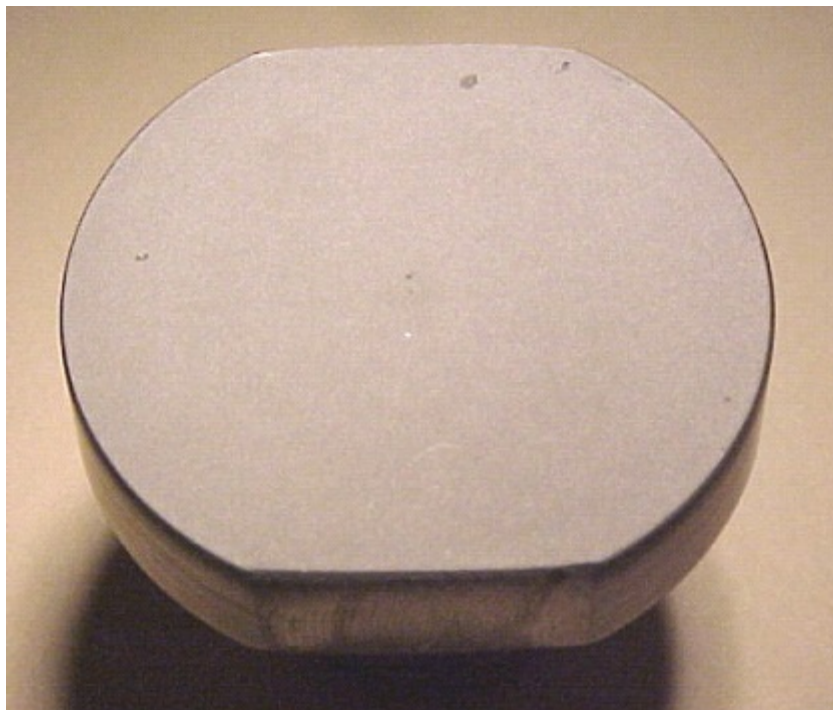
Fig. 12. Comparison of post-test surfaces of as-sonicated specimens. Top: K+N specimen (#16) after 4.5 h. Bottom: K-layer specimen after 12 h. Actual diameter of both specimens = 16 mm.

The difference in average surface profile as a function of sonication time is readily apparent on the post-test cavitation buttons, even to the unaided eye. Figure 12 is representative of this result, and it depicts the test surface of a K+N layer specimen (#16) after 4.5 h sonication compared to a K-layer specimen after 12 h sonication. Note that the former specimen has an rough/angular, almost grit-blasted looking appearance, with indications of spallation of the N-layer (e.g., front left corner of the specimen) while the latter specimen is very smooth and uniform with only a couple minor pits.

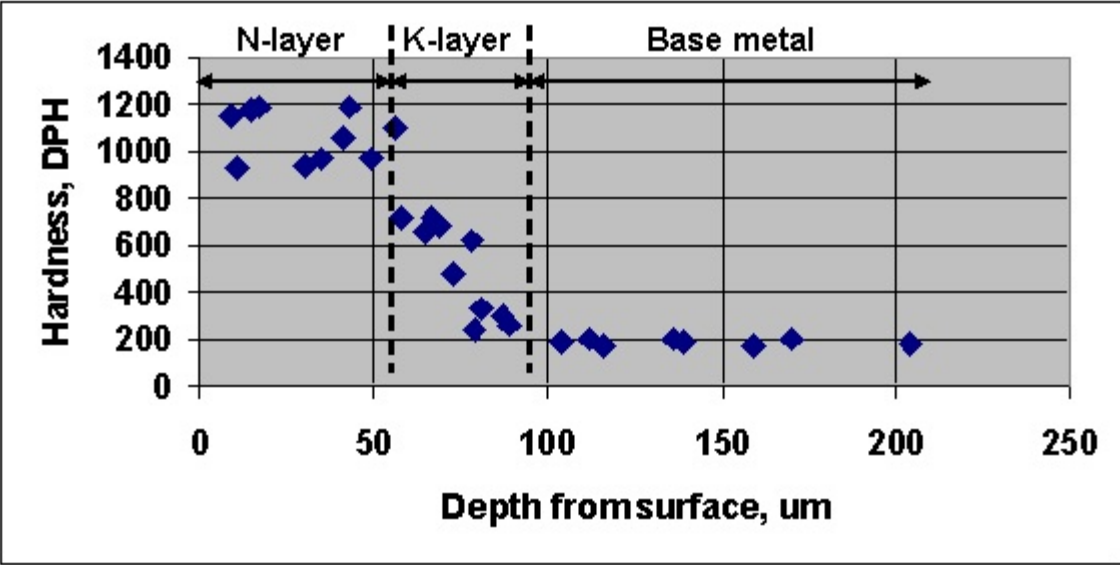
Fig. 13. Microhardness data on K+N layer specimens taken on cross sections of sonicated specimens. The data here represent several different scans (25-g load) taken from the unexposed edges of the test buttons. DPH is diamond pyramid hardness.

Hardness profiles were performed on the polished cross-sections of test buttons following sonication exposures. Figure 13 is a collection of microhardness data taken from the unexposed sides of several K+N layer specimens, and it reveals that the hardness of the N-layer is consistently quite hard (minimum value recorded was 935 DPH, or approximately R_c 68) but somewhat variable (1194 DPH was the maximum value recorded). Consistent with Fig. 3, note that the thickness of the N-layer is readily discriminated by relative hardness and is about 55 μm . The underlying K-layer exhibits

a steep hardness gradient, with maximum hardness approaching that of the N-layer but decreasing rapidly with increasing depth into the specimen. The hardness of the base metal (~180 DPH, or R_b 85) is uniform and generally consistent with typical values for annealed stainless steels.

Microhardness scans taken from exposed test surfaces of K+N layer specimens reveal exactly the same type of curve as shown in Fig. 13, except that the apparent thickness of the N-layer is reduced (consistent with the extent of thinning suggested by Fig. 11). Microhardness scans on K-layer only specimens were also performed in this work, but have been more fully documented elsewhere.¹ The microhardness data measured in cross-section profile tended to yield near-surface hardness (at the outermost reach of the K-layer) about 800 DPH with a rapid decrease across the depth of the carburized layer for both K-layer only specimens as well as K+N layer specimens. This result suggests that the plasma nitriding process had little or no effect on the carburized layer. On-face tests¹ on K-layer only specimens with small loads yielded a surface hardness average of about 1040 DPH, suggesting that at the outermost surface, the hardness of the N-layer and the K-layer is about the same. It is clear, however, that the hardness profiles for the two different layers vary considerably from each other. On tests of sufficient duration to ablate a portion of the K-layer,⁸ surface hardness was found to decrease consistent with the thickness change of the K-layer.
