Complete Non-Radioactive Operability Tests for Cladding Hull Chlorination

Fuel Cycle Research & Development

***Day-Month-2016
FCRD-MRWFD-
ORNL/LTR-2016/172***

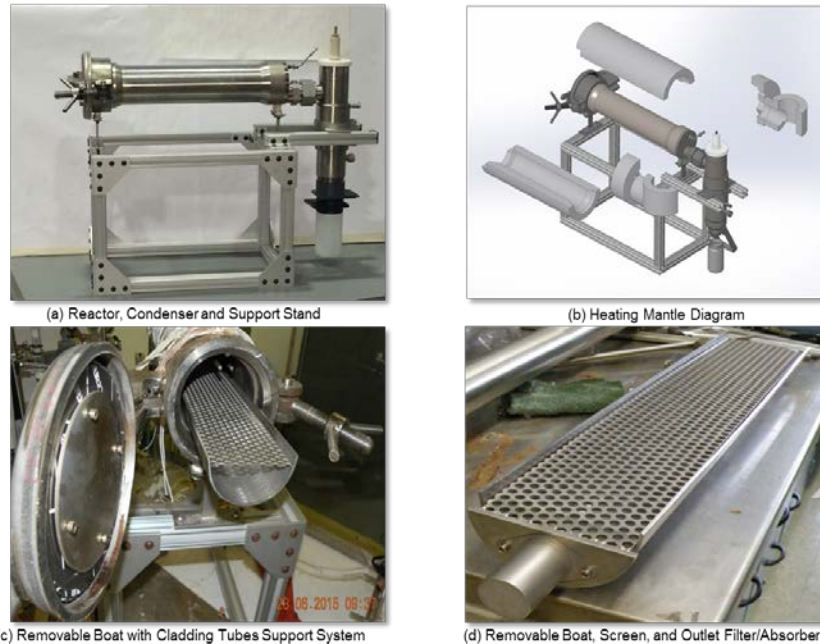
Fig. 1. New metal test equipment for hot cell tests with 100-500g UNF cladding per test.

Metal equipment is being prepared for use in future hot cell tests to develop the chlorination process for recovery, purification, and possible recycle of zirconium from used nuclear fuel (UNF) cladding. The primary components of the equipment are (1) a horizontally-oriented chlorination and sublimation reactor, designed to chlorinate 100- to 500 g batches of UNF cladding, (2), a vertically-oriented condenser to de-sublimate, or condense, the zirconium tetrachloride ($ZrCl_4$) salt product, (3) a replaceable bottle for collecting the salt product, and (4) an off-gas line and trapping system for collection of tritium gas released from the cladding during the chlorination and a neutralization trap for excess chlorine (Cl_2). The reactor is constructed from stainless steel with a nickel-plated internal surface to provide maximum resistance to corrosion, and is equipped with a perforated stainless steel gas inlet and distribution tube and a stainless steel thermocouple well to enable measurement of temperatures inside the reactor. The condenser vessel is also constructed from stainless steel, is equipped with a removable Teflon top plug and rotatable wall scraper (no longer used), plus a conical bottom and O-ring-sealed connection for the replaceable salt product collection bottles, and an off-gas tube. The reactor and condenser vessels are connected with a ~4-in.-long, 2-in, diameter stainless steel “neck” tube containing a large Swagelok[®] connector for separating the two vessels when/if necessary. Top and bottom heating mantles are provided for heating the reactor and neck tube to the reaction temperature (350-400°C) and the condenser is jacketed for air cooling to <200°C (<50°C). The test unit and internal reactor removable boat, cladding support screen, and gaseous $ZrCl_4$ filter unit are shown in Fig. 1.

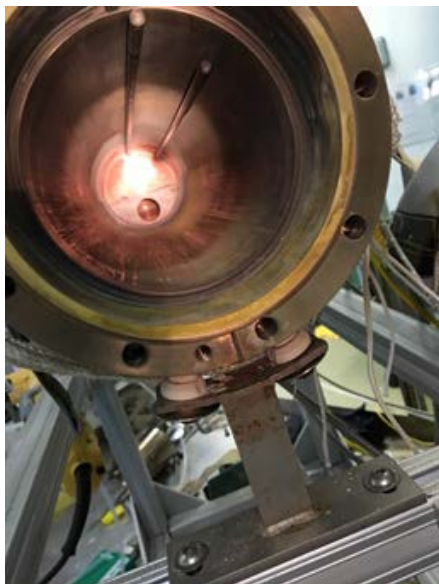
The color of the salt product from the first test was dark orange, indicating the presence of stainless steel corrosion products. Subsequent mass analysis (ICPMS) confirmed the presence of excess iron in the salt product. However, upon disassembly of the test apparatus, very little physical evidence of corrosion was observed, as shown in Figures 2 and 3.

Fig. 2. Bore of Reactor

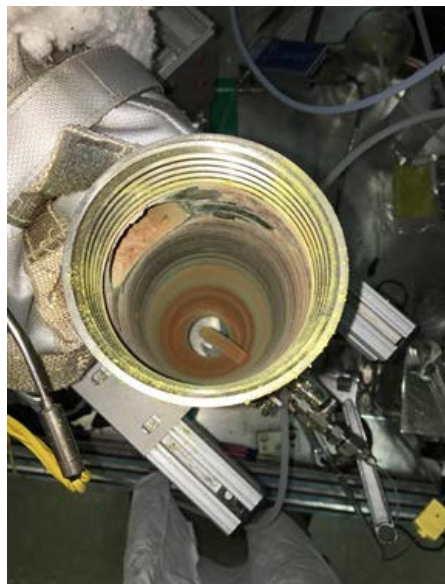
Fig. 3. Bore of Condenser

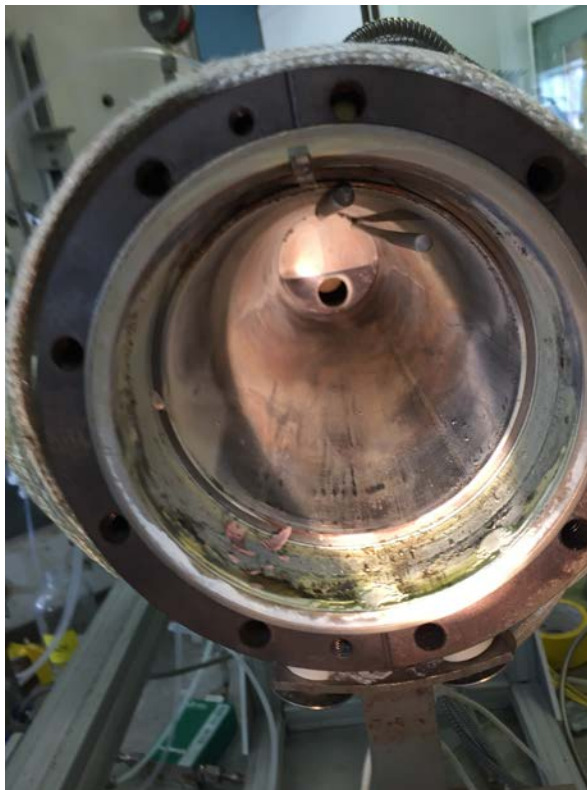
However, physical evidence of pitting corrosion of the stainless steel reactor end plate was observed (Fig. 4) after the last chlorination test was completed. The initial design contained a graphite end block which might have protected the end plate from high temperature and exposure to Cl_2 but had been removed for spacing purposes prior to testing. This problem must be resolved prior to hot cell installation of the equipment.

Fig. 4. Physical evidence of pitting corrosion of the stainless steel reactor end plate.

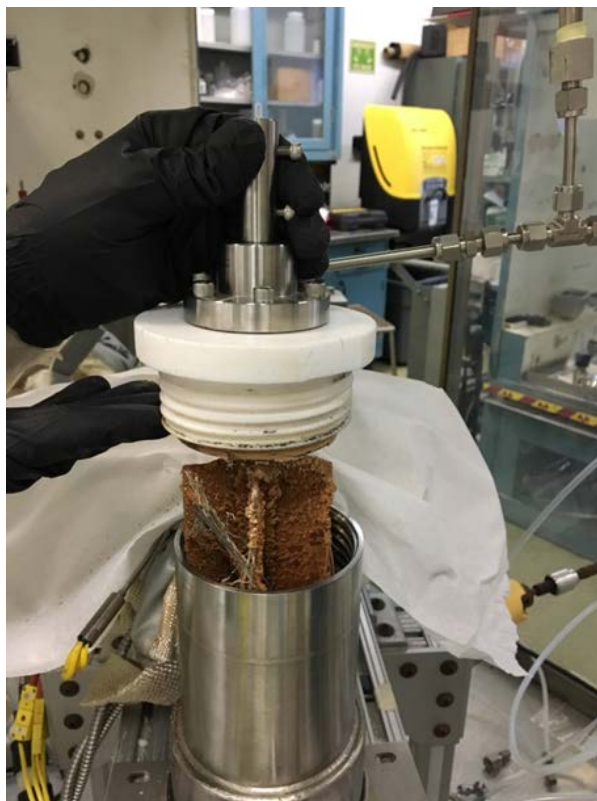
A vibrator attached to the outside of the condenser, plus periodic manual tapping, were used to maintain flow of the condensed ZrCl_4 product salt into the collector bottle. Post-test inspection showed that the inside condenser walls were clean, but a significant salt deposit was accumulated at the condenser gas inlet. Such deposits will require periodic removal. During the first test, a substantial amount of ZrCl_4 salt product was deposited on the condenser wall scraper blades (Fig. 5), and during the second test, binding of the rotating wall scraper in the condenser occurred; subsequent disassembly and observation of the ferroseal shaft seal indicated corrosion of the iron component (Fig. 6).

Fig. 5. Condenser Scraper

Therefore, a decision was made to remove the wall scraper from the condenser and replace the function with an external accelerator applied to the condenser wall to provide continuous or periodic vibration and downward movement of the $ZrCl_4$ product salt into the collector bottle. This method was tested during the third chlorination test and satisfactory performance was achieved; therefore, this method will be used in future hot cell tests.

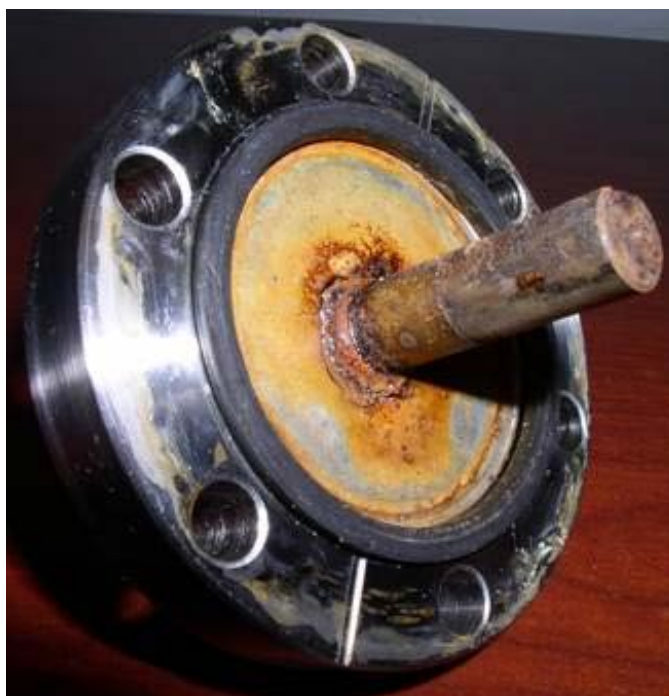
Fig. 6. Ferro fluidic rotary seal coupling.

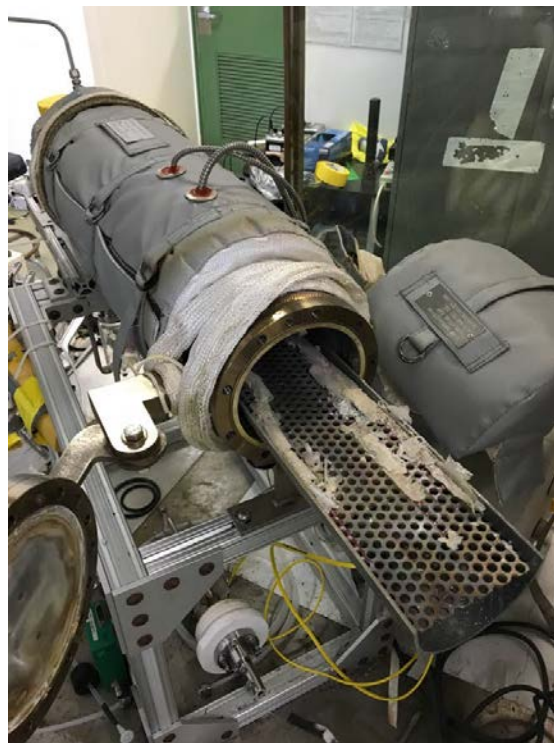
Experience with this operation during the tests indicated that the oxide ash remaining on the reactor boat perforated tray was light and fluffy and might be airborne during removal from the reactor (Fig. 7). Therefore, a clamp-on containment tube has been designed as shown in Fig. 8 and will be tested prior to hot cell installation of the equipment.

Fig. 7. Residual Ash.

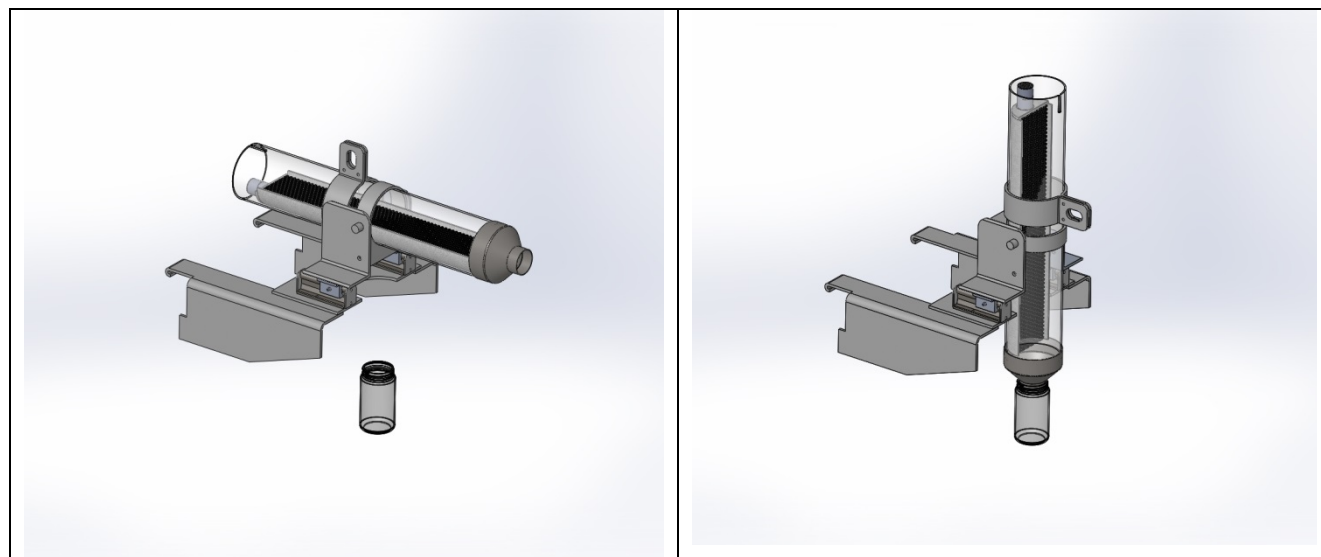
(a) Horizontal position.

(b) Vertical position.

Fig. 8. Dump bracket for the internal SS boat.

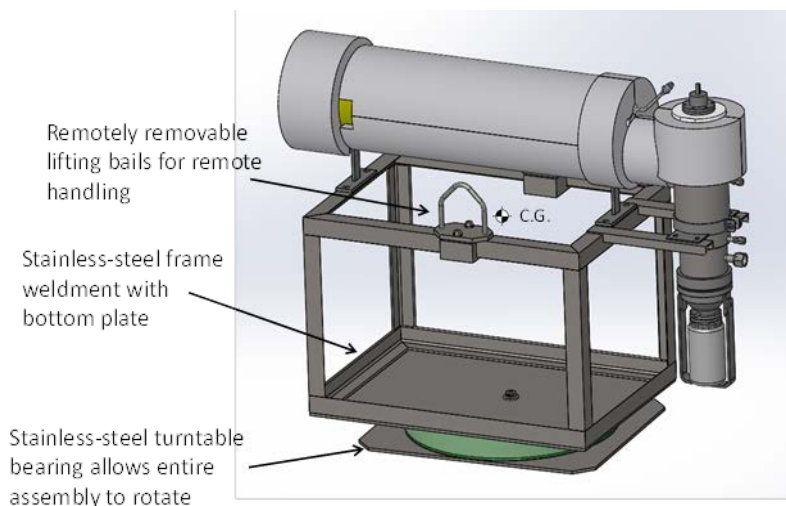
Hot cell management and operators observed the operation of the metal equipment during the second chlorination test, and offered several suggestions for improved operability. In addition, they confirmed that with the small operating table space inside the hot cell (approximately 6 ft. x 6 ft.), the turntable and pedestal base (Fig. 10) will be essential for the manipulator operations that will be necessary (loading cladding and removing ash from the reactor at one end of the support stand, and installing product salt collector bottles at the bottom of the condenser, plus handling off-gas traps for tritium capture at the opposite end of the support rack).

**Fig. 9. Turntable Zr reactor support stand for remote handling and rotation.**
