Assessment of End-of-Life Behavior of the Surface Modification to Improve Cavitation-Erosion Resistance in the Mercury Target at the Spallation Neutron Source

S. J. PAWEL

June 2007

Materials Science and Technology Division

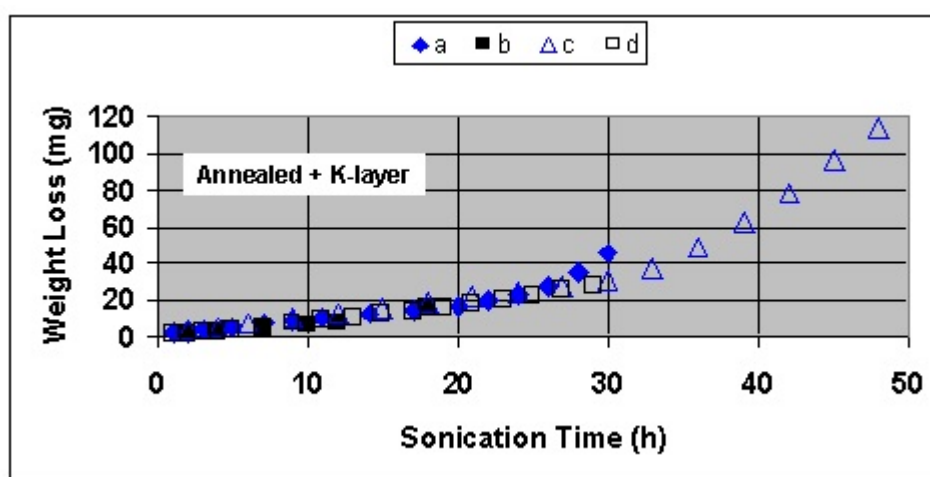
Fig. 1. Weight loss as a function of sonication time in Hg at 25-27°C for annealed 316LN specimens that received the Kolsterising® surface treatment. Specimens “a” and “b” exhibited an initial K-layer about 33 μm thick, while specimens “c” and “d” had an initial K-layer thickness of about 40 μm . Note that there is sufficiently little scatter in the data that many of the data points are individually indistinguishable.

Figure 1 shows the weight loss data as a function of total sonication time in mercury for the annealed specimens receiving the Kolsterisation® treatment. There are a total of four specimens represented in this graph. Among these, specimens “a” and “b” had an initial case depth (also termed K-layer in this report) of 32-33 μm , while specimens “c” and “d” exhibited an initial K-layer thickness of 40 μm .

Figure 1 suggests that the Kolsterisation® process results in a relatively consistent surface condition in that there is remarkably similar weight loss and resistance to pitting among a group of specimens treated in three different processes over a span of almost two years. The steady-state weight loss rate observed for each specimen – independent of initial K-layer thickness within the limited range examined – was essentially constant at 0.7-0.8 mg/h over a sonication period of up to 25 h or more. The weight loss rate observed previously for identical annealed specimens without the Kolsterisation® treatment was also constant over extended periods but in the range of 12-13 mg/h.^{2,3} In

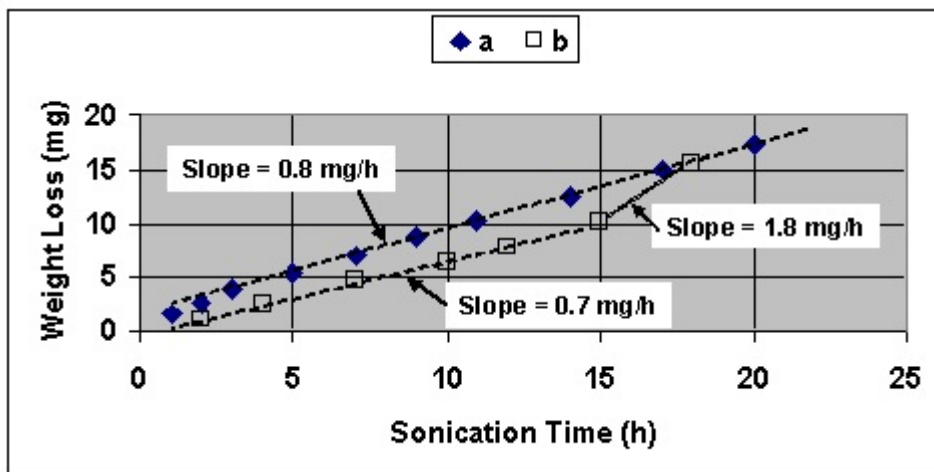
Fig. 2. Weight loss as a function of time for two of the annealed 316LN specimens. Note the change in slope in the data for specimen “b” between 15 and 18 h sonication time.

Figure 2 is a segment of the data in Fig. 1 that has been re-scaled for clarity. It shows the weight loss data as a function of sonication time for the first two K-layer specimens with an annealed substrate (“a” and “b”) evaluated in this investigation. Aside from a slightly accelerated weight loss very early in the exposure for specimens “a,” the weight loss as a function of time for these two specimens was nearly identical over a period of about 15 h. Following 15 h sonication, both specimens exhibited a nominal surface profile on the order of 5 μm and only very limited/isolated pitting – perhaps 8-12 roughly hemispherical pits in the range of 50-100 μm deep. In addition, immediately following sonication, the specimen test surfaces shed essentially all mercury within seconds of removal from the mercury bath, indicating very limited wetting had developed.

However, a change in the slope of the weight loss curve between 15 and 18 h exposure for annealed specimen “b” signaled the potential onset of a change in the protective quality of the Kolsterised® layer. As a result, specimen “b” was sacrificed for metallography after 18 h of sonication; Fig. 3 shows a representative cross-section of the specimen following light etching to reveal the structure. The band of material across the top of the specimen that appears relatively featureless is the Kolsterised® layer – in this view, the layer has a relatively uniform thickness of about 20 μm . Heavier etching would reveal that the Kolsterised® layer actually has a structure continuous with the substrate features, but one aspect of Kolsterising® is that it tends to impart slightly increased corrosion resistance to many environments, and that feature was utilized here to highlight the thickness of the remaining layer with very light etching. The specimen surface, as represented by the view in Fig. 3, reveals a maximum surface profile of less than 10 μm between the high and low spots and an average roughness of less than 5 μm .

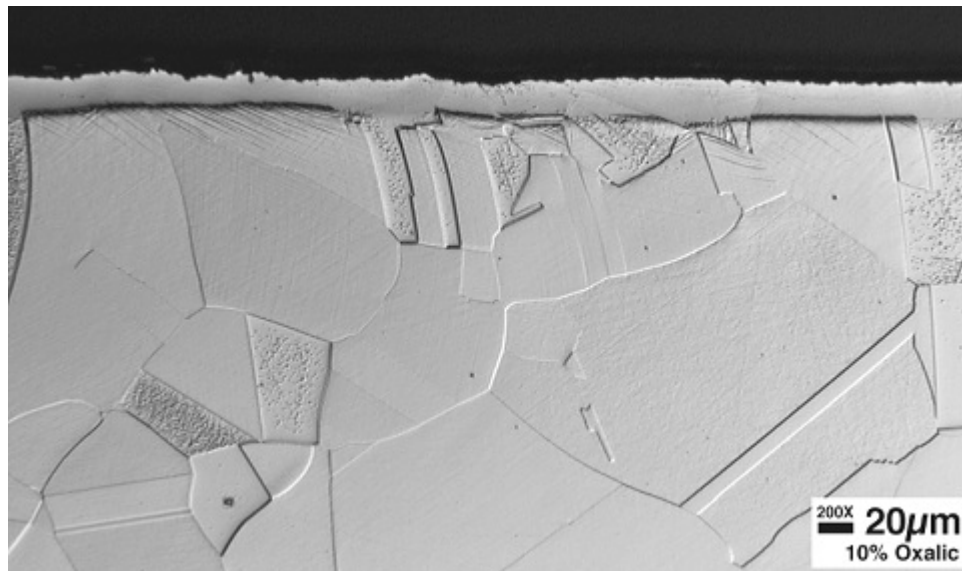
Fig. 3. Representative cross-section of the annealed/Kolsterised® specimen “b” following sonication in mercury for 18 h. The mounting epoxy (appears black) is at the top of the photograph and the test surface exposed to mercury is immediately adjacent to the mounting epoxy. The Kolsterised® layer is the essentially featureless band roughly parallel to the test surface that is about 20 μm thick.

From views of parts of the specimen unexposed to sonication conditions (for example, the “backside” of the test button), it is clear that the original Kolsterised® layer was about 32 μm thick on average. Based on the metallographic examination like that shown in Fig. 3, specimen “b” exhibited a remarkably uniform thinning of the Kolsterised layer from the original value of 32 μm to an average of 20 μm in the 18 h exposure. Based on uniform weight loss over the same period, this degree of thinning corresponds to about 0.7 $\mu\text{m}/\text{h}$. (For comparison, a value of about 2.0 $\mu\text{m}/\text{h}$ was previously observed for thinning of plasma-nitrided layers applied to Kolsterised layers on 316LN specimens.)⁵ Using the density of the 316LN material (8.0 g/cm^3) and the total test surface area (1.8 cm^2), note that the total mass associated with uniform removal of about 12 μm of K-layer thickness (~17.3 mg) corresponds almost exactly with the total weight loss (17.5 mg) experienced by the specimen in 18 h (see Fig. 3). This result indicates that mass loss to this point in the sonication exposure has been almost exclusively due to uniform thinning (general erosion and micro-pitting) of the protective layer of carburized material and very little mass loss has occurred due to localized pitting, which is readily confirmed by observation of the test surface prior to metallographic examination.

Also in Fig. 3, the substrate material immediately adjacent to the Kolsterised® layer (just beneath the layer in the photograph) reveals a high density of slip lines. The slip lines appear as clusters of short parallel indications within the grains of the substrate. Slip lines like these are not present within the grains of fully annealed material (the starting stock to fabricate these specimens) but are present beneath all of the treated surfaces of each specimen and thus it is likely the slip lines result from the high localized lattice strain – in effect, a modest amount of cold-work – associated with the diffusion of extreme amounts of carbon into a restricted volume of material and the steep composition gradient that results between the fully carburized layer and the substrate material. The presence of the slip lines beneath the layer confirms strength/hardness benefits associated with the Kolsterised® layer penetrate further into the specimen than the obvious “boundaries” of the physical layer itself. [Note that the slip lines are rarely seen in all grains of the substrate – particular grain orientations and etching conditions make these features more or less visible.]

Aside from thinning of the K-layer to about 20 μm , however, no features such as breaching/spalling of the K-layer were observed on the specimen “b” test surface to suggest a reason for the relatively abrupt change in slope associated with weight loss as a function of sonication time. Consequently, data for the equivalent annealed-plus-

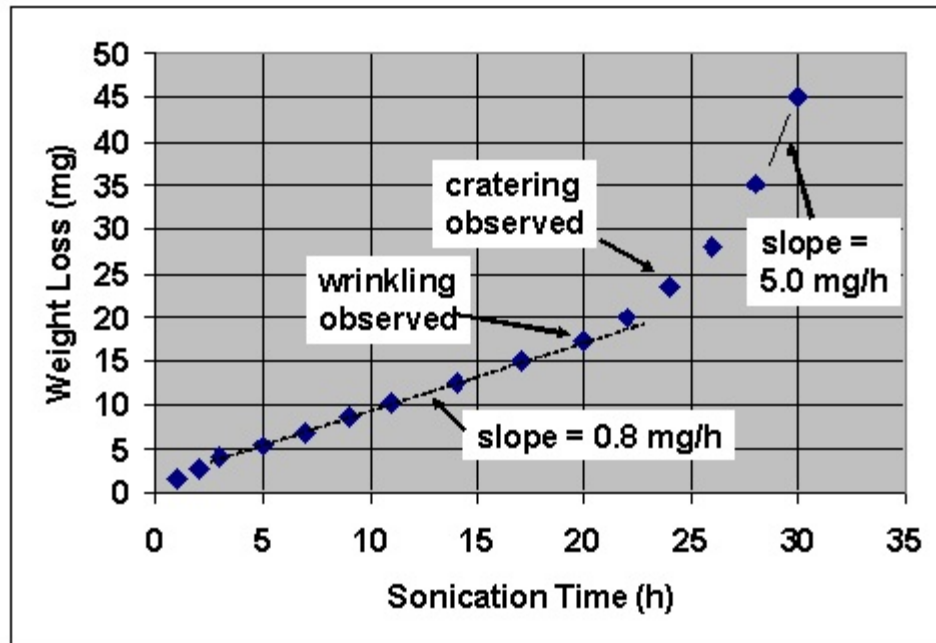
Fig. 4. Weight loss as a function of sonication time in mercury at 25-27°C for specimen “a” (annealed 316LN with a Kolsterised® surface).

olsterised® specimen “a” was extended until a much more significant/persistent change in slope was observed at 30 h total exposure. Figure 4 incorporates the extended exposure time data for specimen “a” as a stand-alone curve.

Corresponding surface profile data for the weight loss curve in Fig. 4 revealed that the test surface roughness remained at about 3 µm or less until about 9 h exposure, and the surface roughness had increased to only about 5 µm following 14 h exposure. Following 20 h of exposure for specimen “a,” the average surface profile was measured with the optical microscope to be 19 µm. Figure 5 shows the test surface of annealed-plus-Kolsterised® specimen “a” following 20 h exposure – it includes about 10 pits large enough to easily detect at this modest magnification and some “wrinkling” of the surface – a general loss of smoothness that seems to be a precursor to the initiation of higher weight loss rates. This “wrinkling” of the specimen surface is simply the macroscopic manifestation of the increase in surface roughness/profile of the specimen – in effect, the onset of failure in the K-layer – and as a generality among these test specimens, it becomes detectable at low magnification (e.g., 10x) at 10-12 µm roughness. Among the

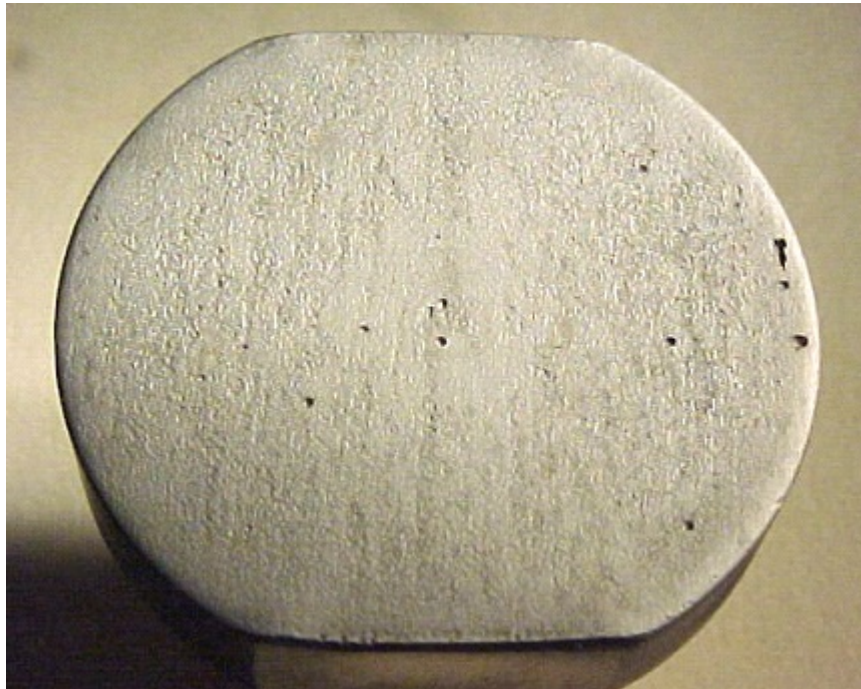
Fig. 5. Test face of specimen “a” (annealed 316LN specimen) following Kolsterising® and 20 h sonication in mercury. Actual specimen diameter is 16 mm.

pits observed on the specimen surface following 20 h sonication, only eight were recorded having depths greater than 75 μm , with the deepest being the somewhat elongated pit near the right edge of the specimen (215 μm). Also, following 20 h exposure, increased post-test wetting of mercury was observed on the test surface, which was apparently related to the development of wrinkled areas on the surface. Nevertheless, the cleaning process remained effective (albeit somewhat slower) for mercury removal.

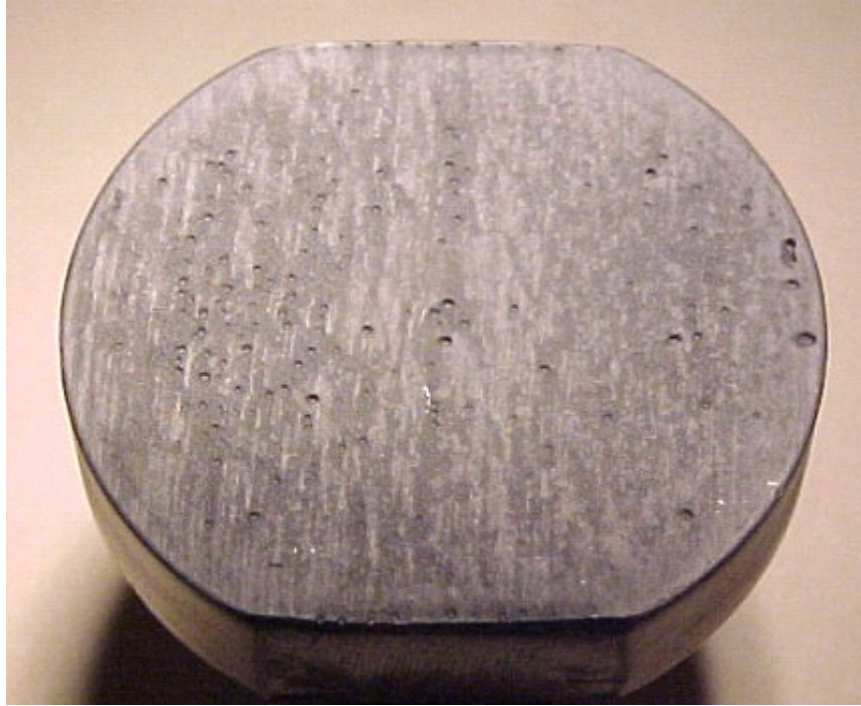
Fig. 6. Test face of specimen “a” (annealed 316LN specimen) following Kolsterising® and 26 h sonication in mercury. Actual specimen diameter is 16 mm. Compare to Fig. 5.

Extended exposure steadily increased the nominal surface roughness of specimen “a” while existing pits grew deeper and new pits formed more and more densely on the surface. Interestingly, pits were not regularly observed to increase in diameter as the pits grew deeper. Apparently, the remaining Kolsterised® layer (covering areas surrounding the pit) tends to inhibit a pit diameter increase, but at areas where the protective layer has been breached, there is little resistance to the pits becoming deeper at a rate similar to that observed on untreated material. The edges of the pits formed to this point in the exposure generally exhibited a largely flat surface profile (same relative

elevation and surface roughness as areas remote to any pitting). However, between about 24 and 26 h exposure, some pits on this specimen began to resemble an impact crater in that the pit rim was no longer an extension of the bulk surface (relatively smooth), but exhibited a raised (above the surrounding profile) rim around the pit. This change in behavior corresponds to enlarged areas where the carburized layer has been breached, and indicates the substantial power/deformation associated with the cavitation process.

Following 26 h exposure, the slope of the weight loss curve for specimen “a” approximately tripled from the steady state value observed during the initial 20 h of testing (see Fig. 4), and Fig. 6 records the test face of this specimen following 26 h sonication. At this point, the nominal surface roughness had increased to about 36 μm – independent of the many pits, which also became much more numerous (compare to Fig. 5). Also, note the almost complete absence of relatively smooth (non-wrinkled) areas on the surface. At this point in the exposure, a large fraction (>75%) of the specimen surface tended to exhibit wetting by mercury for an extended period following testing.

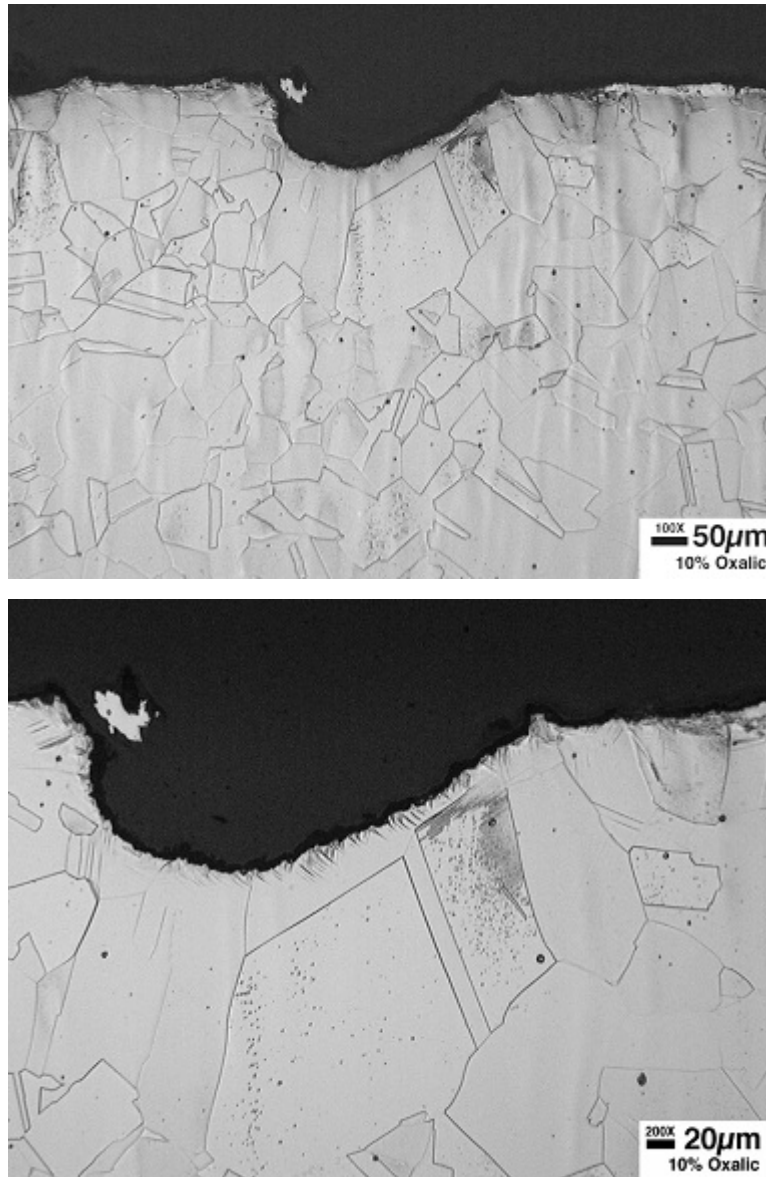
Fig. 7. Cross-section of specimen “a” following 30 h sonication time. Top photo: Low magnification view showing a pit on an otherwise relatively undisturbed area. Bottom photo: Higher magnification of the same pit showing slip lines at the bottom, indicating deformation of the substrate at this location.

Following 30 h sonication, annealed-plus-Kolsterised® specimen “a” was sacrificed for metallographic examination. Figure 7 reveals a test surface cross-section almost devoid of the Kolsterised® layer. A representative of the last vestige of the Kolsterised® layer in Fig. 7 is the light colored surface material about 15 μm thick (original thickness ~32 μm) near the right edge of the top photo Fig. 7. Compared to a loss of about 12 μm of K-layer following 18 h exposure for specimen “b,” the loss of K-layer seems to be accelerating locally over the next few hours of exposure as it is absent over large areas altogether at 30 h exposure, and generally has 15 μm or less in areas where it remains on specimen “a” after this exposure period. Figure 7 also reveals a pit without a raised lip, indicating either that this pit was formed by multiple tiny impacts insufficient to produce a raised lip or that the raised edges have been eroded away. In the bottom photo in Fig. 7, slip lines can be seen along the bottom edge of the pit, indicating significant stress/strain deformation associated with the cavitation-erosion process in the annealed substrate material. In addition, at the extreme right edge of the specimen surface in the bottom photo of Fig. 7, the remnants of the Kolsterised® layer are fully

contiguous/adherent with the surface material. The piece of metallic material that appears near, but slightly removed from, the pit surface at the left is attached to the test face at a point somewhat removed from the view in this particular cross-section. The pits shown in Fig. 7 also represent the consistent observation that the pits formed as a result of vibratory horn exposures in mercury in these experiments often have asymmetrical shapes – in particular, one side of the pit is often very steeply sloped while the other is not – but that undercut of the exposed surface has not been observed by the author on similar specimens in any related work.²⁻⁵

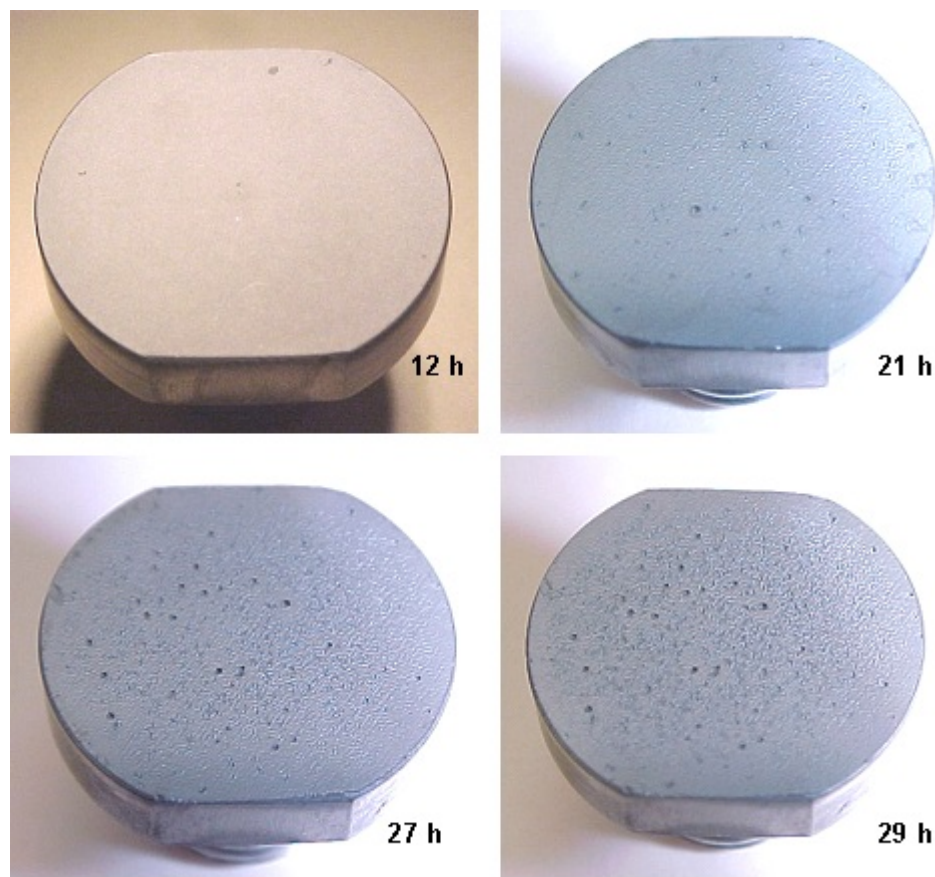
Fig. 8. Photographs of the test surface of the annealed-plus-Kolsterised® specimen “d” following the indicated sonication times. The surface following 12 h exposure is essentially smooth and free of pits; however, a few small water stains are visible on the test surface. Wrinkling and pitting of the surface develop rapidly from 21 to 29 hours of exposure.

Figure 8 is a series of photographs of the test surface of specimen “d” as the point of deviation from the steady state weight loss rate was approached and exceeded. Following 12 h sonication, the specimen surface was largely smooth and free of significant pits or surface roughness (~3 µm). After 21 h sonication, isolated pits (only four pits deeper than 100 µm, deepest was about 225 µm) were observed to be getting deeper at a rate similar to the pits on untreated material, and “wrinkling” of the surface was observed (perhaps initiated at 19 h exposure but required some low magnification to resolve), generating a nominal surface roughness of about 23 µm. Following 27 h sonication, there were many pits ≥ 100 µm deep – two pits were greater than 200 µm deep – and the nominal surface roughness had increased to 57 µm. After 29 h sonication, when a modest but definite change in the weight loss curve became readily detectable, the pitting observed was extensive and the nominal surface roughness had increased to 74 µm accompanied by extensive post-test wetting of mercury.

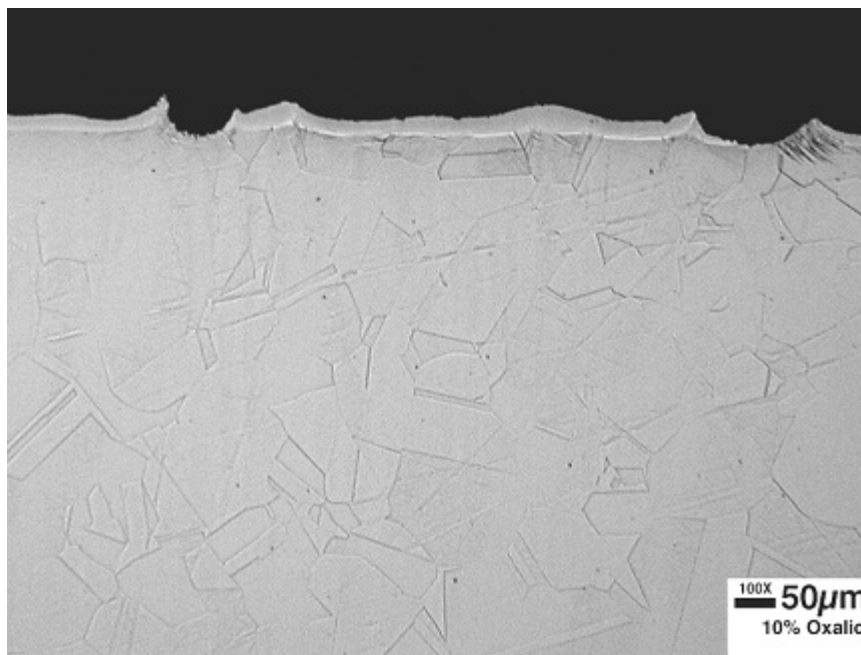
Fig. 9. Etched cross-section of the test surface of specimen “d” following 29 h sonication in mercury at ambient temperature. Note cavitation craters that have breached the K-layer.

Figure 9 is a relatively low magnification view of the “d” specimen test surface in cross-section following 29 h sonication, and it reveals representative modest surface relief and the onset of pitting that has breached the remaining Kolsterised® layer thickness. Although the thickness of the remaining surface layer is not particularly uniform, the average remaining thickness of 20 μm (equates to a loss of 20 μm from the initial 40 μm thickness) after 29 h sonication corresponds to a thinning rate of about 0.7 $\mu\text{m}/\text{h}$, or essentially identical to the value estimated for the annealed “a” and “b” specimens. Also similar to specimens “a” and “b,” the onset of failure in the K-layer (increase in weight loss, initial pitting) seems to have begun with about 20 μm K-layer remaining.

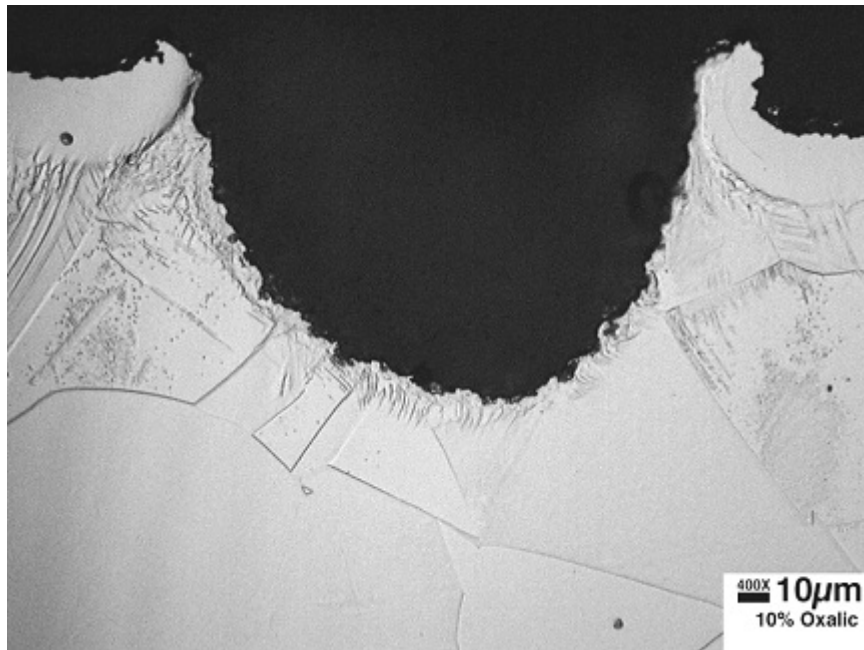
Fig. 10. Cross-section of a pit that has breached the remaining K-layer of the annealed-plus-Kolsterised® “d” specimen after 29 h sonication. Note the raised lip at the edge of the pit and the slip lines in the annealed material at the bottom of the pit.

Figures 10-12 are additional cross-section photographs of the initiation of the pitting process on the “d” specimen. Figure 10 shows a 120 µm deep pit that has breached the remaining thickness of the Kolsterised® layer. This view reveals several facets of the cavitation-erosion process. Note that the surfaces of the pit itself are rough and irregular (consistent with the type of damage observed in scanning electron microscopy photographs of surfaces cavitated in mercury).^{2,3} Also note that, as before, slip lines in the substrate metal (bottom and sides of the pit) indicate significant deformation is associated with the cavitation-cratering process. Further, note that the Kolsterised® layer itself has been pushed upward by the force of the cavitation-cratering event, as seen best by the raised/curved lip of Kolsterised® material at the surface of the right side of the pit. [As the raised lip becomes more and more pronounced, the author has used the term “crater” to distinguish this feature from a “pit” – the latter term implying the surrounding topography has not been disturbed significantly.] Figure 11 shows a particularly pronounced lip at the edge of the developing crater. At the surface of the left edge of the crater, note the uplifting of the Kolsterised® layer and also the very thin layer

of substrate material adhering to the underside of the lifted Kolsterised® material. Such behavior demonstrates a special feature of the Kolsterising® process compared to other surface treatments: because it is a diffusion process rather than something discretely applied to the surface, there is no precise interface between the protective layer and substrate and therefore the protective layer tends not to exhibit the shortcomings often associated with poor adhesion between layers. Also note that the Kolsterised® layer itself has developed modest surface relief (localized wastage and tiny pits/cracks) at this point in the sonication process. Figure 12 exhibits a crack that has formed at the interface of the remaining Kolsterised® material and the substrate metal near the right side of the developing crater.

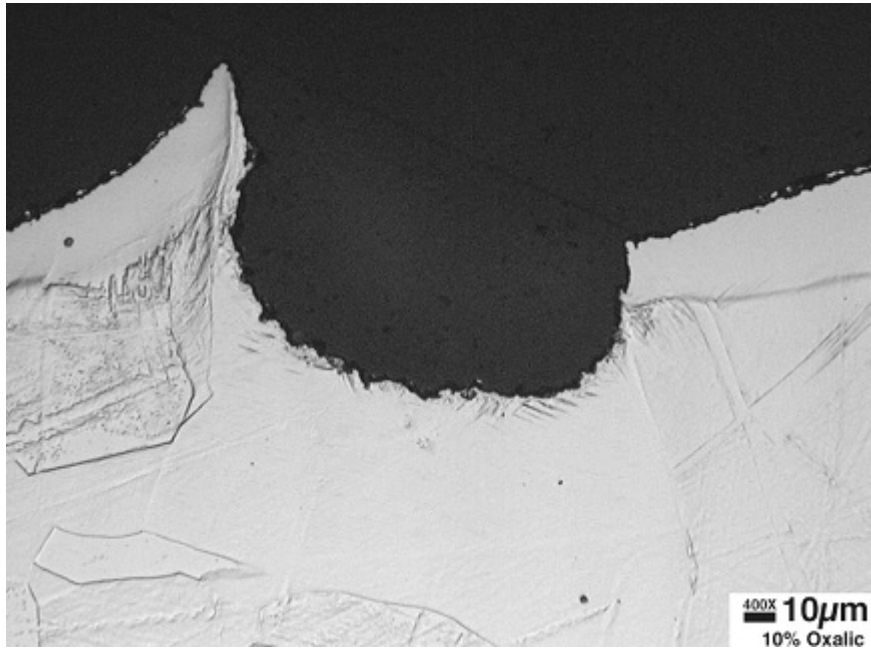
Fig. 11. Raised lip at the edge of a pit on the annealed-plus-Kolsterised® “d” specimen following 29 h sonication. Note the adherence of a thin layer of base material beneath the raised K-layer.

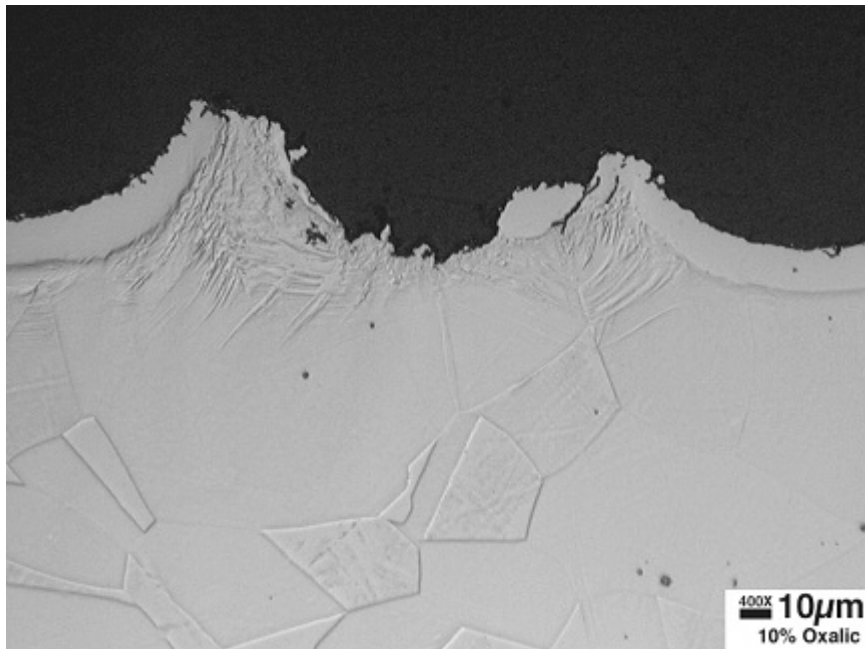
Fig. 12. Small crack at the interface between the remaining K-layer and the annealed substrate on the “d” specimen following 29 h sonication. Note also the roughening of the surface of the remaining K-layer.

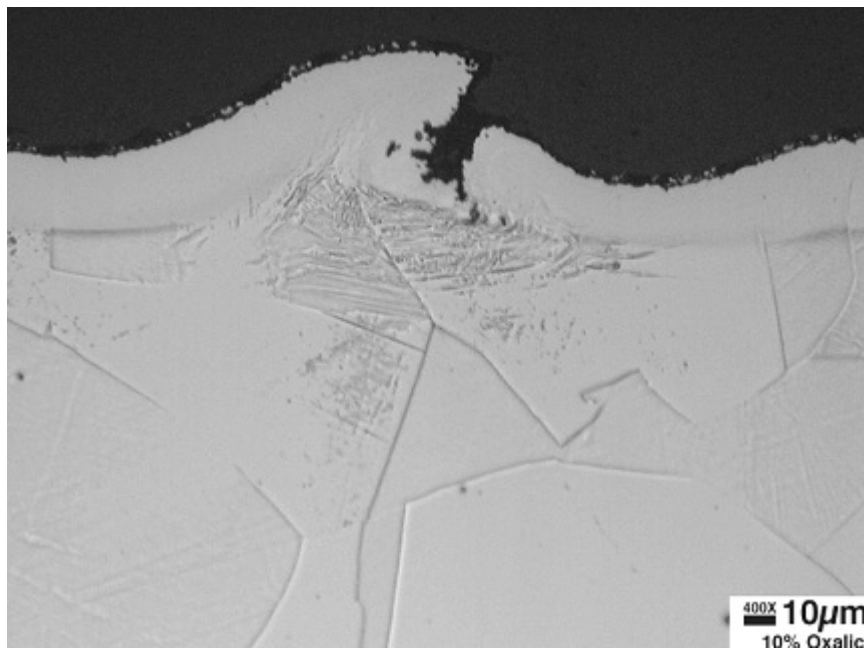
Fig. 13. Crack/pit within the remaining K-layer on the annealed-plus-Kolsterised® “d” specimen following 29 h sonication. Note the concentration of slip lines in the annealed substrate immediately beneath the near-breach in the K-layer.

Figures 13 and 14 are somewhat different from the previous views of specimen “d” in that they show the initiation of the pitting process while it is confined within the remaining Kolsterised® layer. Figure 13 reveals what appears to be the initiation of a pit/crack within the remaining Kolsterised® layer. At the place where pitting has initiated in the K-layer, the local thickness is again near the apparent threshold for initial breakdown (20 µm). Note particularly at the left edge of the near-breach in the K-layer, localized deformation associated with the cavitation process has uplifted and elongated even the very hard protective layer compared to its original thickness and position. Deformation of the substrate (as indicated by the high concentration of slip lines) appears concentrated in the substrate just beneath the near-breach. Figure 14 shows a more developed pit/crater, but one that is nevertheless fully contained within the Kolsterised® material. It also reveals significant deformation of the Kolsterised® layer itself.

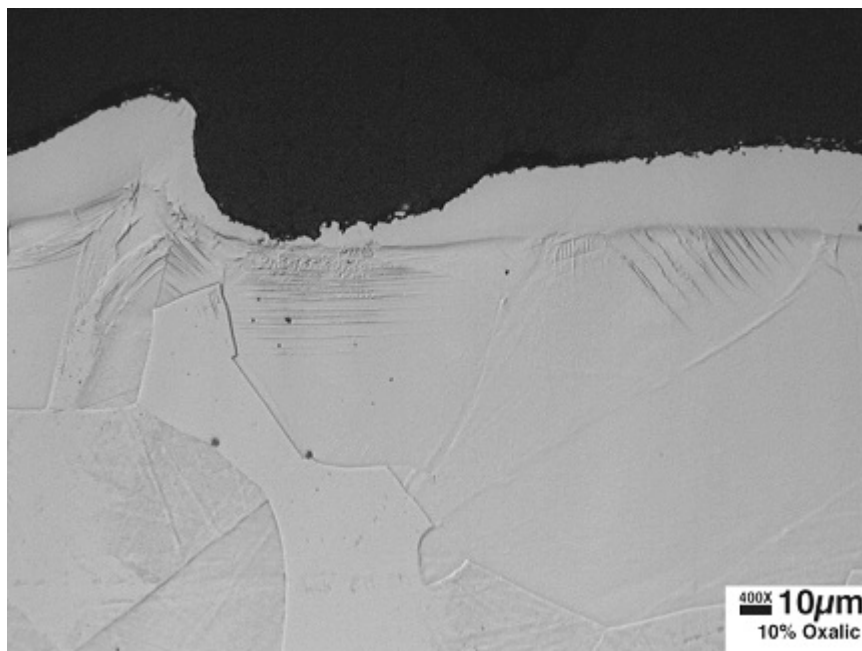
Fig. 14. Pit contained within the remaining K-layer on the annealed-plus-Kolsterised® “d” specimen following 29 h sonication. Note the extent of K-layer removal from the high point to the low point within the layer.

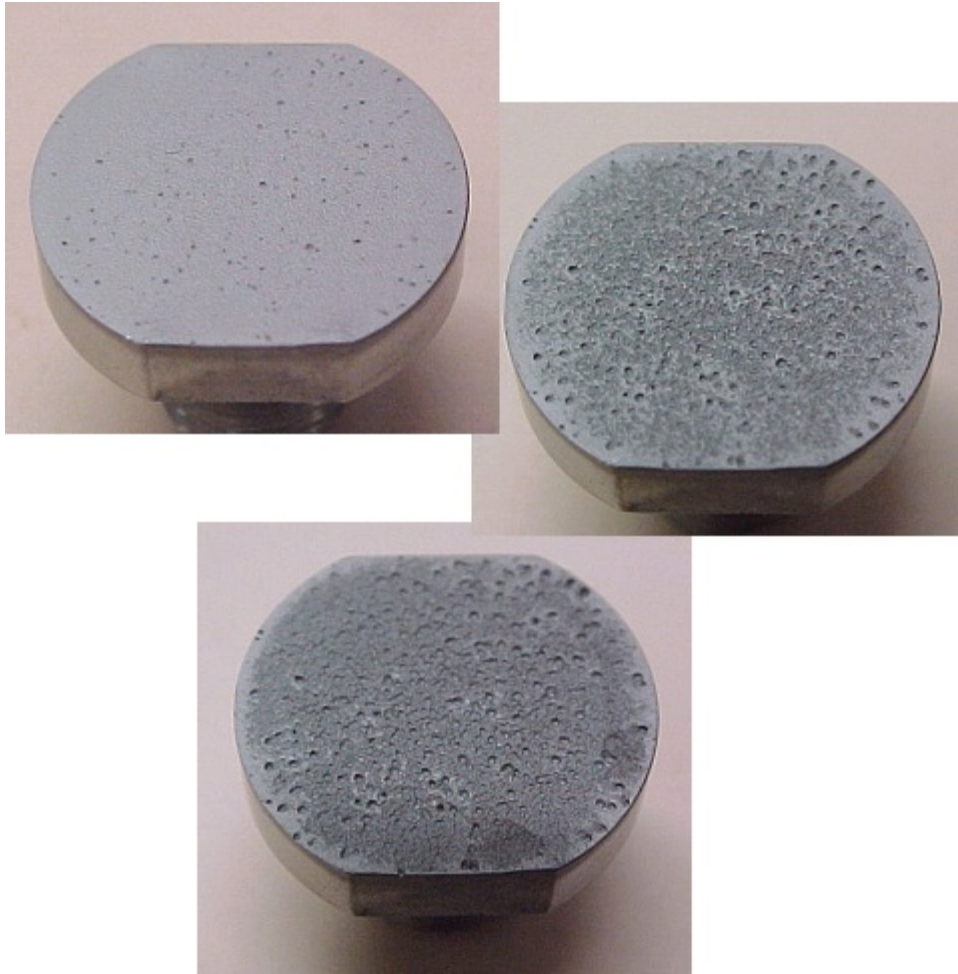
Fig. 15. Annealed-plus-Kolsterised® specimen “c” following 24-, 36-, and 42-h of sonication in mercury, respectively, clockwise from top left. Actual test surface diameter is 16 mm.

In light of the results for specimens “a,” “b,” and “d” indicating that only modest departure from the steady-state weight loss rate was associated with the onset of K-layer failure (as evidenced by K-layer thinning and surface cratering), specimen “c” was further sonicated in 2-3 h increments to a total of 48 h exposure prior to being sectioned for metallography. Like specimen “d,” specimen “c” also exhibited an initial carburized layer thickness of about 40 μm on the annealed substrate. Figure 15 shows a sequence of pictures of the test surface of specimen “c” at various intervals during extended sonication. Consistent with Fig. 8, wrinkling and the onset of cratering were observed following 21-24 h exposure. Following 36 h, the specimen surface exhibited substantial general surface roughness and many large craters – generally similar in appearance to an untreated annealed substrate after only 2-3 hours sonication in mercury. Following about 42 h exposure, the surface had become sufficiently rough and cratered that little additional (macroscopic) change was observed. At the termination of this test (48 h), the weight change rate for specimen “c” was about 5.7 mg/h, which remains less than half of the steady-state weight loss rate observed for the annealed but

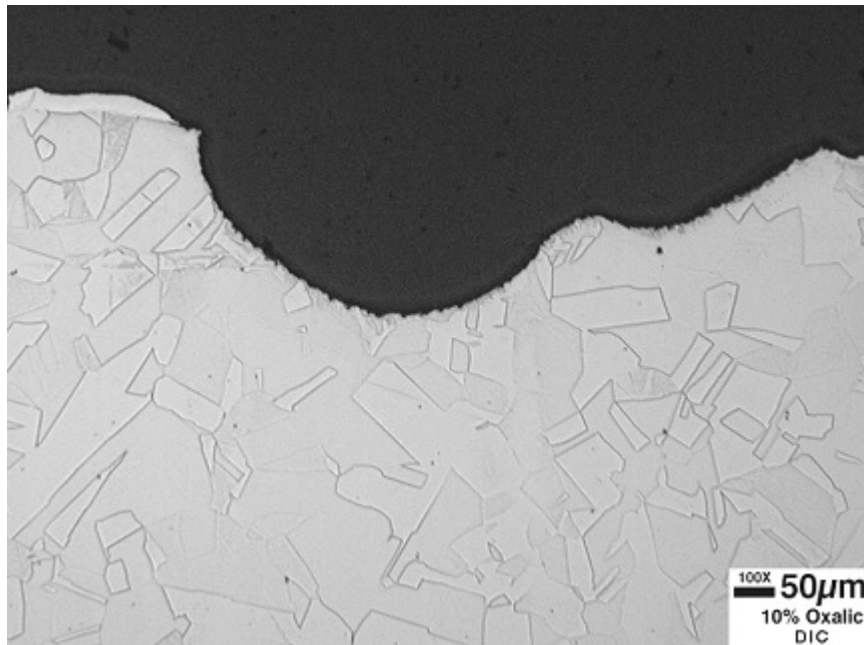
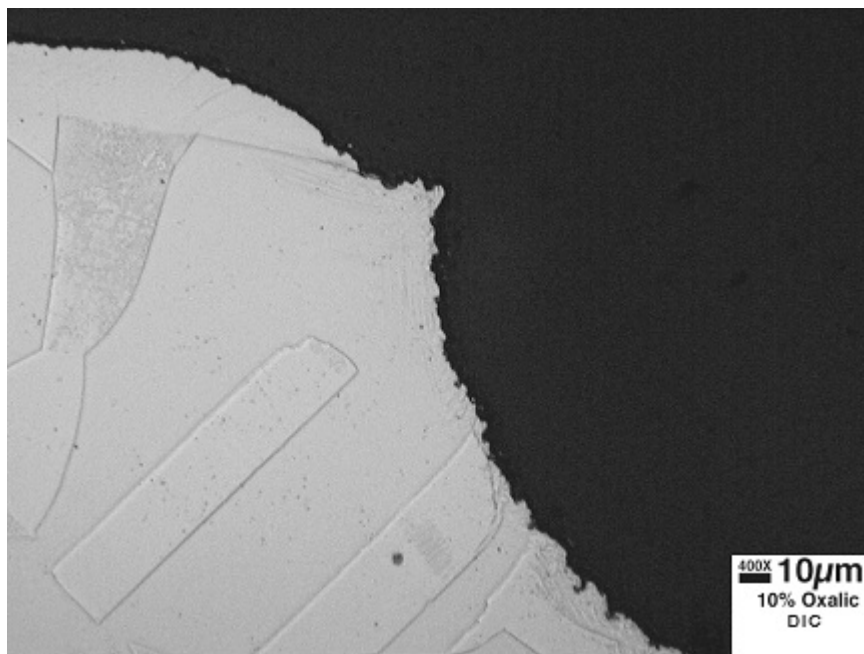
Fig. 16. Etched cross-section of annealed-plus-Kolsterised® specimen “c” following 48 h sonication in mercury. Note that just to the left of the pit (higher magnification view in bottom photograph), about 20 µm of K-layer remains intact.

Figure 16 is a representative cross-section of the post exposure test surface of specimen “c” following 48 h sonication, and it indicates a surface profile dominated by pits/craters (here, more than 250 µm deep). Even following 48 h exposure, it was observed that regions of Kolsterised® material remain on the test surface, as evidenced here by the ~20 µm thick layer on the upper left portion of the specimen. That the weight loss rate for this specimen remains less half of the weight loss rate expected from the equivalent untreated specimen suggests that a significant fraction of the test surface retains at least a partially protective Kolsterised® layer thickness after this extended exposure period. Also note that in the higher magnification photograph of Fig. 16, a small region of original substrate (left edge of the pit) devoid of Kolsterised® layer but only very slightly attacked by the sonication process is apparent. It is likely that this region was only recently exposed due to failure/loss of the coating layer, or more attack at this location would be evident.

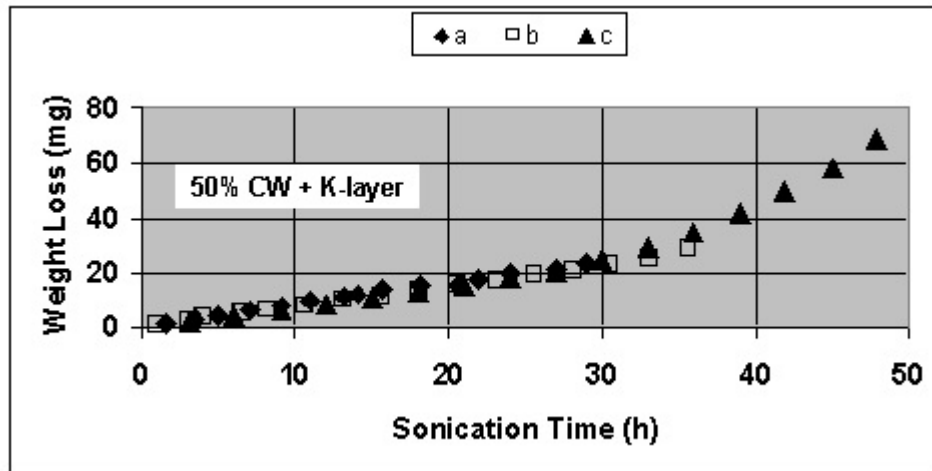
Fig. 17. Weight loss as a function of sonication time for specimens of 50% cold-worked 316LN that received the standard Kolsterisation® treatment.

Three identical specimens that were machined from 50% cold-worked material and subsequently received the standard Kolsterising® treatment (resulted in an initial K-layer thickness of about 35 μm on each specimen) were also examined for end-of-life characteristics of the protective layer. The weight loss as a function of sonication time for the treated specimens with the cold-worked substrate is presented in Fig. 17. Similar to the case for the specimens with an annealed substrate, the scatter in the weight loss results among the Kolsterised® cold-worked specimen was very modest, and a steady-state weight loss rate essentially identical to that for the specimens with an annealed substrate (0.7-0.8 mg/h) was observed. At the maximum of the specimen “c” exposure, the weight loss rate increased to about 3.2 mg/h, or about 75% of the expected weight loss rate (4.4 mg/h) for the equivalent untreated 50% cold-worked substrate. Note that even after almost 36 h sonication, specimen “b” in this set had not yet deviated significantly from the steady-state weight loss rate observed for these specimens.

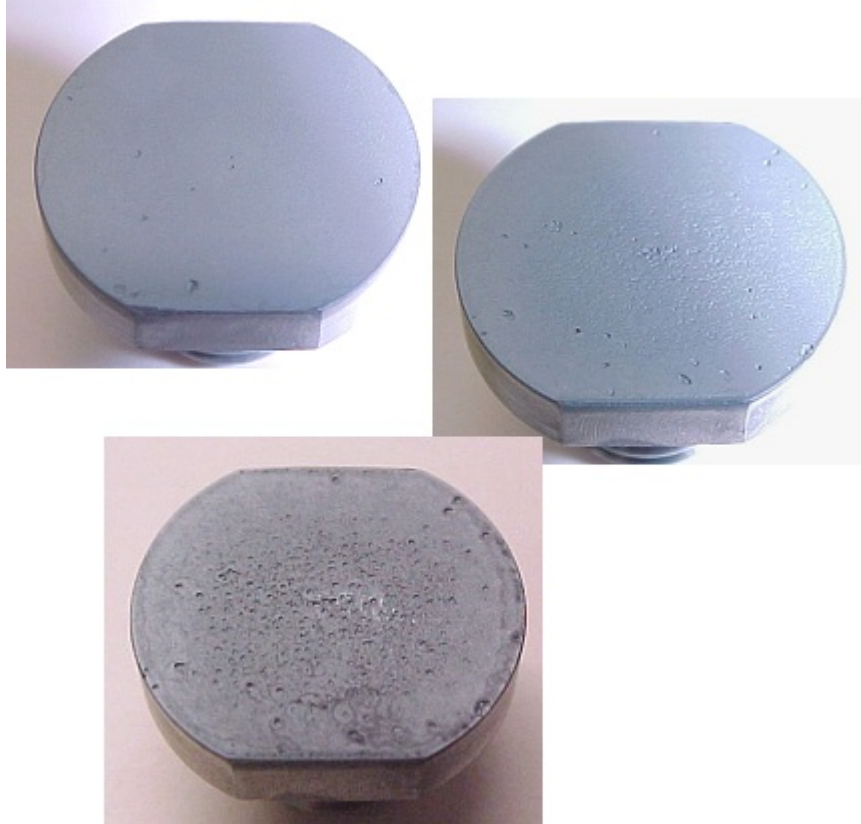
Fig. 18. Test surface of Kolsterised® specimens with a cold-worked substrate exposed to sonication in mercury for 27 h, 33 h, and 42 h, clockwise from top left. Actual specimen diameter for all buttons was 16 mm.

Figure 18 shows a sequence of photographs representing the change in the test surface appearance as a function of sonication time for the treated specimens with a cold-worked substrate. For exposure times up to 20-22 h, each specimen in this set was observed to exhibit only 2-4 modest pits on an otherwise smooth and featureless surface. After 26-28 h exposure, more numerous (and deeper) pits were commonly observed. At longer exposure times (but greater than for the equivalent specimens with an annealed substrate), more and more of the test surface became wrinkled and eventually cratered.

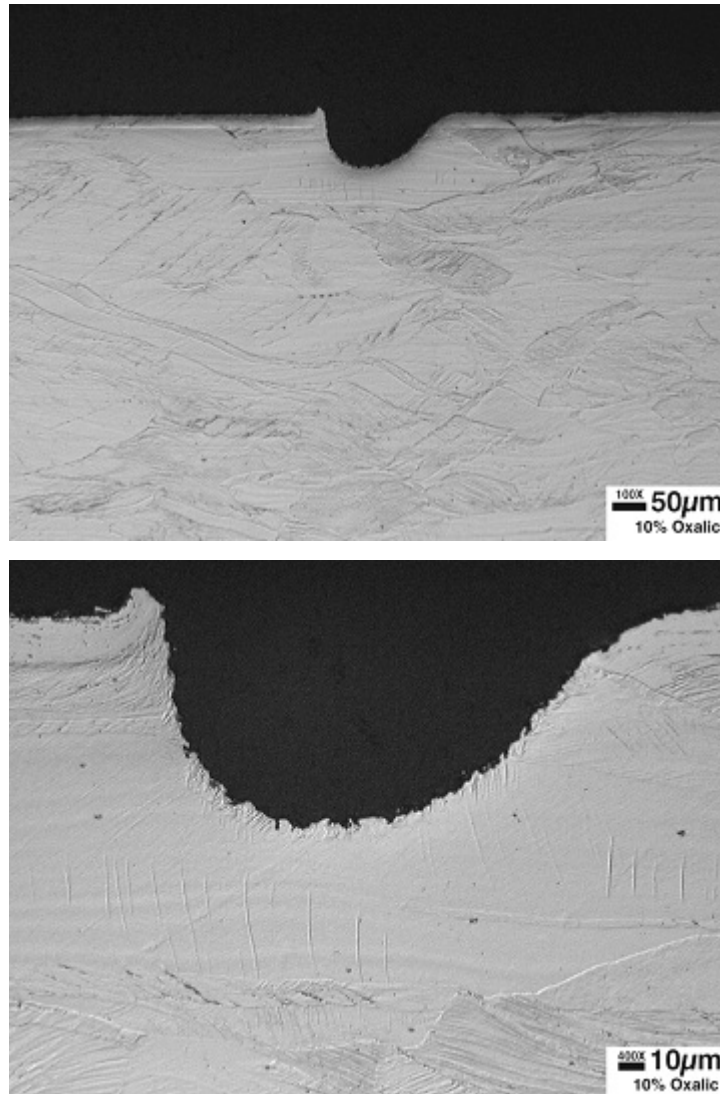
Fig. 19. Etched cross-section of cold-worked and Kolsterised® specimen “a” following 29 h sonication.

Figures 19 and 20 are representative of the pitting observed on specimens with a cold-worked substrate following extended exposures. In particular, Fig. 19 shows cold-worked/treated specimen “a” following 29 h exposure – prior to serious deviation from the steady-state weight loss rate shown in Fig. 17. It reveals a remarkably smooth and uniform surface interrupted by a single pit. The average remaining K-layer thickness on this specimen at this apparent onset of pitting was determined to be 19-20 μm , which is very similar to the “threshold” result observed for the onset of pitting in treated specimens with an annealed substrate. As a rule, however, it was observed that the cold-worked substrate specimens yielded far fewer – and generally much more shallow – pits during the same exposure time as specimens with an annealed substrate. Note that the cold-worked substrate does not eliminate the displacement of the substrate via formation of a “lip” at the edge of the cavitation crater (Fig. 19). In addition, the

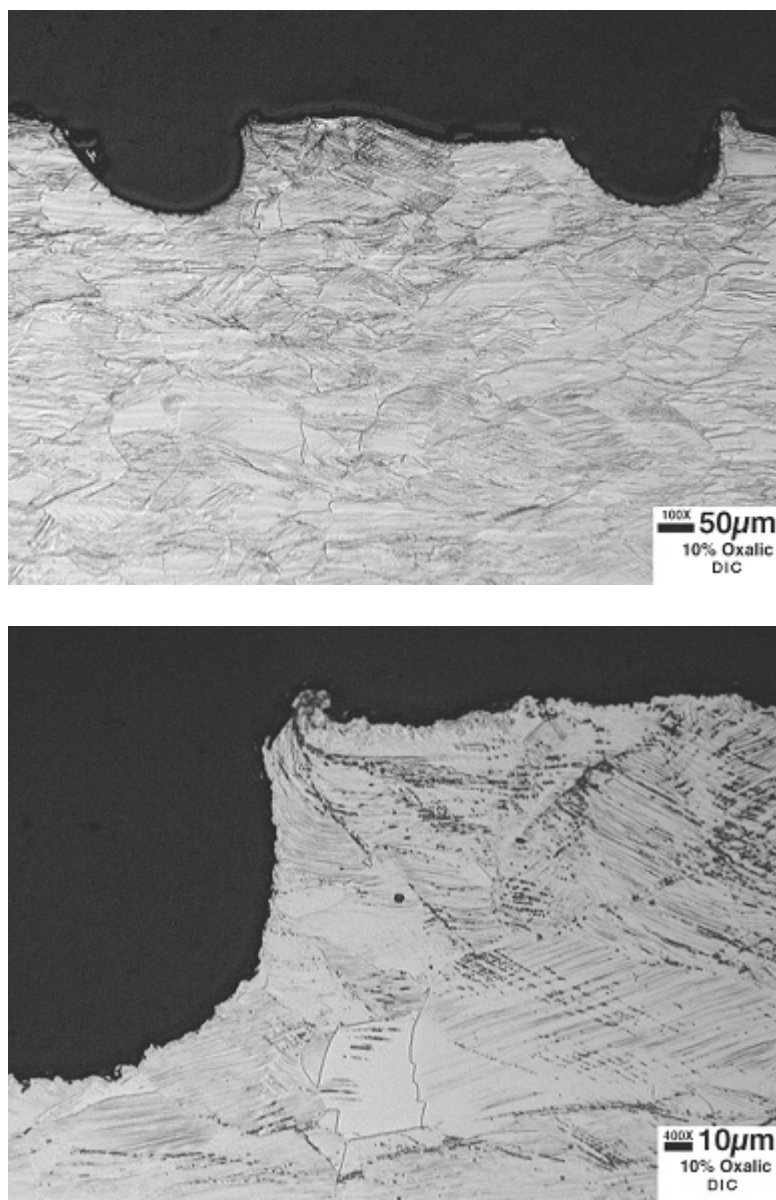
Fig. 20. Etched cross-section of cold-worked and Kolsterised® specimen “c” following 48 h sonication in mercury.

bottom of the pit reveals a roughened surface similar to that observed for specimens with an annealed substrate. Figure 20 shows a similar cross-section of the “c” specimen with a cold-worked substrate following 48 h sonication. Again, the bulk surface remained relatively smooth but only small areas with residual K-layer were observed. The similarity in size/shape of the craters in the cold-worked substrate with those in the annealed substrate is striking and is a testament to the power in the cavitation process that similarly pits materials with substrates as hard as 340 DPH (Rc 35).

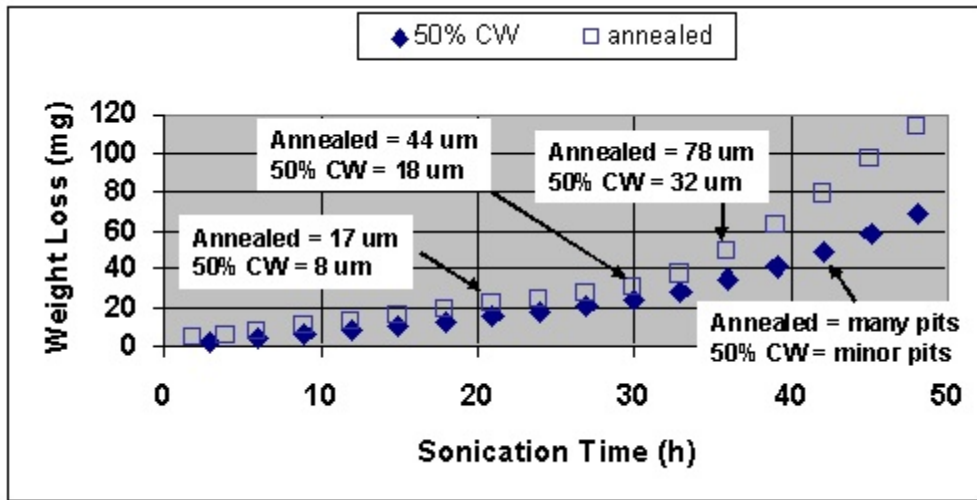
Fig. 21. Weight loss as a function of sonication time for annealed/Kolsterised® specimen “c” and cold-worked/Kolsterised® specimen “c.” Average surface profile is given for each specimen at equivalent exposure durations denoted by the arrows.

Figure 21 shows a comparison of the weight loss results for the two specimens with the longest exposure times in this evaluation; that is, annealed substrate specimen “c” with an initial K-layer thickness 40 µm, and cold-worked substrate specimen “c” with an initial K-layer thickness of 35 µm. Graphed in this fashion, it is easy to see that the

steady-state weight loss rate for each specimen type is essentially identical. Although limited in number, remaining K-layer thickness measurements as a function of sonication time collected via metallography confirm this trend. The similarity in the steady-state weight loss and K-layer thinning rates for the two different substrates suggests general erosion is primarily controlled by the properties of the K-layer itself as opposed to the properties of the substrate. However, note that as the K-layer is degraded by thinning and cavitation damage begins to accumulate in both the remaining K-layer (thinned to less than 15-20 μm) and the adjacent substrate, the average mass loss rate and the average surface profile both become much greater much faster for the K-layer on the annealed substrate.

In addition to data on the average surface roughness as a function of sonication time included in Fig. 21, the depth of a few individual pits on the surface of each specimen was also tracked as a function of sonication time. For both the annealed/treated specimens as well as the cold-worked/treated specimens, pit depth increased slowly – only about 2 $\mu\text{m}/\text{h}$ or less – until the pit depth reached approximately 30-35 μm . Beyond this depth, the K-layer was either breached or sufficiently thinned that its protective ability was compromised and the pit growth rate accelerated. On the annealed substrate specimens, pits were found to increase in depth at an average rate in the range of approximately 5-9 $\mu\text{m}/\text{h}$ following breach of the K-layer, while the rate for specimens with a cold-worked substrate was only 3-6 $\mu\text{m}/\text{h}$. In each case, these rates are roughly consistent with the rate of change in average roughness of the bulk surface following the departure from steady-state change associated with a protective K-layer. For both substrates, however, pit depth did not necessarily increase uniformly with time. Rather, there was significant variability and even occasional exposure periods during which the pit depth did not measurably increase followed by a period in which the pit depth increased significantly more than the average rate. This behavior may have occurred across the entire surface, but individual pits in specific locations on the specimen surface lend themselves to trending this pattern, while more generalized areas on the specimen surface do not. In any case, these data suggest that the cavitation-erosion process on the test surface of vibratory horn specimens is somewhat random in that damage is not necessarily focused at existing flaws/pits – otherwise, the pits would grow deeper at a rate much faster than the change in the average profile of the surface. That there are periods during which existing pits do not change depth appreciably is curious but nevertheless a reproducible observation in the vibratory horn testing.
