Analysis of Selected Legacy ⁸⁵Kr Samples

Fuel Cycle Research & Development

***Prepared for
U.S. Department of Energy
Material Recovery and Waste Form
Development Campaign***

ORNL/TM-2016/350

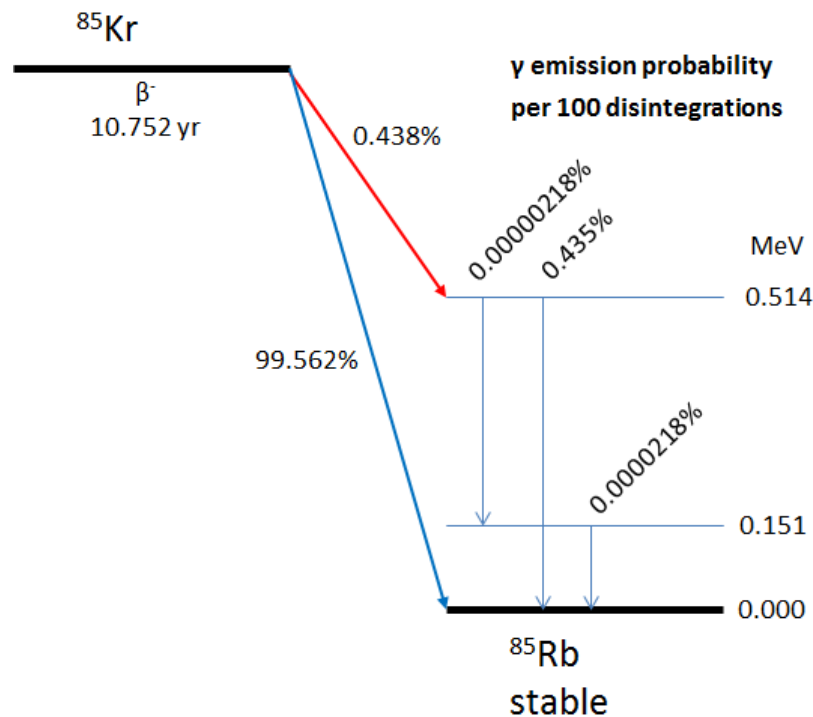
Figure 1: Graphical depiction of the Kr-85 decay chain. Kr-85 with a 10.752 y half life decays by emitting a beta particle. About 0.43 percent of the beta decays (red line) produce Rb-85, in the second ground state at 0.514 MeV which subsequently decays to the ground state, Rb-85, by emitting a gamma ray. About 99.56 percent of the decays (blue line) produce Rb-85 directly. Rb-85 is stable.

Legacy samples composed of ^{85}Kr encapsulated in solid zeolite 5A material and five small metal tubes containing a mixture of the zeolite combined with a glass matrix resulting from hot isostatic pressing have been preserved. The samples are a result of krypton R&D encapsulation efforts in the late 1970s performed at the Idaho Chemical Processing Plant (ICPP). The samples were retrieved from archive storage and transported to the Hot Fuels Examination Facility (HFEF) within the Materials Fuels Complex at the Idaho National Laboratory (INL). Examination of such samples can lead to invaluable information on the long-term stability of ^{85}Kr waste forms. These samples are unique in the sense that these have undergone decay of three plus half-lives of the ^{85}Kr while in storage. Kr-85 decays with about a 10.75 year half-life by emitting a beta particle. About 99.56 percent of the decays produce Rb-85 in the ground state while about 0.44% result in a 0.514 MeV gamma emission via the pathways depicted in Figure 1.

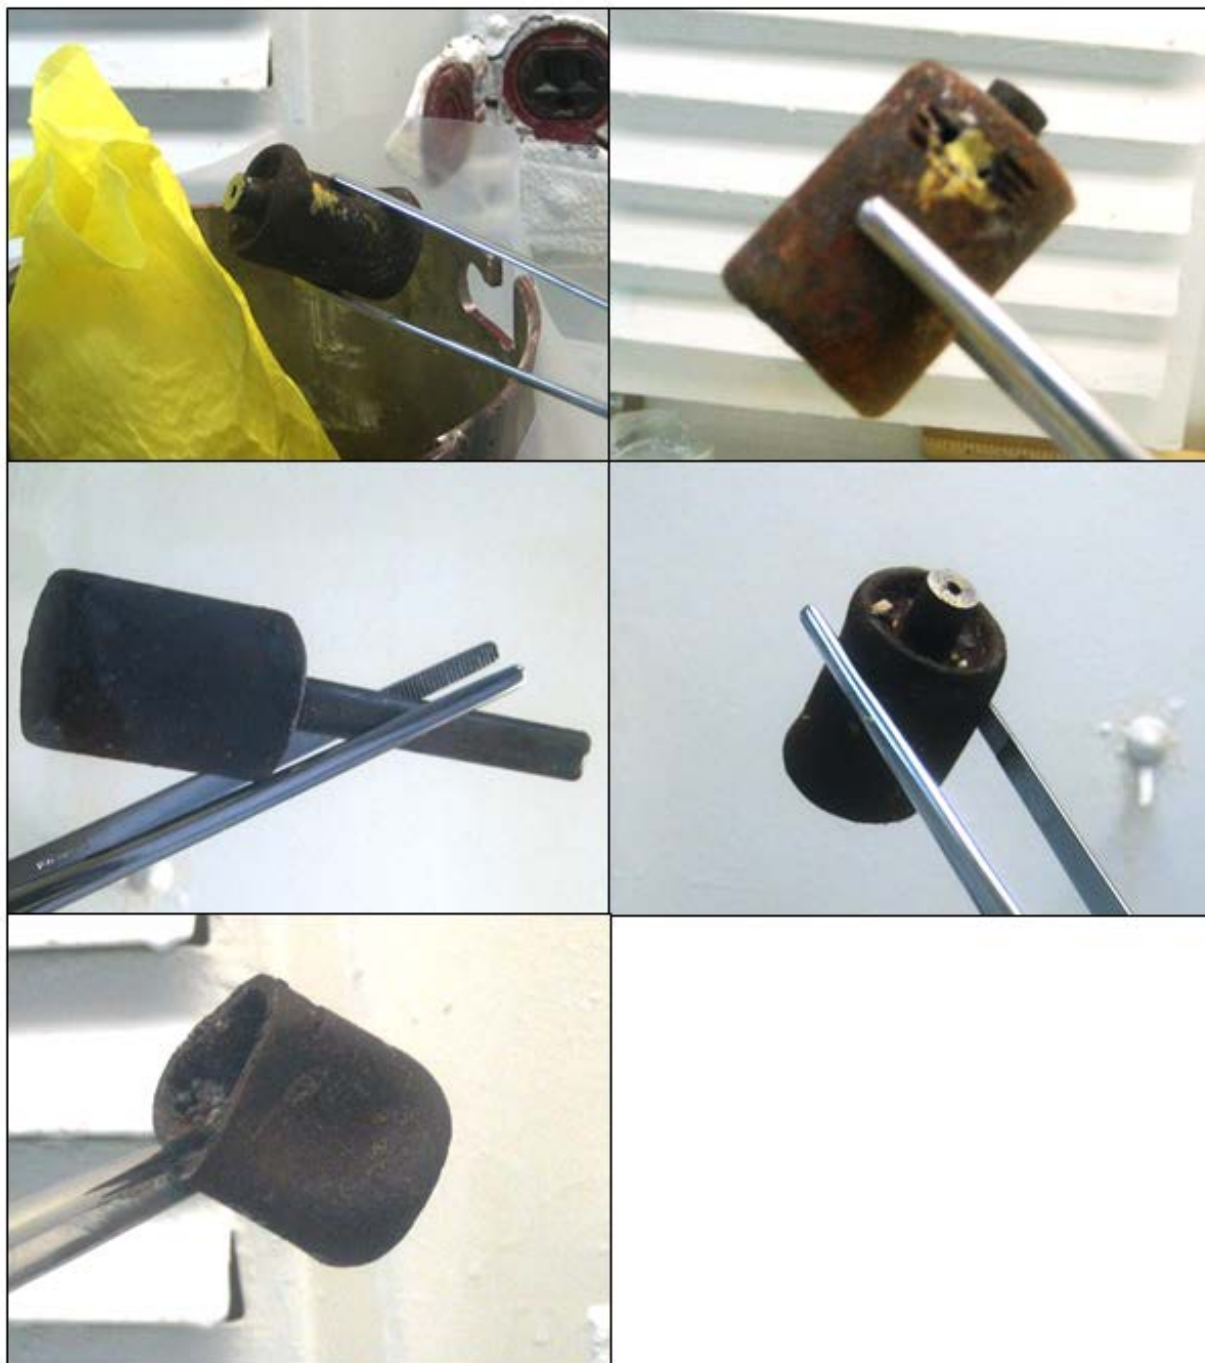
Figure 4: Kr-85 Capsules (Top, L-R: Capsule 1, Capsule 2; Middle, L-R: Capsule 3, Capsule 4; Bottom: Capsule 5).

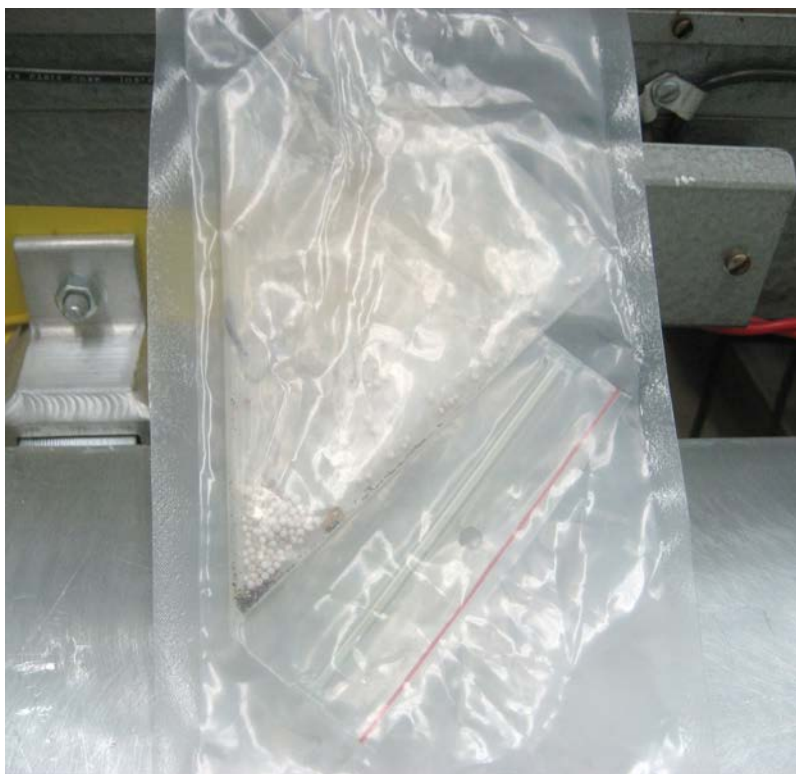
Figure 9: Loose material from Capsule 2.

Figures 7 and 8 show capsules 2 and 5, respectively, as they were removed from the shipping package and shielding. Figure 9 shows the loose material that fell out of capsule 2.

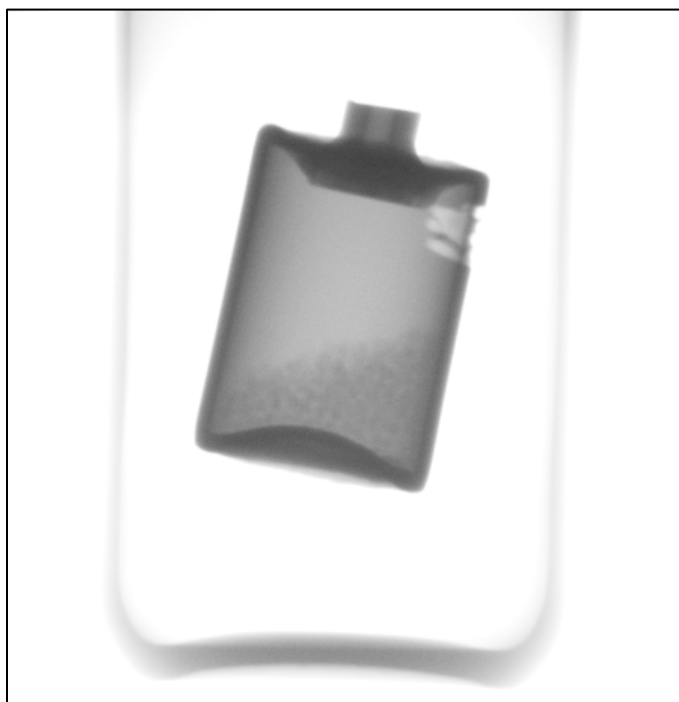
Figure 10: X-ray image of Capsule 2.

The five capsules were then x-ray imaged. Capsules 1 and 4 appear intact and to contain an amorphous mass within the capsules. Capsule 2 clearly shows the saw marks on the capsule and a quantity of loose pellet or bead-like material remaining in the capsule. Capsule 3 shows similar bead-like material within the intact capsule. Capsule 5 had been opened at an undetermined time in the past. The end of this capsule appears to have been cut off, and there are additional saw marks on the side of the capsule. X-ray tomography allowed the capsules to be viewed along the three axes. Of most interest was determining whether there was any residual material in the closed end of Capsule 5. The images confirmed the presence of residual material within this capsule. The material appears to be compacted but still retains some of the bead-like morphology.

Figures 10 and 11 are the x-ray images of Capsules 2 and 5, respectively. Figure 10 clearly shows the saw marks on the capsule and a quantity of loose pellet or bead-like material remaining in Capsule 2.

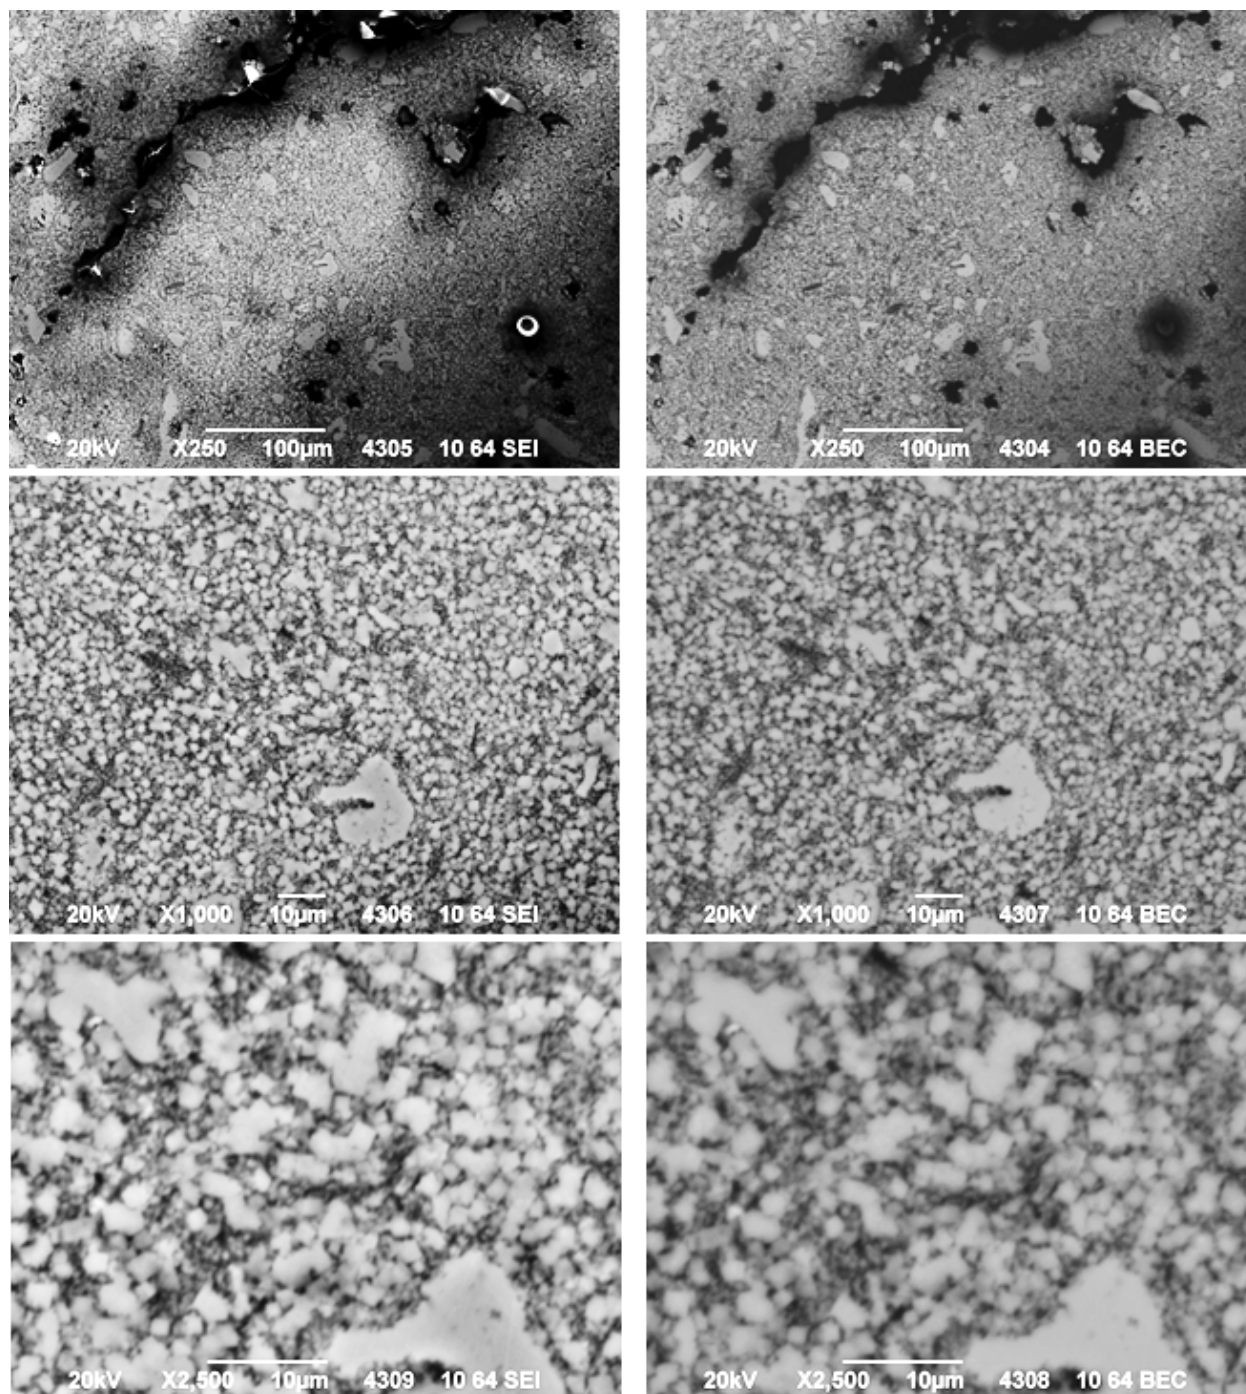
Figure 18: Detailed images of area near center of pellet recovered from Capsule 2 at 250× to 2500× magnification. SEI images on left and backscatter images on the right (Images 4304 – 4309) [Sample K3].

The SEM images appear to indicate an area of lower density material near the center of the pellet. During the polishing of the pellets shown in Figures 13-16 it was observed that the center was relatively soft, and great care had to be applied to not pull out this material. In all cases, the elemental mapping of the three points across the pellets showed that the Al, Si, and Ca were coincident with each other. The approximate atom % numbers obtained from the EDS analysis are consistent with the composition of 5A molecular sieves. The presence of some Na is also consistent with the production of 5A MS from 4A with the exchange of Ca for Na in the 4A molecular sieve⁴. A type A zeolite has an oxide formula of $\text{Na}_2\text{O} \cdot \text{Al}_2\text{O}_3 \cdot 2\text{SiO}_2 \cdot 4.5 \text{H}_2\text{O}$. In 3A molecular sieves, the Na is replaced with K, and in 5A the Na is replaced with Ca. The Kr and Xe elemental maps are also coincident with the Al, Si, and Ca, which is indicative of the Kr being trapped in the zeolite structure. The Kr:Xe atom % numbers would indicate that the Kr that was loaded into the zeolite had some Xe impurities, ~20% Xe. Note that carbon is present in all samples because it was used to coat the sample in preparation for SEM examination and is ignored when considering the composition of the sample by creating ratios of the remaining elements to each other.

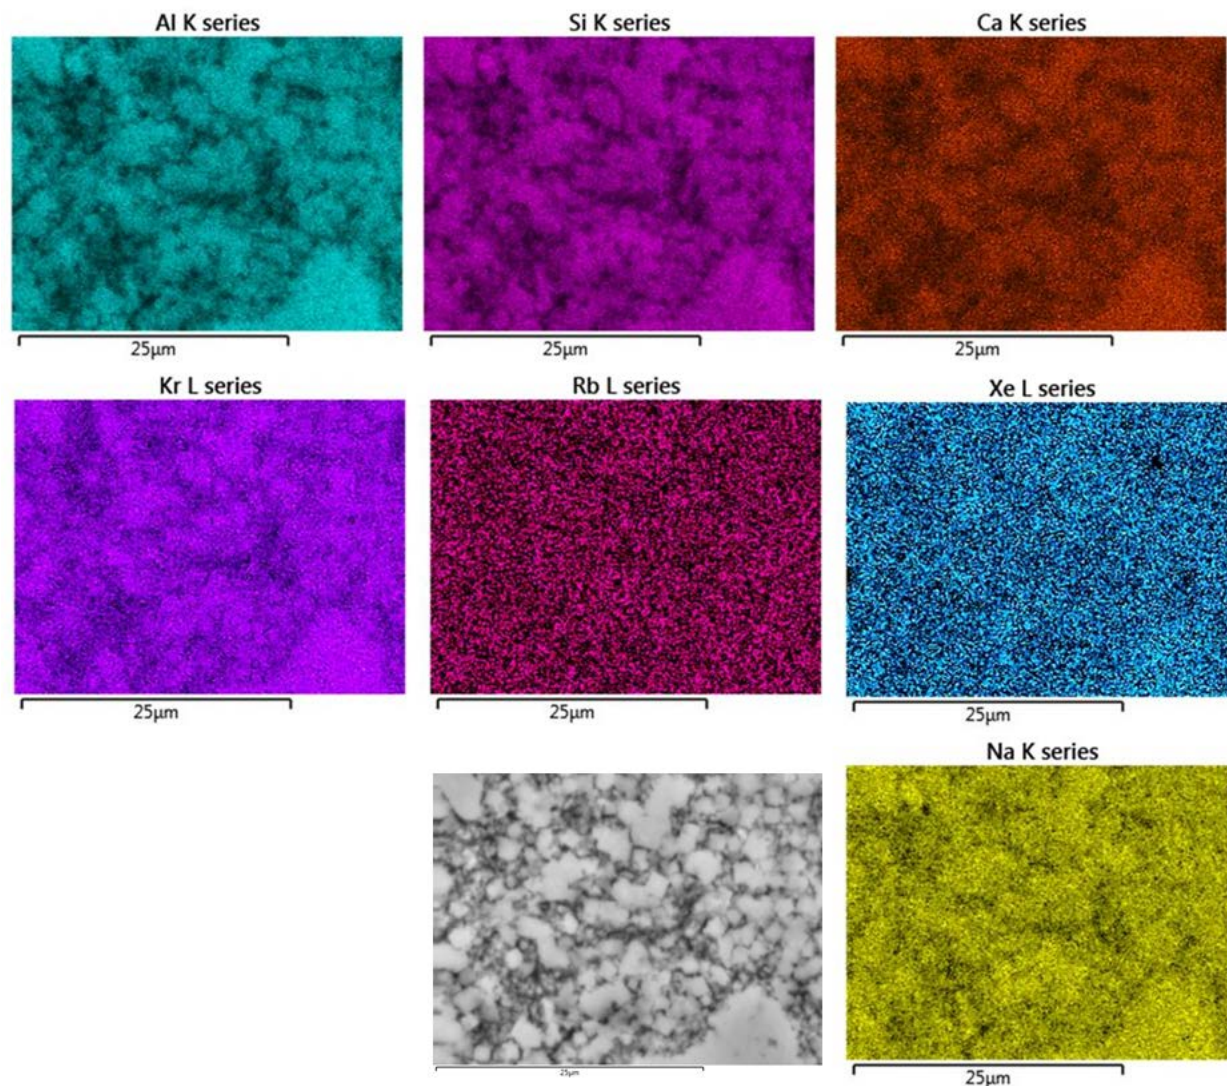
Figure 19: Elemental maps of area shown in bottom images of Figure 18 for pellet recovered from Capsule 2 [Sample K3].

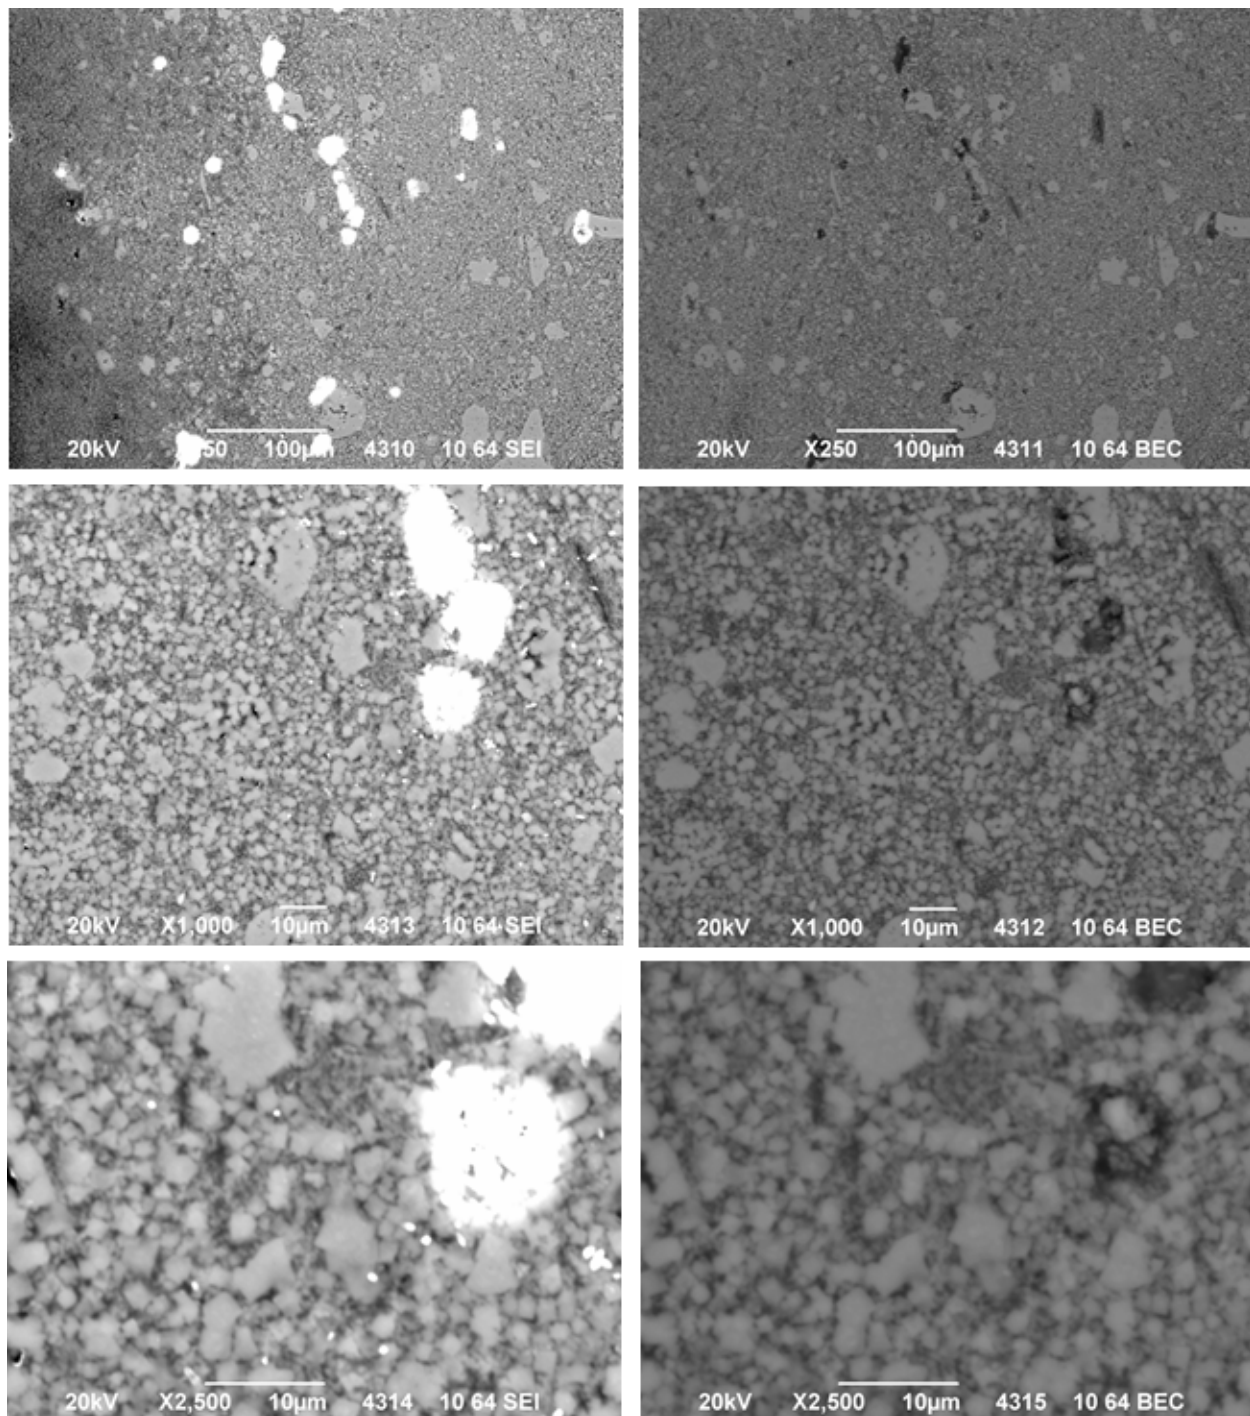
Figure 21: Detailed images of area near midpoint between center and edge of pellet recovered from Capsule 2 at 250× to 2500× magnification. SEI images on the left and backscatter images on the right (Images 4310 – 4315) [Sample K3].

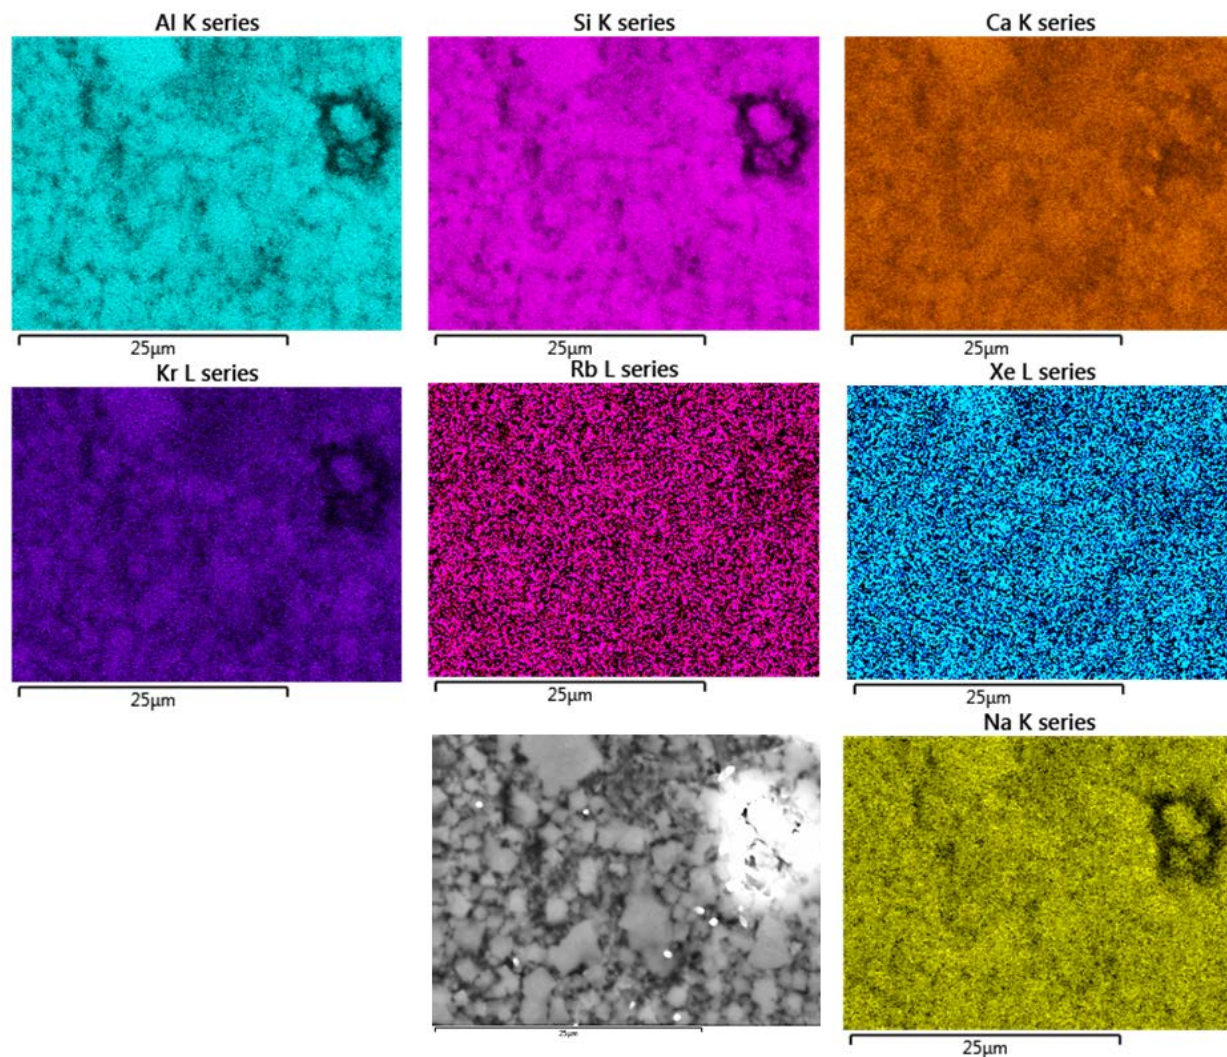
Figure 22: Elemental maps of area shown in bottom images of **Figure 21** for pellet recovered from Capsule 2 [Sample K3].

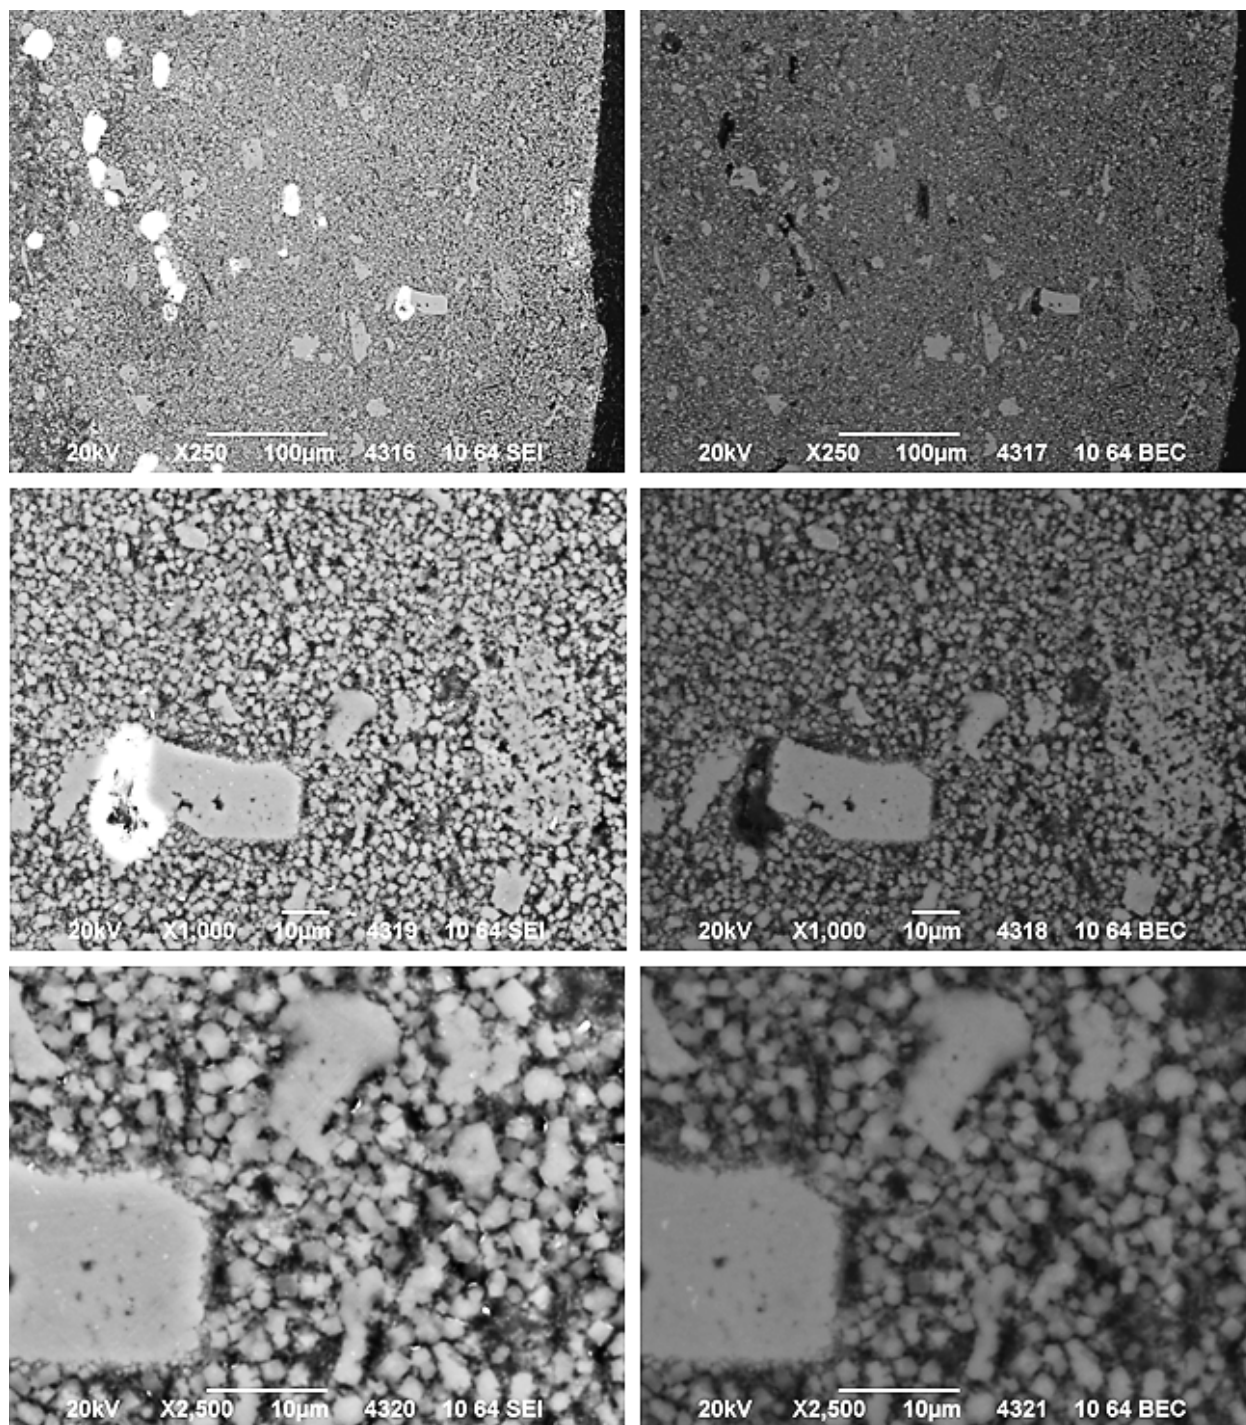
Figure 24: Detailed images of area near outer edge of pellet recovered from Capsule 2 at 250× to 2500× magnification. SEI images on left and backscatter images on the right (Images 4316 – 4321) [Sample K3].

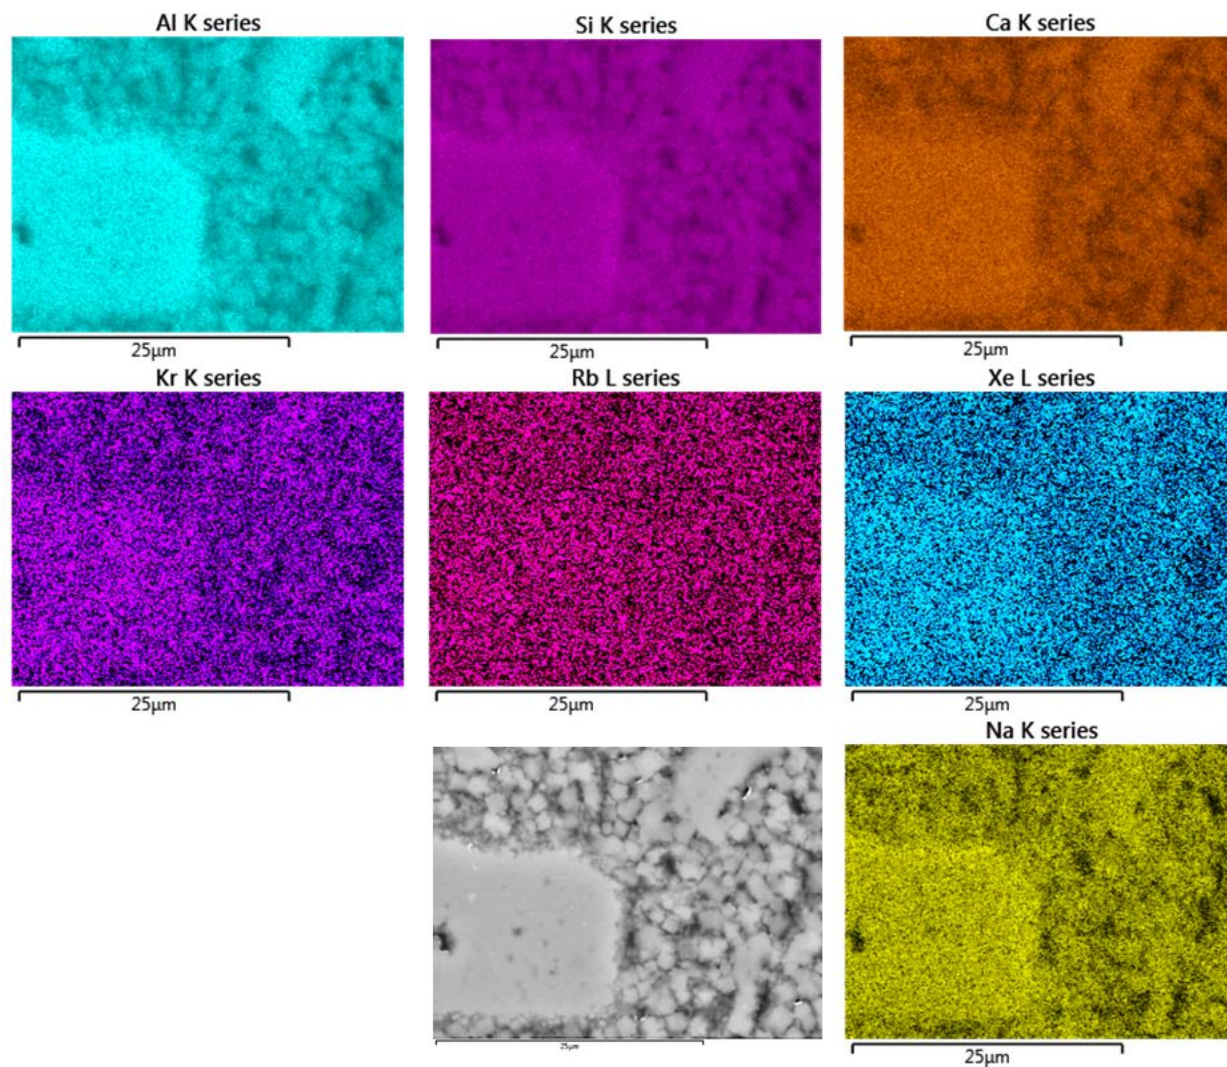
Figure 25: Elemental maps of area shown in bottom images of Figure 24 for pellet recovered from Capsule 2 [Sample K3].

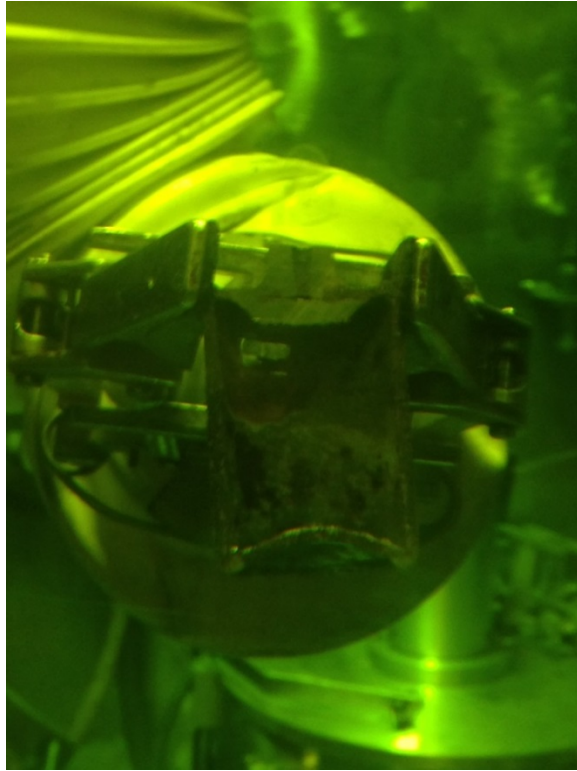
Capsule 2 was sectioned vertically, i.e., cutting down through the stem and down the vertical sides of the right circular cylinder using a diamond rotary saw. Water was used to cool the blade during cutting. The sectioned capsule (Figure 28) was examined visually with the aid of an optical microscope within the hot cell. Composite images from the optical microscope showing the interior of a halved Capsule 2 are shown in Figures 29 and 30. These figures show areas of probable corrosion damage on the inside of Capsule 2. Figure 31 is a magnification of the lower portion of Section A of the capsule that shows pitting and corrosion at multiple points on the Capsule 2 inner walls. Figure 29 also shows areas of apparent corrosion around the cut that was made on the capsule at an unknown time before the capsule was sent to Oak Ridge National Laboratory (ORNL). Note that both this capsule and Capsule 5 have been open to the atmosphere for extended periods of time, and any observations must be interpreted within that context. One potential concern is that the capsule may be reacting with the water and with air that was used while polishing was performed. Figures 29-31 also appear to show discoloration or potential areas of corrosion on the capsule wall cross section. This does not appear to be uniform across all of the cross-section area, with the weld areas showing far less discoloration or corrosion.

Figure 28: Section “A” of Capsule 2 looking through cell window.

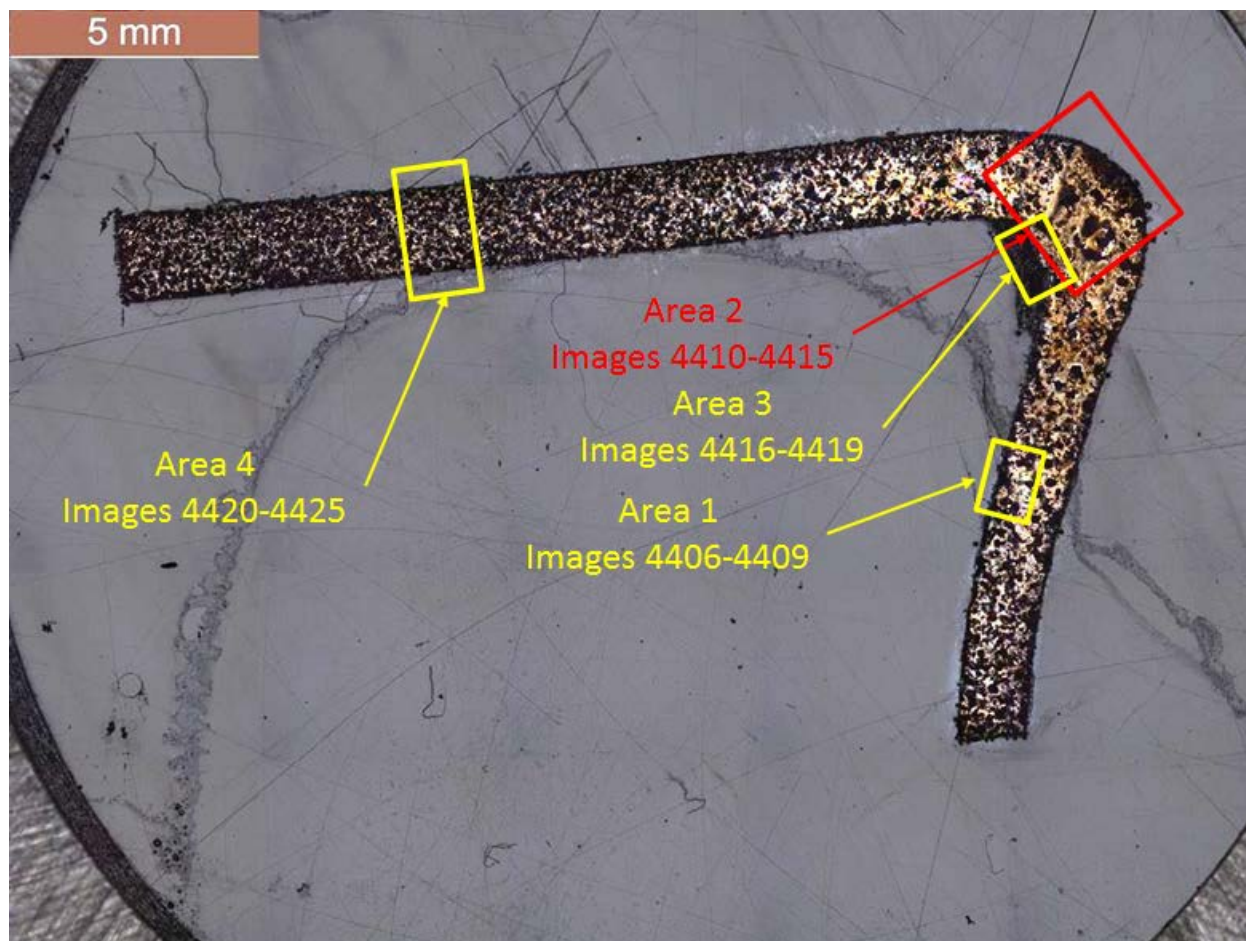
Figure 37: Annotated optical microscope image of Section "A" of Capsule 2 showing locations that were examined by SEM (Image MM2B2-0MS-001).

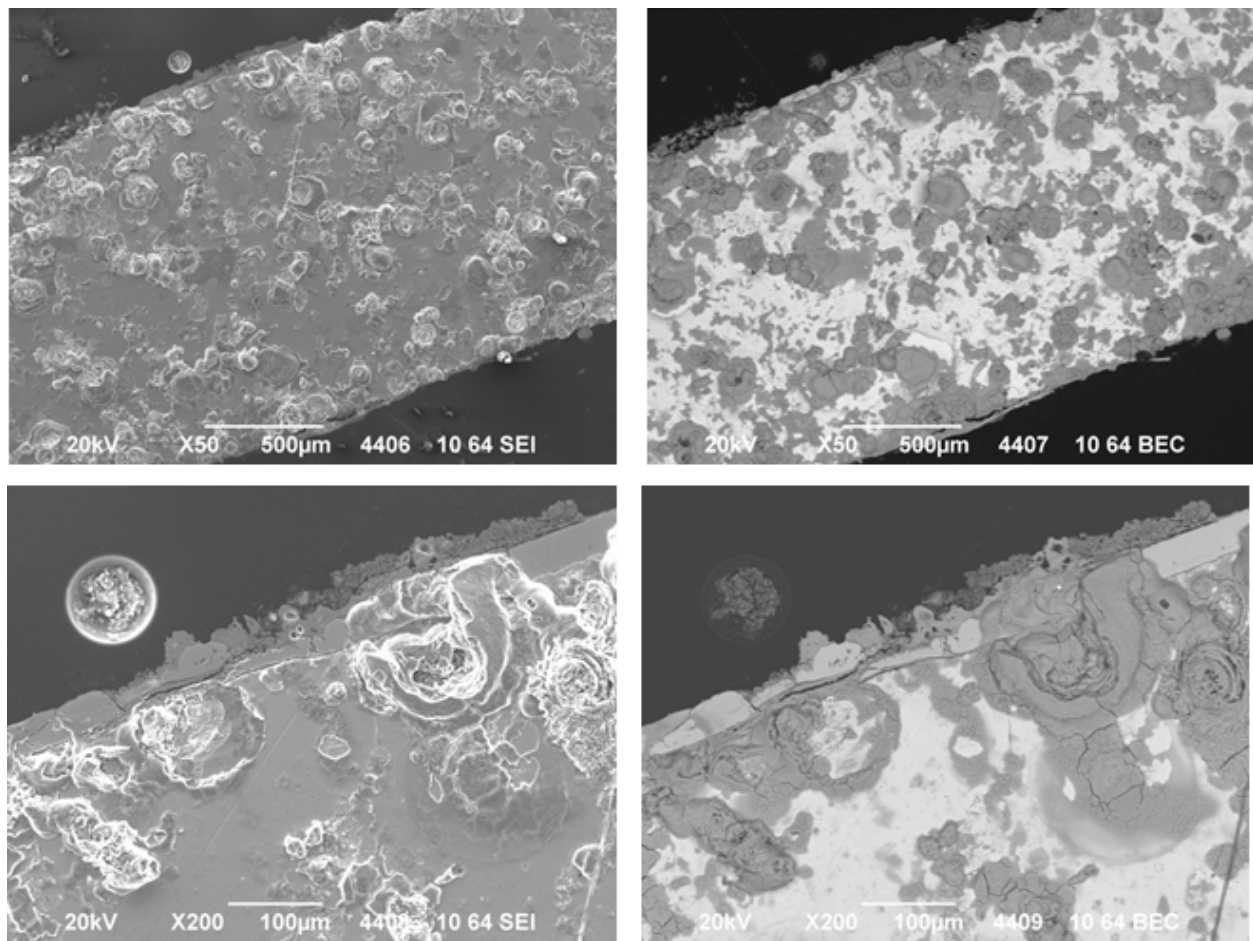
Figure 38: Detailed images of the wall of Capsule 2 at 50× to 200× magnification at Location 1. SEI images on the left and BEC images on the right (Images 4406 – 4409) [Sample 2B2].

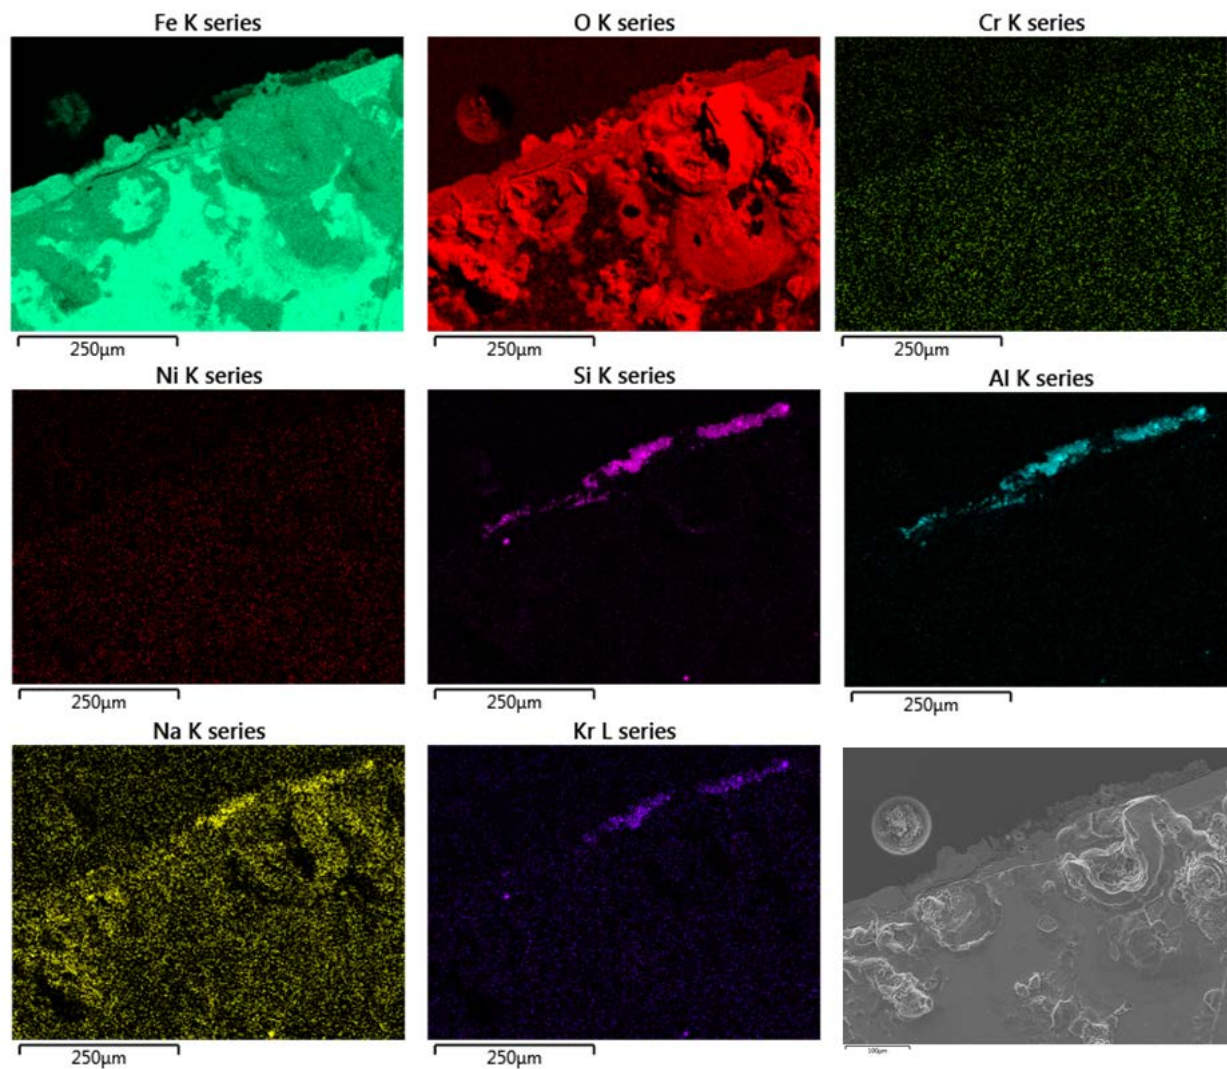
Figure 39: Elemental maps of area shown in bottom images of **Figure 38** for Area 1 of the wall segment from Capsule 2 [Sample 2B2].

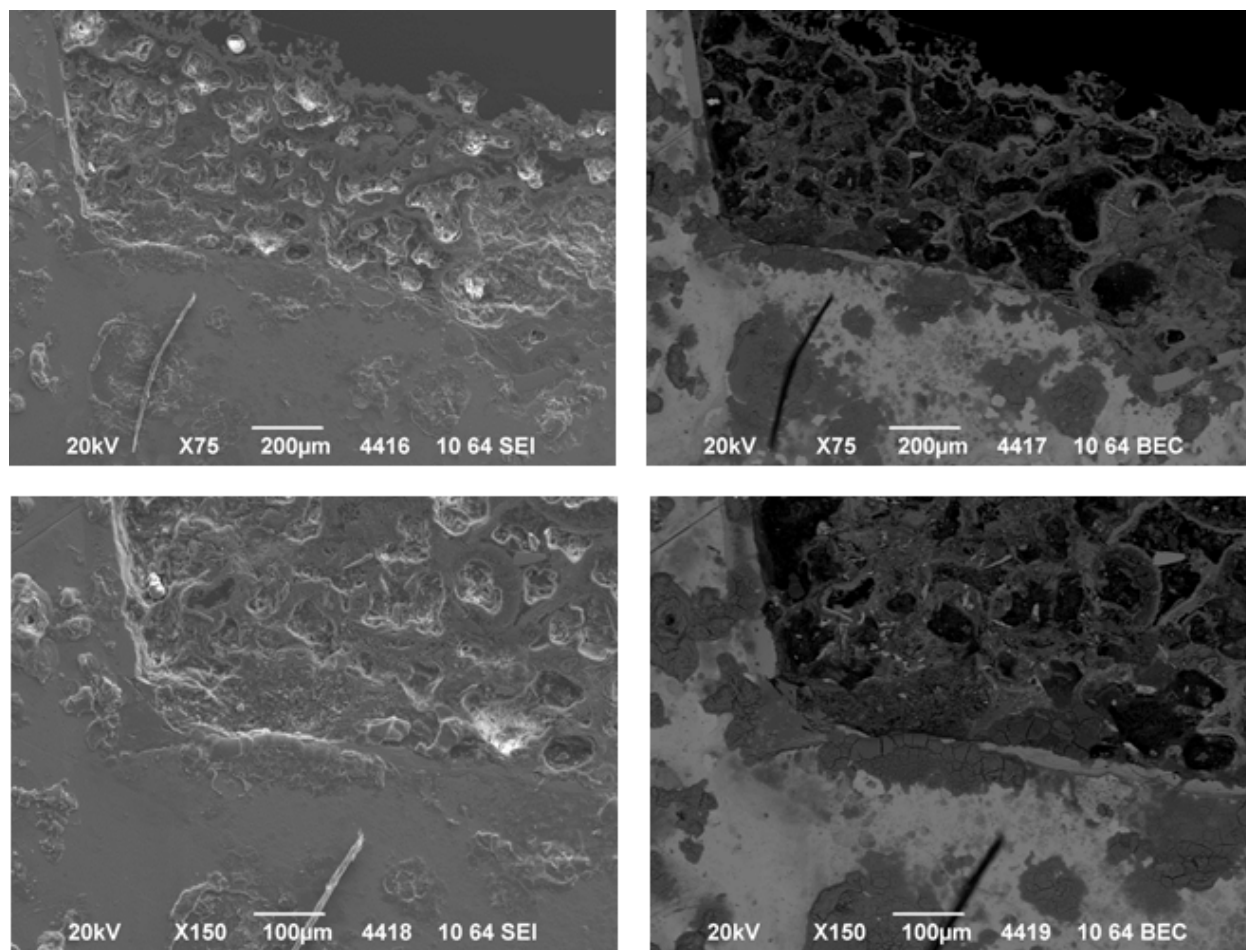
Figure 46 shows an interior corner of the weld site at 75 \times and at 150 \times magnification. Figure 47 shows the EDS elemental map for the higher resolution image associated with Figure 46. Note that only a portion of the area showing the presence of iron also shows the presence of Cr and Ni. It was also noted that elements associated with the zeolite material are located in a corner formed by the metal walls. Figure 48 is the annotated EDS layered image of the same location showing the areas at which individual elemental spectra were produced. These individual spectra are shown in Figure 49. The spectra in Figure 49A show a significant amount of Si but no Al. Manganese is present, but the origin is unknown at this time. Also the absence of Al is unexpected. It is possible that the Si and Mn are simply an impurity that was incorporated into the sample. The spectra in figure 49B show the presence of elements associated with the zeolite material and some Fe.

Figure 46: Detailed images of the wall of Capsule 2 at 75× to 150× magnification at Location 3. SEI images on the left and BEC images on the right (Images 4416 – 4419) [Sample 2B2].

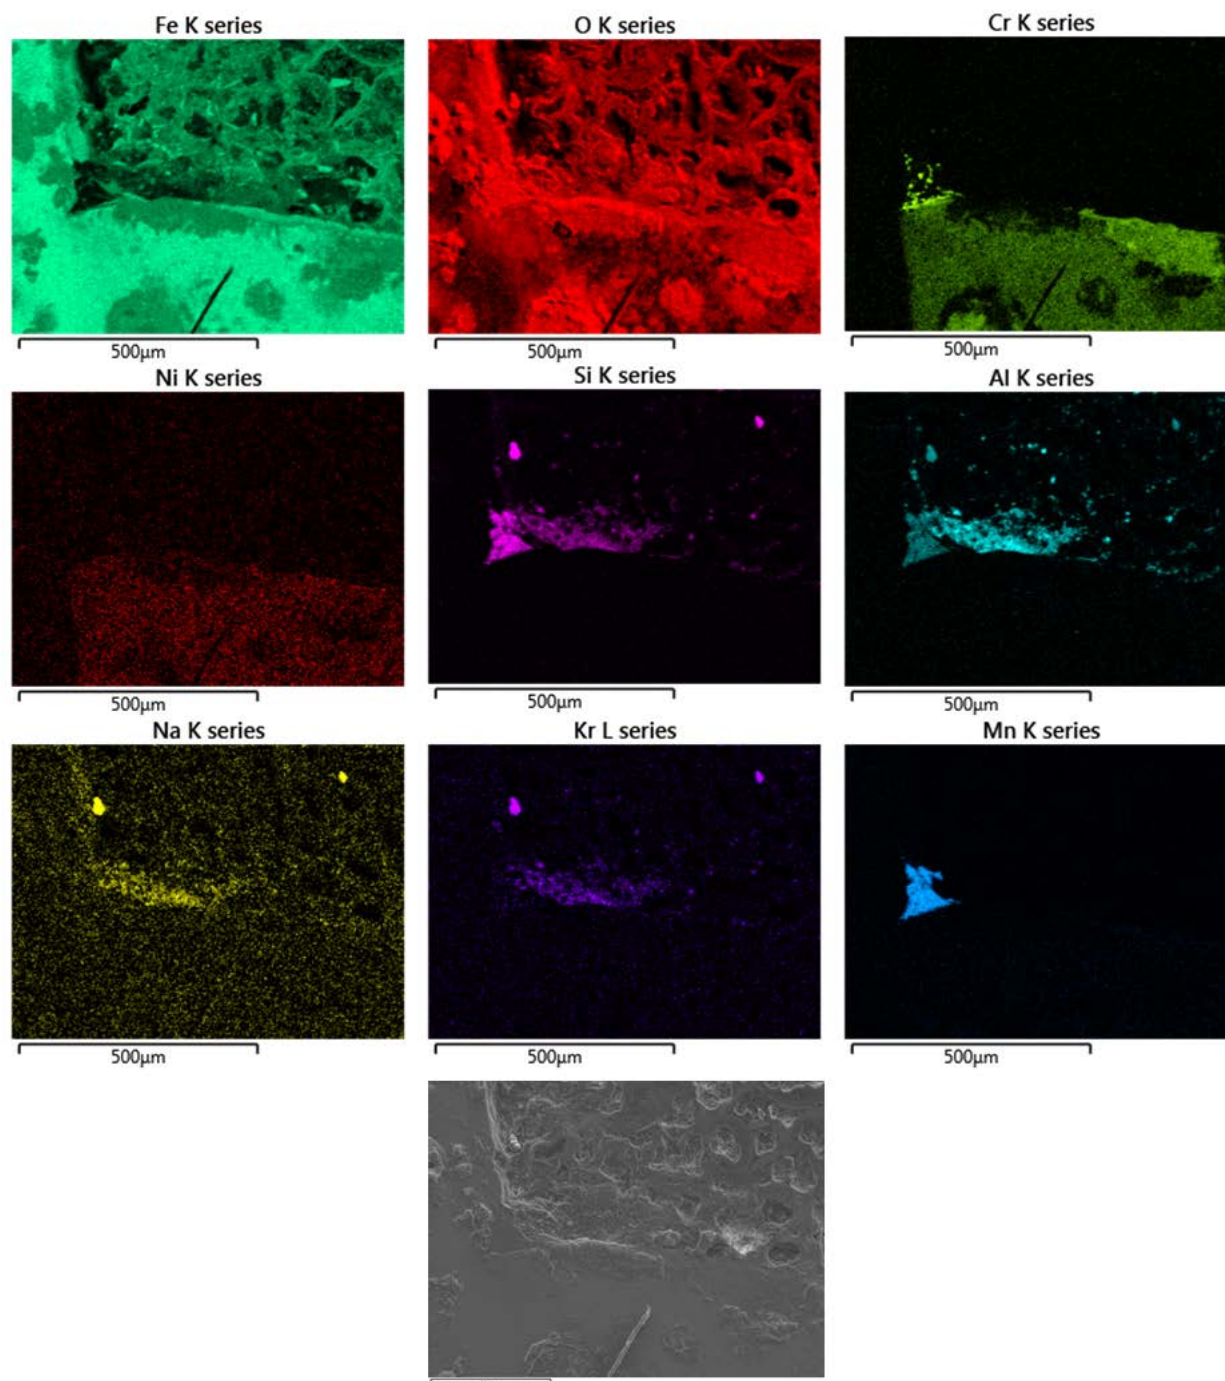
Figure 47: Elemental maps of area shown in bottom images of Figure 46 for Area 3 of the wall segment from Capsule 2 [Sample 2B2].
