Analysis of Selected Legacy ⁸⁵Kr Samples

Fuel Cycle Research & Development

***Prepared for
U.S. Department of Energy
Material Recovery and Waste Form
Development Campaign***

ORNL/TM-2016/350

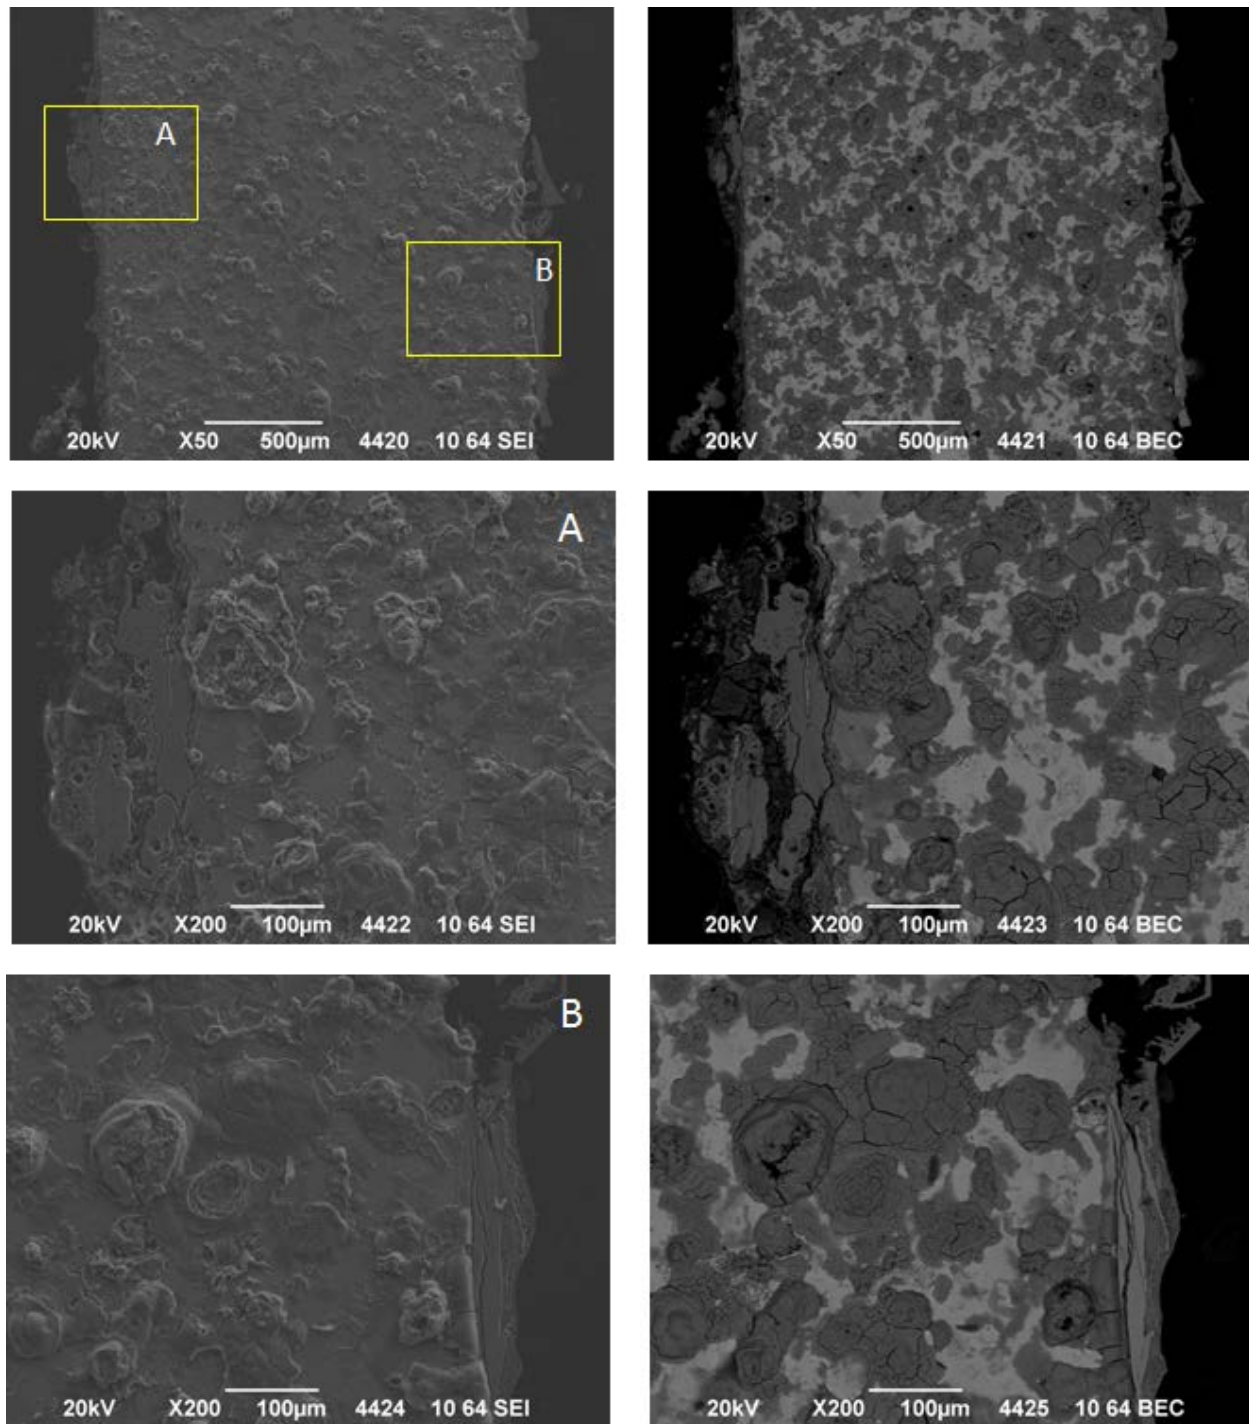
Figure 50 shows an interior corner the weld site at 50 \times and at 200 \times magnification. The middle images in Figure 50 are for area “A” noted in the top row of images. This is the exterior surface of the capsule. Figure 51 shows the EDS elemental map for the higher resolution image associated with middle row of images in Figure 50. Only Fe and O are observed in addition to the carbon used to coat the sample. This is consistent with the previous observations for area 1. Figure 52 shows the EDS elemental map for the higher resolution image associated with bottom row of images in Figure 50. These appear to show a number of individual layers on the interior surface of the capsule wall. Figure 53 is the annotated EDS layered image of the same location showing the areas at which individual elemental spectra were produced. These individual spectra are shown in Figure 54. The spectra in Figure 54A show iron oxide associated a pit within the wall. The spectra in Figure 54B show iron metal within the wall. The spectra in Figure 54C show an iron oxide layer with an O:Fe ratio of ~ 1 . The spectra in figure 54D show an iron oxide layer with a higher O:Fe ratio of ~ 2 . The spectra in Figure 54E show an iron oxide layer with an O:Fe ratio of ~ 1 .

Figure 50: Detailed images of the wall of Capsule 2 at 50× to 200× magnification at Location 4. SEI images on the left and BEC images on the right (Images 4420 – 4425) [Sample 2B2].

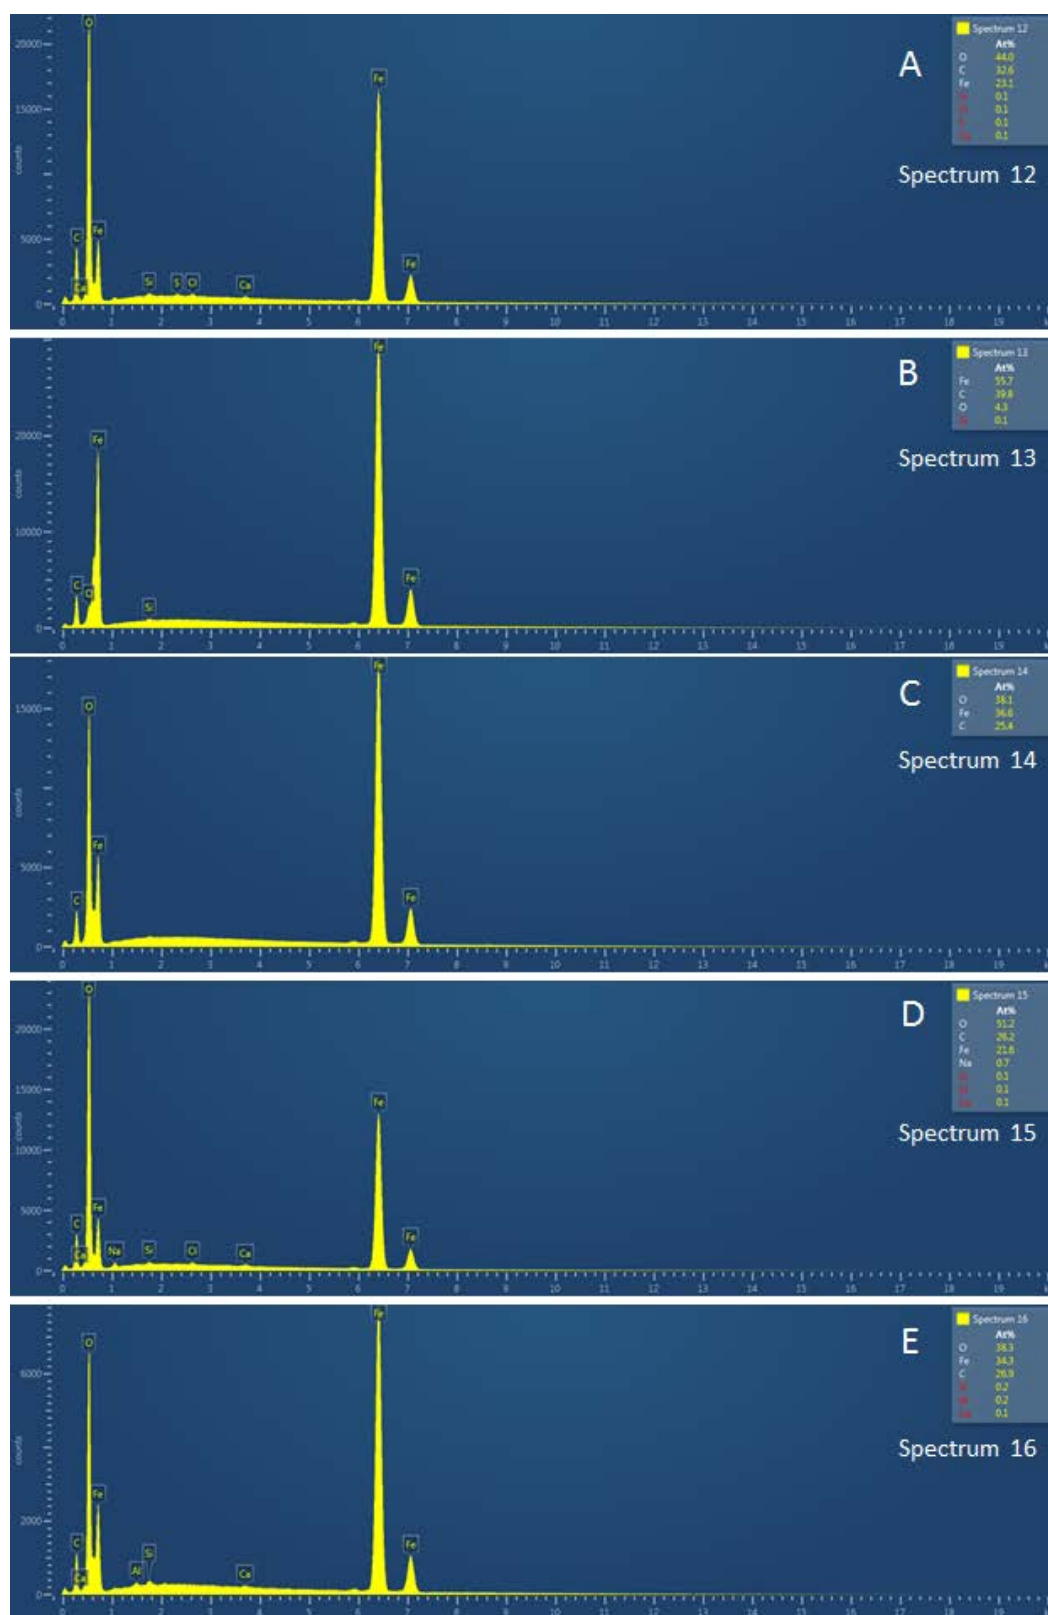
Figure 54: SEM-EDS spectra for the five sub-areas of the Capsule 2 wall segment shown in Figure 53 [Sample 2B2].

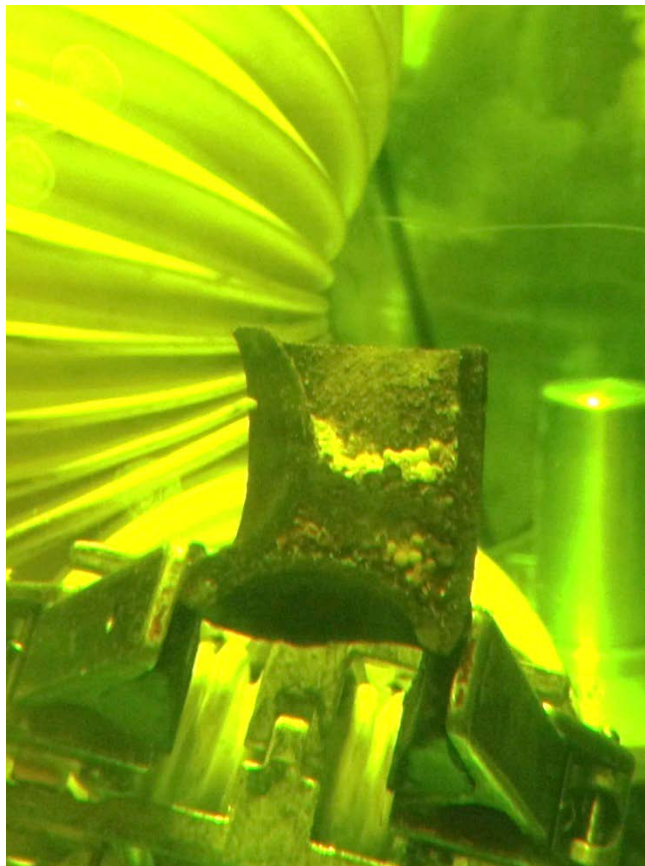
Figure 55: Section “A” of Capsule 5 looking through cell window.

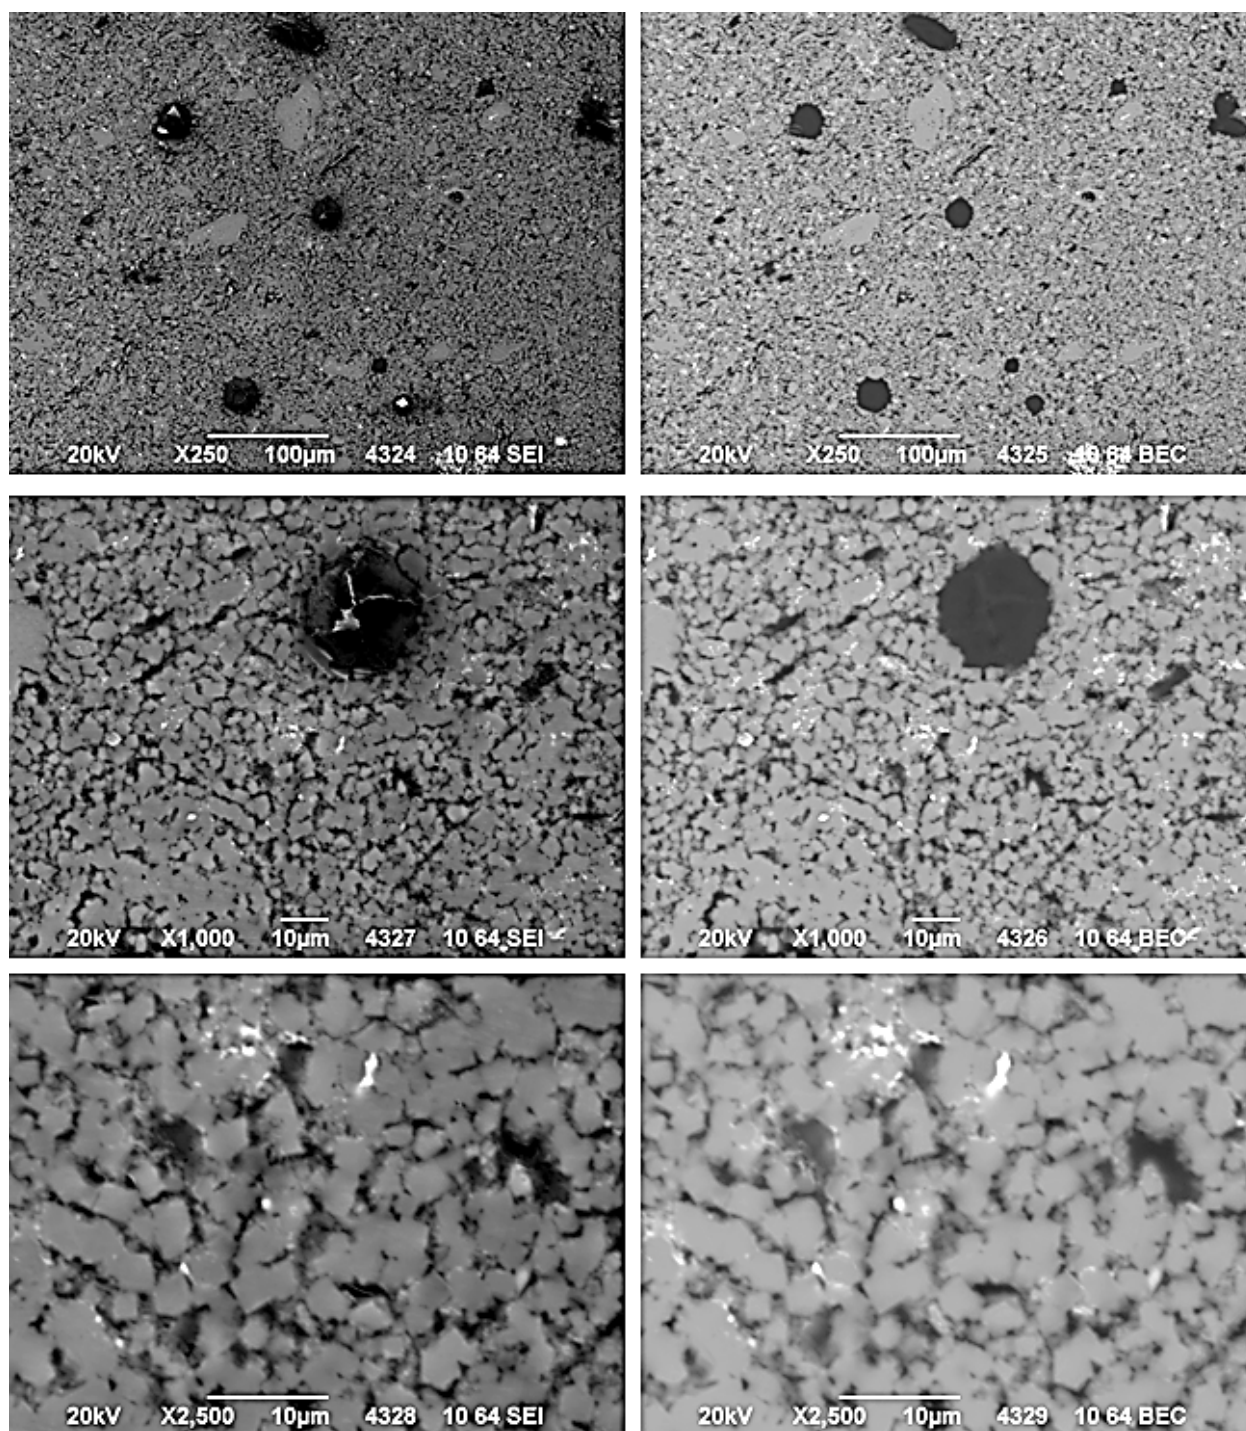
The SEM images do not appear to indicate an area of lower density material near the center of the pellet as was observed for the pellets from the unHIPed Capsule 2. In all cases, the elemental mapping of the three points across the pellets showed that the Al, Si, and Ca were coincident with each other. The approximate atom % numbers obtained from the EDS analysis are consistent with the composition of 5A molecular sieves. The Na is also consistent the production of 5A molecular sieve (MS) from 4A with the ~67% exchange of Ca for Na in the 4A molecular sieve⁴. The Kr and Xe elemental maps are also coincident with the Al, Si, and Ca which is indicative of the Kr being trapped in the zeolite structure. The Kr:Xe atom % numbers would indicate that the Kr that was loaded into the zeolite had some Xe impurities, ~20% Xe. These results are completely consistent with those from the material recovered from Capsule 2.

Figure 66: Detailed images of area near center of pellet recovered from Capsule 5 at 250× to 2500× magnification. SEI images on the left and backscatter images on the right (Images 4324–4329) [Sample K5].

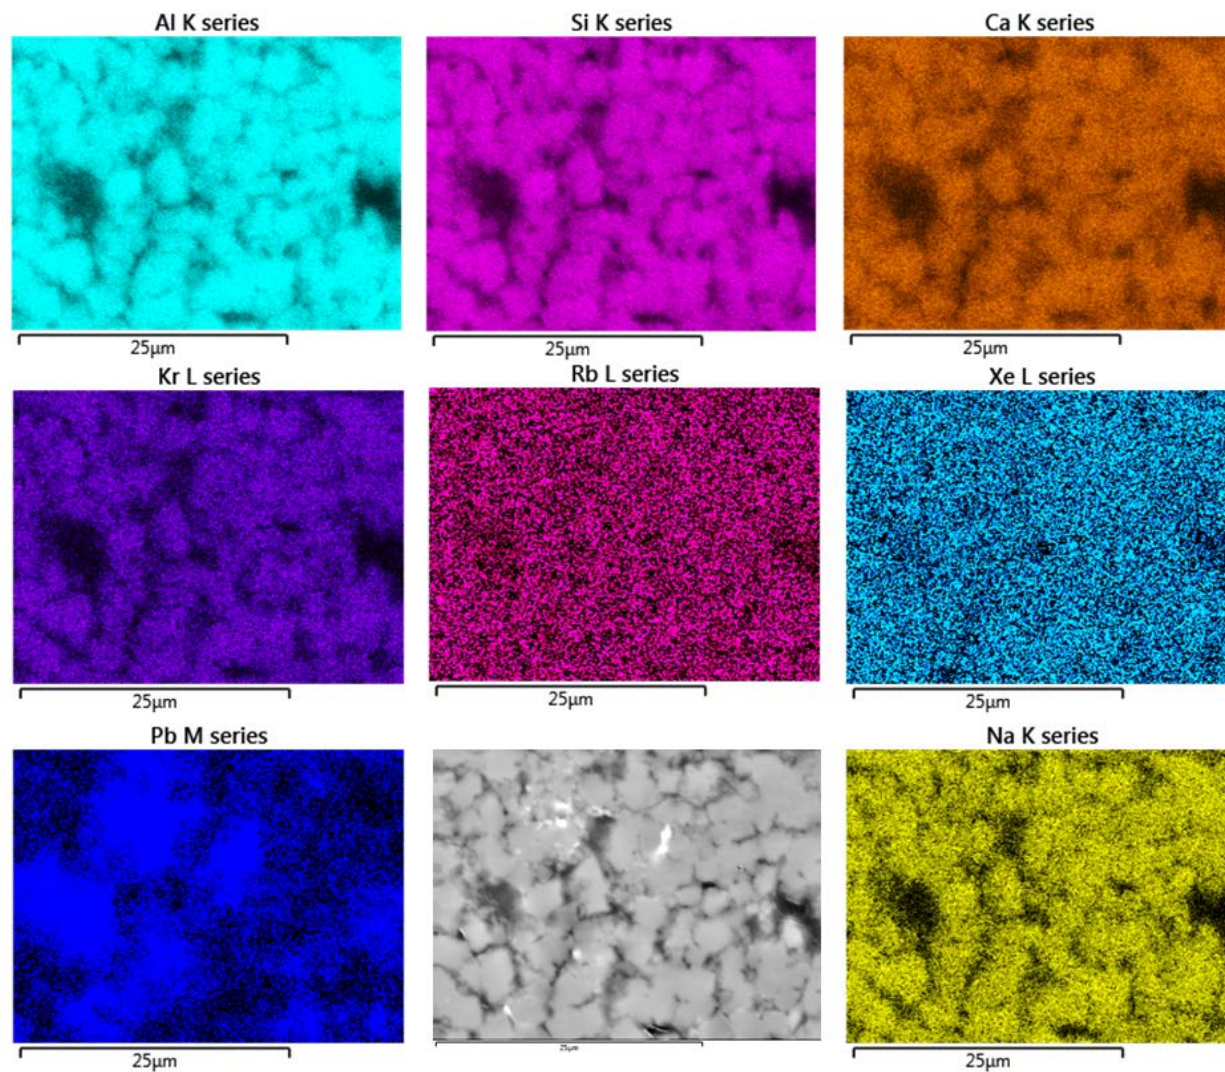
Figure 67: Elemental maps of area shown in bottom images of **Figure 66** for pellet recovered from Capsule 5 [Sample K5].

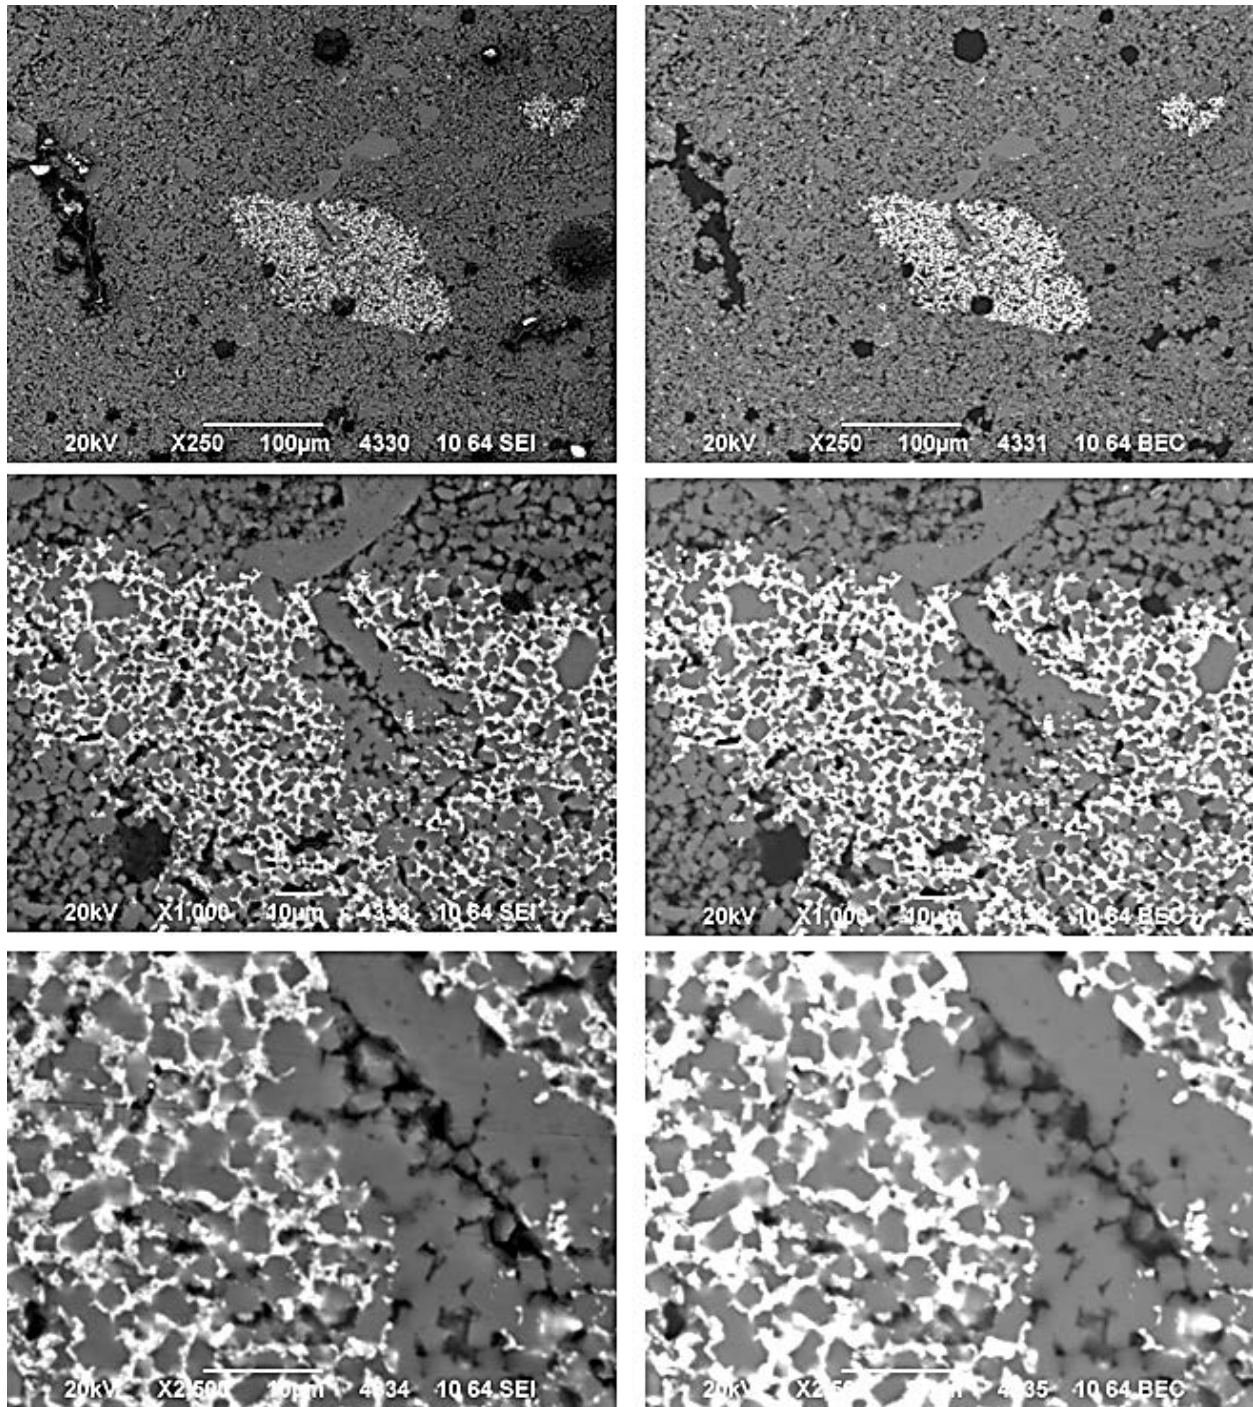
Figure 75: Detailed images of high-Z area near center of pellet recovered from Capsule 5 at 250× to 2500× magnification. SEI images on the left and backscatter images on the right (Images 4330–4335) [Sample K5].

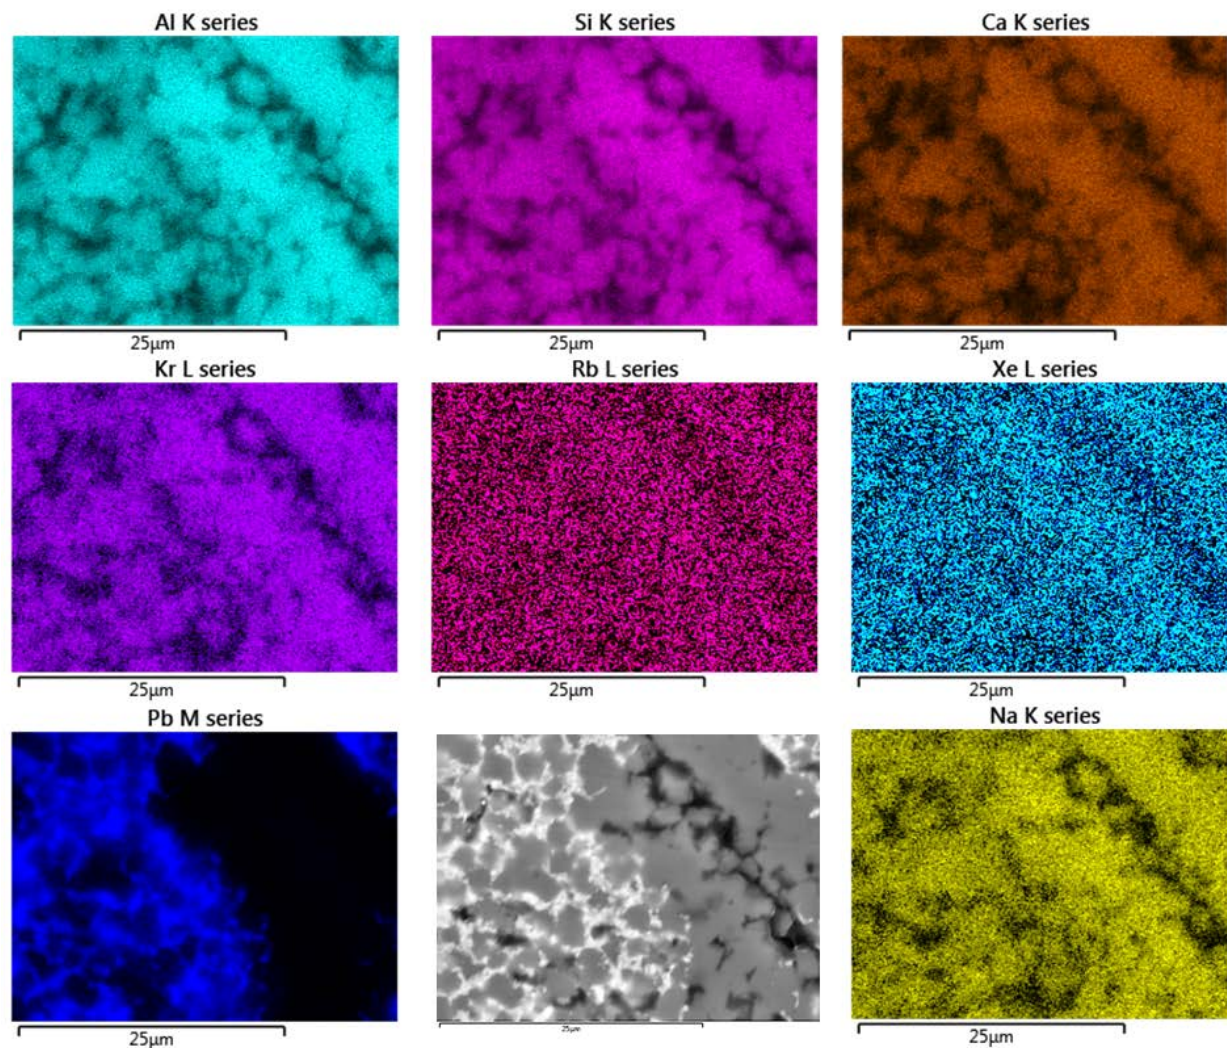
The examination of the bright spot noted on Figure 65 using EDS (Figures 76 and 77) revealed the presence of lead at about 1 at. %. The origin of the lead is currently unknown. This may have been used as a sintering aid during the HIPing process or for internal shielding. However, neither use has been noted in the literature found thus far regarding the origin of these samples.

Figure 76: Elemental maps of area shown in bottom images of Figure 75 for pellet recovered from Capsule 5 [Sample K5].

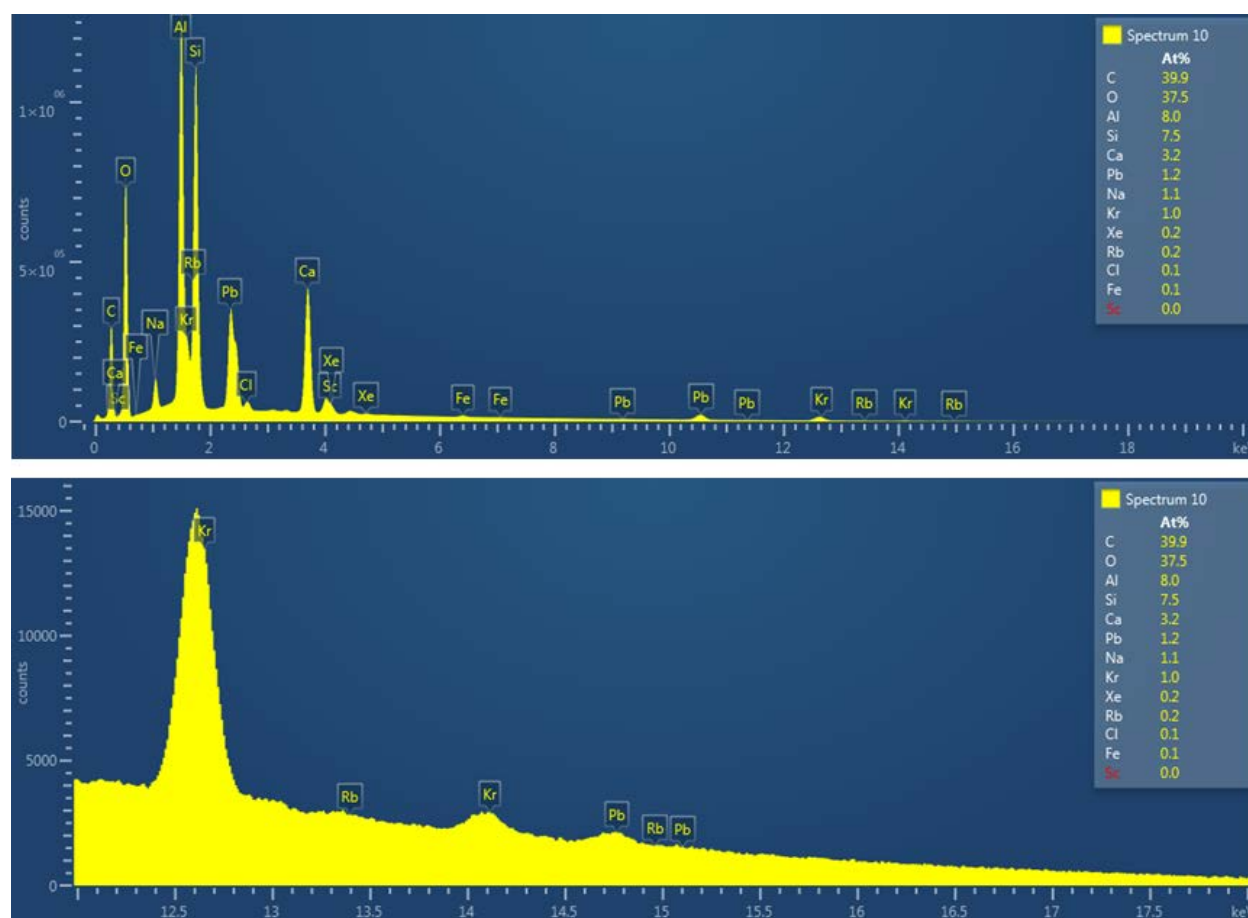
Figure 77: SEM-EDS of the high-Z area shown in the elemental maps for Image 4335 near center and edge of pellet recovered from Capsule 5 [Sample K5].

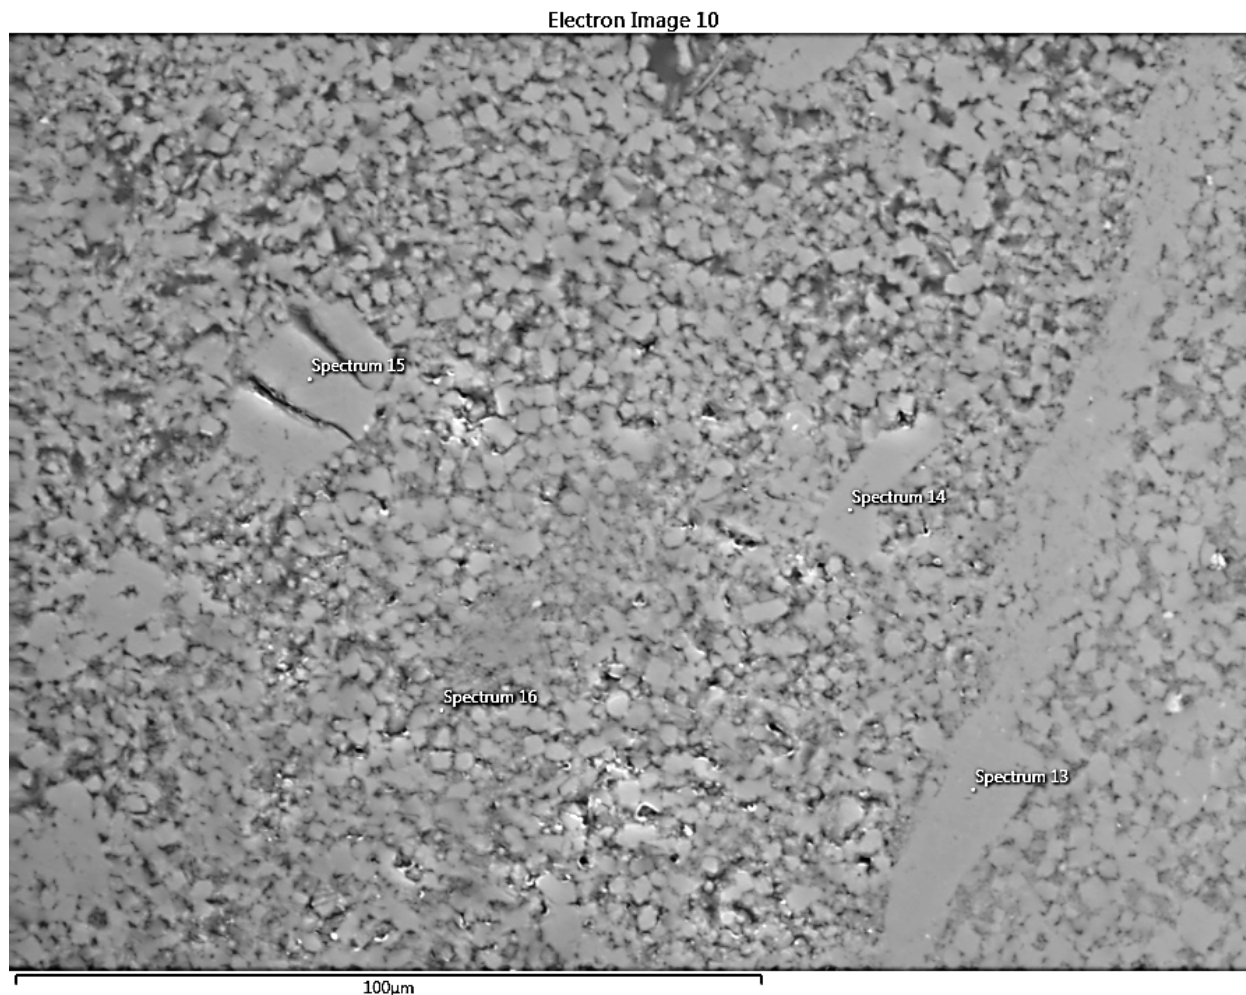
Figure 81: Backscatter electron image of interface area for HIPed pellet recovered from Capsule 5 at 750× magnification showing location for EDS point scans shown in Figures 82-85 (Image 4349) [Sample K5].

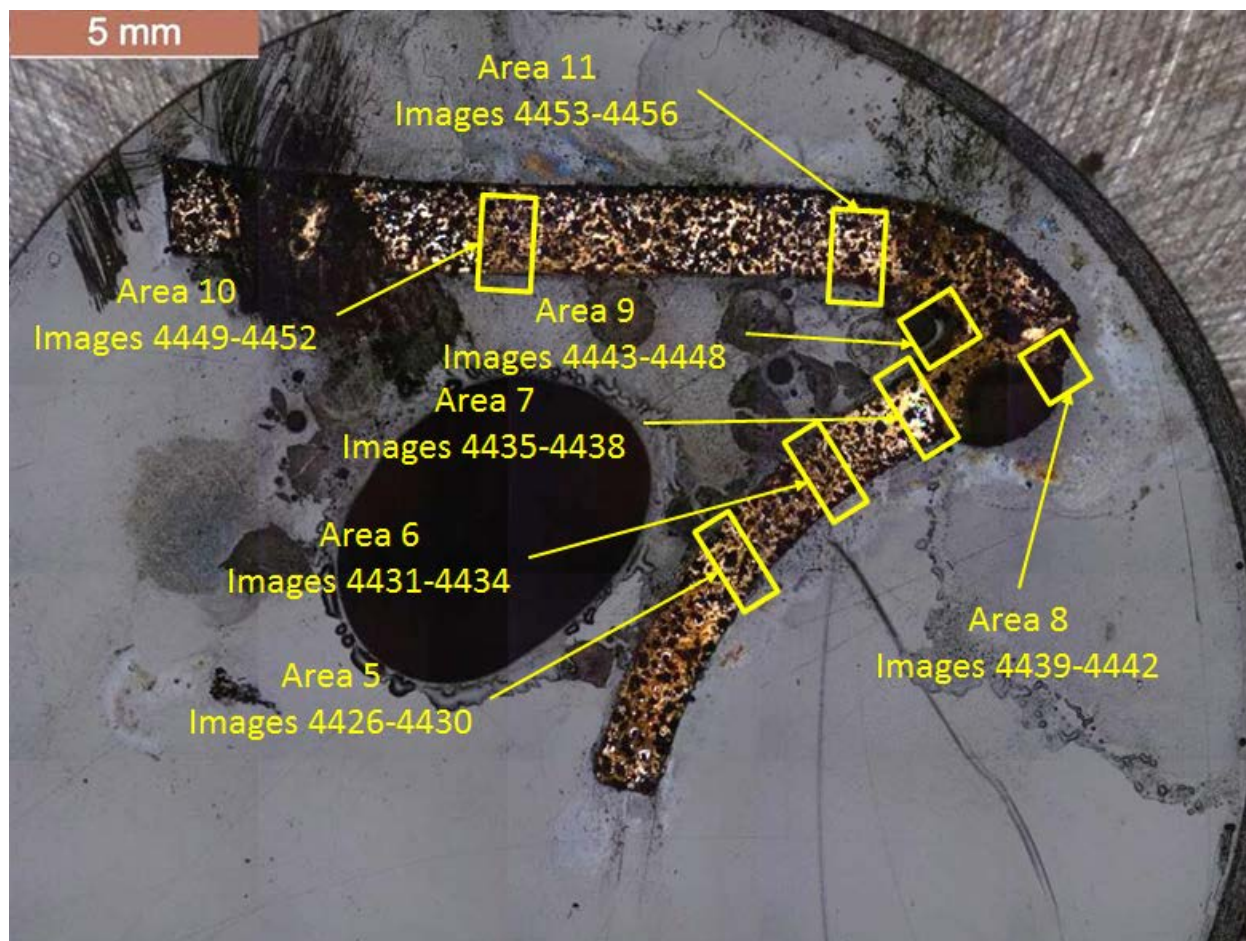
Figure 88: Annotated optical microscope image of Section "A" of Capsule 5 showing locations that were examined by SEM (Image MM5A2-0MS-001).

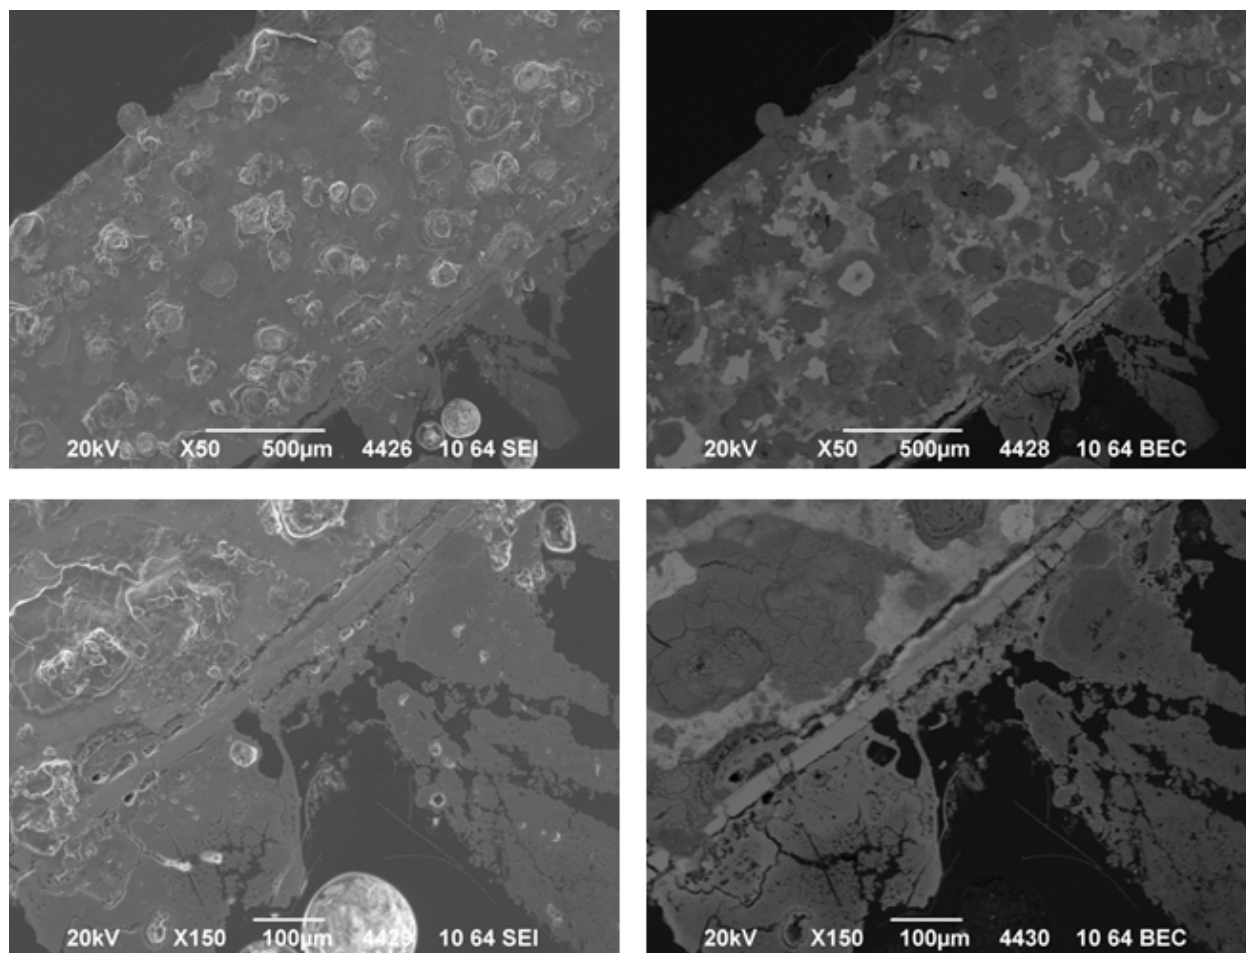
Figure 89: Detailed images of the wall of Capsule 5 at 50× to 200× magnification at location 5. SEI images on the left and BEC images on the right (Images 4426–4429) [Sample 5AB2].

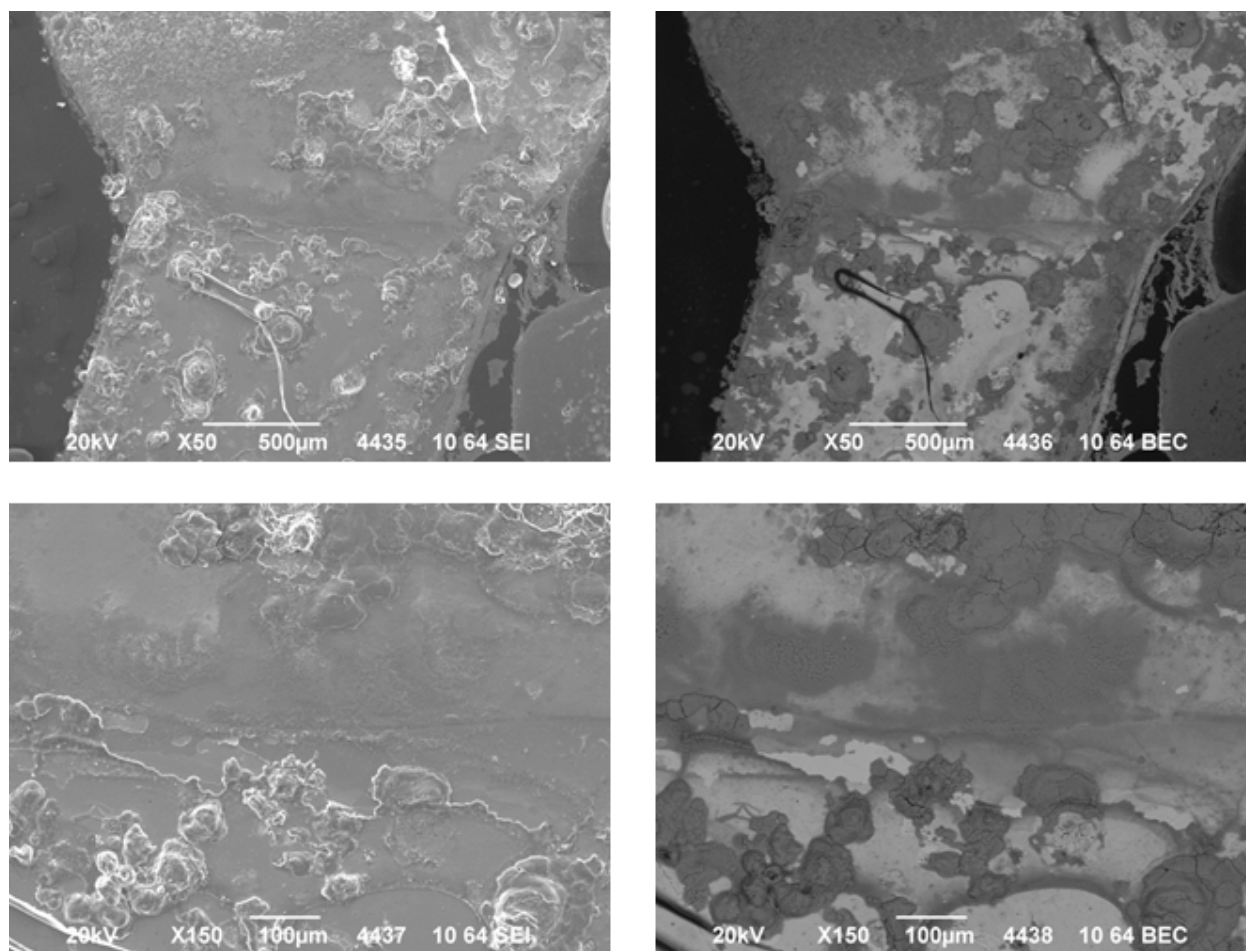
Figure 97 shows the cross section of the capsule wall in area 7 at 50× and a 150×. This area appears to be a weld. Figure 98 shows the EDS elemental map for the higher resolution image associated with Figure 97. Of note is the clear line separating the region containing Cr and, to a lesser degree, Ni from the carbon steel areas. Figure 99 is the annotated EDS layered image of the same location showing the areas at which individual elemental spectra were produced. These individual spectra are shown in Figure 100. The spectra for the weld metal, weld interface and base metal are shown in Figures 100A, 100B and 100C, respectively.

Figure 97: Detailed images of the wall of Capsule 5 at 50× to 150× magnification at location 7. SEI images on the left and BEC images on the right (Images 4435–4438) [Sample 5A2].

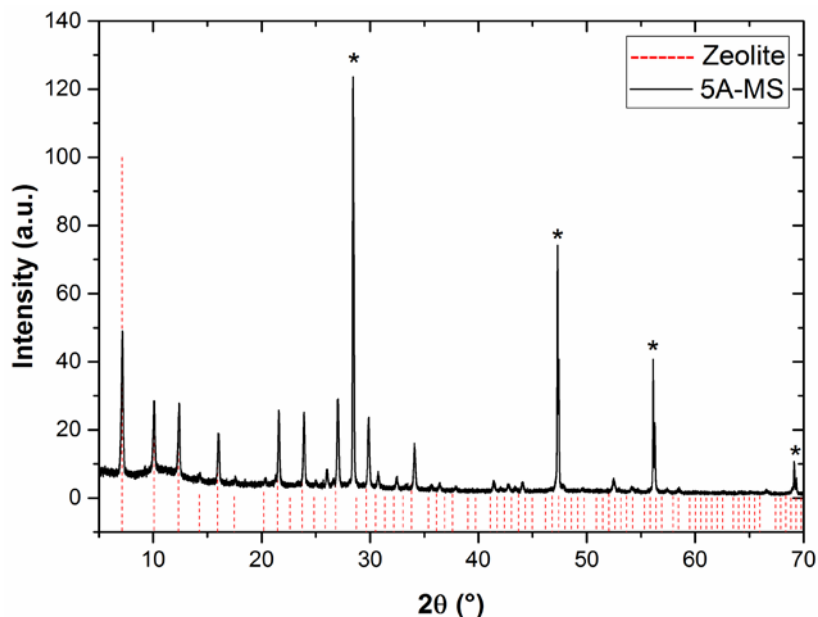
Figure 121: Experimental XRD pattern of fresh 5A zeolite sample (black color) and the reference pattern for zeolite 5A (red color lines). Asterisks indicate the reflections corresponding to Si standard.

The XRD patterns (Figure 122) of the samples of the zeolite material recovered from Capsules 2 and 5 did not show significant peak intensities that correspond to the reflections of recently procured commercially available zeolite 5A MS material. Samples from Capsule 2 are designated K2 and K3, and those from Capsule 5 are noted as K4 and K5. K3 and K5 were coated with a thin layer of carbon to improve the SEM analysis, and samples K2 and K4 were not coated. The XRD patterns for these four samples are remarkably similar and show a significant alteration from the presumed 5A zeolite starting material.
