Complete Status Report Documenting Weld Development for Thin Wall Tubing of ODS Ferritic Alloys

Fuel Cycle Research and Development (FCRD) Program

Oak Ridge National Laboratory

Date Published: September 16, 2016

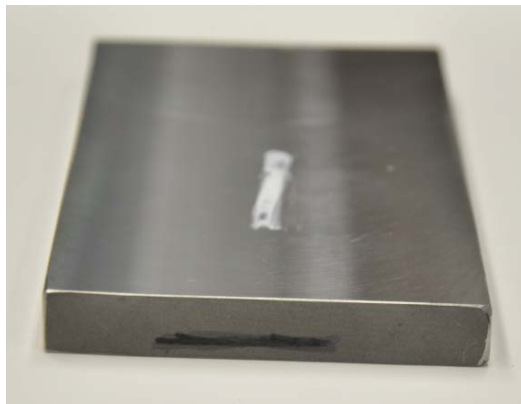
Figure 1. Digital image showing the 1.06 cm thick plate of 14YWT used for hot rolling to thinner plate thicknesses.

The plate used in the initial FSW experiment in FY15 was produced from 14YWT (SM13 heat). Figure 1 shows the 1.06 cm thick plate of 14YWT that was used in the rolling experiments to produce the 0.1 cm thick plate. Three rolling passes were performed after annealing the plate at 1000°C for ~10 minutes using both cross rolling (perpendicular relative to the extrusion direction) and parallel rolling orientations.

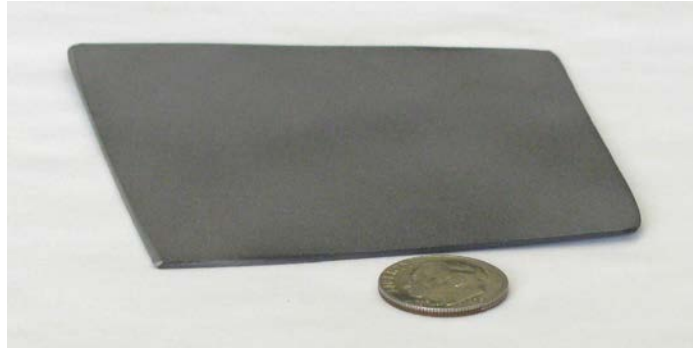
Figure 2. Digital image showing the 0.1 cm thick plate used in the first FSW experiment.

After the 3 rolling passes of ~50% reductions in thickness (RIT) each, the 0.1 cm plate shown in Figure 2 was produced. Inspection of the plate showed no edge cracks were present, which was significant since

the total amount of rolling deformation from the initial thickness of the extruded bar (~2.12 cm) to the final thickness of 0.1 cm was 95.3% RIT.

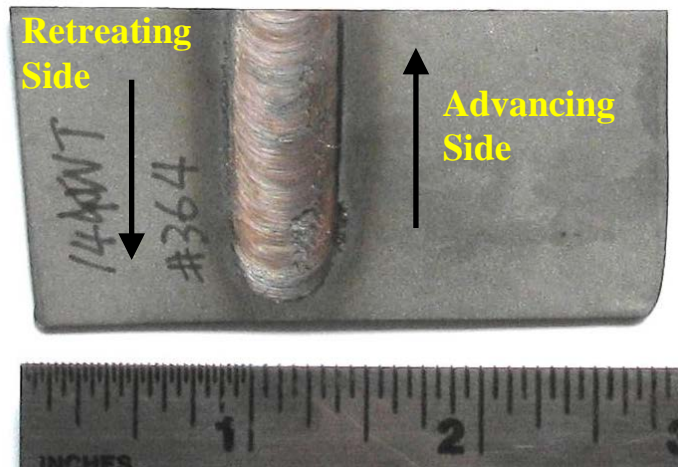
Figure 3. Digital image showing the bead-on-plate weld zone obtained by FSW on the 0.1 cm thick plate of 14YWT.

The initial FSW run performed on the 0.1 cm thick plate successfully produced a bead-on-plate stir zone shown as shown in Figure 3. The advancing and retreating sides of the spinning pin tool are shown in the Figure, in this case the pin tool traveled in the direction of the advancing side. From optical inspection, the bead-on-plate weld zone showed good mixing with no evidence of defects such as cavities. The swirl flow pattern observed for the bead-on-plate stir zone is commonly observed with FSW joints, which indicates that sufficient heat from friction generated between the rotating and traveling shoulder and pin tool with the 14YWT plate caused material to be redistributed from the front to the rear (retreating side) of the bead-on-plate stir zone. The success of the first FSW attempt was novel, since there have been no studies in the published literature that have attempted FSW on thin plates of ODS alloys.

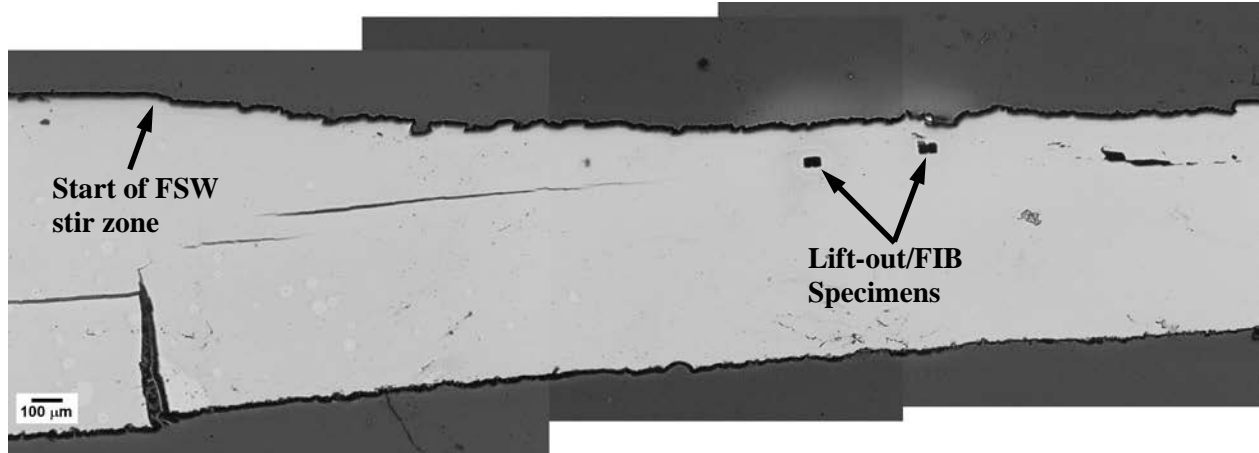
Figure 5. Composite of three OM images at higher magnification showing the location and orientation of several cracks and the two lift-out/FIB specimens on the retreating side of the bead-on-plate stir zone.

A composite of three OM images at a higher magnification showing the region containing the crack on the retreating side of the FSW bead-on-plate stir zone is shown in Figure 5. In addition to the large crack emanating from the bottom surface, several approximately horizontal cracks are observed both in the stir zone and outside the stir zone that lie closer to the top surface of the sample. This composite OM image also shows more clearly the reduction in thickness of the material associated with FSW bead-on-plate stir zone, which appears to be more severe on the top side compared to the bottom size. This observation is expected since the tapered pin tool did not penetrate through the 0.1 cm thick plate. Also shown in the composite image are the two regions used in preparing the lift-out/FIB specimens for STEM analysis. Their location indicates that their microstructures are representative of the stir zone. In both cases, the lift-out/FIB specimens were oriented vertically in reference to the composite OM image. This orientation captures the deformation flow of material caused by the traveling spinning pin tool during FSW.

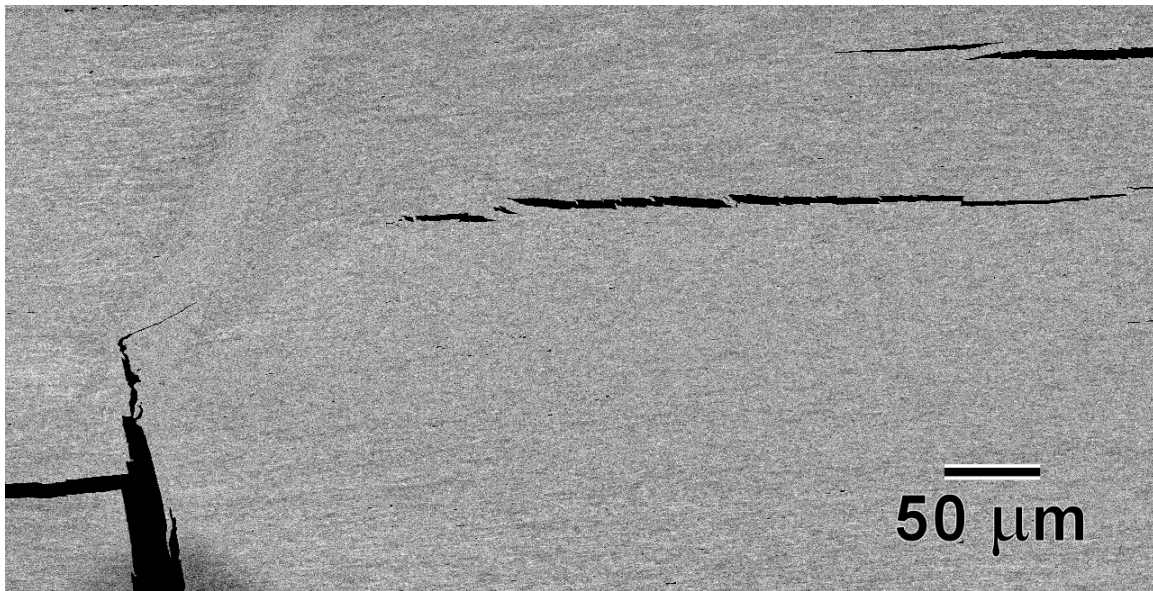
Figure 6. SEM BSE image at low magnification showing the grain structure associated with the stir zone and cracks on the retreating side of the bead-on-plate stir zone.

The BSE micrograph shown in Figure 6 was recorded at low magnification to show the grain structure texture on the retreating side of the bead-on-plate stir zone. The speckled contrast is due to the ultra-fine grain size, which is not resolved at the low magnification, and appears to be fairly homogeneous across the field of view. No interfacial boundary was observed that clearly defined the stir zone (SZ) from the thermo-mechanically affected zone (TMAZ). The BSE image shows that the horizontal cracks are not continuous, but contain small ledges protruding from the top and bottom internal surfaces. These features are also observed with the large crack that formed from the bottom surface of the 0.1 cm thick plate. The reason for the formation of the horizontal cracks is not known, but may be due to insufficient pressure from the spinning shoulder and pin tool during the FSW run. In this case, bands of material that are sheared on the advancing side of the spinning pin tool flow around to the retreating side where they are consolidated by forging processes. However, if the pressure is not high enough then the down ward force

will not be sufficient to consolidate the sheared bands of material resulting in the horizontal cracks. Although this is conjecture, research will continue for explaining the formation of the cracks.

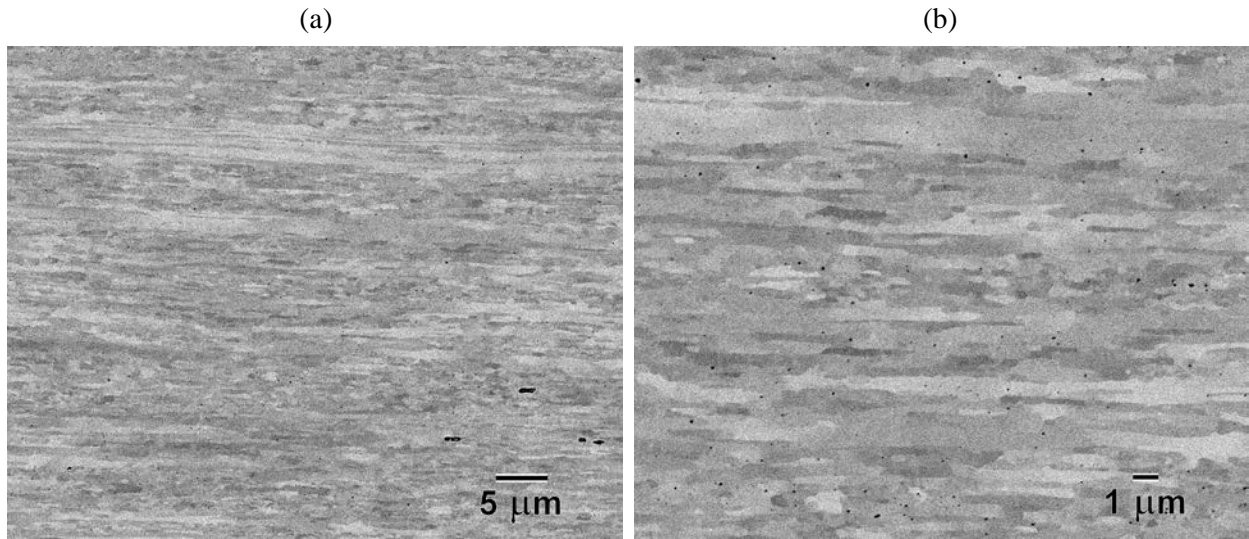
Figure 7. BSE micrographs showing the elongated morphology and horizontal orientation of the grain structure in the unaffected zone of the FSW sample at (a) lower and (b) higher magnifications.

The microstructure observed away from the SZ in the unaffected zone is shown in Figure 7. The BSE micrographs were recorded at lower (Fig. 7a) and higher (Fig.7b) magnifications to show that the grain structured was highly elongated and oriented horizontally, i.e. in the plane of the 0.1 cm thick plate. The severe elongation and orientation of the grains was due to the 95% deformation during hot rolling to form the 0.1 cm thick plate of 14YWT.

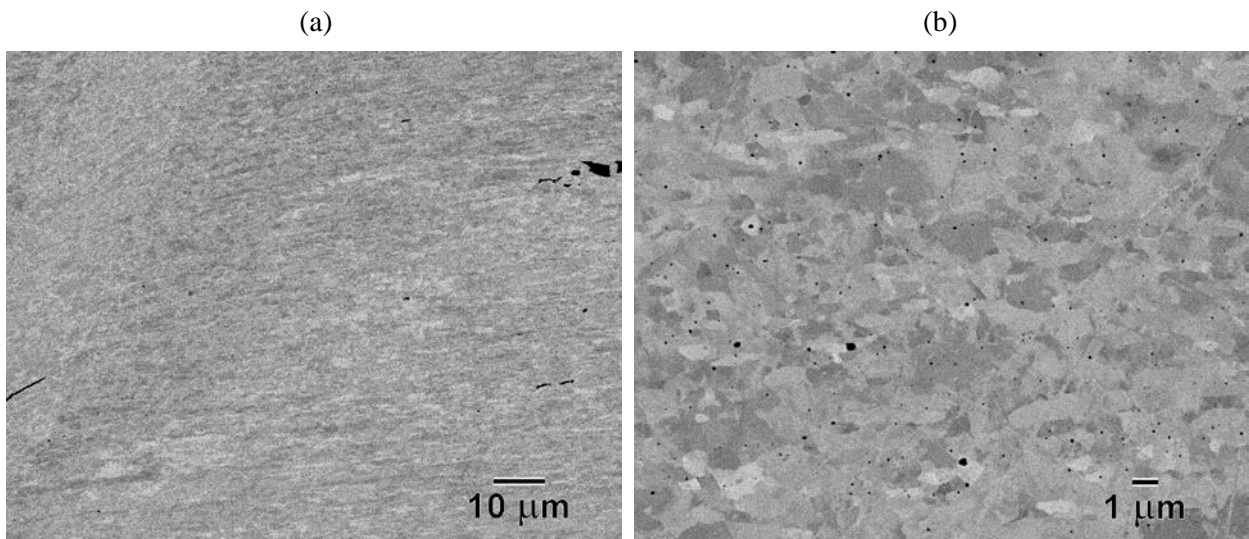
Figure 8. BSE micrographs showing the grain structure observed in the (a) TMAZ and (b) SZ in regions of the FSW sample located on retreating side.

Figure 8 shows BSE micrographs of representative regions for the TMAZ (Fig. 8a) and SZ (Fig. 8b) located on the retreating side of the FSW plate. Although the grains in the TMAZ are elongated and oriented horizontally, there appears to be some texture that cause variations in the observed contrast. This could be due to small variations in grain size and orientation in the TMAZ. In this case, the microstructure of the TMAZ still maintains similarities with that of the unaffected zone, but experiences some frictional heat and limited deformation caused by the spinning pin tool during FSW. Compared to the grain structure observed in the unaffected zone (Fig.7b), the grain structure observed in the SZ appears more isotropic and irregular in shape with some degree of increase in size. These observations indicate that the grains associated with the SZ experienced much higher levels of frictional heat and deformation.

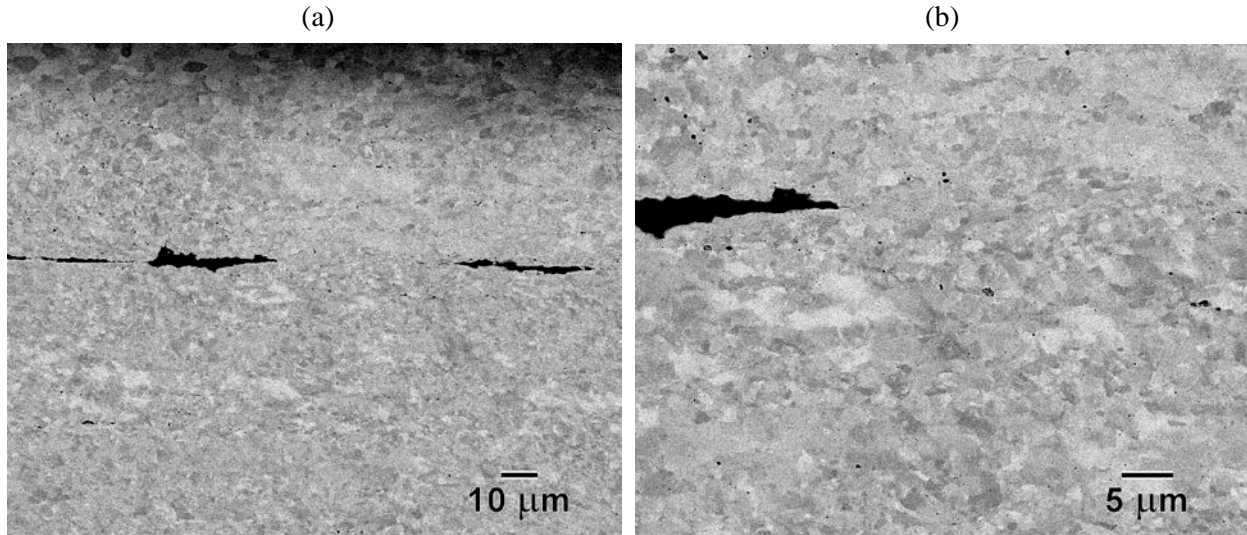
Figure 9. BSE micrographs showing the grain structure observed in the SZ in the vicinity of horizontal cracks at (a) lower and (b) higher magnifications.

The analysis of the SZ showed an inhomogeneous grain structure. Figure 9 shows BSE micrographs recorded near the top surface of the FSW plate that reveal variations in texture and grain size along with

several horizontal cracks. These textured variations occur mostly in the horizontal directions, which may provide some evidence of the heat distribution and plastic deformation mechanisms that influence the flow of material during FSW. To explore these mechanisms in the future, investigations using electron back scattered diffraction (EBSD) and transmission Kikuchi diffraction (tKD) will be useful by obtaining details about differences in texture of the grain structures in the SZ.

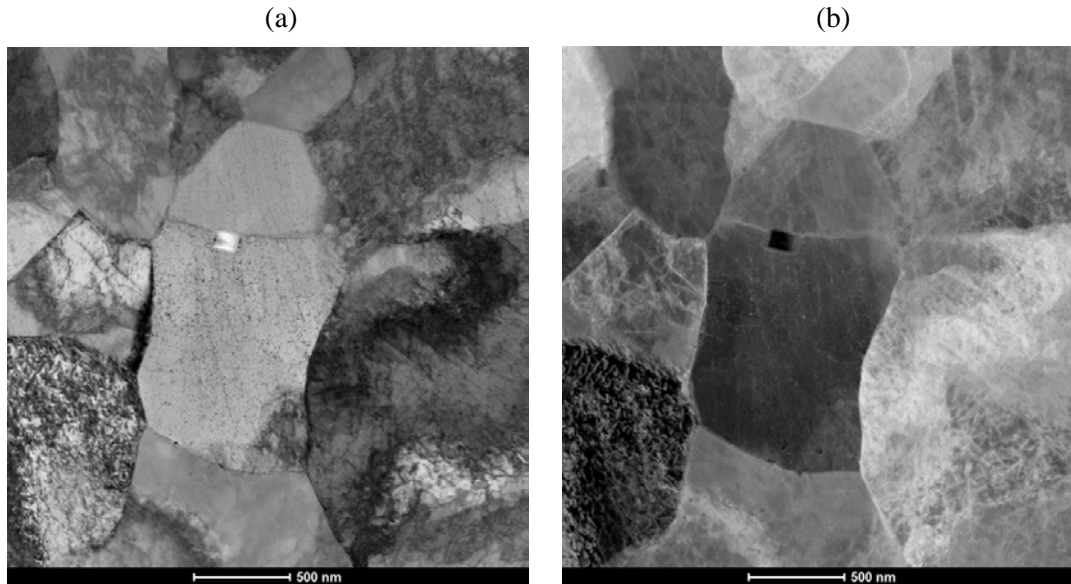
Figure 10. STEM micrographs (a) BF and (b) HAADF showing the grain structure observed in the SZ.

The detailed microstructural analysis of the SZ was conducted using STEM imaging and high-spatial resolution element mapping. Figure 10 shows the grain structure observed in the SZ using bright-field (BF) and high angle annular dark field (HAADF) imaging conditions. The grains appear fairly isotropic in shape with a size of ~500 nm. This size compares closely with that determined by EBSD in the reference characterization study reported in FY milestone report (M3FT-15OR0203122), which was 430 nm. Thus, at least in the region of the SZ that the FIB specimen was prepared from, the effects of FSW were not detrimental to grain coarsening. The evolution in grain morphology from highly elongated grains oriented horizontally prior to FSW to the isotropic grain morphology observed in the SZ suggests that dynamic recovery and/or recrystallization processes occurred. However, the fact that the grain size in the SZ did not change appreciably indicates that the temperature due to frictional heat and the magnitude of deformation were nearly optimized for the FSW parameters used.

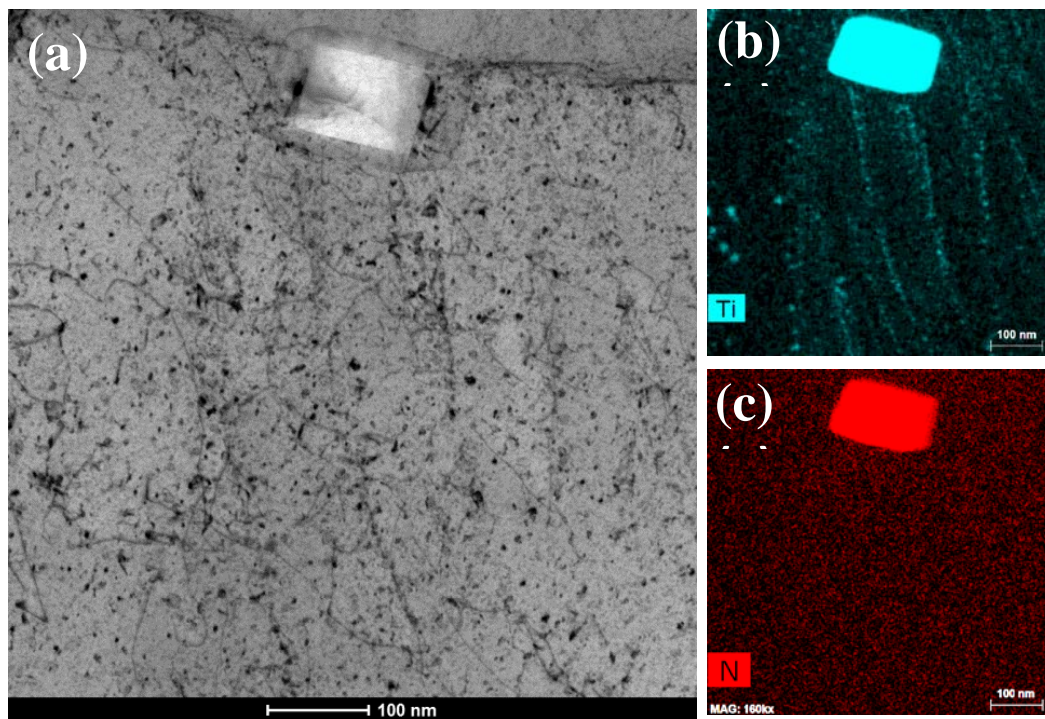
Figure 11. STEM analysis showing the presence of a large blocky-shaped Ti,N-rich particle on the grain boundary, a relatively high dislocation density and a high number of Ti-rich nano-size particles associated with straight dislocations. (a) STEM BF micrograph and EDS element maps for (b) Ti and (c) N.

The central grain observed in Figure 10 is shown at a higher magnification in Figure 11. The BF STEM micrograph (Fig. 11a) reveals a blocky-shaped particle on the grain boundary and a relatively high dislocation density with many of the dislocations appearing relatively straight. The accompanying X-ray EDS (XEDS) maps of Ti (Fig. 11b) and N (Fig. 11c) of the same area and the multivariate statistical analysis (MSA) of the XEDS data suggests that the large blocky-shaped particle is TiN, since the XEDS map showed no O associated with the particle. The Ti map also reveals the presence of a high number of Ti-rich nano-size particles aligned along the threading dislocations.

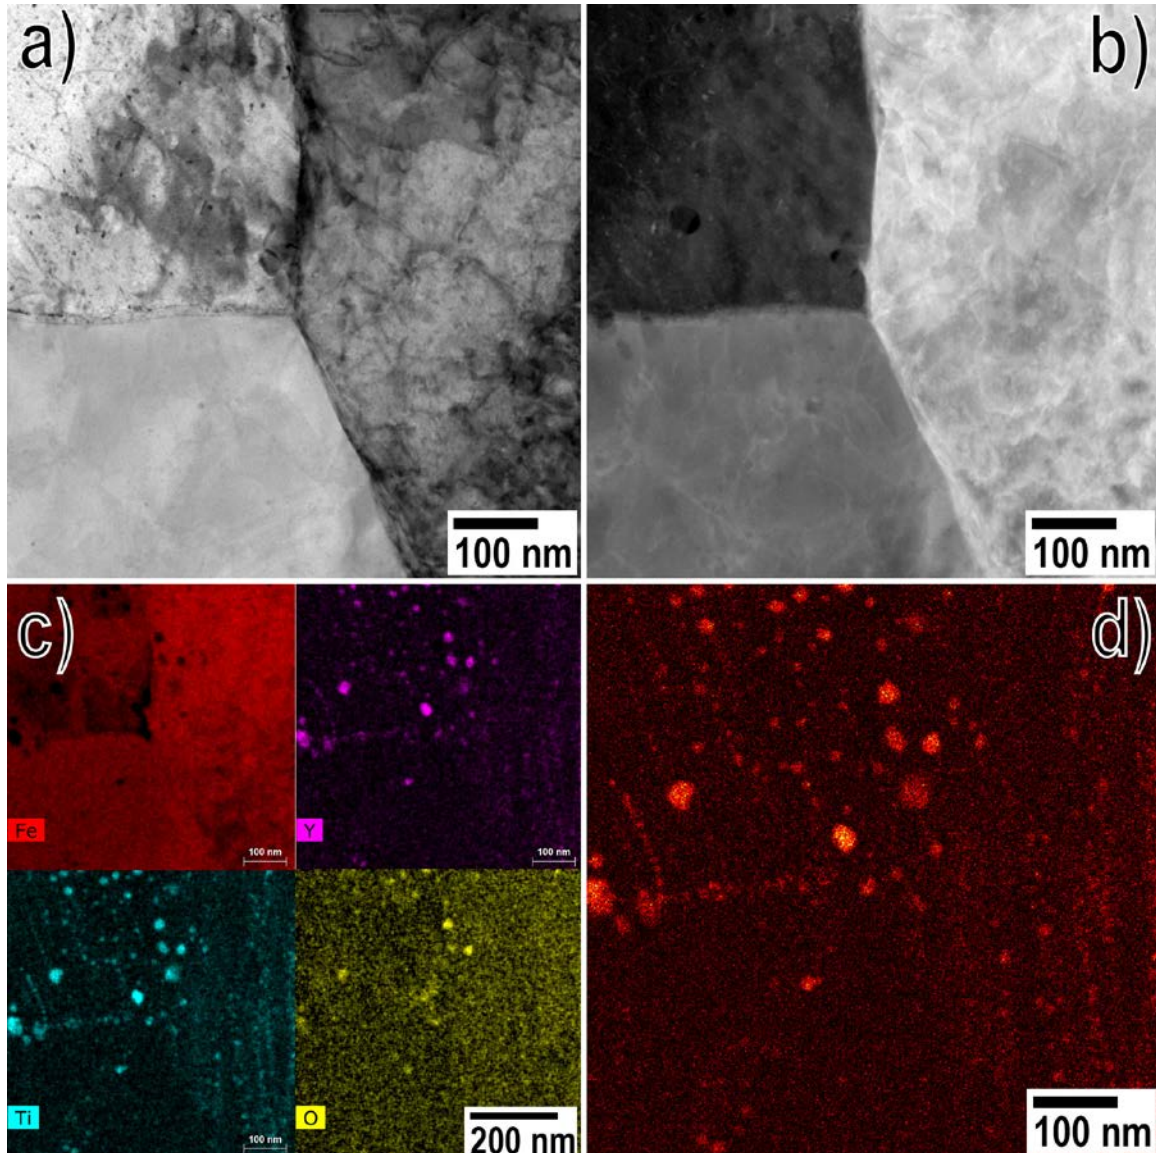
Figure 12. High magnification STEM-EDS results showing the distribution of Y-Ti-O particles near the junction between 3 grains. (a) BF, (b) HAADF, (c) raw XEDS maps for Fe, Y, Ti, and O and (d) results of the multivariate statistical analysis of the data in (c) showing the Y-Ti-O particle distribution more clearly.

Figure 12 shows the high magnification STEM-EDS results from a junction of 3 separate and distinct grain boundaries. The STEM BF micrograph (Fig. 12a) shows the dislocation structure in two grains oriented near Bragg diffraction conditions. The STEM HAADF micrograph (Fig. 12b) does not show much contrast associated with nano-size particles, but shows contrast variation between grains due to different orientations and diffraction conditions. The raw XEDS maps for Fe, Y, Ti, and O (Fig. 12c)

reveal a high concentration of nano-size particles enriched with Y, Ti and O. The MSA of the data raw XEDS data (Fig. 12d) clearly reveals the Y-Ti-O particle distribution. These results show that some Y-Ti-O particles have increased in size, yet there are many other particles that are still in the size range <5 nm. A more detailed particle size analysis is required. However, these microstructural results suggest that FSW is a viable method for joining ODS alloys.

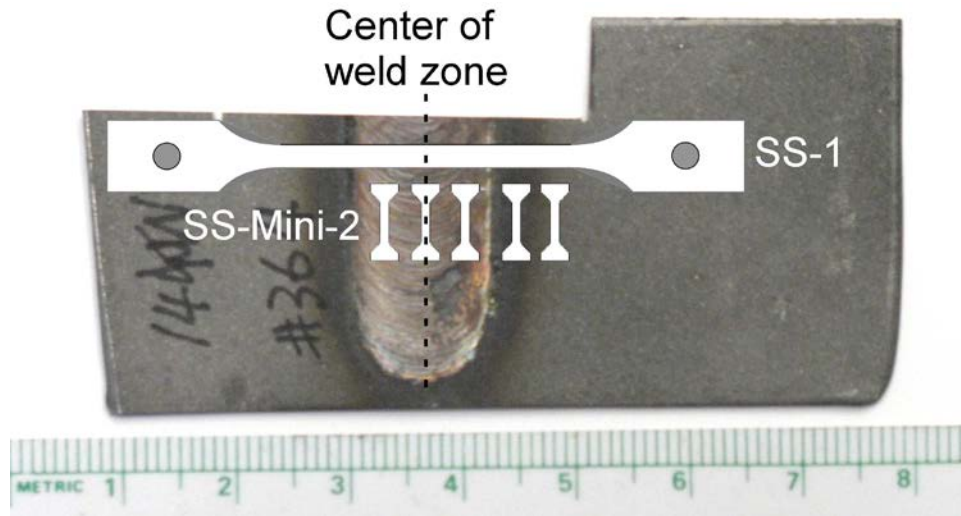
Figure 13. Template showing the layout of tensile specimens that were attempted to be fabricated from the 0.1 cm thick plate of 14YWT containing the bead-on-plate SZ.

The investigation of the mechanical properties of the bead-on-plate SZ produced by FSW was initiated using the digital image correlation (DIC) approach, which is based on optical extensometry. In this approach, the surface of a miniature tensile specimen is coated with droplets in order to measure localized extensions, or strain, along the gage during the tensile test. Figure 13 shows the layout of tensile specimens planned for the first DIC experiments. The goal was to fabricate an SS-1 tensile specimen spanning the SZ into each side of the base plate and five small SS-Mini-2 tensile specimens aligned parallel to the SZ with three from the SZ and two from the adjacent plate of 14YWT. Unfortunately, in the attempt to fabricate the SS-1 tensile specimen by wire electro-discharge, a sudden crack pop-in

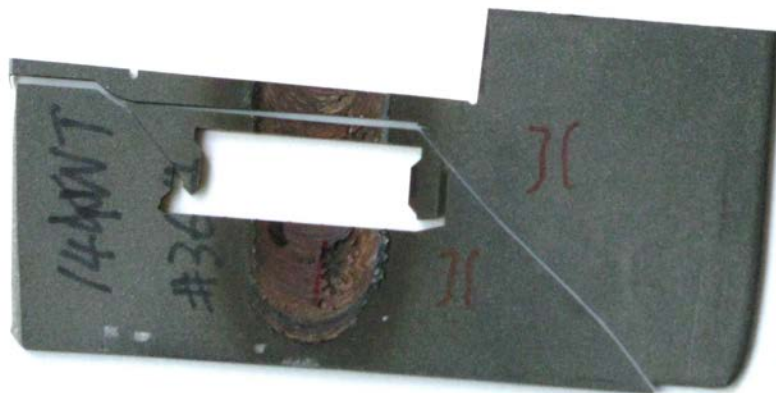
Figure 14. The 0.1 cm thick plate of 14YWT following the abrupt crack pop-in that occurred during fabrication of the SS-1 tensile specimen by wire EDM.

occurred that propagated through the 0.1 cm thick plate of 14YWT. This crack is shown in Figure 14 with a digital image of the pieces of the plate reassembled. The crack pop-in is observed on the right side of the SZ at a $\sim 45^\circ$ angle. Fortunately, 5 SS-Mini-2 tensile specimens were successfully fabricated from the plate, which is the region in the SZ in Figure 14 that is missing. The image in Figure 15 shows the location of the three SS-Mini-2 tensile specimens that were fabricated from the SZ. Their location is not centered as in the template shown in Figure 13, since two SS-Mini-2 specimens fractured during fabrication. The results showing the abrupt crack pop-in occurring in the 0.1 cm thick plate of 14YWT are most likely due to residual stresses due to the hot rolling steps and/or during the FSW run. Investigations in the next FY research will focus of residual stress measurements and the effects of post-weld heat treatments on FSW joining of 14YWT.

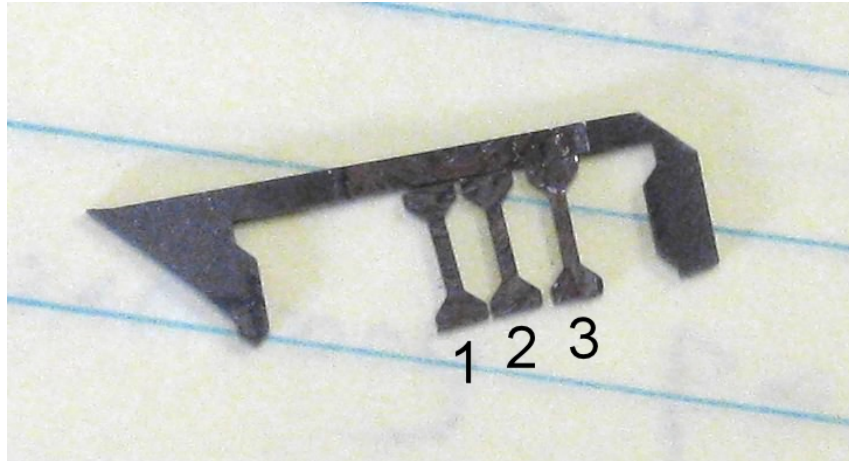
Figure 15. The location the three SS-Mini-2 tensile specimens fabricated from the bead-on-plate SZ.

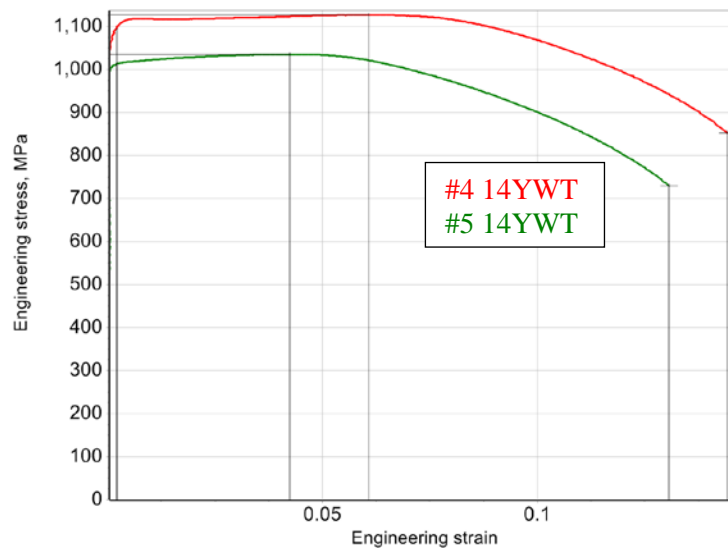
Figure 16. Engineering stress-strain curves of the two SS-Mini-2 specimens of 14YWT.

The DIC analysis of the two SS-Mini-2 tensile specimens prepared from the 0.1 cm thick plate of 14YWT was conducted recently. Figure 16 shows the engineering stress-strain curves of the two 14YWT specimens obtained from tensile tests at room temperature. The values obtained for the yield and ultimate stresses and the uniform and total elongations are shown in Table 1. The strength and ductility of sample #4 was better than that of sample #5.

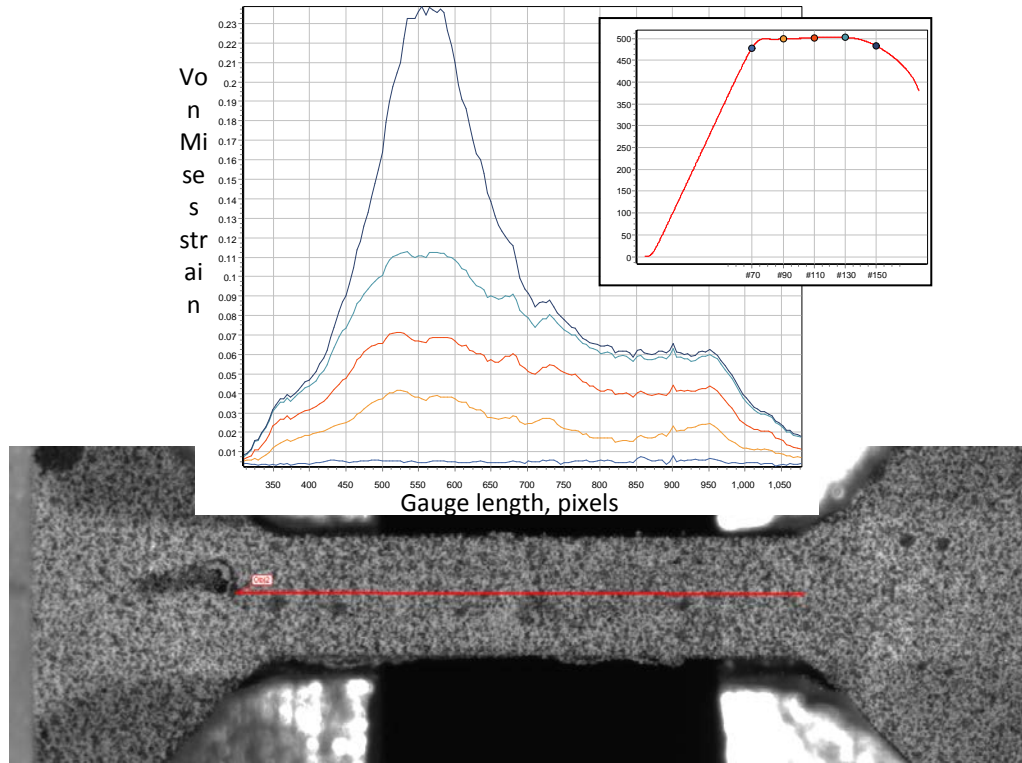
Figure 17. The strain distribution (Green-Lagrange strain tensor) along the gauge of specimen #4 at different time (Frame #).

The results of the DIC analysis of sample #4 are shown in Figure 17. The image shows the SS-Mini-2 tensile specimen with the coating of droplets on the surface and a line along the gauge length representing the location of the strain distribution that was analyzed. The plot of Von Mises strain as a function of position along the gauge length shown by the line shows the distribution of strain for the 5 points of the stress strain curve. The results indicated that strain was localized in the left region of the gauge soon after yielding occurred and gradually intensified at this location until the instability at uniform strain was reached when the localized strain significantly intensified until failure of the specimen.

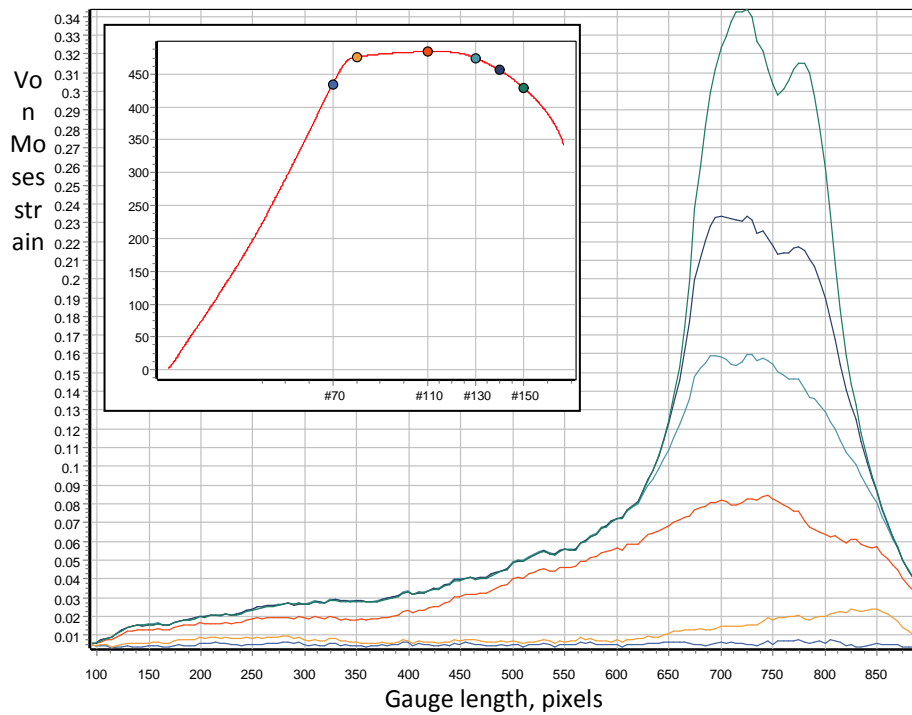
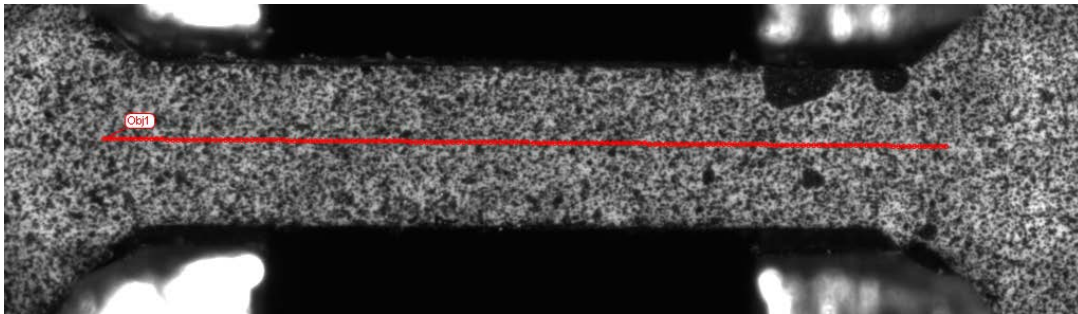
Figure 18. The strain distribution (Green-Lagrange strain tensor) along the gauge of specimen #5 at different time (Frame #).

The results of the DIC analysis of sample #5 are shown in Figure 18. In this case, the results showed that strain was localized in the right side of the gauge after yielding and more rapidly intensified in this region. The location of the strain localization was determined to be too close to the gauge head of the SS-Mini-2 tensile specimen and the grip used for restraining the specimen along the shoulder most likely influenced the strain localization. However, it cannot be ruled out that inhomogeneity in the microstructure of the tensile specimen may have played a role in the location and intensification of strain in sample #5. Regardless of the actual mechanism the data correctly accounted for the location and intensification of strain during the tensile test. It will be interesting to compare these results with those that are planned for similar DIC tests on the SS-Mine-2 specimens prepared from the stir zone. Nevertheless, the DIC results obtained in this study are the first to be generated for the advanced ODS 14YWT ferritic alloy.
