ASSESSMENT OF SAN ONOFRE CONCRETE SUSCEPTIBILITY AGAINST IRRADIATION DAMAGE

Research Information Letter
Office of Nuclear Regulatory Research

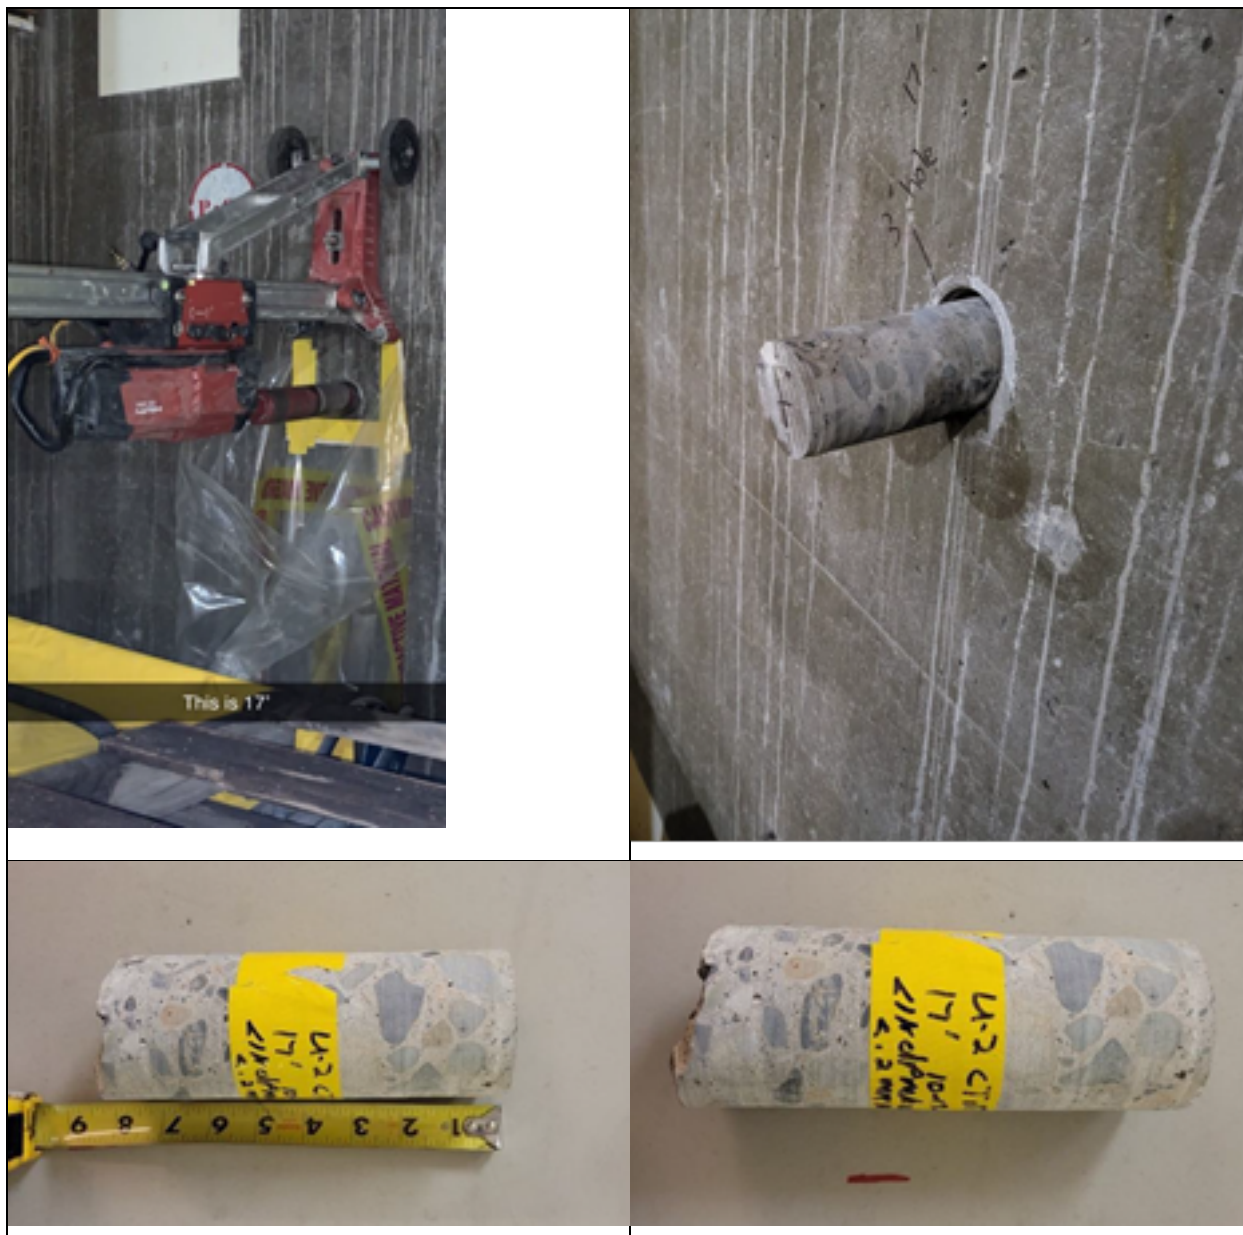
SONGS-PS-17 (Figure 3-1): The length of the specimen is about 9 in. The specimen appears to be intact.

Figure 3-1. Cored specimen at 17 ft elevation

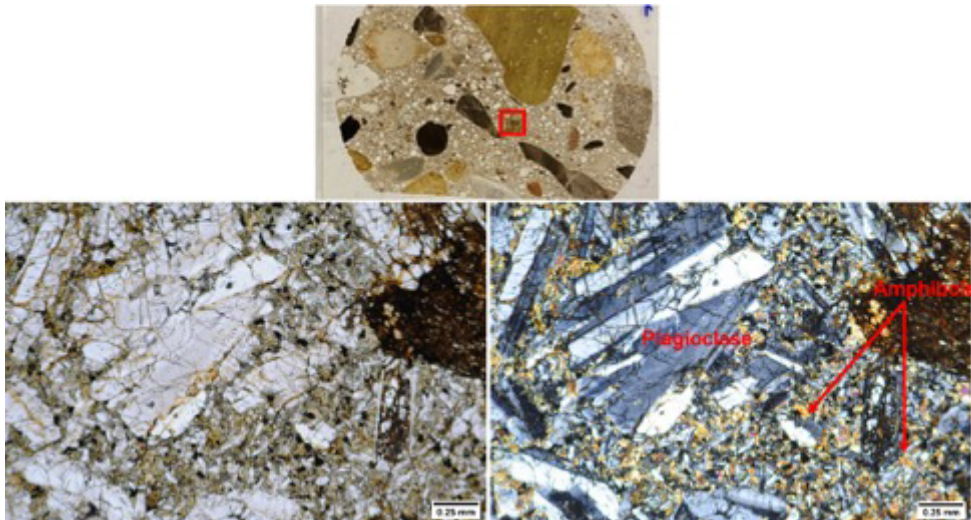
The second aggregate that was investigated corresponds to the one shown in thin section 1 in Figure 4-7. QEMSCAN maps for two areas in this aggregate are displayed in Figures 4-35 and 4-36. As described in the petrographic thin section study, this aggregate contains mainly plagioclase feldspar and amphibole. The twinned plagioclase grains observed in polarized light have mostly Ca-rich cores with more Na-rich rims, although they do not exhibit the albite composition observed in the volcanic rock in Figures 4-32 through 4-34. Most of the black pixels labeled as "others" are Ca-Al-Si silicate that are similar to the plagioclase standard but that do not exactly match it. In a very strongly altered plagioclase grain, some of the core is Fe-rich enough to match the epidote standards. Most of the ground mass of this rock is fine-grained amphibole as identified in the petrography study, and some of the grains also show evidence of crystallinity in SEM, with cleavage and well-defined crystal shapes. In Figure 4-36, there is a very strongly altered mafic grain that is composed mainly of Fe-oxide and "Al-Silicate trap standard definitions. There are also a few relict pyroxene pixels, so this grain is interpreted as a strongly altered pyroxene grain. The hematite standard is most closely associated with this strongly altered region, and ilmenite grains mainly occur in the lower part of Figure 4-36 as discrete grains that are not associated with alteration.
