PIE on Safety-Tested Loose Particles from AGR-1 Compact 4-4-2

PIE ON SAFETY-TESTED LOOSE PARTICLES FROM AGR-1 COMPACT 4-4-2

Date Published: April 2016

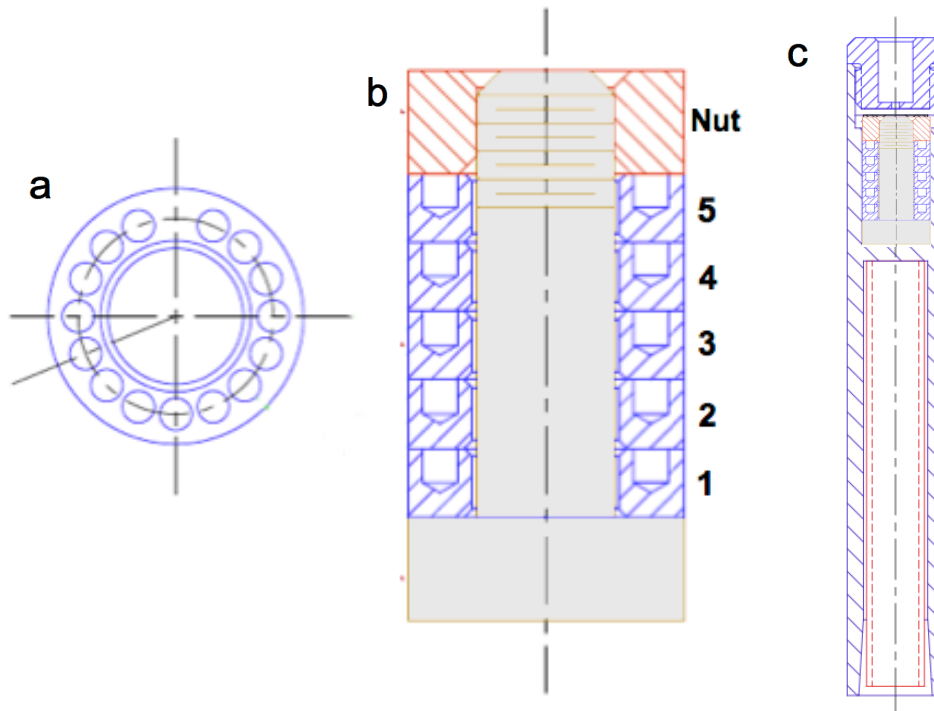
Figure 1. CCCTF fuel holder assembly for the loose-particle test: a) fifteen-particle tray, b) five-tray assembly, and c) tray assembly in standard CCCTF graphite holder.

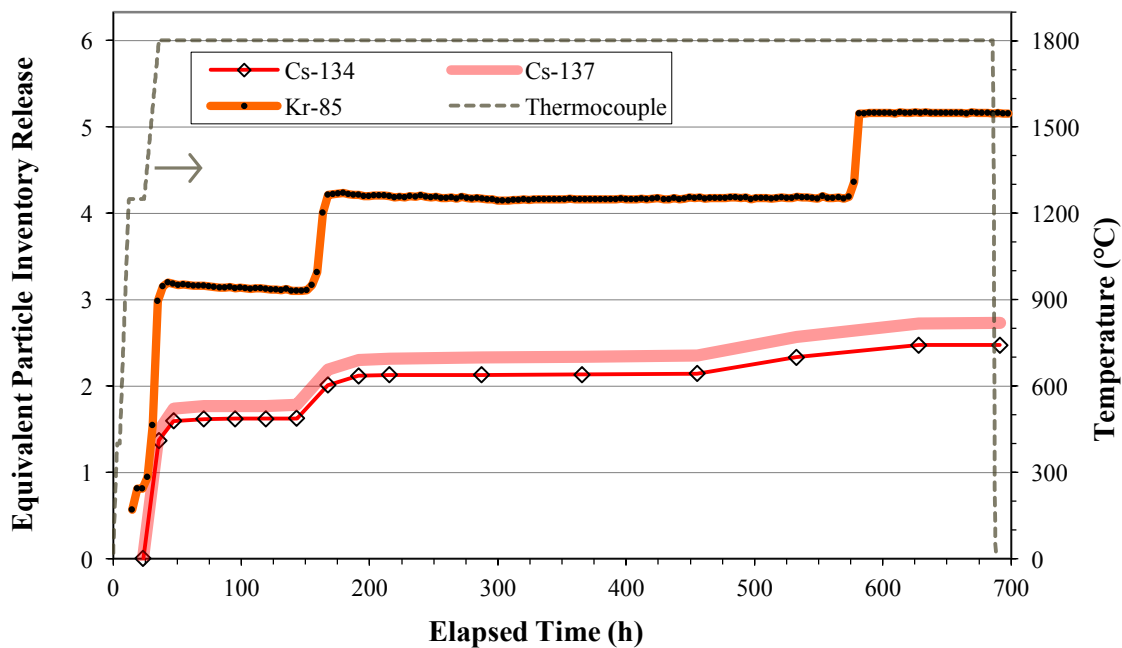
Figure 2. Cumulative release of cesium and krypton from Compact 4-4-2 loose particles at 1800°C. Note that the magnitude of the cesium release may be off due to uncertainty in the deposition cup collection efficiency, as discussed at the end of this section.

Krypton release from failed TRISO is an unusual result for AGR-1 safety testing. None of the other thirteen CCCTF tests exhibited this type of krypton release (only diffusive releases of <25% of one particle's ^{85}Kr inventory from particles with SiC failure has been observed in the CCCTF). However, one 1800°C test in the INL Fuel Accident Condition Simulator (FACS) furnace released krypton from failed TRISO with similar release kinetics to that shown in Figure 2 [Demkowicz et al. 2015a, 323–325].

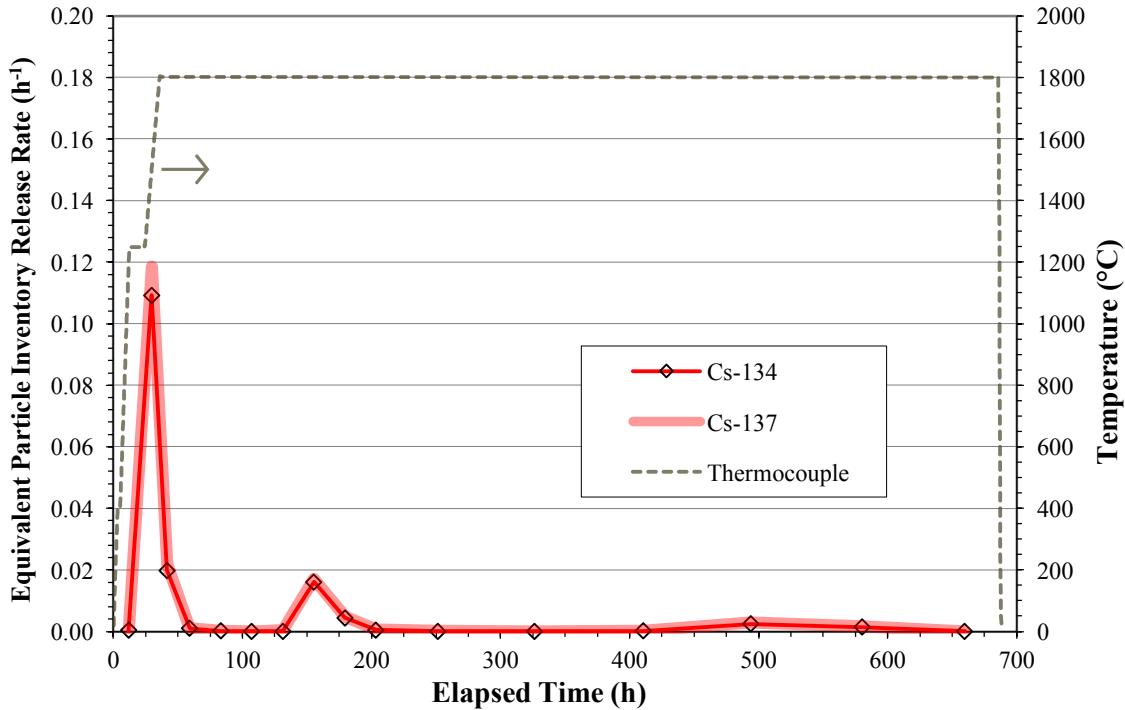
Figure 3. Average rate of cesium release during each deposition cup collection interval.

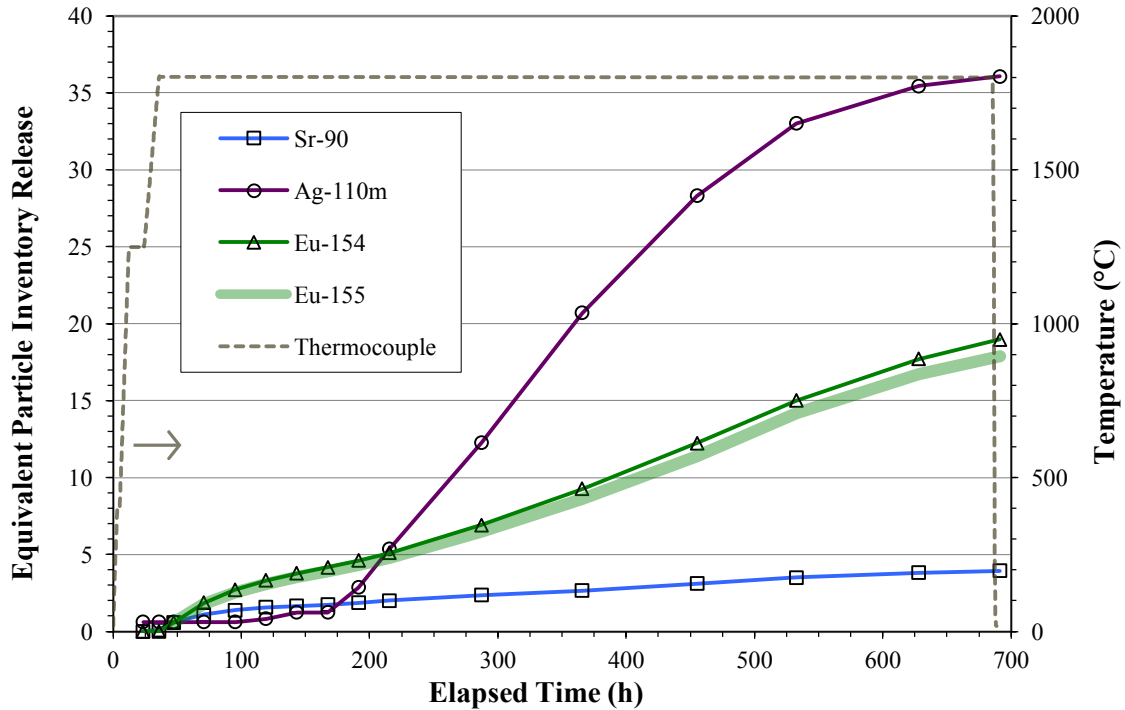
Release of some of the other measured radioisotopes is shown in Figure 4. Europium and strontium were gradually released throughout the test. Similar behavior has been observed in CCCTF tests of AGR-1 compacts and is believed to have been dominated by slow migration of these elements from the OPyC and surrounding graphite, as well as possible retention by the tantalum components. Table 1 lists the fraction of the total furnace test releases detected on various internal CCCTF furnace components at the end of the loose particle safety test and most of the europium appeared to be captured by the tantalum. The fraction of europium released during the loose particle safety test was, however, much greater than has been released in 300-hour safety tests of AGR-1 compacts, and is indicative of release through intact SiC during the safety test. Europium release during the shorter whole-compact safety tests has not been high enough to rule out the possibility that the observed release may have been limited to release from the matrix and OPyC of europium previously released through intact SiC during irradiation.

Figure 4. Cumulative release of silver, europium, and strontium from Compact 4-4-2 loose particles at 1800°C. Note that the magnitude of the plotted release may be off due to uncertainty in the deposition cup collection efficiency, as discussed at the end of this section.

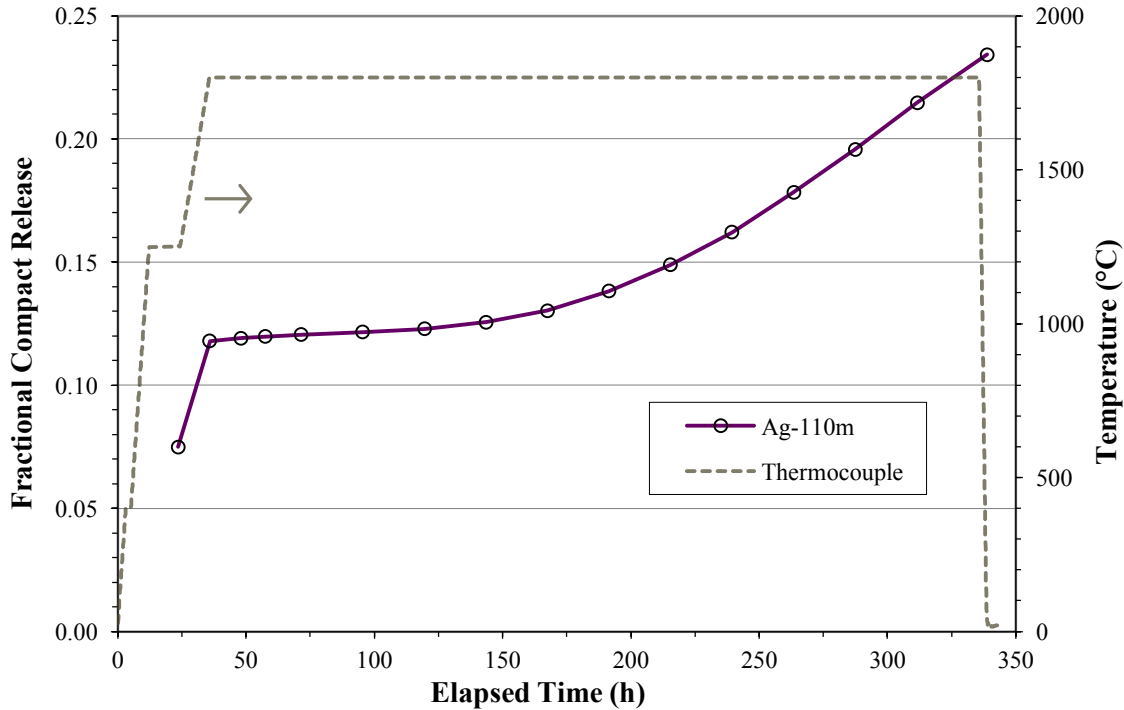
Silver release and distribution within the furnace was anomalous to typical CCCTF behavior. Silver is usually released from the compact matrix and OPyC during the initial heatup of a compact, with relatively little additional release from the compact through the remainder of the safety test. Two exceptions to this behavior have been when test temperature was not held constant and below 1600°C [Hunn et al. 2014c; Hunn et al. 2015], which is not relevant here, and during the test of Compact 4-4-1, which released the typical initial burst of silver during heatup followed by a secondary increase in silver release after about 70–100 h at 1800°C (Figure 5) [Hunn et al. 2013b, 8]. It is speculated that this secondary silver release from Compact 4-4-1 may have been related to diffusive release through the finer-grained SiC microstructure unique to this AGR-1 Variant 3 fuel type. Compact 4-3-2 (also Variant 3) was safety tested in the INL FACS furnace and showed a similar behavior [Demkowicz et al. 2015a, 327]. The Compact 4-4-2 loose particles did not release much silver during initial heatup (Figure 4); this indicates that there was not significant silver inventory remaining in the OPyC of the deconsolidated and acid leached particles. The onset of significant silver release from the Compact 4-4-2 particles around 170 h into the test is reminiscent of the Variant 3 compacts safety tested at 1800°C. Figure 5 shows that additional silver was released from Compact 4-4-1 at essentially a constant rate for the last 100 h at 1800°C (from roughly 230 to 330 h into the test). Figure 4 shows a similar constant silver release from the Compact 4-4-2 loose particles over the same time interval, followed by an eventual tapering off in the release rate; this tapering off was a result of depletion of the silver inventory in the 75-particle test sample.

Figure 5. Time-dependent cumulative release of silver from 1800°C safety test of Compact 4-4-1.

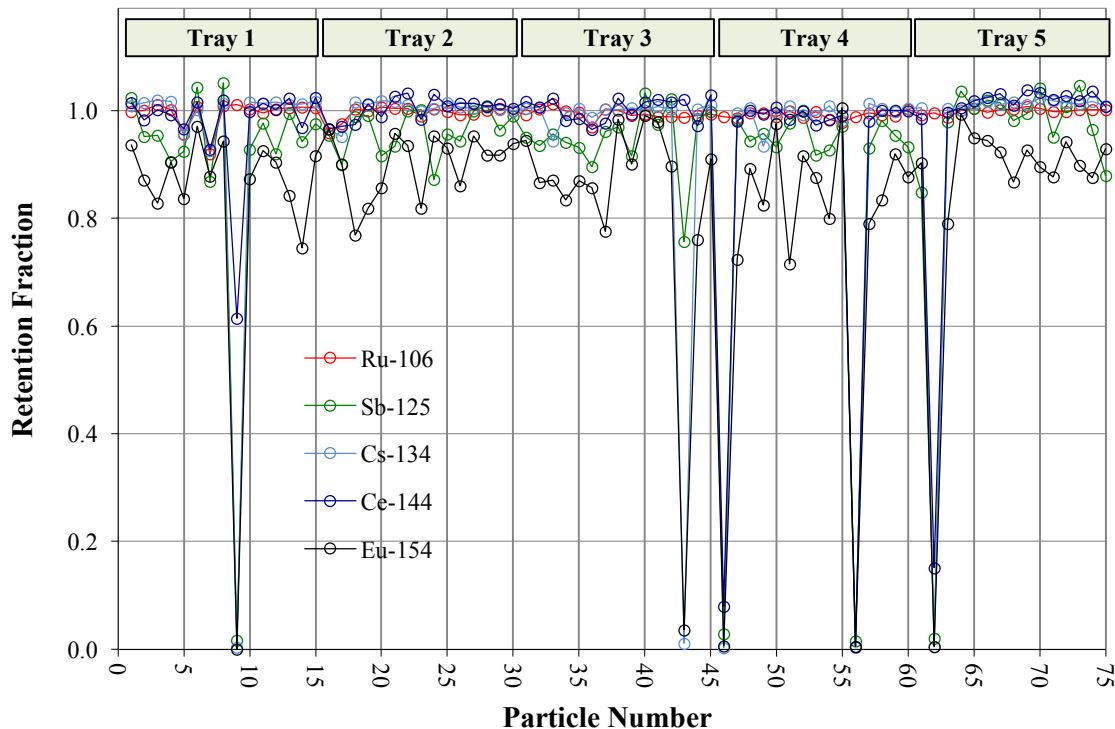
Figure 10. Radioisotope retention fraction of 75 particles after 1800°C safety testing.

Not counting the five abnormal particles, there was no measurable release of [106]Ru, [134]Cs, [137]Cs, or [144]Ce from the remaining seventy particles; the average retention fraction for these isotopes was close to 100%. The average retention fraction for [125]Sb was 96%, but this deviation from 100% may not be significant compared to the measurement uncertainty. However, the average retention fraction for [154]Eu of 89% indicates a measurable release of europium from the particles. Comparison of the [110m]Ag activity in each particle before and after the safety test clearly shows that silver was also released from the particles during the 1800°C safety test, as expected based on the silver release observed in the CCCTF (Figure 4). The remaining [110m]Ag activity in most of the particles was too low to measure with IMGA; for these particles the estimated [110m]Ag activity quantification limit and retention fraction are given as less-than values in Table 4 and Table 5. The overall low [110m]Ag inventory after the safety test agrees with the indication in the CCCTF time-dependent [110m]Ag release data that the [110m]Ag inventory was becoming depleted by the end of the safety test. Only six particles retained enough silver to measure the [110m]Ag activity with IMGA using a six-hour counting time. At least one of these particles, Particle 442-A074, had a [110m]Ag inventory that indicated high retention, in contrast to most of the particles in the test.

Figure 10 and Table 5 show that most of the 70 particles with intact SiC still released a measurable amount of europium during the heating test. Two particles with the greatest fractional europium release were selected for further analysis; Particle 442-A055 and Particle 442-A059 both exhibited release fractions close to 30%. For comparison, two additional particles were selected that had higher europium retention, Particle 442-A063 and Particle 442-A016. Particle 442-A063 also retained about half its silver, while ^{110m}Ag retention could not be measured in Particle 442-A016. Particle 442-A074 and Particle 442-A046, selected for their high silver retention, also retained europium.

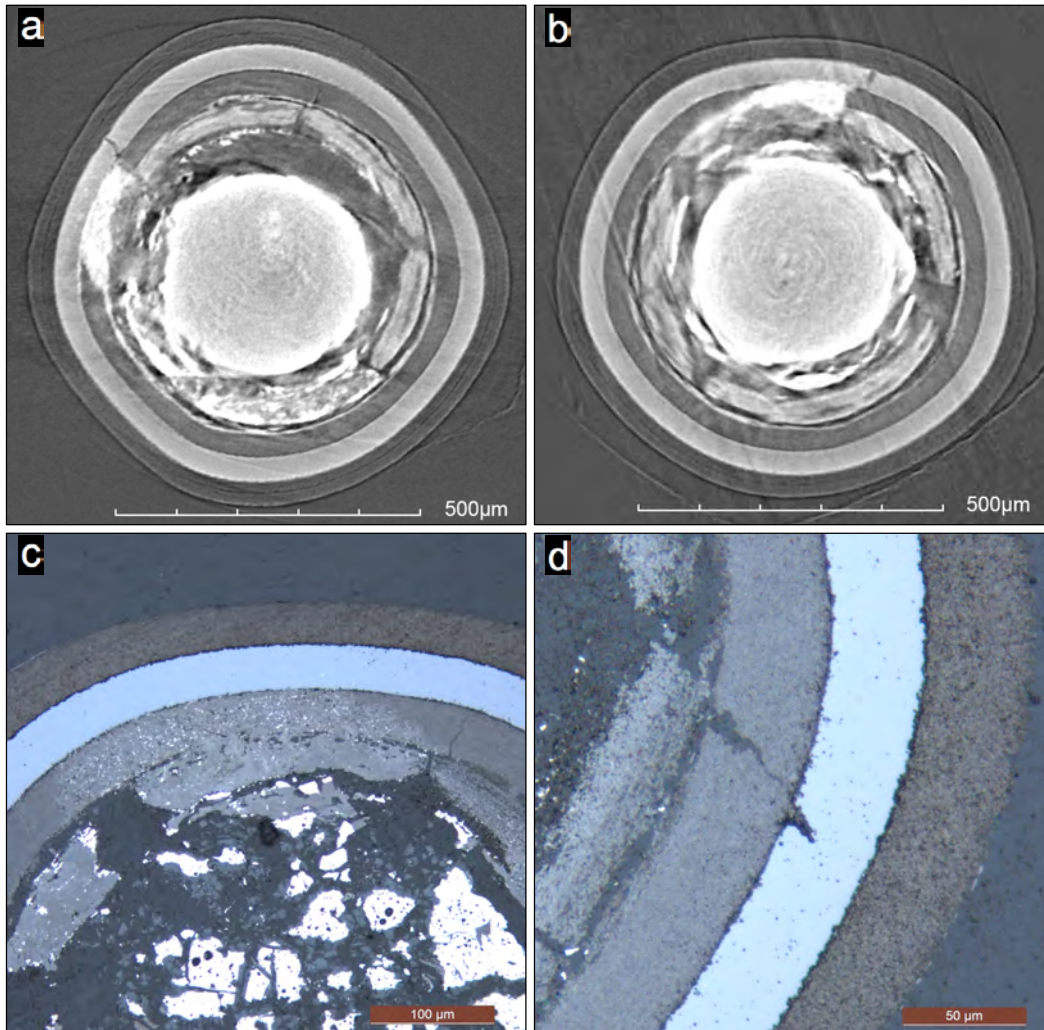
Figure 11. Particle 442-A009: (a and b) oblique orthogonal x-ray tomographs showing SiC crack aligned with buffer/IPyC crack, with adjacent U-dispersion in IPyC; (c) optical micrograph of a polished section showing U dispersion in the IPyC; (d) another area in the same polished section where typical local SiC degradation at the tip of an IPyC crack was observed that was not associated with the TRISO failure.

Figure 11a and Figure 11b show a pair of orthogonal planes passing through the approximate center of Particle 442-A009. These images provide two views of a crack in the SiC that was closely aligned with cracks in the buffer and IPyC layers. The SiC crack extended above and below the image plane in Figure 11a but was not as long as the cracks observed in some of the other particles with failed TRISO. The x-ray imaging was not able to resolve any through-layer pathways or cracks in the OPyC, and none were apparent in the polished section; however, based on the release of krypton and other fission products from this particle, an OPyC failure is suspected. A dense, triangular-shaped cloud of higher-density elements was observed in the IPyC on one side of the crack (Figure 11a and Figure 11b). The optical micrograph in Figure 11c shows a cross section through this unusual feature, which was identified by EDS as containing predominantly uranium deposits (see Section 5.2). Significant uranium dispersion from the kernel was also evident throughout the entire buffer layer, with heavy pileup at the outside surface of the buffer, where it was detached from the IPyC. Figure 11d shows a region away from the TRISO failure containing an IPyC crack with localized SiC degradation more typical of what has been observed in failed-SiC particles from 1800°C safety-tested AGR-1 compacts; however, this region did not appear to be associated with the TRISO failure, because the SiC degradation did not penetrate the layer and the IPyC crack was isolated from the failed region discussed above. Particle 442-A009 released most of its silver, antimony, cesium and europium, but retained more than half of its cerium (Table 5).

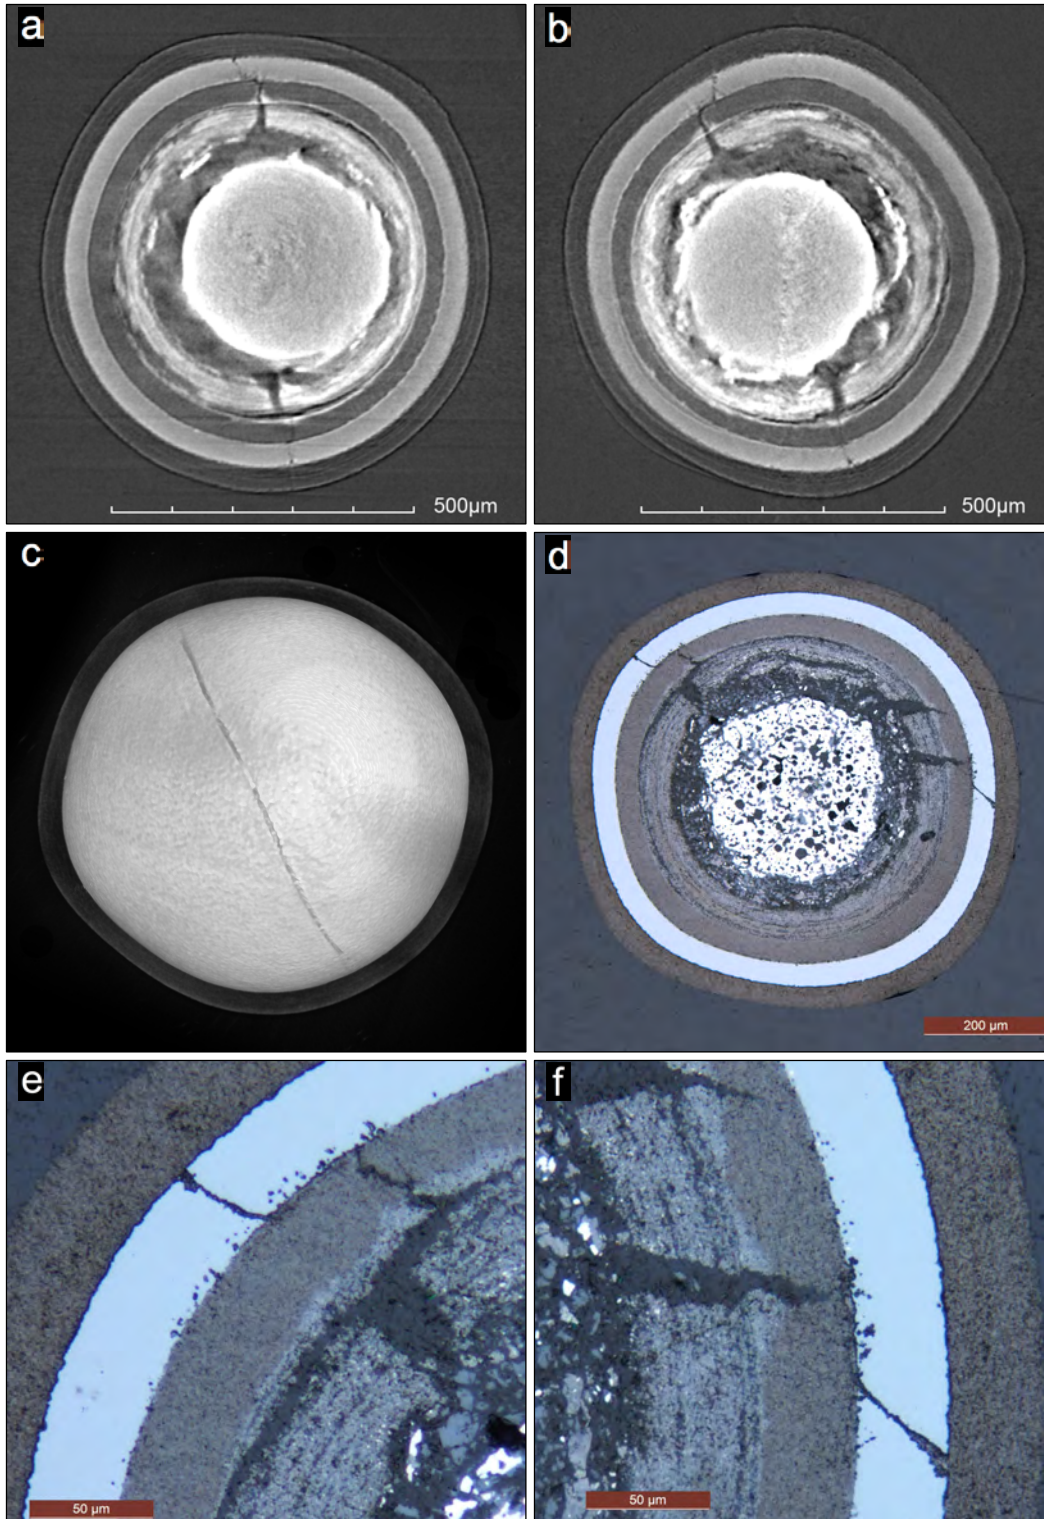
Figure 12. Particle 442-A064: (a and b) oblique orthogonal x-ray tomographs showing SiC crack at top and bottom of image and noticeable loss of kernel material; (c) 3D visualization using threshold filter to display SiC surface (OPyC layer is semitransparent) to show extended SiC crack that almost circumnavigated this particle, (d–f) optical micrographs of polished section showing SiC crack and degradation at IPyC/SiC interface.

Figure 12a and Figure 12b show orthogonal x-ray tomographs through the center of Particle 442-A064; cracking of the SiC is evident at the the top and bottom of both images. These features are part of a single crack extending almost all the way around the particle. Figure 12c is a 3D visualization using a threshold filter to display the crack on the SiC surface (the OPyC layer is presented as semitransparent). Similar to Particle 442-A009, the kernel in Particle 442-A064 exhibited a noticeable volume reduction and there was a considerable amount of kernel material dispersed in the buffer. This particle, however, did not show the same large-area dispersion in the IPyC seen in Figure 11b and Figure 11c. The optical micrographs in Figure 12 show a cross section where a small offset is evident between the IPyC crack and the SiC crack and degradation can be seen along the IPyC/SiC interface in the crack locations. Examination of the tomography data in three dimensions showed that this offset varied along the length of the crack and the SiC crack was aligned with the IPyC crack in some locations, which suggests that the SiC crack may have initiated where it was aligned with the IPyC crack and then deviated from direct alignment as it propagated around the particle. The polished cross section also revealed some uranium dispersion in the IPyC, radiating in from the buffer near the IPyC crack. As with Particle 442-A009, obvious cracks in the OPyC (expected based on the krypton release observed in the CCCTF) were not observed; however, x-ray tomography indicated the possible presence of localized low-density regions or very small cracks in the OPyC at the limit of the x-ray resolution. There was no visible OPyC crack circumnavigating the particle adjacent to the SiC crack, as would be expected if these two layer fractured as a unit, and OPyC degradation was not evident in the polished cross section. Particle 442-A064 released greater than 98% of all the isotopes reported in Table 5, except for ruthenium (which was retained in all five failed-TRISO particles).

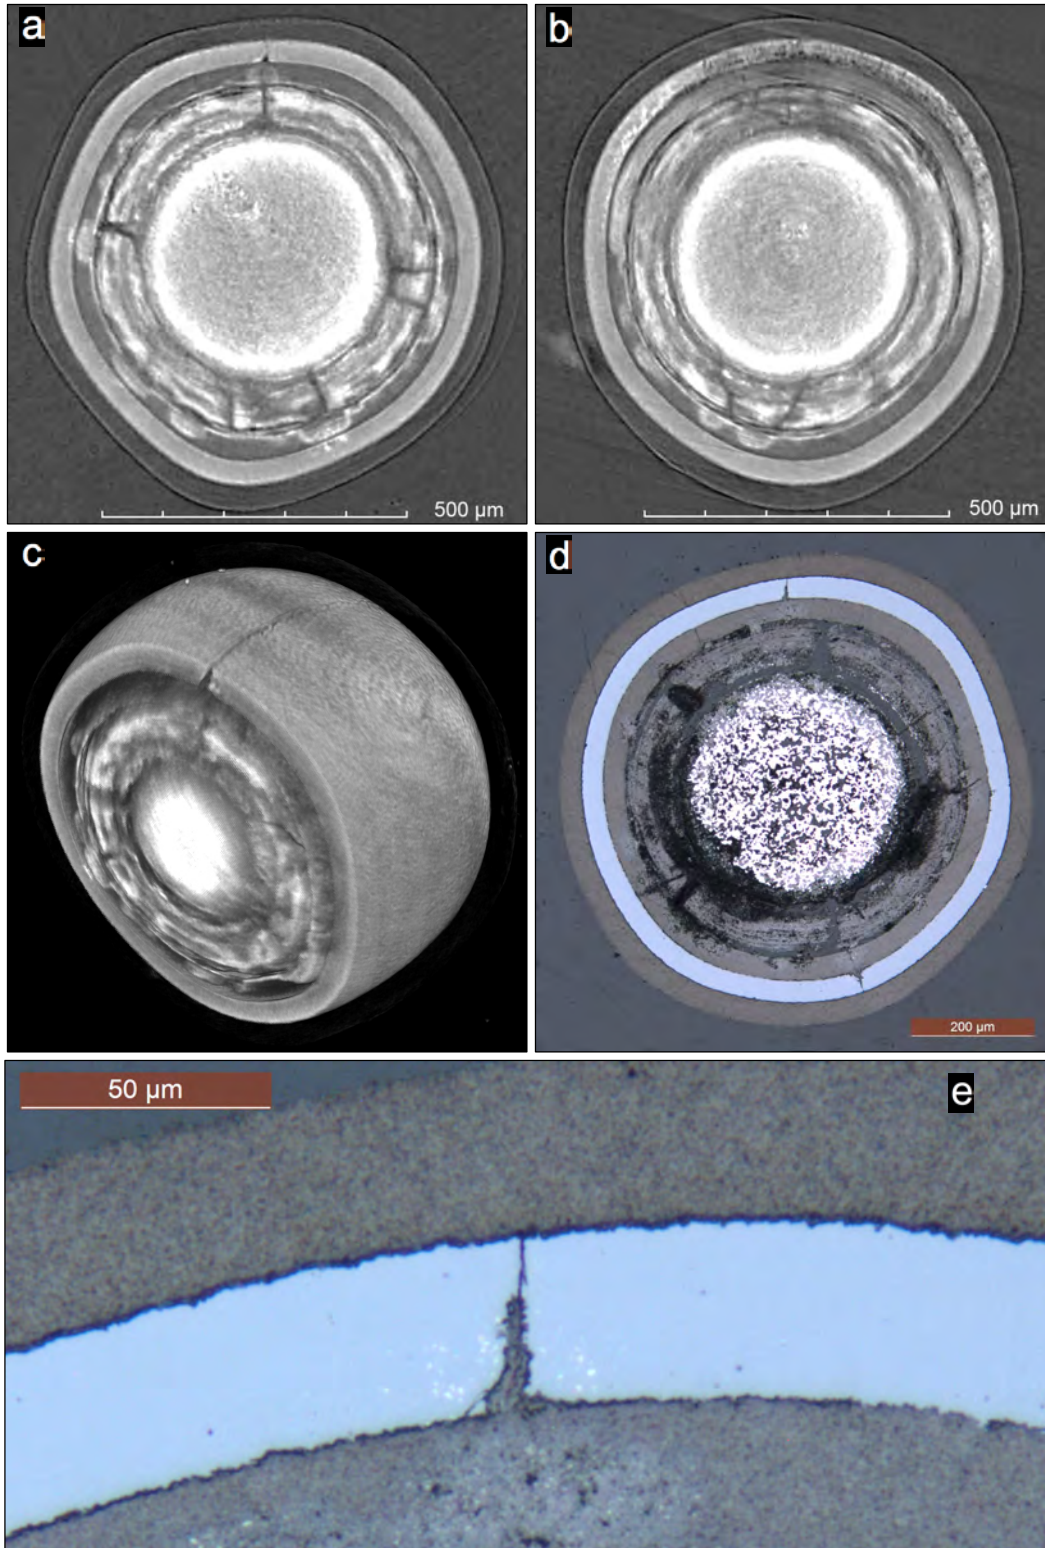
Figure 13. Particle 442-A053: (a and b) oblique orthogonal x-ray tomographs showing through-layer SiC degradation aligned along an IPyC crack and significant uranium dispersion throughout the buffer and IPyC, (c) sectioned 3D visualization using a threshold filter to emphasize SiC and higher-density material (pyrocarbon not visible) and showing an extended SiC crack with degradation, (d and e) optical micrographs of polished section showing metallic clusters in SiC and degradation extending out into SiC along the crack.

Figure 13a and Figure 13b are orthogonal tomographs through the midplane of Particle 442-A053, and Figure 13c is a 3D representation that shows a crack in the SiC layer . A cross section of the crack is shown at the top of Figure 13a such that it is perpendicularly intersecting the tomograph plane. In Figure 13b, the image plane is aligned along the crack direction, such that the structure in the SiC near the crack can be seen along most of the crack length; severe degradation and fission product deposits can be seen along the entire length of the crack in the top half of this SiC cross section in Figure 13b. Similar to the two particles discussed above, Particle 442-A053 also experienced significant dispersion of kernel material into the buffer and IPyC layers. Dispersion into the IPyC was observed to be localized and occurred at numerous positions around the sphere. X-ray tomography revealed numerous semispherical zones of heavy elements that appeared to radiate from single point sources around the buffer/IPyC interface; the dispersed material in these nodules was predominantly uranium, as determined by elemental analysis in the SEM discussed below (see Section 5.2). Figure 13a and Figure 13b show several of the

zones; and at two locations in Figure 13a, degradation of the SiC is evident where the the zones extended all the way through the IPyC.

Figure 13d and Figure 13e show significant SiC degradation occurred at the site where the SiC was fractured. Figure 13e shows a brown area inside the degraded region that looks optically similar to the carbon material in the IPyC in this brightfield, reflected-light image. Surrounding this central carbon-rich region are numerous bright spots in the SiC due to uranium deposits in the SiC. Similar structure was evident in the other polished plane revealed in Figure 14c and Figure 14d, and Figure 14f shows the same area as Figure 14c prior to polishing to reveal the plane in Figure 14c. Figure 14f and Figure 13e both clearly show a crack through the center of the carbon-rich degraded zone in the SiC. Whether the crack preceded or followed the SiC degradation is a matter for debate. The fact that the degradation is fairly symmetric about the crack suggests that the crack occurred first. Imaging and elemental analysis in the SEM of the polished plane shown in Figure 13 is discussed in Section 5.2. Particle 442-A053 exhibited fission product release behavior somewhere between Particle 442-A009 and Particle-A064, releasing most of its silver, antimony, cesium and europium, but retaining ~8% of its cerium (Table 5).

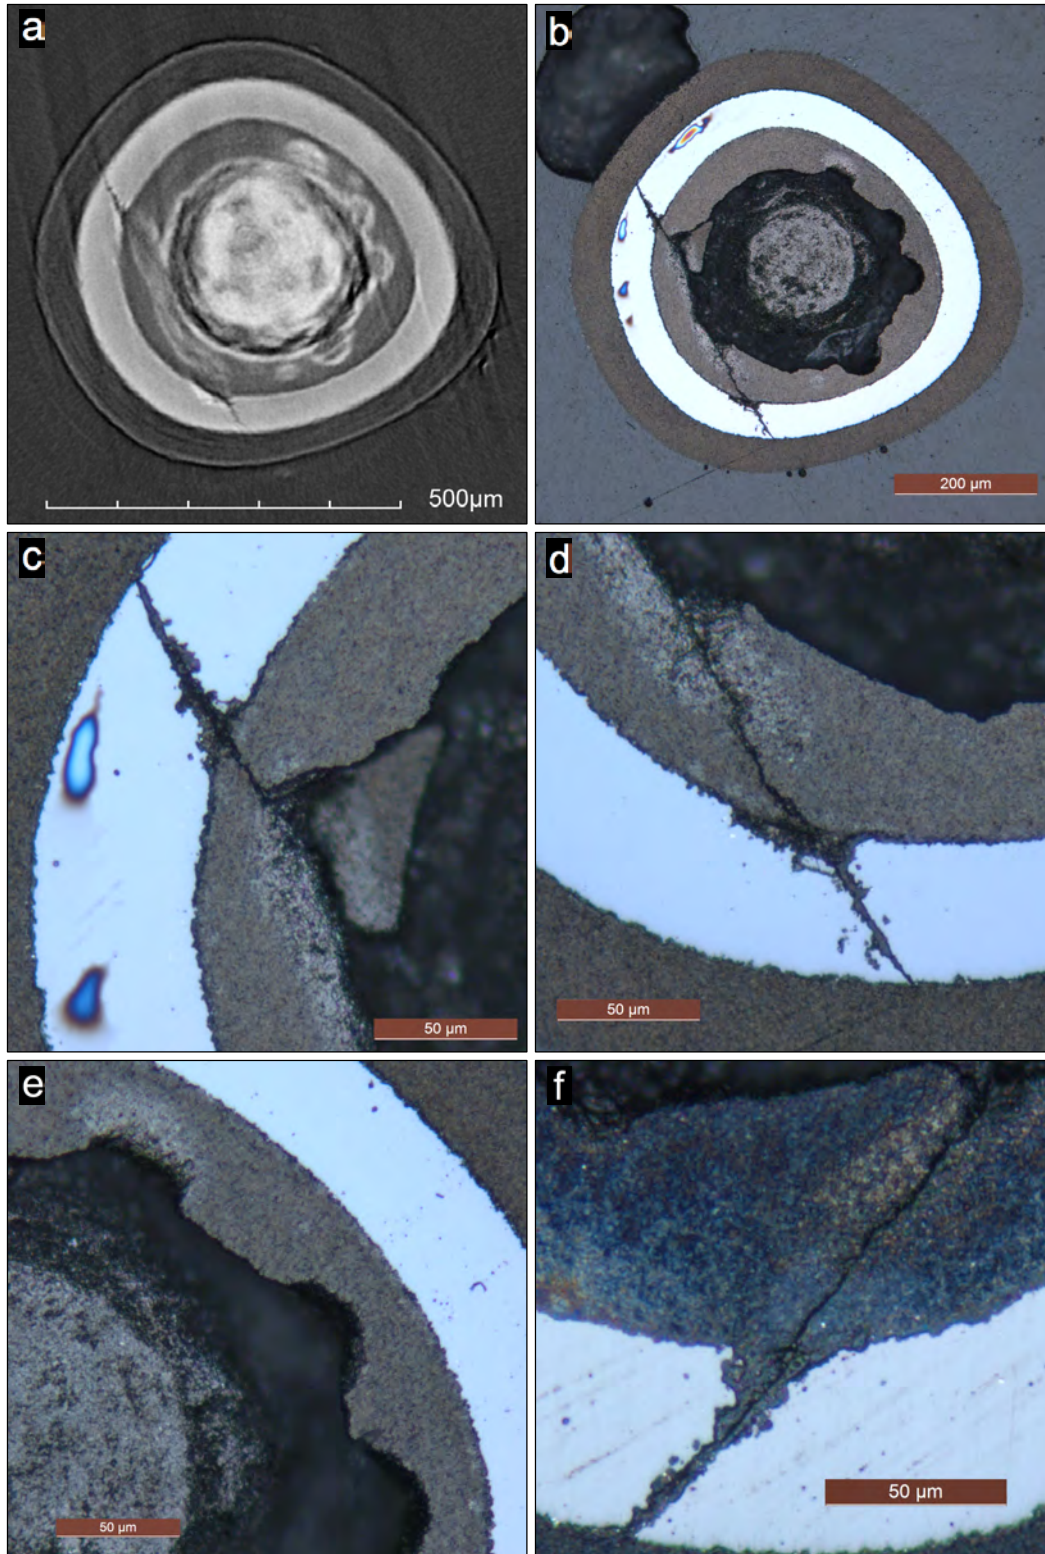
Figure 14. Particle 442-A053: Set of images obtained further from midplane compared to Figure 13; (a) x-ray tomograph showing same plane as (b), (b–e) optical micrograph of polished section showing SiC degradation along crack and missing pockets of IPyC associated with radial dispersions of uranium visible in (a), (f) SiC degradation in another plane that was parallel and close to (c) showing a crack through the degraded region.

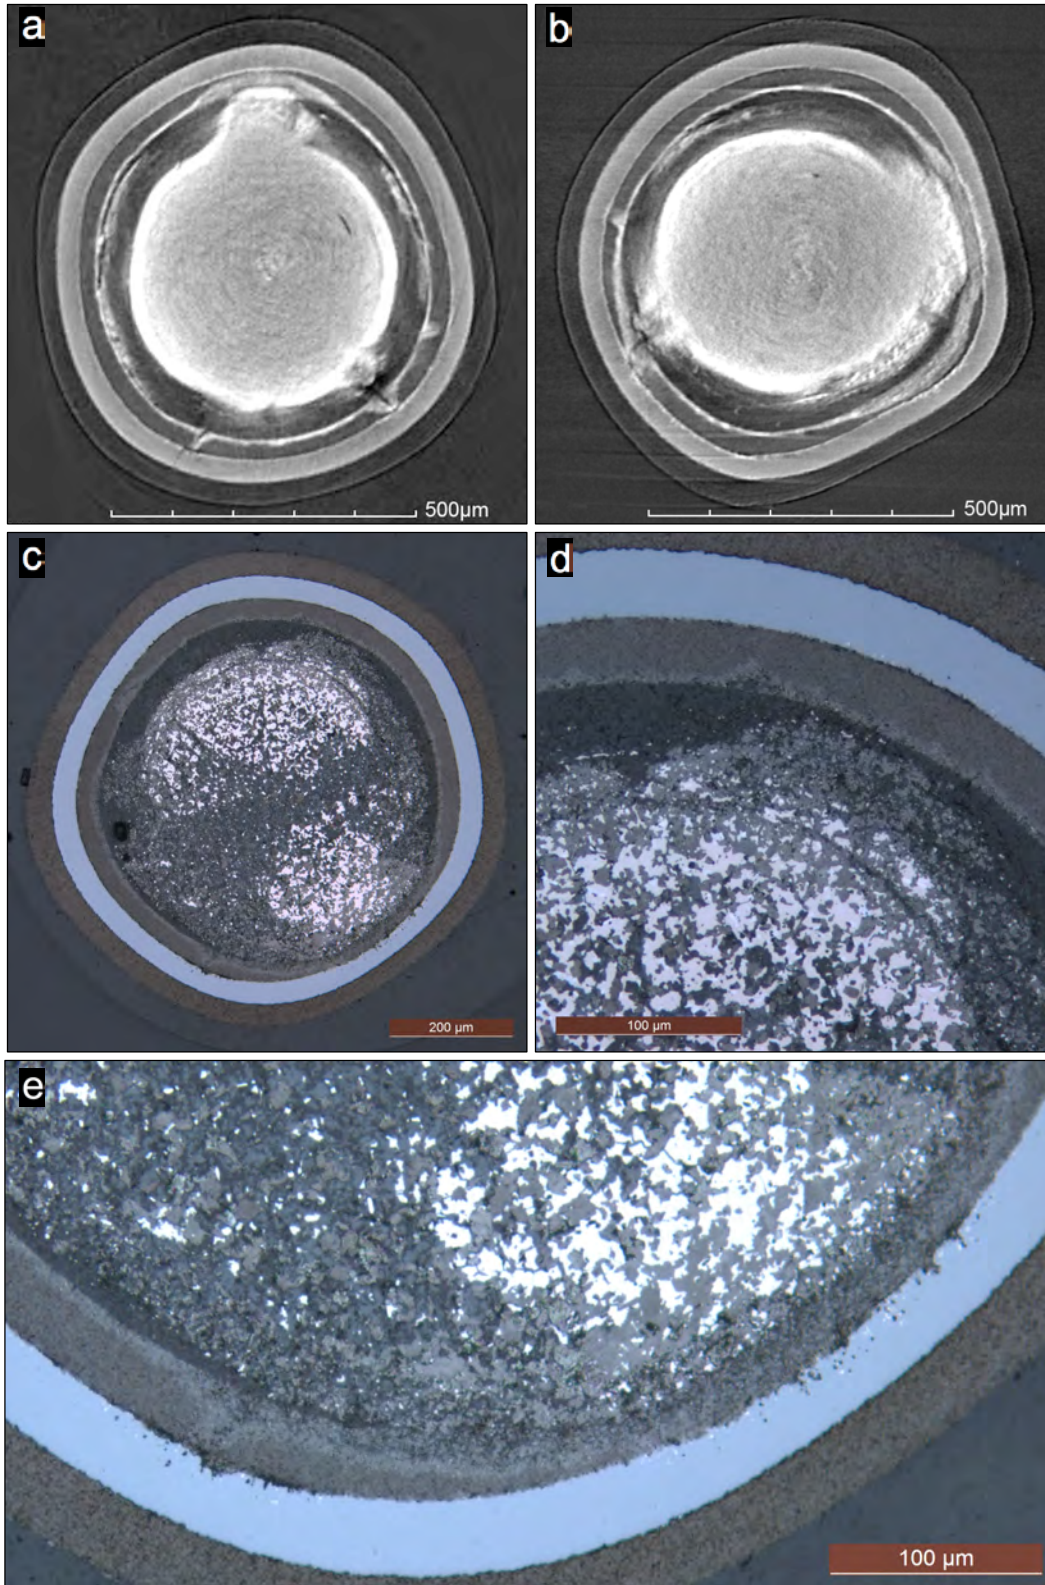
Figure 15. Particle 442-A072: (a and b) oblique orthogonal x-ray tomographs showing SiC crack (lower left) and kernel protrusion with significant local dispersion in IPyC with related SiC degradation that did not penetrate the layer, (c–e) optical micrographs of polished section showing kernel reaction with buffer and degradation in the IPyC and SiC where kernel material had protruded to the IPyC.

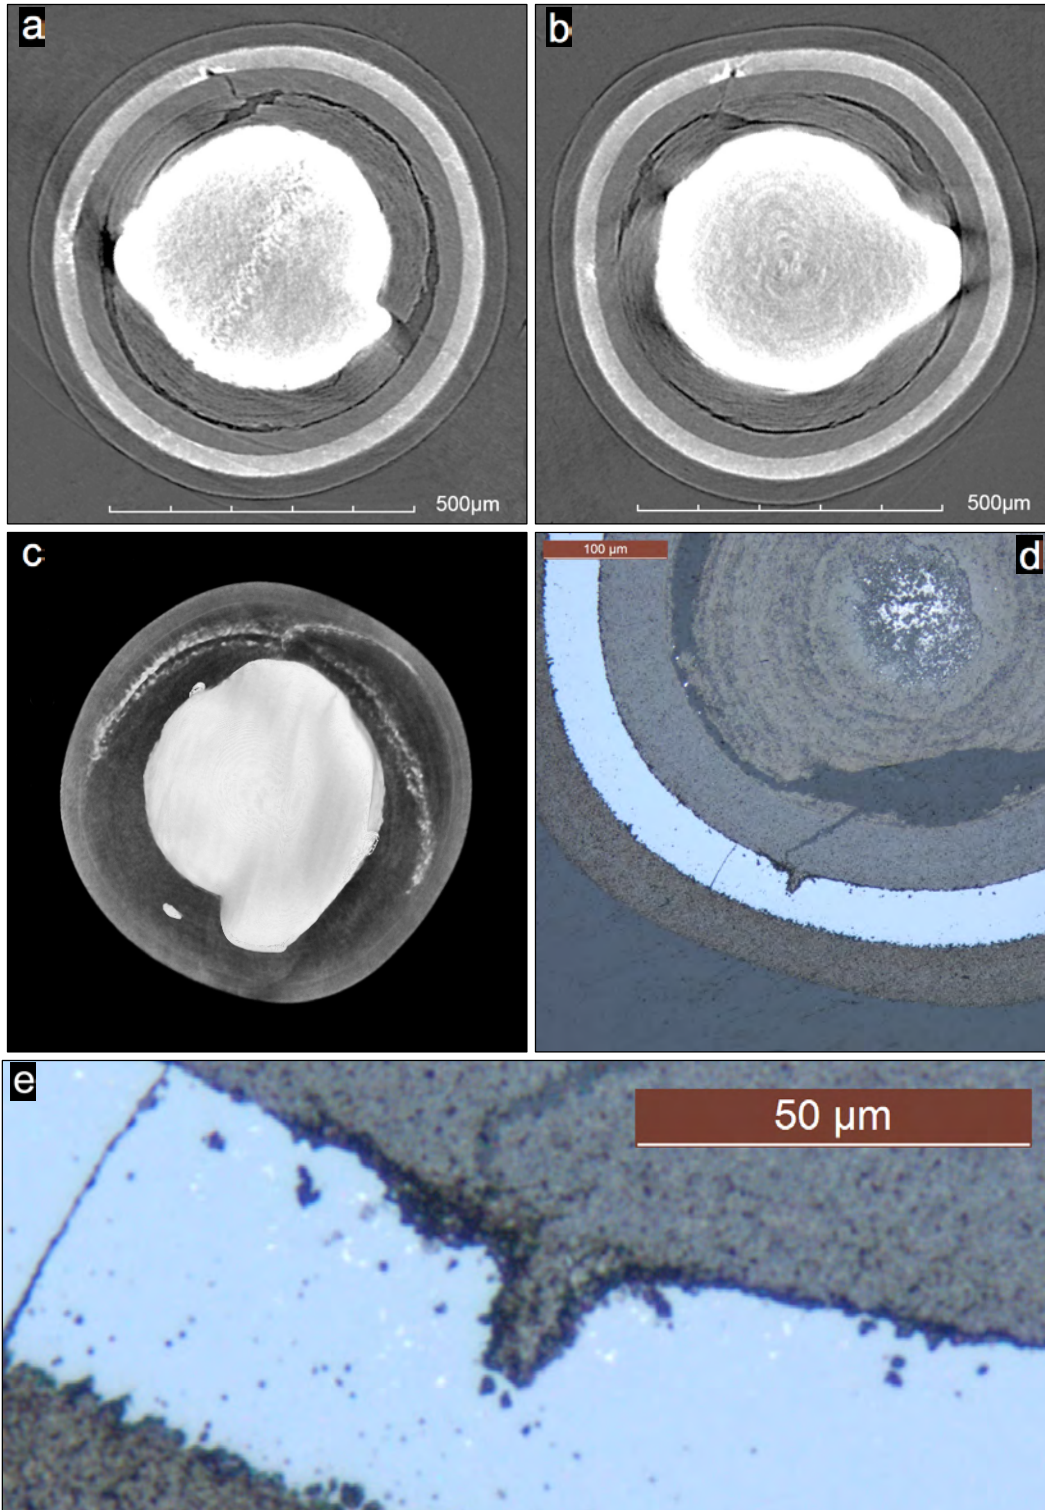
With the exception of Particle 442-A050 (Figure 16), four of the five TRISO-failed particles exhibited significant dispersion of kernel material into the surrounding layers, and some of the kernels were noticeably reduced in volume. This unusual lack of stability and material retention by the kernel was presumably related to the TRISO failure. Because the TRISO failure allowed various elements and compounds to easily migrate out of the particle during the safety test, certain reactions and diffusion processes may have been able to proceed unchecked that would otherwise be limited in a closed system with intact coating layers. For instance, it is well-known that the reaction where carbon reduces uranium oxide can proceed at safety test temperatures of 1600–1800°C if a sufficient partial pressure of carbon monoxide is not maintained by the gas-tight coating layers [Wilhelm 1964].

Figure 16. Particle 442-A050: (a and b) oblique orthogonal x-ray tomographs showing SiC degradation through layer at tip of IPyC crack associated with edge of buffer delamination, (c) 3D semitransparent visualization showing kernel protrusion and extended SiC degradation along a crack in the SiC, (d and e) optical micrographs of polished section showing SiC degradation at tip of IPyC crack.

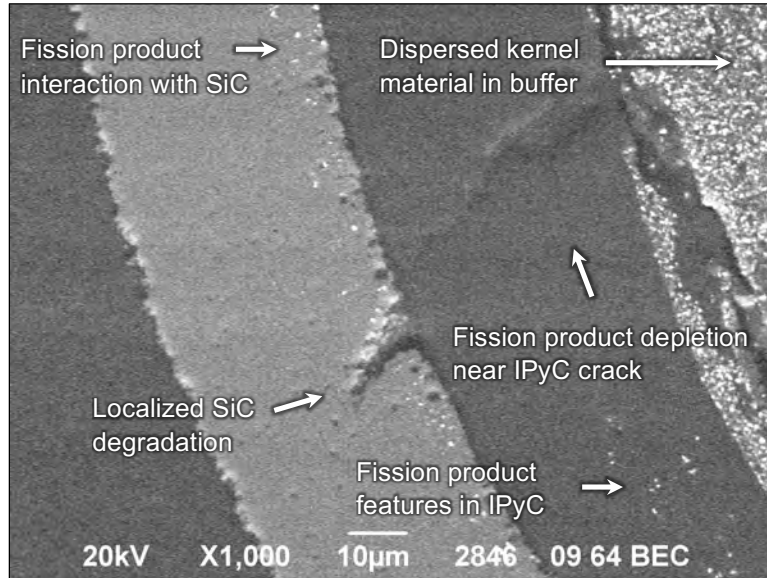
Figure 17. BEC micrograph from Particle 442-A009 showing the localized SiC degradation at the tip of an IPyC crack also shown in Figure 11d.

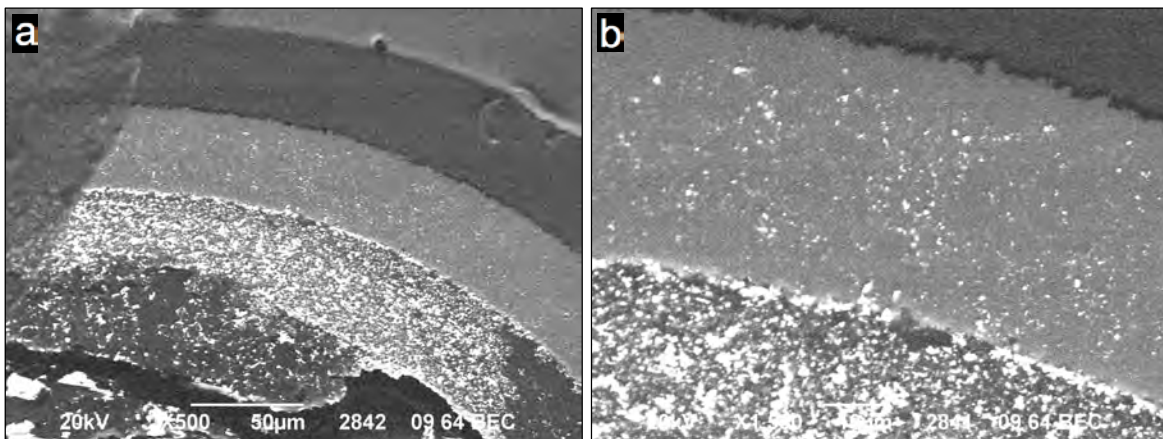
Figure 18 shows the region of IPyC discussed in Section 5.1 that exhibited a high-concentration of high-Z elements only on one side of the crack through the buffer, IPyC, and SiC (Figure 11a–c). It is evident that there was also a high frequency of fission product features in the SiC layer adjacent to this IPyC region. This behavior differs from the nature of the fission product distribution observed in the SiC layer away from the high-Z accumulation area in the IPyC. Notably, a lower frequency of features were observed in the SiC layer and at depths limited to the inside half of the SiC layer (Figure 19 and Figure 17). Spot analysis with EDS revealed that the material in the IPyC layer was predominantly uranium, although some molybdenum was also detected at the IPyC/SiC interface. In the SiC, the bright spots coincided with high concentrations of uranium and, in a few cases, traces of ruthenium. Silicon was also observed in the IPyC, presumably as a result of the migration of silicides formed in the SiC.

Figure 18. BEC micrographs of Particle 442-A009 showing two magnifications of the region near the through-layer crack with a large, concentrated dispersion of high-Z features in the IPyC and SiC.

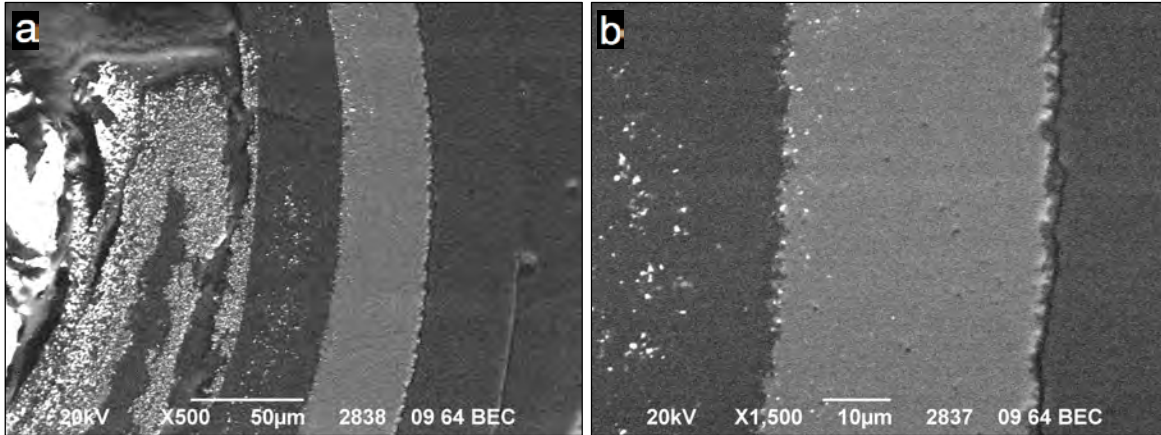
Figure 19. BEC micrographs of Particle 442-A009 for comparison to Figure 18 showing two magnifications of a region away from the through-layer crack with more typical dispersion of high-Z features.

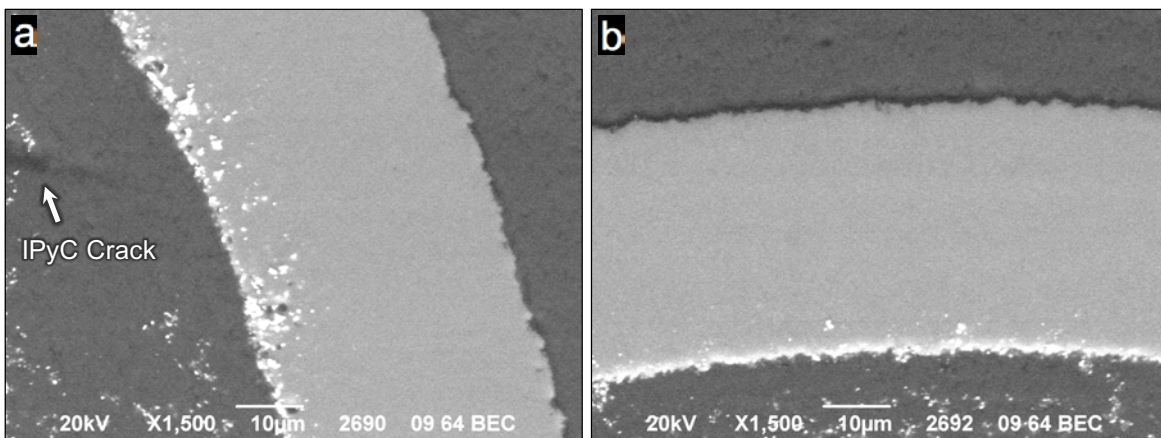
Figure 20 shows two SiC regions in Particle 442-A064 away from the SiC crack, one adjacent to an IPyC crack and one bordered by intact IPyC. The bright features were identified by EDS analysis as primarily due to clusters of uranium. The concentrations of silicon and carbon in the clusters could not be explicitly determined due to beam interaction with the surrounding SiC. As has been typically observed in AGR-1 PIE [Demkowicz 2015b], the distribution of these uranium-rich features in the SiC layer was more limited where IPyC cracks were not observed.

Figure 20. BEC micrographs of Particle 442-A064 showing the distribution of uranium features in the SiC layer in (a) a region with an IPyC crack near the IPyC/SiC interface, and (b) an area away from any cracks in the TRISO layers.

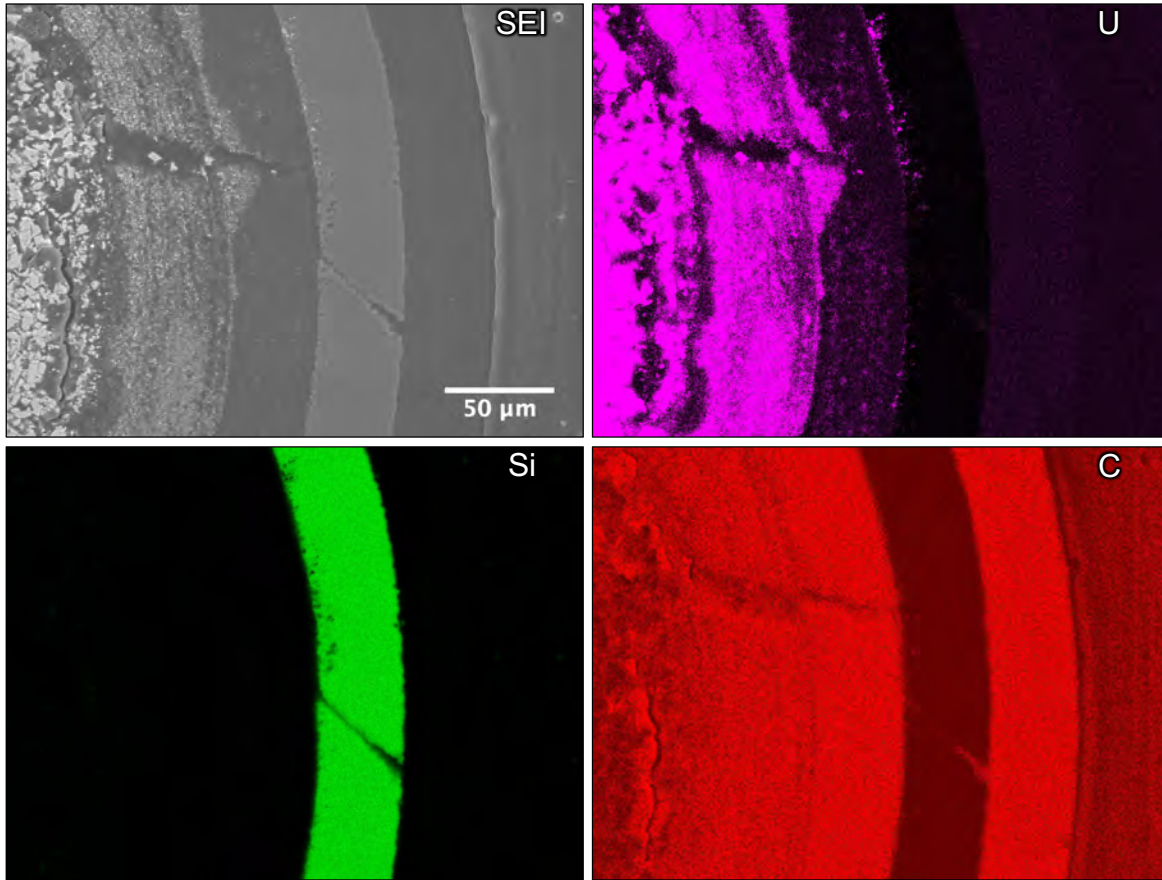
this is especially evident in Figure 21 where the crack widens at the outer edge of the SiC and suggests local decomposition of the SiC at the crack surface.

Figure 21. SiC fracture area in Particle 442-A064 showing SEI micrograph and corresponding EDS maps of x-ray intensity indicating concentration profiles of uranium, silicon, and carbon.

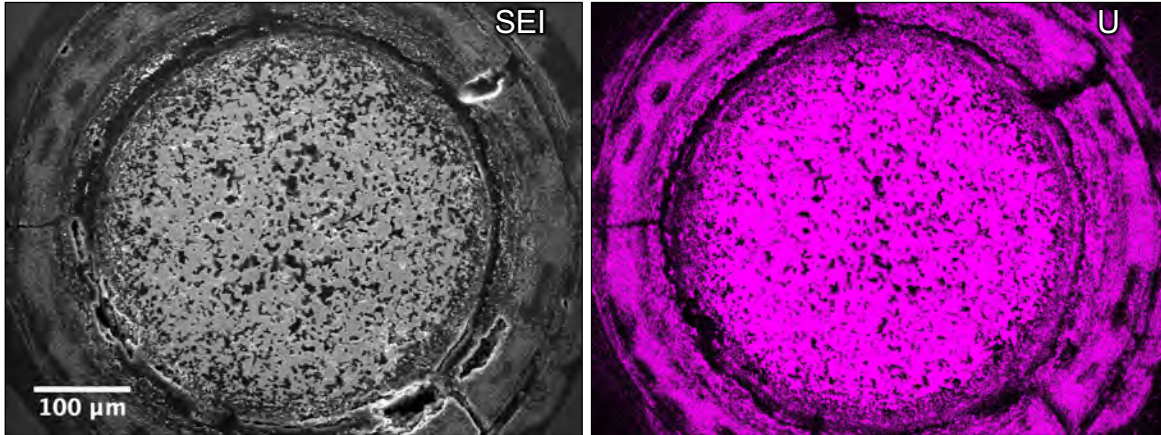
Figure 22. SEI micrograph and corresponding EDS x-ray intensity map of the uranium concentration showing the dispersion of uranium in the buffer of Particle 442-A053.
