PIE on Safety-Tested Loose Particles from AGR-1 Compact 4-4-2

PIE ON SAFETY-TESTED LOOSE PARTICLES FROM AGR-1 COMPACT 4-4-2

Date Published: April 2016

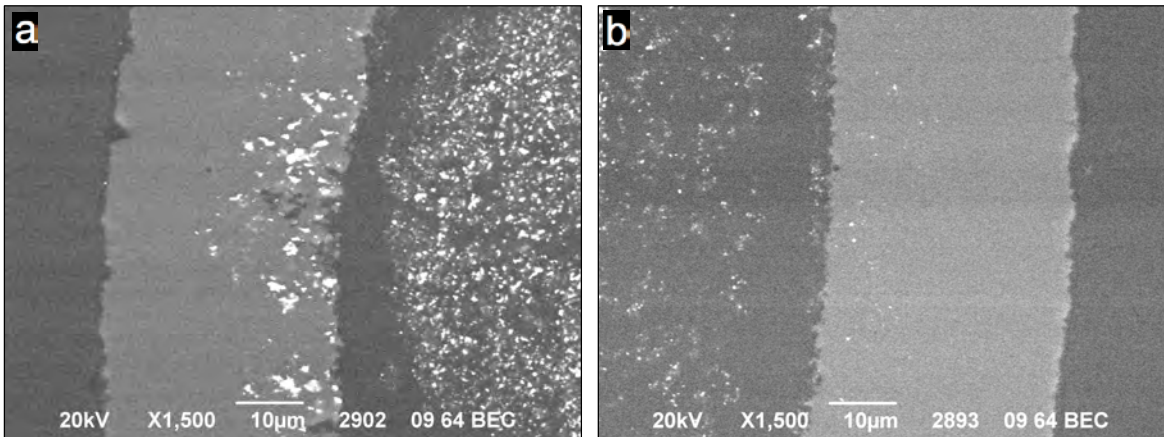
Figure 23. Particle 442-A053 SEM micrographs showing (a) the SiC layer next to a uranium dispersion lobe with significant SiC attack and (b) the SiC layer with no adjacent uranium dispersion lobe in the IPyC layer.

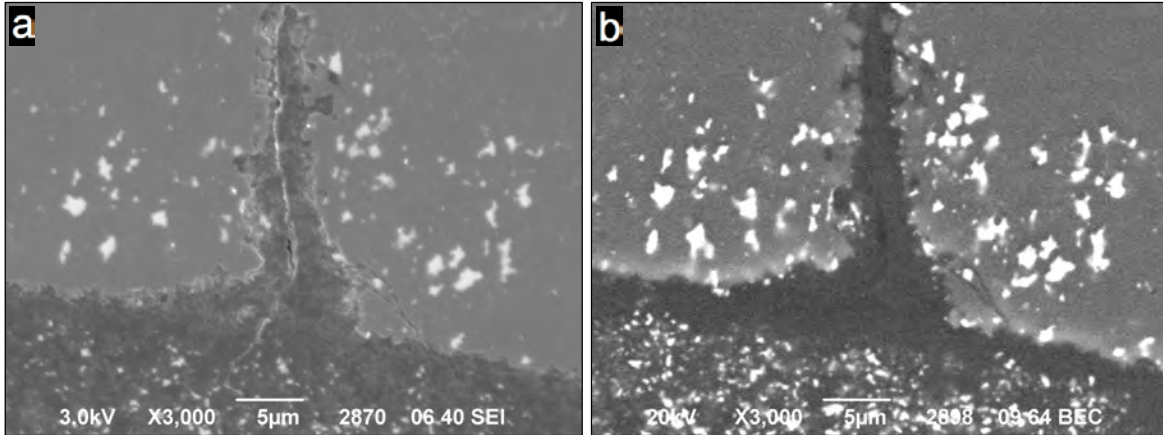
The images presented in Figure 24 and Figure 25 show the SEM analysis of a region surrounding a through-layer crack in the SiC of Particle 442-A053 (also shown in Figure 13). Figure 24a shows the degraded region on either side of the crack was filled with a dense material that EDS determined to be mostly carbon (Figure 25), and the SiC around this degraded region was populated with high-Z features determined by EDS to be predominantly uranium and depleted of silicon (Figure 25). No other significant intensity from other elements were observed, with the exception of zirconium found in a single analyzed feature. The EDS mapping in Figure 25 also confirmed the crack was positioned next to a uranium-rich lobe in the IPyC layer. While it is difficult to draw firm conclusions as to the timing of the formation of the through-layer crack in the SiC, Figure 25 does suggest some relationship to the enhanced degradation of the SiC in the vicinity of the lobe-shaped uranium dispersion in the IPyC layer. These lobe-like features were observed to be associated with SiC degradation in regions away from the SiC crack (e.g, Figure 23), suggesting they may have formed prior to the SiC crack; and it is reasonable to assume that SiC failure could be facilitated by local decomposition of the SiC layer.

Figure 24. SEM analysis of Particle 442-A053 showing (a) close-up SEI micrograph of degraded region surrounding a SiC crack filled with a dense material, and (b) close-up BEC micrograph confirming high-Z features flanking the degraded region and low-Z material nearest the crack.

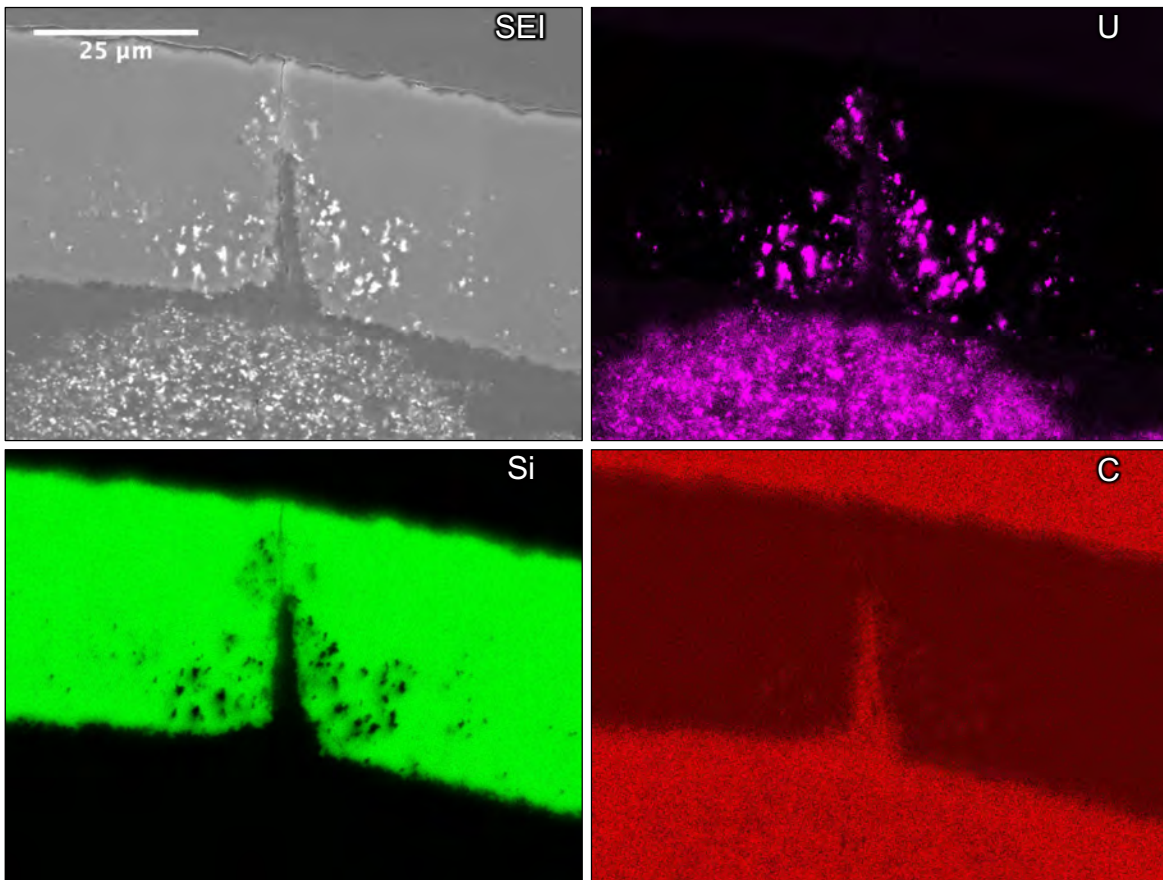
Figure 25. SEM/EDS analysis of Particle 442-A053 showing an overview SEI micrograph of the region surrounding a through-layer crack in the SiC and corresponding EDS x-ray intensity maps indicating relative concentrations of uranium, silicon, and carbon.

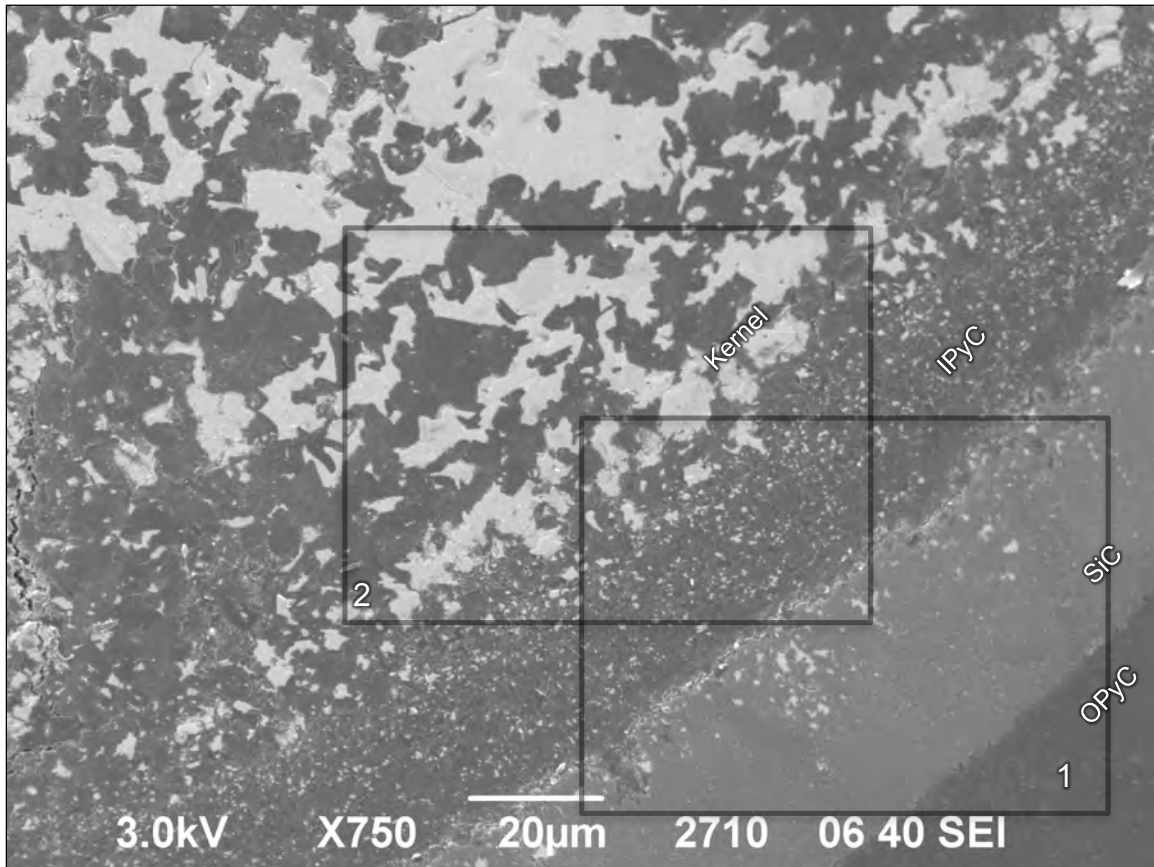
an SEI micrograph of this region is shown in Figure 26. In the optical micrograph, the IPyC layer appears to be thinner where it is in contact with the kernel mass. In the SEI micrograph, there is no clear demarcation between the kernel material and the IPyC material. These observations indicate that significant reaction has occurred between these two components. Small white spots throughout the remaining IPyC layer and larger spots in the SiC layer indicate kernel material (identified below as predominantly uranium) moved into these layers ahead of the primary reaction boundary. Figure 15e also shows that the SiC layer appears to be thinner immediately across from the kernel protrusion. Figure 26 shows that the inside surface of the SiC in this region has been degraded.

Figure 26. SEI micrograph of Particle 442-A072 showing an area where the kernel protrusion contacted the IPyC layer; the marked zones (1 and 2) indicate regions investigated by the EDS x-ray mapping presented in Figure 27 and Figure 28.

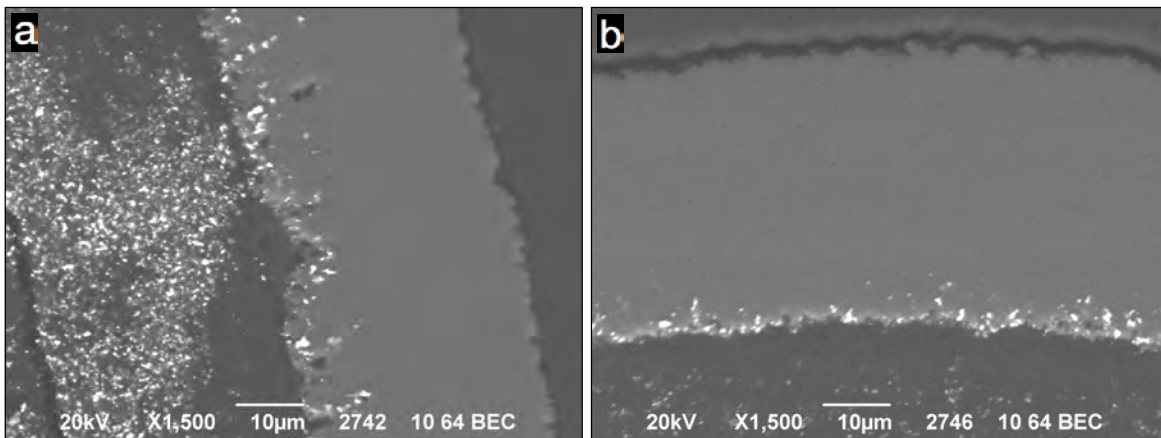
Figure 29. Particle 442-A072 BEC micrographs showing (a) the SiC layer next to a uranium dispersion lobe with significant SiC attack and (b) the SiC layer with no adjacent uranium dispersion lobe in the IPyC layer.

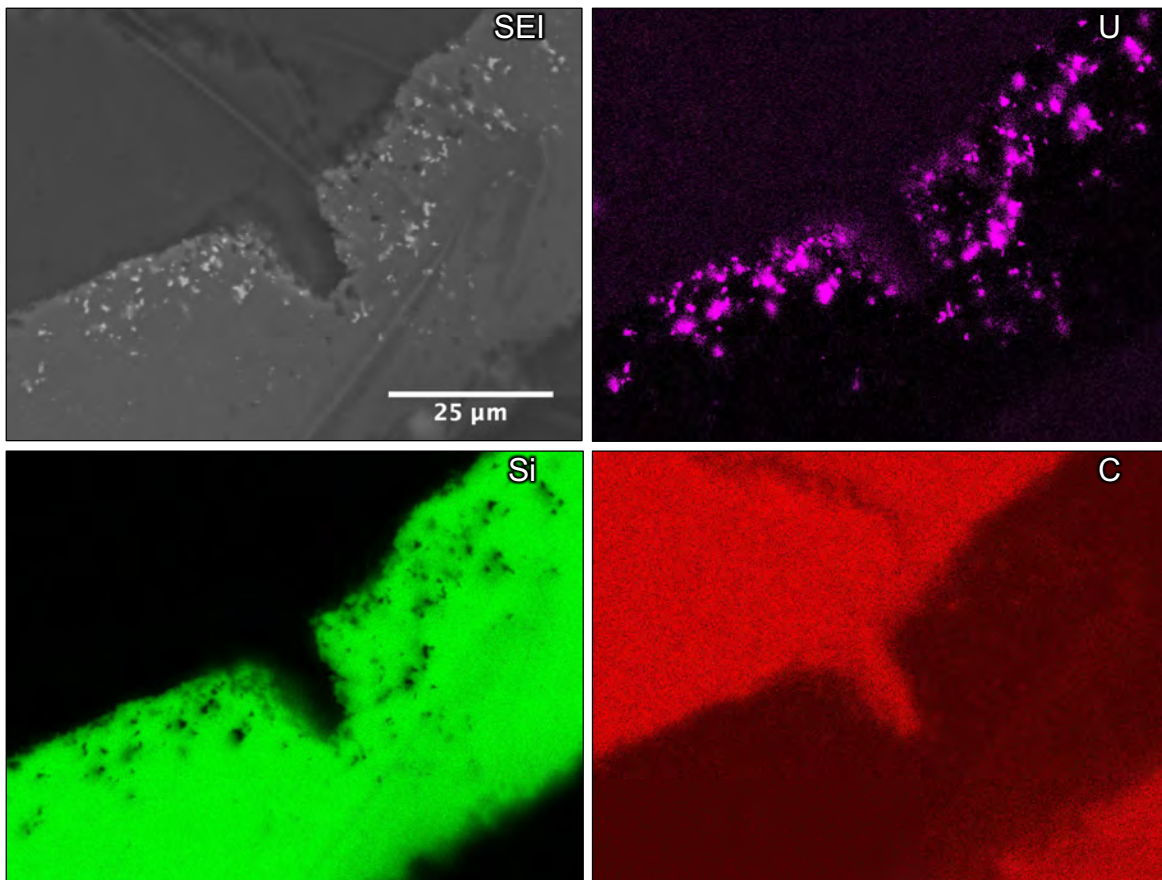
**Figure 30. SEM analysis of a SiC decomposition area in Particle 442-A050 showing SEI micrograph and corresponding EDS x-ray intensity maps indicating relative concentrations of uranium, silicon, and carbon. The linear features observed in the SEI micrograph are due to delamination of the ~8-nm-thick carbon coating applied to reduce charging of the sample during analysis.**

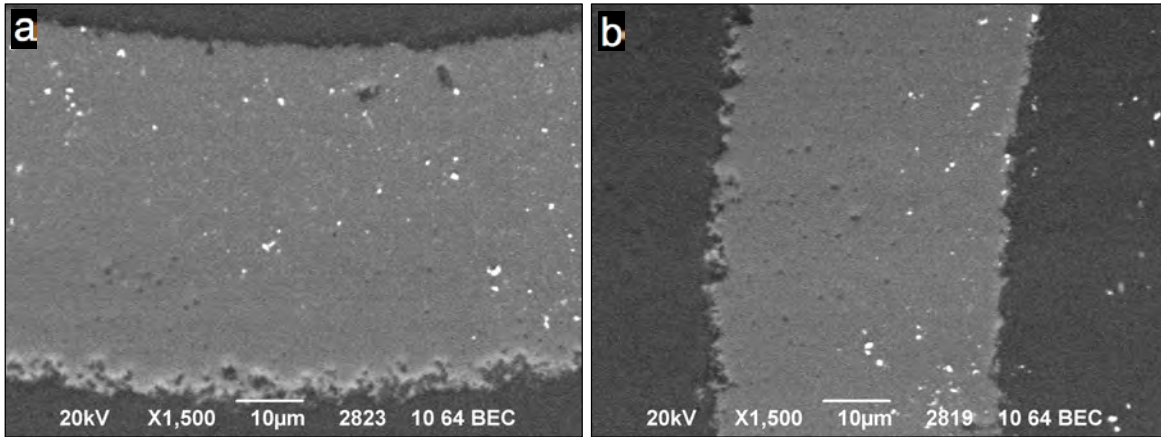
Images of two areas in the SiC layer of Particle 442-A050, away from any IPyC cracks, are shown in Figure 31. In general, the SEM analysis showed high-Z features distributed primarily in the first half of the SiC layer. However, as evident in Figure 31a, features were also present in the outer half of the SiC layer in some locations. The features were confirmed to be uranium-rich and showed no significant EDS signal from other elements. Also evident in Figure 31 are darker spots in the SiC that were most prevalent in the outer half of the SiC. These were carbon-rich areas and have been observed in particles from other 1800°C safety tests. It has been postulated that these spots indicate where clusters of palladium may have resided in the as-irradiated particle prior to heating to 1800°C and that the palladium silicide may have diffused out at this temperature [Hunn et al. 2013b, 28]. Similar out-diffusion of palladium silicide has been proposed as an explanation for only observing uranium clusters in the SiC layers of particles heated to 1800°C, while as irradiated particles and those safety tested to lower temperature usually exhibit clusters of palladium or palladium colocated with uranium. Figure 31 also shows obvious degradation of

the SiC outer surface. This was observed to some extent in all the heated particles and is discussed further in Section 5.3.

Figure 31. Particle 442-A050 BEC micrographs showing SiC layer not adjacent to a crack in the IPyC layer.

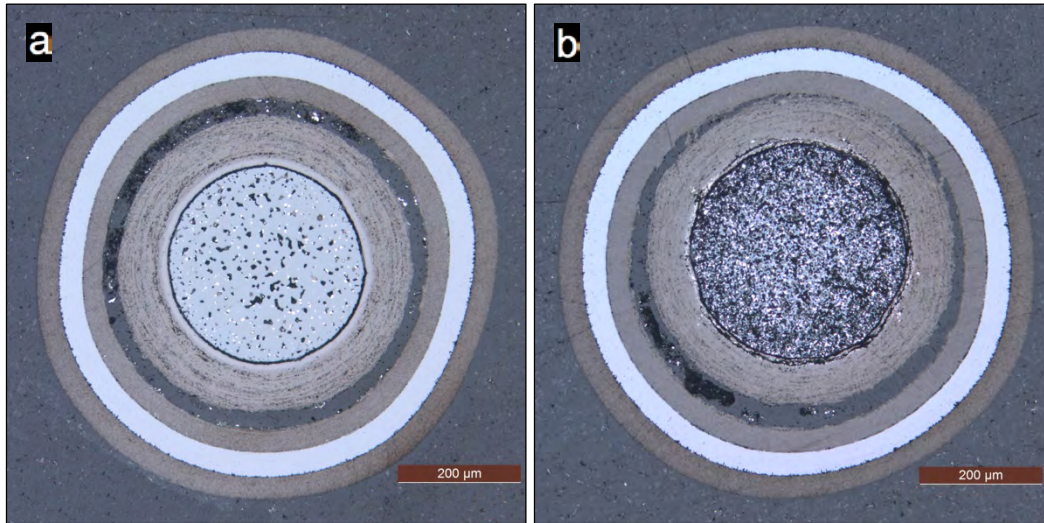
Optical micrographs showing cross-sections of Particle 442-A074 and Particle 442-A016 are shown in Figure 32. Particle 442-A016 exhibited the most typically observed microstructure, namely an intact TRISO layer, buffer shrinkage with near-complete delamination from the IPyC layer, and a slightly friable kernel with a fine-grain structure. Particle 442-A074 had a different and unusual kernel structure. To better understand the kernel variation, EDS x-ray mapping was performed on all kernels. The analysis indicated that the kernel in Particle 442-A074 had a lower carbon to oxygen ratio than all other analyzed kernels. This suggests the Particle 442-A074 kernel initially had relatively more uranium oxide versus uranium carbide compared to the typical AGR-1 kernel. The enhanced retention during heating may have been due to the higher oxide content and denser kernel structure.

Figure 32. Optical micrographs of particles that retained cesium: (a) Particle 442-A074 with high silver retention, and (b) Particle 442-A016 with low silver retention.

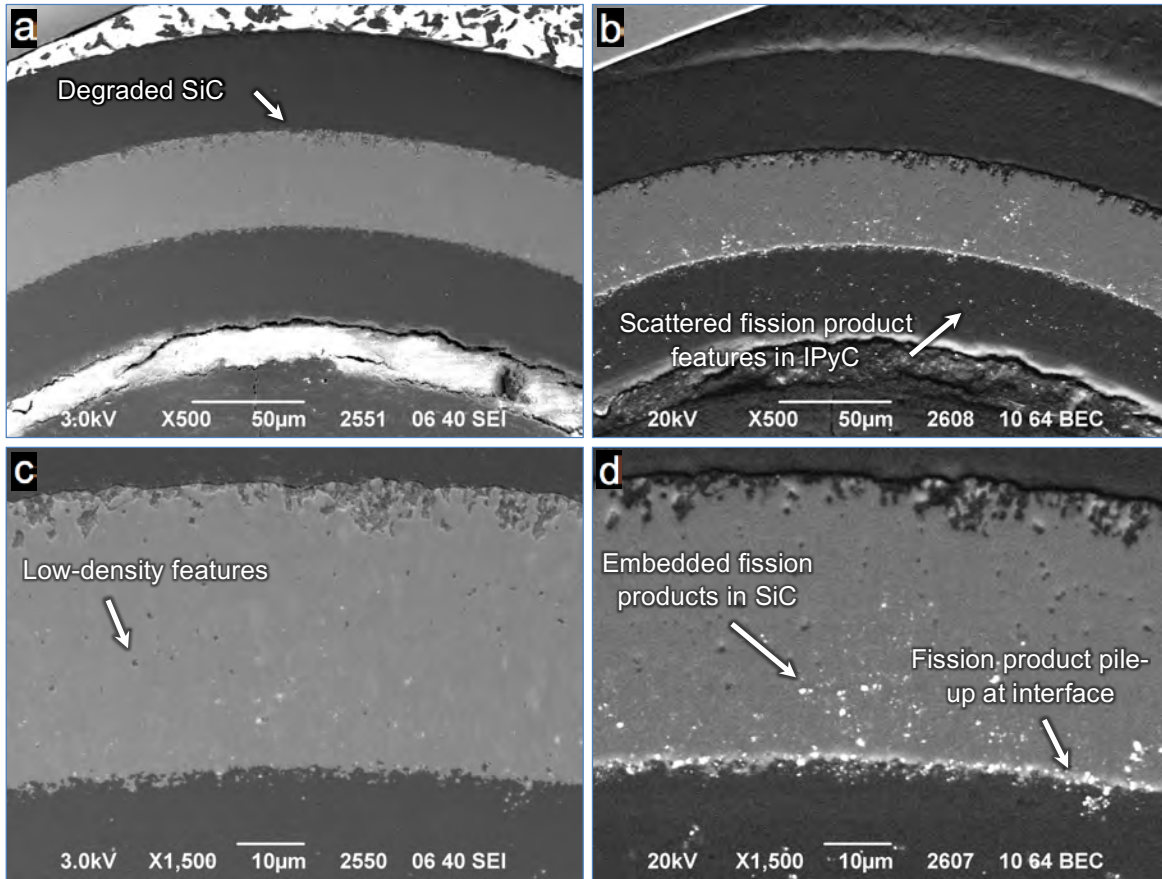
The SEM analysis of the particles in Table 7 focused on microstructural variations and changes in the fission product distribution in the TRISO layers. Figure 33 shows two SEI/BEC image pairs acquired at one location on the polished cross section of Particle 442-A063. Distinct features are labeled in Figure 33 that were observed to some extent in all the particles analyzed in this study. With the exception of the degraded SiC at the OPyC/SiC interface (also shown in Figure 34), these features have been previously observed in other 1800°C safety-tested particles [Hunn et al. 2014e]. As already discussed in Section 5.2 with regard to the SEM analysis of the five failed-TRISO particles, bright spots in the BEC micrographs indicate clusters of high-Z elements, and these were observed finely scattered throughout the IPyC layer, embedded in the SiC in larger clusters (especially in the inner half of the layer), and piled up at the IPyC/SiC interface. In the outer half of the SiC layer, dark spots indicate low-density volumes that have been previously studied in other samples [Hunn et al. 2013b] and appear to be residual carbon-rich features left behind when palladium exited the layer. Degradation of the outer surface of the SiC layer was also observed in the particles with failed TRISO (e.g., Figure 31). This degradation was observed around the circumference of each particle cross-section, for all particles analyzed. Spot analysis with EDS indicated the degraded region was primarily silicon and carbon with low concentrations of oxygen, and the region was depleted of silicon relative to an unaffected reference volume in the SiC bulk. The nature of the degraded region suggests that thermal decomposition of the SiC layer may have occurred, followed by transport of silicon away from the SiC/OPyC interface. However, this feature was not observed in previous 1800°C safety tests. Multiple variables may have contributed to the observed SiC/OPyC degradation. Firstly, the loose particle testing was carried out for 600 h compared to 300 h for previous tests and the longer exposure may have led to observable decomposition. Secondly, the particles were subjected to deconsolidation prior to the heating test and the lack of surrounding matrix may have influenced the high-temperature decomposition behavior of the SiC layer.

Figure 33. Particle 442-A063 SEM analysis showing (a and c) SEI versus (b and d) BEC micrographs at two magnifications; some typically-observed features are identified.

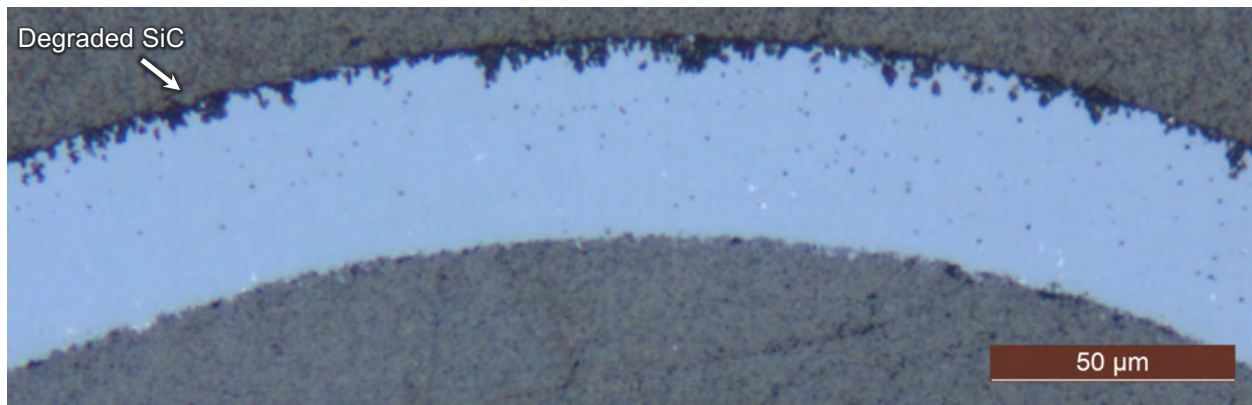
Figure 34. Optical micrograph of Particle 442-A063 showing SiC degradation at OPyC/SiC interface.

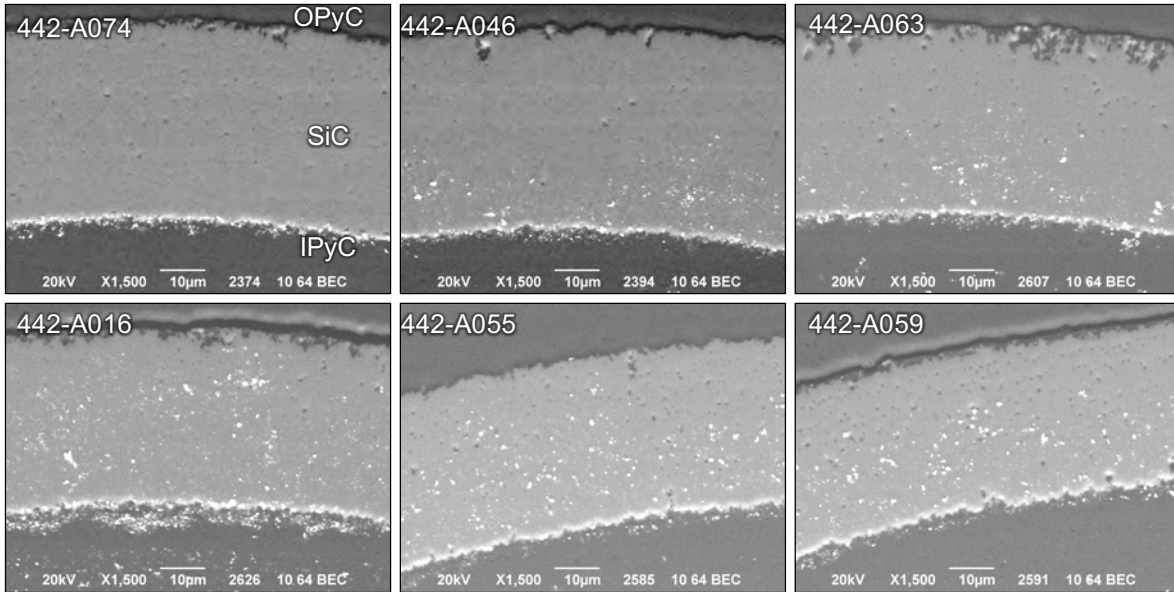
The distribution of high-Z features in the SiC layer varied qualitatively as a function of [110m]Ag retention. Figure 35 compares BEC micrographs of all six particles in Table 7. Particle 442-A074 showed almost no high-Z features in the SiC and limited high-Z pileup at the IPyC/SiC interface. Particle 442-A046 and Particle 442-A063, which still retained measurable inventories of [110m]Ag appeared to have the majority of their high-Z features limited to within 10 µm from the IPyC/SiC interface. The particles that released the most [110m]Ag had a higher frequency of high-Z features in the SiC, and these were distributed across the entire SiC layer. Local SiC degradation at the IPyC/SiC interface was also observed for Particle 442-A055 and Particle 442-A059. An example of this local attack is shown in Figure 36.

Figure 35. Comparison of BEC micrographs of TRISO layers from particles in Table 7 highlighting the interaction of fission products with the SiC as a function of silver retention.

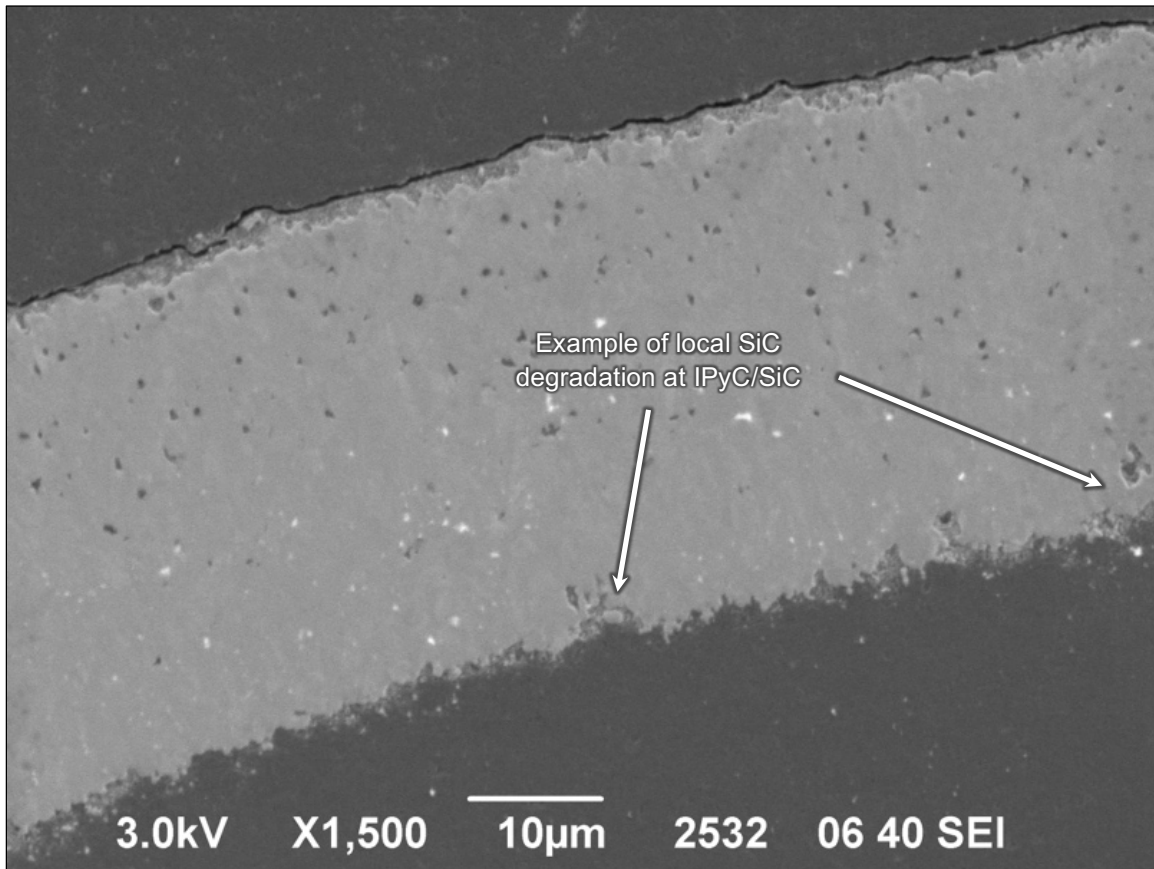
Figure 36. SEI micrograph of Particle 442-A055 showing regions of SiC degradation.

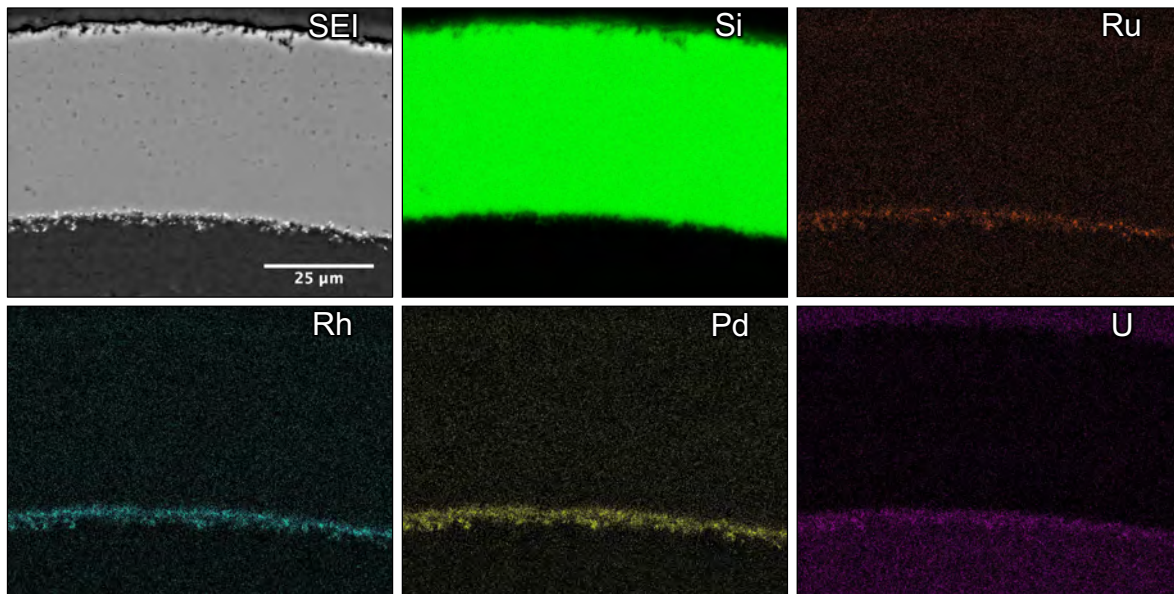
Table 7, presumably due to the low carbon content in the kernel. As noted earlier, the features were primarily isolated in the IPyC layer and at the IPyC/SiC interface. A compositional EDS map of the SiC layer of Particle 442 A074 is shown in Figure 37, the mapping indicates pileup of palladium, rhodium, and ruthenium at the IPyC/SiC interface with trace uranium concentrations observed in the IPyC layer. Fixed-spot analysis provides improved compositional sensitivity and was employed to better understand the nature of the observed features. The composition of the features at the IPyC/SiC interface were confirmed to be palladium, rhodium, and ruthenium. Trace technetium and molybdenum concentrations were also identified in these features as was trace uranium in select cases. The features were mostly palladium-rich, however, multiple analyzed features were observed to be rhodium or ruthenium-rich. A few fission product features located in the SiC layer close to the IPyC were primarily palladium, with trace rhodium and ruthenium.

Figure 37. SEM/EDS analysis of IPyC and SiC layers in Particle 442-A074 showing SEI micrograph and corresponding EDS x-ray intensity maps of relative silicon, ruthenium, rhodium, palladium, and uranium concentrations.

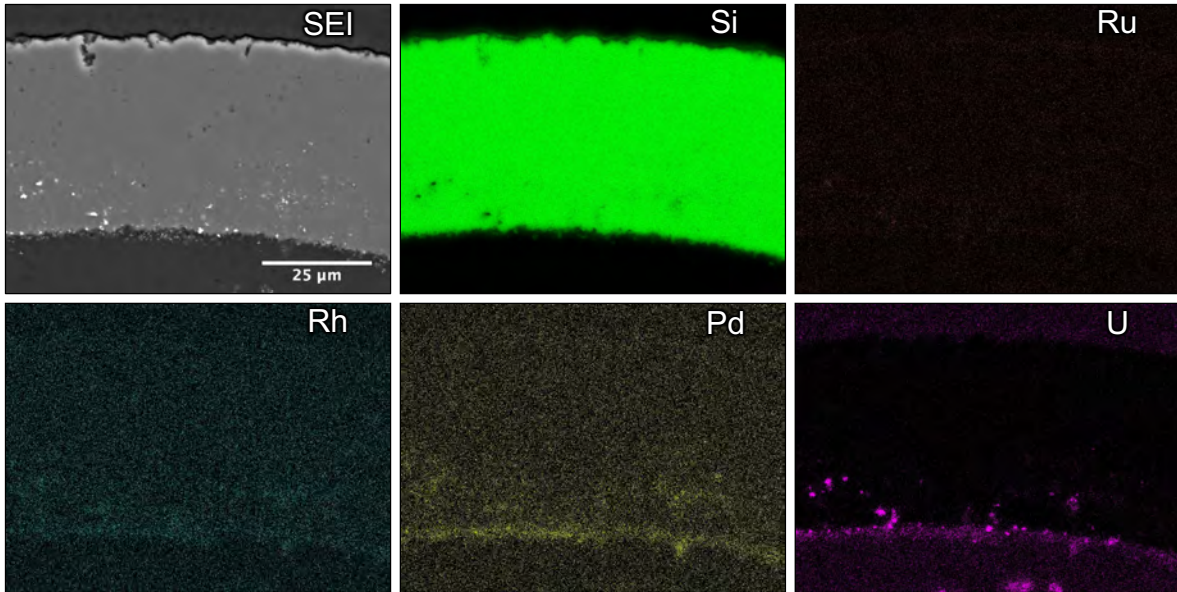
The analysis of the other five particles with normal cesium retention indicated four common feature types; these common features were uranium-only (U-only) features, uranium with relatively-low concentration palladium (U-dominant) features, uranium molybdenum zirconium (U-Mo-Zr) features, and complex palladium, uranium, rhodium, and ruthenium (Pd-U-Rh-Ru) features. Both the U-Mo-Zr and the Pd-U-Rh-Ru features had varying relative compositions based on the particle of interest and location of the feature. Trace concentrations of Nd, Ce, and Pu were also identified by the Oxford automatic identification software routine, however the intensity of the representative x-ray lines for each species were not statistically significant or could not be confirmed due to peak overlap with primary components. The four feature types were observed at varying degrees in all the particles in Table 7 but Particle A074. Figure 38 through Figure 42 show the EDS x-ray maps of the SiC layer for these five particles. The EDS maps visually indicate the difference in fission product distribution at the IPyC/SiC interface and in the SiC layer. The mapping shows that the uranium-rich features were distributed within the SiC layer and at the IPyC/SiC interface. The intensity of palladium, rhodium, and ruthenium signals were generally concentrated at the IPyC/SiC interface, but lower intensities were also observed in the SiC layer, especially for palladium.

Figure 38. SEM/EDS analysis of IPyC and SiC layers in Particle 442-A046 showing SEI micrograph and corresponding EDS x-ray intensity maps of relative silicon, ruthenium, rhodium, palladium, and uranium concentrations.

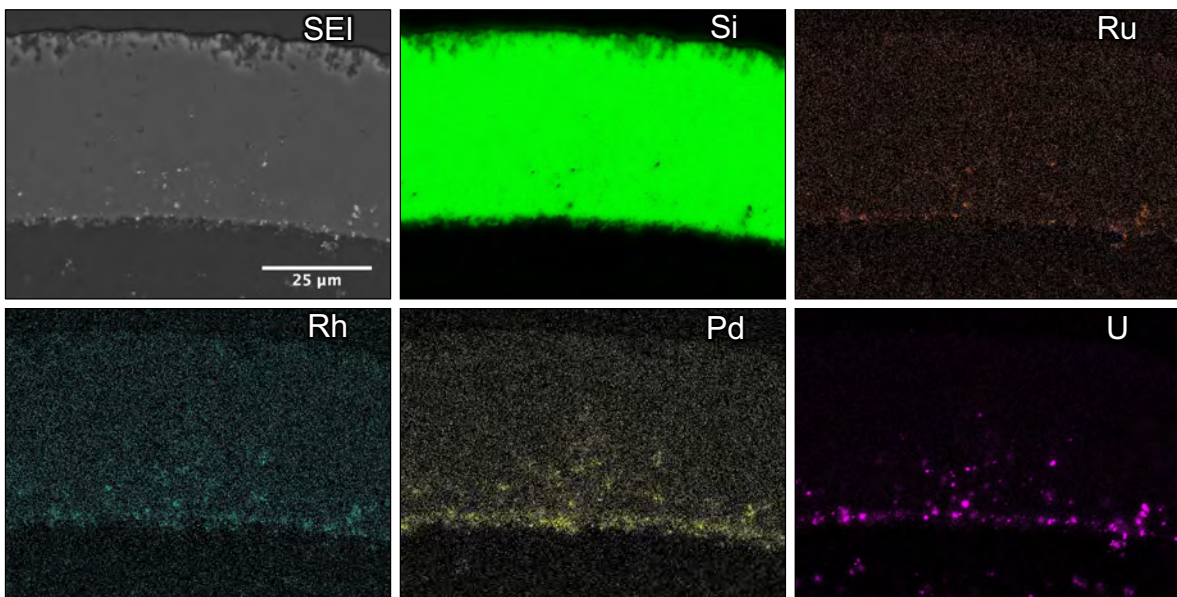
Figure 39. SEM/EDS analysis of IPyC and SiC layers in Particle 442-A063 showing SEI micrograph and corresponding EDS x-ray intensity maps of relative silicon, ruthenium, rhodium, palladium, and uranium concentrations.

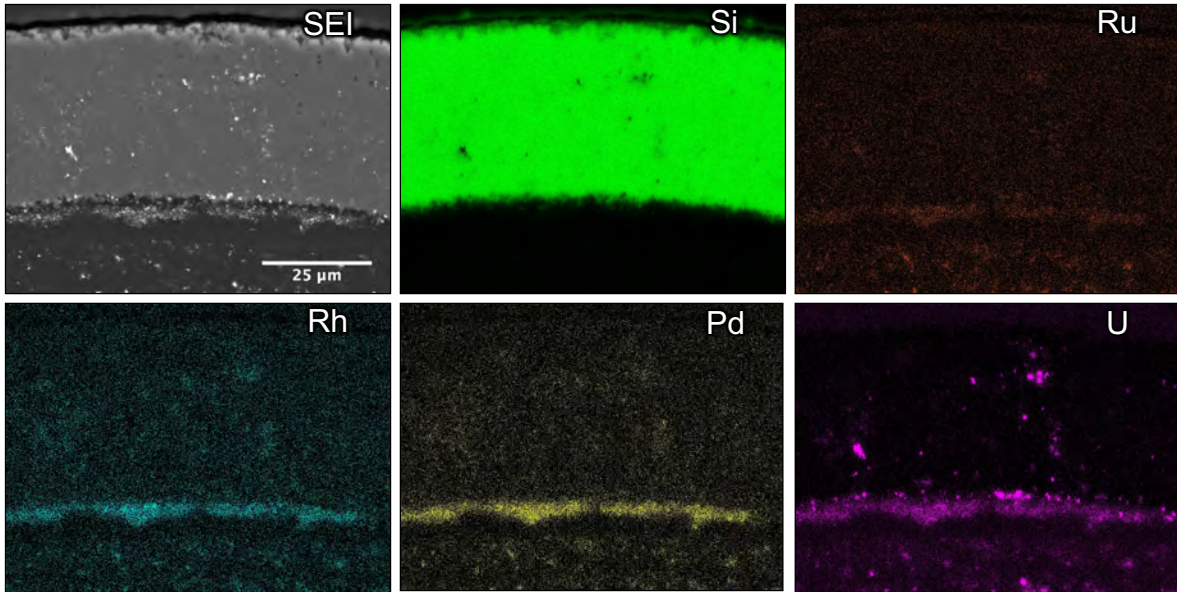
Figure 42. SEM/EDS analysis of IPyC and SiC layers in Particle 442-A059 showing SEI micrograph and corresponding EDS x-ray intensity maps of relative silicon, ruthenium, rhodium, palladium, and uranium concentrations.

The different fission product distributions and compositions in Particles 442-A059 and 442-A055 reflect the different silver and europium retention behavior of these two particles, compared to the other particles in Table 7. The uranium was distributed further out in the SiC than in Particles 442-A046 and 442-A063 and, as discussed with regard to Figure 35 above, this trend correlated to the silver retention and was also seen in Particle-A016, which also released most of its silver. However, in contrast to Particle-A016 that did not release measurable europium, Particles 442-A046 and 442-A063 also showed less palladium remaining in the SiC or at the IPyC/SiC interface.
