Wear Analysis of Wind Turbine Gearbox Bearings

March 31, 2010

**P. J. Blau, L.R. Walker, H. Xu, R. Parten, J. Qu, and T. Geer
Materials Science and Technology Division
Oak Ridge National Laboratory**

Final report

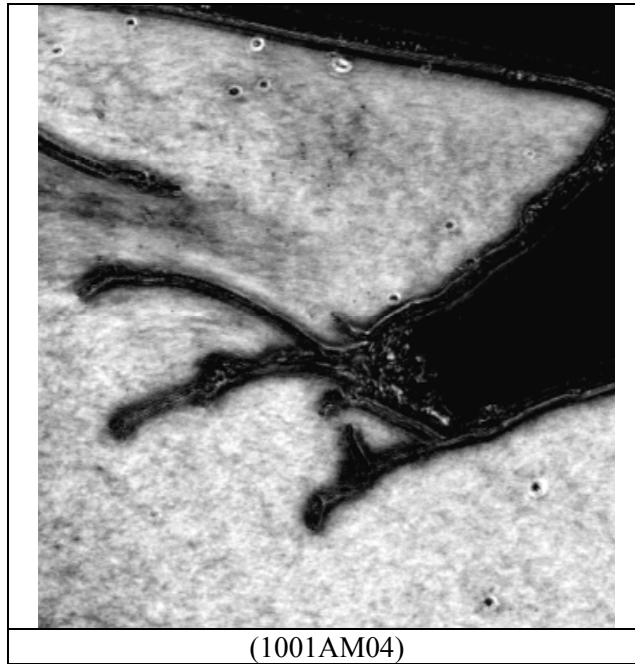
(1001AM04) Scanning acoustic microscope image of the edge of a spall at 1 GHz frequency and with a focus of $z = -4.5\mu\text{m}$. The magnification is the same as that for Fig. (1001OM33).

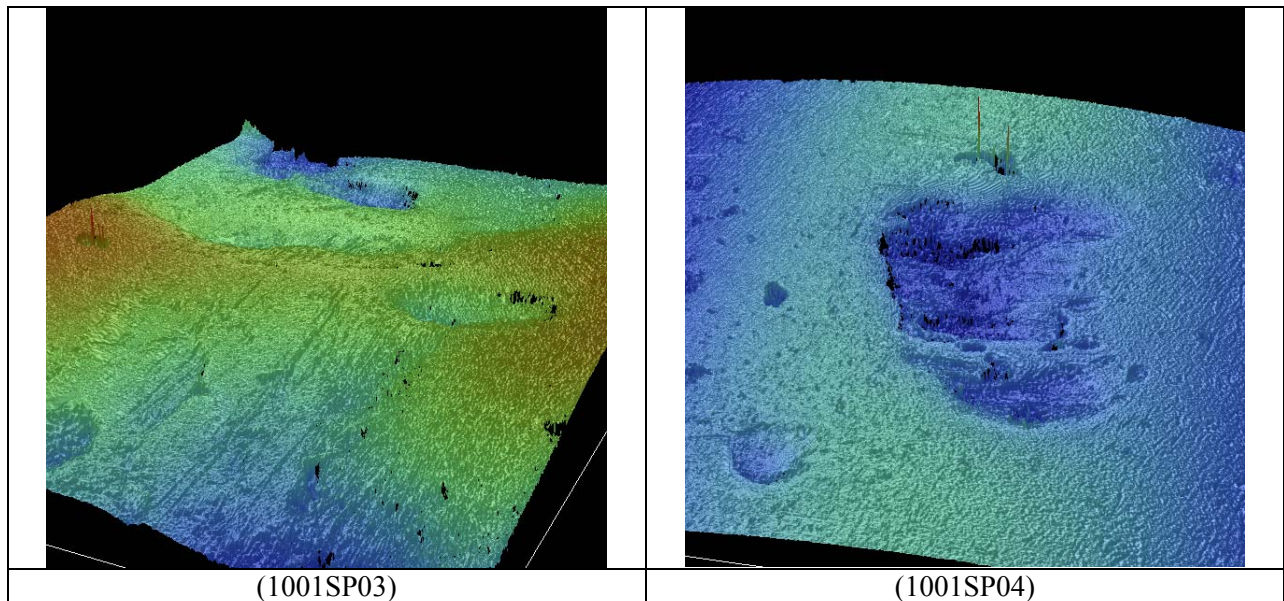
Vertical scanning interferometry (VSI) 3D images were also obtained using a Wyko Model NT9100 system. Images were generated by progressive scanning of a selected region at steps in the vertical axis and post-processing of the data to construct three-dimensional representations of surface features with color coding of the feature heights. In the less worn rolling elements, the shallower indents, due to hardened wear particle crushing and embedment, were less than 1 μm deep and the deepest were about 3 μm deep. Figures 1001SP03-04 show typical 3D VSI reconstructions of indented areas on the circumference of a SRP. Note the faint (blue) scratches in the lower center of image 1001SP03. They run in the circumferential direction of the roller.

(1001SP03) 3D map of indents on the surface of a less-worn bearing. The area of analysis for this scan is approximately 0.878 mm long x 0.657 mm wide. Depressions measured about 2-6 μm deep. The highest point to the lowest point on the entire figure (z-direction) is 40 μm .

(1001SP04) 3D map of a relatively large indentation in the curved surface of the less-worn bearing. The area of analysis for this scan is approximately 0.878 mm long x 0.657 mm wide. Its depth is $\sim 6\mu\text{m}$.

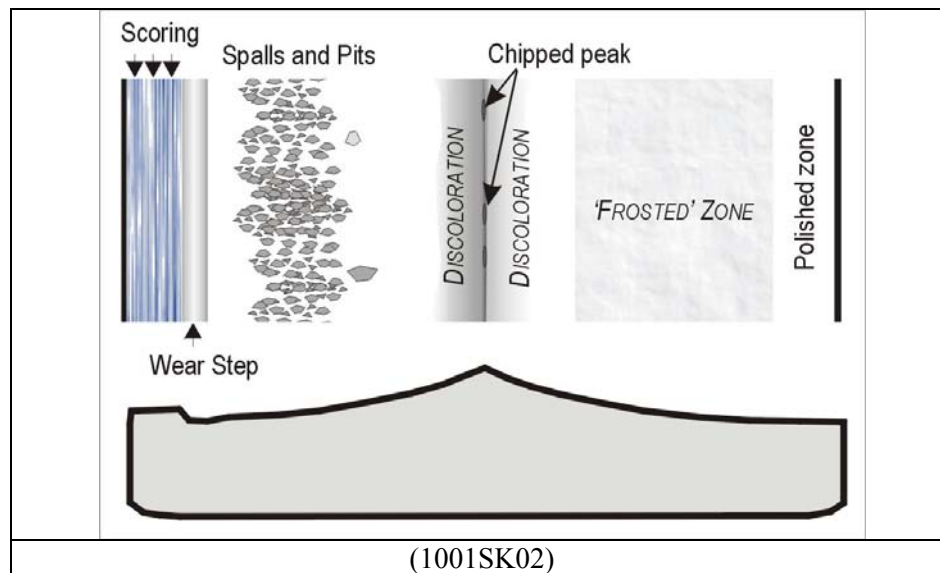
A diagram of the zones and types of damage on the inner race is presented in Figure (1001SK02).

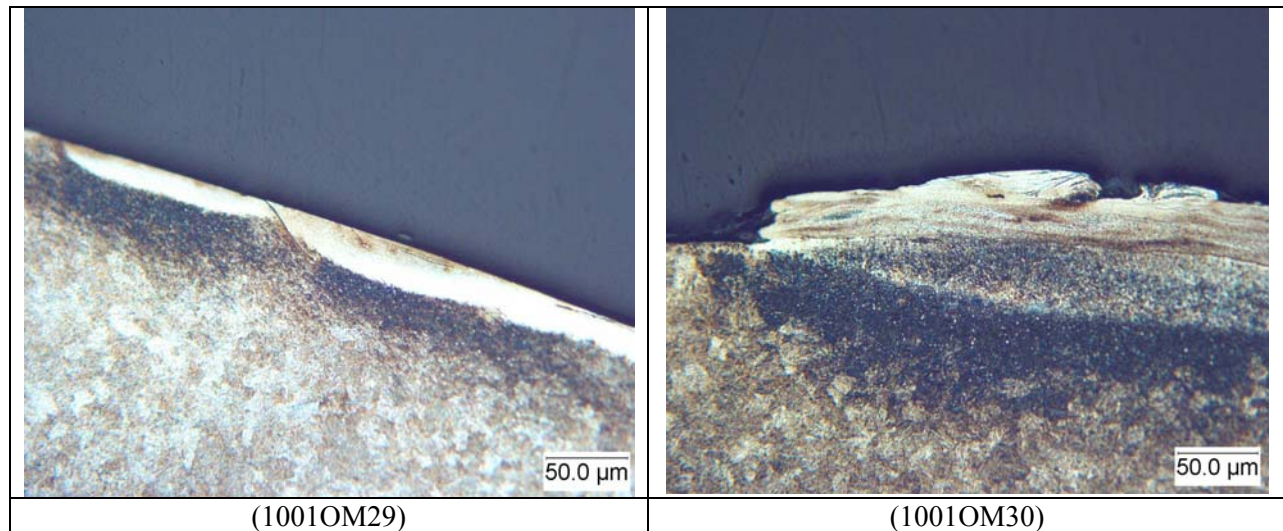
(1001OM29) Higher magnification view of the flowed material shown in (1001M28).

(1001OM30) Adherent deposit on a flat zone outboard of the wear step. Several distinct microstructural zones are evident. The tip feature seemed to be adhered (transferred) material. Underlying that was a lighter gray zone of finer grain structure, and below that a quite dark zone. Finally, the grain structure of the bulk material is below the dark etching zone.

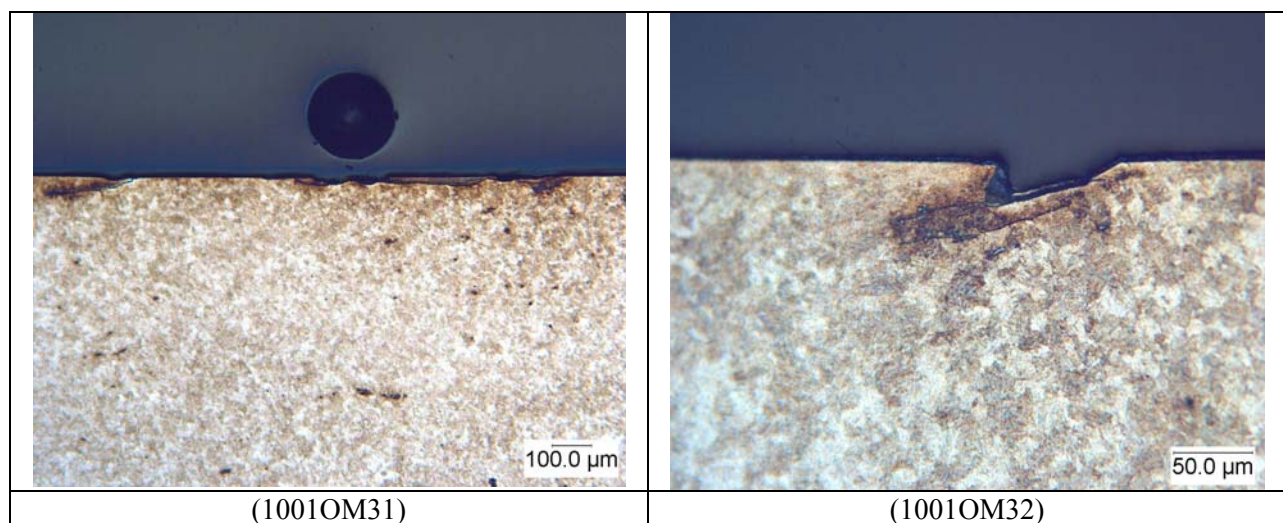
The less worn side of the inner race showed no evidence of white layers, but some of the shallow features associated with indentations were associated with micro-cracks. These microcracks were not nearly as long or deep as those on the more worn side (see below).

(1001OM31) Etched area of the less worn race indicating some indenting, but no white layers.
