Sister Rod Nondestructive Examination Final Report

Spent Fuel and Waste Disposition

***December 21, 2018
SFWD-SFWST-2017-000003 Rev. 1
(M2SF-17OR010201021)
ORNL/SPR-2017/484 Rev. 1
(ORNL/SPR-2018/801)***

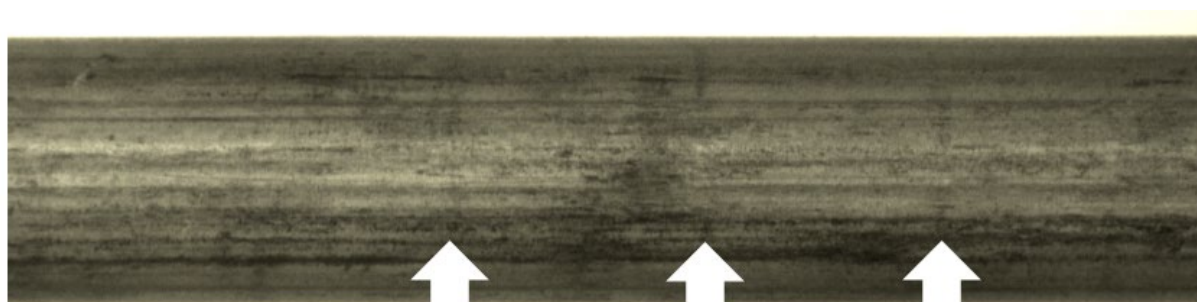
For the Zircaloy-4 (Zirc-4), low tin (LT) Zirc-4, and ZIRLO fuel rods, when the parent fuel assembly was fabricated, the fuel rods were pulled or pushed through the spacer grids with the springs/dimples engaged. Interaction with the spacer grid springs and dimples during rod insertion can produce long, shallow axial scratches along much of the rod’s length at the azimuthal locations of the grid springs/dimples. These are visible on the rod as oxidized scratches, as shown in Figure 3. Likewise, in many cases, interaction with the spacer grid springs and dimples during rod removal created long axial scratches along much of the rod length at orthogonal locations consistent with the location of the grid springs/dimples, removing surface CRUD and perhaps some oxide. Because the rods are not expected to rotate significantly in the reactor, it is likely that the rod removal scratches are collocated with the rod insertion scratches; however, two sets of scratches were noted in at least one sister rod. The rod insertion scratches oxidize in the reactor and the presence of oxide in the scratch would indicate that it occurred during fuel assembly fabrication. In contrast, for the Framatome Advanced Mark-BW fuel assembly design, the M5 fuel rods were inserted into the assembly using a method called “keying,” in which the springs and dimples are depressed to prevent scratching of the cladding during assembly fabrication. Therefore, it is likely that any axial scratches observed on the M5 rods occurred only during rod removal.

Figure 3. Typical Appearance of Orthogonal Longitudinal Scratches Consistent with Spacer Grid Spring/Dimple Interaction during Rod Insertion and Withdrawal from the Fuel Assembly.

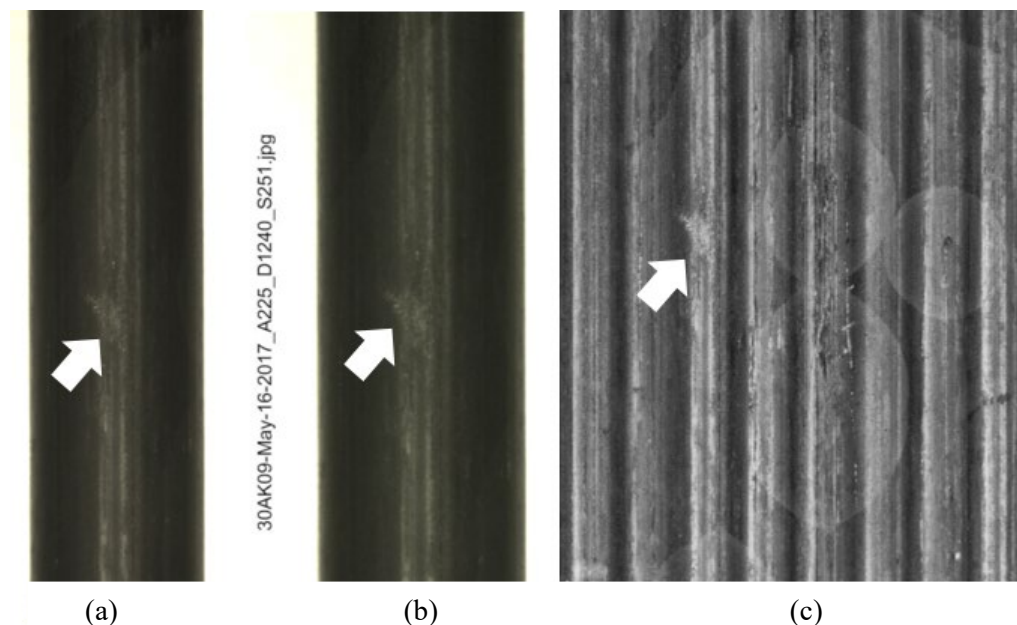
During the visual examination, the rods are moved and rotated to the position in front of the camera using the ADEPT system. The large amount of rod handling required for the photos can introduce some rubbing or polishing to the cladding’s outer surfaces, resulting in minor visual artifacts that could be confused with pellet-pellet interfaces. Since the pellets are approximately 10 mm long, banding that is spaced at a frequency other than 10 mm is likely a result of clad polishing during handling. Additionally, necessary handling of the rods using the in-cell manipulators can produce scratches, typically visible as bright diagonal marks on the rod’s surface, as illustrated in Figure 6. Some additional examples of handling marks are provided in Tables 1 and 4. Finally, the profilometry measurements (see Section 3.5) were completed prior to the visual examinations. Based on previous experience with contact probes such as the LVDTs used for the profilometry exam, the profilometry scans may have removed some CRUD or left some markings on the rod, although no such markings were identified as of this review.

Figure 6. Typical Appearance of ADEPT Handling Marks (Left) and Manipulator Scratches (Right).

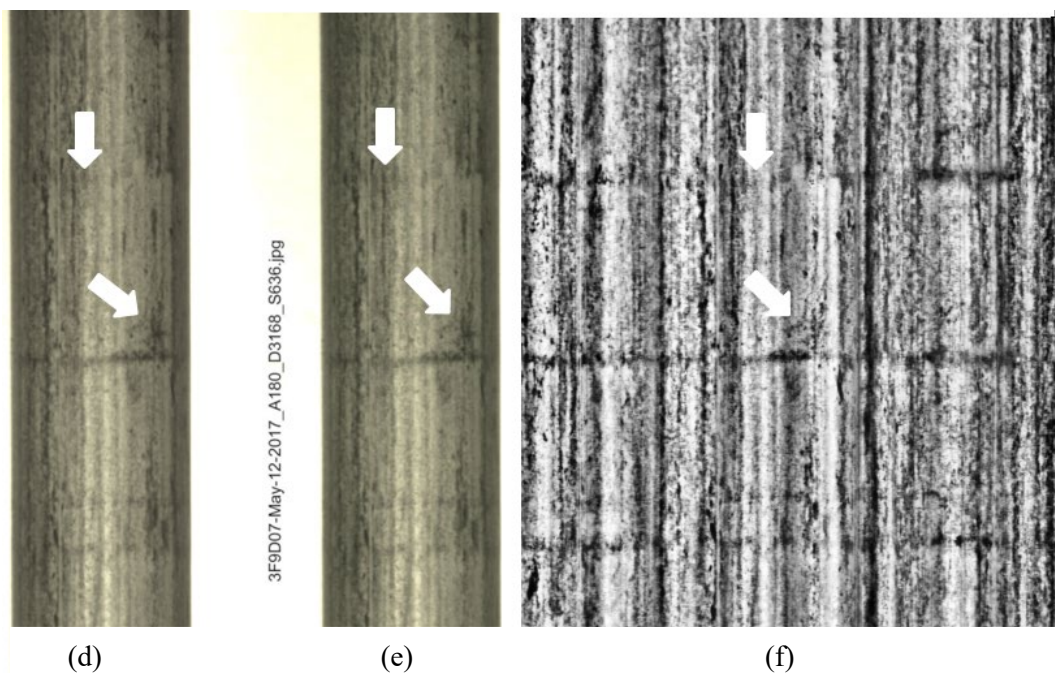
Due to their dark matte black appearance, it is difficult to detect features on the surface of the M5 rods using the interactive images or the raw images. As an illustration, Figure 7(a)(b)(c) shows side by side images of the same rod with an elevation and rotation having a burnishing mark (a very shallow fretting wear mark). The burnishing mark is clearly visible in the flattened and contrast filtered collage, but it is barely discernible in the SWF format. Features on the Zirc-4, LT Zirc-4, and ZIRLO rods are also generally more discernible in the flattened collage format, as well, but some features can become less apparent due to the large format and high contrast filtering used, as illustrated in Figure 7(d)(e)(f).

On the matte black M5 rods above, features such as the fretting mark (as indicated by the arrow) and the circular patches of oxidation become more visible.

On the shiny grey surfaces of the Zirc-4, LT Zirc-4 and ZIRLO rods, the flattened and filtered image can make some features such as the pellet-pellet boundaries more visible, while some features, such as the dark patch highlighted with the arrow, become indistinct.

Figure 7. Illustration of Visible Features on an M5 Sister Rod using (a) the Unprocessed Individual Photo, (b) the Interactive SWF, and (c) the Flattened and Filtered Collage and a ZIRLO Sister Rod using (d) the Unprocessed Individual Photo, (e) the Interactive SWF, and (f) the Flattened and Filtered Collage.

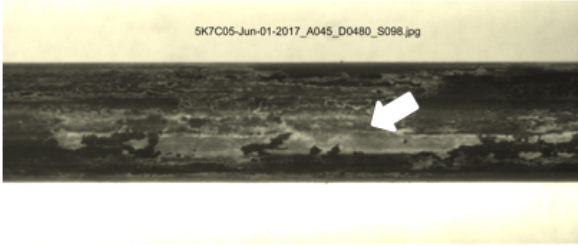
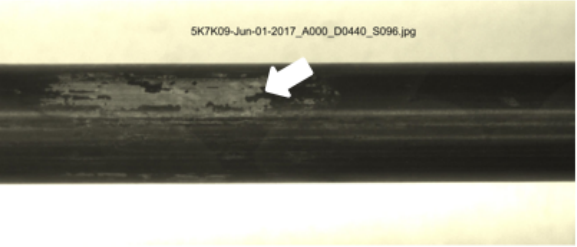
(a) Localized CRUD peeling.	(b) Localized CRUD peeling.

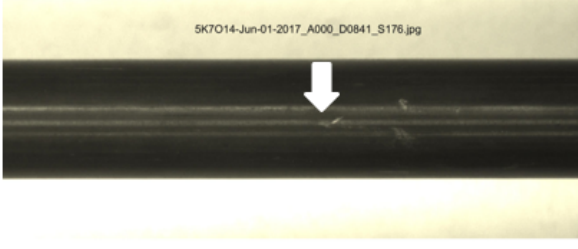
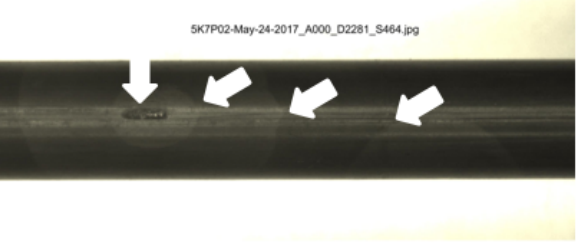
(c) Shallow GTRF	(d) Shallow GTRF with light oxidation in circular patches.

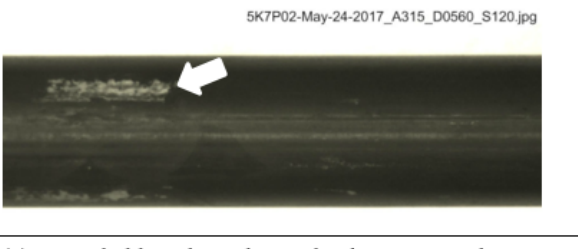
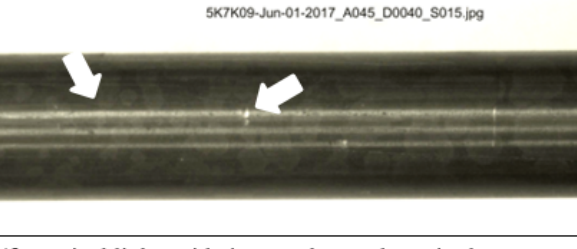
(e) Extended length moderate depth GTRF mark.	(f) Typical light oxidation patches and manipulator scratches.

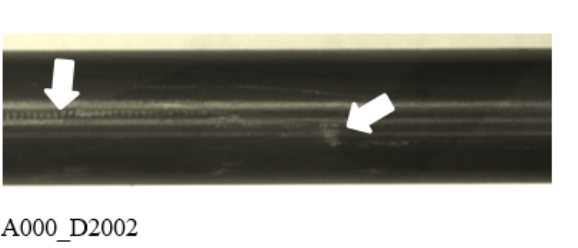
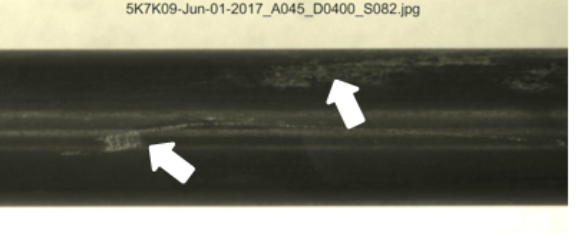
<p>A000_D2002</p>

(g) Typical rod removal scratch and a shallow GTRF mark.	(h) Shallow GTRF with rod removal scratch and peeling CRUD.

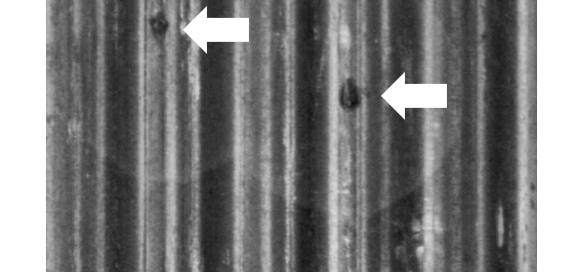
<p>(i) an example of center peeling oxide rings (note the image was extracted from a flattened collage and the axial direction of the rod is oriented perpendicular to the other images shown on this page).</p>

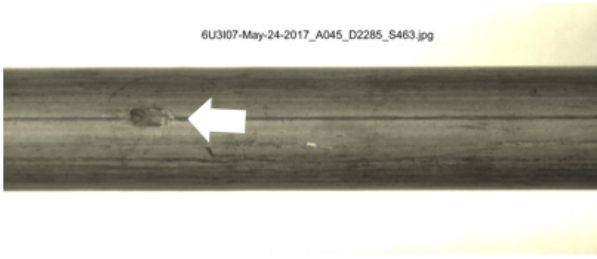
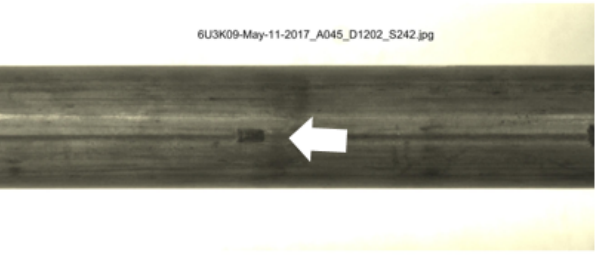
(a) Relatively deep GTRF.	(b) Moderate GTRF.

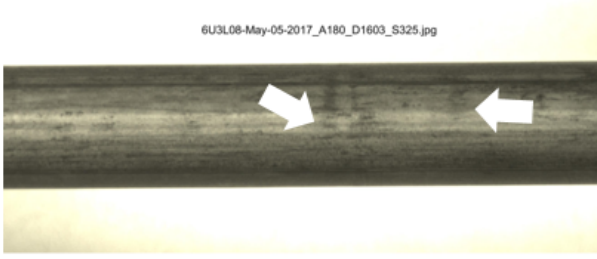
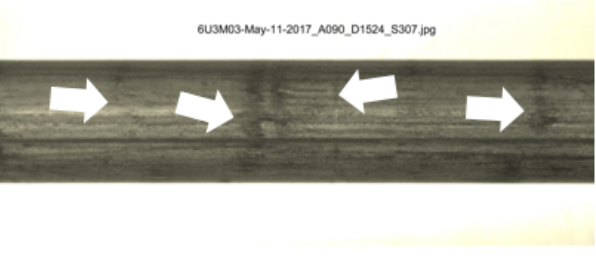
(c) Possible handling marks and pellet-pellet interface bands.	(d) Possible handling marks and pellet-pellet interface bands.

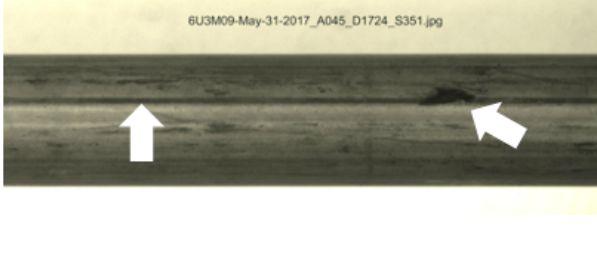
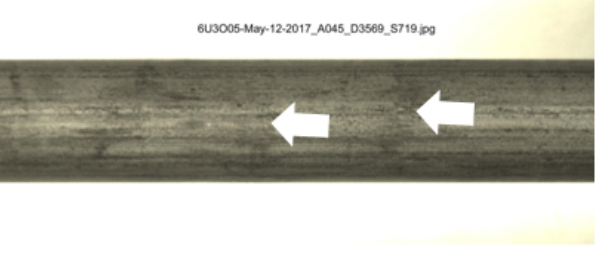
(e) Rod insertion or removal scratch with shallow GTRF.	(f) Possible handling marks.

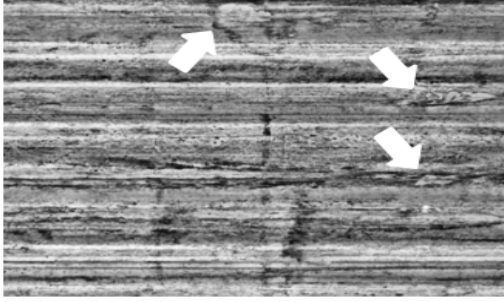
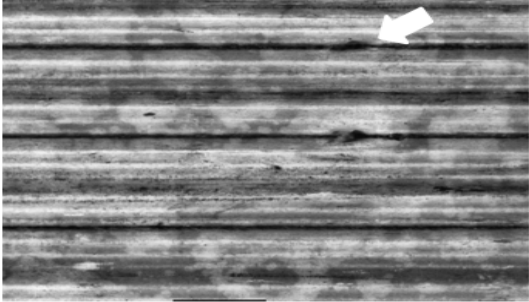
(c) Moderate GTRF, completely oxidized, and a patch of locally heavy oxidation.	(d) Moderate GTRF.

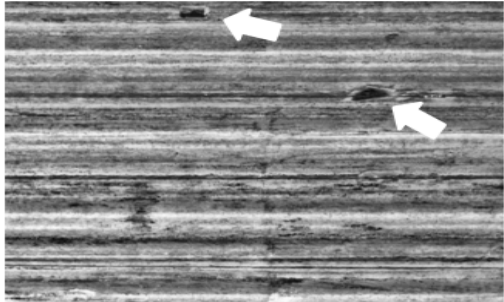
(e) Moderate GTRF that likely occurred during an early cycle since the mark appears to be partially oxidized.	(f) Typical appearance of pellet-pellet interfaces; this section near a gamma scan-reported axial stack gap (~3 mm).

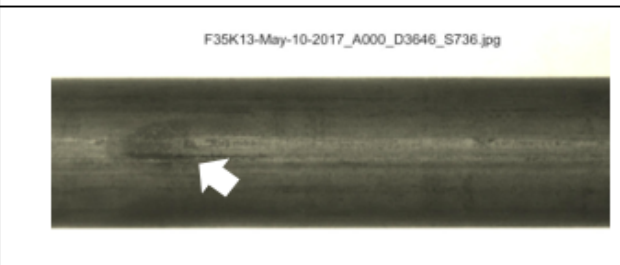
(f) Flow pattern at a grid elevation.

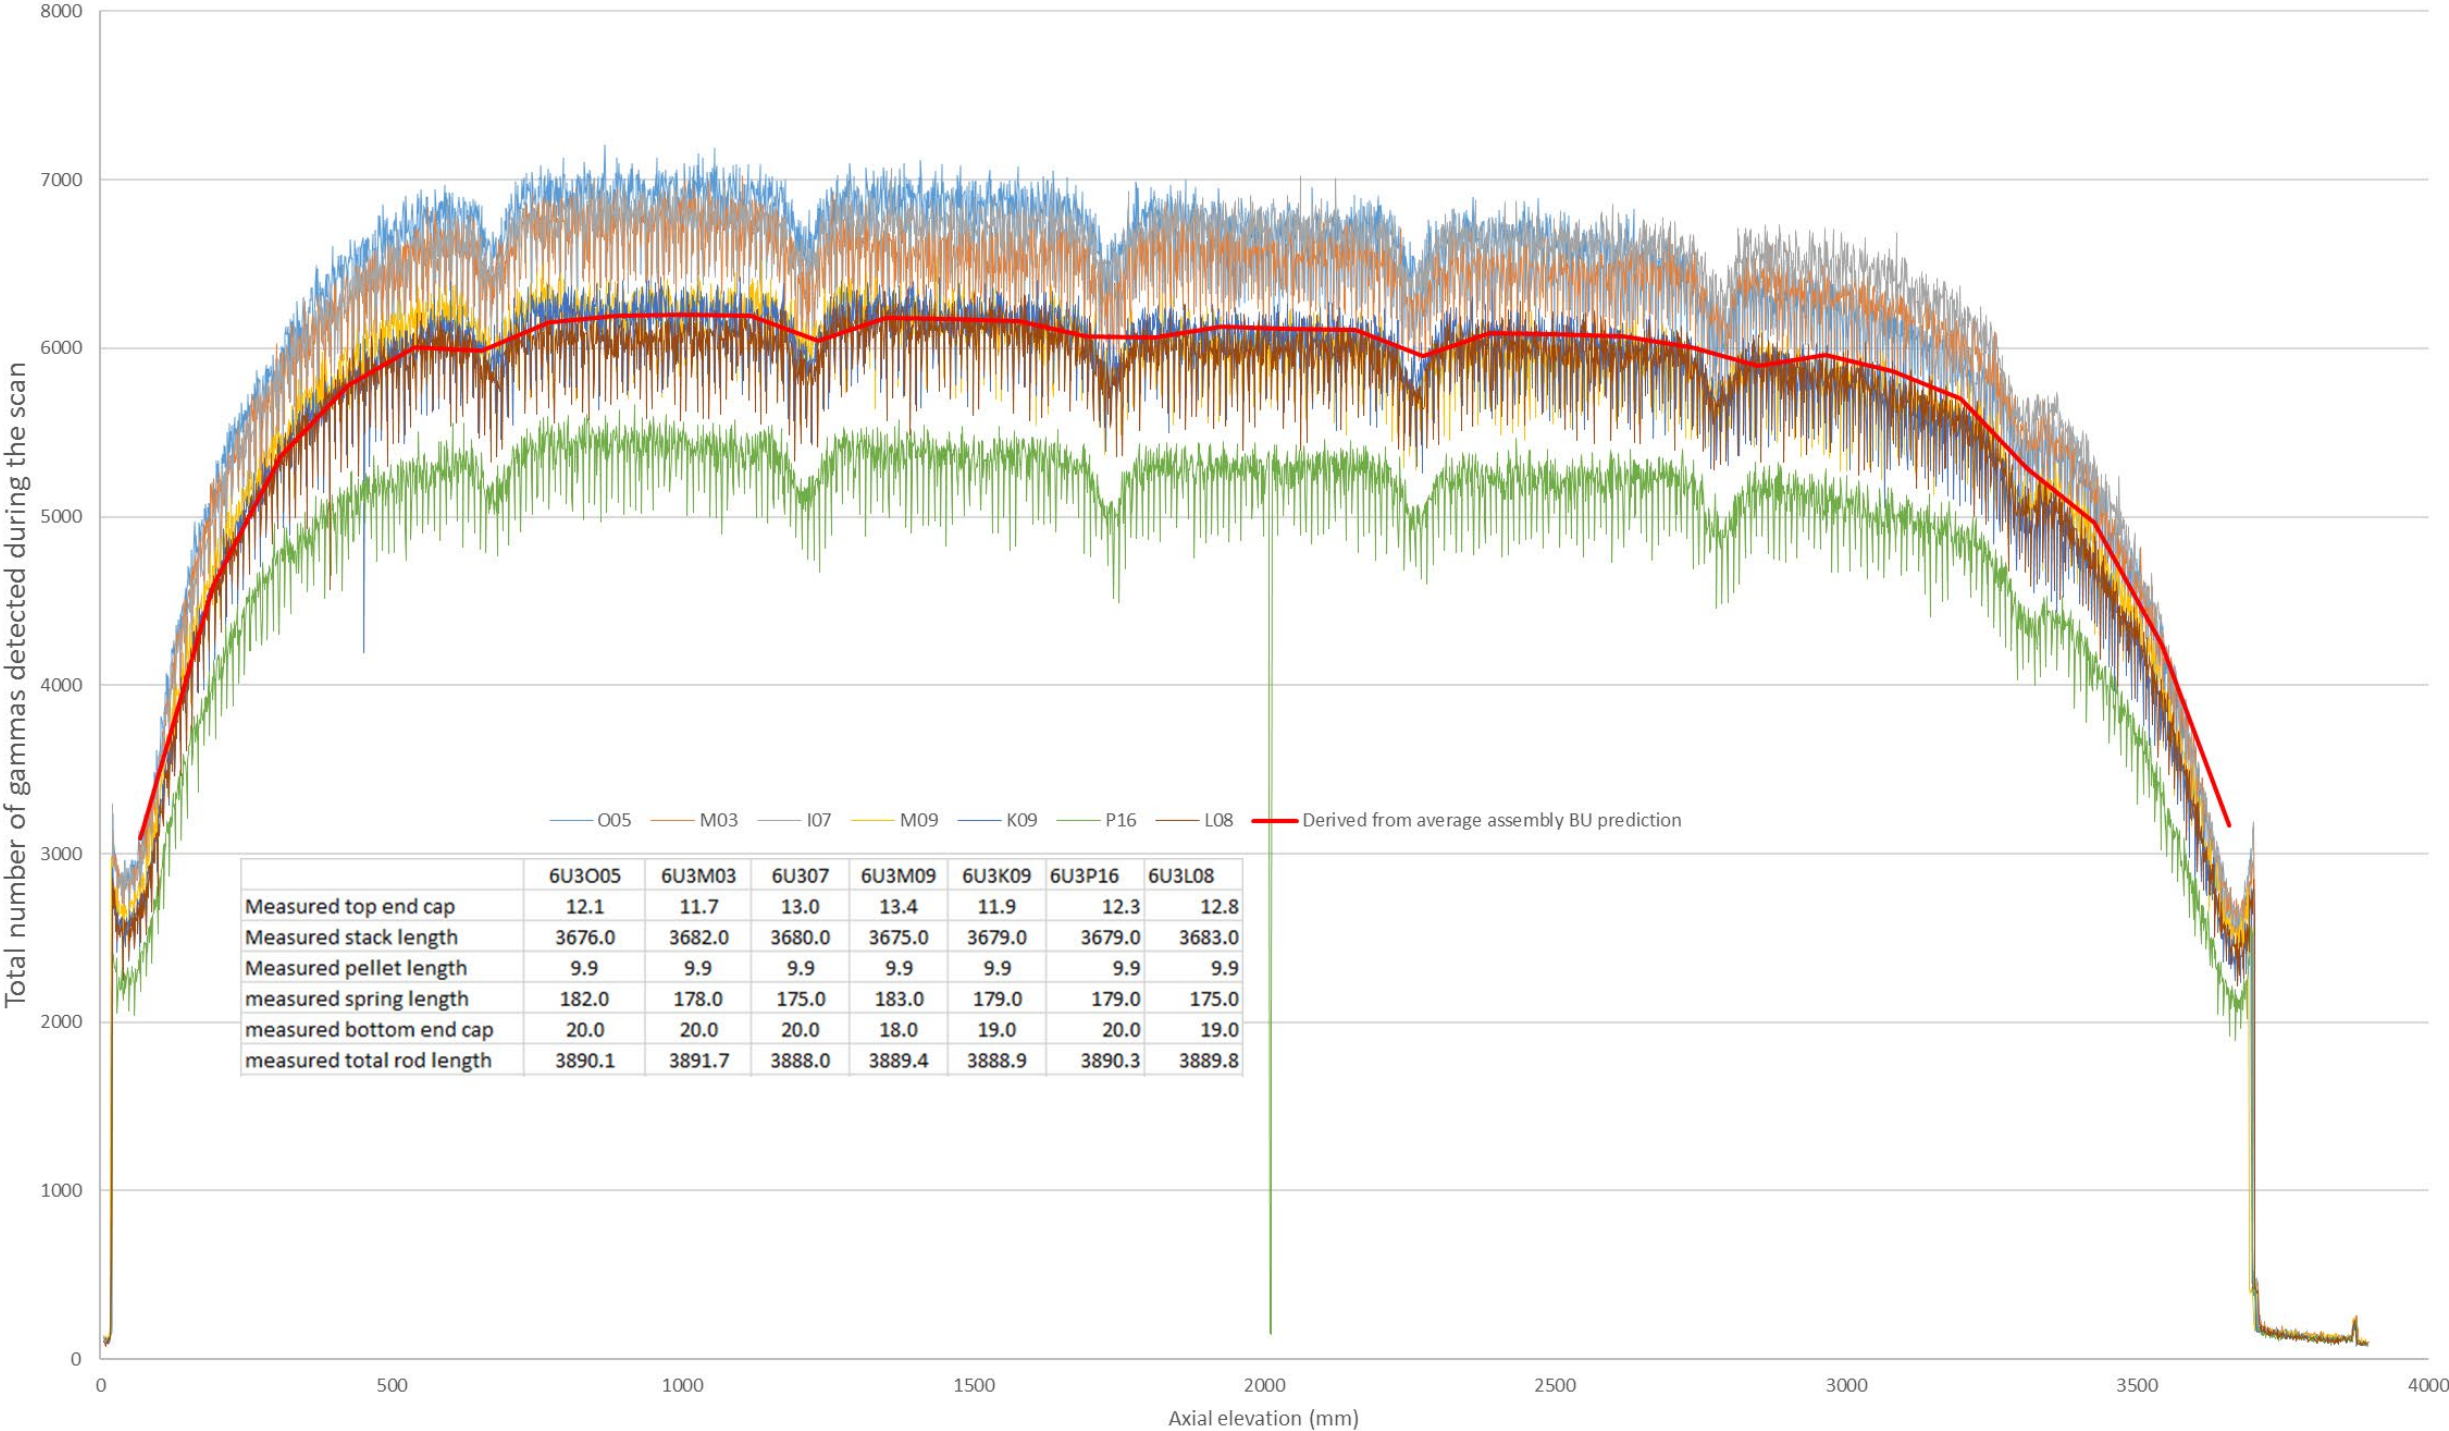
Figure 22. Gamma Scans for Sister Rod from Fuel Assembly 6U3.

No serious structural defects were noted in any of the rods because of the gamma scanning; some small fuel stack gaps were observed, and the largest was estimated as 5 mm on sister rod 6U3P16.

Rod*	Location from rod bottom (mm)	Estimated gap width (mm)
30AD05	3,635	1
	3,646	2
	3,657	2
	3,667	1
	3,678	2
6U3P16	2,010	5
6U3K09	453	1
5K7P02	448	1
5K7C05	755	2
	948	1
	1,559	2
3F9D07	462	2
3F9P02	1,303	2
	1,313	1
	1,373	2
3D8E14	1,403	3
F35P17	1,655	3

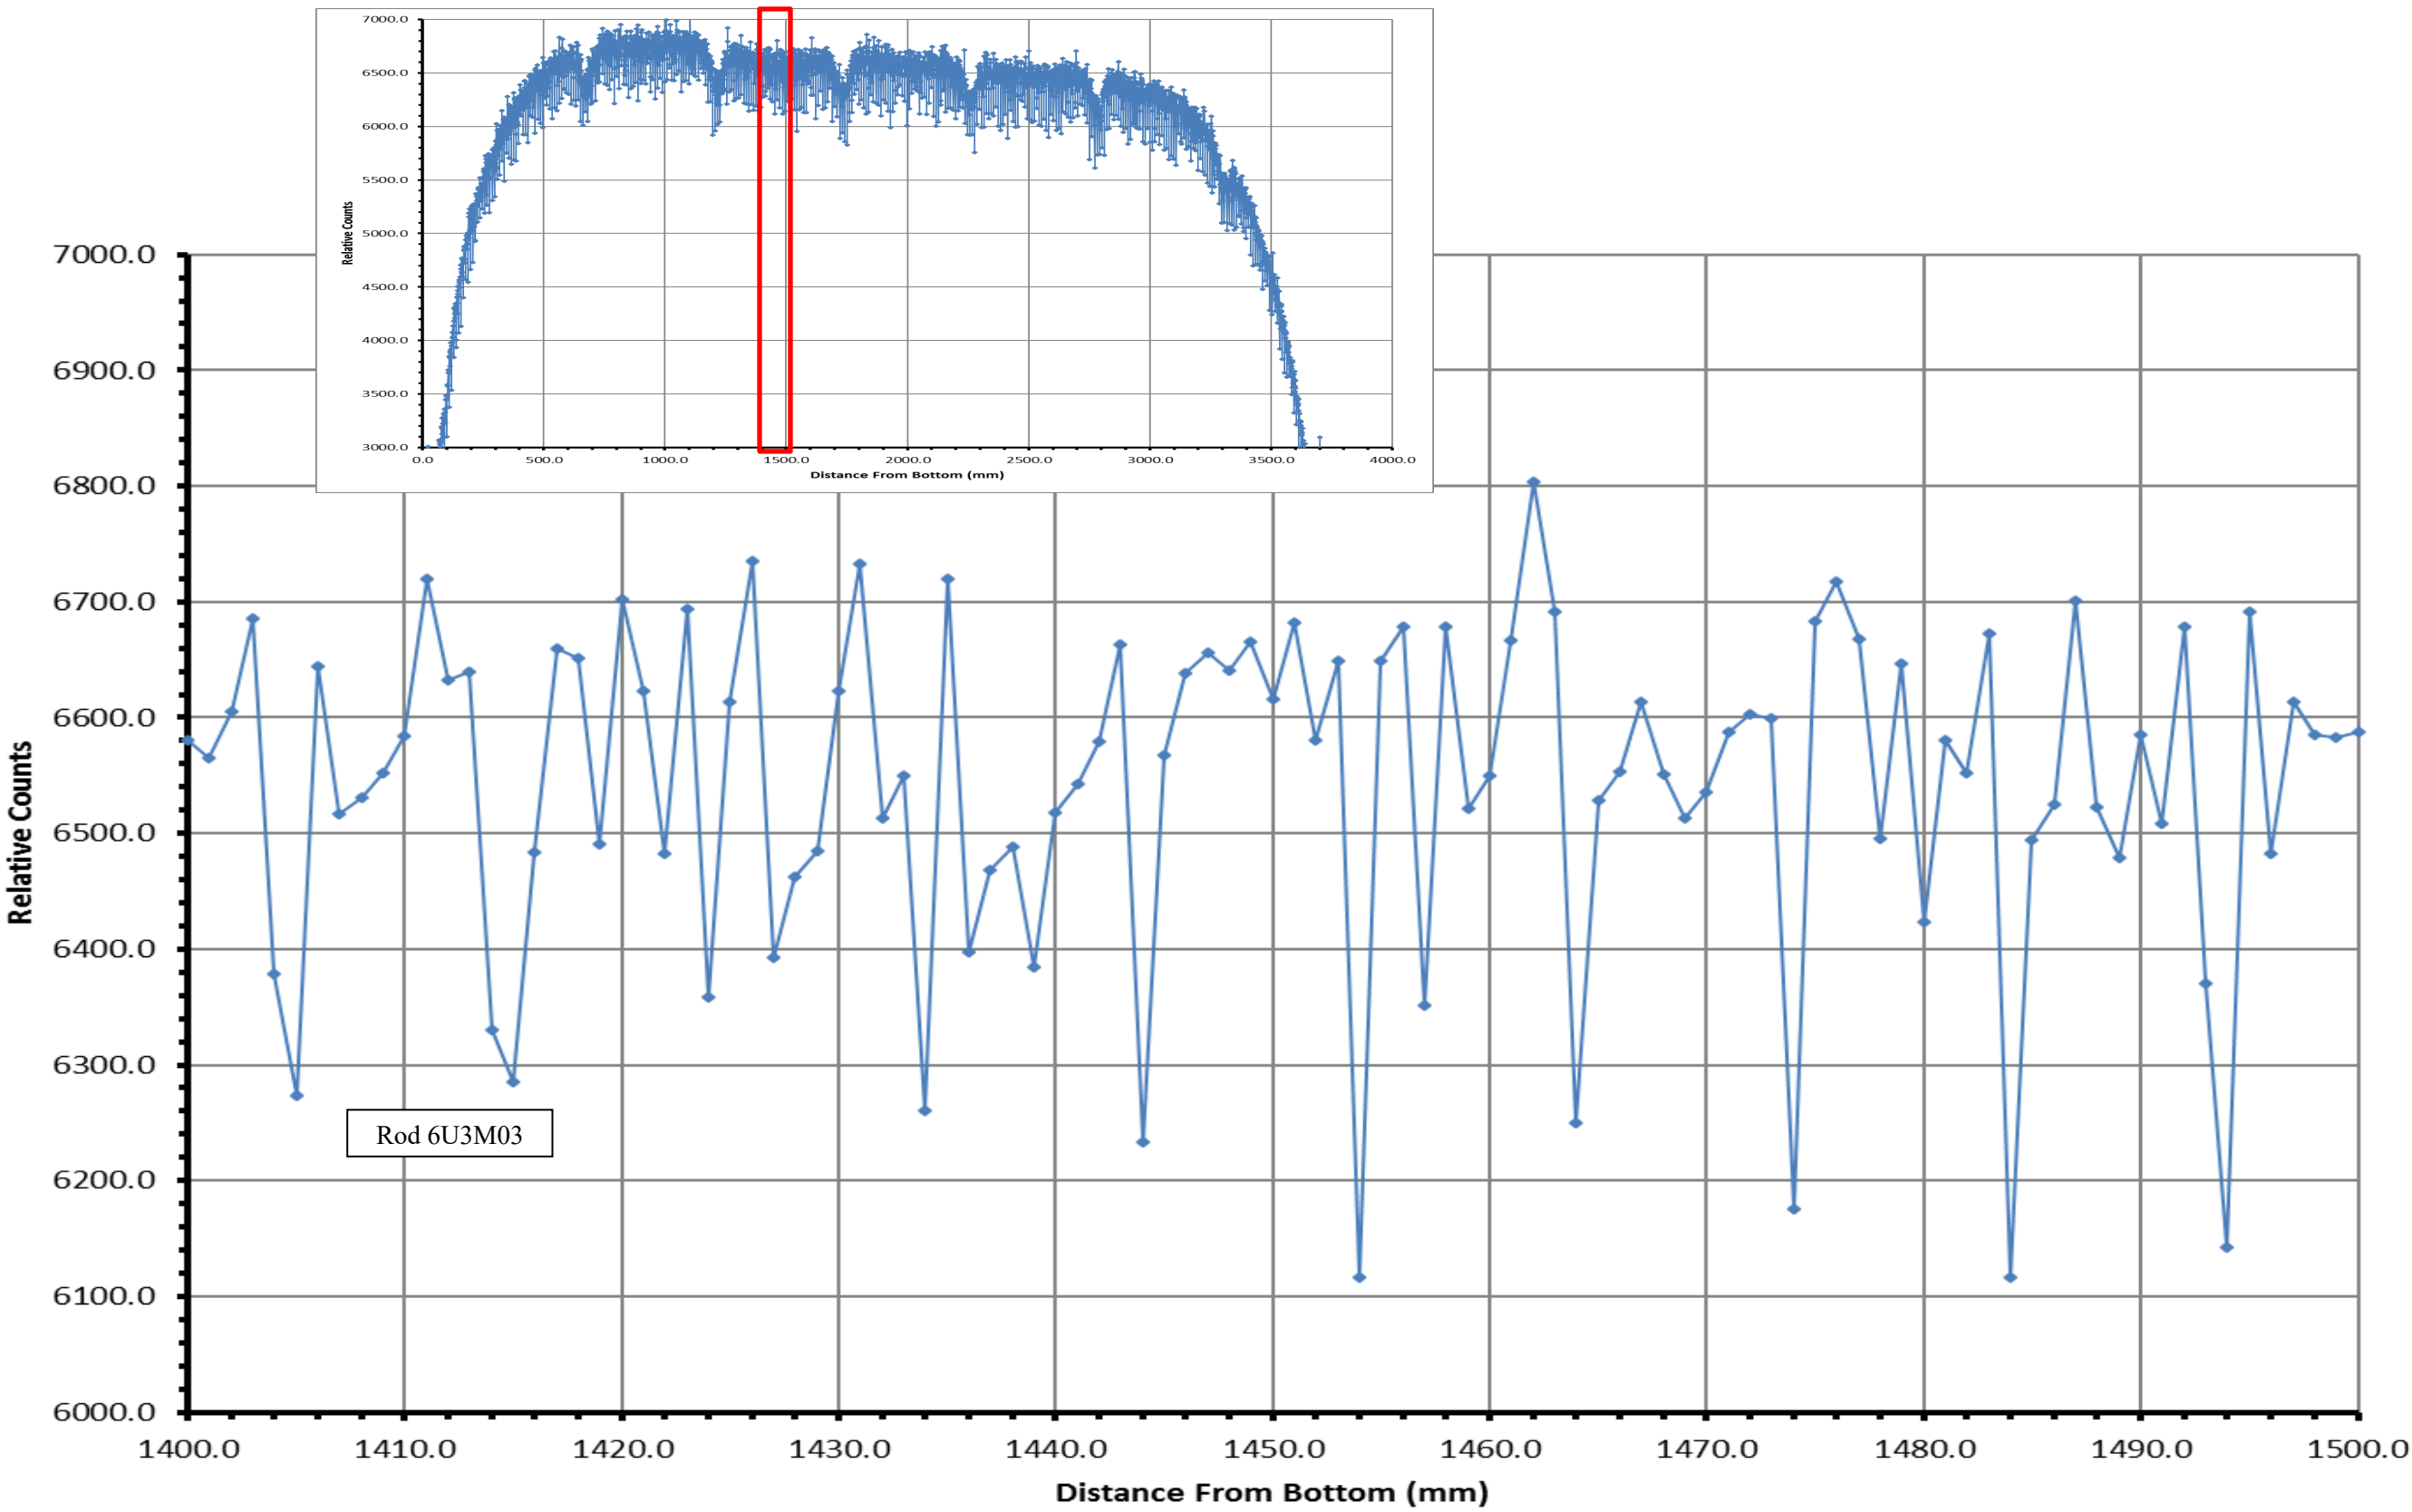
Since the dish and chamfer regions are large enough to provide a significant drop in gamma source term, the gamma scan allows for differentiation of every pellet in the rod. This is visible in the full-length rod graphs (Figure 16 through Figure 22) as chatter in the data. Zooming into a specific segment of the rod, as illustrated in Figure 23, provides differentiation of each pellet. An estimate of the number of pellets in each fuel rod was determined by spectral methods in which the gamma scanning data were examined for shallow reductions in the fuel stack gamma count associated with pellet end geometry (chamfers and dishes). The average pellet length was determined by dividing the pellet stack length by the number of pellets counted. Since partial pellets are not used, the fractional estimated number of pellets was rounded off to the nearest integer value.

Figure 23. Typical Pellet Ridging on a Fuel Rod Observed Via Gamma Scanning; Scales are Magnified to Show the Detail. The Typical Pellet is Approximately 10mm Long.

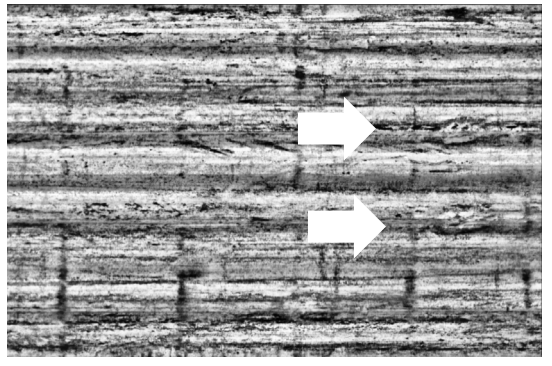
3F9D07	3,299	Likely oxidized GTRF: 3% local reduction in total cladding cross-sectional volume. A rotational scan in this region shows a $\sim 30 \mu\text{m}$ higher lift-off that would be consistent with base metal relocation as discussed in Section 3.4.2.5.

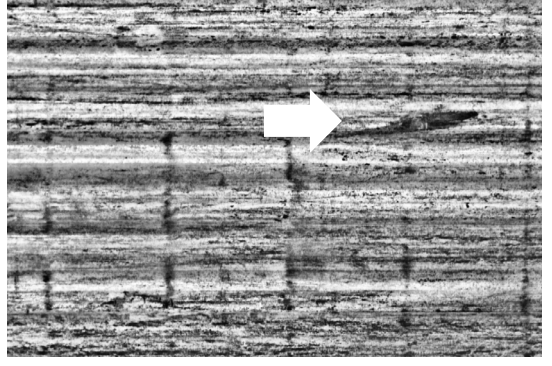
3F9D07	3,332	GTRF: 1% local reduction in total cladding cross-sectional volume.

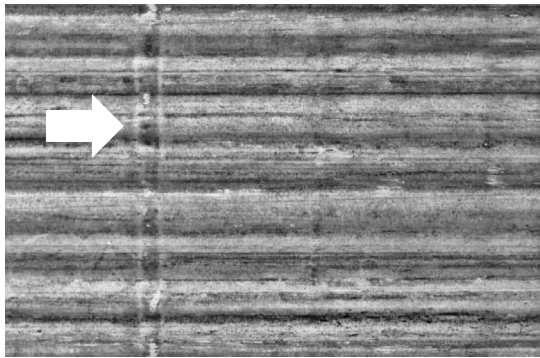
F35P17	1,604* 1,632* (repeated scan) *F35 rods are reversed in the cell, location is adjusted to be consistent with other sections	OD reduction due to a pellet-pellet gap, 35% through wall and 7% reduction in total cladding cross-sectional volume.

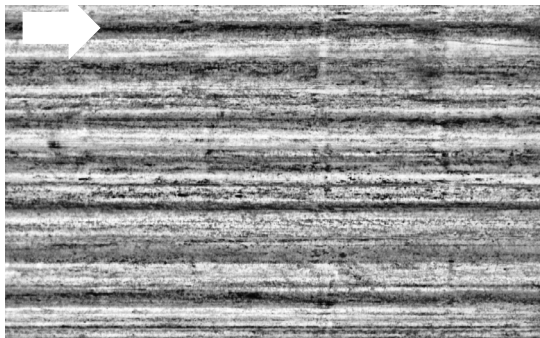
6U3O05	3,032	23 mm long scratch with a 2% reduction in total cladding cross-sectional volume, likely deeper than typical rod insertion scratch.

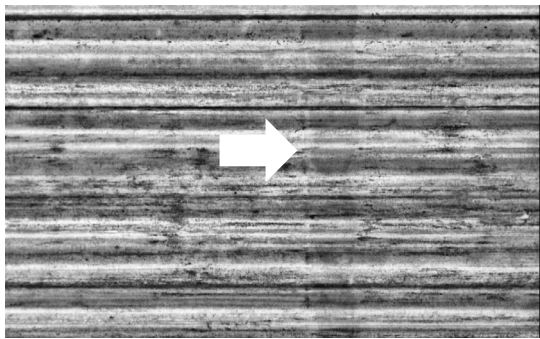
6U3P16	2,003	OD reduction due to a pellet-pellet gap.

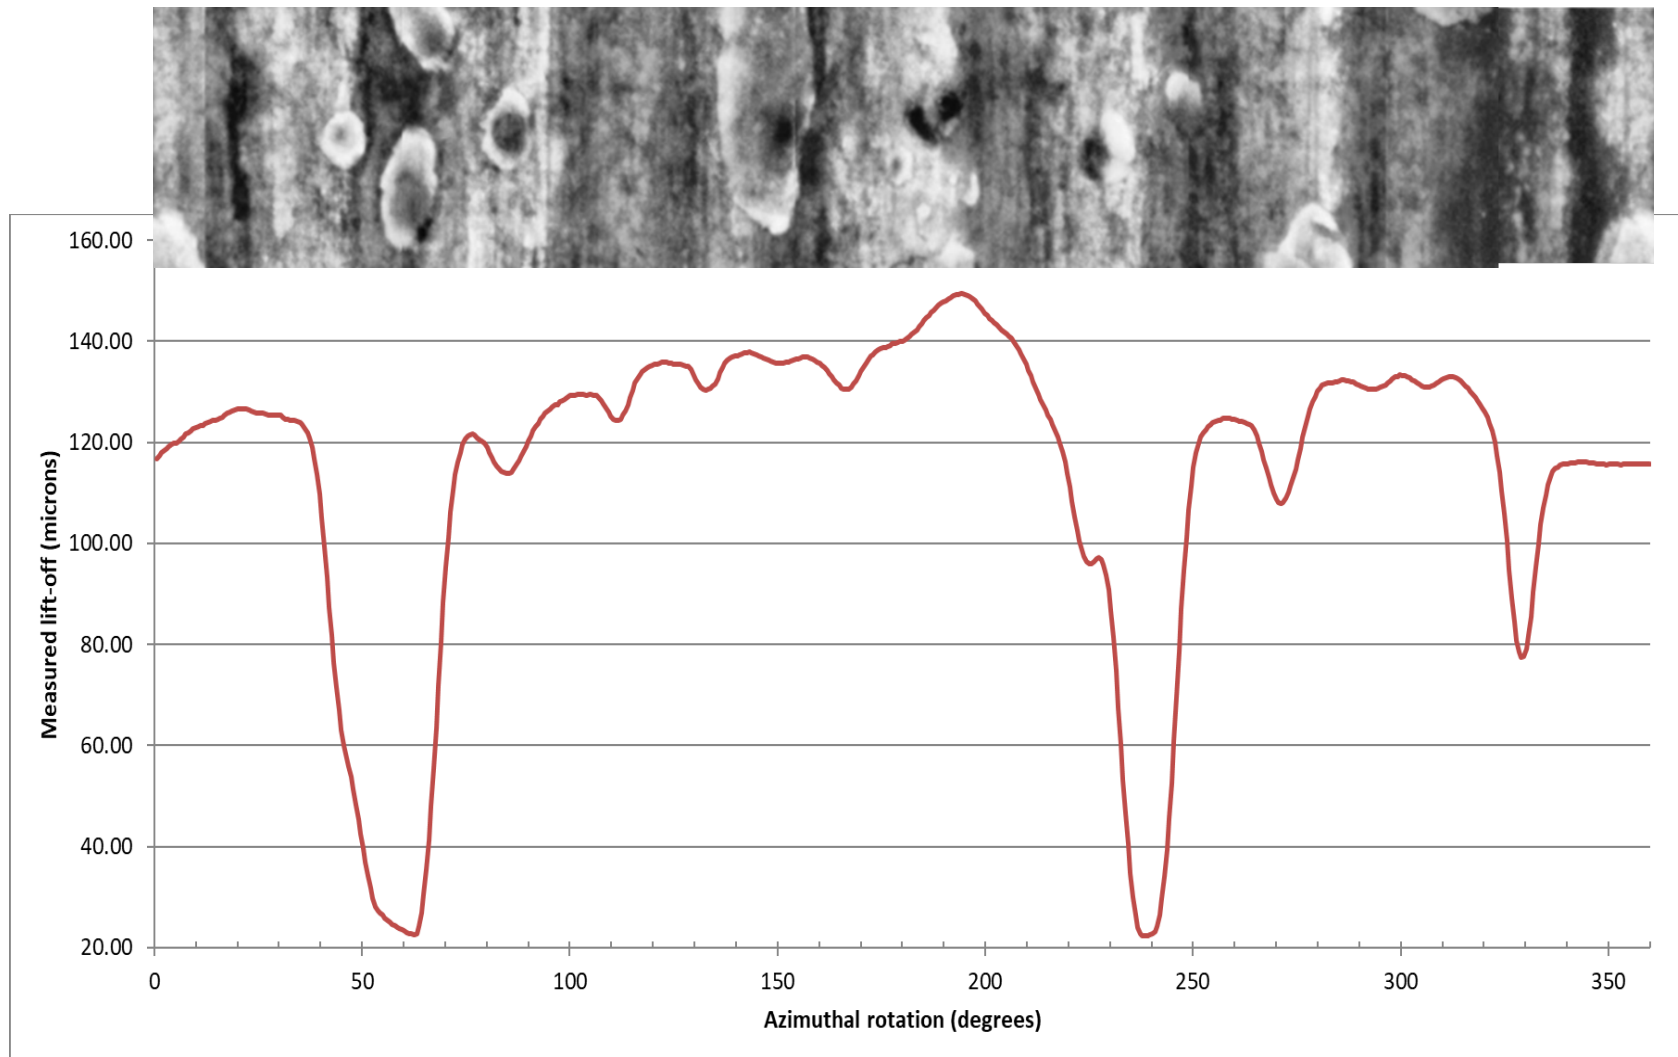
Figure 58. Rotational Eddy Current Lift-Off Scans of 3A1B16 at 3,101 mm.

In most cases, the lift-off followed a smoothly increasing and decreasing trend. However, where oxide spalling or peeling is present, the lift-off measurements appear very noisy, with very high thickness measurements alternating with very low thickness measurements where the oxide has spalled or peeled off. As observed in both the visual and profilometry examinations, there is a large amount of spalling on some of the sister rods. Spalling/peeling oxide is observable on the lift-off traces as alternating high and low lift-off and is particularly significant in the higher elevations of rods 3A1B16, 3A1F05, F35K13, F35P17, and 3F9N05. An example of the lift-off data obtained in spalled areas of the rod is provided in Figure 57 for rod F35K13. As mentioned previously, several rotational scans were completed at discrete rod elevations. Figure 58 provides an example of a rotational scan in spalled areas of rod 3A1B16.

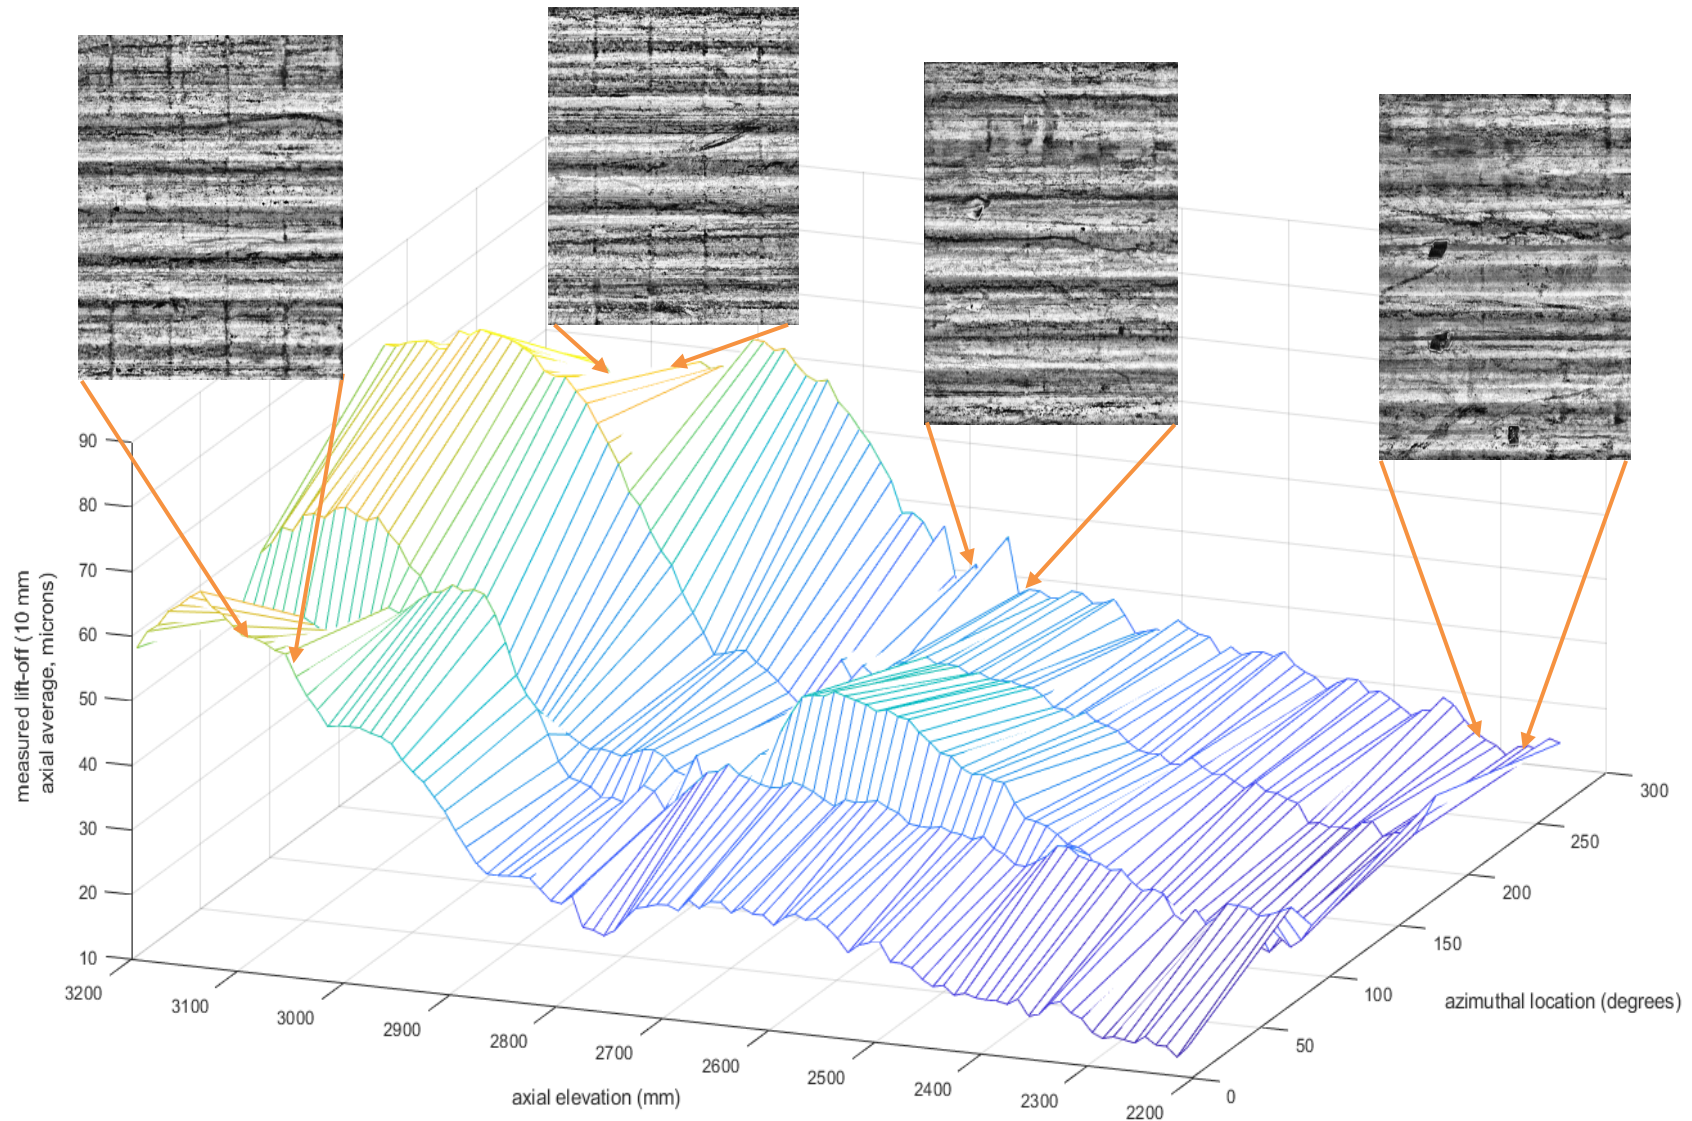
Figure 59. A 3D Surface Plot Illustrating the Variations in Measured Lift-Off Over the Circumference of Sister Rod 3F9D07 in Higher Burnup Elevations Compared with Visible Rod Features.

Sister rod 3F9D07 was additionally axially scanned at 75° over the upper high burnup rod elevations. This rod's additional axial data, along with its 0°, 90°, 180°, and 270° data, were used to generate a rod average lift-off surface plot. The surface plot shown in Figure 59 illustrates the lift-off variation in the higher burnup elevations of the rod, where thermal and flow mixing effects and GTRF related to the spacer grid locations produced local reductions in oxide thickness.

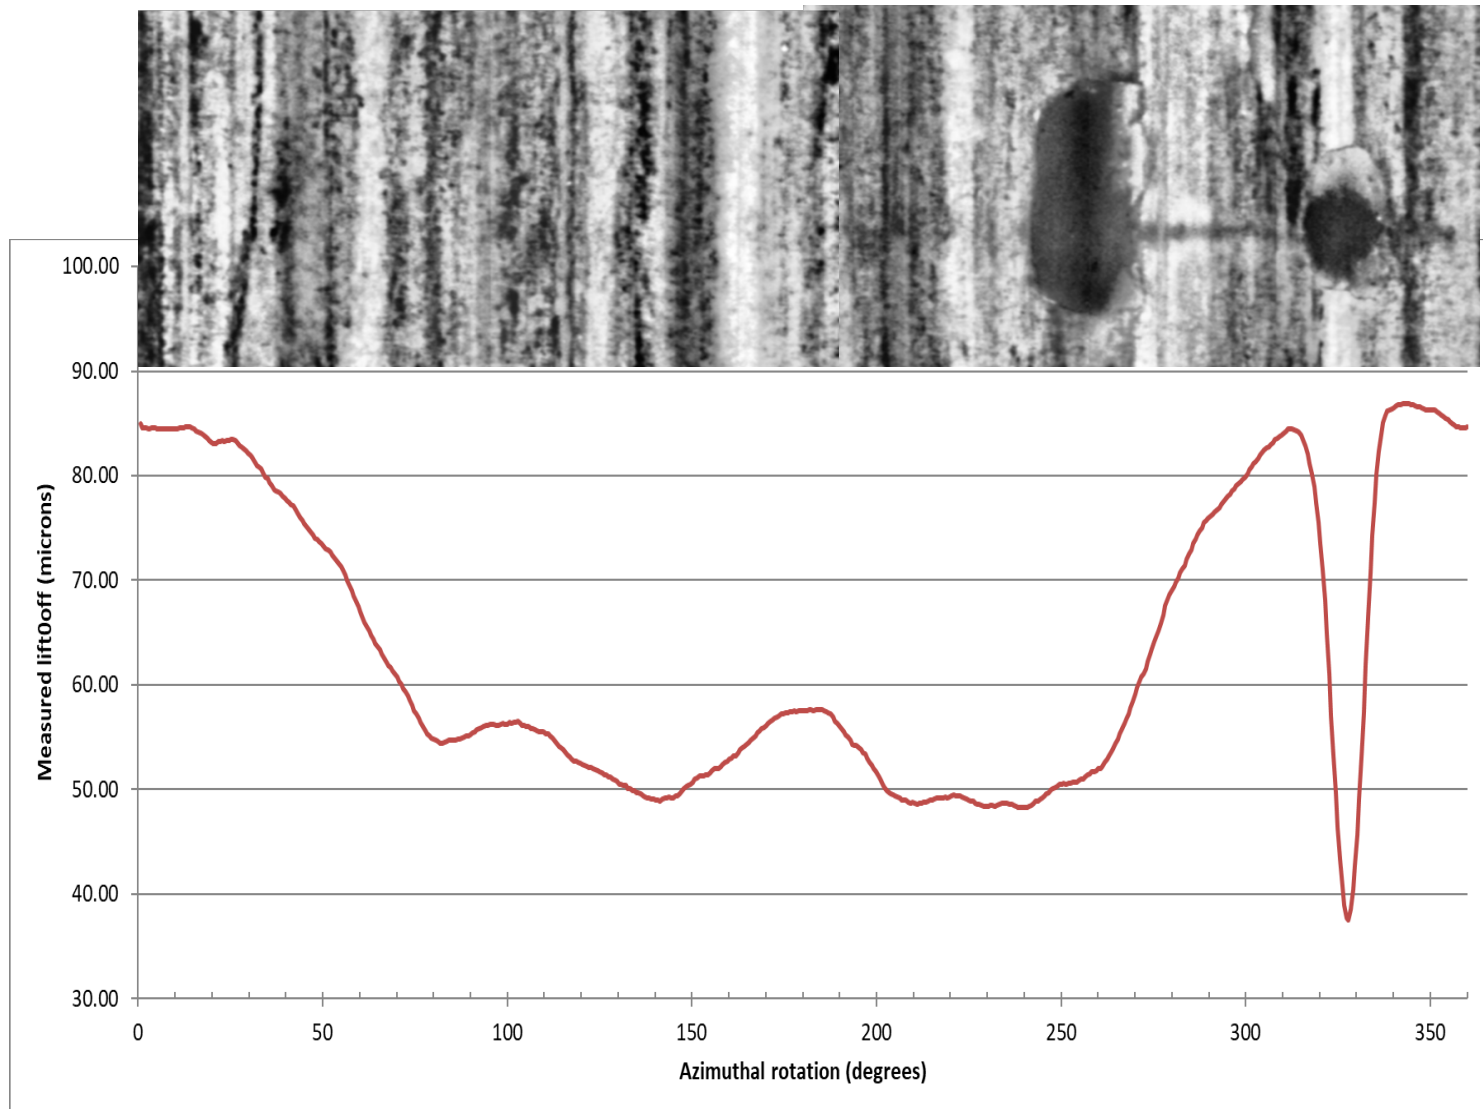
Figure 60. Rotational Eddy Current Lift-Off Scan of 3F9N05 at 3,209 mm.

rod in its fuel assembly, with corner and peripheral rods being more susceptible. For example, sister rod 3F9N05 was measured rotationally at an elevation of 3,209 mm, revealing an increase from $\sim 50\text{ }\mu\text{m}$ to $\sim 85\text{ }\mu\text{m}$. The locally high oxide thickness produced some spalling, as shown in Figure 60. A second example is provided in Figure 61 for sister rod 6U3P16.

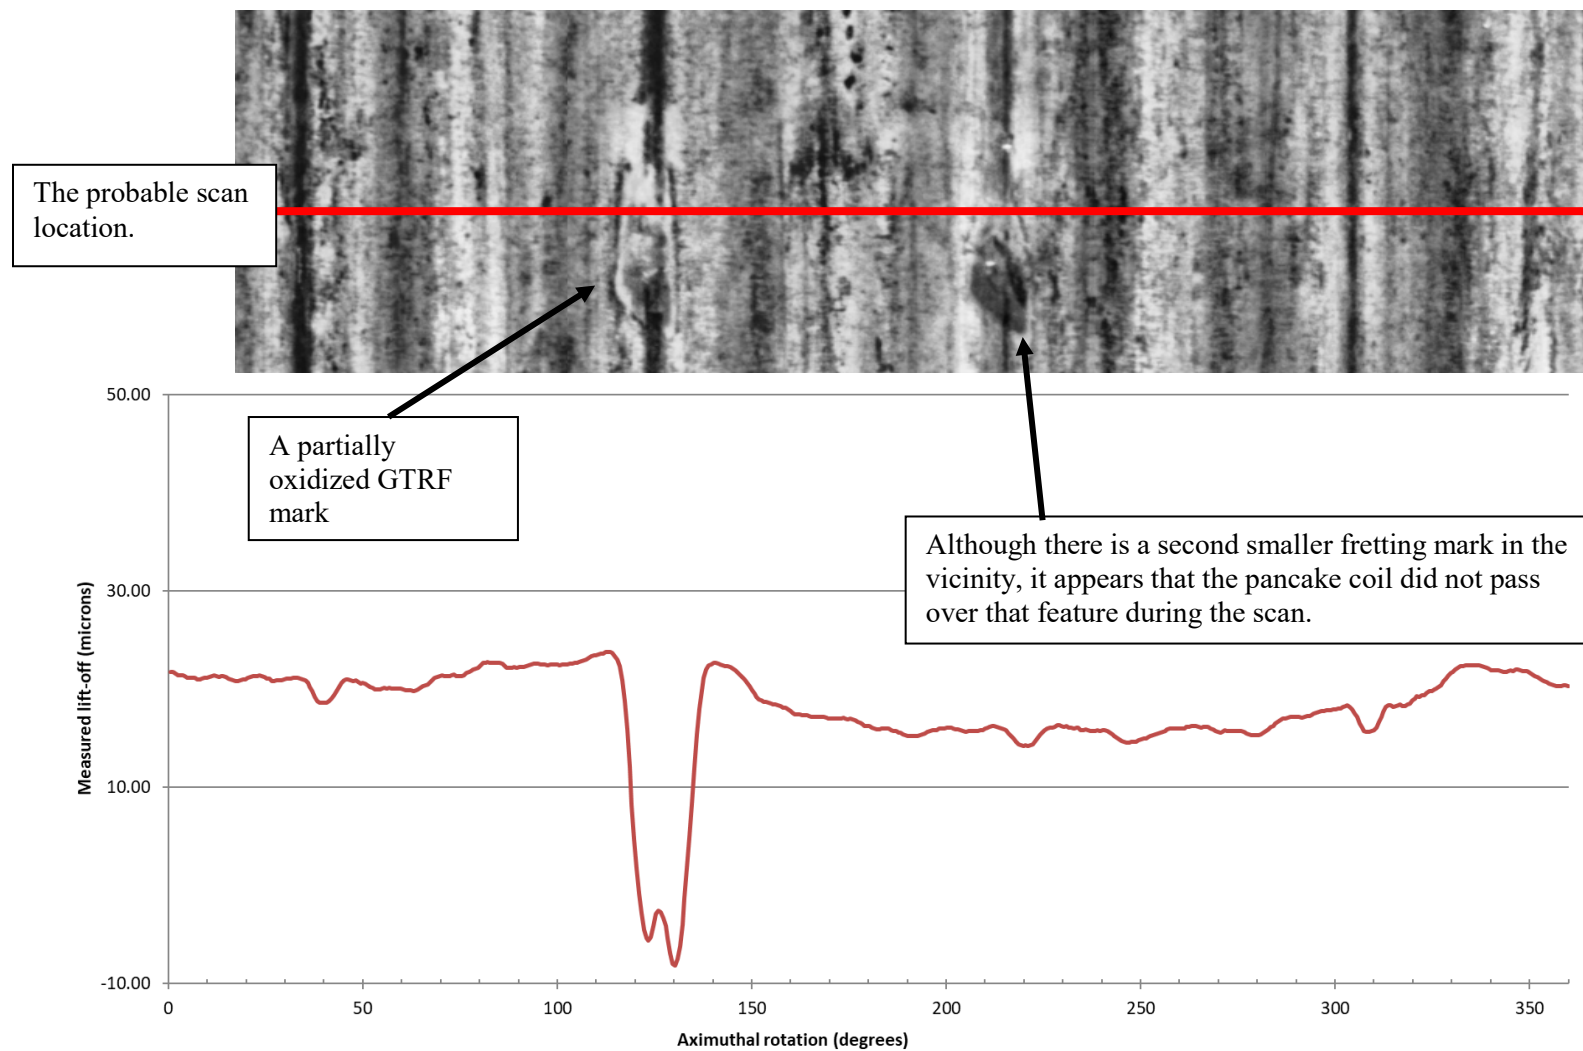
Figure 63. Rotational Scan of Sister Rod 3F9D07 at 1,765 mm Elevation Indicating Depth of a Partially Oxidized Fretting Mark and Axial Scratches in the Waterside Surface of the Rod.

Figure 63. The grid insertion/removal axial scratches are visible as square-bottomed features in most of the rotational traces, typically $\sim 3\text{ }\mu\text{m}$ deep, and serve to align the images with the rotational trace. The larger GTRF mark visible at 1,765 mm is partially oxidized (indicating that GTRF was not active in later cycles) with a maximum depth indication of 8 μm . The rotational trace seems to indicate that the smaller wear scar had very little depth ($\sim 2\text{ }\mu\text{m}$) and in fact did not appear to penetrate the oxide layer to the metal surface. However, the image indicates a matte black metal surface in the center of the wear scar. Based on the image, it is likely that the rotational trace missed the deeper portions of the larger wear scar and completely missed the smaller wear scar. For GTRF marks, the lift-off technique requires that the GTRF mark be aligned with the tip of the pancake probe, and the alignment relied on visual confirmation looking through the hot cell window. Given the inaccuracies associated with the alignment, it is evident that the scans did not always measure the desired location on the rod. The measured depths of the axial scratches at the 1,765 mm elevation on 3F9D07 are 2 – 3 μm .
