Sister Rod Nondestructive Examination Final Report

Spent Fuel and Waste Disposition

***December 21, 2018
SFWD-SFWST-2017-000003 Rev. 1
(M2SF-17OR010201021)
ORNL/SPR-2017/484 Rev. 1
(ORNL/SPR-2018/801)***

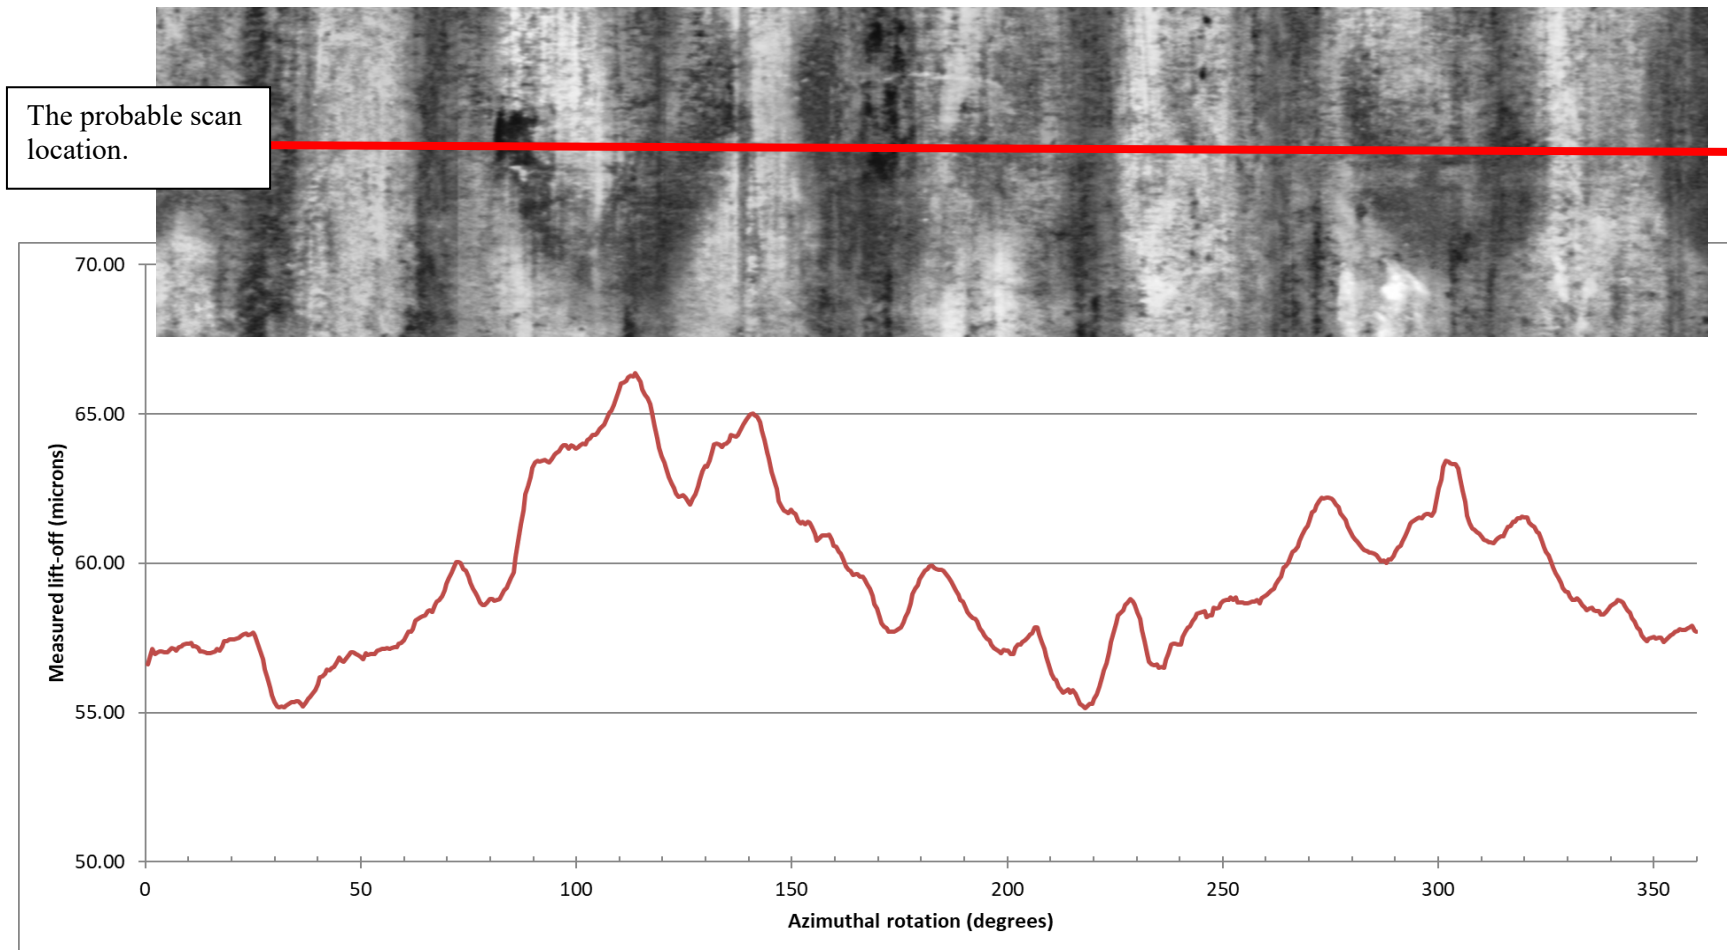
Figure 64. Rotational Scans of Flow Markings at the Exit of a Spacer Grid, F35P17 at 3,650 mm.

Several rotational scans were taken at grid exit locations, where visible flow patterns were observed. As illustrated in Figure 64, for sister rod F35P17, the difference in lift-off around the circumference resulting from differential flow at a spacer grid location is about 10 μm . This was consistent for the sister rods measured at this type of visible flow patterns.

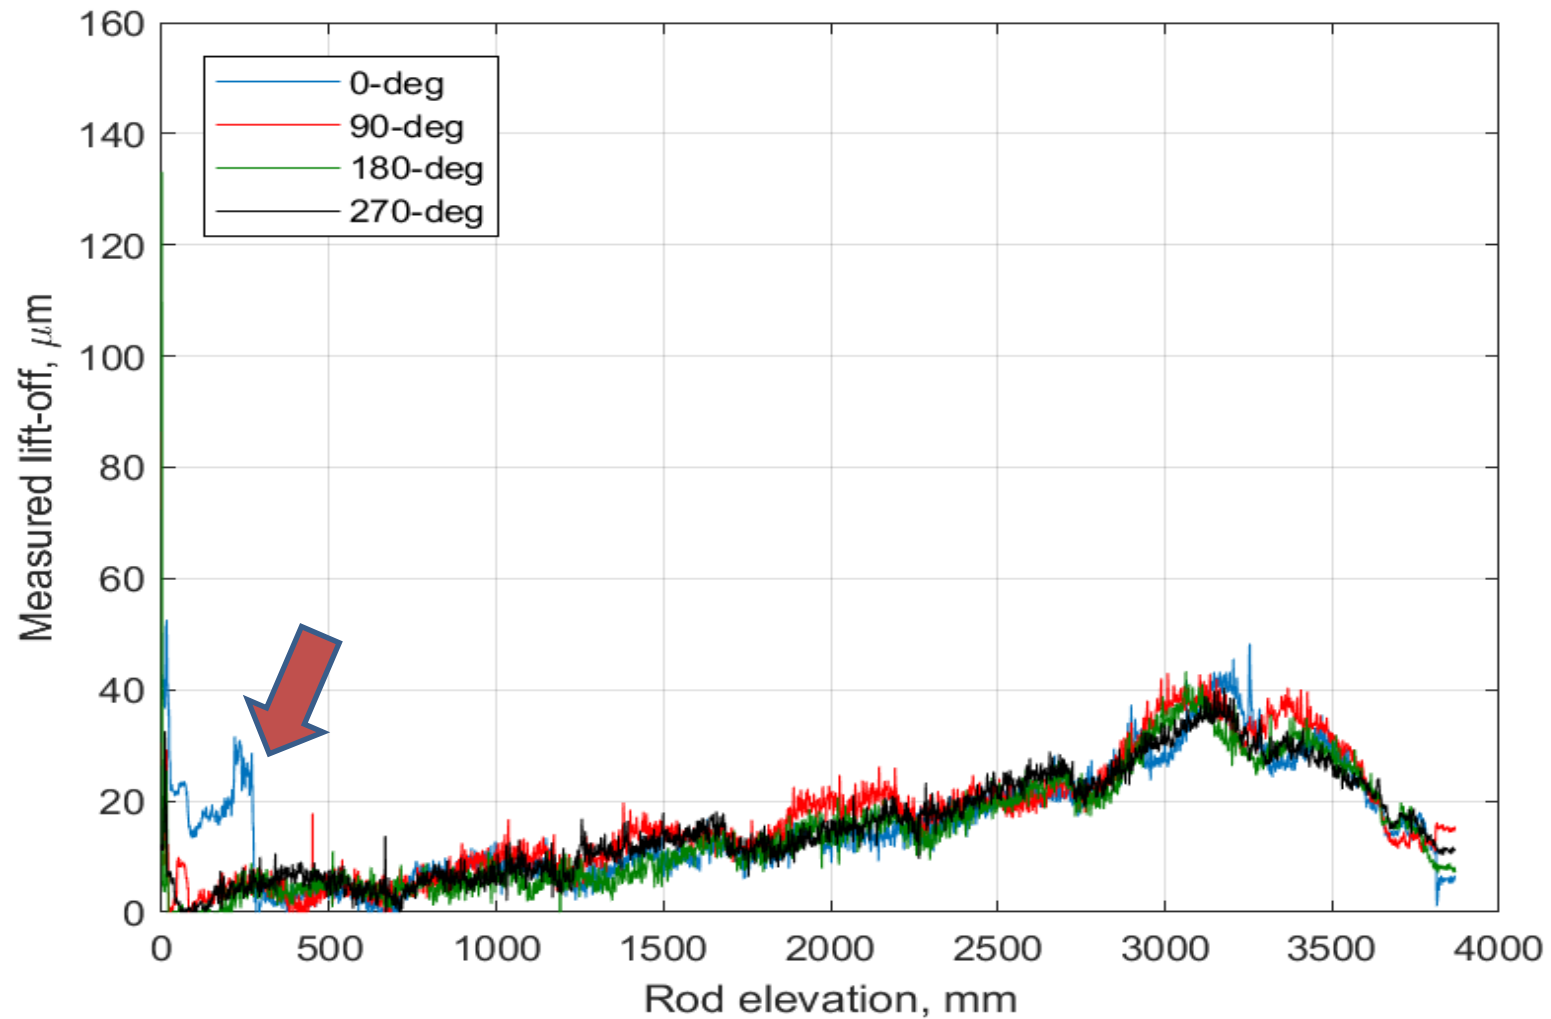
In some cases, the lift-off trace appears to shift, as illustrated in Figure 65. There are two likely sources of this shift: (1) sticking of the pancake coil in its spring-loaded fixture and (2) the accumulation of debris underneath the contact surface of the coil that is dislodged later in the scan. Although it is possible for signal drift to affect the scan results, it is unlikely to be the source of these observed deviations, as the post-rod calibration was successful in all cases. Furthermore, signal drift is typically a gradual process and would not be expected to result in abrupt shifts in the trace. These data were not discarded, but the averaging of the four quadrants tends to minimize the effects of the shift.

Figure 65. An Example of An Abrupt Shift in Lift-Off Magnitude Associated with Either the Coil Sticking in Its Housing or an Accumulation of Debris Under the Coil Head.

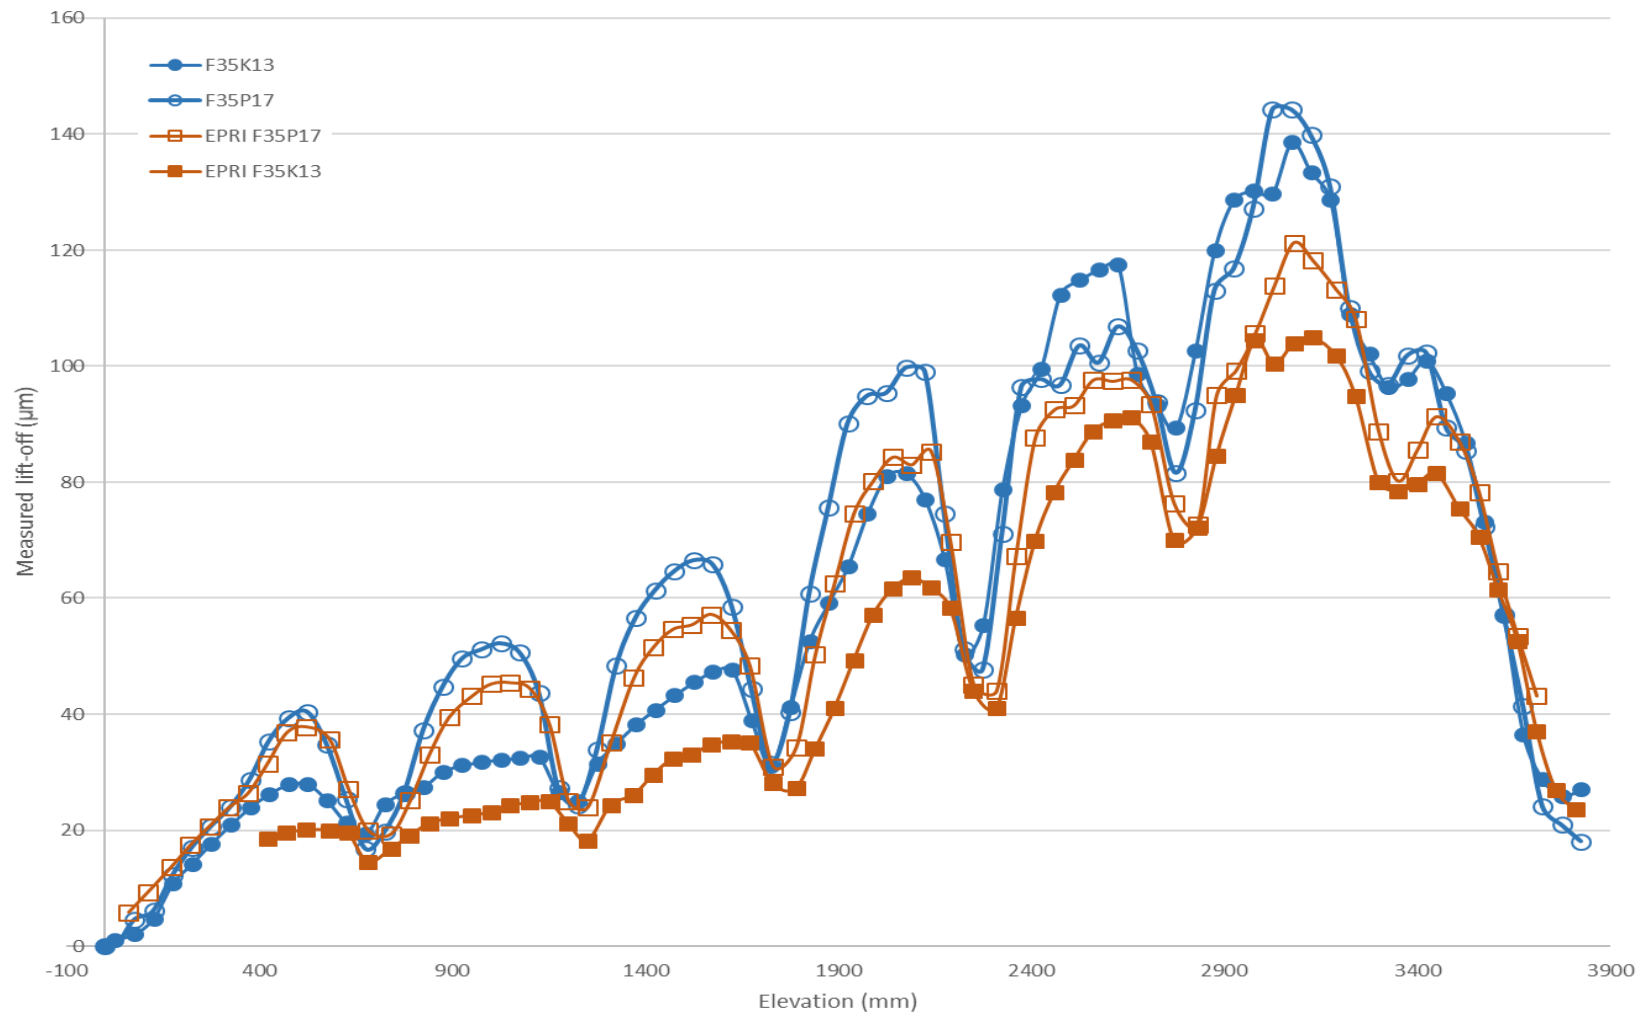
Two sister rods, F35P17 and F35K13, were previously measured at poolside after reactor discharge [9]. Figure 66 compares the poolside lift-off measurements with the average hot cell lift-off measurements. While the trends between the EPRI and ORNL measurements are very similar, the difference in the average lift-off magnitude is fairly significant. The differential of the ORNL lift-off measurements from the EPRI reported "Avg.02" value at the peak lift-off location is 23 μm for F35P17 and 34 μm for

Figure 66. A Comparison of the 1992 EPRI-Reported Poolside Average Lift-Off Measurements and the ORNL Hot Cell Lift-off Measurements for Sister Rods F35K13 And F35P17 [9].

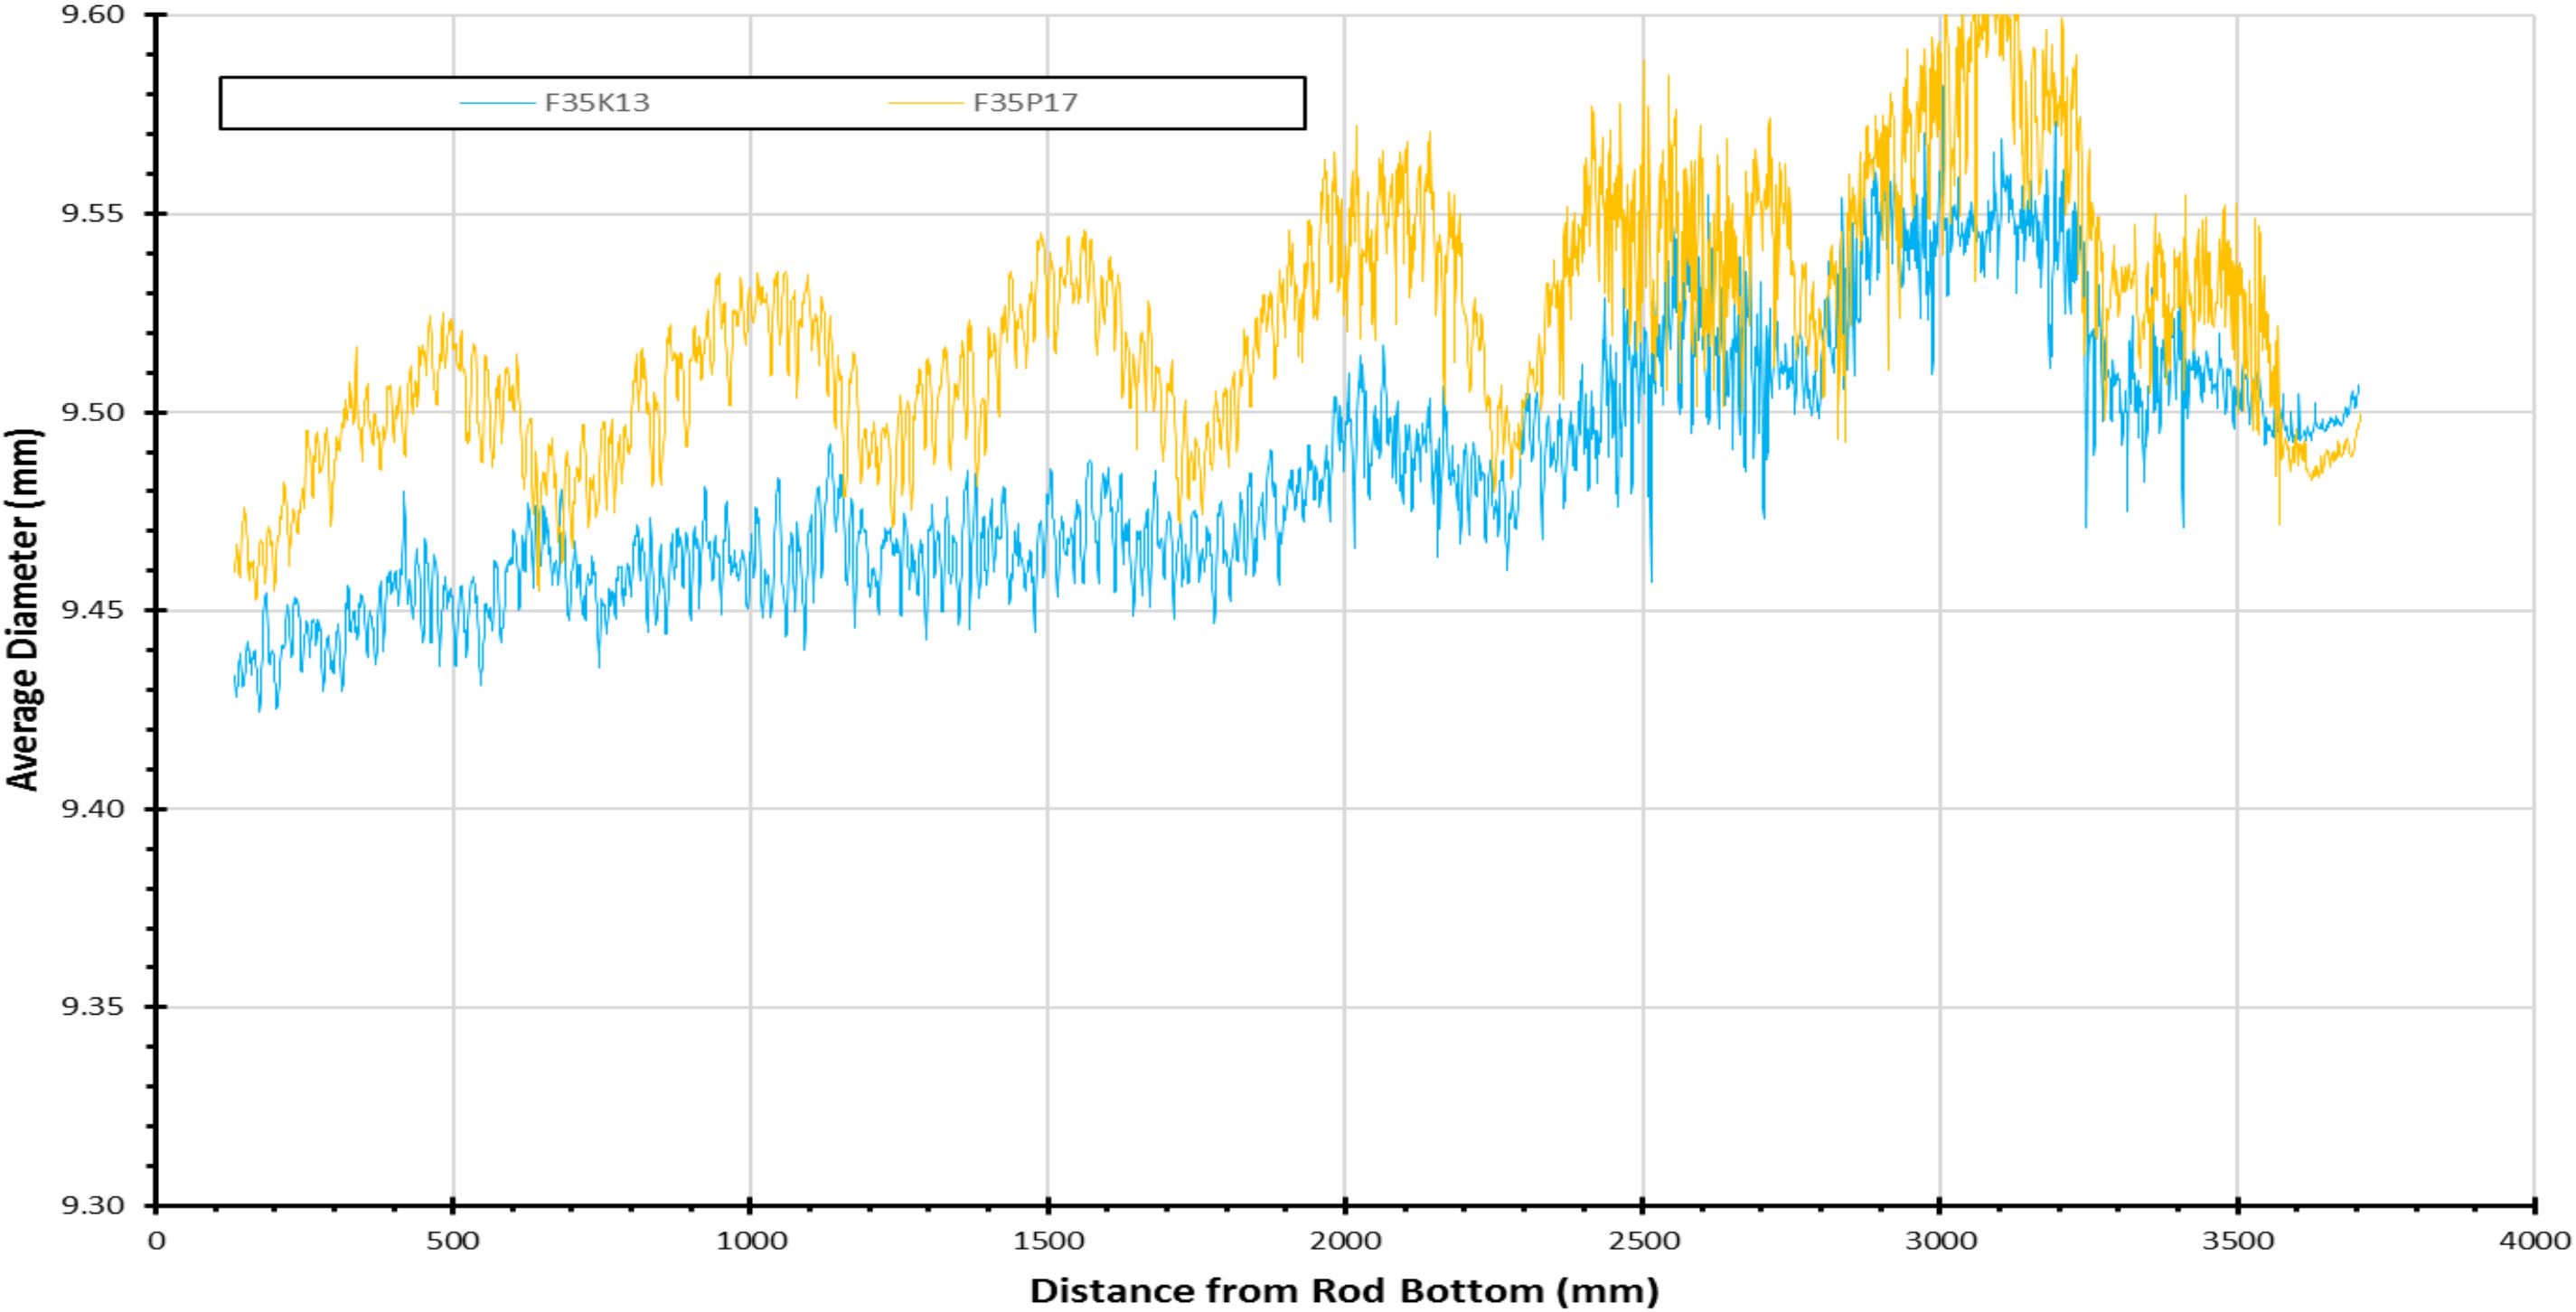
Some rods had very thick oxide layers with large spalled areas (see Section 3.1). Rods with the thickest oxide layers appear to have erratic diameter measurements. In particular, Assemblies 3A1 and F35 show the expected increasing diameter from the bottom to the top of the rod (referenced to the true bottom for the F35 rods), but there is a large amount of point-to-point variation in the higher rod elevations due to the uneven spalling oxide layer.

Figure 69. Profilometry Scans for Assembly F35.

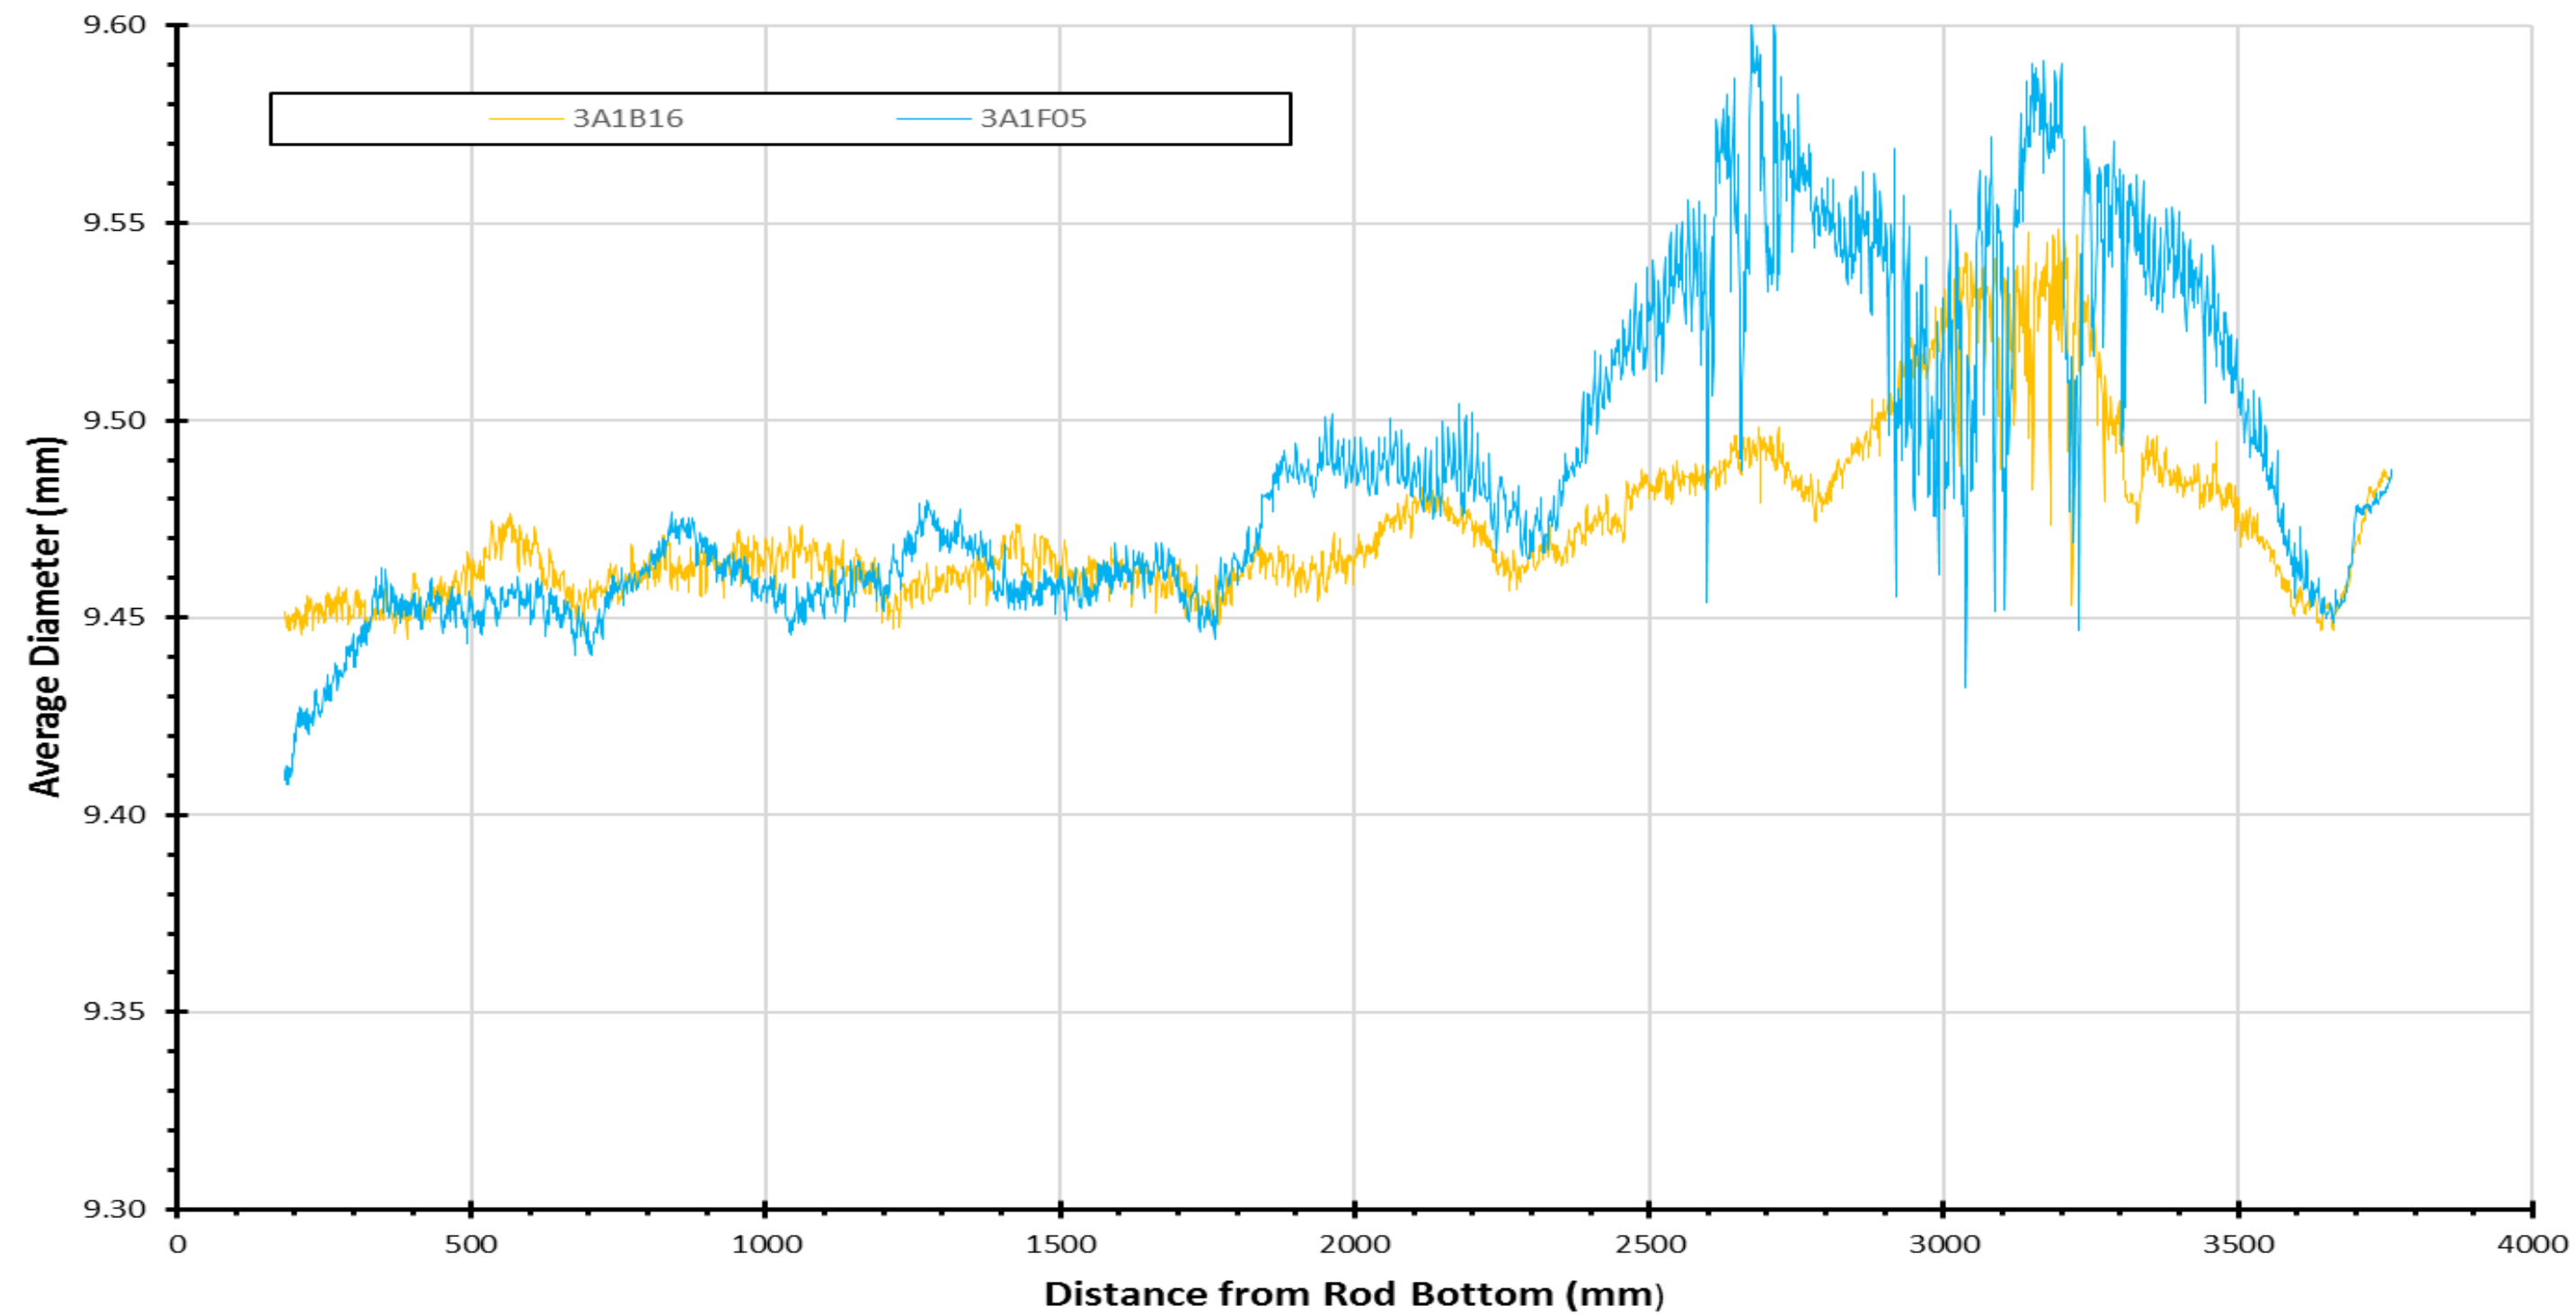
Figure 70. Profilometry Scans for Assembly 3A1.

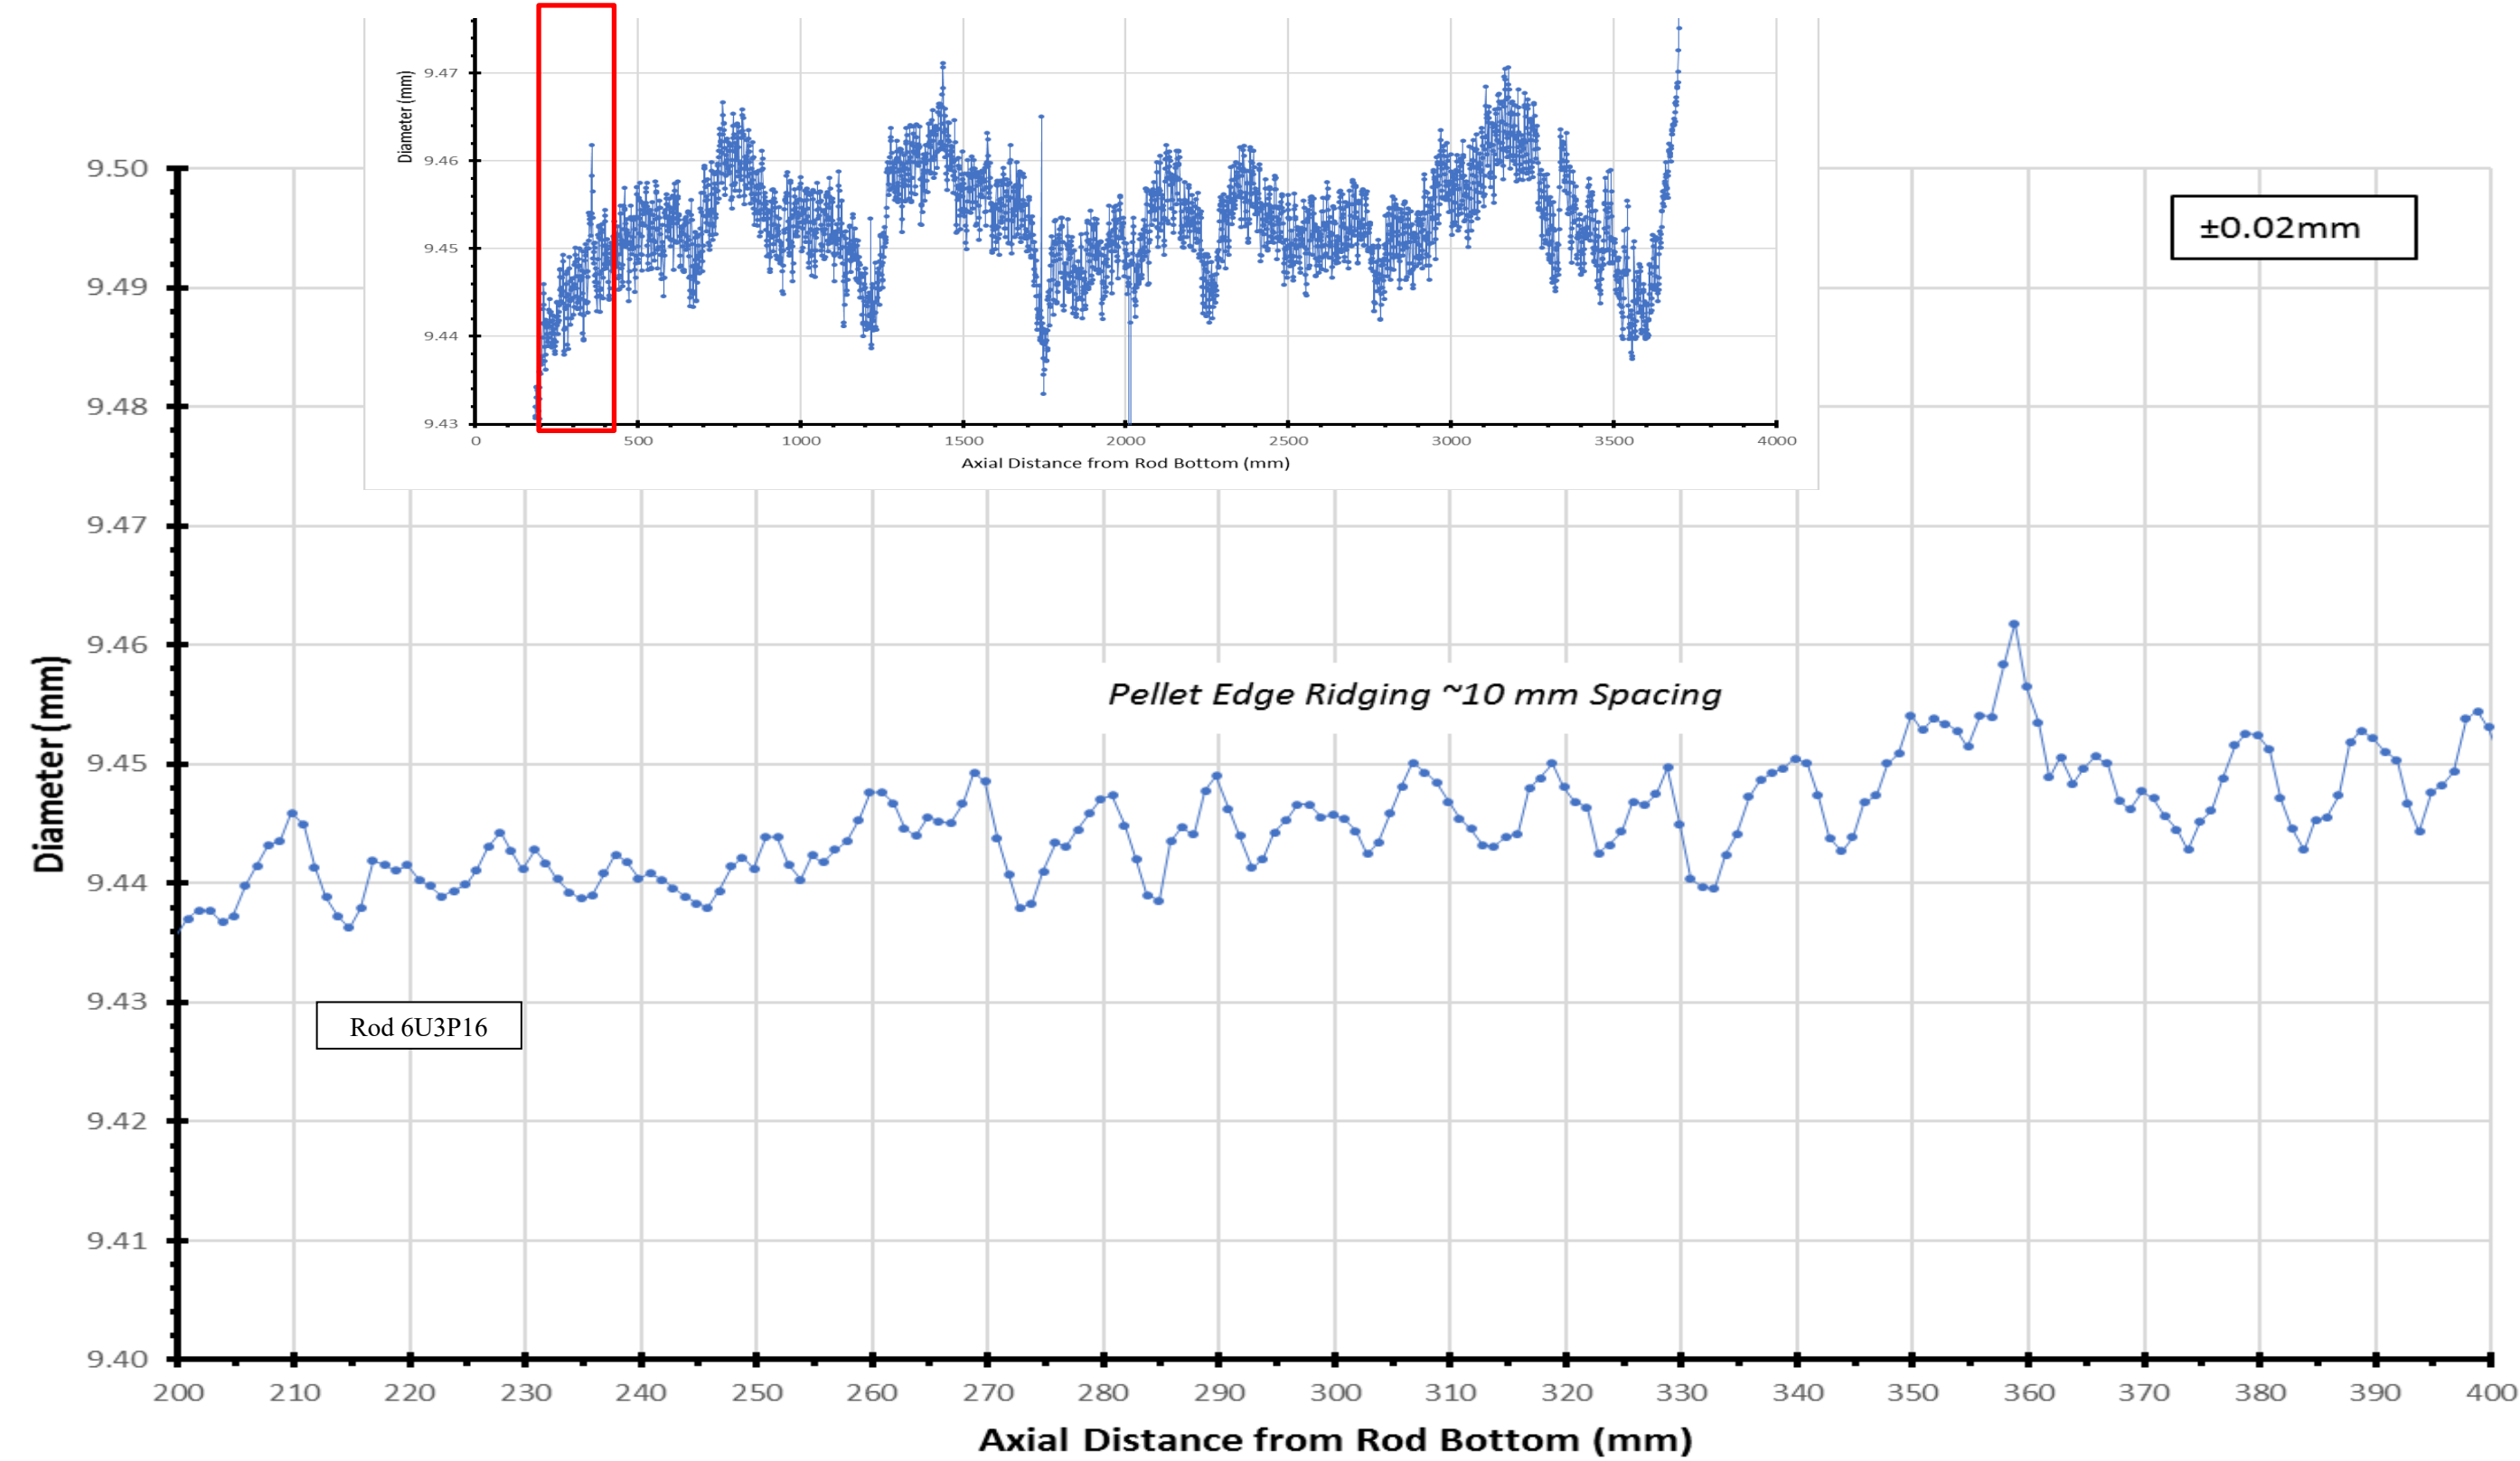
Bambooing — a small diameter variation with a period of about 10 mm (the pellet length) — was observed in all rods. Figure 74 shows a portion of the bottom region of rod 6U3P16, where bambooing caused by pellet-cladding interaction during operation can be observed.

Figure 74. Typical Pellet Ridging on a Fuel Rod via LVDT-Based Profilometry; Scales are Magnified to Show the Detail. The Typical Pellet is Approximately 10mm long.

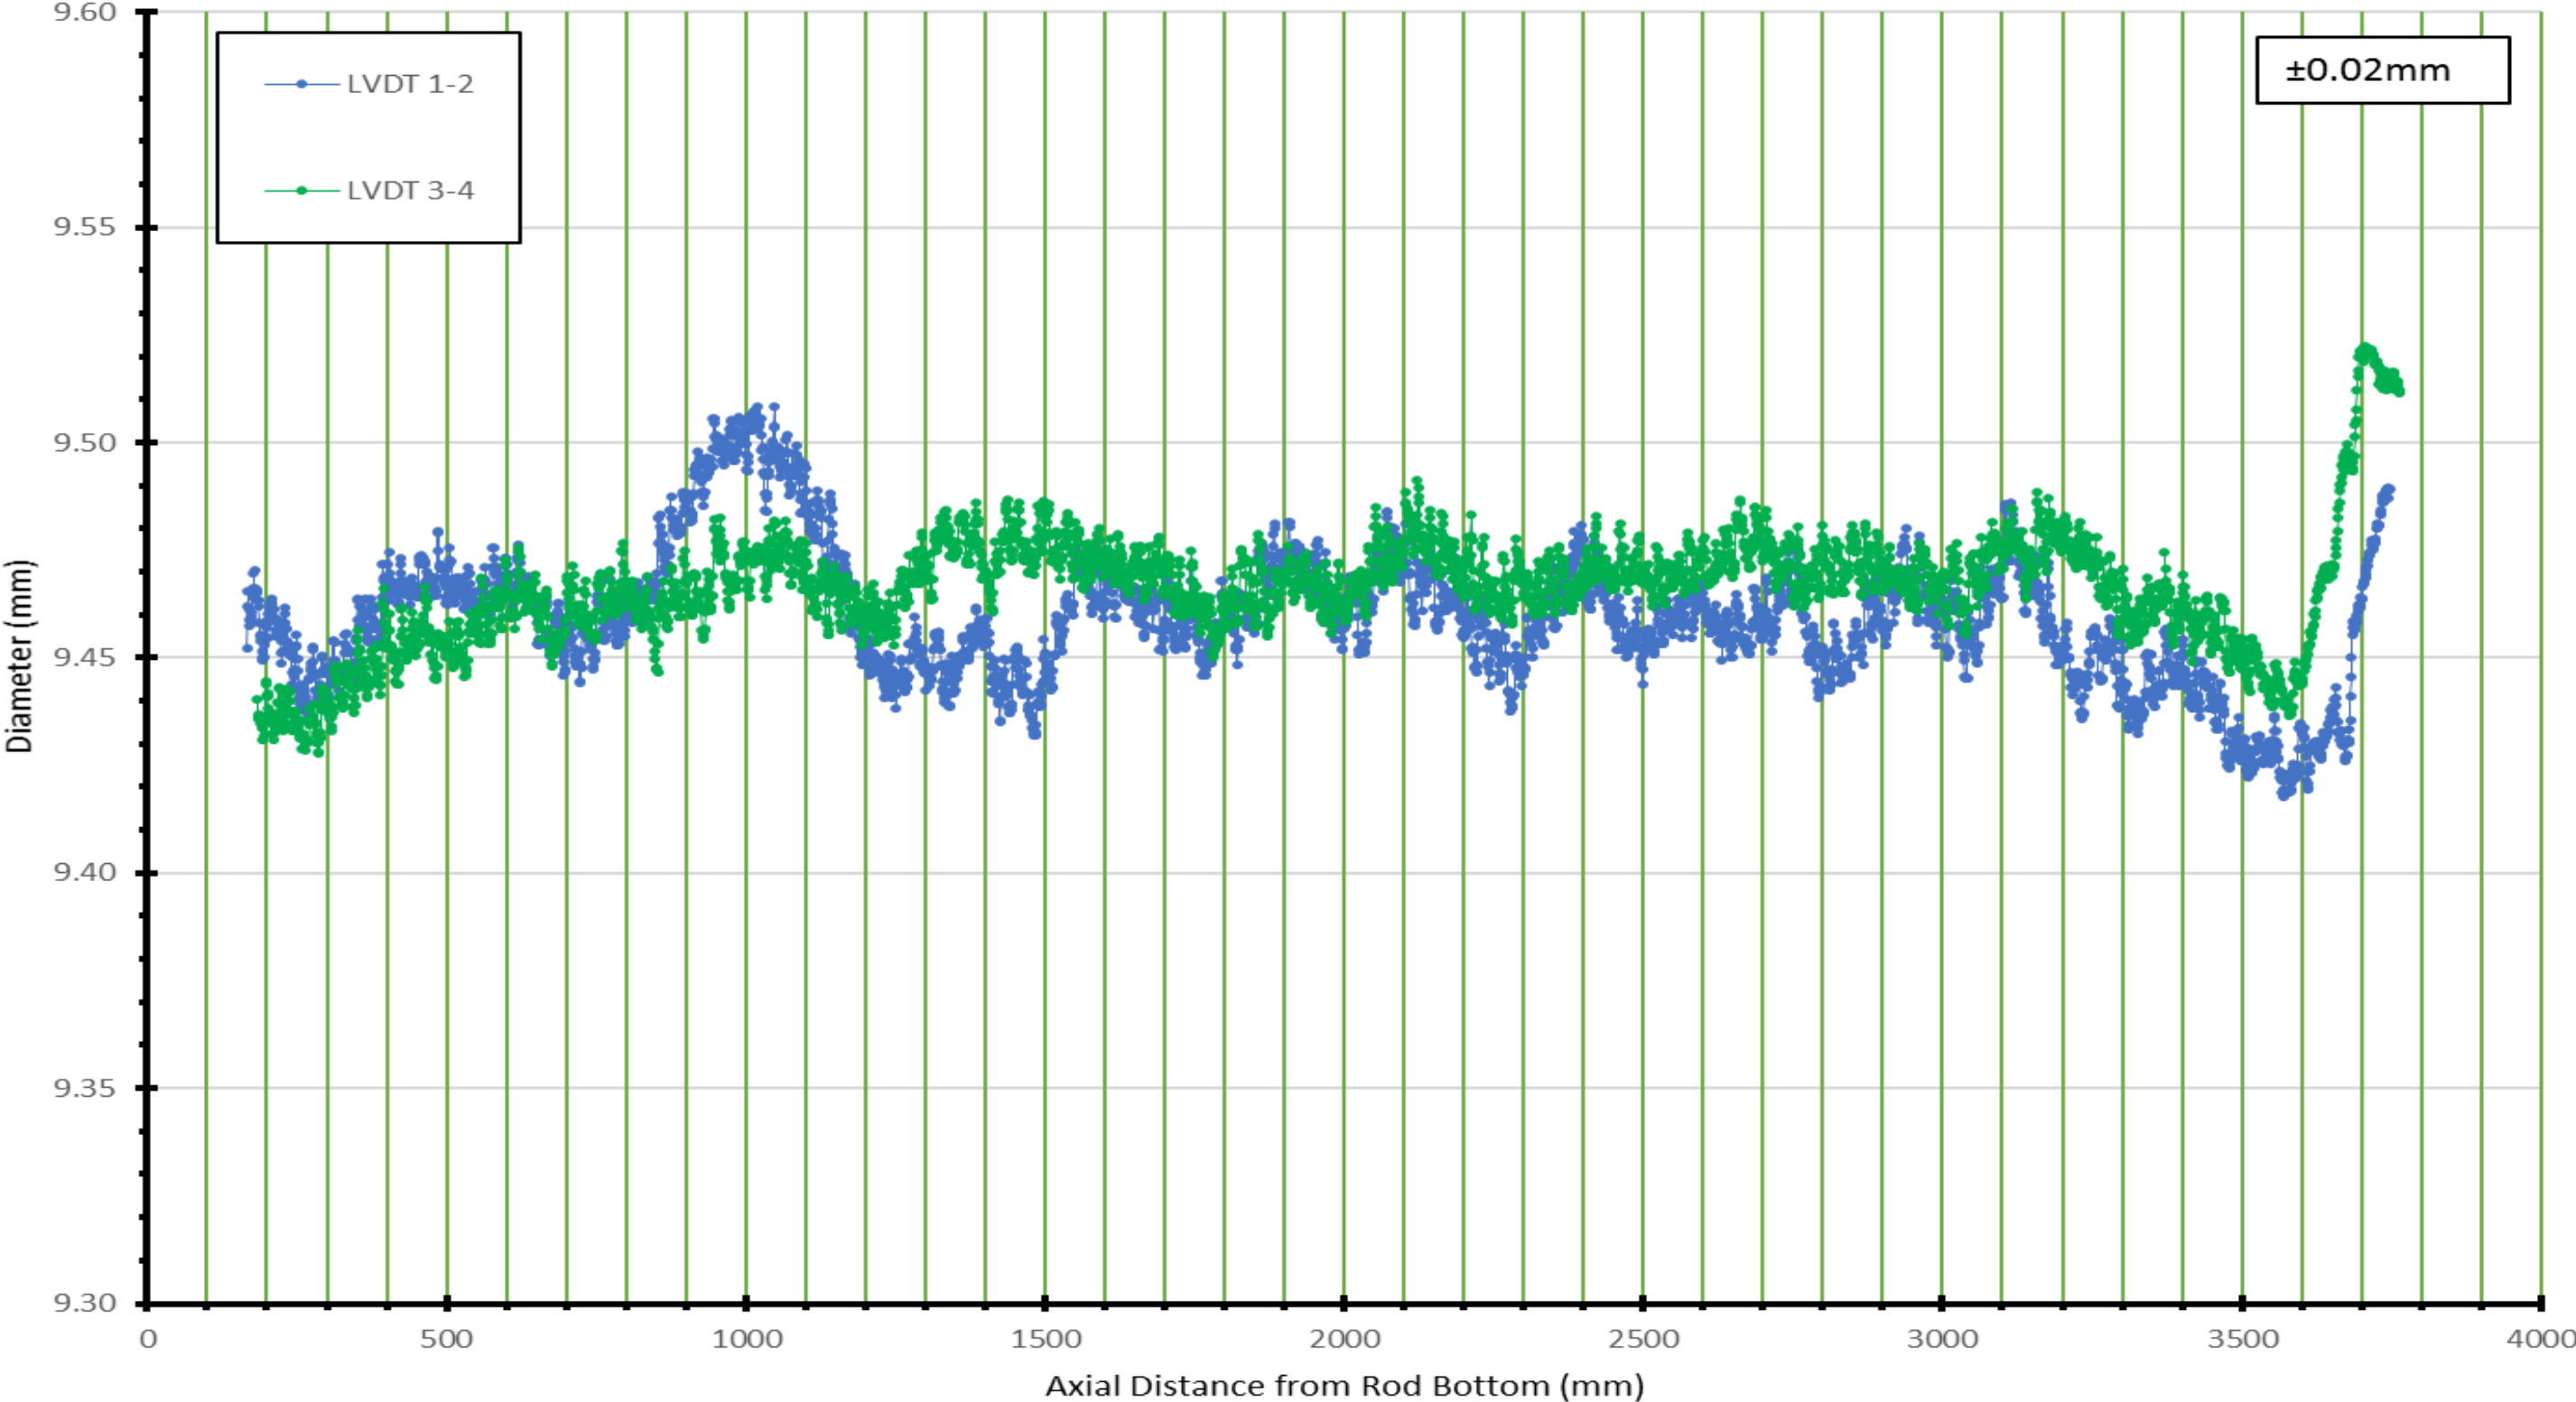
The average LVDT-measured rod diameter for rod 30AG09 displayed a region of increased diameter near 1,000 mm; the visual exam showed nothing unusual in this region. Upon examination of the individual LVDT data shown in Figure 75, it is evident that the spike in diameter was only measured by the

Figure 75. Individual LVDT Measurements for Rod 30AG09 Illustrating the Difference in Measurements for the Two Pairs between 900 and 1,600 mm.
