Sister Rod Nondestructive Examination Final Report

Spent Fuel and Waste Disposition

***December 21, 2018
SFWD-SFWST-2017-000003 Rev. 1
(M2SF-17OR010201021)
ORNL/SPR-2017/484 Rev. 1
(ORNL/SPR-2018/801)***

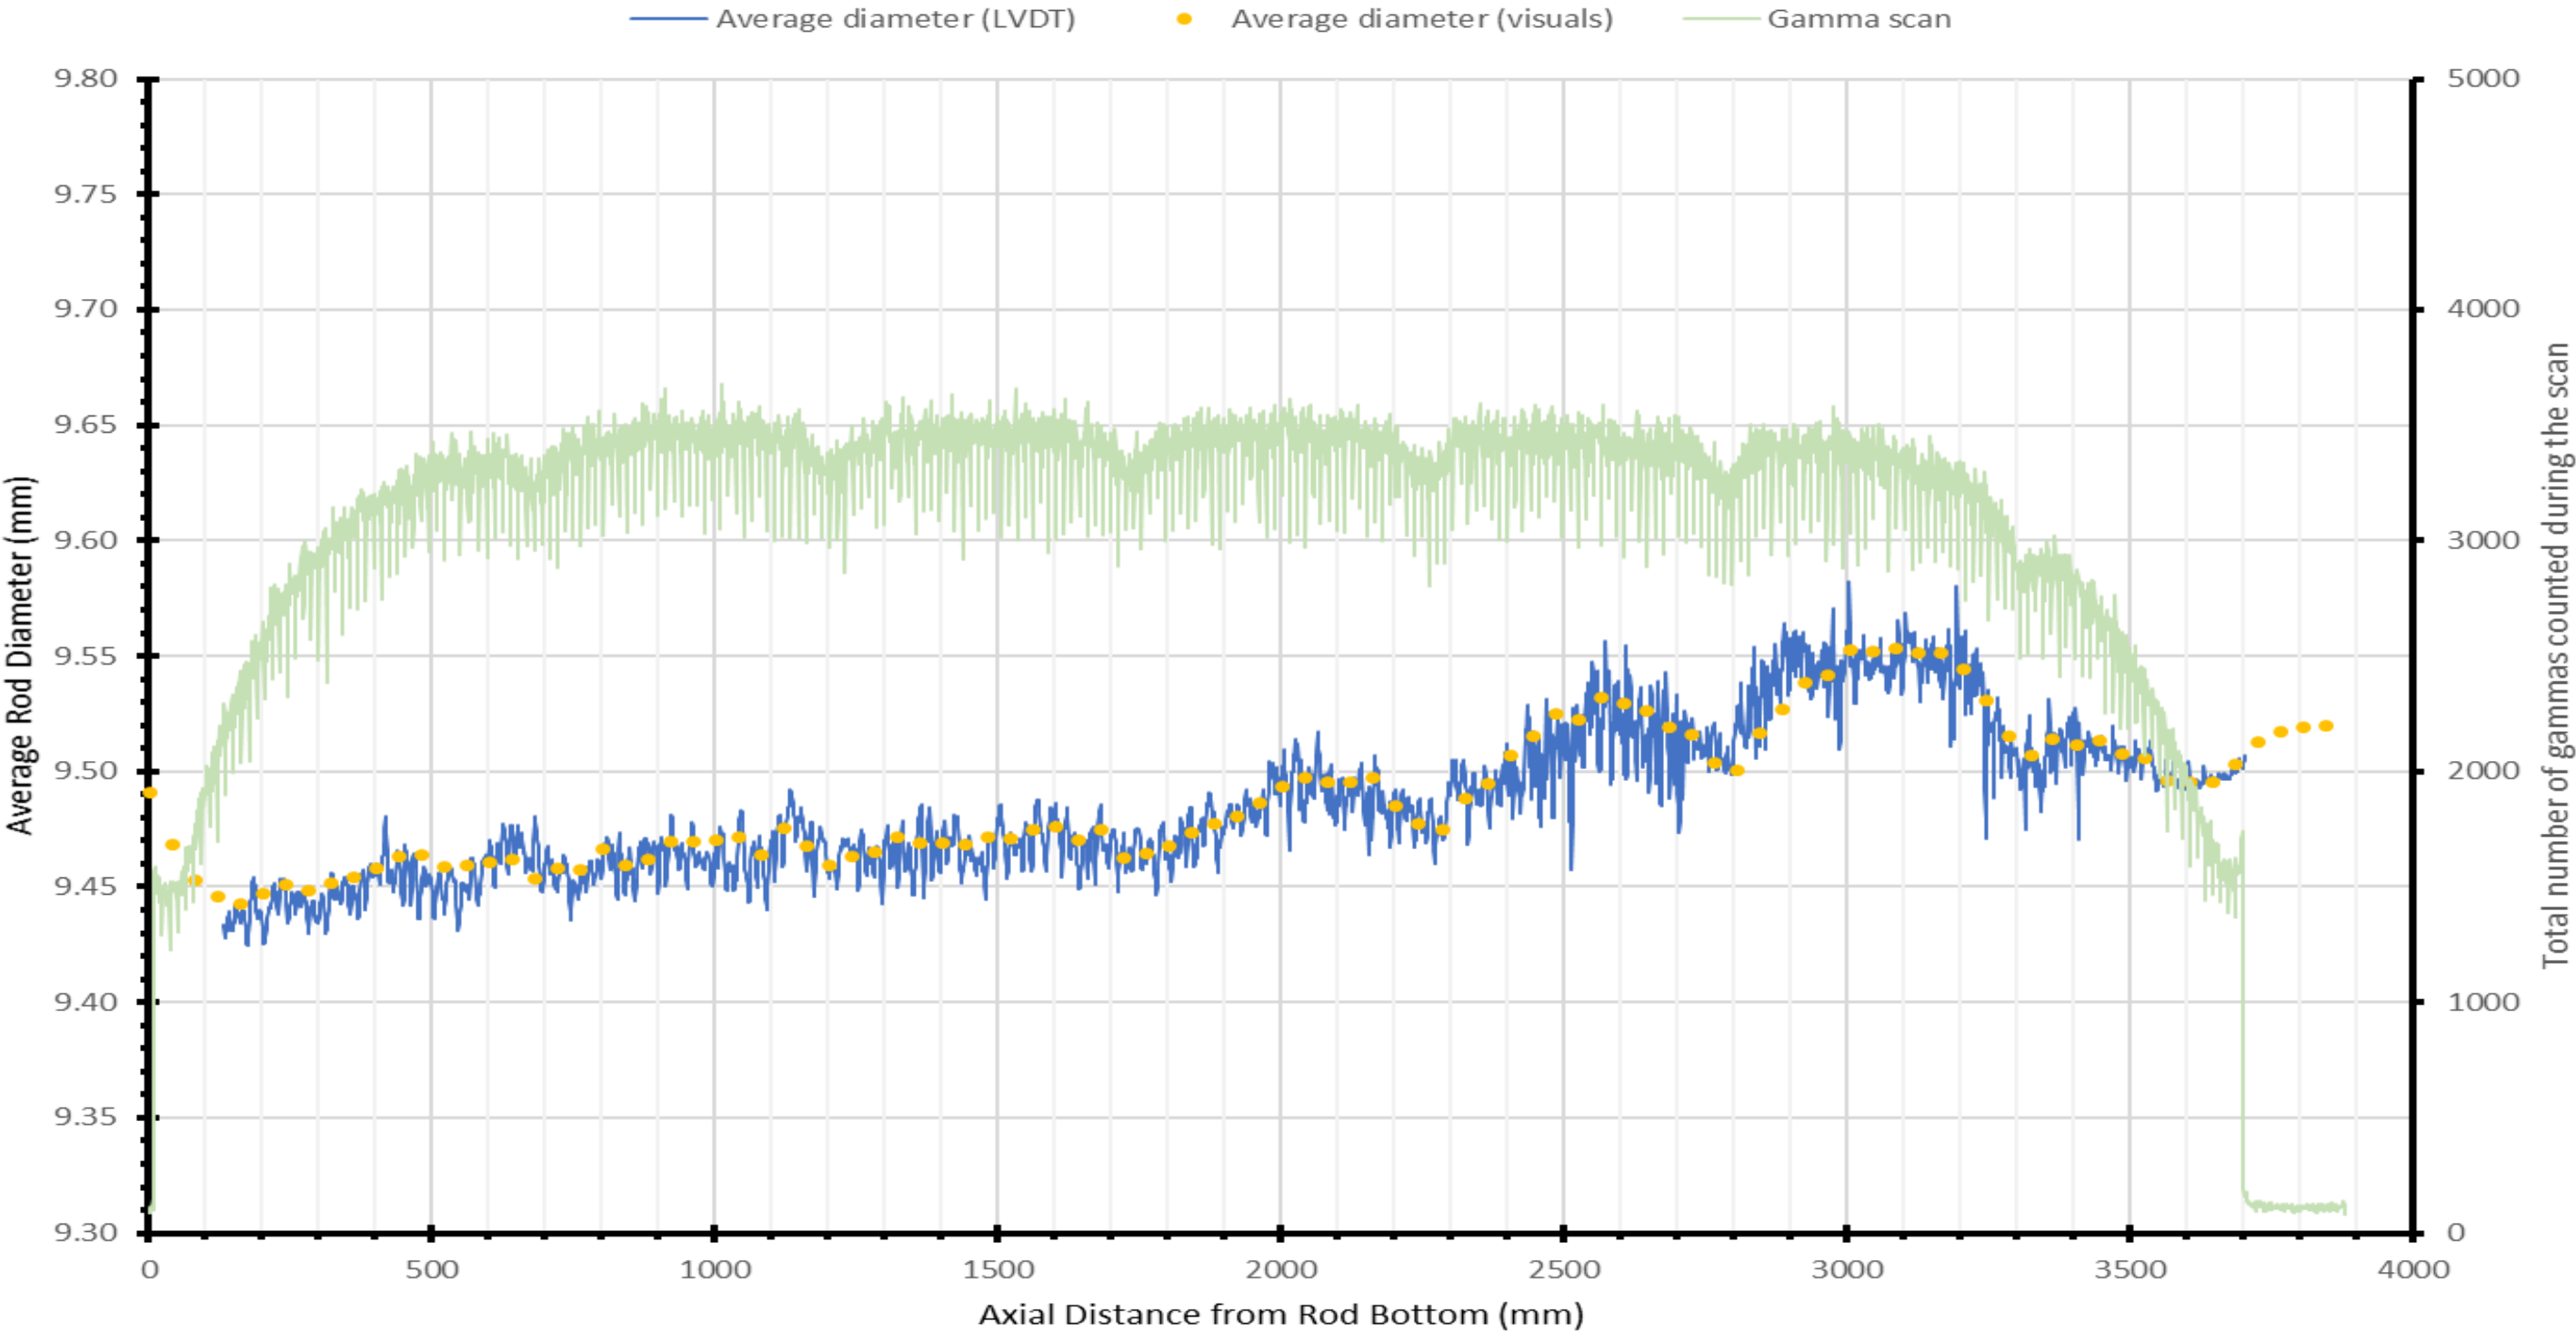
All of the sister rods were extensively photographed. The camera used was in a fixed location, and the rods in the ADEPT were at a constant distance with respect to the camera. While rod bow and ADEPT handling features can induce some small off-axis movements, the distance from the rod to the camera can only vary an estimated 3.2 mm in an approximately 216 cm optical path. The visual camera was also used to photograph the profilometry calibration rod which has a known nominal diameter of 9.53 ± 0.0025 mm. Although the axial variation of the calibration rod diameter is unknown, it is likely in the range of 0.0025–0.0127 mm. The photographs of the calibration rod (diameter) were used to determine the length-to-pixel ratio for the images. This information was used to resolve boundary pixel criteria (edge of rod versus background) and to scale the pixel count to diameters. The diameter was measured in 1 mm increments along the length of the rod at 0-, 45-, 90-, 135-, 180-, 225-, 270-, and 315-degree rotations. An average diameter was calculated at 40 mm intervals by (1) averaging the 1 mm measurements contained within the interval for each rotation angle and (2) averaging all rotations at that elevation. This provided 97 average diameter measurements along the length of the sister rod. An example of the measurements is provided in Figure 77 as compared with the LVDT measurements and features identified by gamma scan.

Figure 77. Example of LVDT Measurements and Visuals Diameter Measurements as Compared with Features Indicated by the Gamma Scans for Rod F35K13.

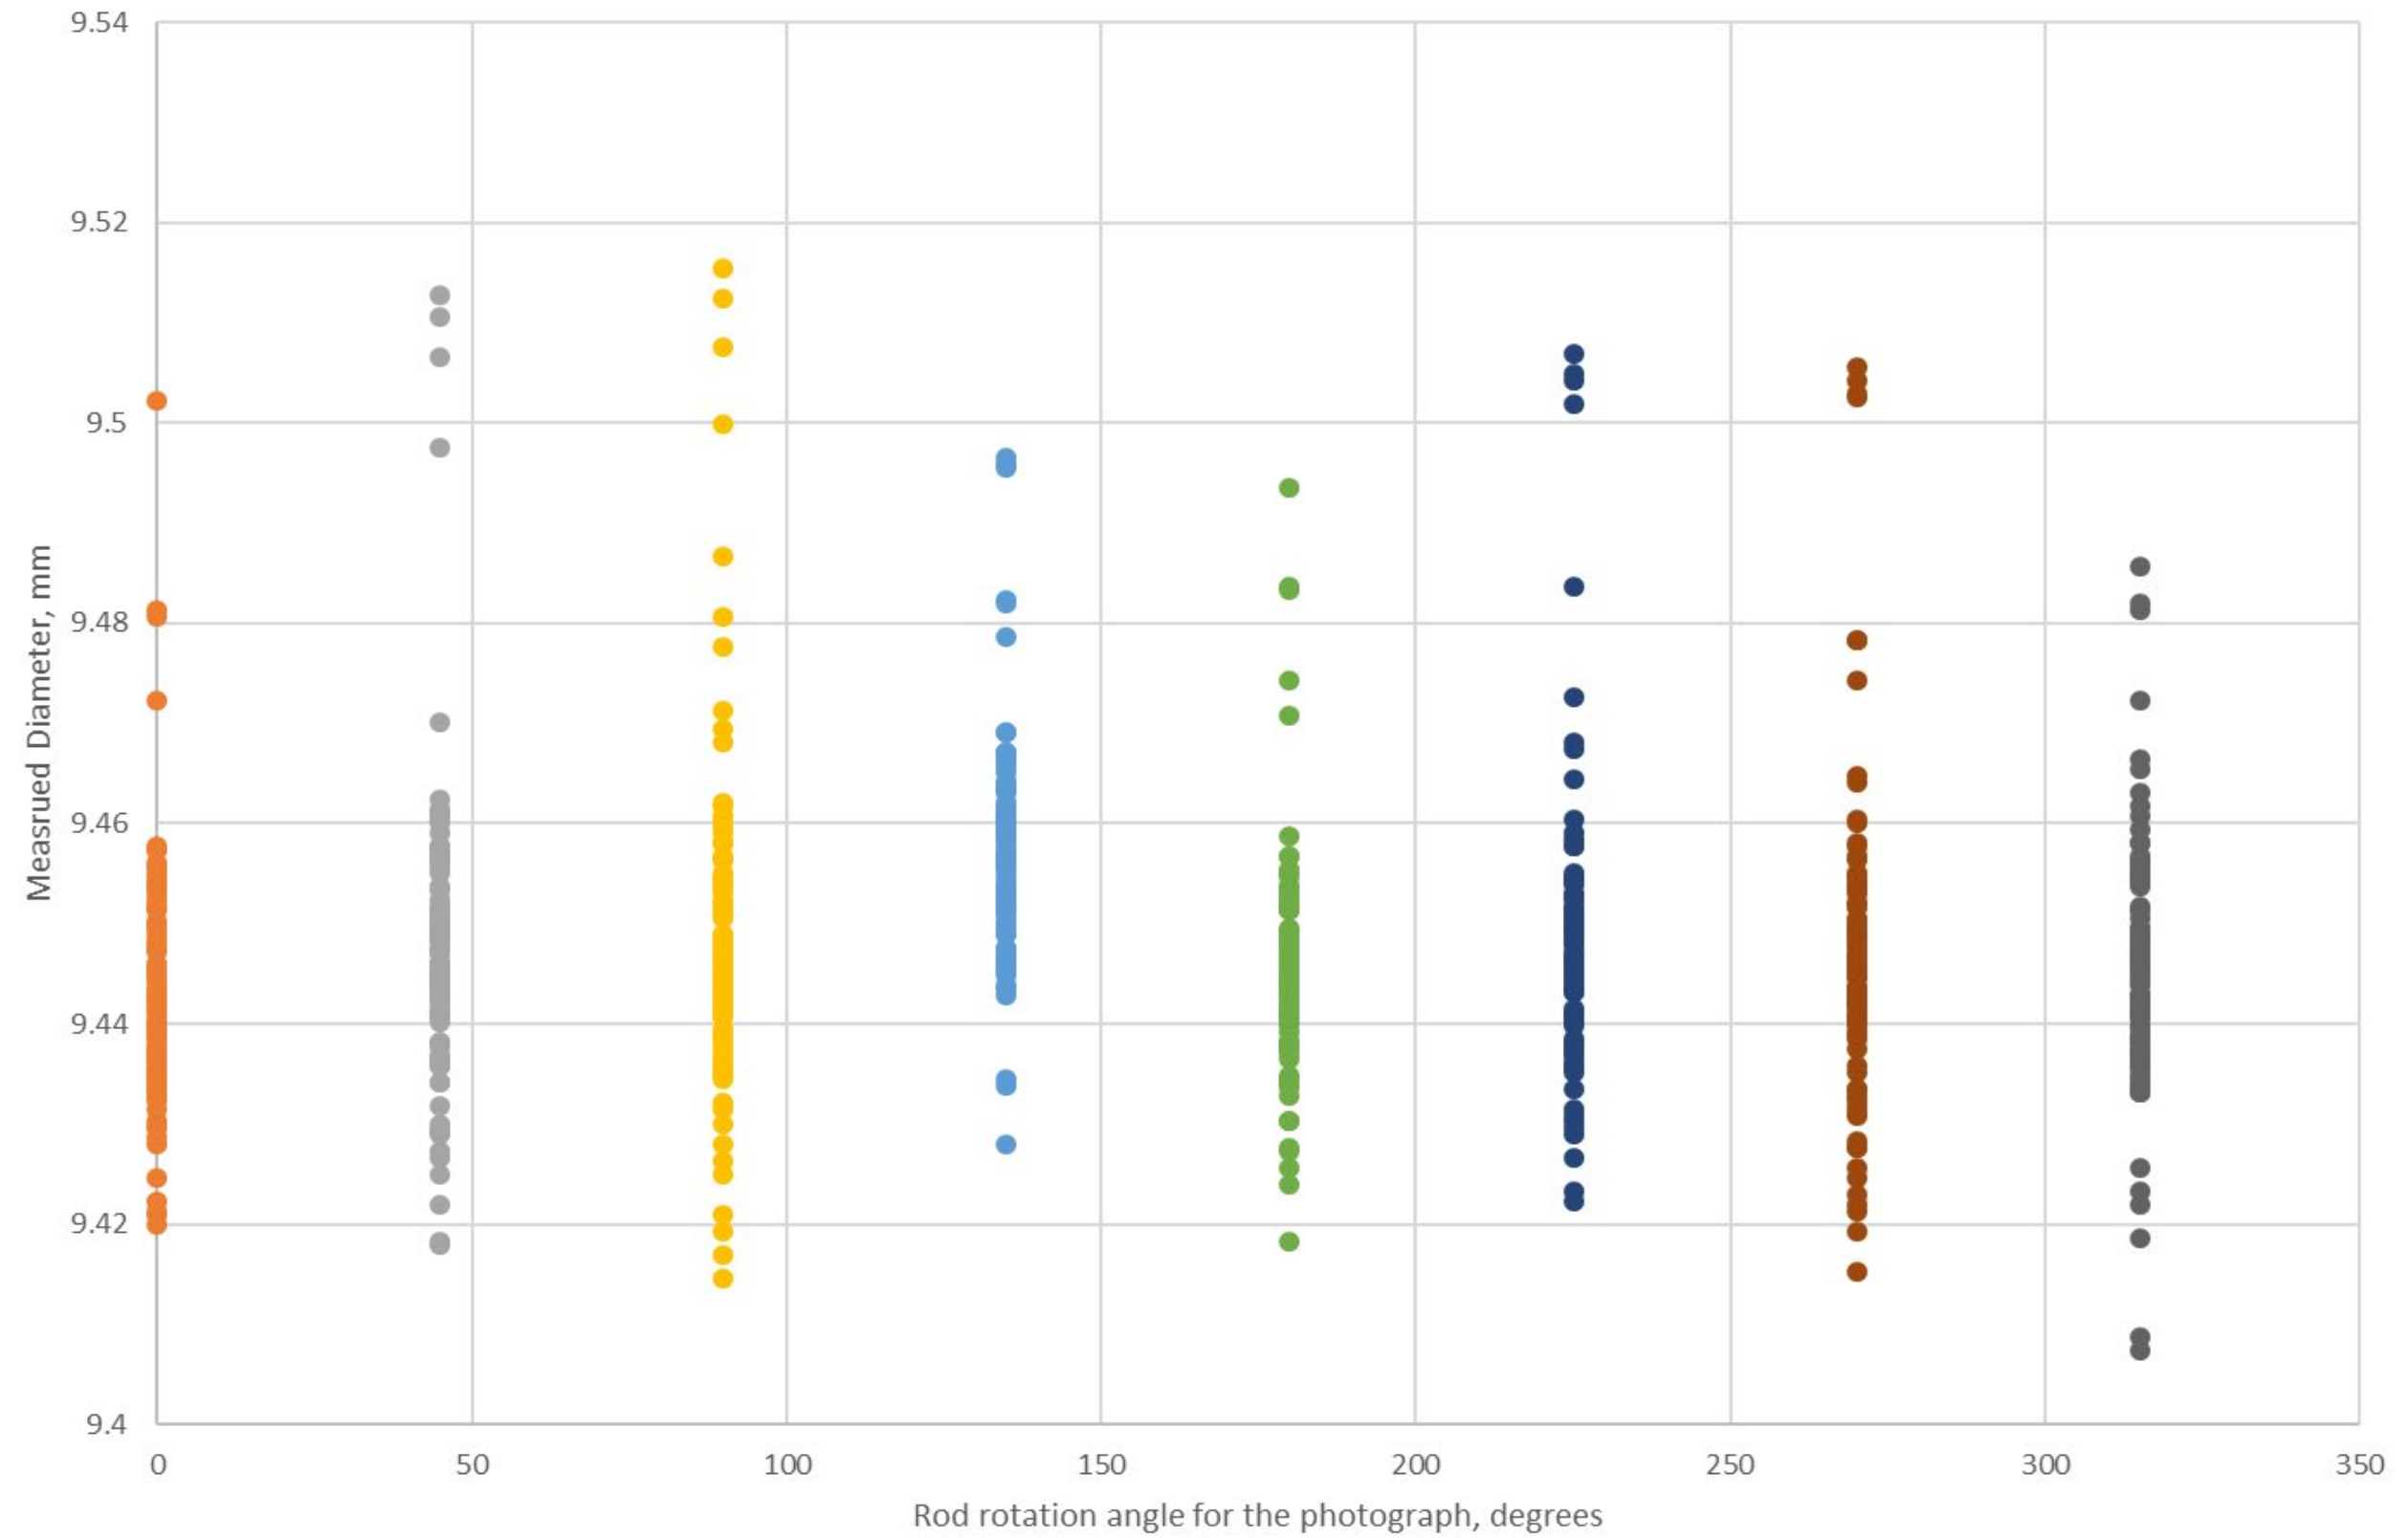
Although these measurements are not considered to be as accurate as the LVDT measurements in total, they are useful in verifying trends, measuring the ends of the rods that cannot be measured with the LVDTs, and for additional observations around the circumference of the rod. For example, the discrepancy in the local measurement of rod 30AG09 (mentioned above) was verified using the visual data. However, there appears to be a measurement effect related to the angle of view, as the data tend to exhibit a sinusoidal trend with the rod rotation angle, as shown in Figure 78. The effect, roughly ± 0.05 mm, could be related to a lens distortion, or it is more likely due to an ADEPT off-center rotational effect combined with uneven lighting/background making the edge determination inconsistent. However, it seems that calibration with the imaging must be completed for each angle of rotation to ensure better accuracy, and work beyond the scope of this program would be required to process these data. The averaging mentioned above eliminates some of this effect.

Figure 78. Observed Sinusoidal Trend in Visual Profilometry Data with Angle of Rod Rotation.

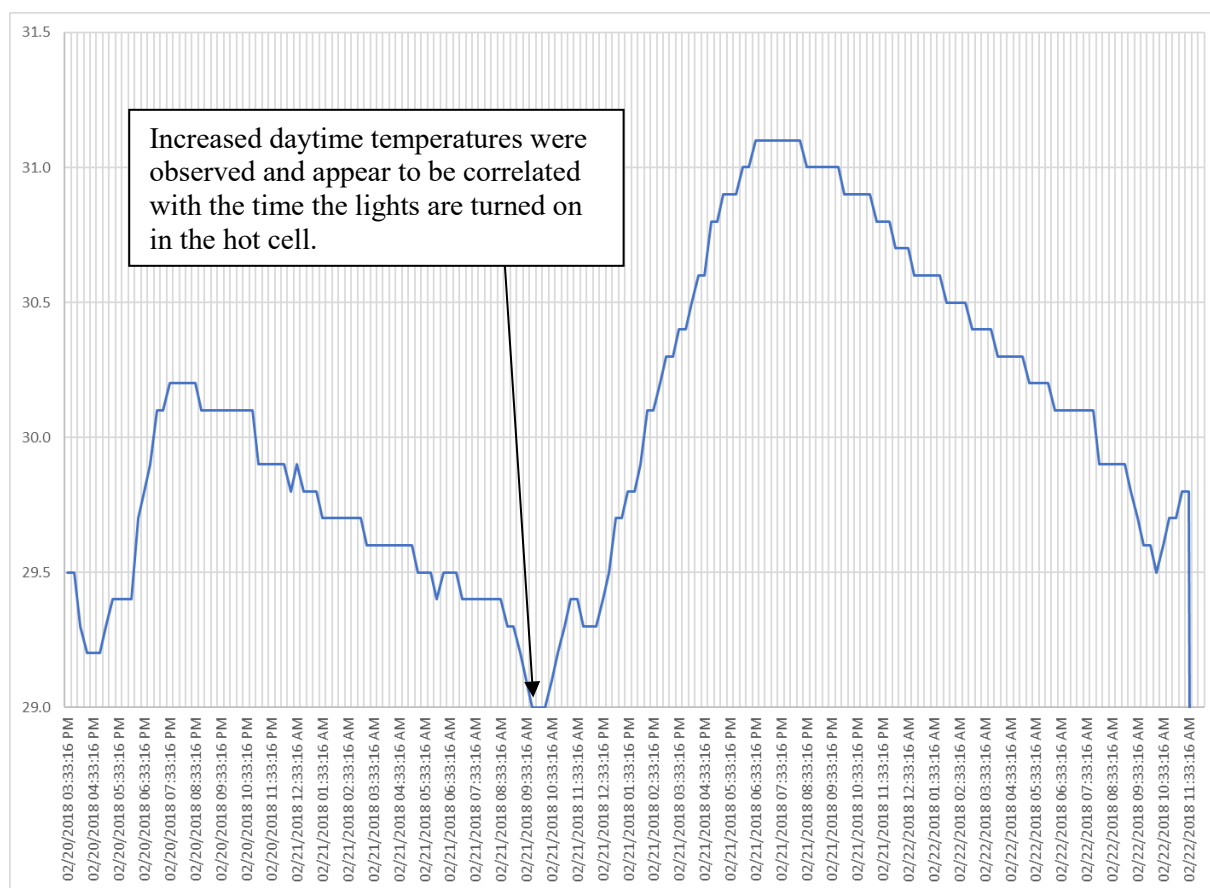
Using the isolation housing, the surface temperature of several rods was measured at the axial mid-plane over several days. The maximum temperature measured, for sister rod 5K7P02, was 31.1 °C. Although the temperature was observed to vary in the daytime hours, the variation was not significant and did not appear to correlate with outdoor conditions. Rather, it is likely that the variation is related to the times when the lights are on in the hot cell, as the lights in the cell produce quite a bit of heat. Measurements during a cycle of approximately 24 hours are shown in Figure 80.

Figure 80. 24-Hour Measurement of Surface Temperature of Sister Rod 5K7P02 at Midplane, in the Temperature Housing and on the ADEPT (Not in the Storage Array).

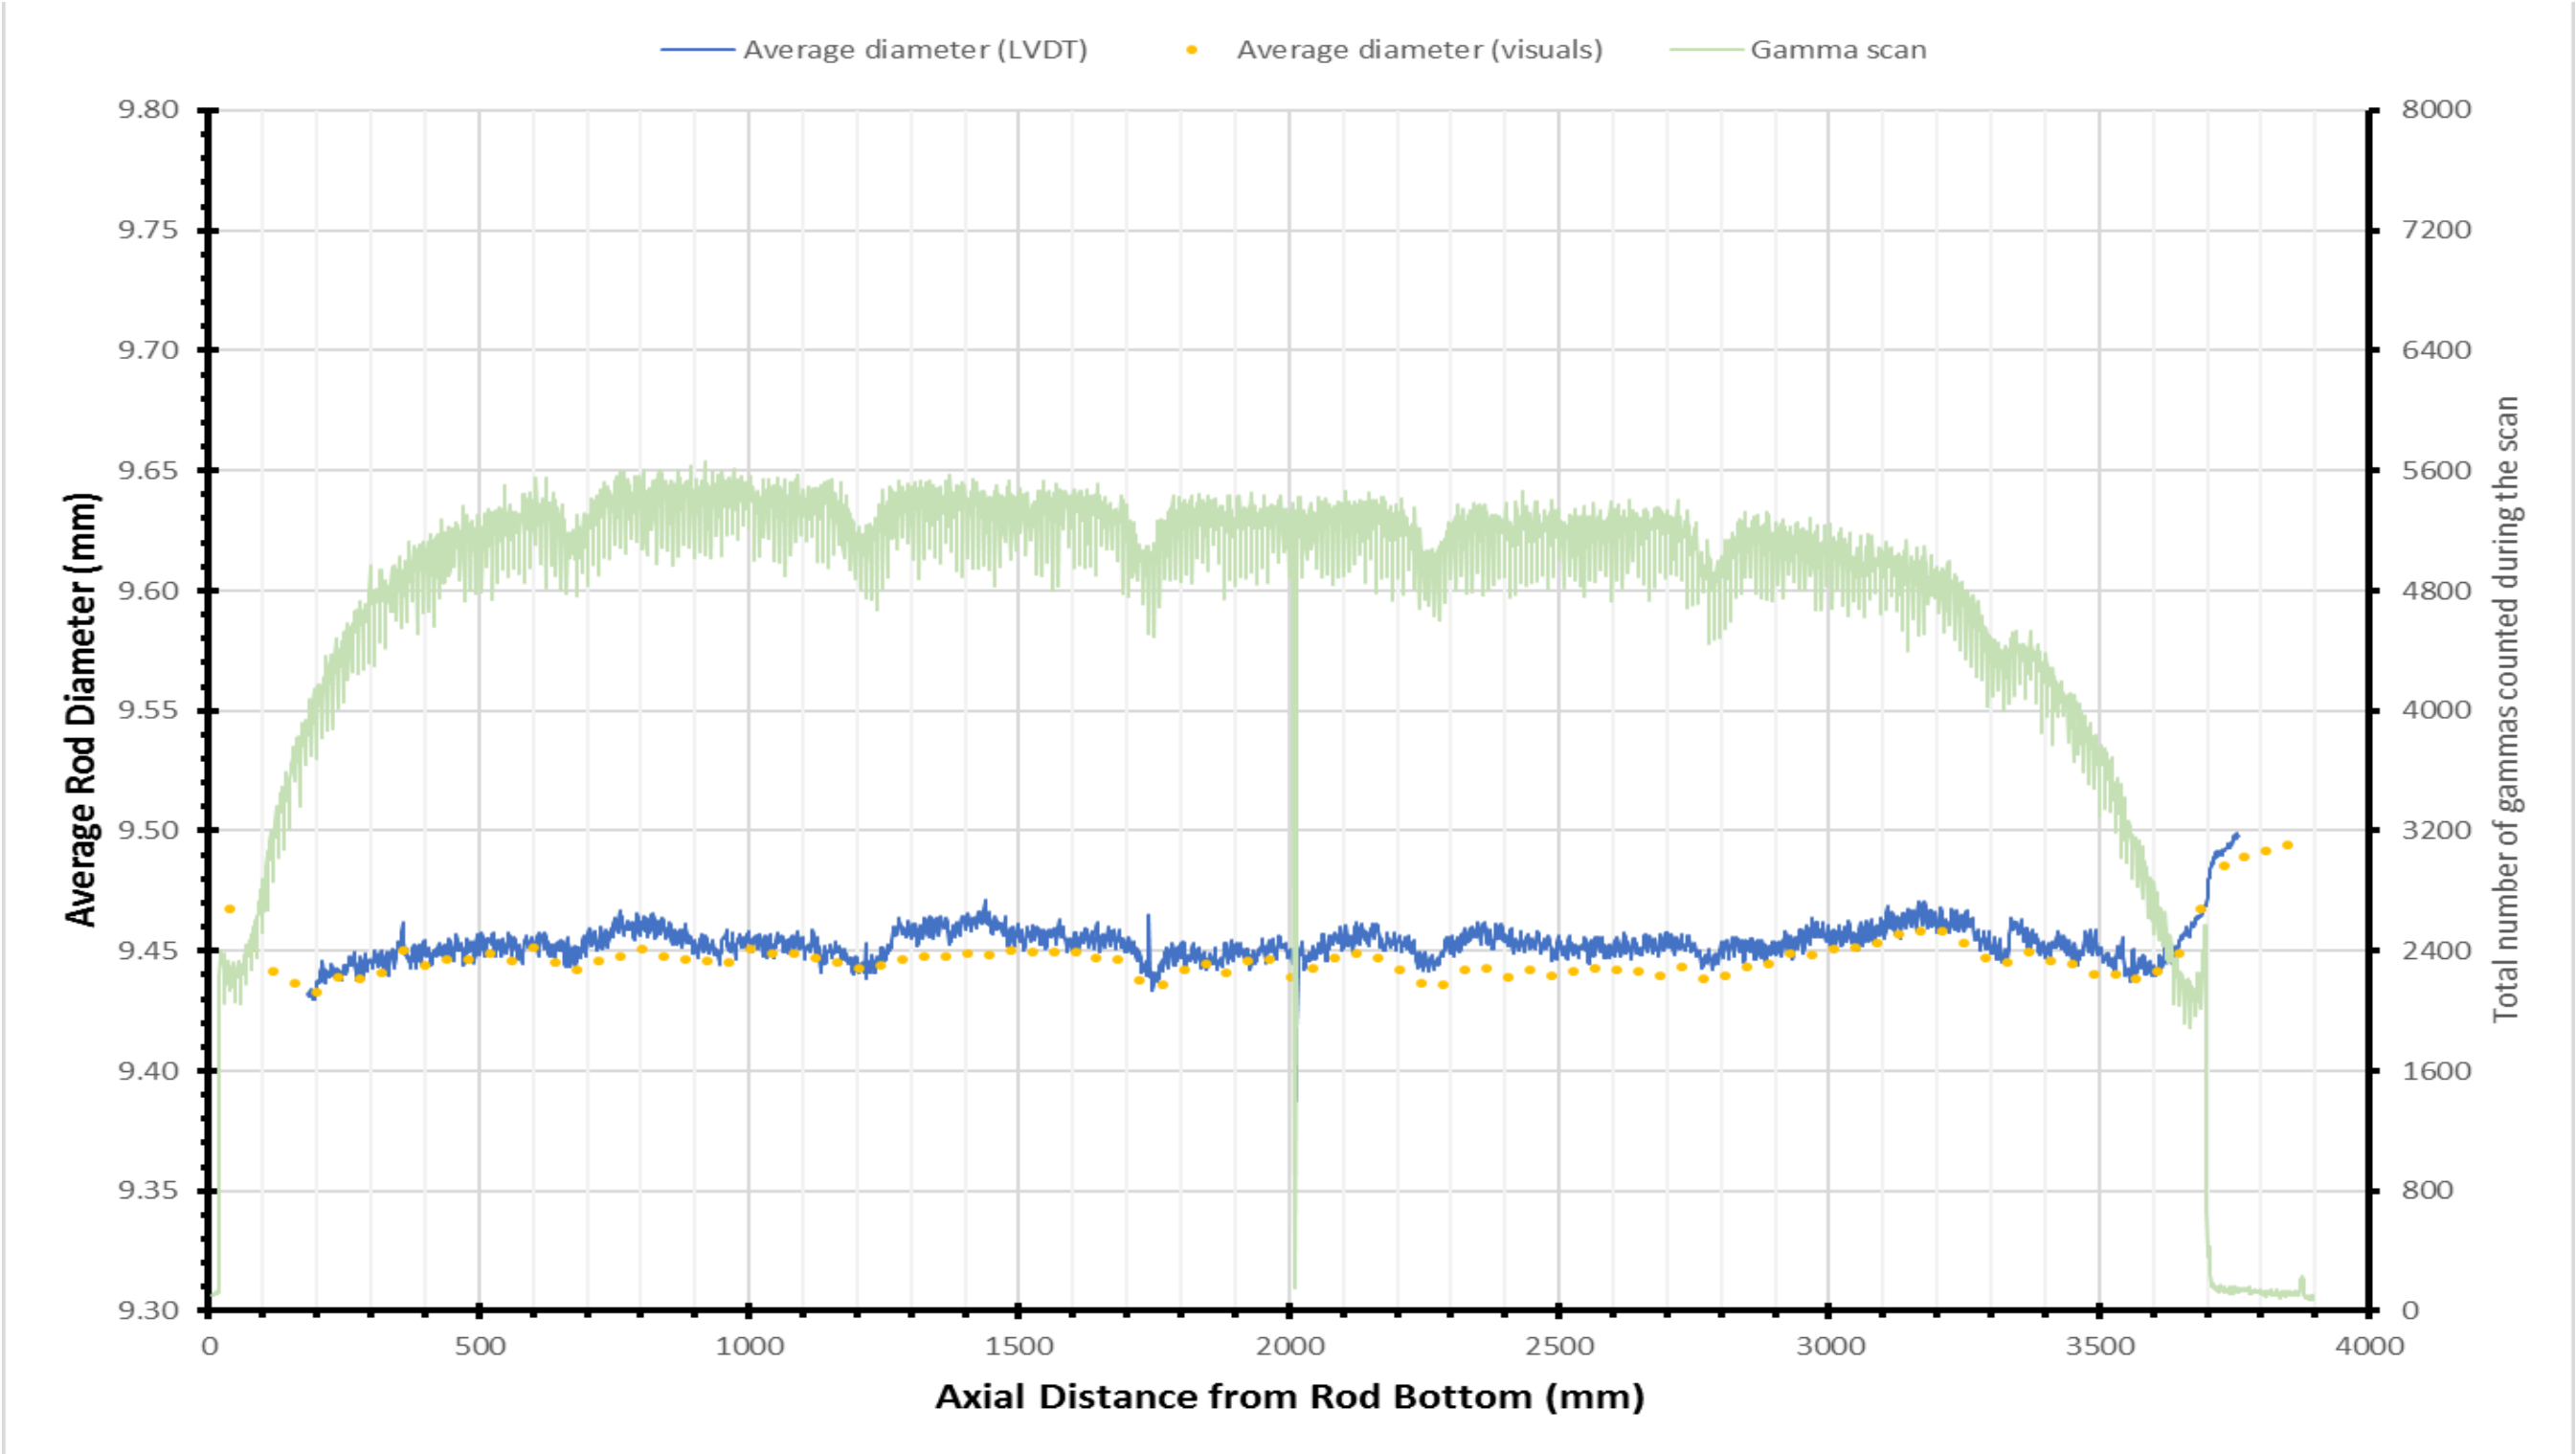
Bambooing — a small diameter variation with a period of about 10 mm (the pellet length) — was observed in all rods. Figure 74 shows a portion of the bottom region of rod 6U3P16, where bambooing caused by pellet-cladding interaction during operation can be observed.

Finally, a fairly large ($\sim 3/4$ pellet length) reduced diameter (~ 0.5 mm) region was noted in the profilometry scan for rod 6U3P16, as shown in Figure 76. The reduction was measured by both pairs of LVDTs, but it is not observable in the visual profilometry. This is likely due to the visual method's lower axial resolution, which only has measurements every 40 mm. This reduced diameter region aligns well with the reported gamma scan pellet gap (see Table 5) and is likely the same feature.

Figure B.18. Rod 6U3P16 LVDT Profilometry, Visual Profilometry, and Gamma Scan Data.

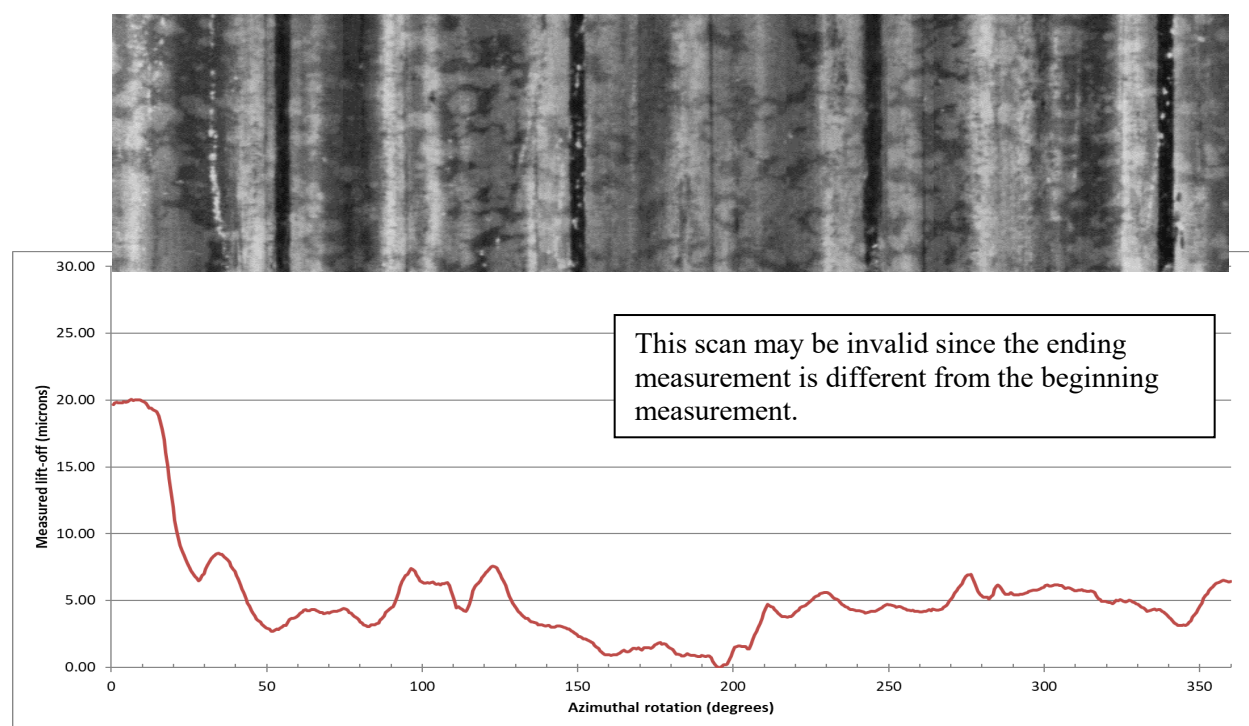
Figure C.54. Rotational eddy current lift-off scan of 6U3L08 at 55 mm.

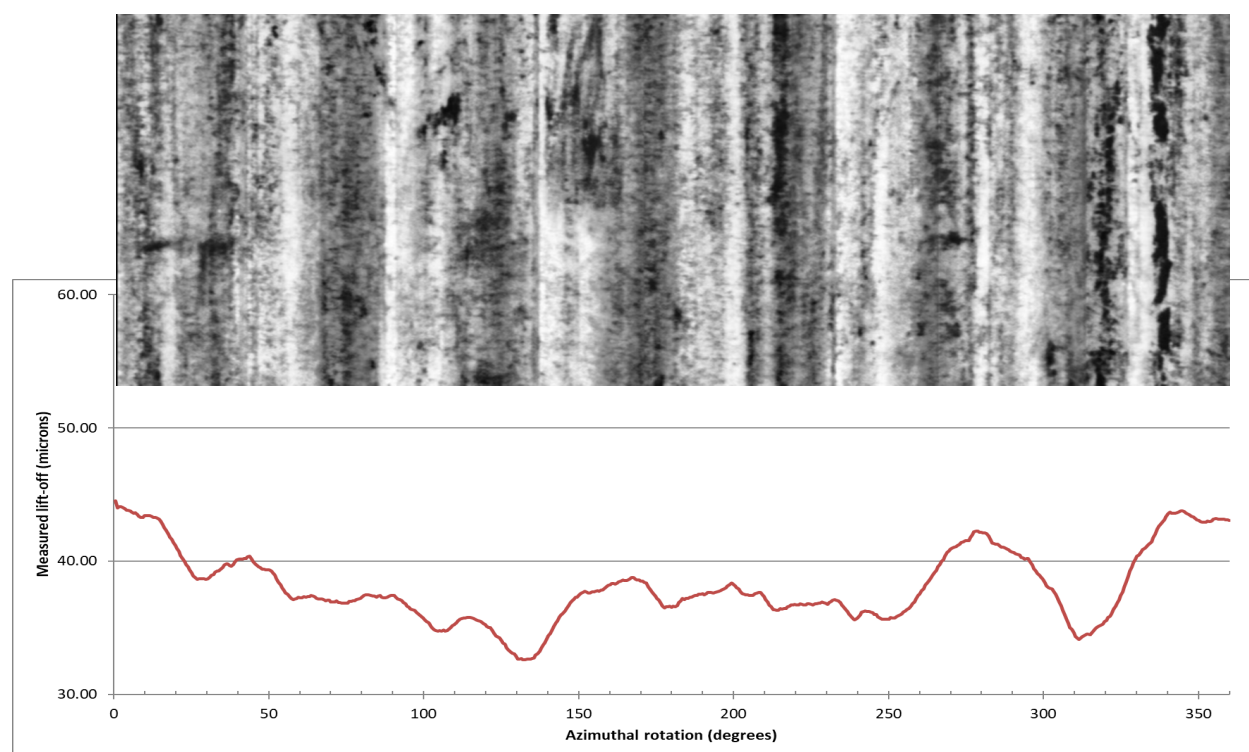
Figure C.55. Rotational Eddy Current Lift-Off Scans of 6U3L08 at 3,364 mm.

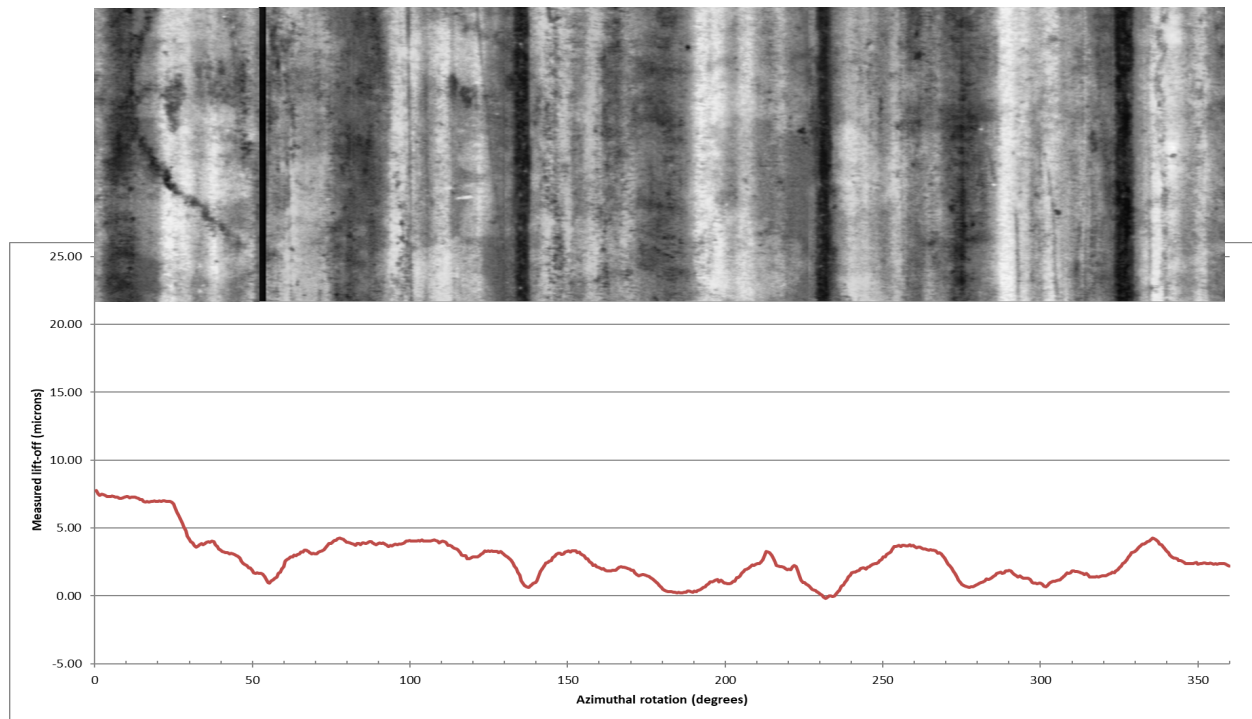
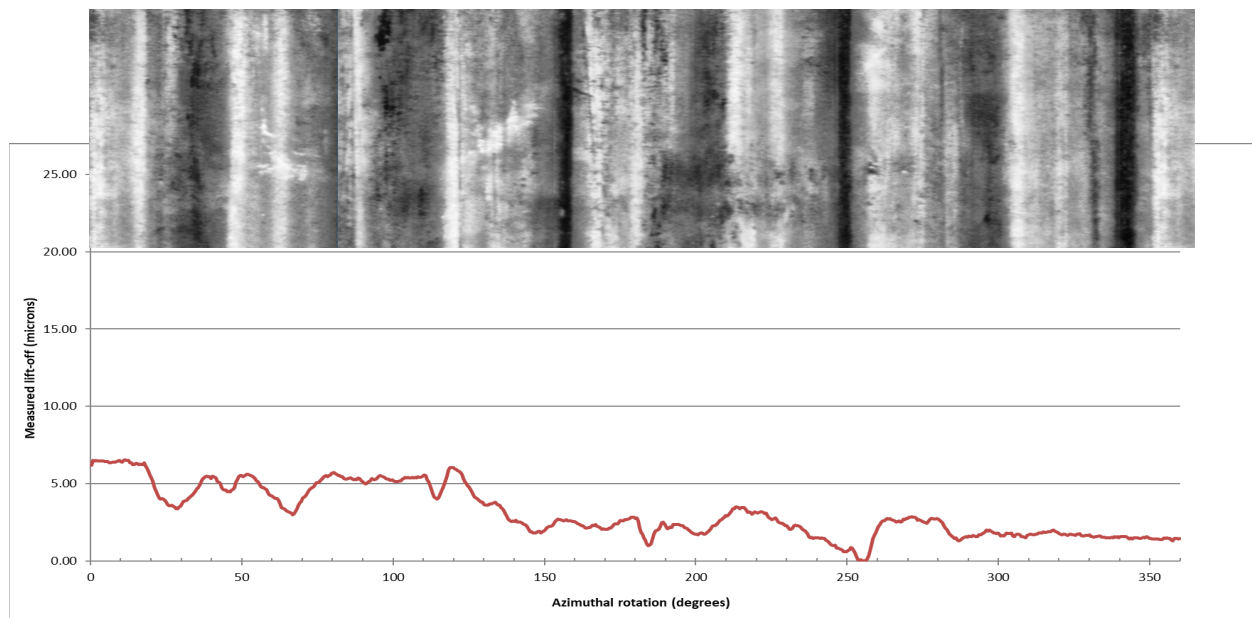
Figure C.56. Rotational Eddy Current Lift-Off Scans of 6U3P16 at 449 mm (Top) and 516 mm (Bottom).

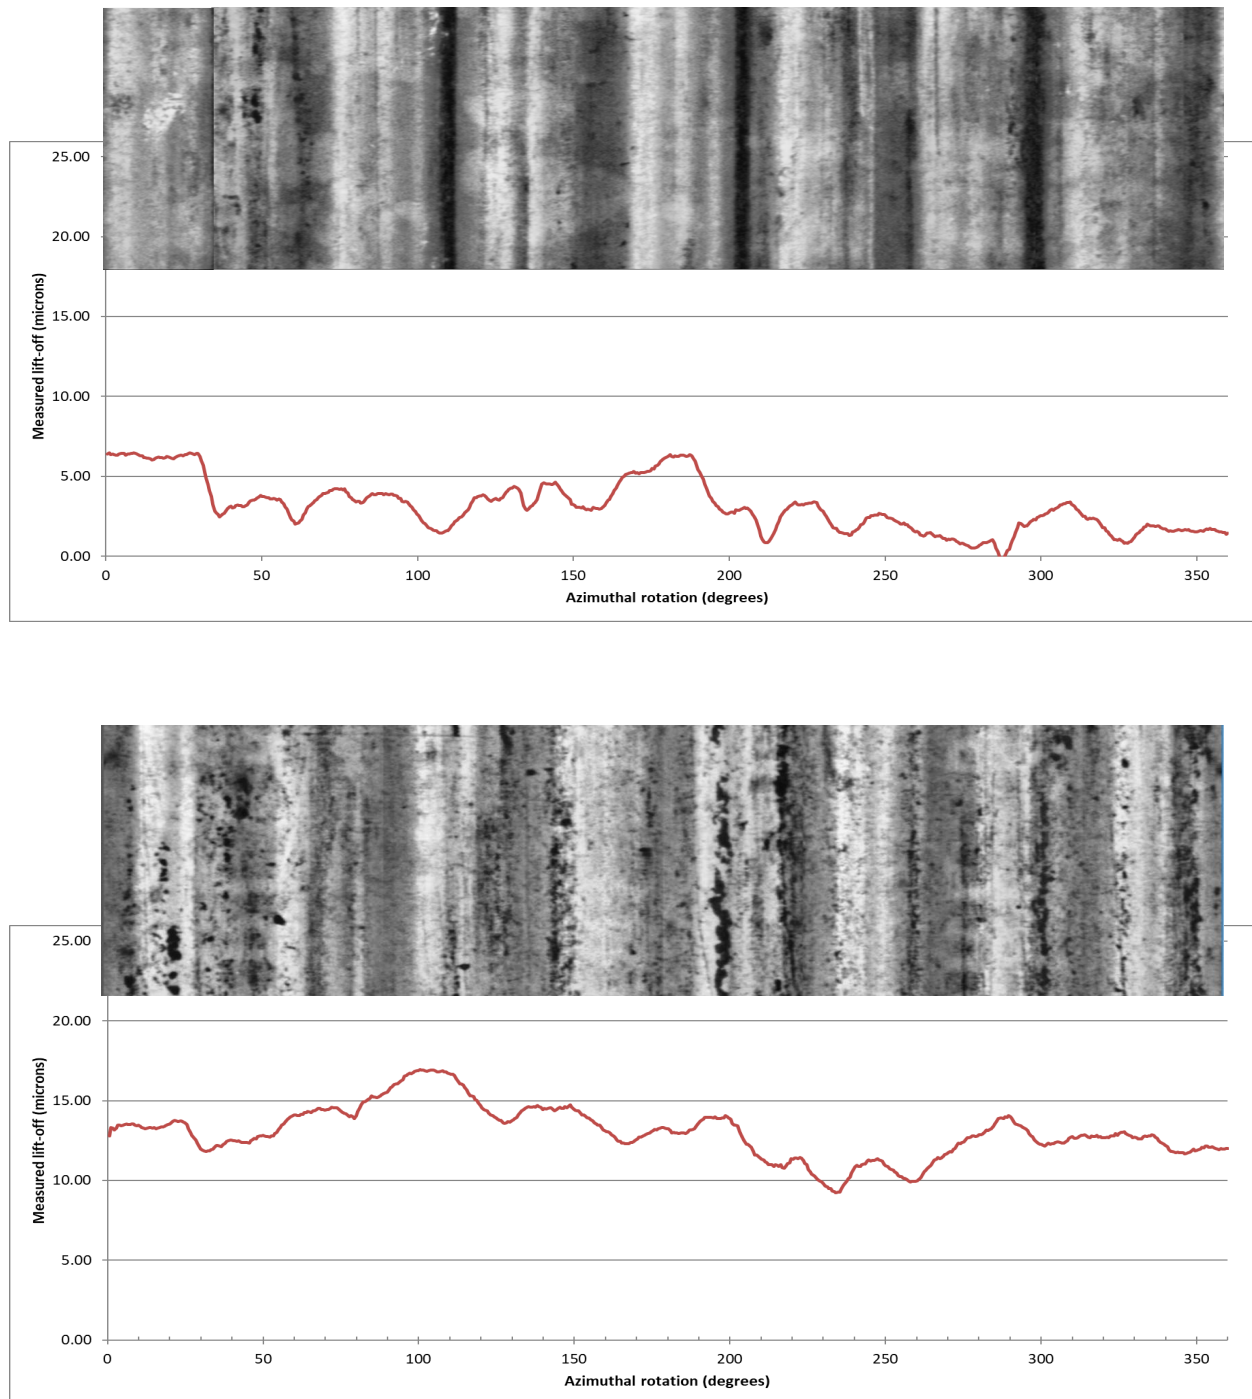
Figure C.57. Rotational Eddy Current Lift-Off Scans of 6U3P16 at 398 mm (Top) and 3835 mm (Bottom).

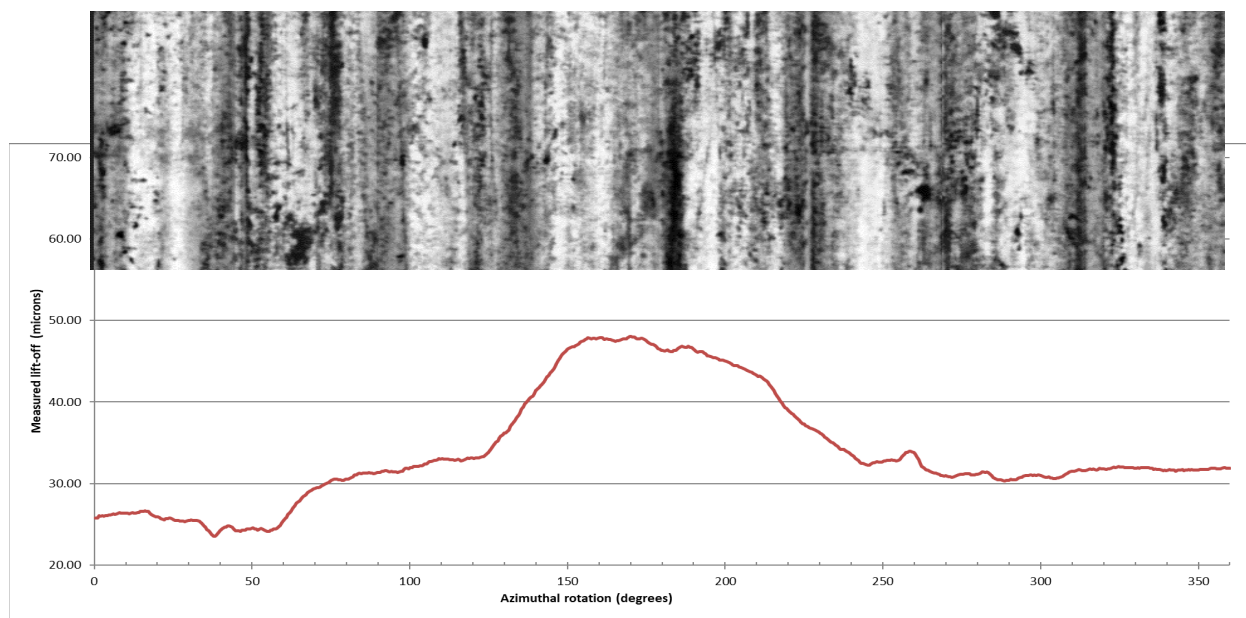
Figure C.58. Rotational eddy current lift-off scan of 6U3P16 at 3,434 mm.

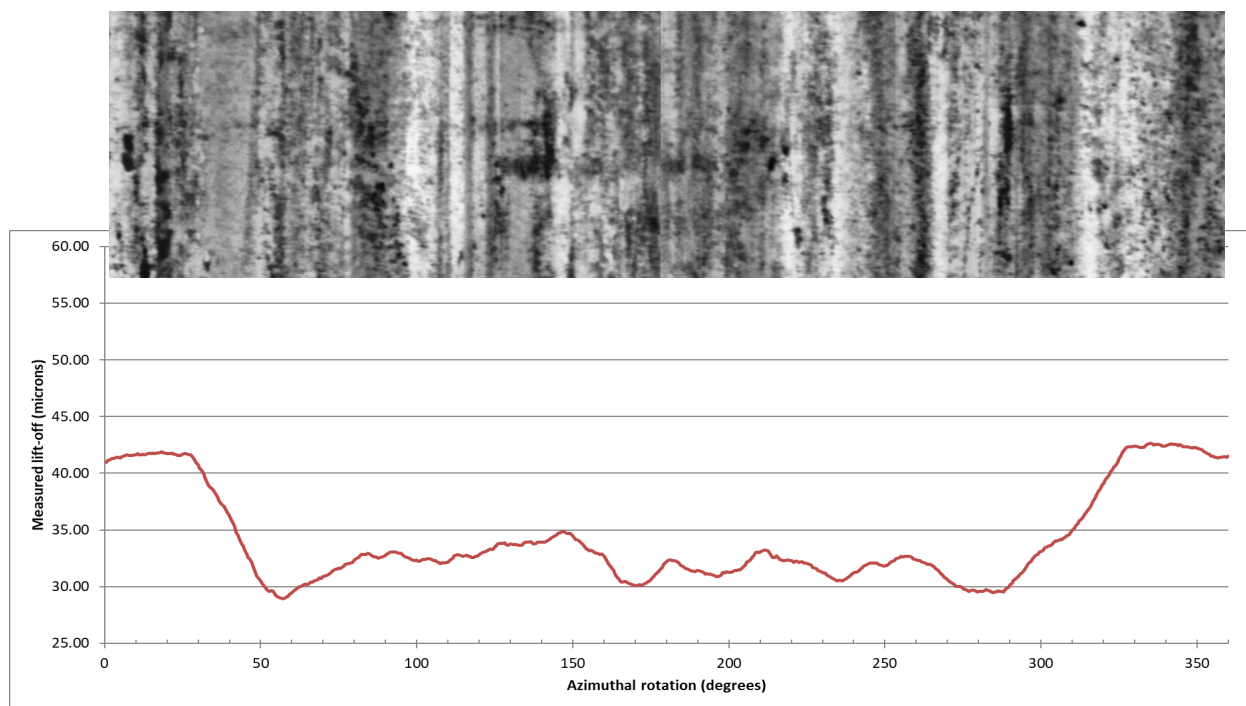
Figure C.59. Rotational eddy current lift-off scan of 3F9P02 at 3,201 mm.

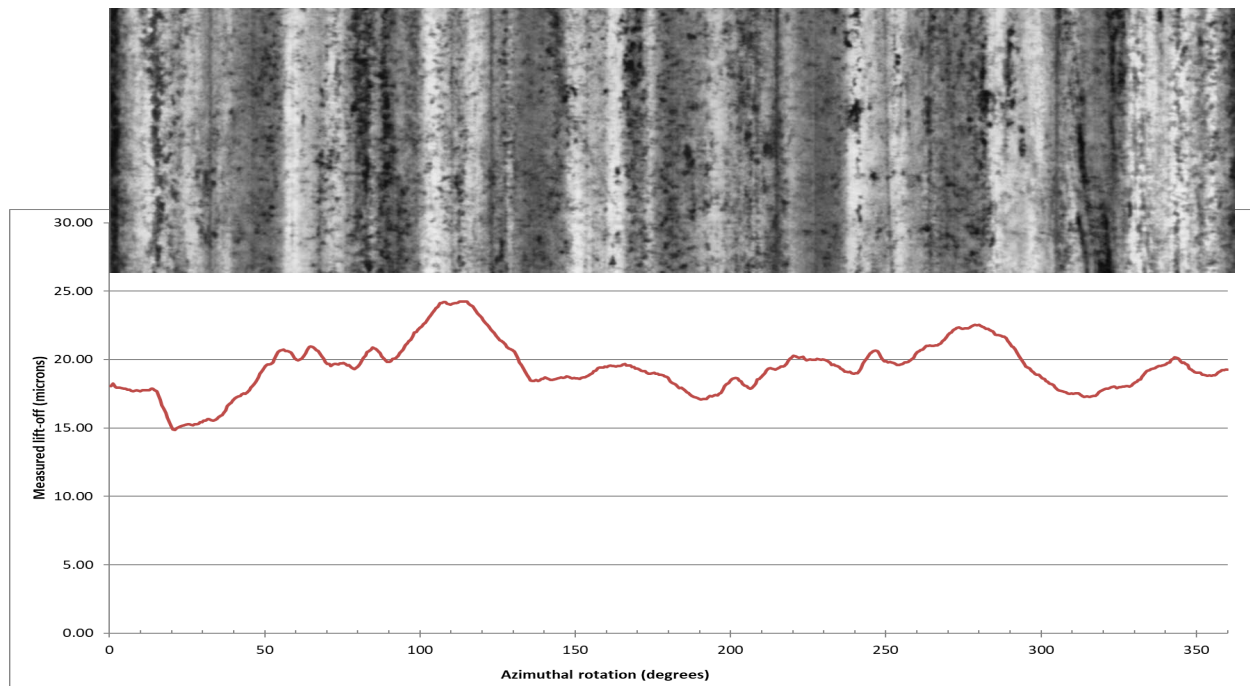
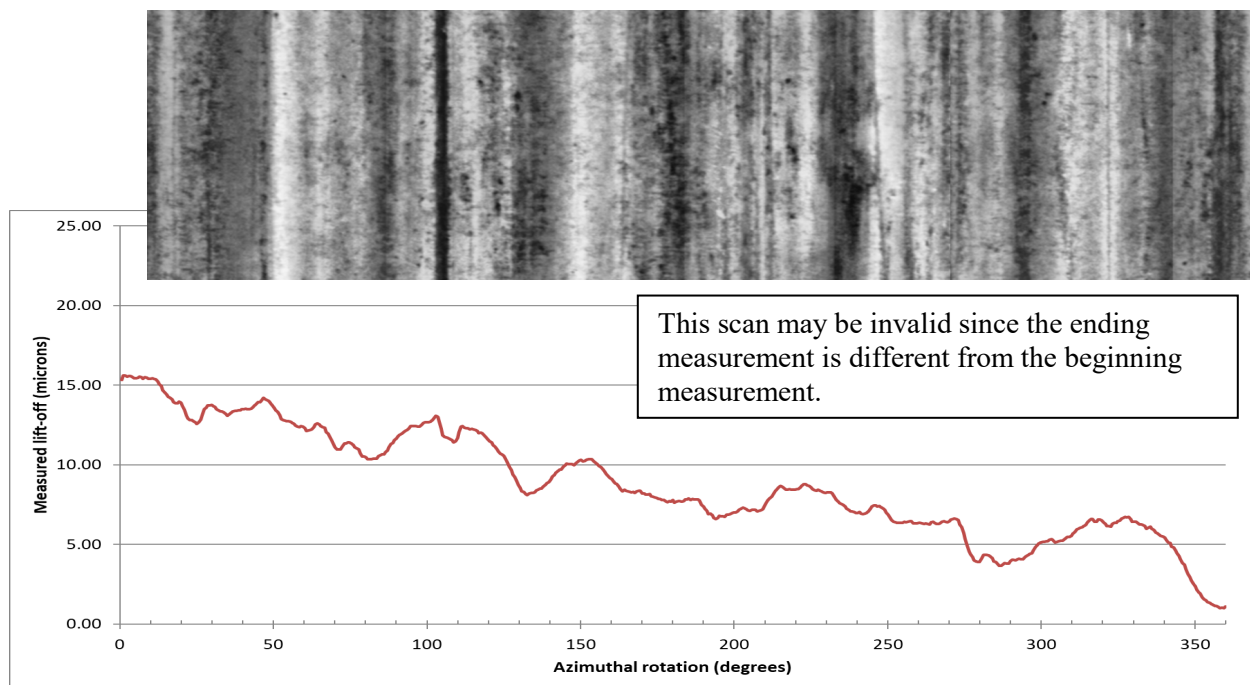
Figure C.60. Rotational Eddy Current Lift-Off Scans of 3F9P02 at 3664 mm (Top) and 2281 mm (Bottom).
