Sister Rod Nondestructive Examination Final Report

Spent Fuel and Waste Disposition

***December 21, 2018
SFWD-SFWST-2017-000003 Rev. 1
(M2SF-17OR010201021)
ORNL/SPR-2017/484 Rev. 1
(ORNL/SPR-2018/801)***

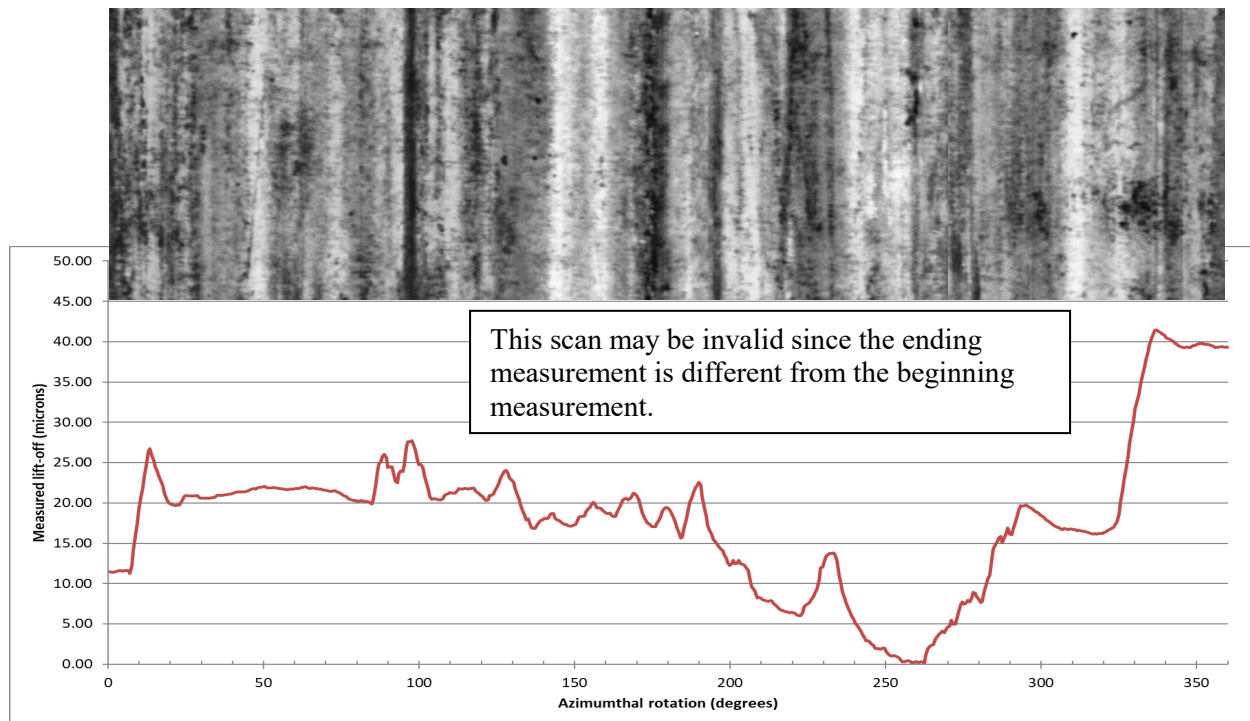
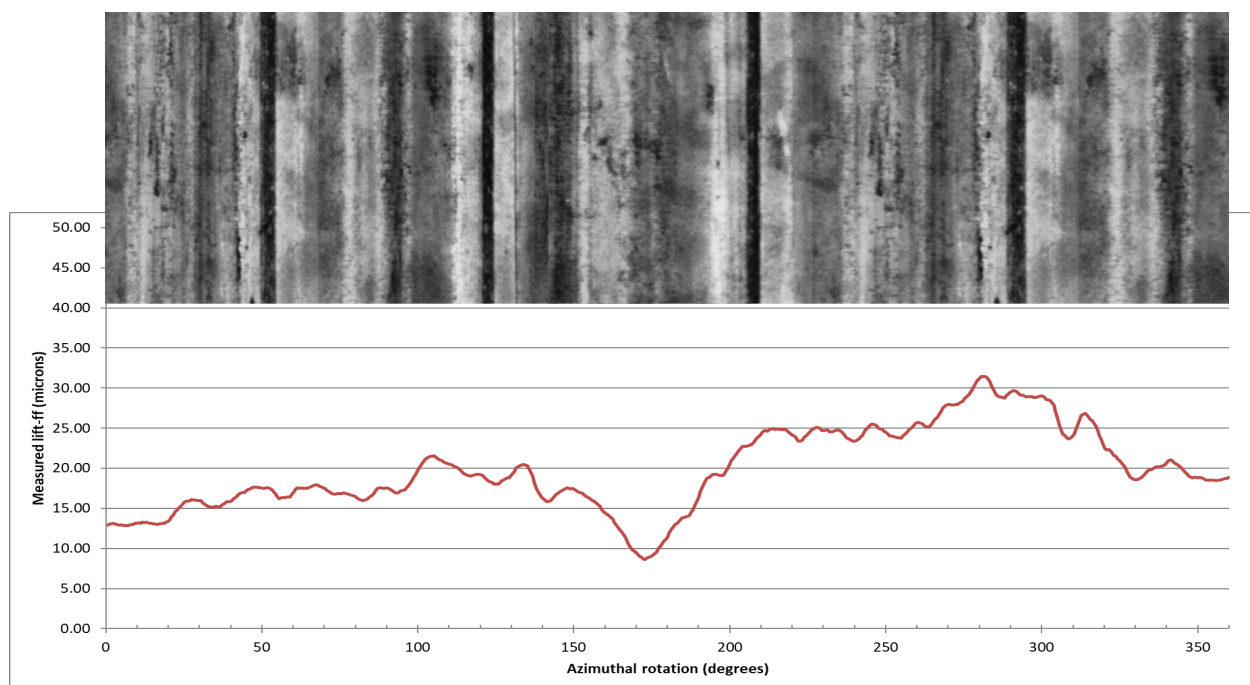
Figure C.61. Rotational Eddy Current Lift-Off Scans of 3F9P02 at 2116 mm (Top) and 307 mm (Bottom).

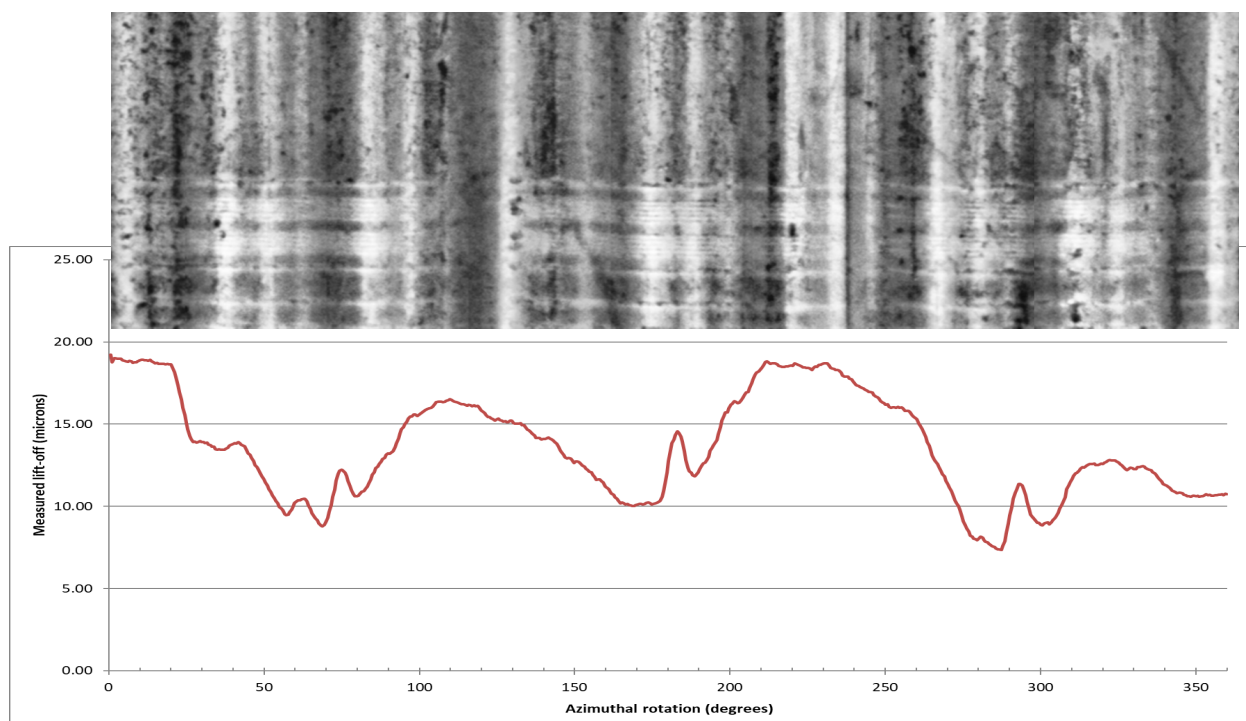
Figure C.62. Rotational eddy current lift-off scan of 3F9P02 at 3835 mm.

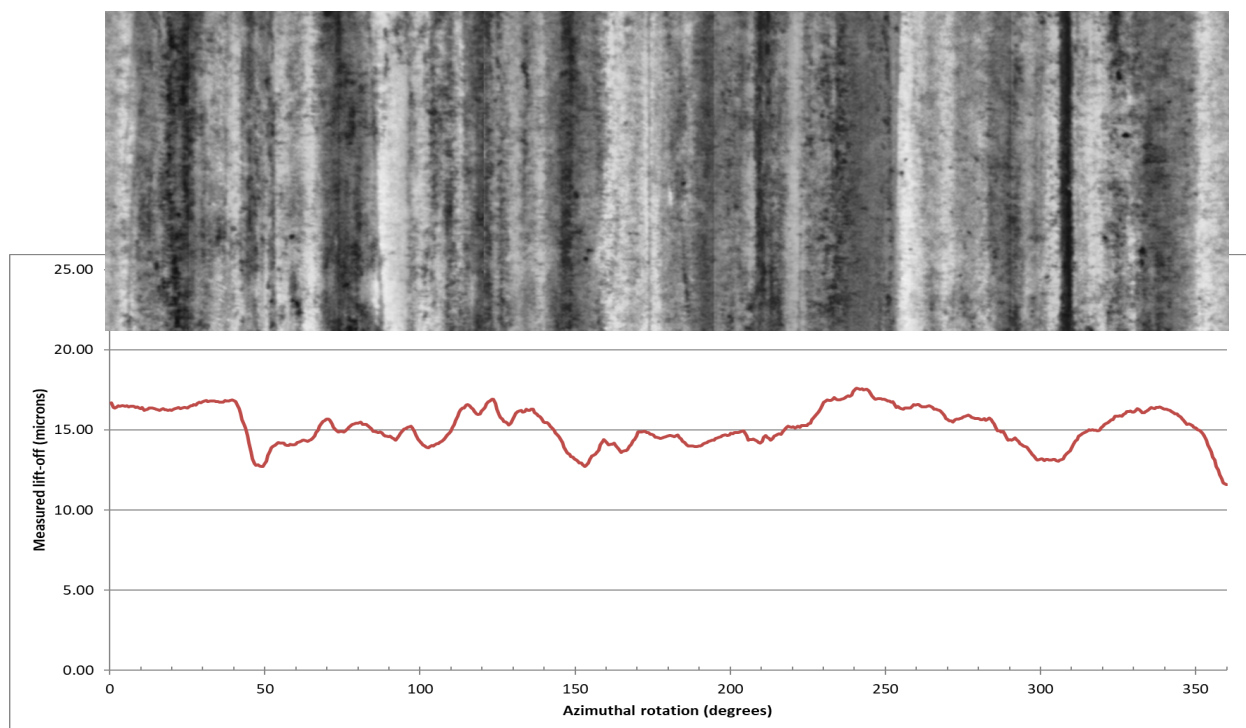
Figure C.63. Rotational Eddy Current Lift-Off Scans of 3F9P02 at 2281 mm (rescan).
