# Laser Line Scan Characterization of Cavitation-Induced Erosion to SNS Mercury Target Vessels

Neutron Technologies Division  
Spallation Neutron Source  
Oak Ridge National Laboratory

**LASER LINE SCAN CHARACTERIZATION OF CAVITATION-INDUCED EROSION TO SNS  
MERCURY TARGET VESSELS**

Date Published: January 2019

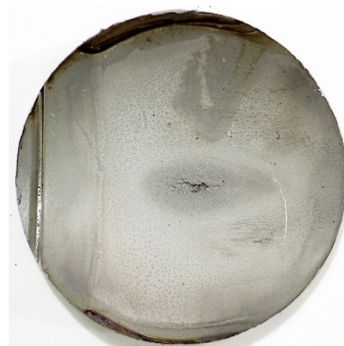
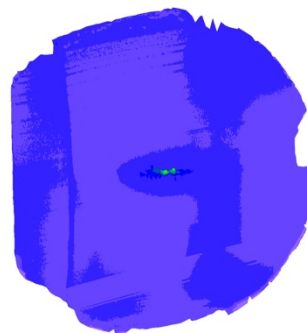
**Target 15/Disk 17**  
(Original Design)

The target management plan was put into place after the leaks in Targets 12 and 13, therefore Target 14 and 15 were the first original design targets operated at fixed powers for a prescribed time period. Erosion patterns on the Disks 13 and 17 samples from Targets 14 and 15 were similar to those observed on Targets 12 and 13, but had a more “comet tail” appearance around the deep-erosion cavities, as shown in Figure 22. It is possible that the same pattern was present on the Target 12 and 13 samples during the early phase of operation, and the dimple-type erosion on around the “comet tail” cavity-type erosion appeared at a later point during operation. The maximum erosion depth was 0.089 in for both Disk 13 and 17 from Target 14, while the maximum erosion depth measured in Target 15 was 0.072 in on Disk 13.

**Figure 22.** Images and erosion plots for Disks 13 and 17 from Targets 14 and 15 (original design).

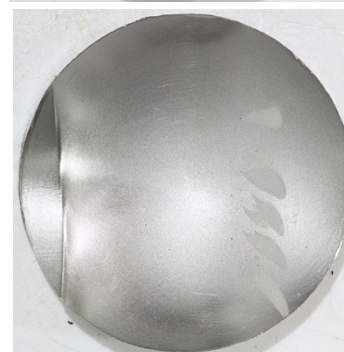
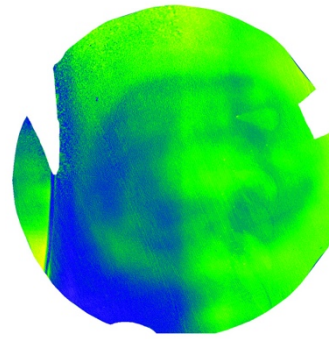
**Target 19/Disk 17**  
(Jet-flow Design)

Targets 18 and 19 were the first two SNS targets to operate with small-bubble gas injection, which reduced the erosion damage to the inner wall, as shown earlier in Figure 12. Images of the Disk 13 and 17 samples from these two targets showed some areas with a dull-finish discoloration, areas where the surface finish was not shiny, but no obvious regions of erosion were observed. The laser scan results verified that very little erosion damage occurred to the Disk 13 and 17 specimens from Targets 18 and 19. Images and plots of the material removed from Disks 13 and 17 removed from Targets 18 and 19 are shown in Figure 24.

**Figure 24.** Images and erosion plots for Disks 13 and 17 from Targets 18 and 19 (jet-flow design with gas injection).
