Federal Emergency Management Agency Mobile Housing Unit Running Gear Testing: Final Report

**FEDERAL EMERGENCY MANAGEMENT AGENCY MOBILE HOUSING UNIT
RUNNING GEAR TESTING: FINAL REPORT**

Date Published: August 2019

Prepared by
OAK RIDGE NATIONAL LABORATORY
Oak Ridge, TN 37831-6283
managed by
UT-BATTELLE, LLC
for the
US DEPARTMENT OF ENERGY
under contract DE-AC05-00OR22725

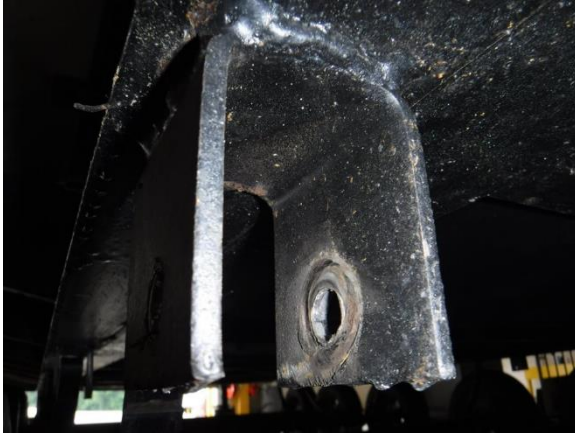
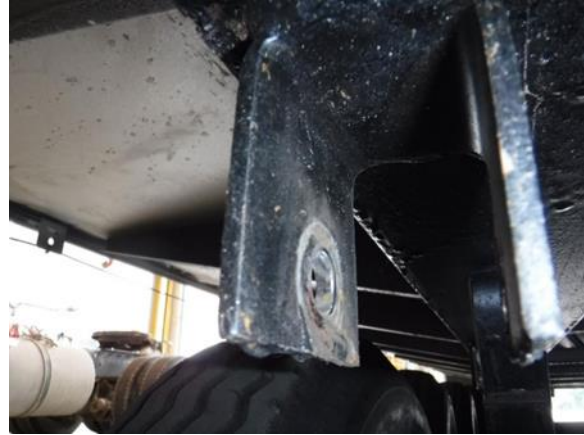
Figure 20. Distorted and Chaffed Spring Hangers.

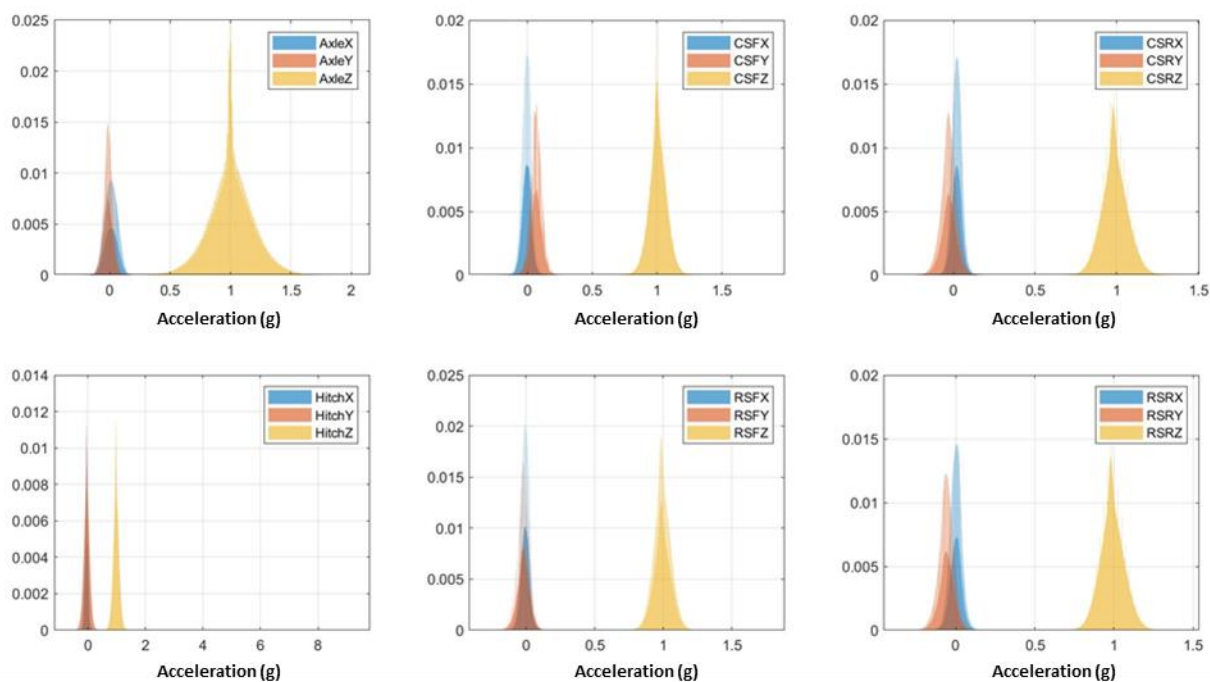
Figure 28. Baseline Unit Acceleration Distributions (x = Longitudinal, y = Lateral, z = Vertical).

These plots revealed some minor zeroing issues with a few of the Y-axis sensors (in red) at the curbside front (top center), curbside rear (upper right), and roadside rear (lower right). The other acceleration reading(s) distributions were as expected. The widest range of accelerations was observed along the Z axis, as expected, with the most extreme accelerations observed at the hitch. Adjustments to the sensors that needed zeroing were made before the start of the Longevity Testing phase.

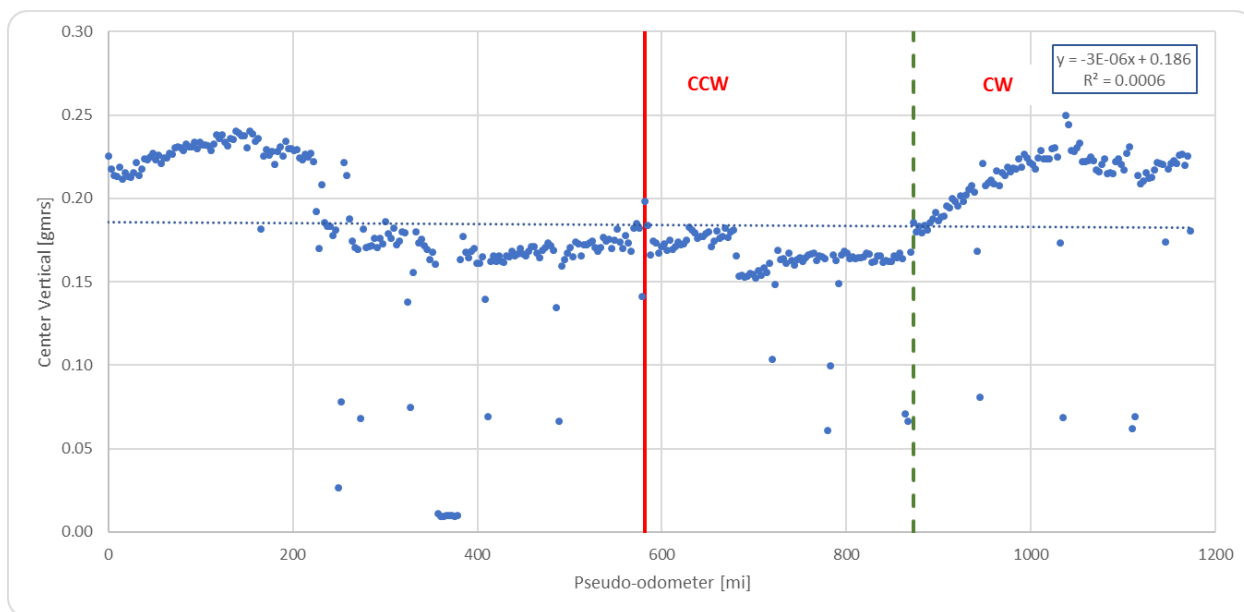
Figure 30 shows an oscillating behavior of the vertical GRMS measure corresponding to the direction of travel (clockwise—CW—or counter-clockwise—CCW). The Baseline Unit did not show a similar behavior in day 1. However, on day 2 it looked as if the Baseline Unit had developed the same behavior as the Upgrade Unit (compare Figure 30 and Figure 31 for day 1 and day 2). This observation triggered an inspection of the Baseline Unit, focusing on the alignment of the axles. Although no problems were found, the decision was made to replace the tires (since the Upgrade Unit would also get new tires with the newly installed axles) and run a small test of 20 laps to determine whether the problem persisted.

Figure 30. Upgrade Unit – GRMS for Vertical Accelerometer at Axle Group (Center).

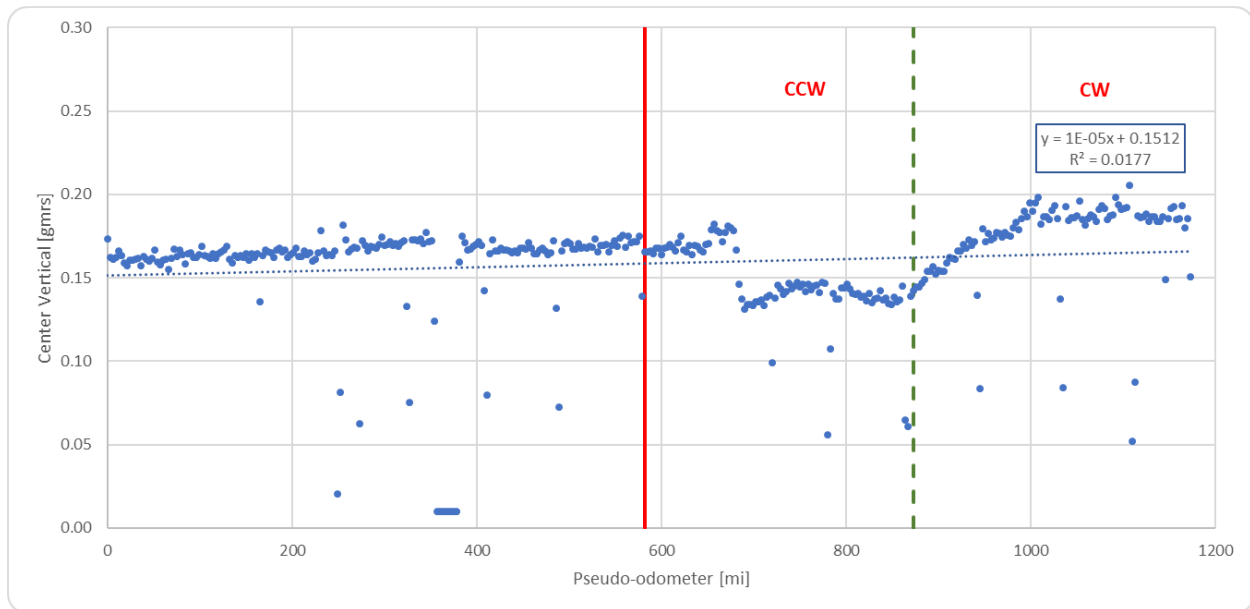
Figure 31. Baseline Unit – GRMS for Vertical Accelerometer at Axle Group (Center).

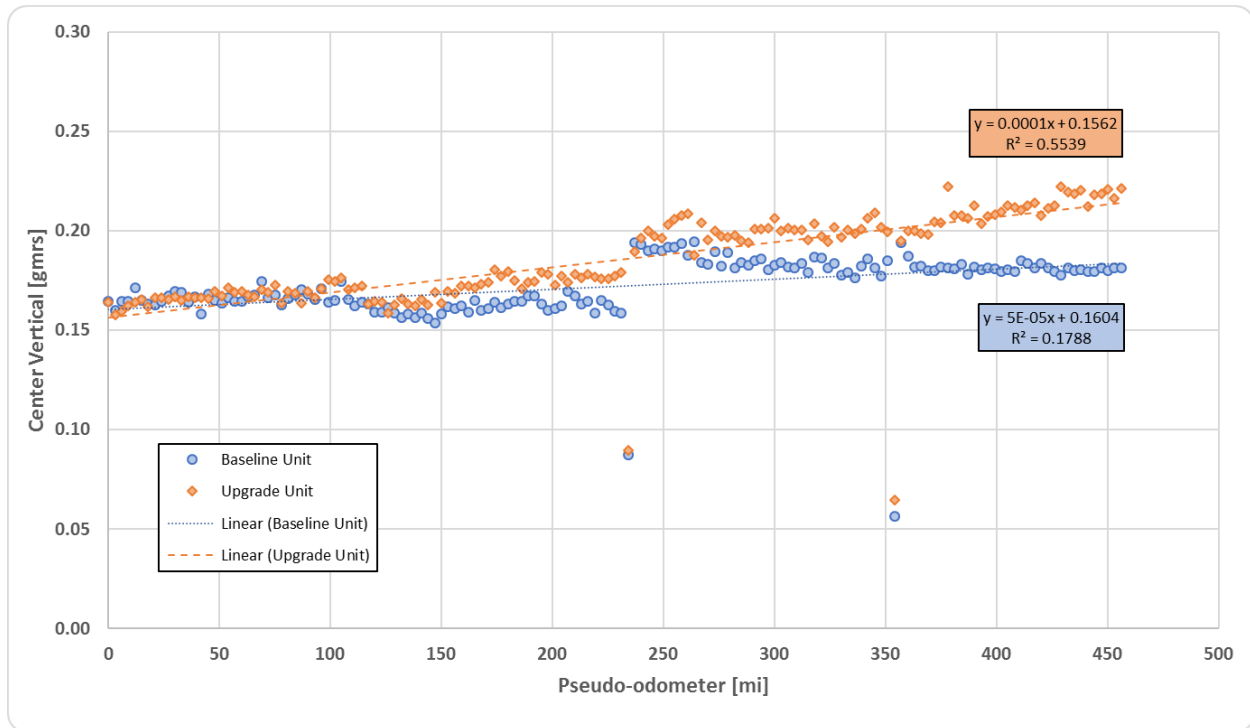
Figure 34, as well as all the graphs presented below, also shows a linear fit of the data to give an idea of the general trend of the vibrations identified by the accelerometers. In this case, it is evident that the Upgrade Unit showed larger GRMS values than the Baseline Unit for any given lap. The reason for this

was later on attributed to the identified “out-of-square” wheel-end to axle tubes of the Upgrade Unit as discussed in APPENDIX B, which was a manufacturing error at the axle manufacturer.

Figure 34. Part B Day 2 – Baseline and Upgrade Units GRMS for Vertical Accelerometer at Axle Group (163 Laps).

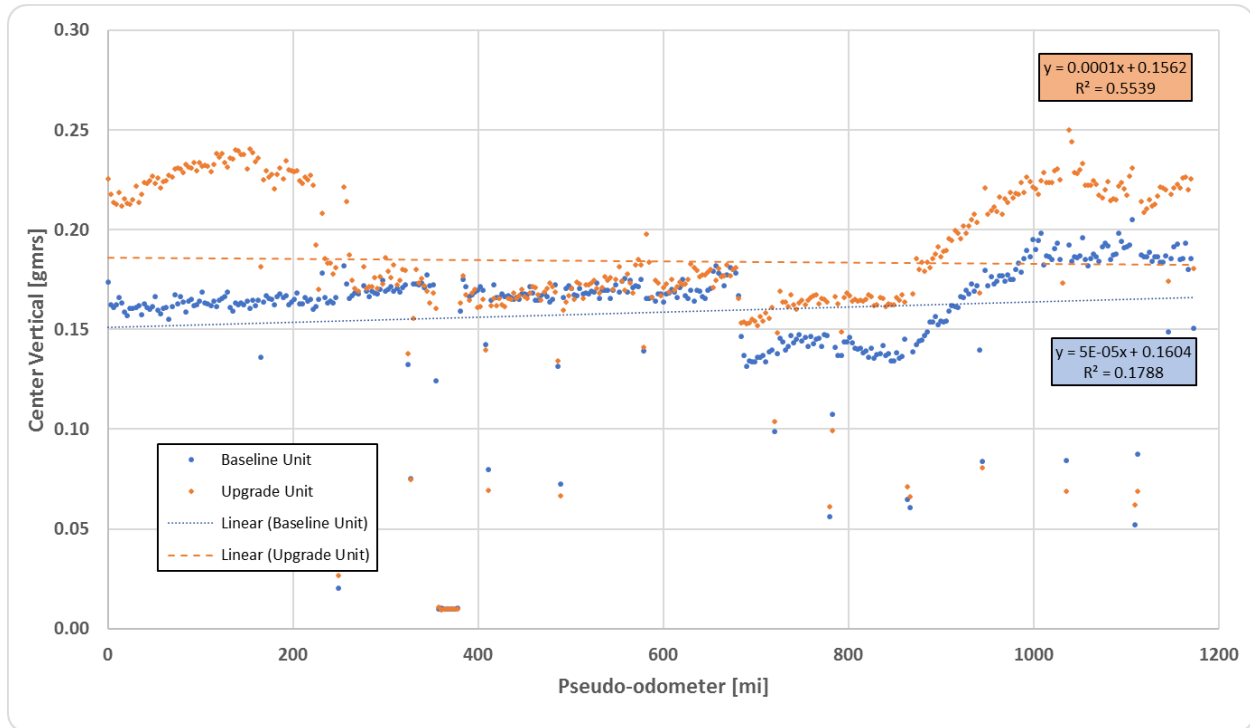
Since the data collection systems and procedures were working according to plan, Part C of the testing (i.e., the main testing regime) started on July 27, 2018. During the first day, 194 laps were run (567 miles), and on the second day of Part C, another 198 laps (599 miles) were completed. The data is presented in Figure 35. As in Part B, the Upgrade Unit showed significantly larger GRMS values for each lap compared to the Baseline Unit. Moreover, during these two days the tire failures of the Upgrade Unit started to grow disproportionately. It was then decided to stop the test and investigate whether there were any apparent reasons for the increase in tire failures. It was then discovered that some of the Upgrade Unit axle wheel-ends were “out-of-square” (see APPENDIX B for more details).

Figure 35. Part C1 (Days 1 and 2) – Baseline and Upgrade Units GRMS for Vertical Accelerometer at Axle Group (Center) 163 Laps.

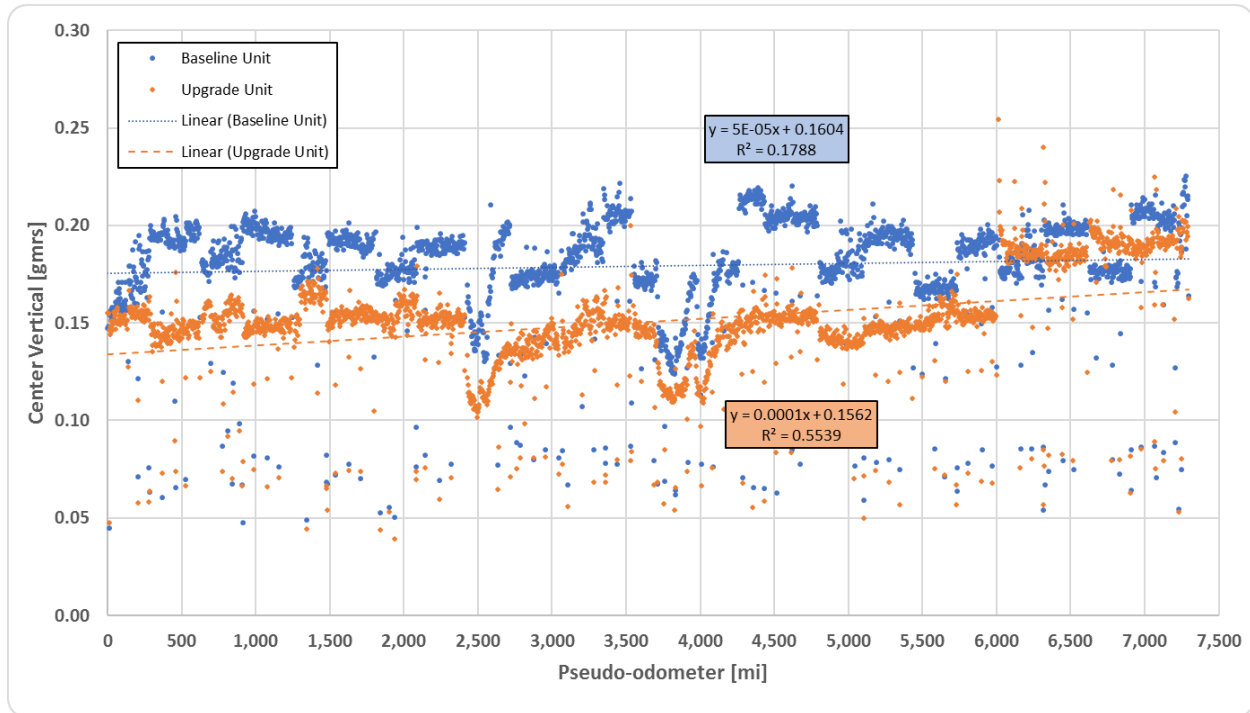
The data collected while running these 2,411 laps is presented in Figure 36, while summary statistics are shown in Table 11. As expected, (and contrary to what was observed in Parts A, B, and C1), in Part C2, the Upgrade Unit showed significantly lower GRMS values compared to the Baseline Unit for almost 100% of the laps run. At the end of the test, there was a slight degradation in the performance of the Upgrade Unit in terms of the vibrations transmitted to the MHU by the transportation system the as shown in the figure. However, the Upgrade Unit still presented lower GRMS values than the Baseline Unit, except during the next-to-last day of Part C2 test (October 15, 2018).

Figure 36. Part C2 – Baseline and Upgrade Units GRMS for Vertical Accelerometer at Axle Group (Center) 2,411 Laps.

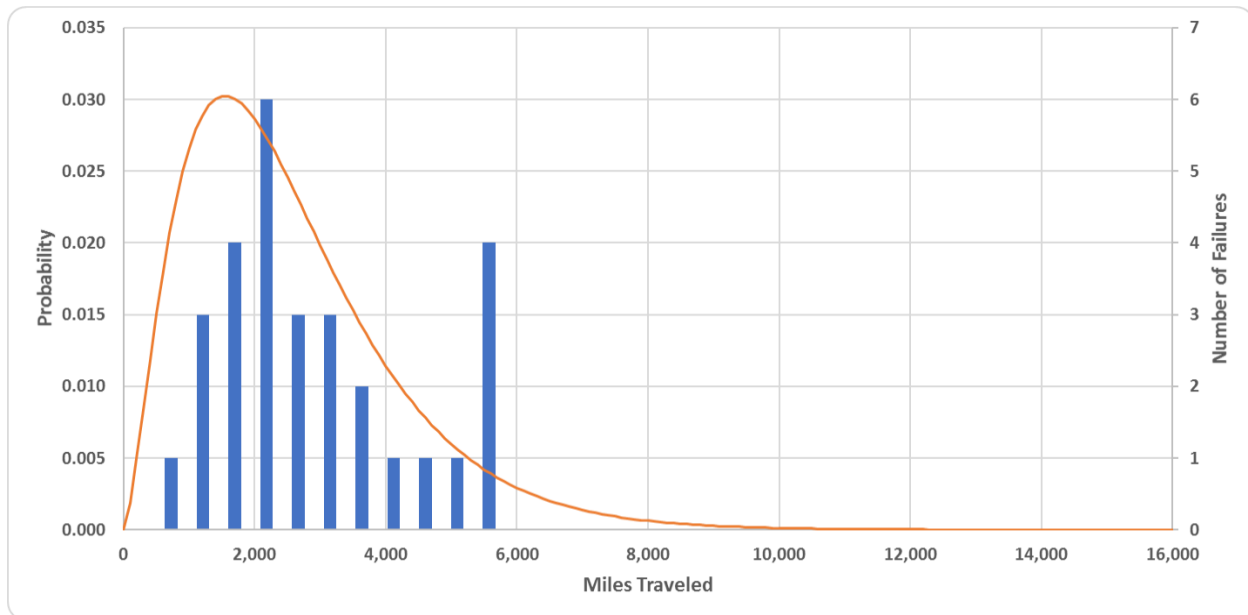
Since information regarding the life of the tires that failed was collected during the test (i.e., the distance traveled by that tire from its new status until it failed) it is possible to build a probability density function that shows how the number of component failures are distributed over distance traveled. The distribution shown in Figure 38 was built with the data presented in Table 15 using 500-mile bins for the histogram. The probability density function (shown as a continuous line in the figure) is the curve that results as the bin size approaches zero, and this density function has been normalized so that its area is equal to 1 (i.e., 100%). In other words, the histogram shows the number of failures per bin, while the probability density function is scaled to show the probability of failure per distance traveled. Using that curve, for the 1,800-mile trip used in the example above, it is expected that 40% of the tires would fail before 1,800 miles, and therefore 60% are expected to last at least 1,800 miles.

Figure 38. Baseline Unit Tire Failure Histogram (500mile Bins) and Fitted Probability Density Function.

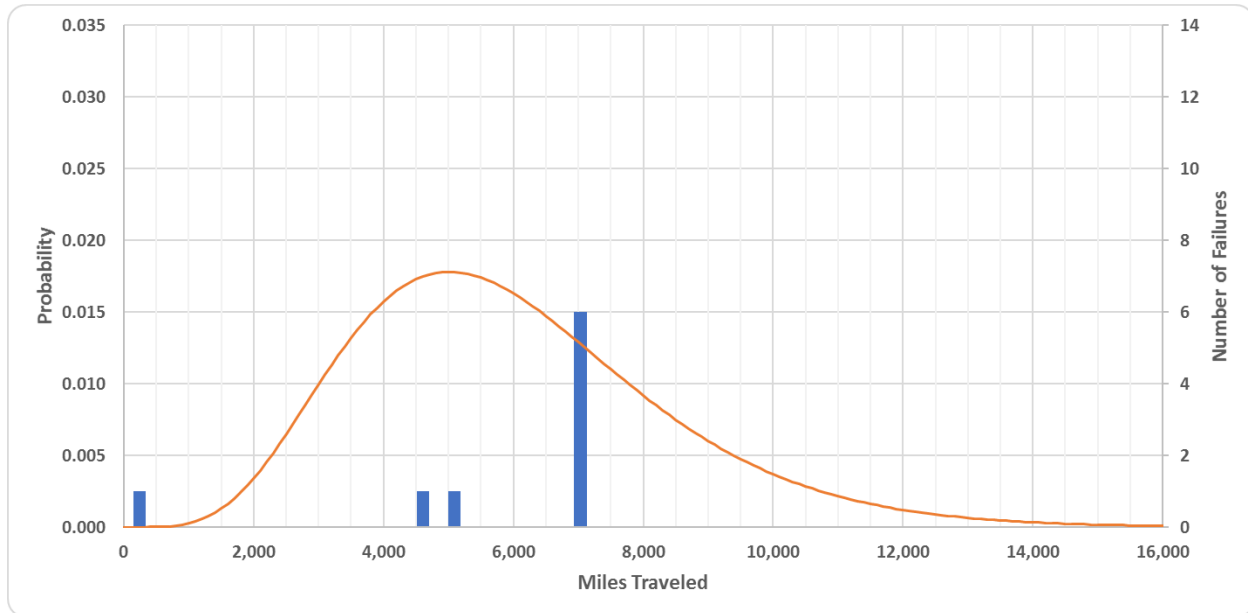
For example, under the tested conditions, and with the observed failure rates, for a 1,800-mile trip about two tire failures are expected to occur. A similar MHU without the correct installation of the transportation hardware would be expected to show 12 tire failures for that same trip. Not only would the additional ten tire failures increase the transportation cost (since ten additional stops would be required to replace these failed tires with new ones), but also the delivery time of the unit would be much longer. As in the case of the Baseline Unit, a probability density function that shows how the number of component failures are distributed over distance traveled was built using information regarding the life of the tires that failed. This distribution, shown in Figure 39, was built with the data presented in Table 17 using 500-mile bins for the histogram. It is presented here for completeness, but since so few tire failures were observed for the Upgrade Unit during the test, this probability distribution has much more uncertainty than the one built for the Baseline Unit (see Figure 38). The probability density function (shown as a continuous line in the figure) is the curve that results as the bin size approaches zero, and it has been normalized so that its area is equal to 1. In other words, the histogram shows the number of failures per bin, while the probability density function is scaled to show the probability of failure per distance traveled. Using the probability density function (shown as a continuous line in the Figure 39), for the 1,800-mile trip used in the example above, it is expected that 1.1% of the tires would fail before 1,800 miles, and therefore 98.9% are expected to last at least 1,800 miles.

Figure 39. Upgrade Unit Tire Failure Histogram (500mile Bins) and Fitted Probability Density Function.

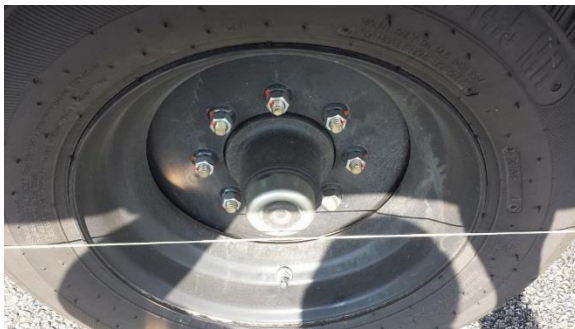
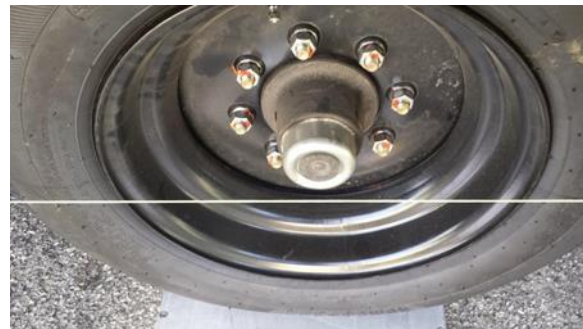
When NPG examined the Upgrade Unit suspension and tires, they found several misalignment issues. First, they stretched a string along the tires on the left side. With the string touching the sidewall on front and rear tires (forward of the rim and rearward of the rim), there were no gaps between string and sidewall on any other tires (see Figure B- 1). This was an indication that all the tires were square with each other.

Then, they stretched the string along the right side in the same manner and found that the tires all appear to be tipped outward on the front side. The string touched the sidewall on the front or leading edge of the tires, but there was as much as a $\frac{3}{4}$ " gap (Axle 4) between string and sidewall on the rear or trailing edge of the tires. These measurements are presented in Table B- 3.

Figure B- 1. Upgrade Unit Aligned (Left Side) and Misaligned (Right Side) Wheels.

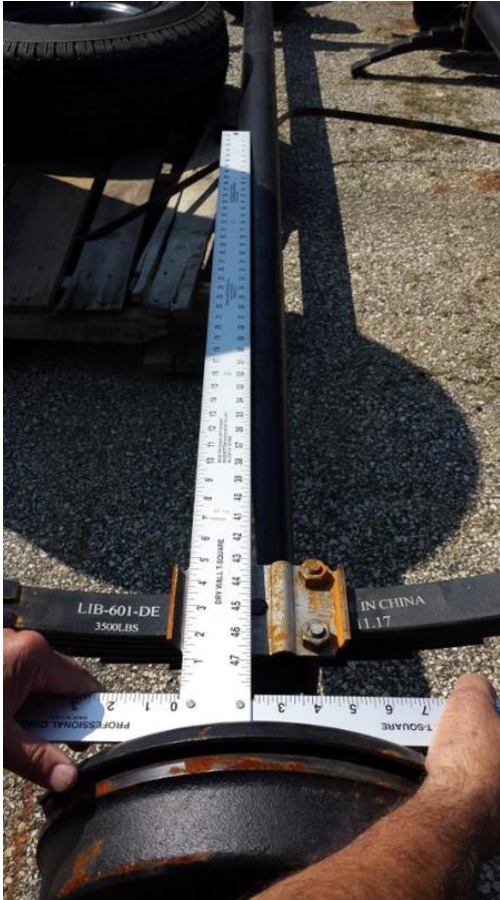
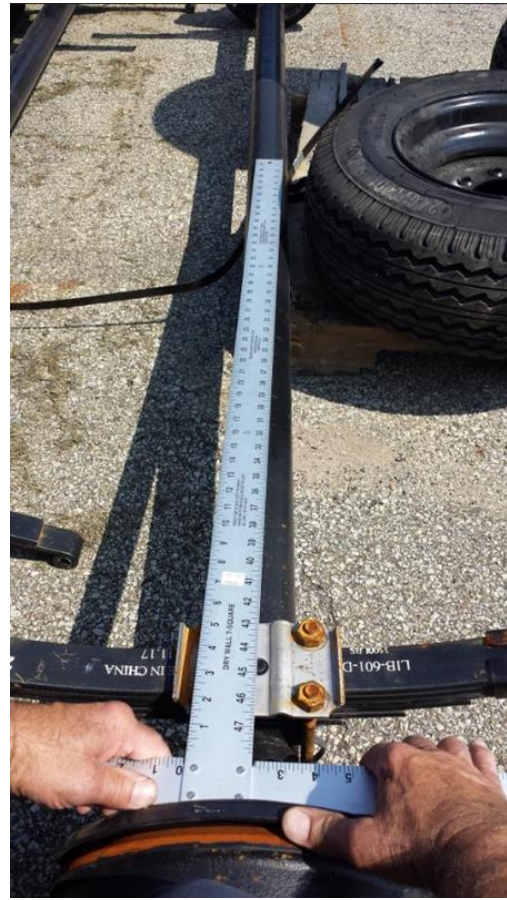
Figure B- 2. Spare-Axle Left Side and Right Side.

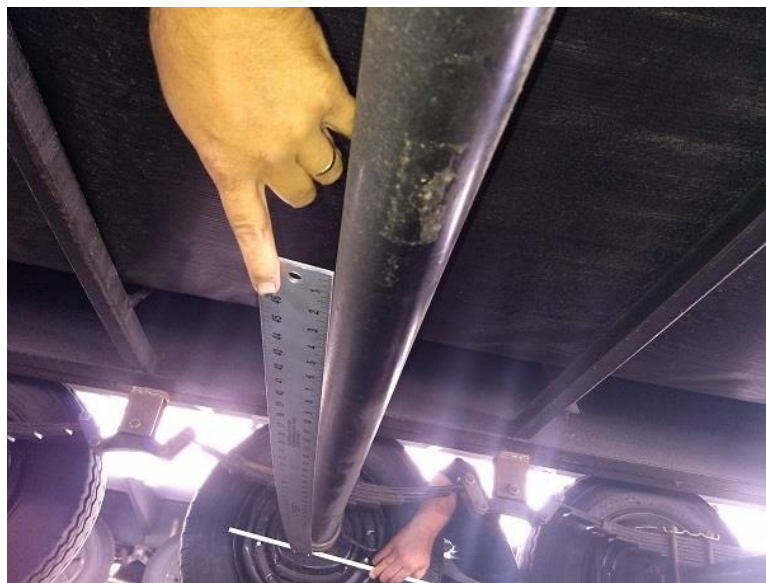
The same procedure was then used on the installed axles with the same results. Figure B- 3 clearly shows that on the right side of axle 4 the packing plate and the axle itself are out-of-square. This was again confirmed once the axles were dismantled (see Figure B- 4).

Twelve of the 7,000-lbs axles that were purchased from Suretrac were deemed defective and new replacement axles were requested from that company. Additional tires were also ordered at that time. With the mounting bolts, equalizers, and other hardware at hand, and the replacement axles and tires, it was decided to reestablish the Upgrade Unit running gear to “as new” condition for restart of testing. It was also decided to replace the equalizers, shackles, and mounting bolts with new ones (but leave the current welded spring hangers in place) before the test was restarted. The rationale for this decision was to eliminate any possible increased wear on those components that might have been caused by the misaligned wheel-ends on the improperly manufactured axles.

Figure B- 3. Upgrade Unit Axle 4 Out-of-Square Packing Plate/Axle.

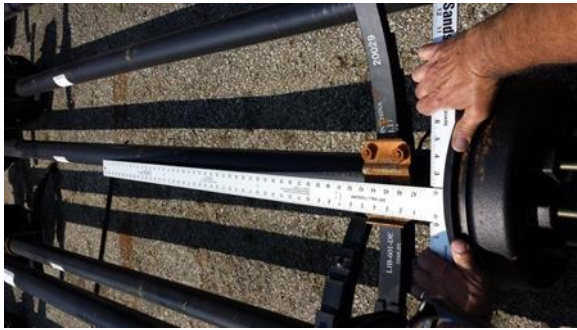
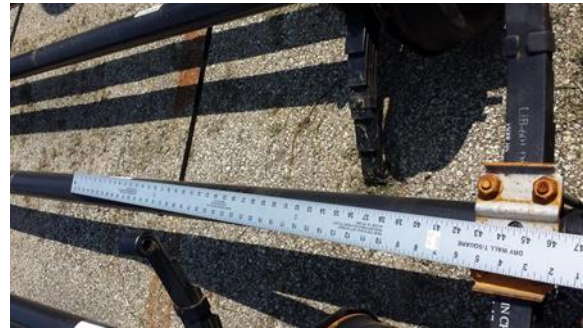
Figure B- 4. Upgrade Unit Perpendicular (Left Side) and Out-of-Square (Right Side) Packing Plates/Axles.

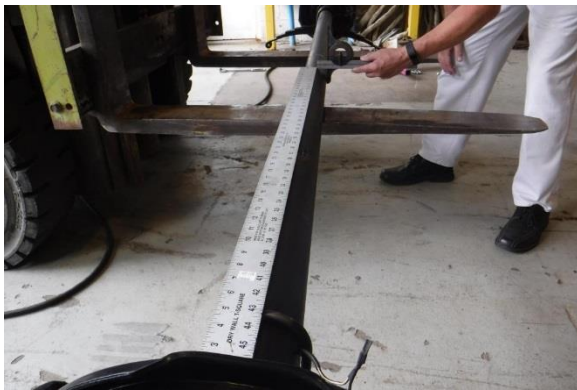
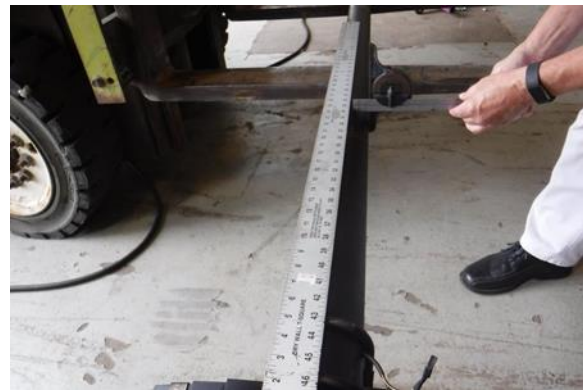
Figure B- 5. Upgrade Unit Perpendicular (Left Side) and Out-of-Square (Right Side) Packing Plates/Axles.

Once all the replacement components arrived at the test site, NPG checked that the new axles were squared. Since that was the case (see Figure B- 5) NPG proceeded to install new upgrade axles on the Upgrade Unit, replacing everything except the hangers.

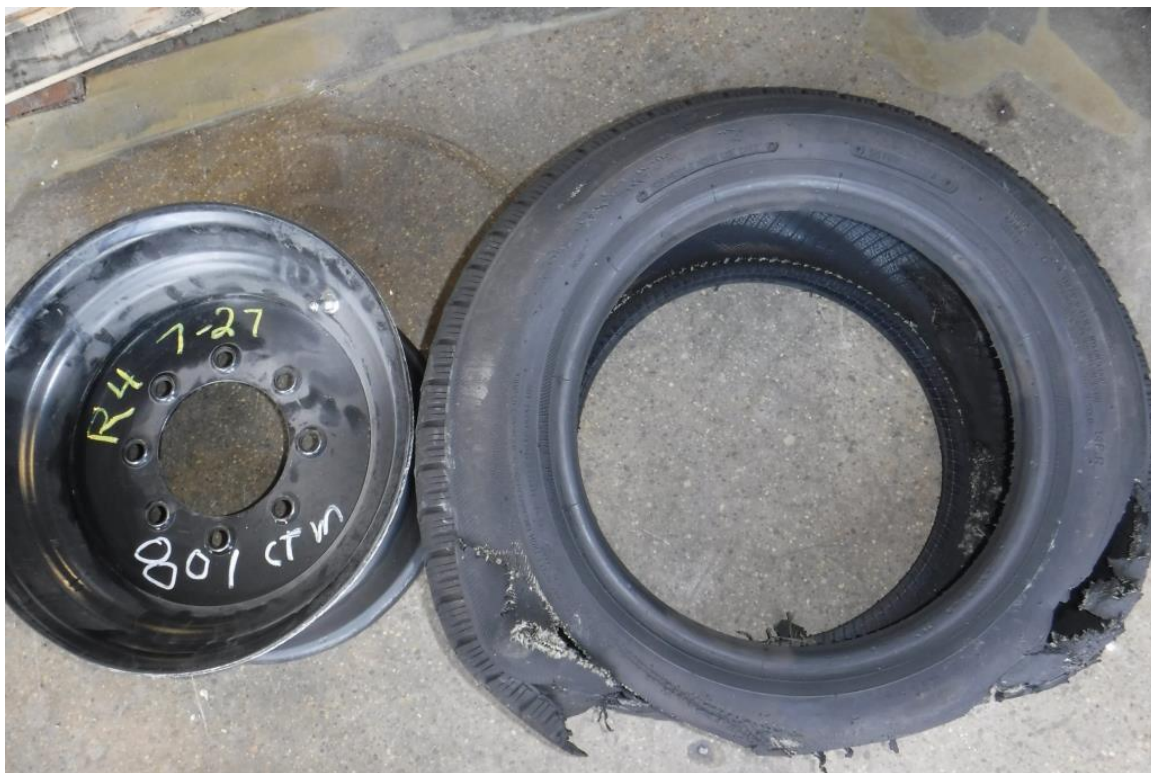
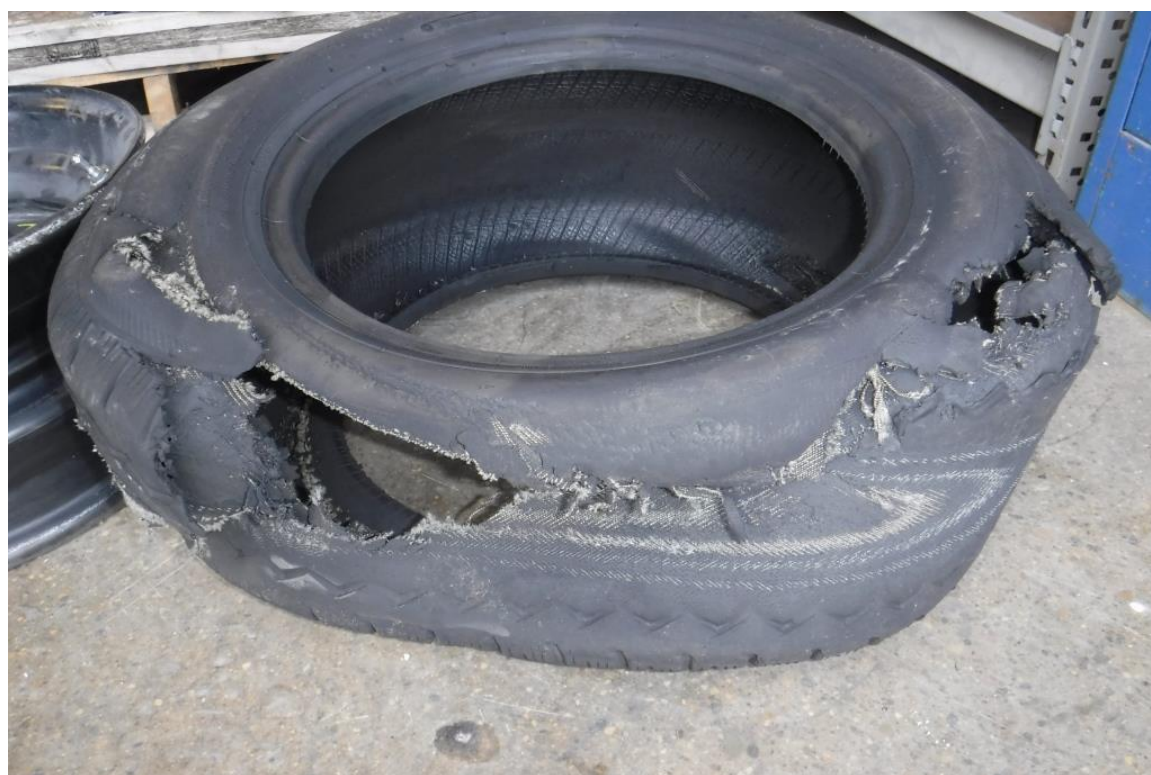
Type of damage: Tire blowout

Location of damage: Axle #4 – Right side tire

Replaced tire & wheel.

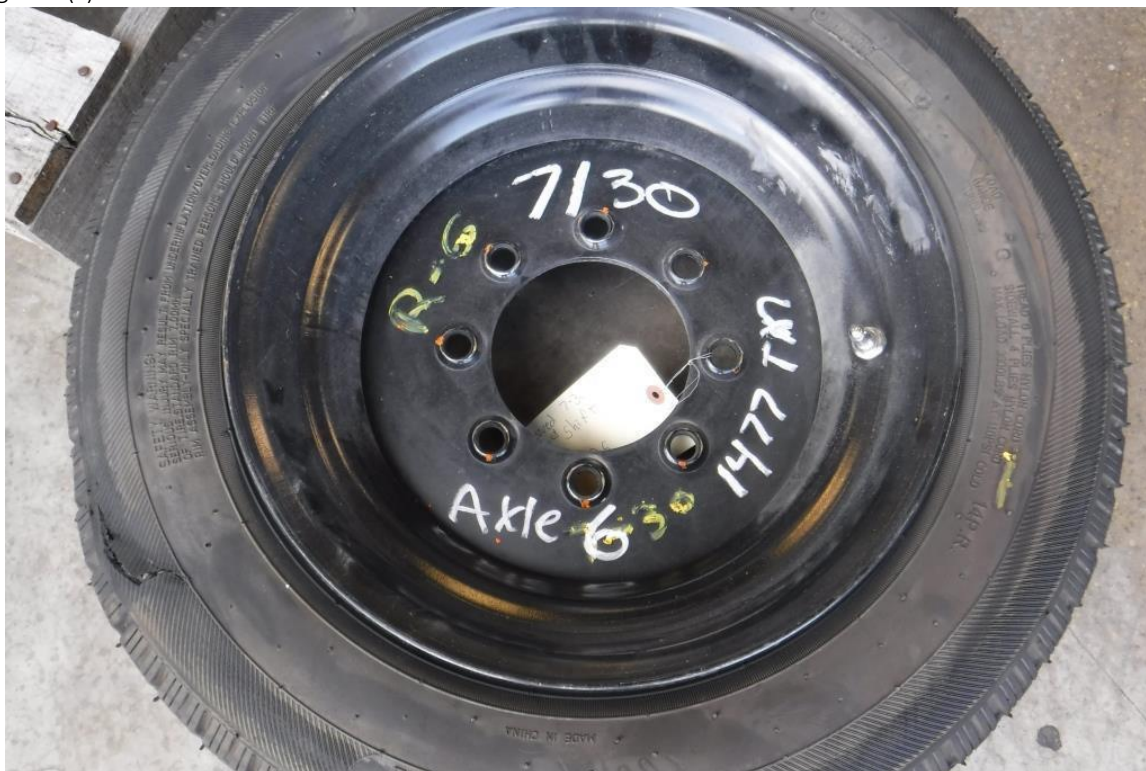
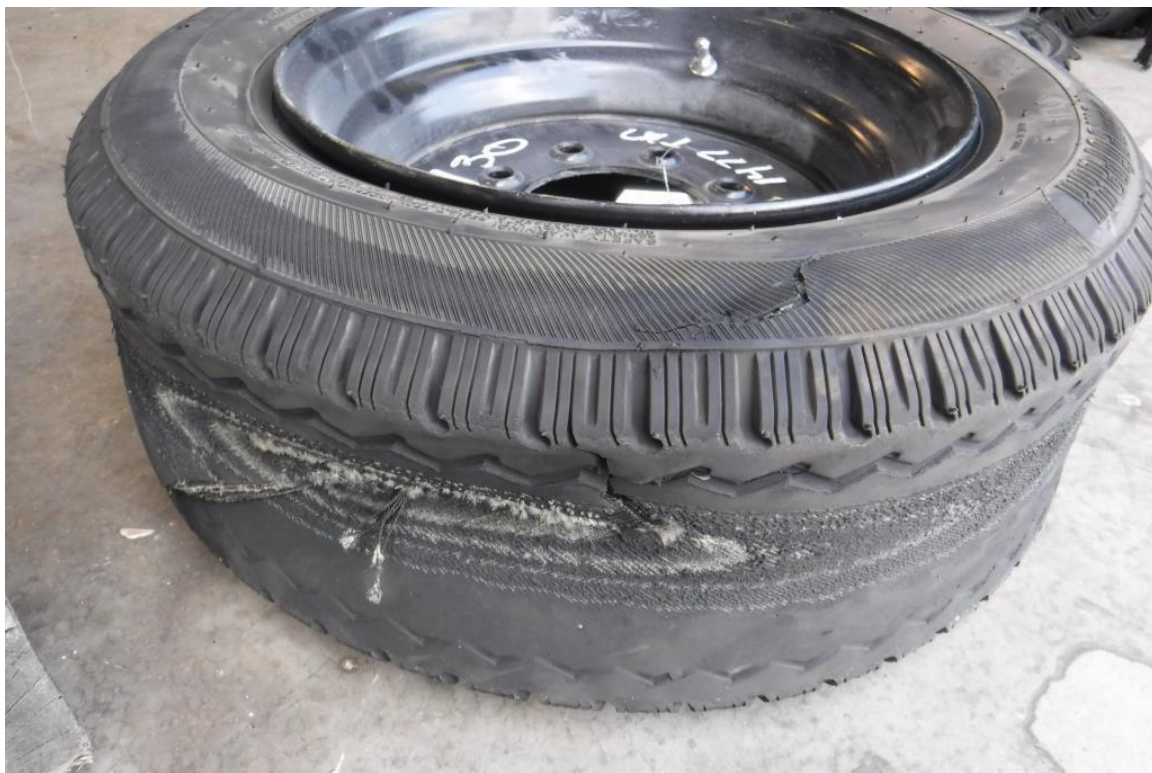
Type of damage: Tire blowout

Location of damage: Axle #6 – Right side tire

Replaced tire and wheel.

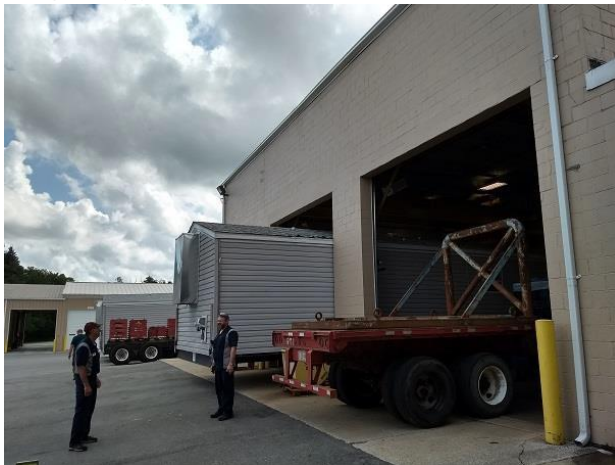
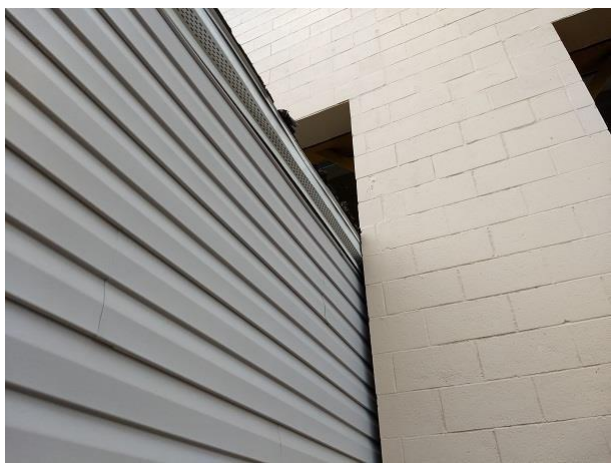
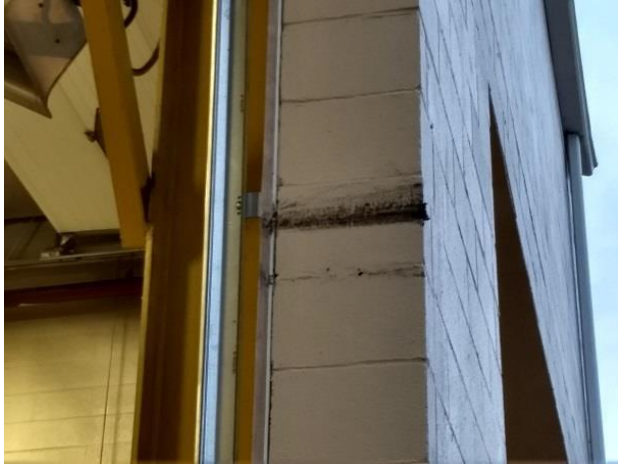
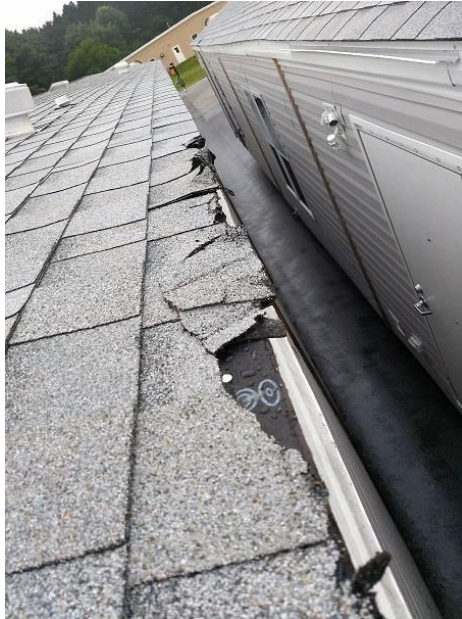
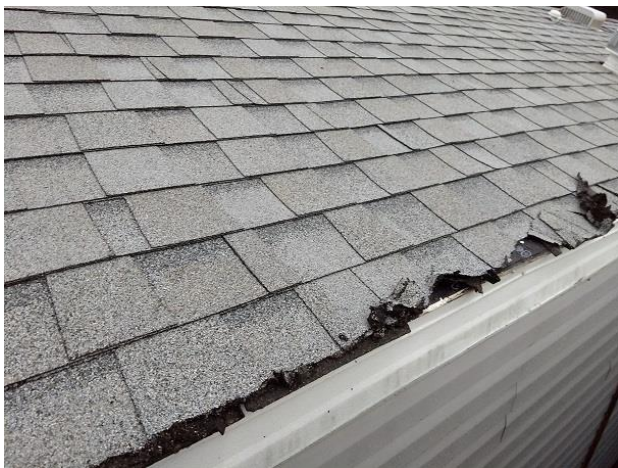
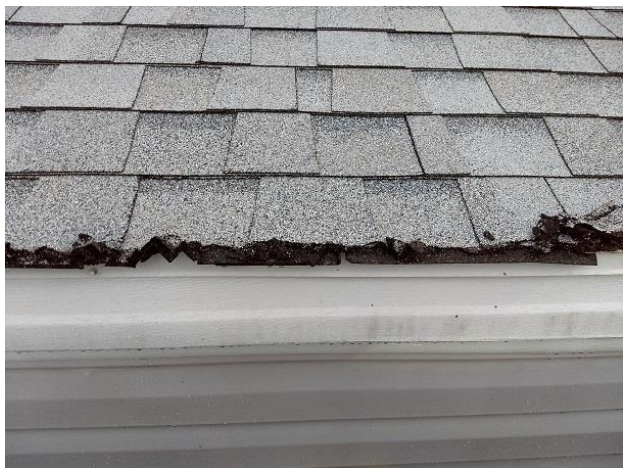
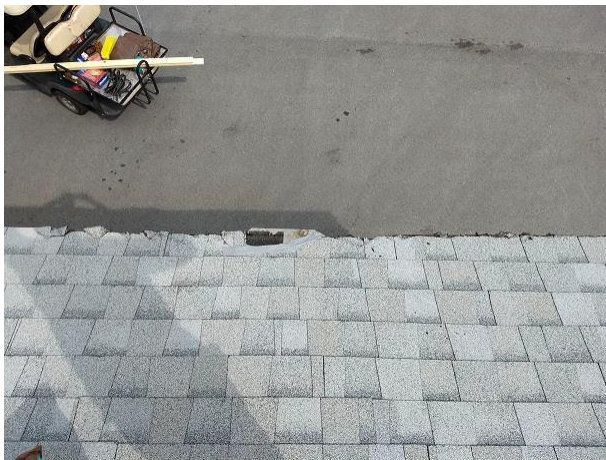
Type of damage: Damage to shingles due to contact with garage door frame.

Location of damage: Curb side of vehicle, outer edge, approximately 20-feet from rear.

1. Contacted FEMA and IBTS regarding incident and repair options. –8/16/18
2. FEMA contacted Champion Homes in Topeka, Indiana to conduct repairs. –8/23/18
3. Navistar purchased materials for use in repairs. Materials approved by FEMA inspector. –8/27/18
4. Champion Homes contractor conducted repairs onsite at Navistar Proving Grounds. –8/27/18.
5. FEMA inspector verbally approved repairs. –8/27/18.

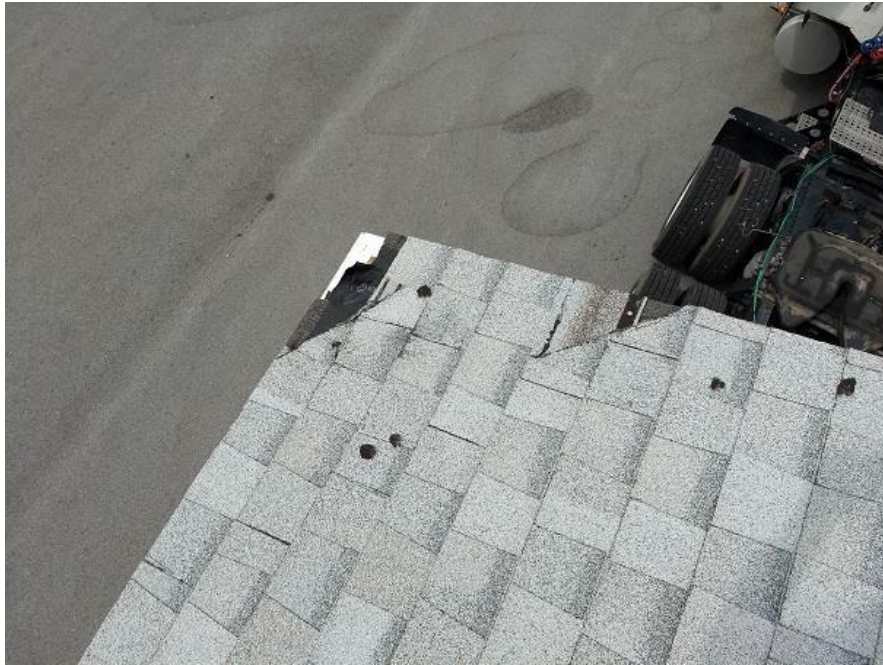
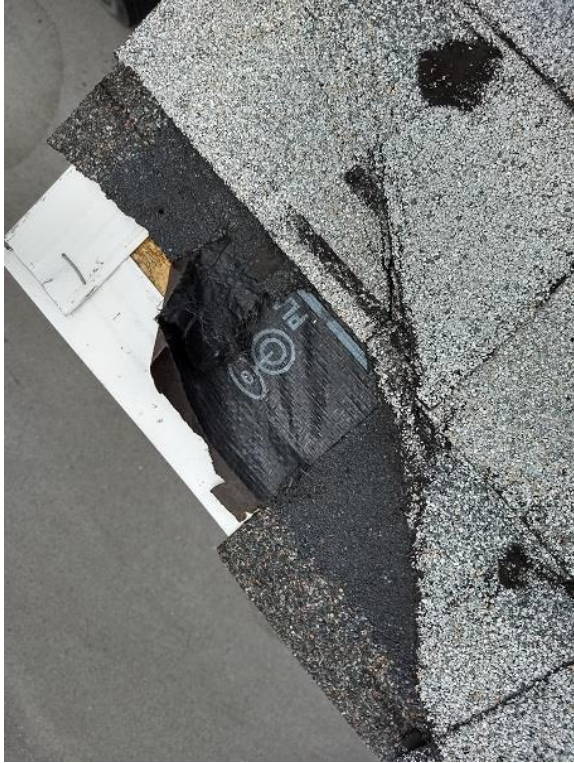
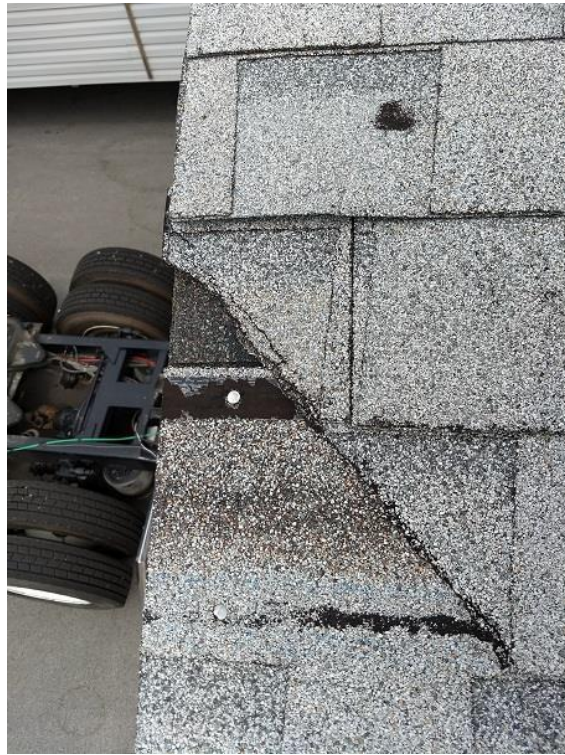
Type of damage: Wind damage to shingles during testing.

Location of damage: Road side of vehicle, forward edge.

1. Contacted FEMA and IBTS regarding incident and repair options. – 8/16/18
2. FEMA contacted Champion Homes in Topeka, Indiana to conduct repairs. – 8/23/18
3. Navistar purchased materials for use in repairs. Materials approved by FEMA inspector. – 8/27/18
4. Champion Homes contractor conducted repairs onsite at Navistar Proving Grounds. – 8/27/18.
5. FEMA inspector verbally approved repairs. – 8/27/18.

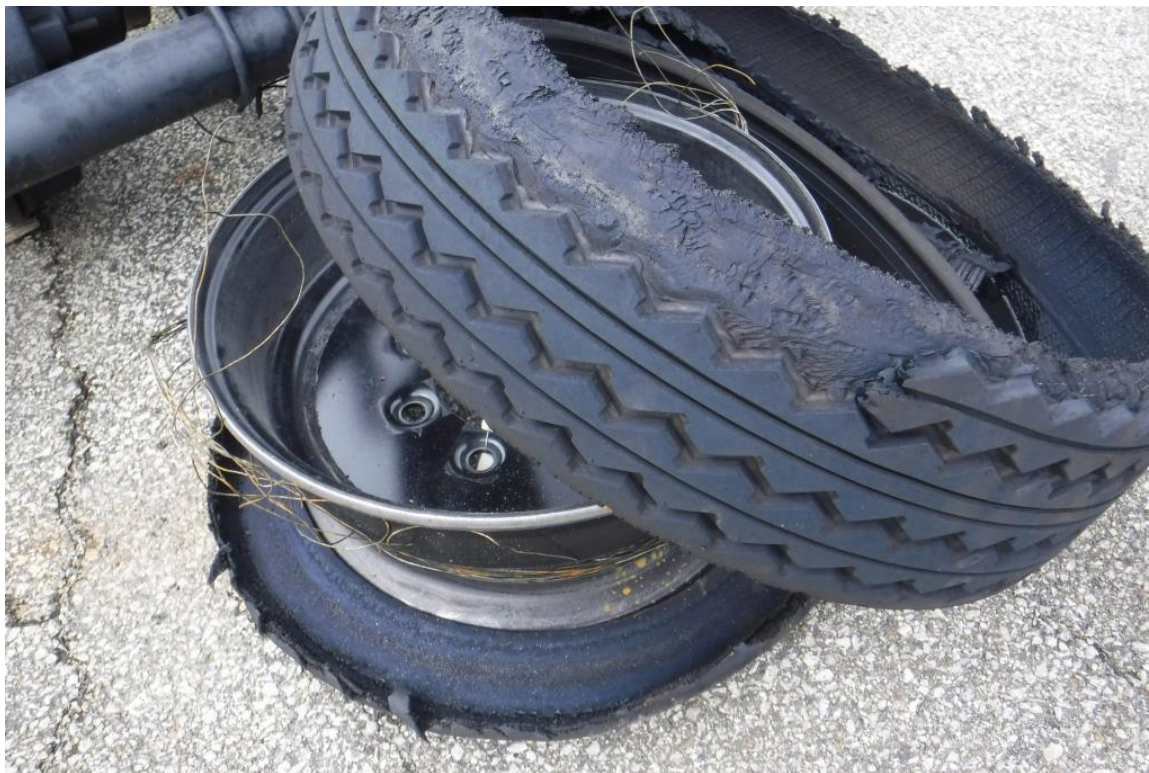
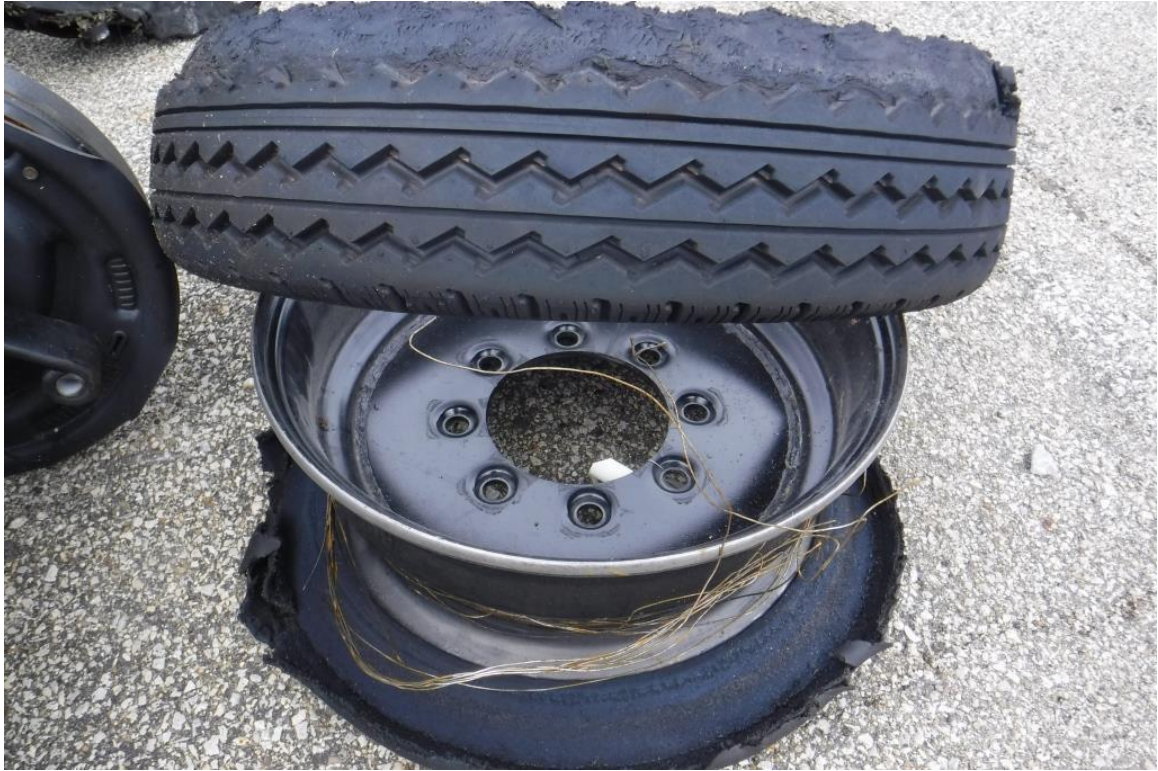
Type of damage: Tire failure – sidewall blowout

Location of damage: #2 axle – left side

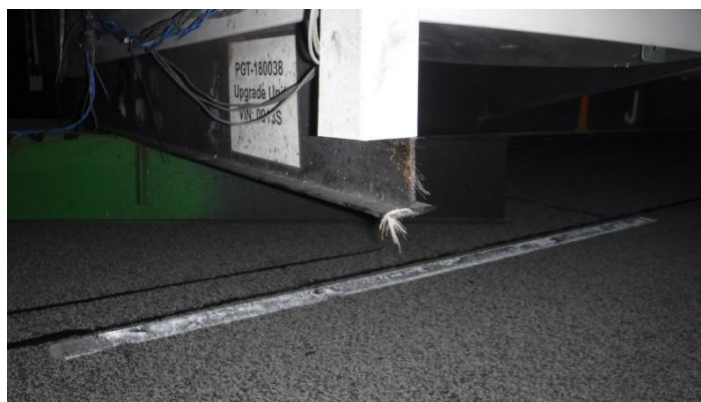
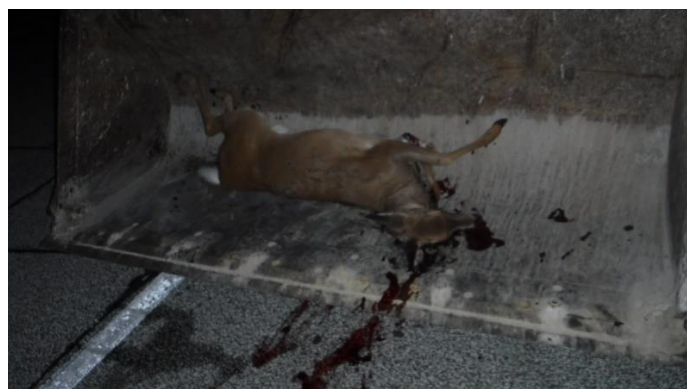
Type of damage: Vehicle struck a deer on the oval track

Location of damage: Front of trailer

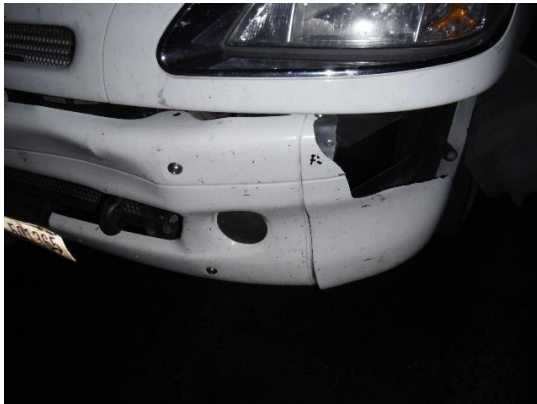
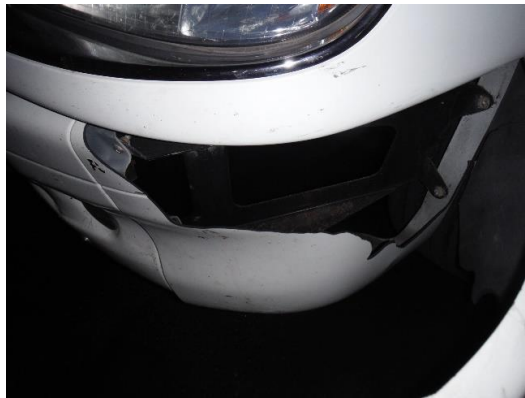
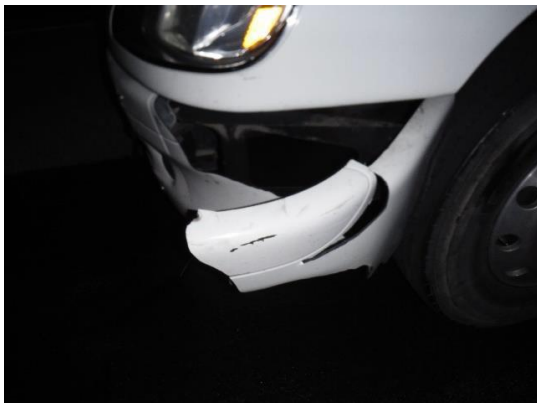
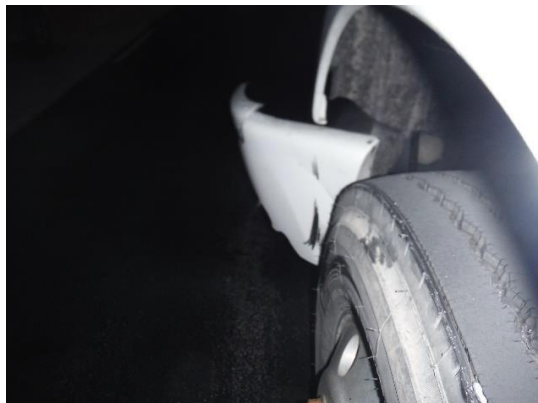
Type of damage: Vehicle struck a deer on the oval track. Destroyed left side bumper fascia.

Location of damage: Front of tractor
