Federal Emergency Management Agency Mobile Housing Unit Running Gear Testing: Final Report

**FEDERAL EMERGENCY MANAGEMENT AGENCY MOBILE HOUSING UNIT
RUNNING GEAR TESTING: FINAL REPORT**

Date Published: August 2019

Prepared by
OAK RIDGE NATIONAL LABORATORY
Oak Ridge, TN 37831-6283
managed by
UT-BATTELLE, LLC
for the
US DEPARTMENT OF ENERGY
under contract DE-AC05-00OR22725

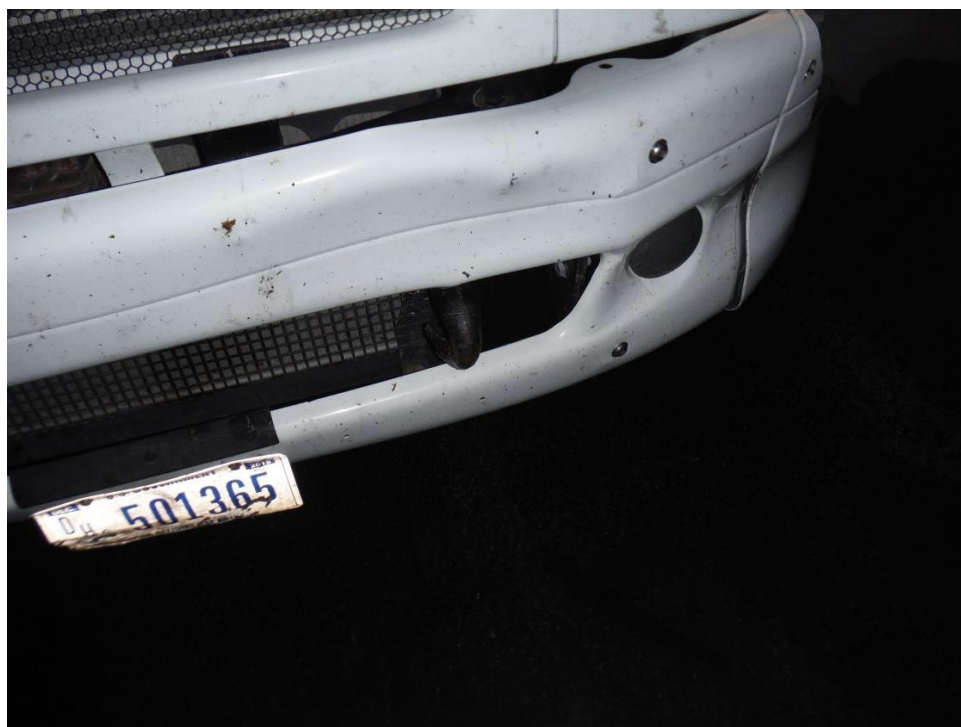
Type of damage: Vehicle struck a deer on the oval track.

Location of damage: Front of tractor
